Proposal Name: Incorporate the Cherokee Park Levee into the Red River below Denison Arkansas, Louisiana and Texas Dam Flood Control Project

Flood Damage Reduction Segment / System Inspection Report

Flood Damage Reduction Segment / System
Inspection Report
Cherokee Park Levee (CHER)

PL 84-99
Initial Eligibility Inspection Report
Cherokee Park Levee
Shreveport, Louisiana

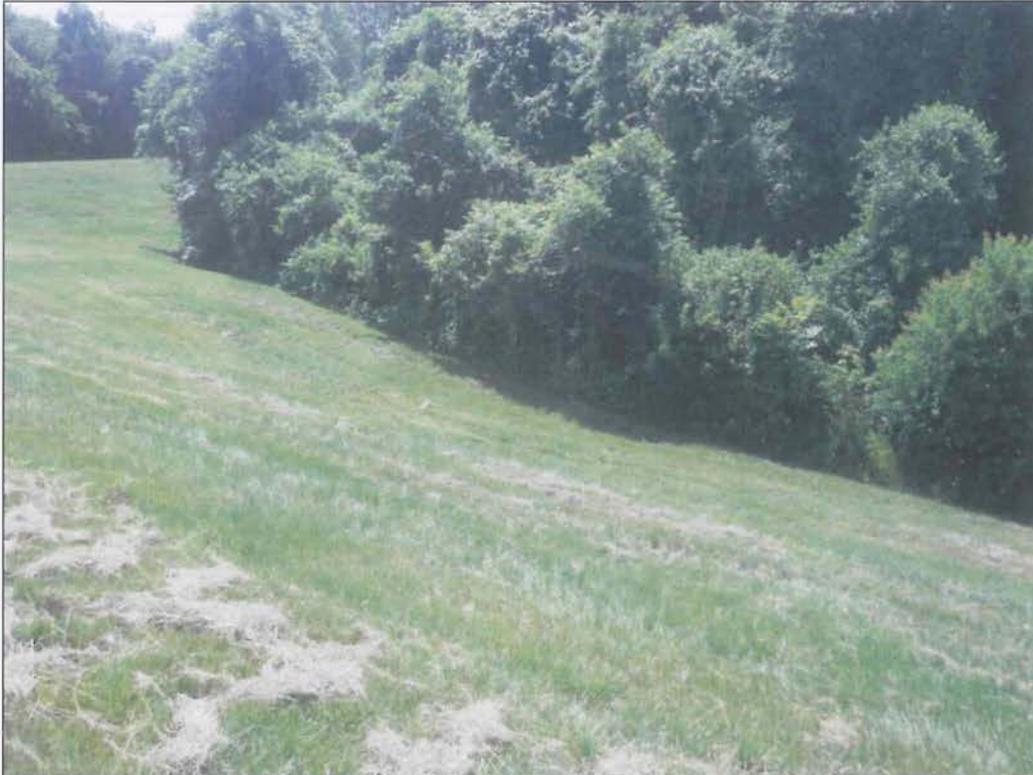
Inspect ID: CHER_2016_a_0002 **Title:** USACE_CEMVK_CHER_2016_a_0002_1.jpg **Rated Item:** 1. Unwanted Vegetation Growth **Caption:** Rating: Minimally Acceptable;
Remarks: Woody growth and trees located within 15' of the landside levee toe.; Station_1: 4+45

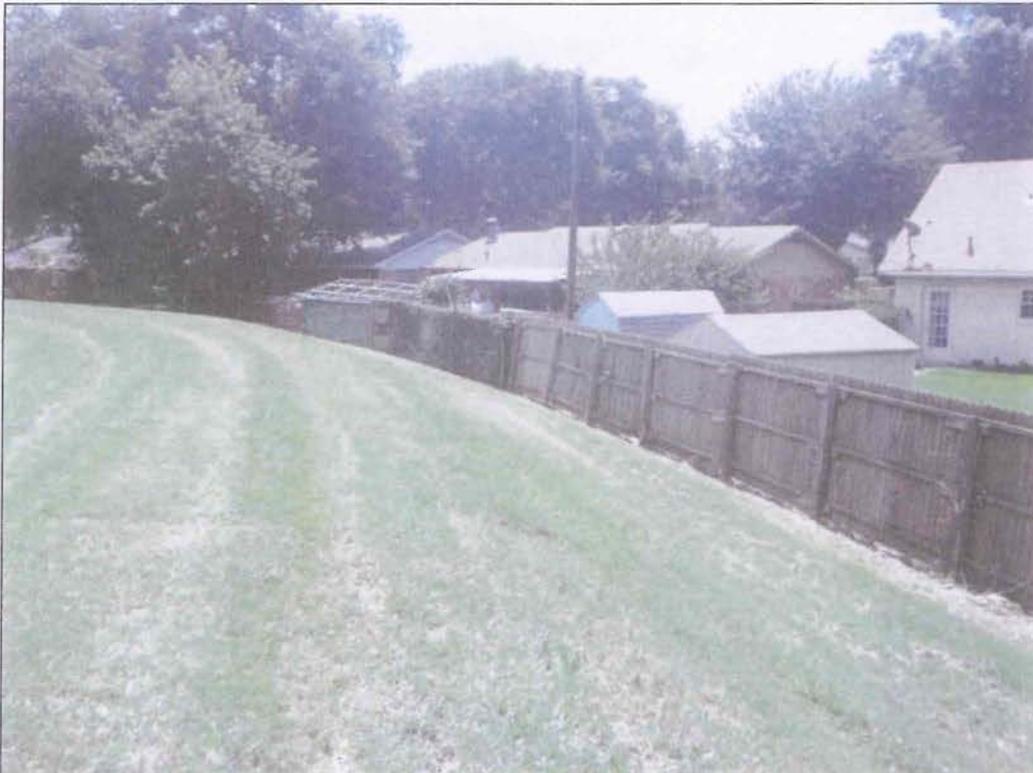
Inspect ID: CHER_2016_a_0011 Title: USACE_CEMVK_CHER_2016_a_0011_1.jpg Rated Item: 3. Encroachments Caption: Rating: Minimally Acceptable; Remarks: Chain link fence, wooden fence, shed, and line of powerpoles located at the landside levee toe.; Station_1: 55+60; Station_2: 60+75

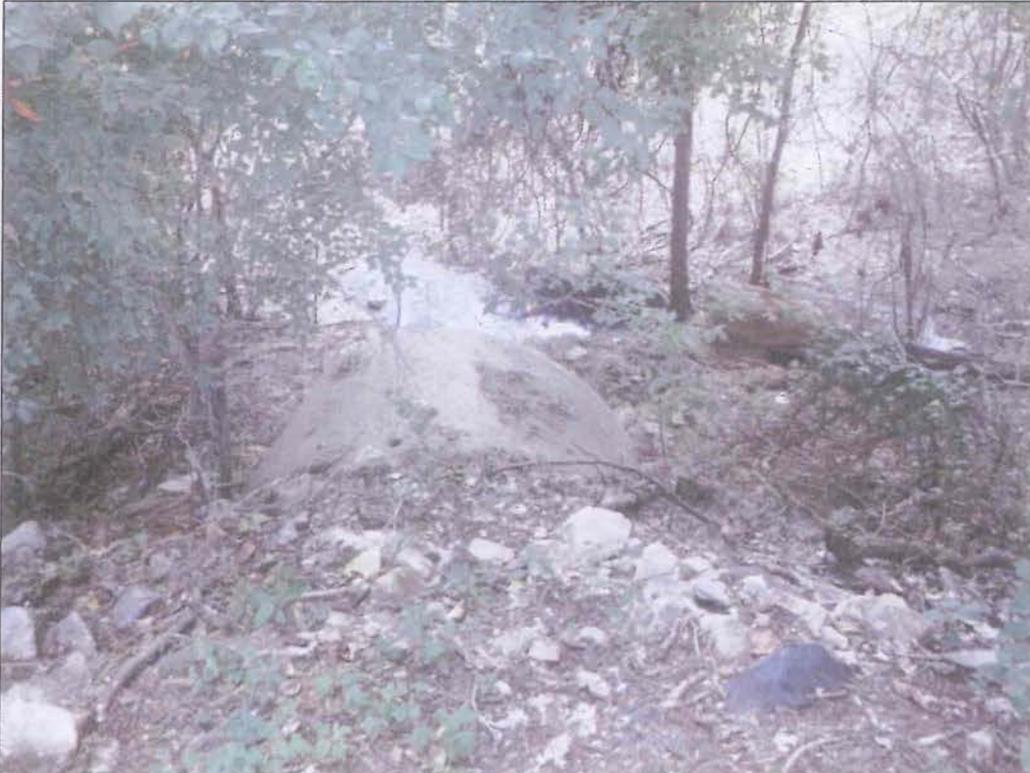
Inspect ID: CHER_2016_a_0021 **Title:** USACE_CEMVK_CHER_2016_a_0021_1.jpg **Rated Item:** 11. Culverts/ Discharge Pipes (This item includes both concrete and corrugated metal pipes.) **Caption:** Rating: Minimally Acceptable; Remarks: Outlet of 72" dia concrete str.. Outlet is free of debris and obstructions and has a positive seal. Other components appears to be in good condition at the time of inspection. Video inspection conducted in 2012. Sponsor has contract to place flap gate.; Station_1: 178+45

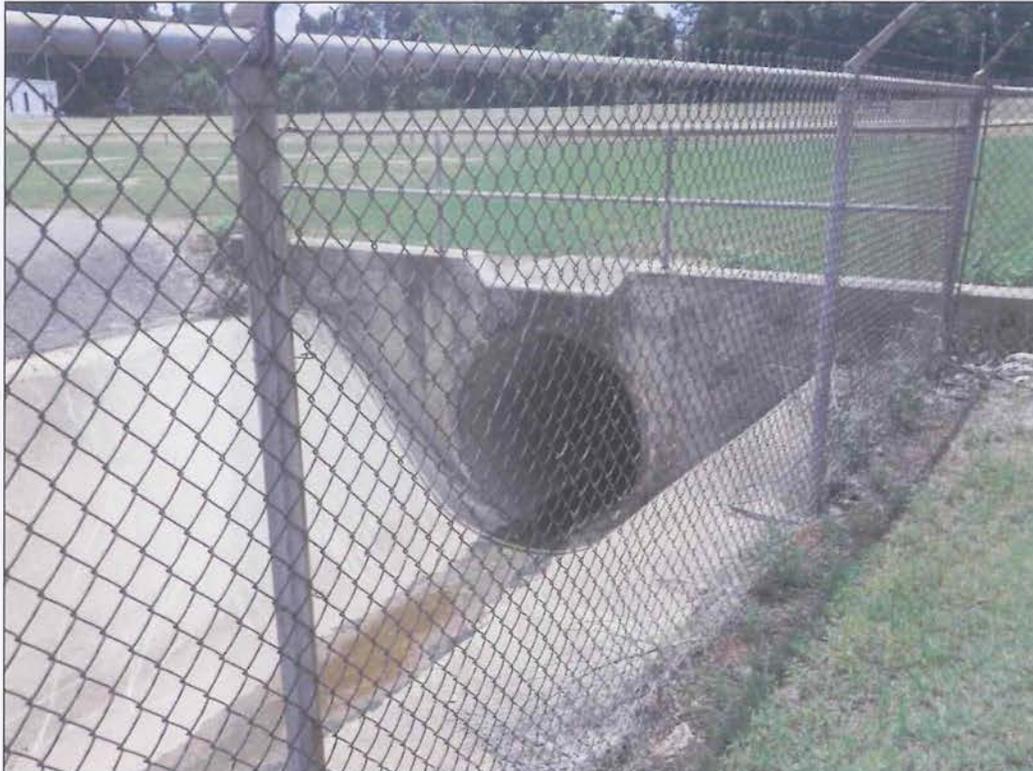
Inspect ID: CHER_2016_a_0022 **Title:** USACE_CEMVK_CHER_2016_a_0022_1.jpg **Rated Item:** 11. Culverts/ Discharge Pipes (This item includes both concrete and corrugated metal pipes.) **Caption:** Rating: Minimally Acceptable; Remarks: Inlet of 72" dia concrete str.. Inlet is free of debris and obstructions and has a positive seal. Other components appears to be in good condition at the time of inspection. Video inspection conducted in 2012. Inlet is located in Clyde Fant Rd ditch.; Station_1: 178+45

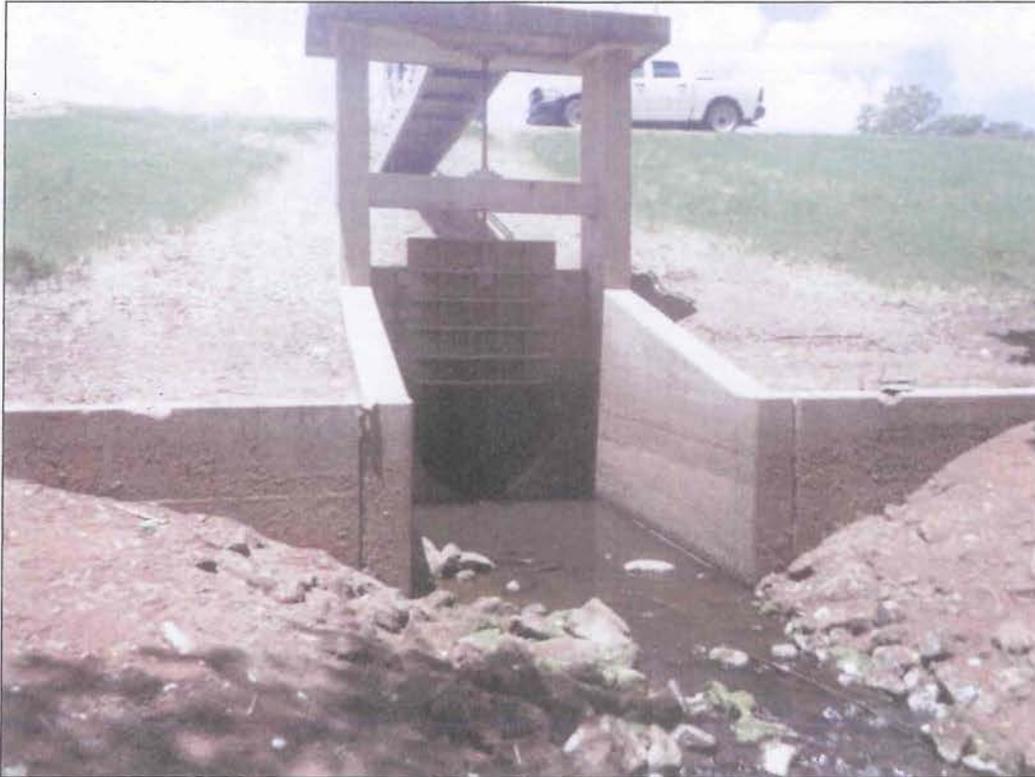
Inspect ID: CHER_2016_a_0026 **Title:** USACE_CEMVK_CHER_2016_a_0026_1.jpg **Rated Item:** 11. Culverts/ Discharge Pipes (This item includes both concrete and corrugated metal pipes.) **Caption:** Rating: Minimally Acceptable; Remarks: Outlet of 60" CMP. Outlet is free of debris and obstructions. Structure appears to have positive seal. Other components appears to be in good condition at the time of inspection. Video inspection conducted in 2012. ; Station_1: 203+53

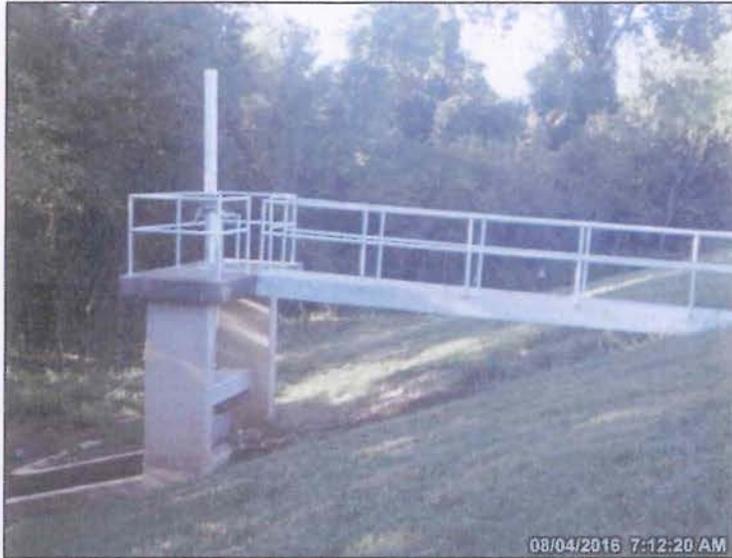
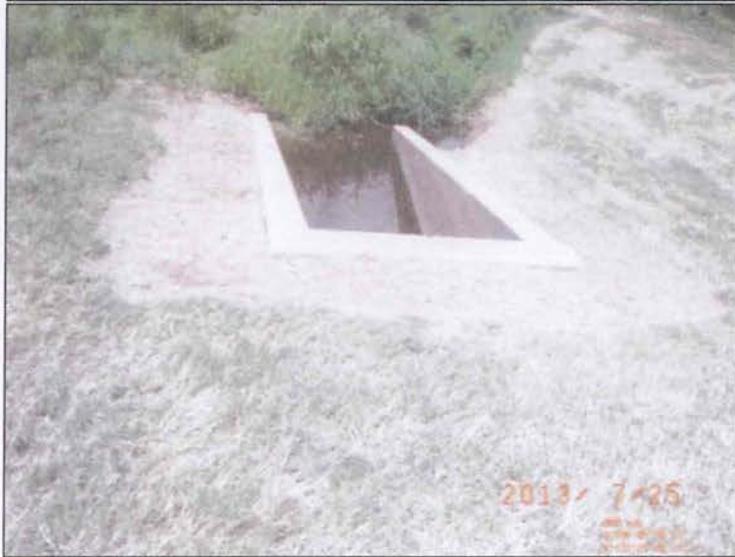
The first structure is located south of the Downtown Airport. It is a single 60-inch CMP that runs underneath a small embankment. The structure has a concrete end section at the inlet and a concrete stem assembly with a steel sluice gate, wing walls and a steel walkway at the outlet. The steel walkway had a couple of bent members, but was in good condition overall.

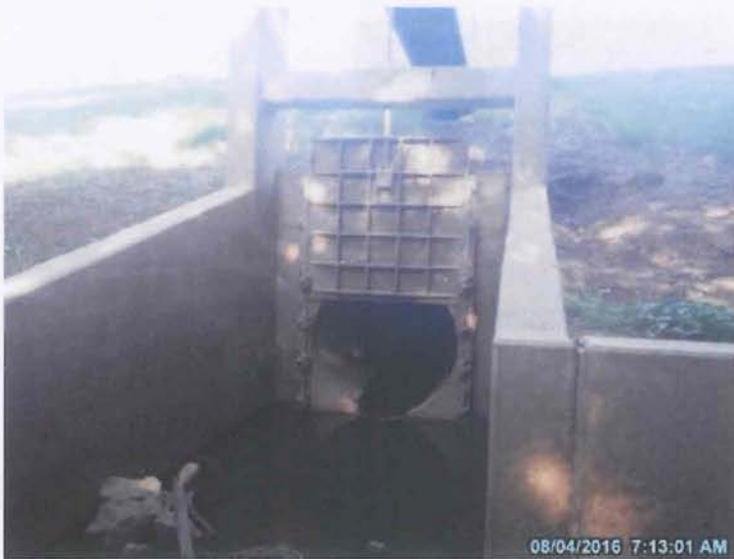
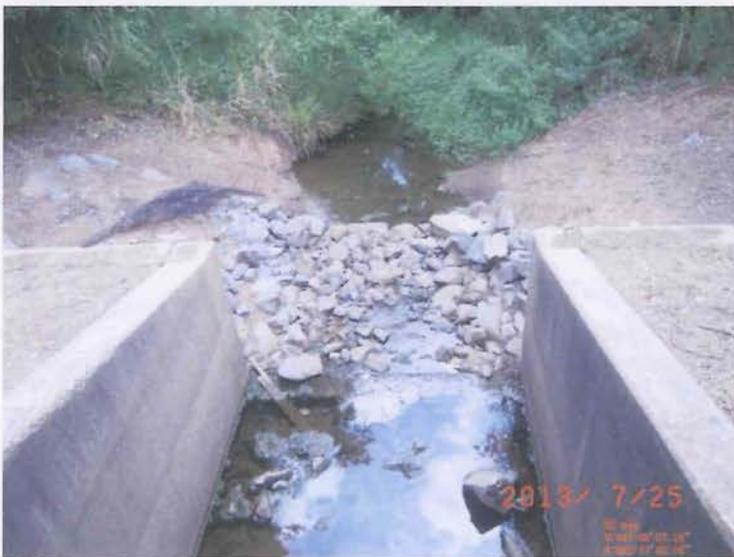
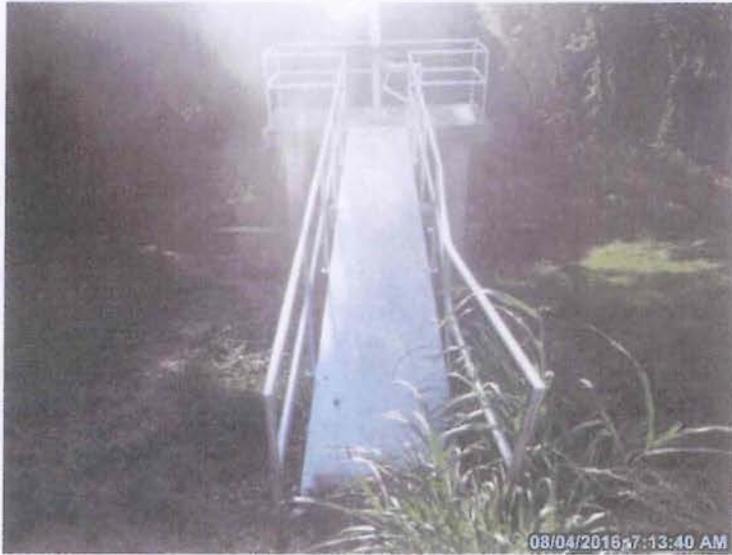
Riprap was seen in the ditch, but there was moderate displacement along the side slopes at the outlet. All concrete features of the structure appeared to be in good condition. The sluice gate was not operated, but appeared to be in good condition.

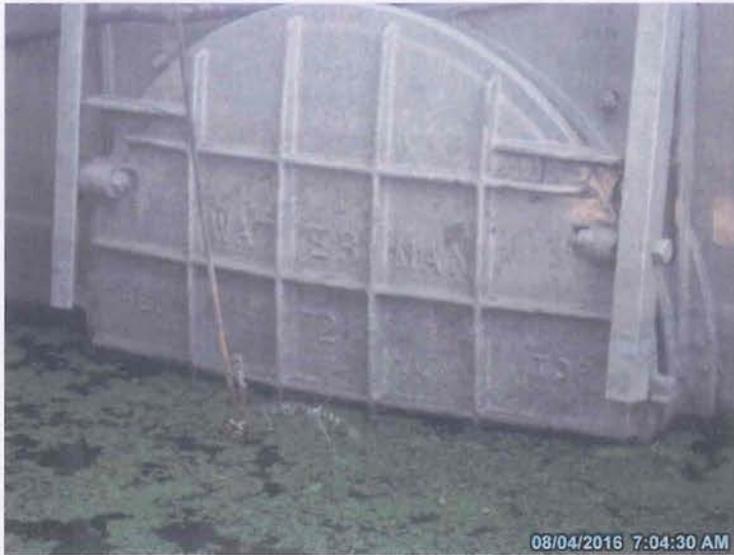
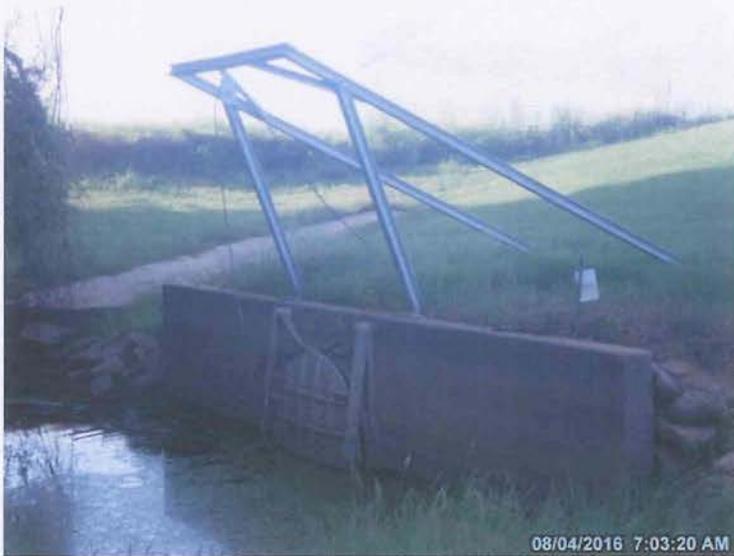
The second structure is located near the Downtown Airport at Station 2671+04 (RR North Levee System). A single RCP runs underneath the airport runway, and has a concrete headwall and 48-inch metal flap gate at the downstream end of the pipe. The flap gate was not operated, but all of its features appeared to be in good condition. The concrete headwall appeared to be in good condition. Moderate displacement of riprap was noted.

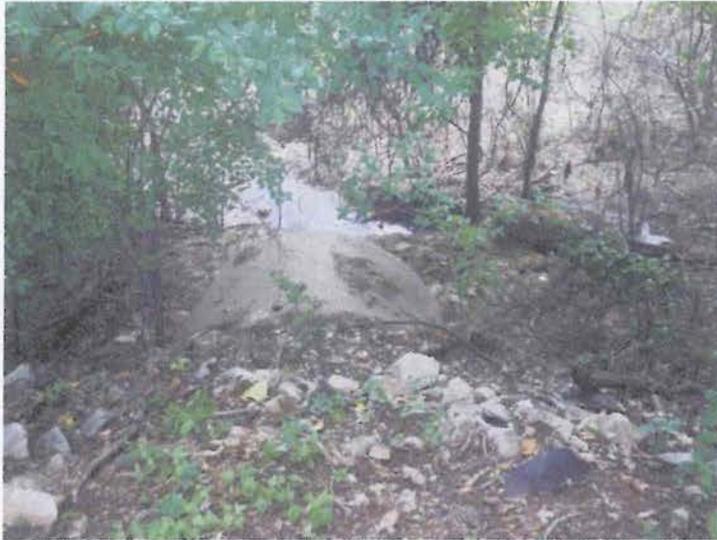
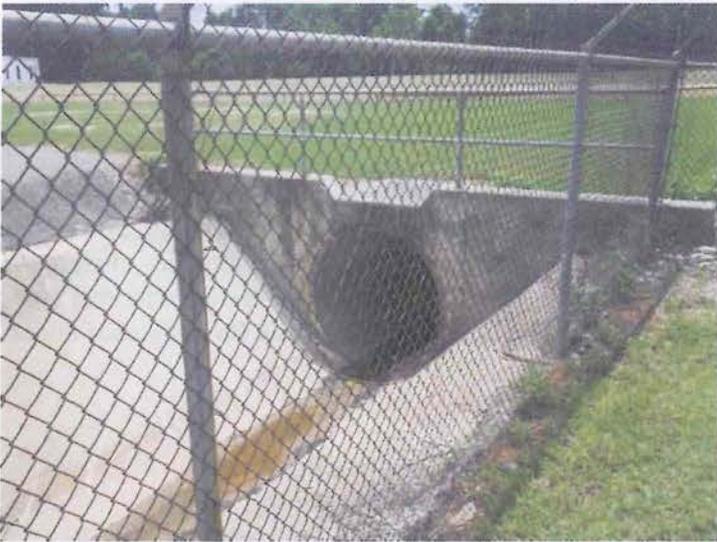
The third structure is located near the Downtown Airport at Station 178+45. A 72" RCP, a gatewell and flume acts as part of the airport drainage system. This pipe is uncontrolled on the downstream end. The existing gatewell will be replaced with a new gatewell containing a vertical lift gate.

Note that this determination is made contingent upon installation of a gatewell over a 72 inch culvert by July 2017, as noted in the report. In the event of a flood event prior to the gate installation, follow the emergency action plan described in the report.
