Flood Damage Reduction Segment / System
Inspection Report
Cherokee Park Levee (CHER)

Initial Eligibility Inspection Report
June 2016

PL 84-99
Initial Eligibility Inspection Report
Cherokee Park Levee
Shreveport, Louisiana

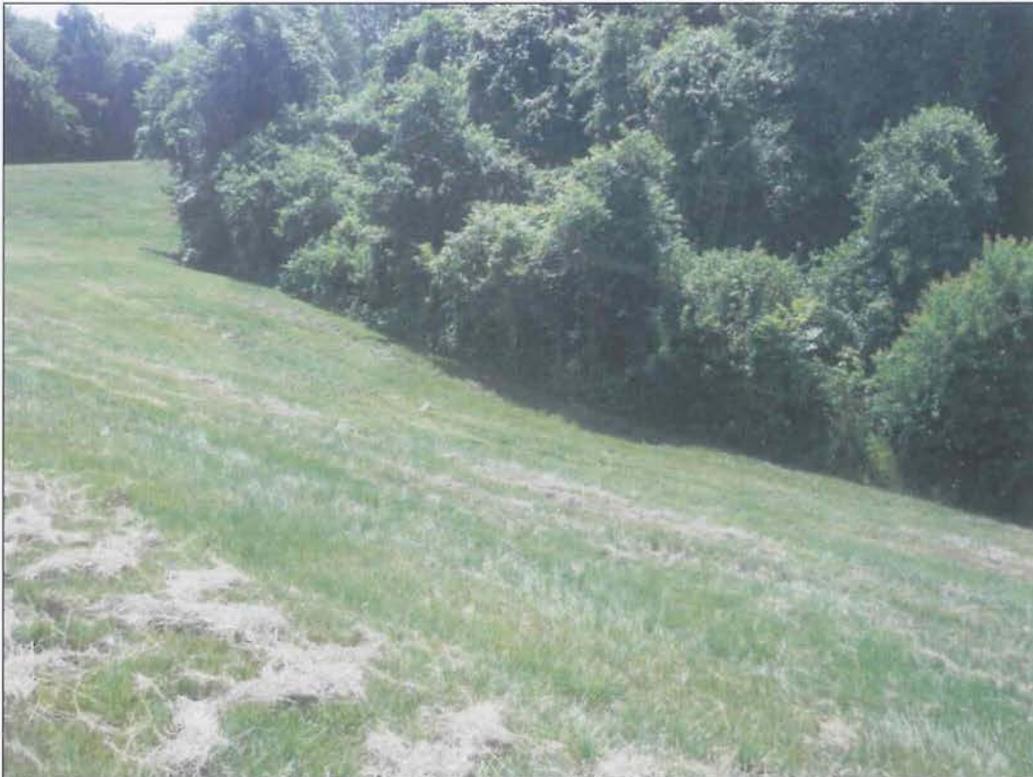
Inspect ID: CHER_2016_a_0002 **Title:** USACE_CEMVK_CHER_2016_a_0002_1.jpg **Rated Item:** 1. Unwanted Vegetation Growth **Caption:** Rating: Minimally Acceptable;
Remarks: Woody growth and trees located within 15' of the landside levee toe.; Station_1: 4+45

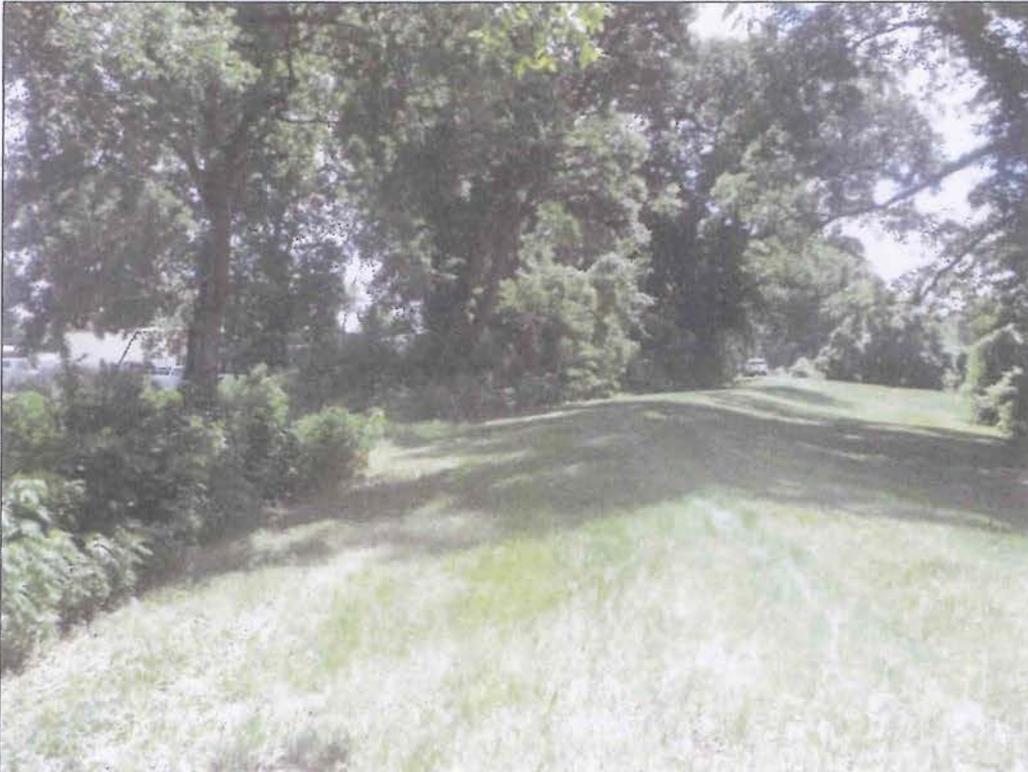
Inspect ID: CHER_2016_a_0003 **Title:** USACE_CEMVK_CHER_2016_a_0003_1.jpg **Rated Item:** 1. Unwanted Vegetation Growth **Caption:** Rating: Minimally Acceptable;
Remarks: Woody growth and small trees located at the riverside levee toe.; Station_1: 19+00; Station_2: 22+00

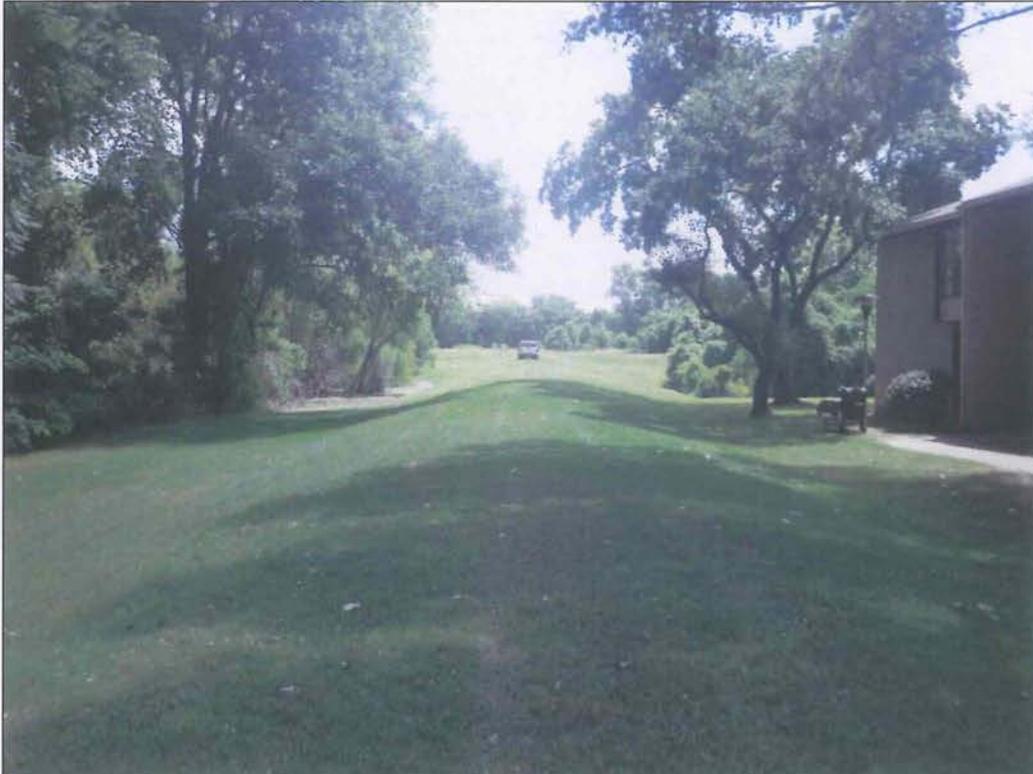
Inspect ID: CHER_2016_a_0001 **Title:** USACE_CEMVK_CHER_2016_a_0001_1.jpg **Rated Item:** 2. Sod Cover **Caption:** Rating: Acceptable; Remarks: Upstream limits of Cherokee levee where levee ties to West Agurs Levee. Levee is in good condition with good sod cover.; Station_1: 0+00

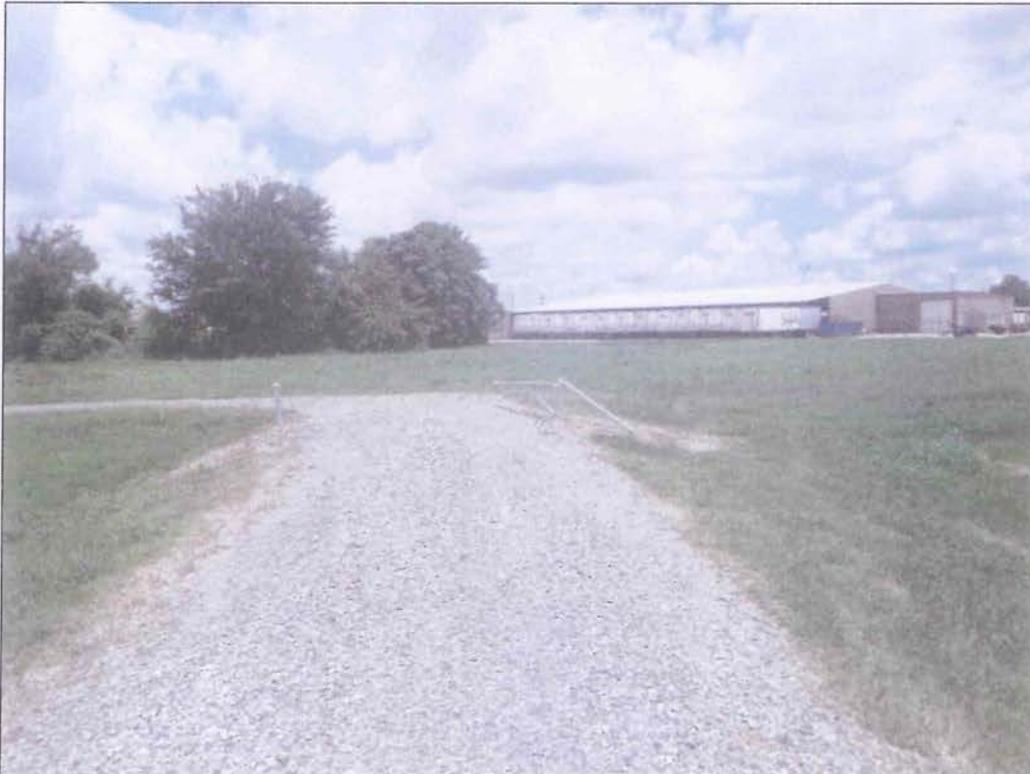
Inspect ID: CHER_2016_a_0024 Title: USACE_CEMVK_CHER_2016_a_0024_1.jpg Rated Item: 2. Sod Cover Caption: Rating: Acceptable; Remarks: Levee ties into high ground at this location. High ground ends and levee alignment begins.; Station_1: 201+90

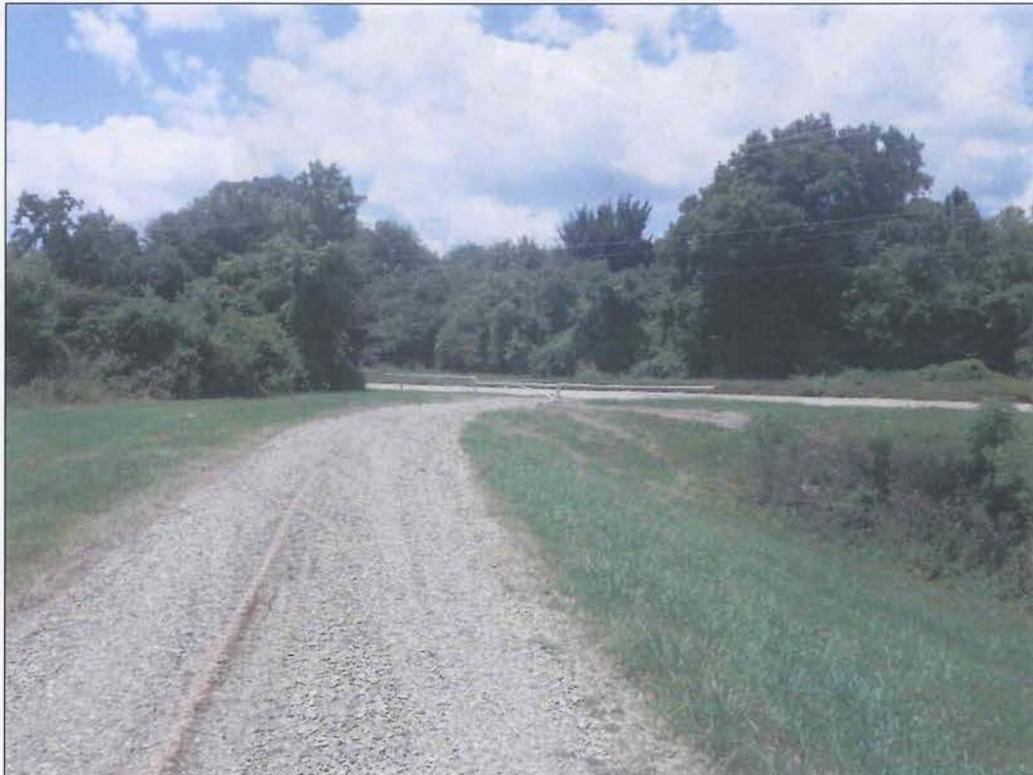
Inspect ID: CHER_2016_a_0028 Title: USACE_CEMVK_CHER_2016_a_0028_1.jpg Rated Item: 2. Sod Cover Caption: Rating: Acceptable; Remarks: Downstream limits of Cherokee Levee segment. Levee found to be in good condition in this area. Levee ties to highground at this location.; Station_1: 205+80

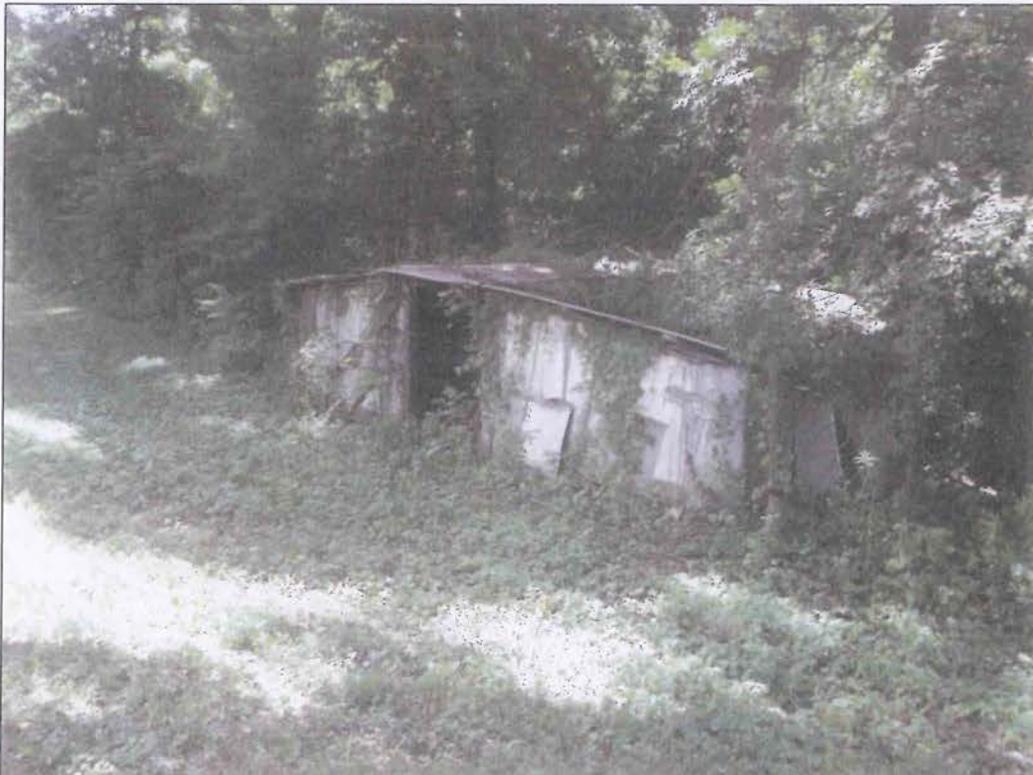
Inspect ID: CHER_2016_a_0005 Title: USACE_CEMVK_CHER_2016_a_0005_1.jpg Rated Item: 3. Encroachments Caption: Rating: Minimally Acceptable; Remarks: Shed located within 15' of landside levee toe.; Station_1: 24+75

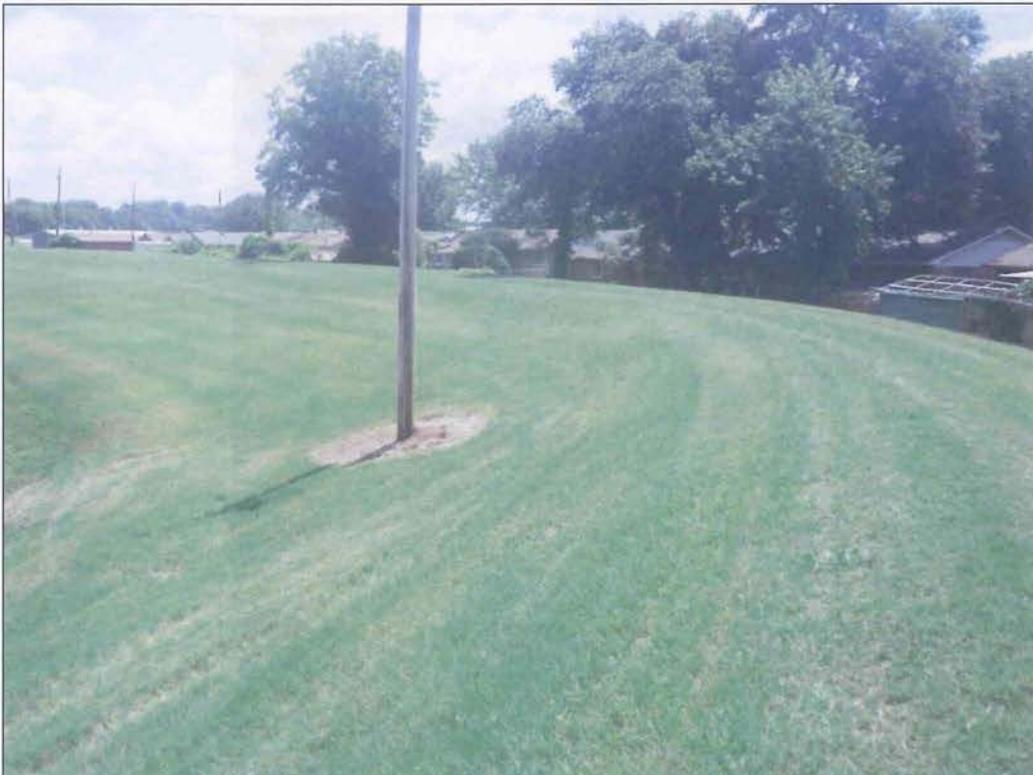
Inspect ID: CHER_2016_a_0010 **Title:** USACE_CEMVK_CHER_2016_a_0010_1.jpg **Rated Item:** 3. Encroachments **Caption:** Rating: Minimally Acceptable; **Remarks:** Powerpole located at the riverside levee toe. Power pole located 2' from the landside levee toe.; Station_1: 55+60

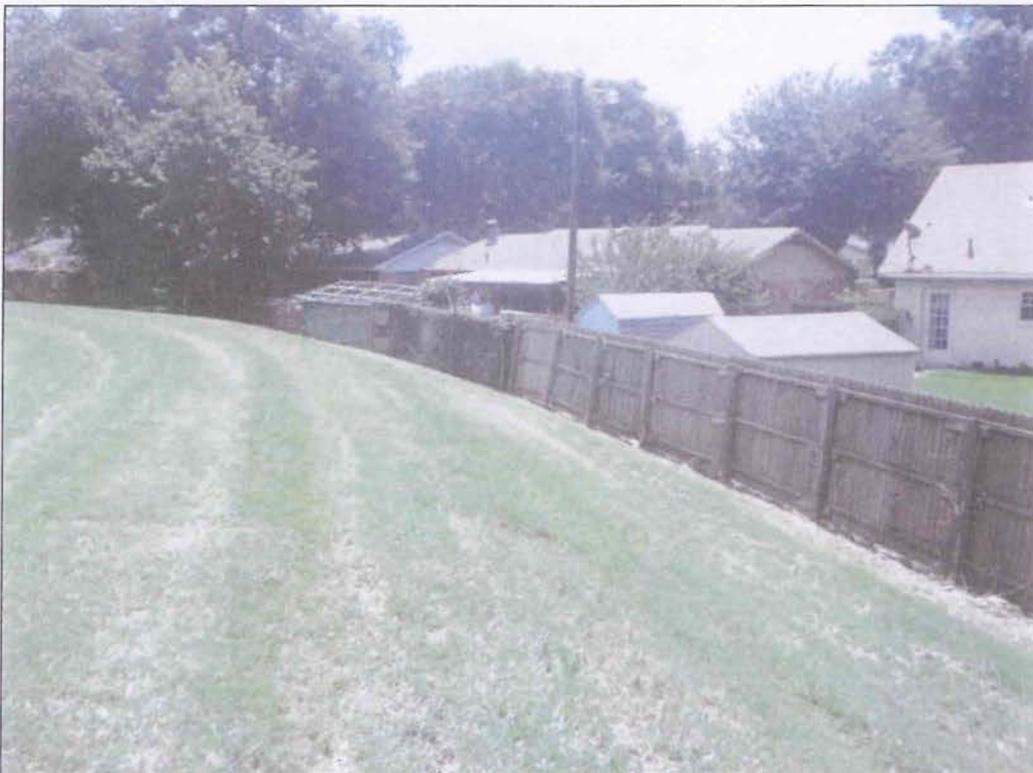
Inspect ID: CHER_2016_a_0011 Title: USACE_CEMVK_CHER_2016_a_0011_1.jpg Rated Item: 3. Encroachments Caption: Rating: Minimally Acceptable; Remarks: Chain link fence, wooden fence, shed, and line of powerpoles located at the landside levee toe.; Station_1: 55+60; Station_2: 60+75

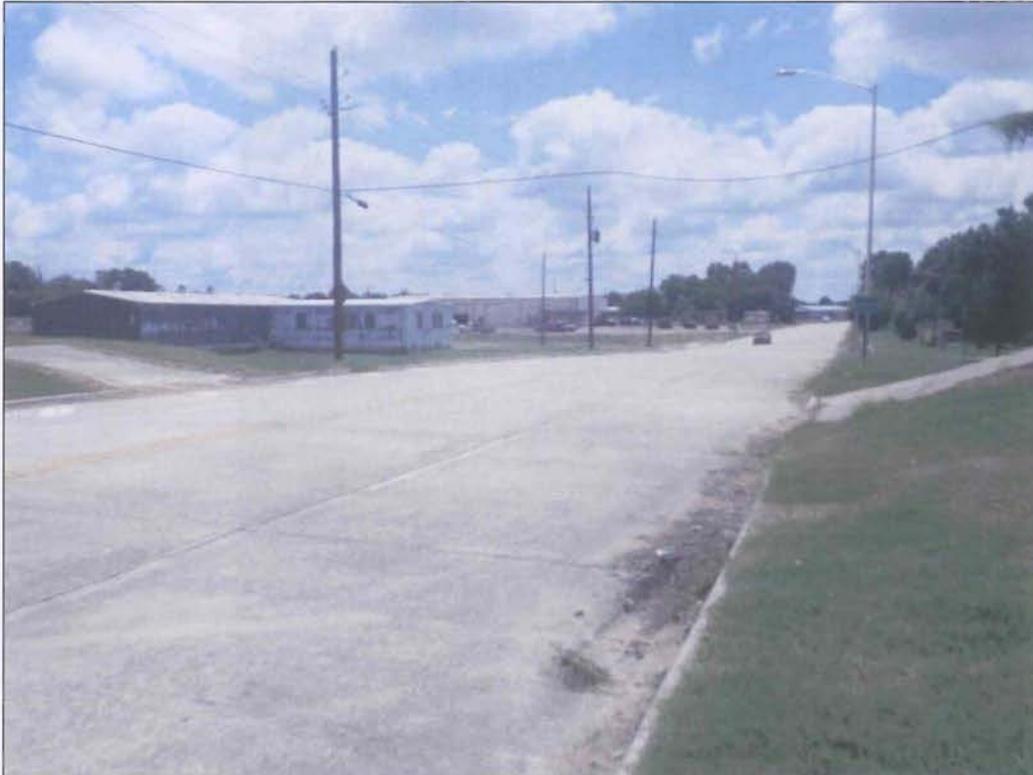
Inspect ID: CHER_2016_a_0013 **Title:** USACE_CEMVK_CHER_2016_a_0013_1.jpg **Rated Item:** 8. Depressions/ Rutting **Caption:** Rating: Acceptable; Remarks: Location where Wells Island Road crosses the levee embankment. Sponsor has gap closure plan for this location.; Station_1: 61+00

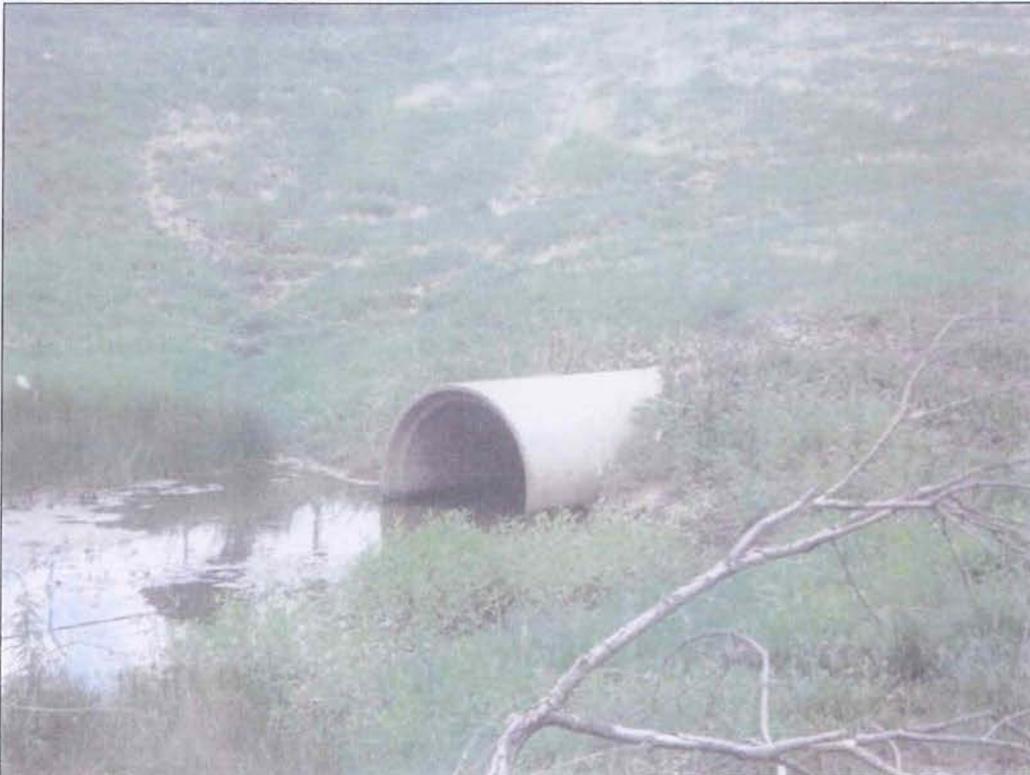
Inspect ID: CHER_2016_a_0017 **Title:** USACE_CEMVK_CHER_2016_a_0017_1.jpg **Rated Item:** 11. Culverts/ Discharge Pipes (This item includes both concrete and corrugated metal pipes.) **Caption:** Rating: Minimally Acceptable; Remarks: Inlet of 48" dia. concrete structure. Video conducted in 2012. Sponsor has contract to place flap gate on structure within the year. Inlet is free of obstructions and debris. All other components appear to be in good condition at the time of inspection.; Station_1: 80+00

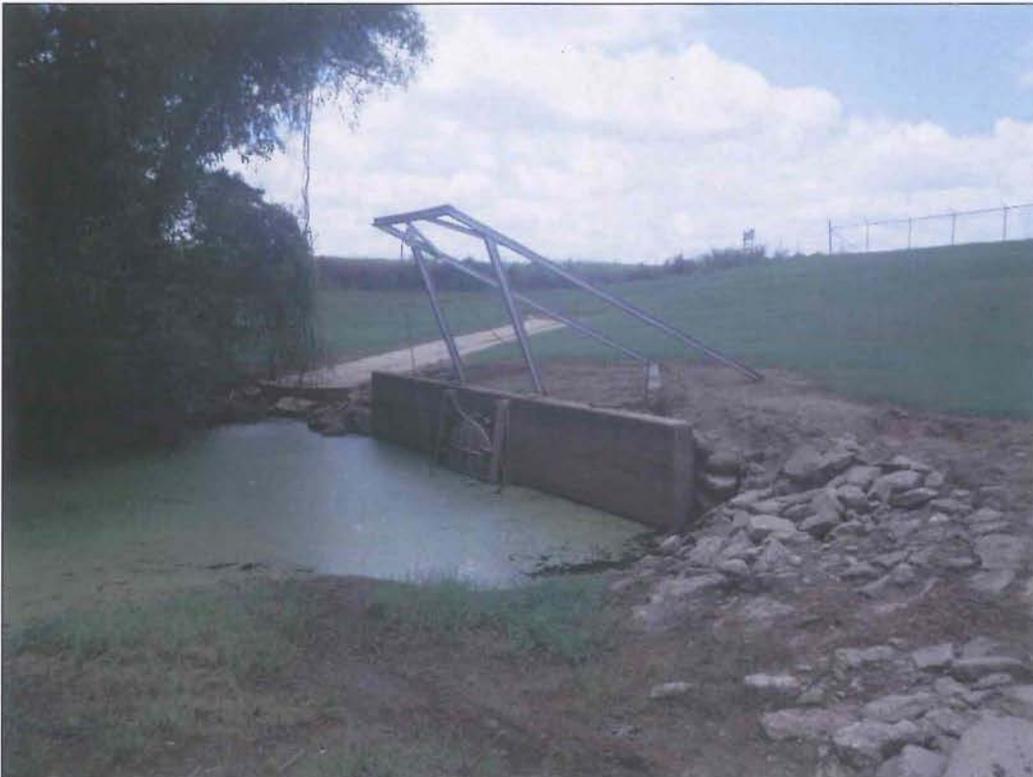
Inspect ID: CHER_2016_a_0018 **Title:** USACE_CEMVK_CHER_2016_a_0018_1.jpg **Rated Item:** 11. Culverts/ Discharge Pipes (This item includes both concrete and corrugated metal pipes.) **Caption:** Rating: Minimally Acceptable; Remarks: Outlet of 72" dia. concrete str. Outlet is free of debris and obstructions and has a positive seal. Other components appears to be in good condition at the time of inspection. Video inspection conducted in 2012. Structure goes under the airport runway.; Station_1: 80+00

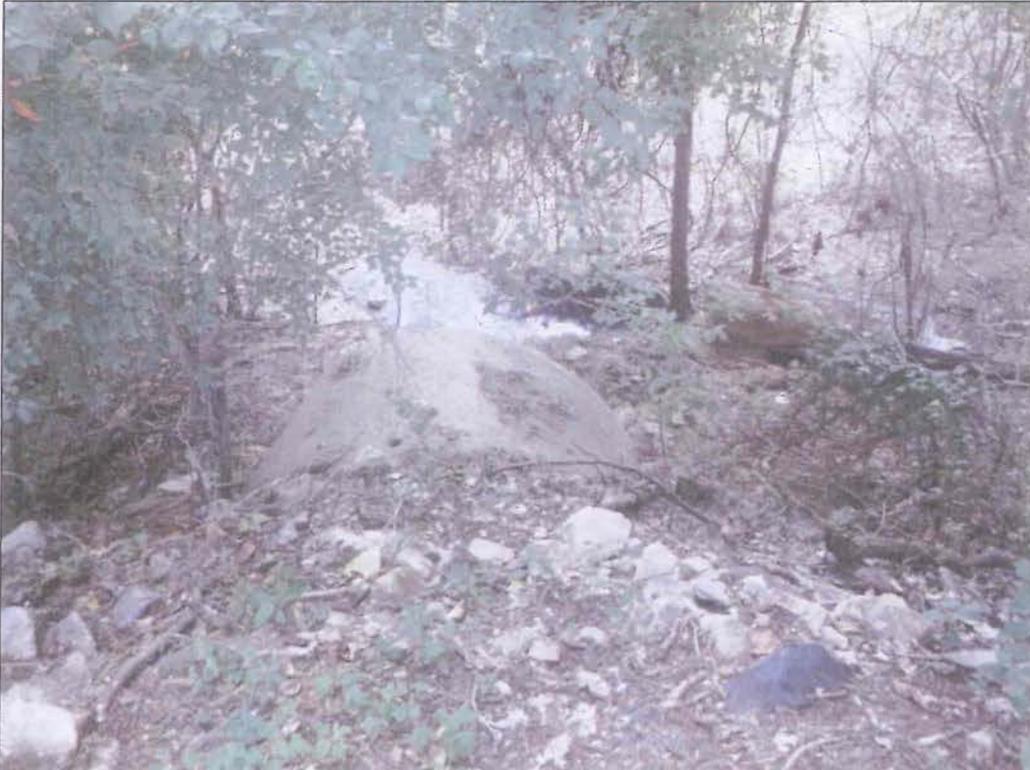
Inspect ID: CHER_2016_a_0021 **Title:** USACE_CEMVK_CHER_2016_a_0021_1.jpg **Rated Item:** 11. Culverts/ Discharge Pipes (This item includes both concrete and corrugated metal pipes.) **Caption:** Rating: Minimally Acceptable; Remarks: Outlet of 72" dia concrete str.. Outlet is free of debris and obstructions and has a positive seal. Other components appears to be in good condition at the time of inspection. Video inspection conducted in 2012. Sponsor has contract to place flap gate.; Station_1: 178+45

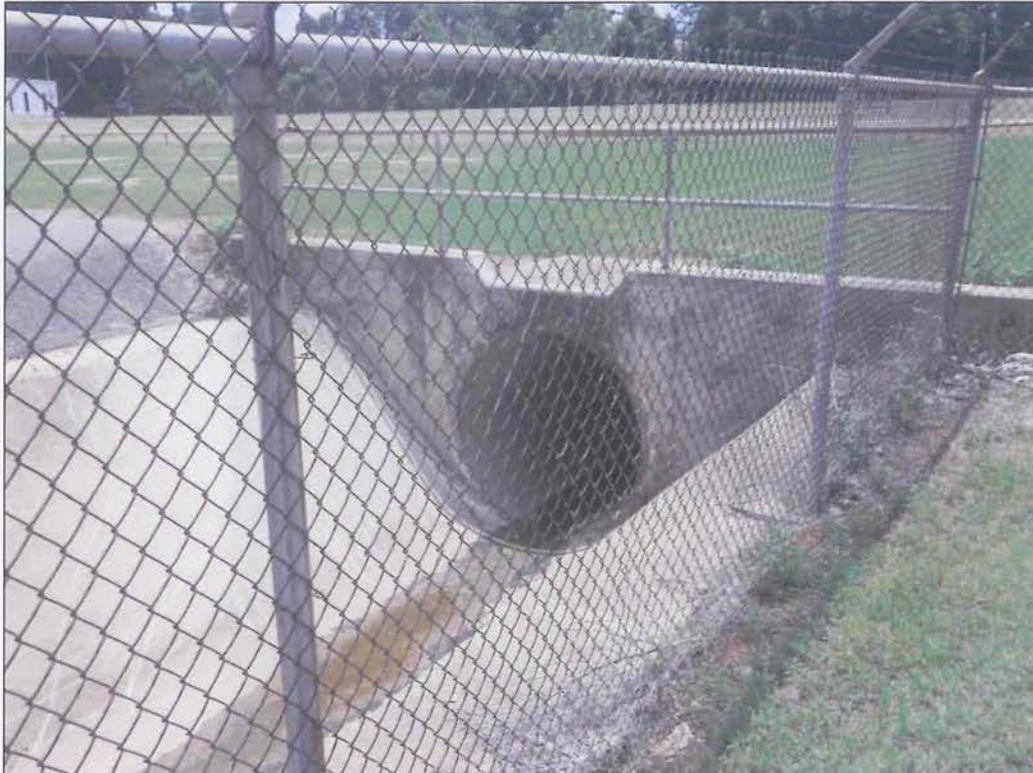
Inspect ID: CHER_2016_a_0022 **Title:** USACE_CEMVK_CHER_2016_a_0022_1.jpg **Rated Item:** 11. Culverts/ Discharge Pipes (This item includes both concrete and corrugated metal pipes.) **Caption:** Rating: Minimally Acceptable; Remarks: Inlet of 72" dia concrete str.. Inlet is free of debris and obstructions and has a positive seal. Other components appears to be in good condition at the time of inspection. Video inspection conducted in 2012. Inlet is located in Clyde Fant Rd ditch.; Station_1: 178+45

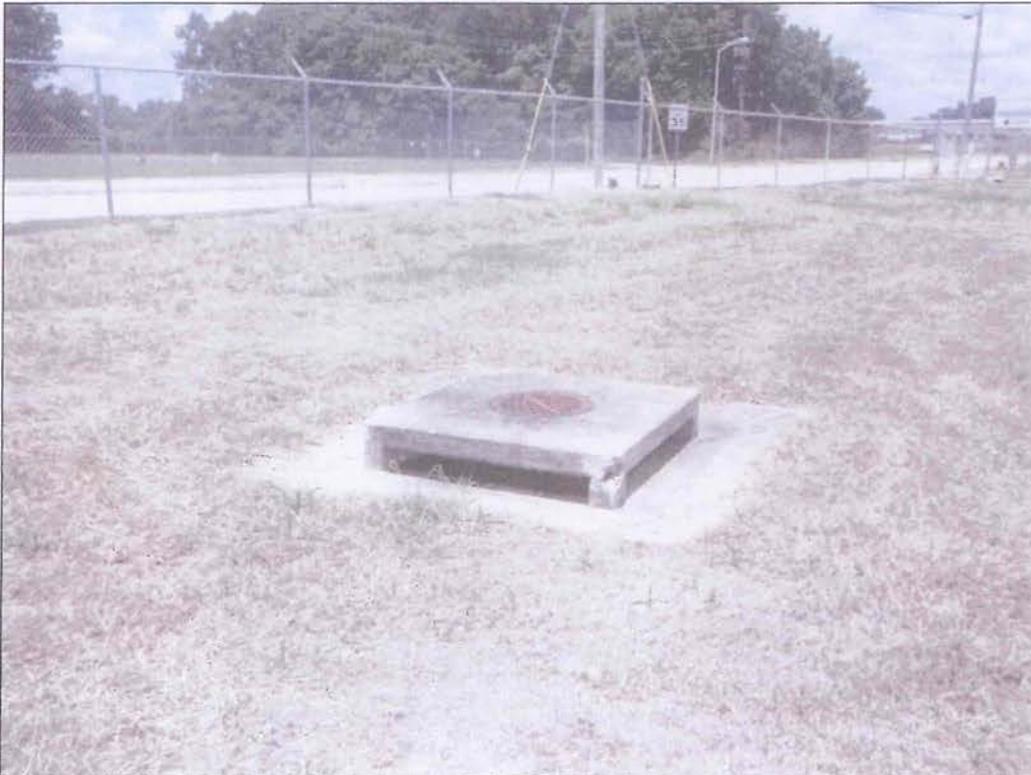
Inspect ID: CHER_2016_a_0023 **Title:** USACE_CEMVK_CHER_2016_a_0023_1.jpg **Rated Item:** 11. Culverts/ Discharge Pipes (This item includes both concrete and corrugated metal pipes.) **Caption:** Rating: Minimally Acceptable; Remarks: Drop inlet located midway of 72" concrete structure. Other components appears to be in good condition at the time of inspection. Video inspection conducted in 2012. ; Station_1: 178+45

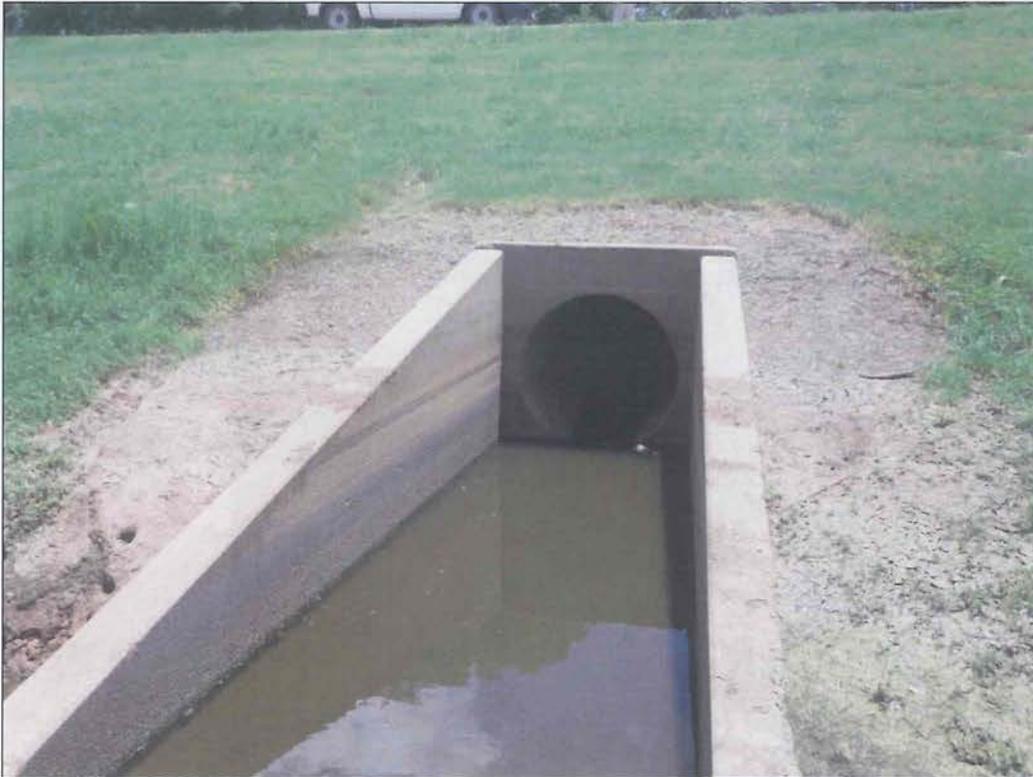
Inspect ID: CHER_2016_a_0025 **Title:** USACE_CEMVK_CHER_2016_a_0025_1.jpg **Rated Item:** 11. Culverts/ Discharge Pipes (This item includes both concrete and corrugated metal pipes.) **Caption:** Rating: Minimally Acceptable; Remarks: Inlet of 60" CMP. Inlet is free of debris and obstructions. Other components appears to be in good condition at the time of inspection. Video inspection conducted in 2012. ; Station_1: 203+53

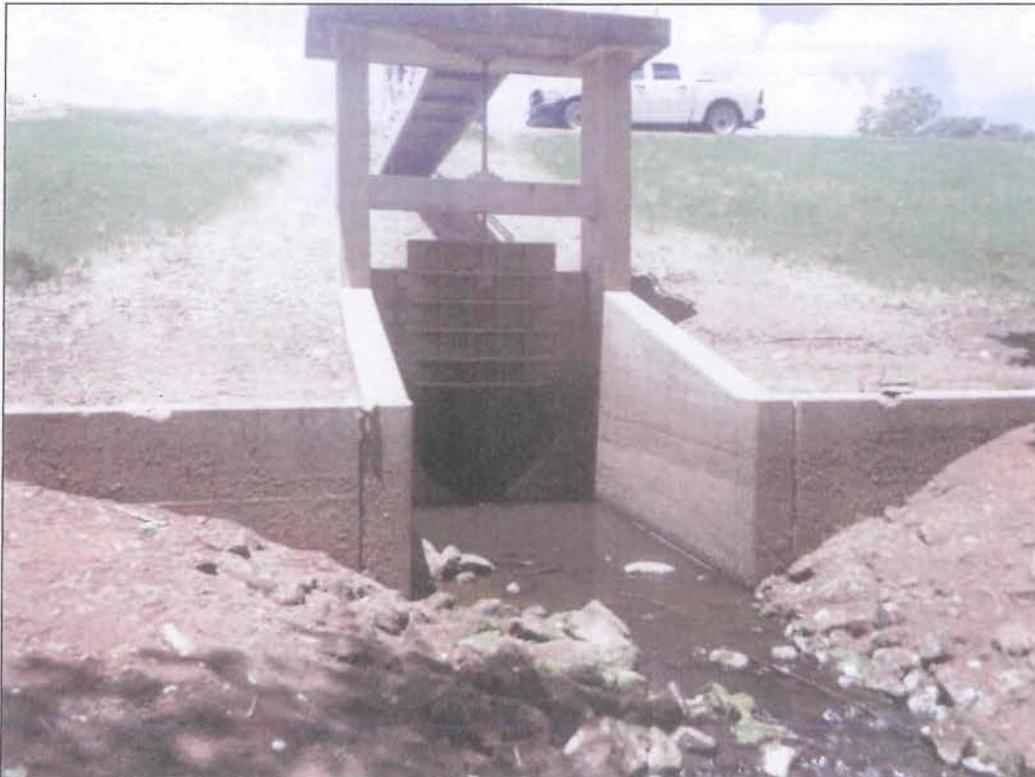
Inspect ID: CHER_2016_a_0026 **Title:** USACE_CEMVK_CHER_2016_a_0026_1.jpg **Rated Item:** 11. Culverts/ Discharge Pipes (This item includes both concrete and corrugated metal pipes.) **Caption:** Rating: Minimally Acceptable; Remarks: Outlet of 60" CMP. Outlet is free of debris and obstructions. Structure appears to have positive seal. Other components appears to be in good condition at the time of inspection. Video inspection conducted in 2012. ; Station_1: 203+53

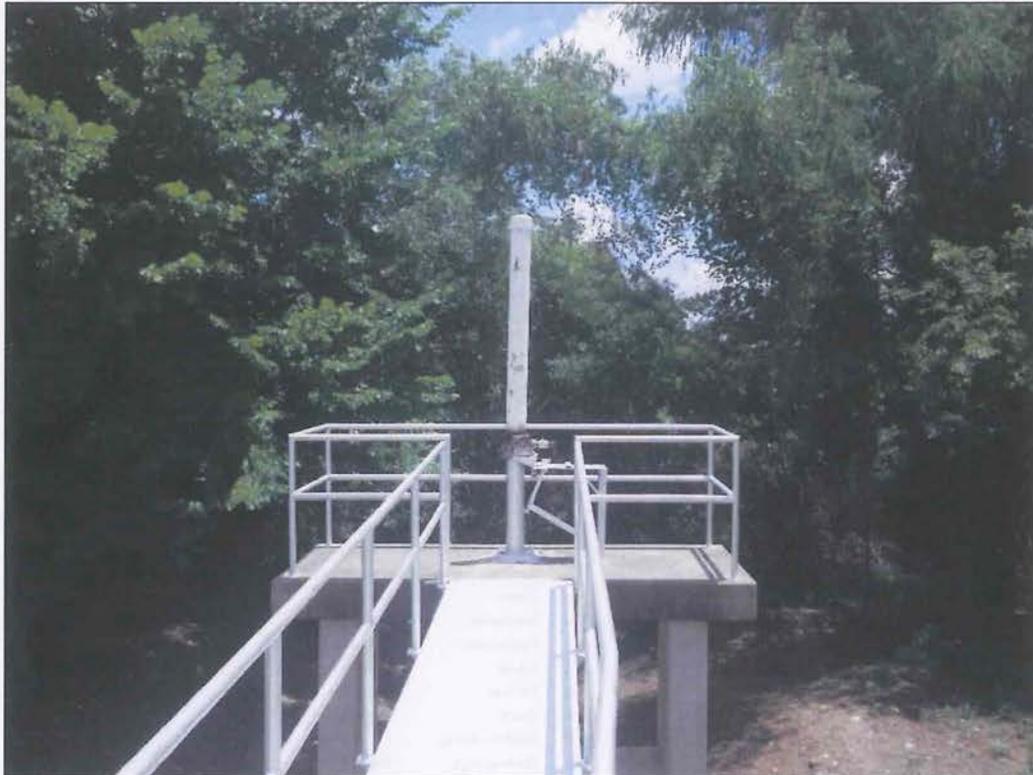
Inspect ID: CHER_2016_a_0027 **Title:** USACE_CEMVK_CHER_2016_a_0027_1.jpg **Rated Item:** 11. Culverts/ Discharge Pipes (This item includes both concrete and corrugated metal pipes.) **Caption:** Rating: Minimally Acceptable; Remarks: Stem assembly for 60" CMP structure. All components appear to be in good condition at the time of inspection. Structure uses a sluice gate to obtain positive seal.; Station_1: 203+53
