**Proposal Name: MAWC Youghiogheny River Dam**

# Inspection and Evaluation Report

*for the*  
**Youghiogheny River Dam**

*for the*  
**Indian Creek Water Treatment Plant**  
Connellsville, Westmoreland County, PA

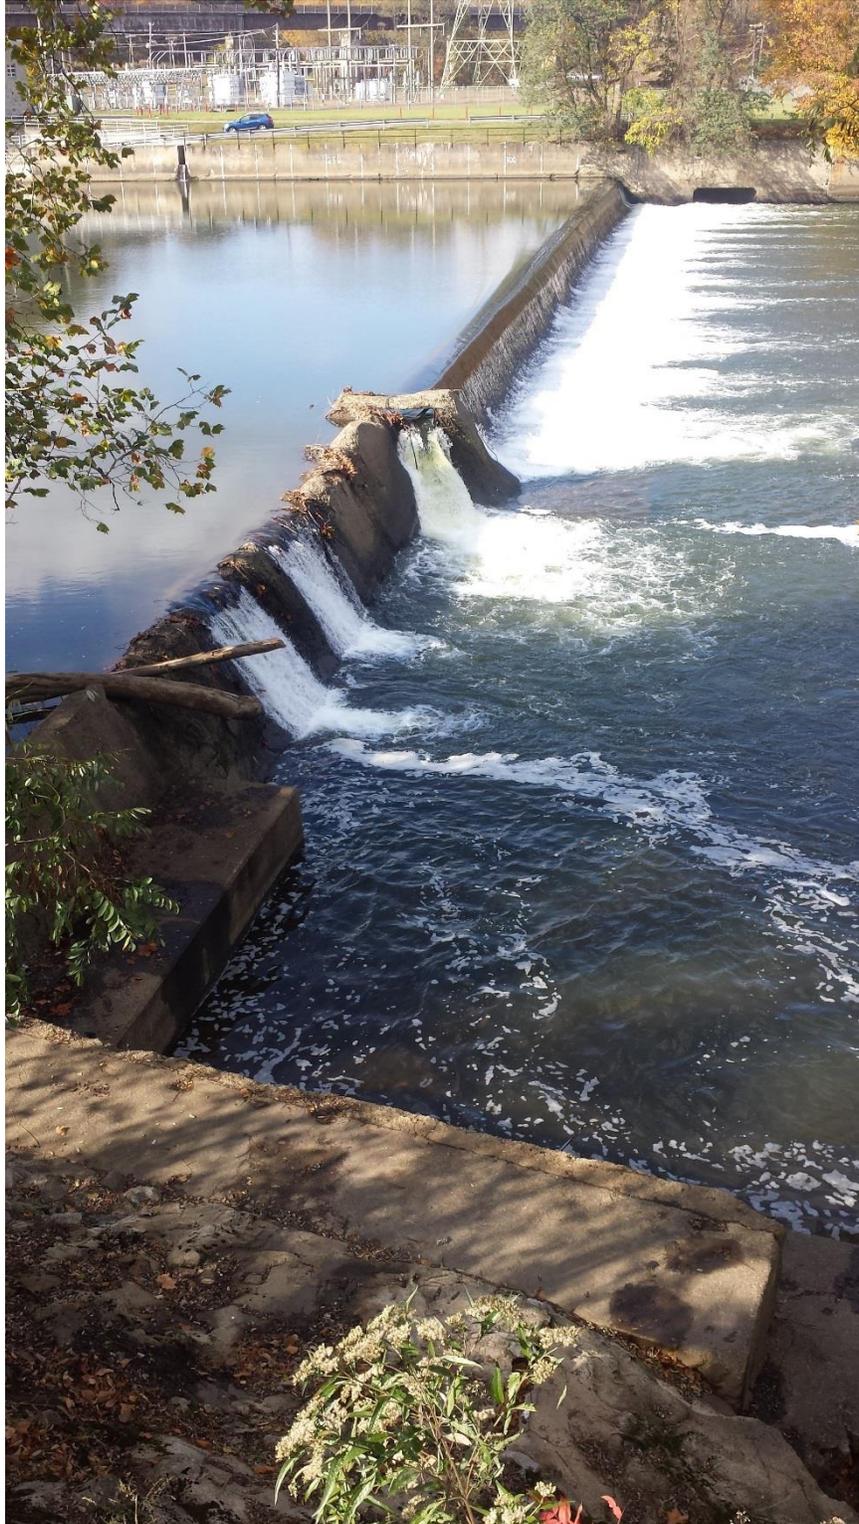
Dam overview from right abutment

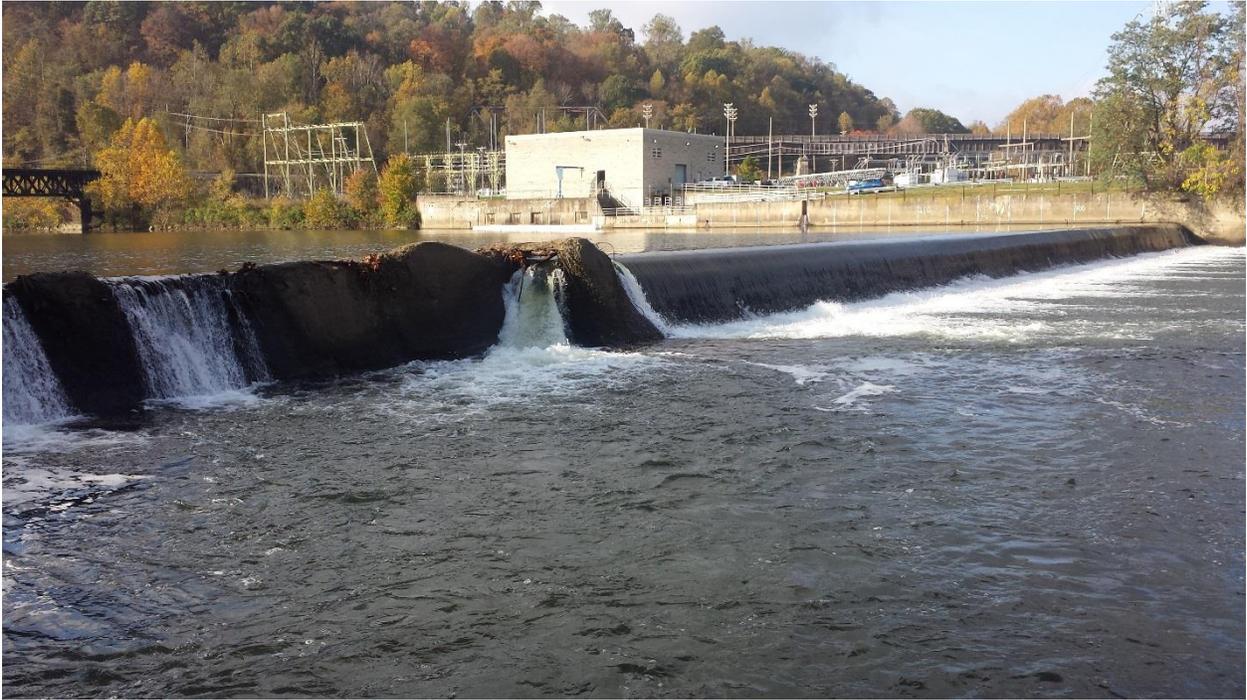
Dam overview from downstream of right abutment

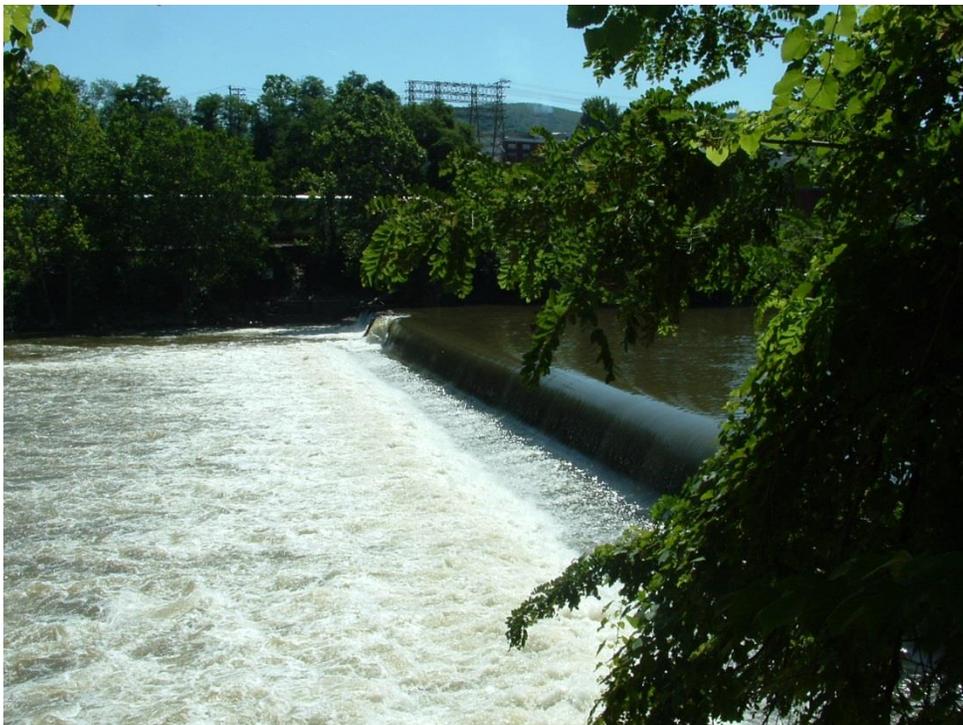
Dam overview from downstream of left abutment

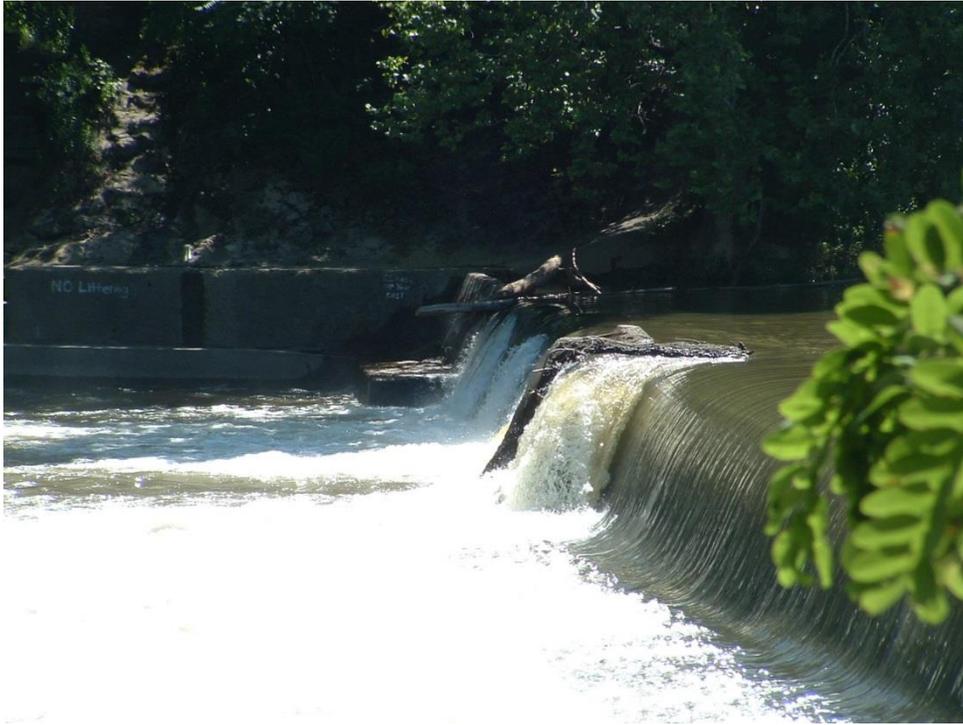
Dam right abutment from downstream of left abutment – severe spalling and exposed rebar

3. *Right Abutment* - Repair the spalling and undercutting of the concrete wall upstream of the dam. Repair spalling concrete on the wall and foundation. Grout the undercut grouted riprap at the end of the right abutment wall and the outlet of the railroad culvert discharging into the grouted riprap.

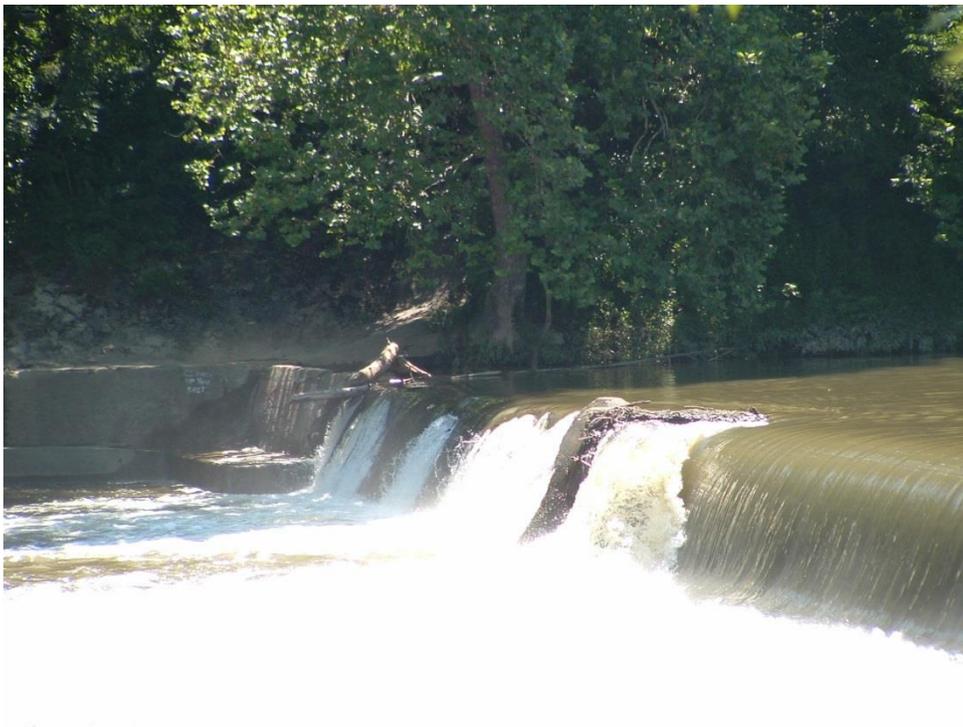
Dam right abutment from downstream of left abutment – severe spalling and exposed rebar

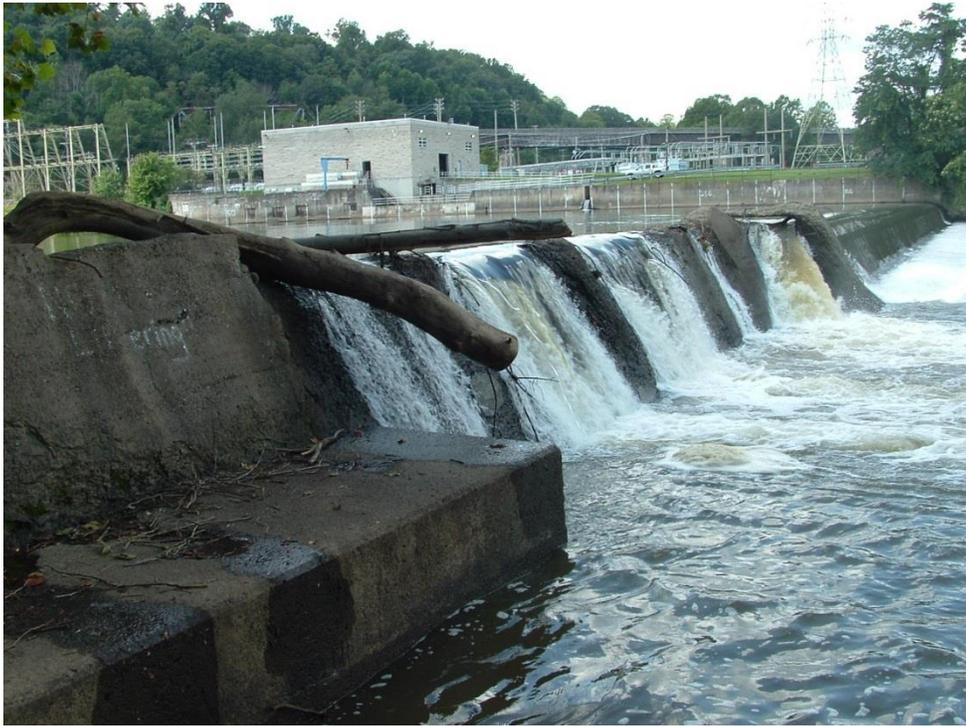
Dam right abutment from downstream – severe spalling and exposed rebar

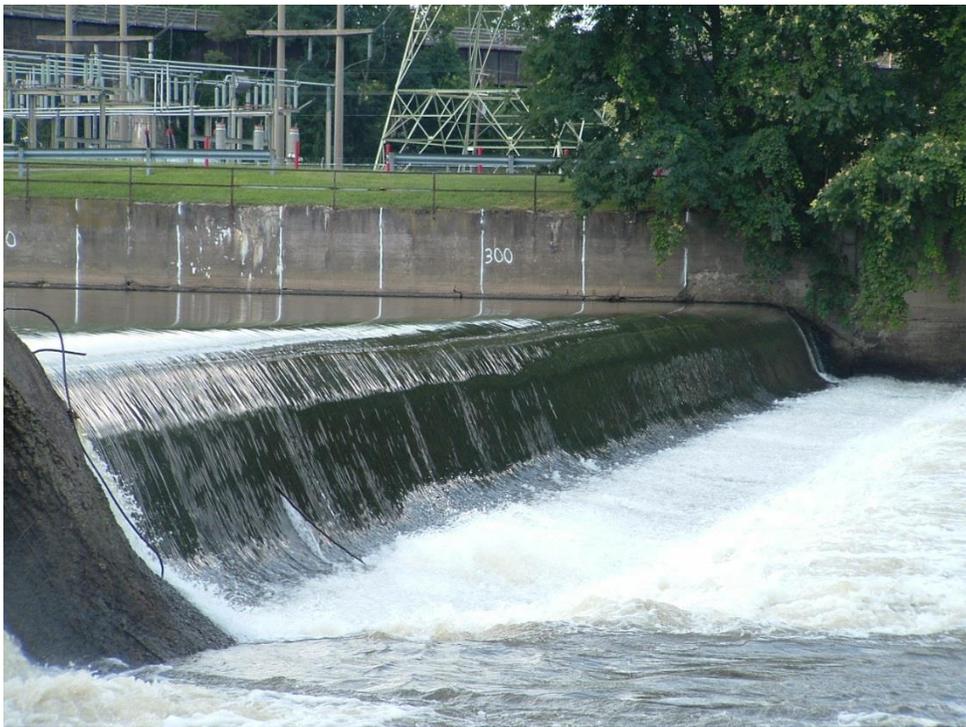
Dam overflow section from downstream from right abutment

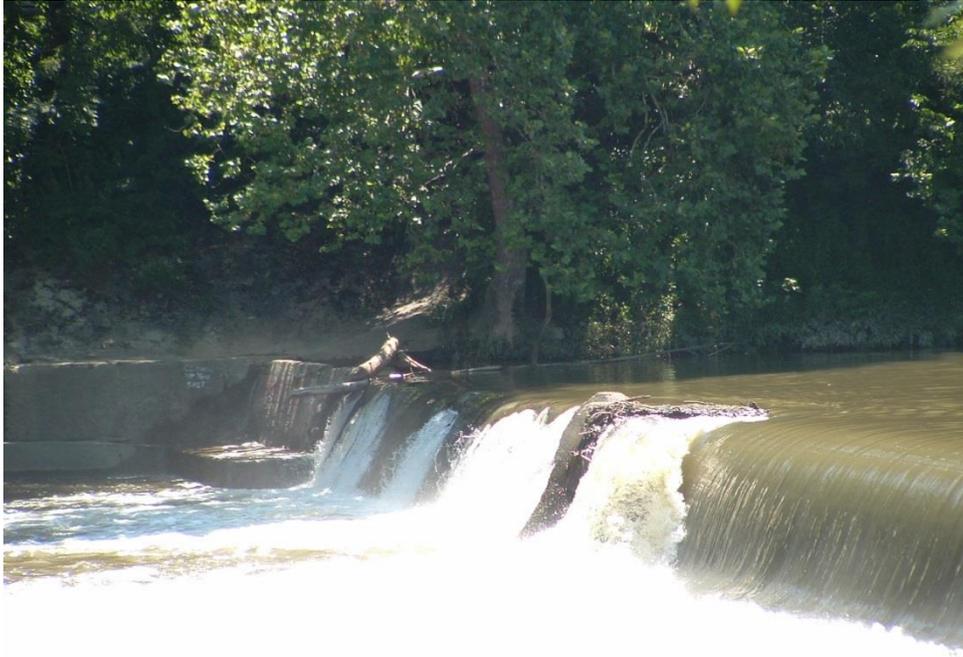
***Downstream Side of Dam – Non-overflow Section*** – Extensive spalling and erosion of the crest and downstream slope has occurred resulting in a significant amount of reinforcement bars being exposed, along with a loss of dam cross section. See photographs in Appendix B. The dam access location (hump) has extensive spalling and allows overflow of water to flow on either side due to deterioration.

Dam right abutment & non-overflow section – severe spalling and exposed rebar

2. *Non-overflow section* - Dewater the non-overflow section of the dam, repair the spalling and restore the cross section of the dam. Fill undercut voids with reinforced concrete, doweled into the existing concrete and bedrock. Remove the remaining top slab of the dam access location (hump), fill the upstream underwater channel, and entire void with reinforced concrete extending to the height of the right abutment.

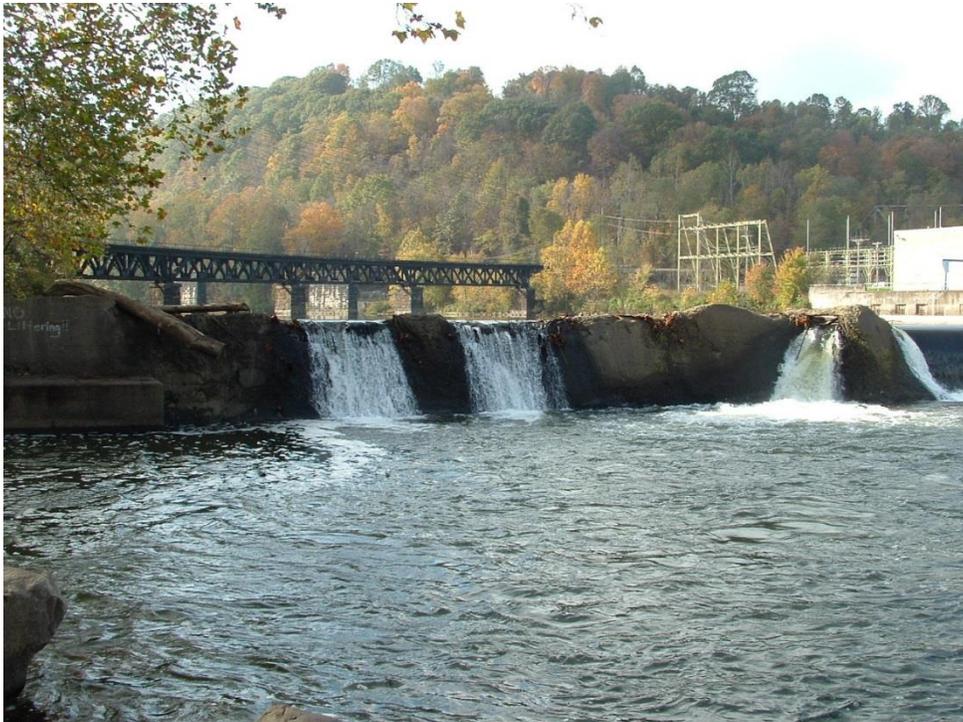
Non-overflow section from downstream – severe spalling and erosion

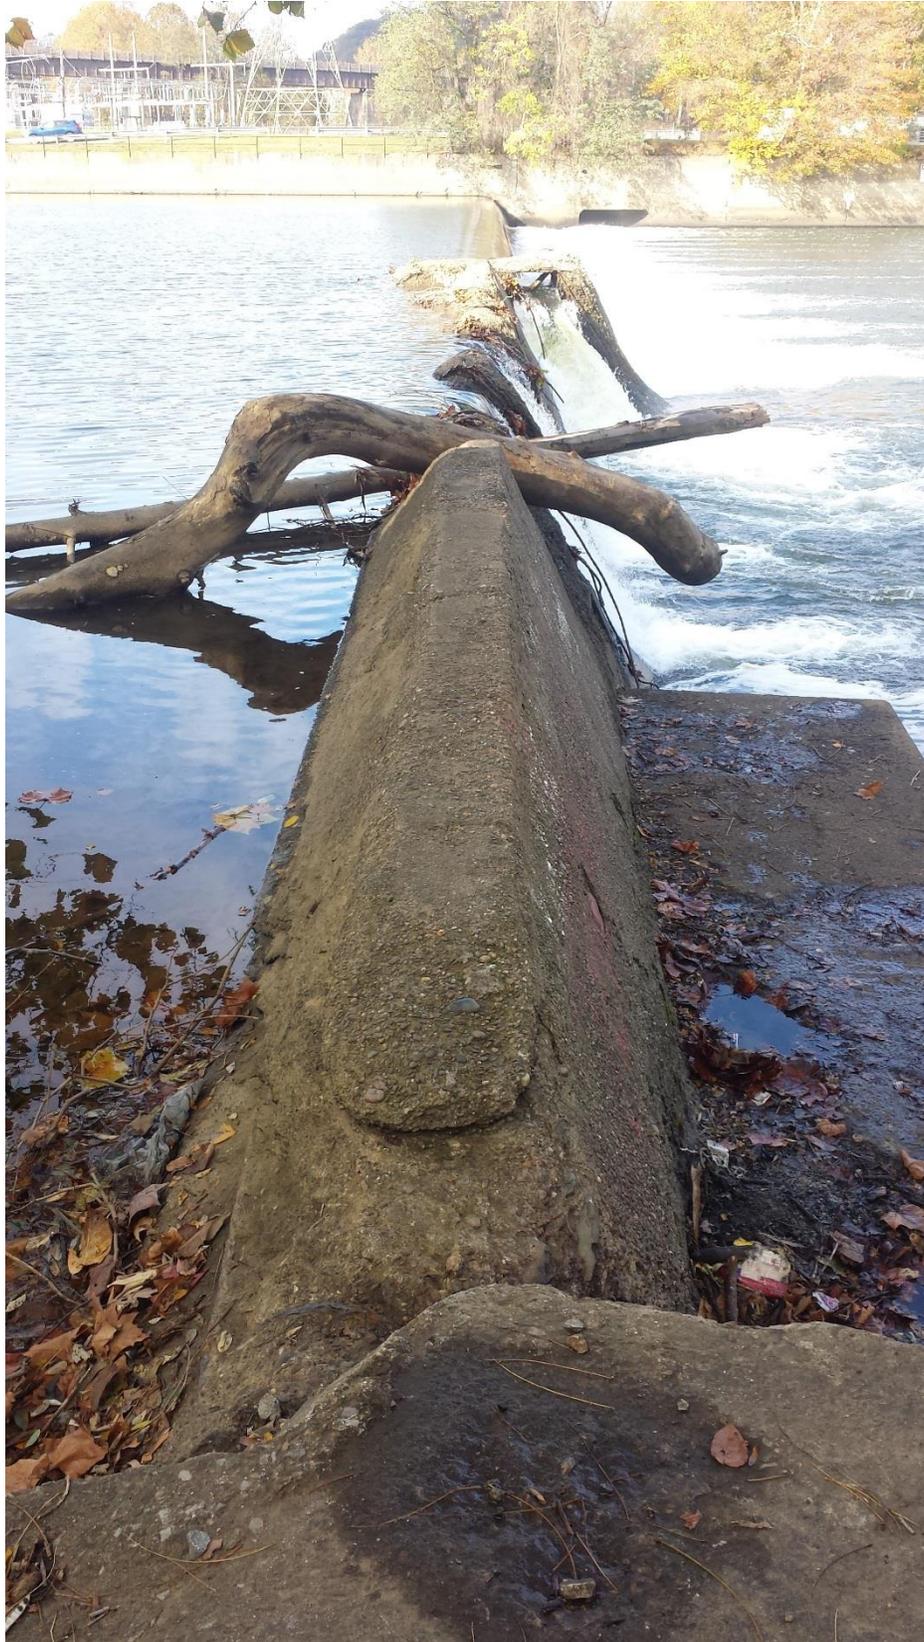
Non-overflow section from left abutment – spalling, section loss and exposed rebar

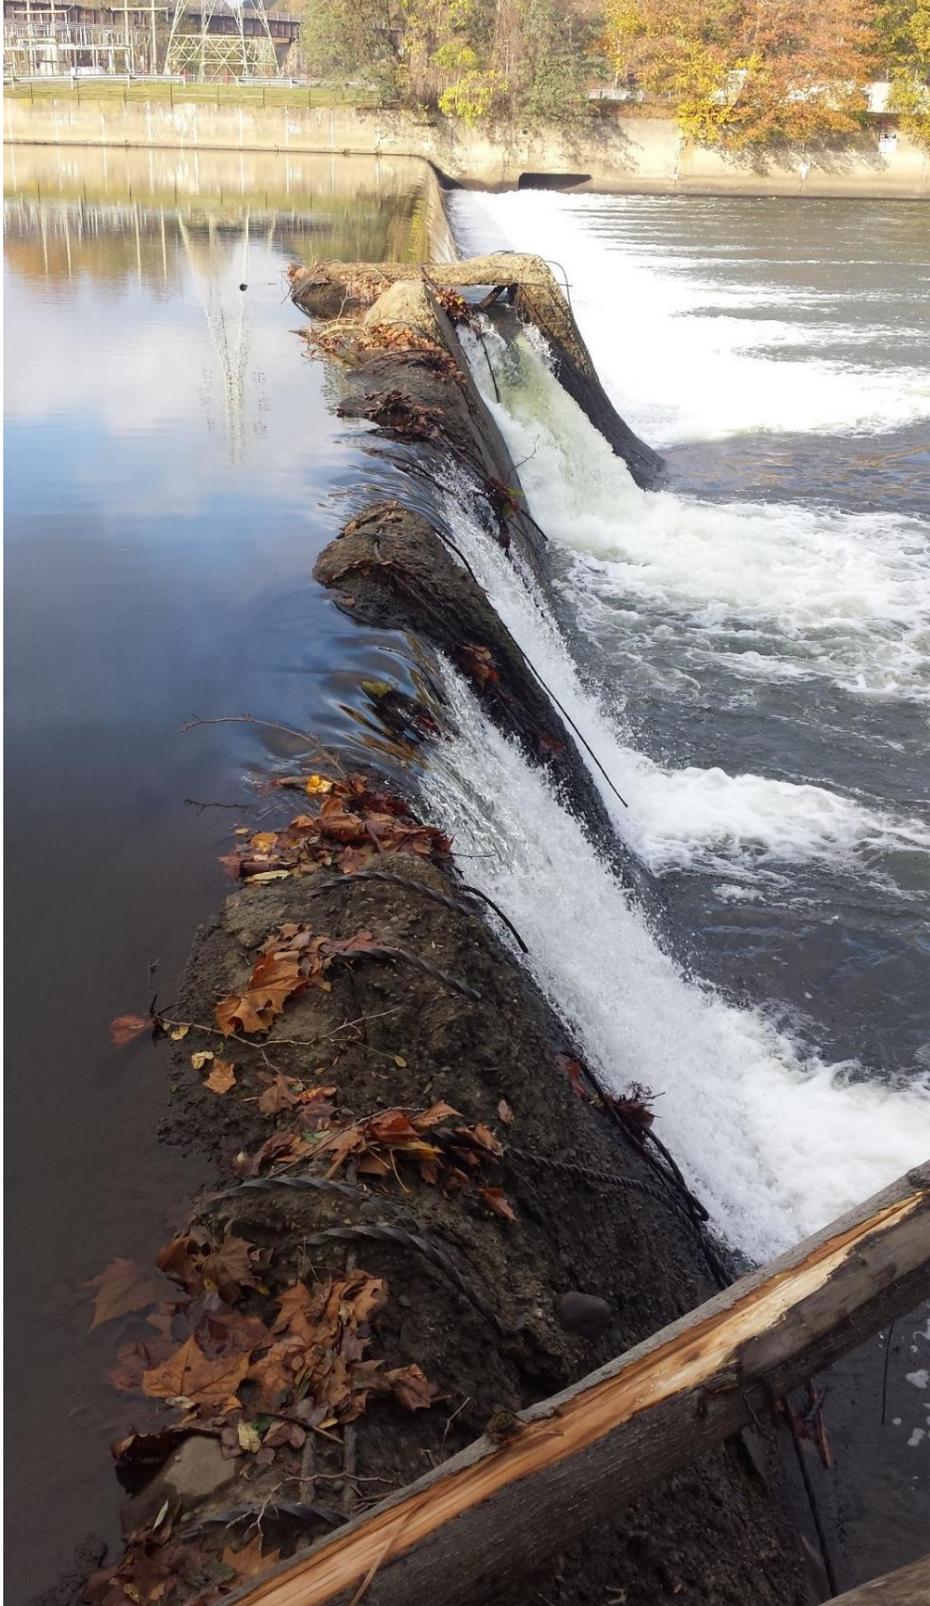
Non-overflow section – spalling, section loss and exposed rebar

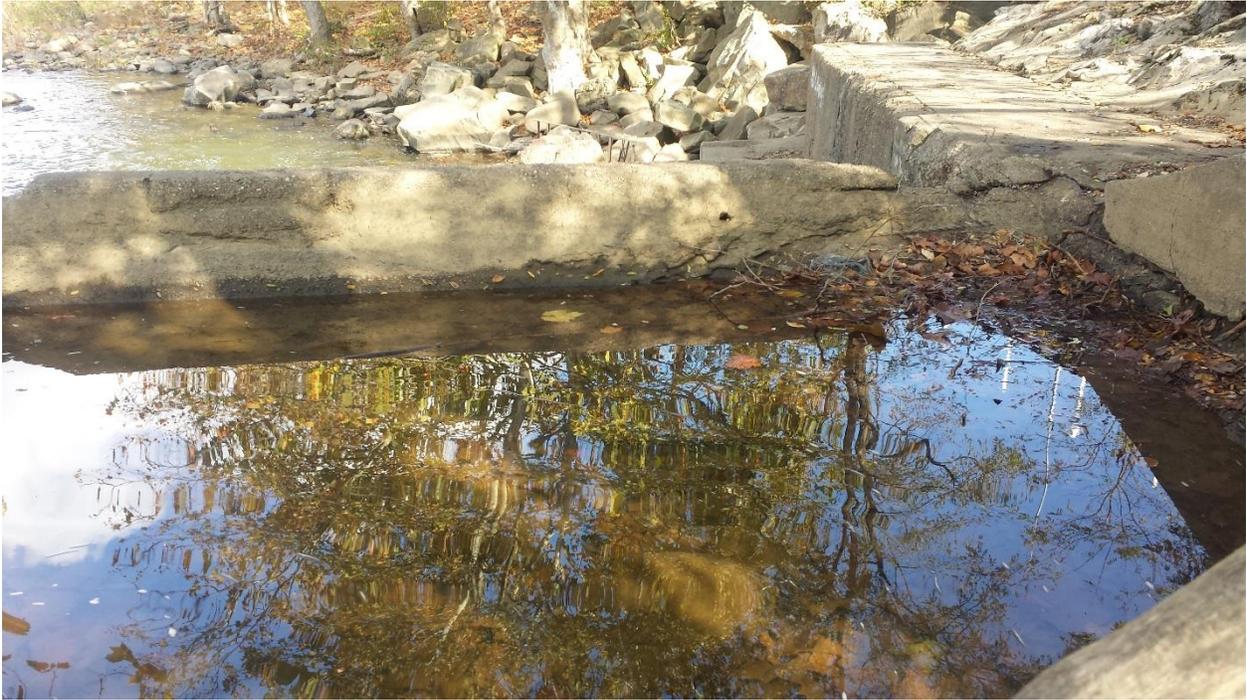
***Right Abutment*** – Surface spalling exists on the existing concrete walls and structure. Grouted riprap at the railroad culvert discharge is undercut, causing voids under the riprap. The upstream abutment wall has erosion creating an undercutting void. See photographs in Appendix B

Right abutment for upstream – spalling and undercutting

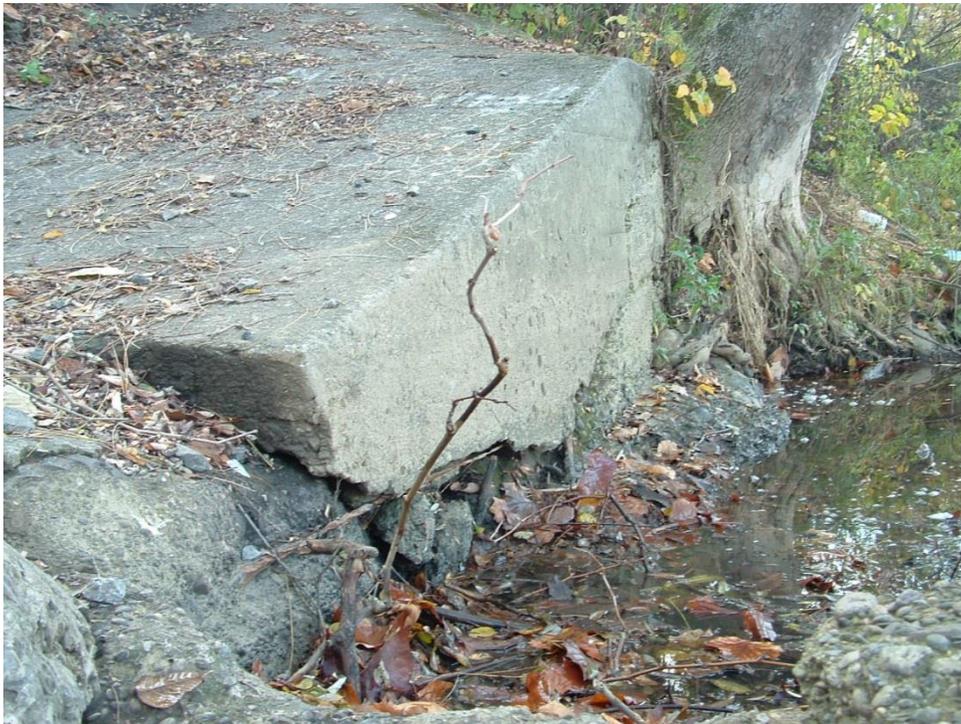
Right abutment upstream bank stabilization deterioration

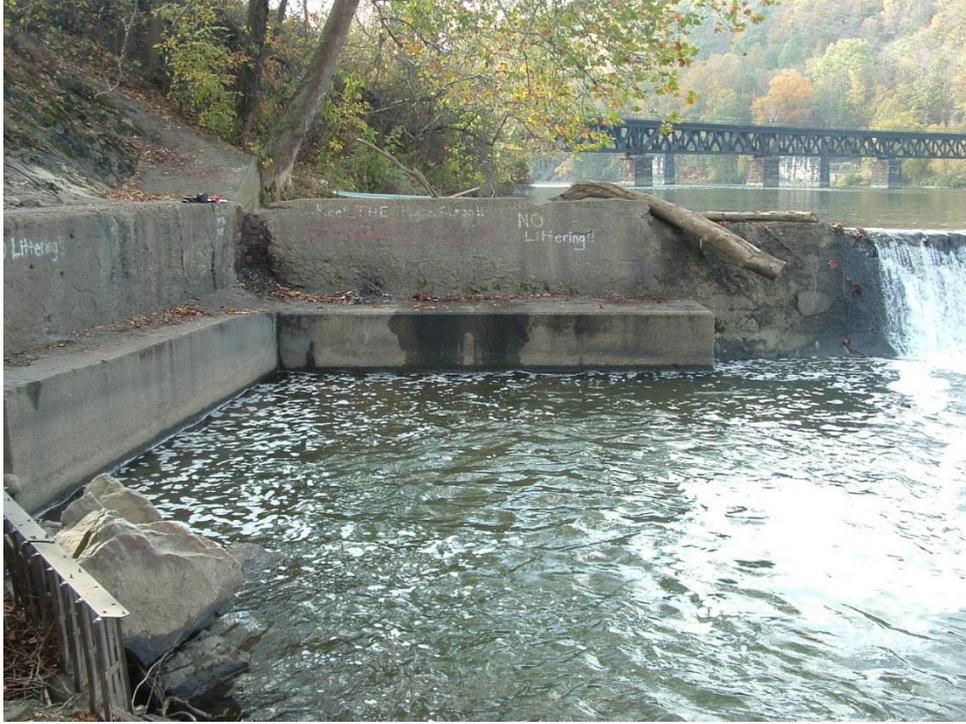
Right abutment from downstream - spalling

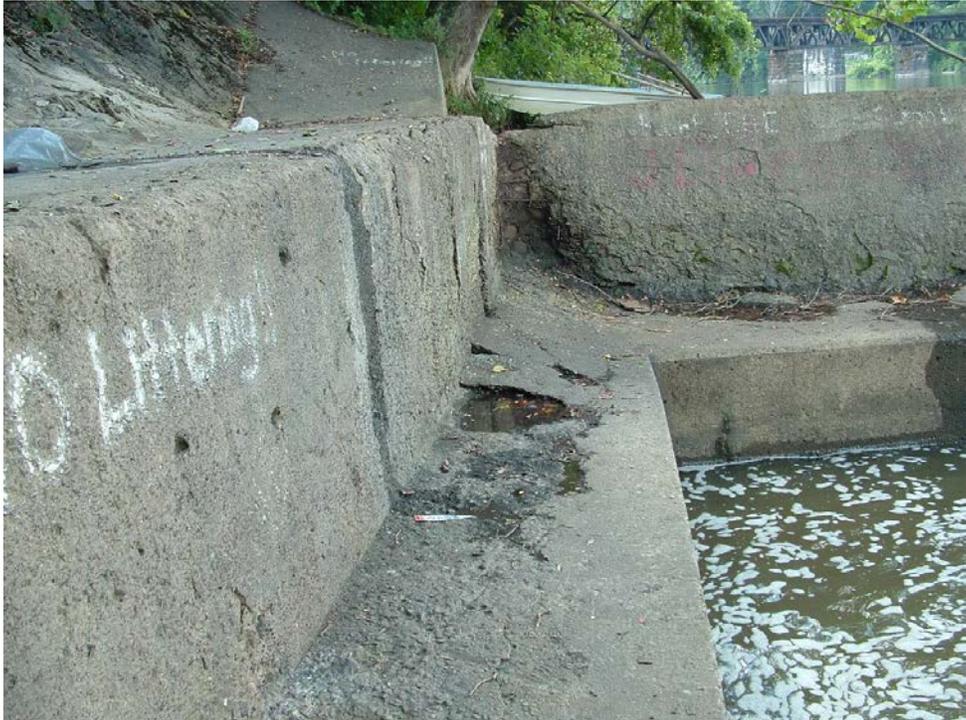
Dam right abutment from downstream – spalling and rebar exposed

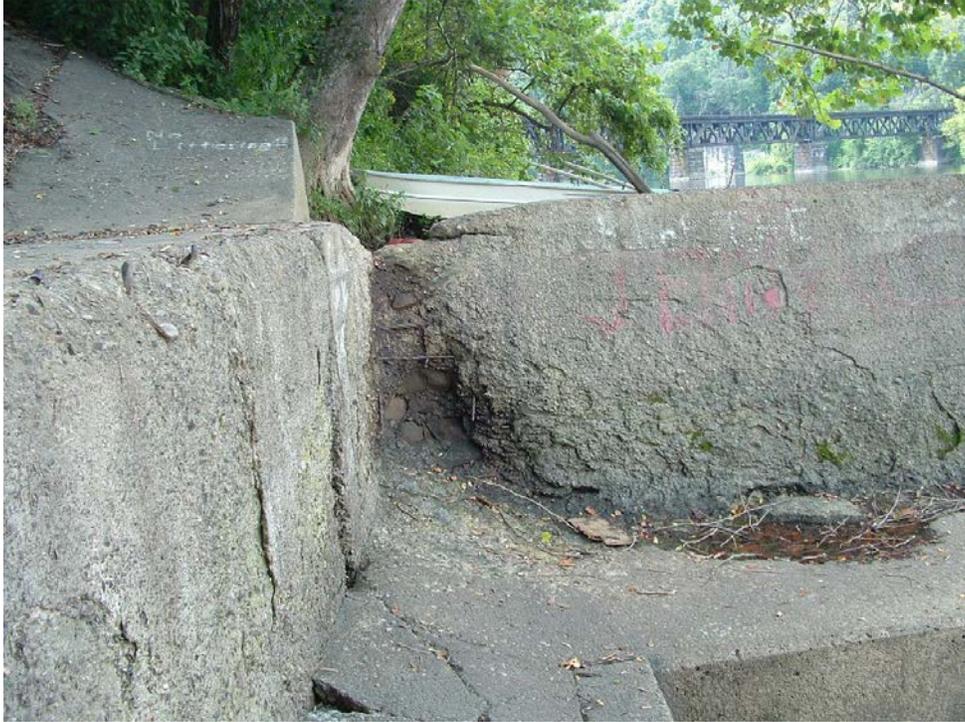
Dam right abutment from downstream – spalling and exposed rebar

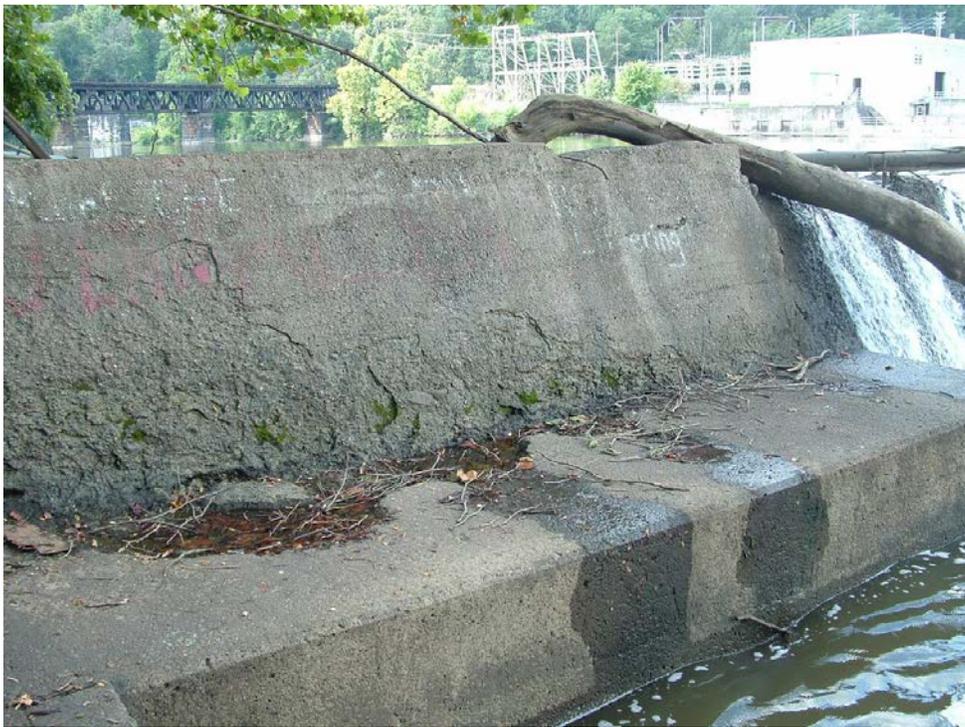
Dam right abutment from downstream – spalling

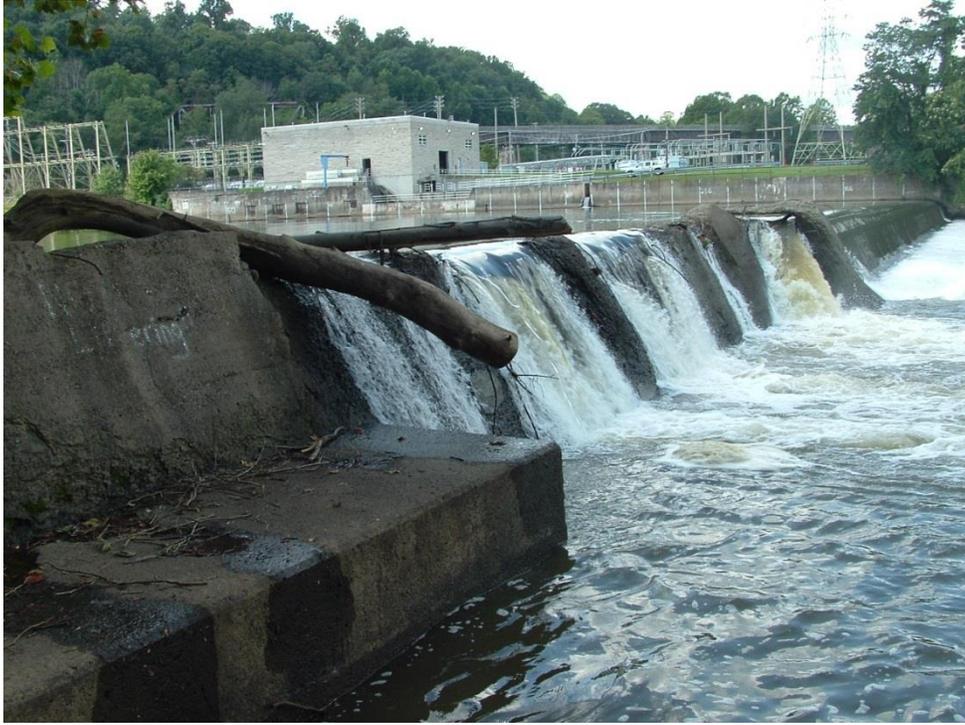
Dam right abutment and non-overflow section from downstream – severe spalling and exposed rebar

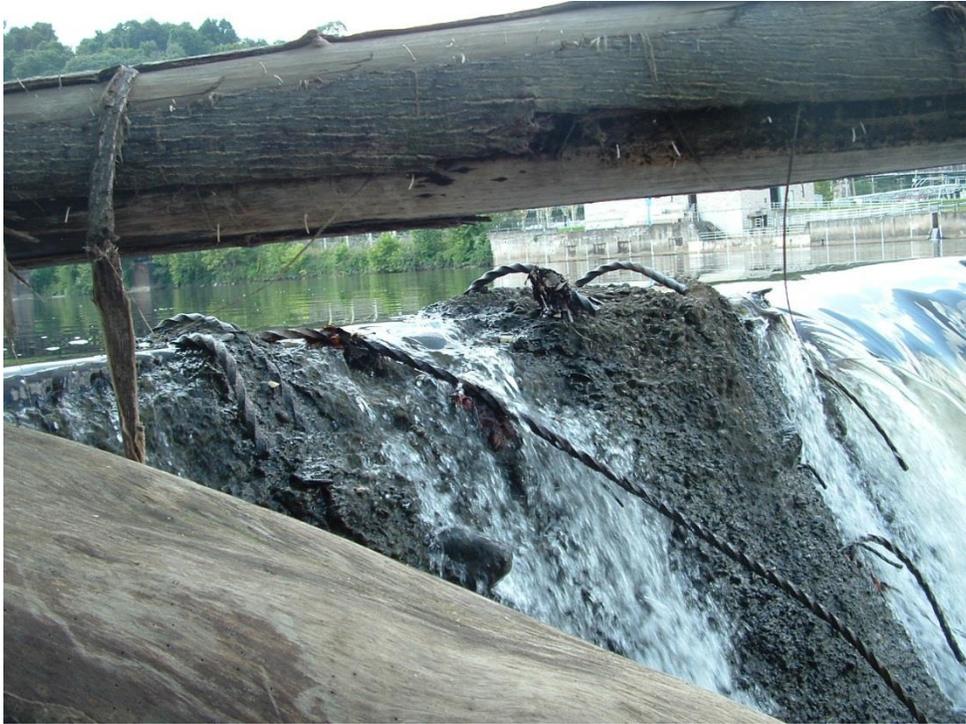
Dam non-overflow section extensive spalling and exposed rebar – enlargement

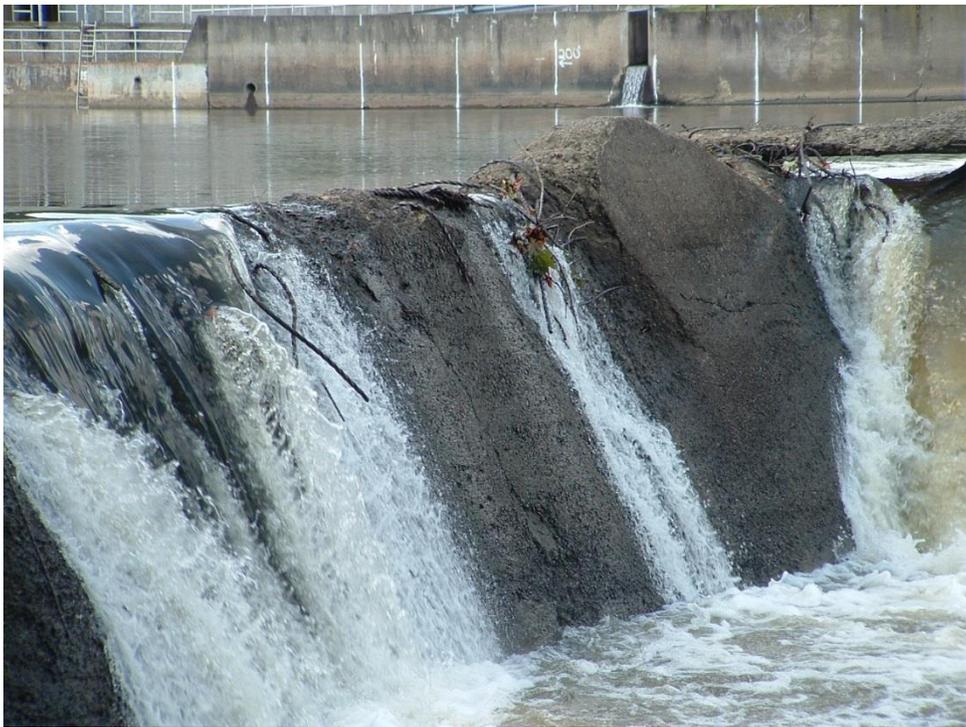
Dam non-overflow section from downstream – severe spalling and exposed rebar – enlargement

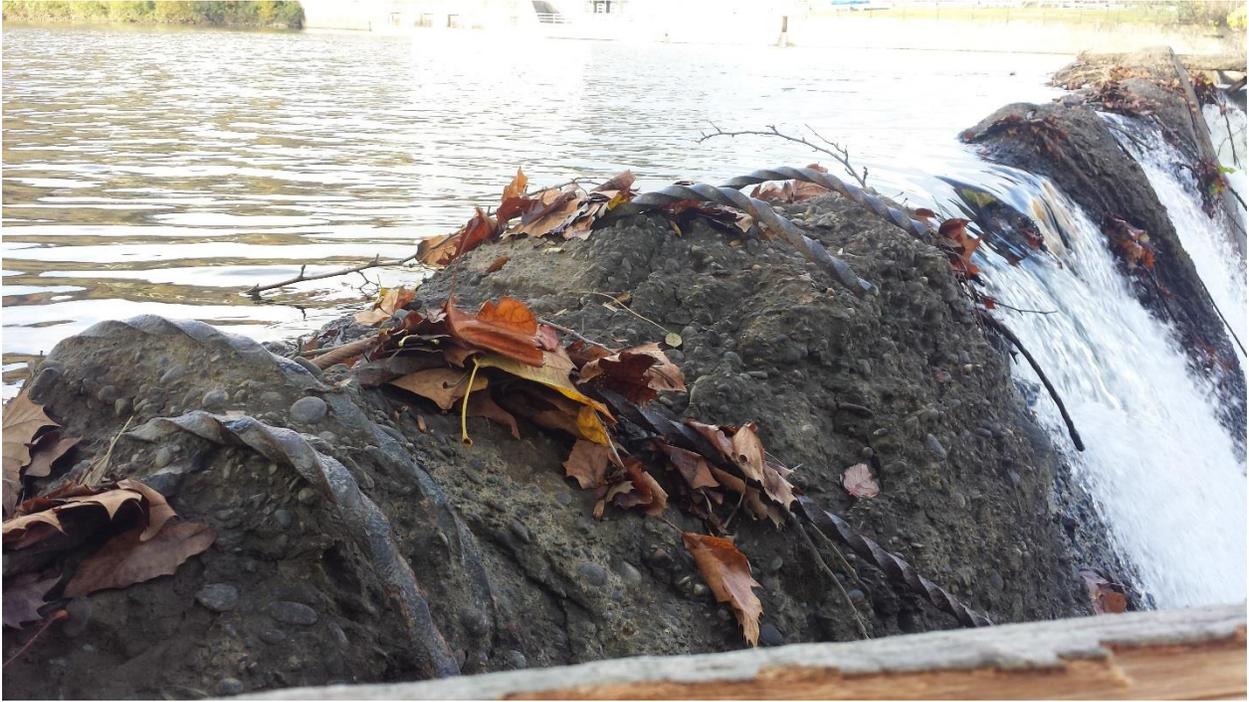
Dam non-overflow section from downstream – severe spalling and exposed rebar – enlargement

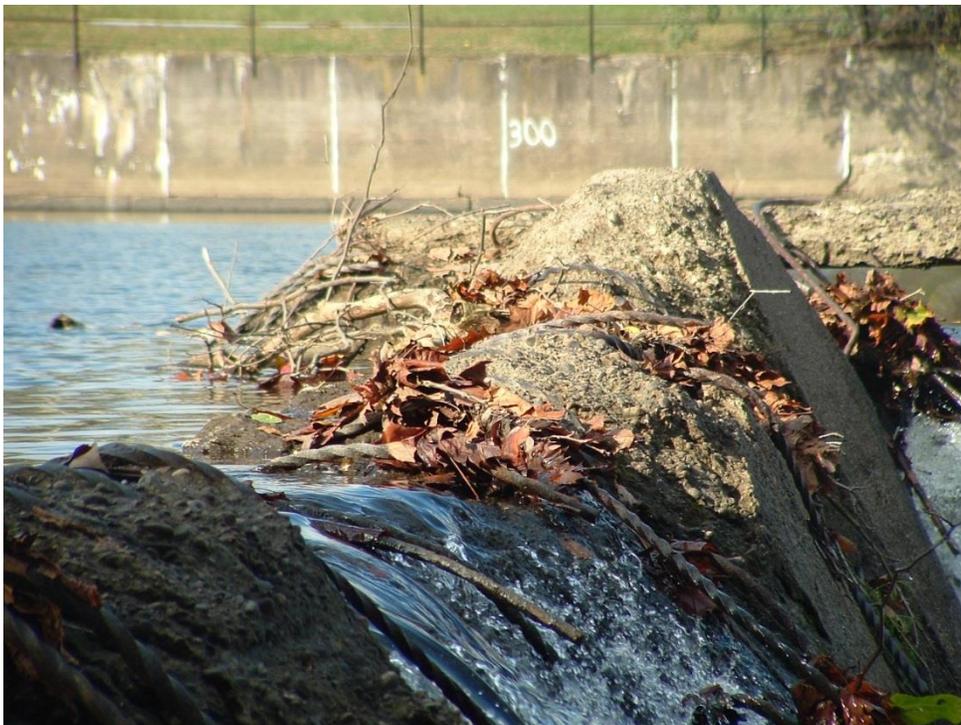
Dam non-overflow section from downstream – severe spalling and exposed rebar – enlargement

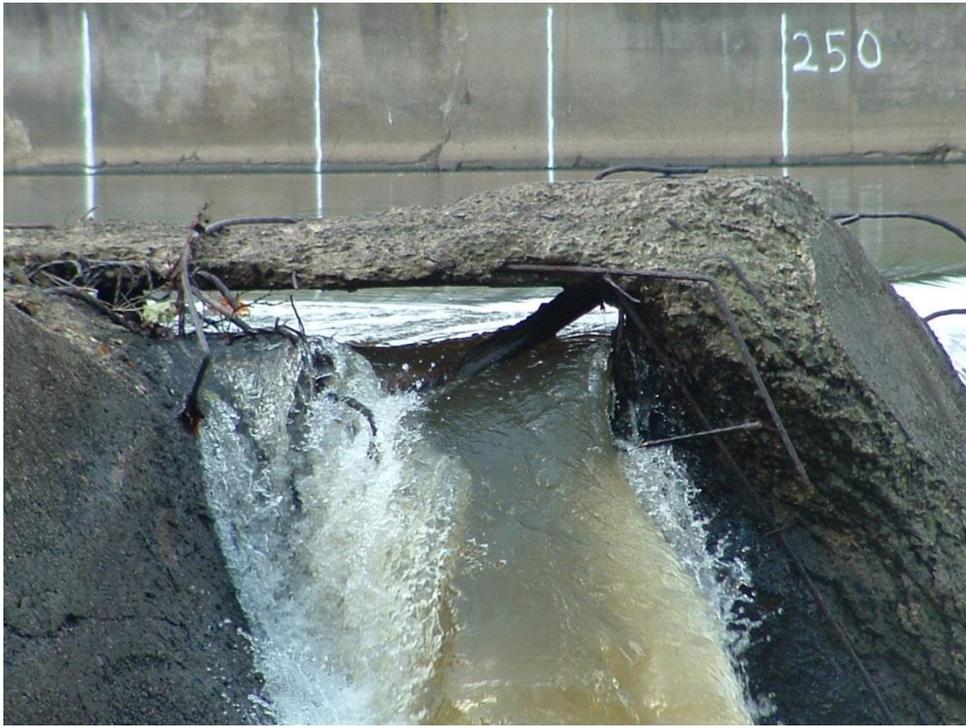
Dam access port (hump) from downstream - severe spalling and exposed rebar – enlargement

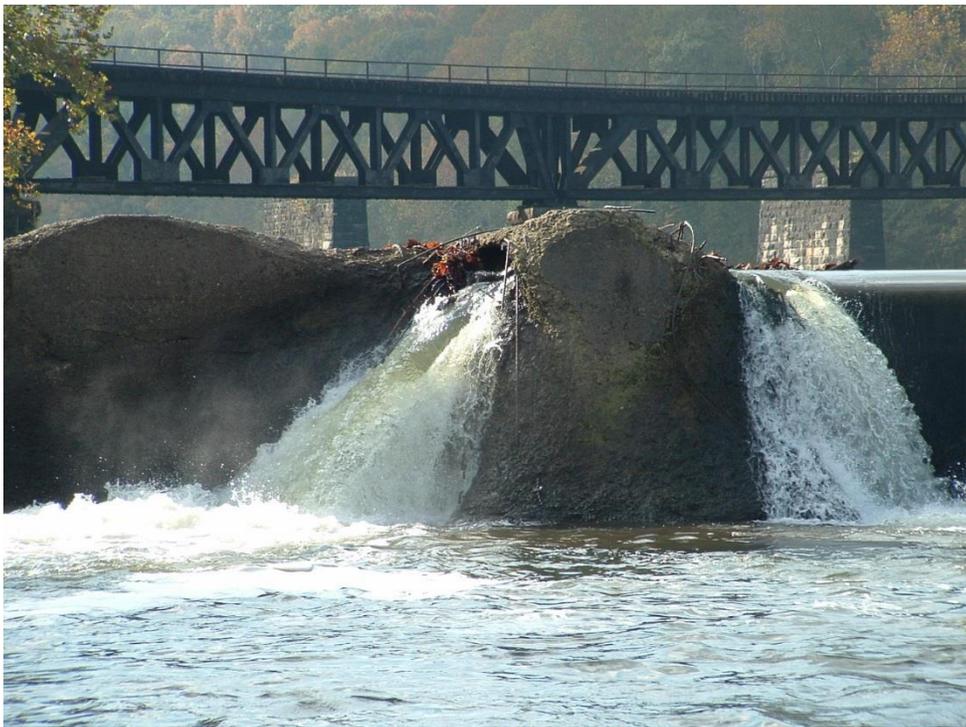
Dam access port (hump) from downstream

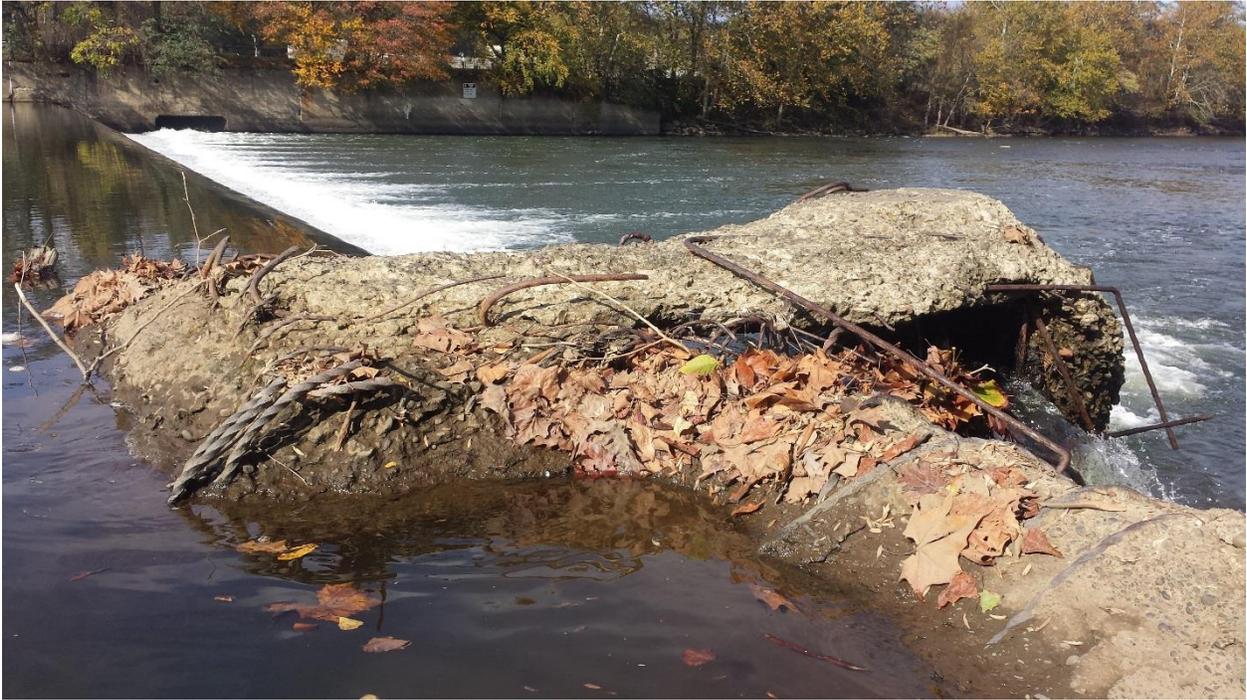
Dam access port (hump) from upstream

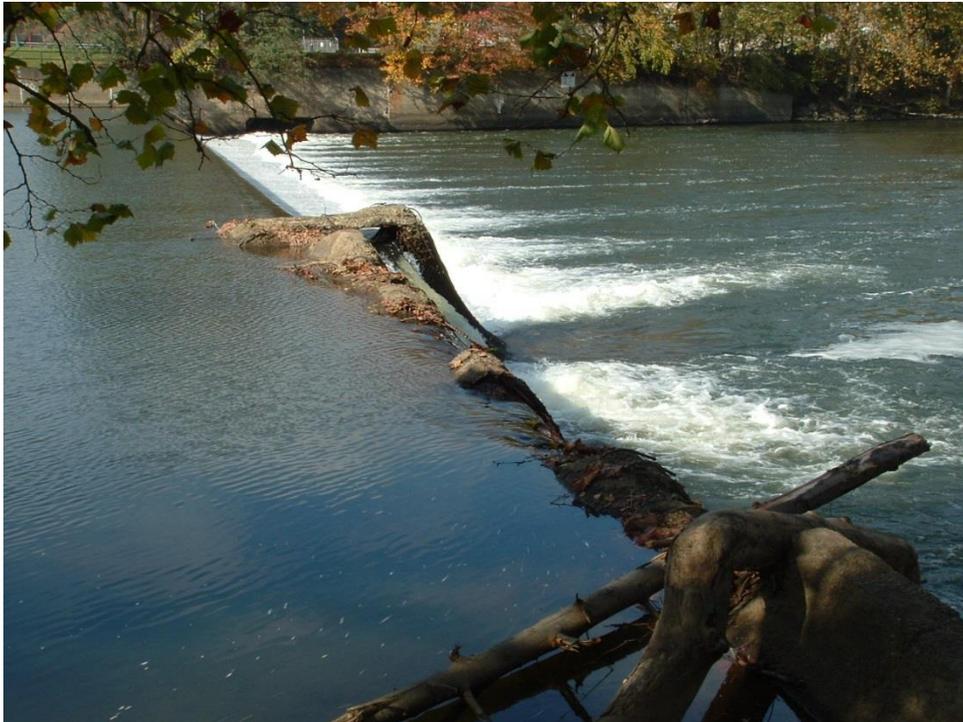
***Upstream Side of Dam*** - The concrete is in fair condition, with several minor undercut areas, small spalling areas, a few exposed reinforcement bars near the silt line, and depressions in the concrete from wood penetrations. See photographs in Appendix C. In the non-overflow section, there is significant spalling near the crest with exposed reinforcement bars. The spalling has resulted in the lowering of the crest of the dam in those location allowing overflows. See photographs in Appendix B.

Non-overflow section from upstream – severe spalling and section loss

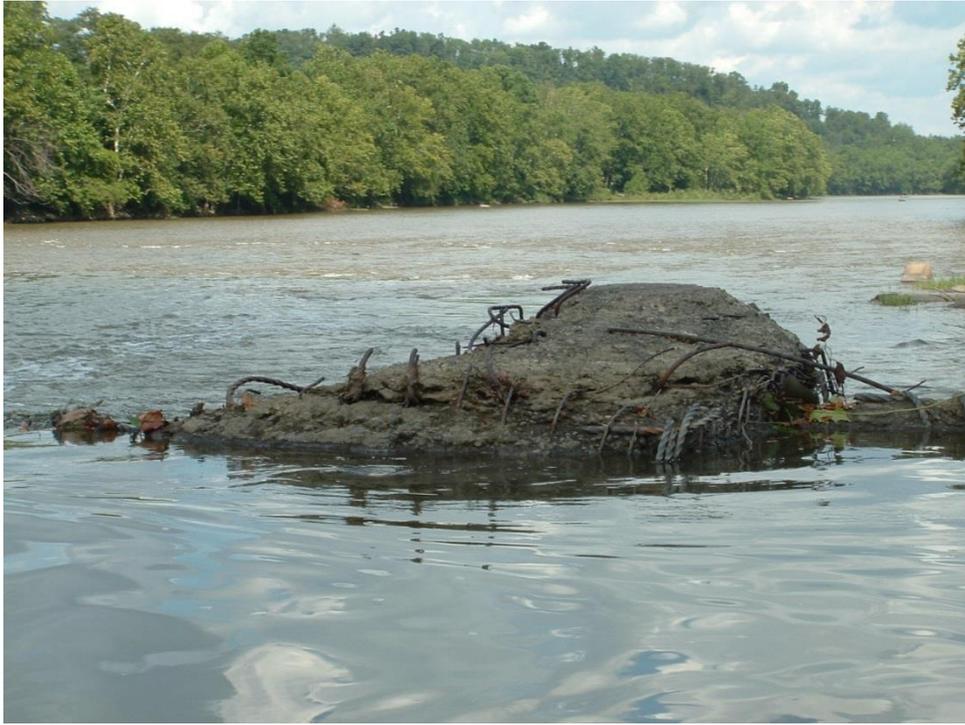
Non-overflow section from upstream – severe spalling, section loss and exposed rebar
