APPENDIX C

APPENDIX D

APPENDIX E

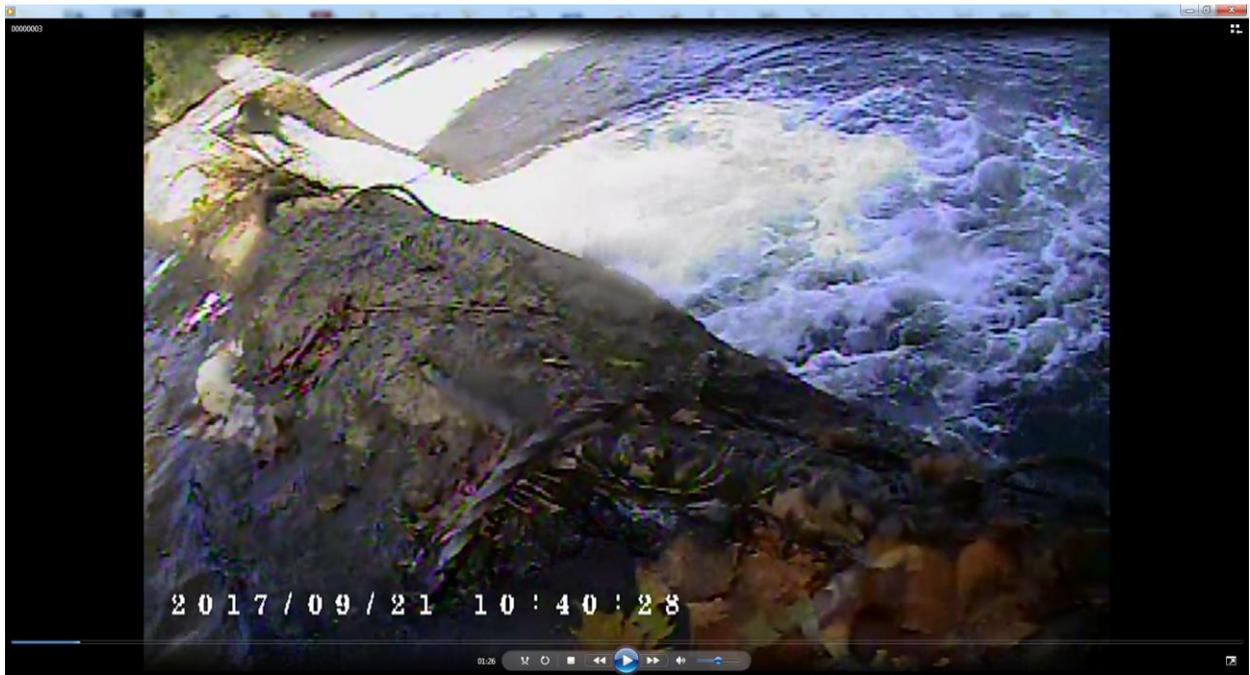
Deterioration of top of non-overflow section – right side of dam

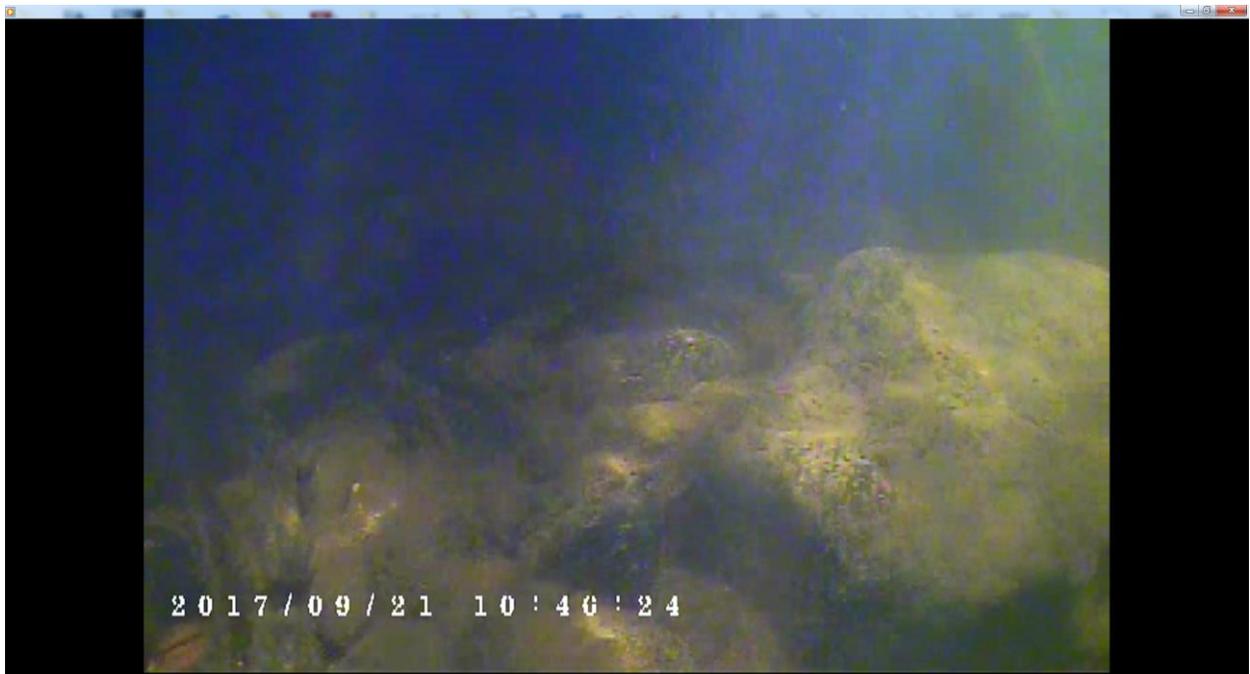
Upstream of dam rocky bottom

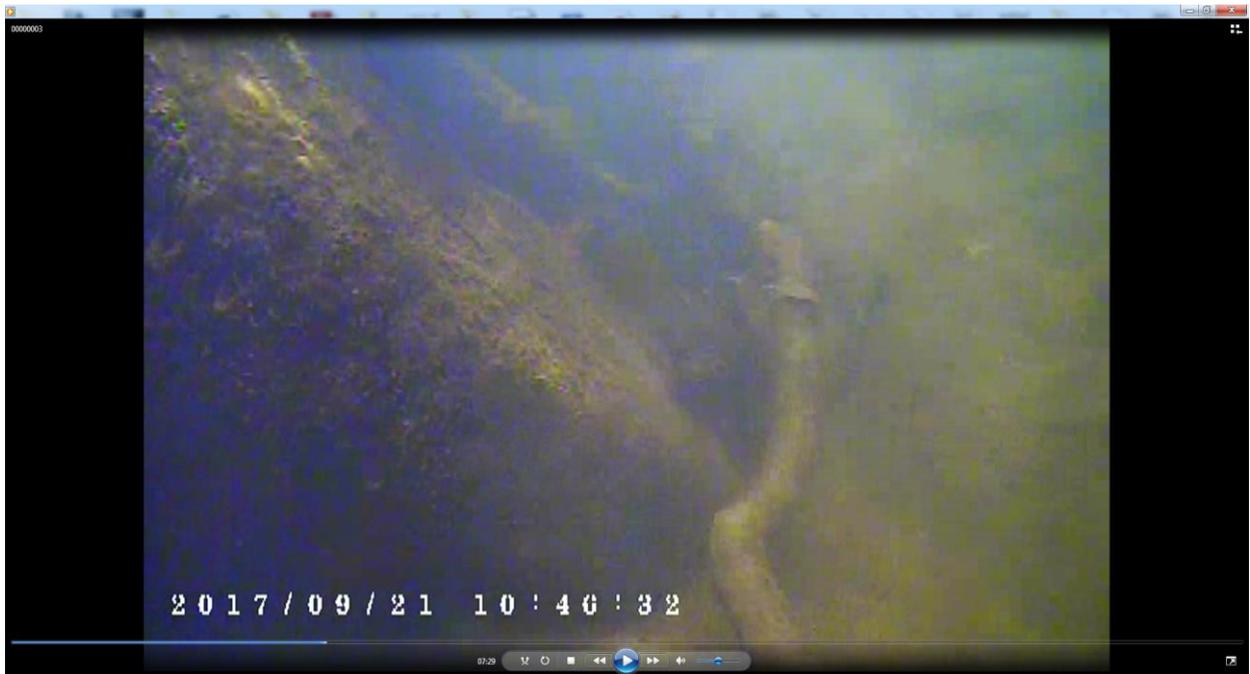
Upstream wall of old dam entrance location – flow beyond wall through 4-foot height window through dam

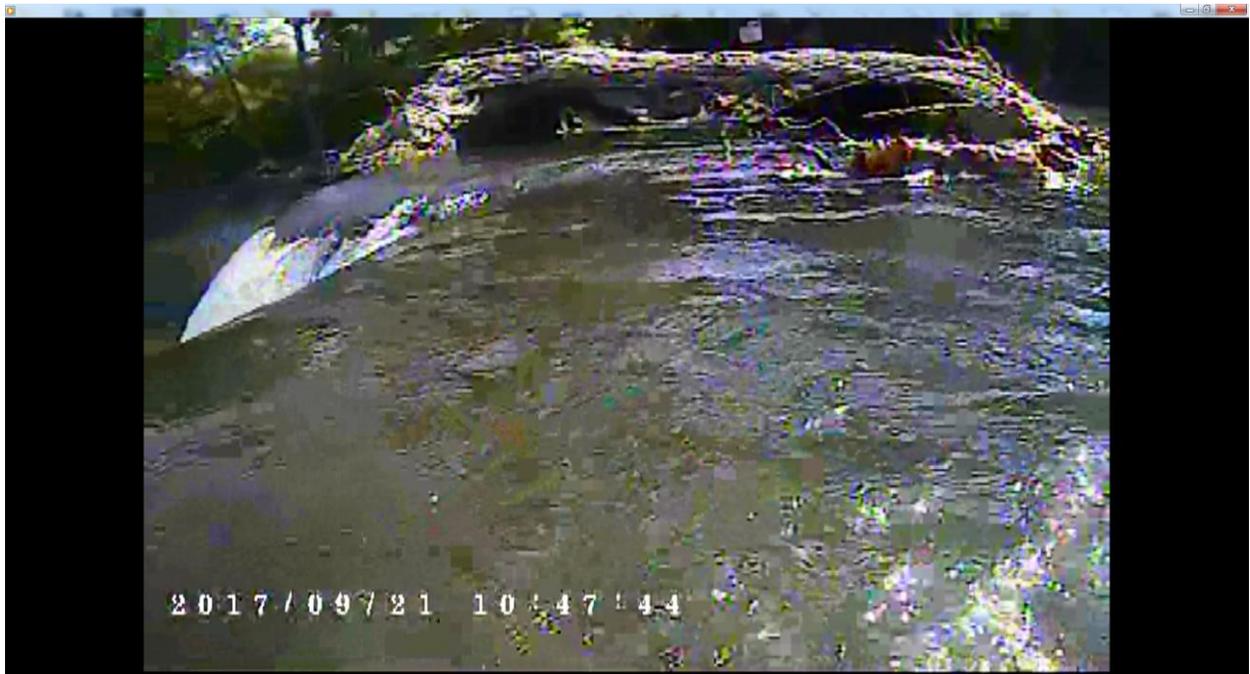
Overflow of old dam access location looking toward the right abutment

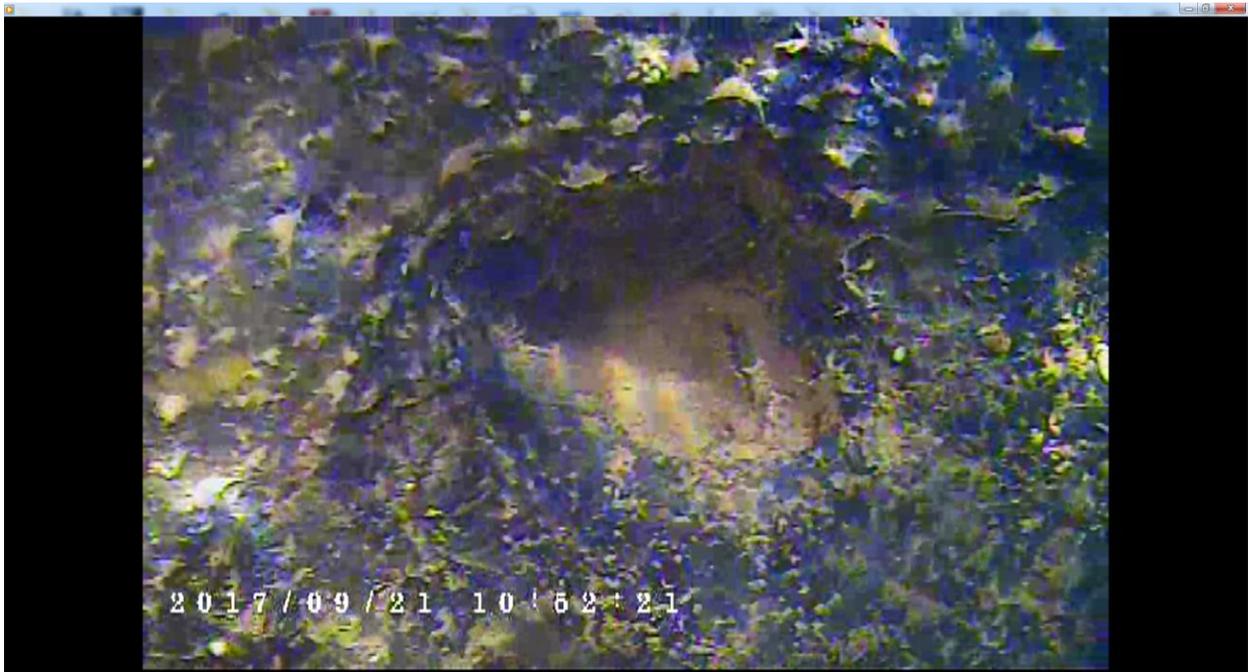
4" x 4" depression in concrete from wood formwork (wood present)

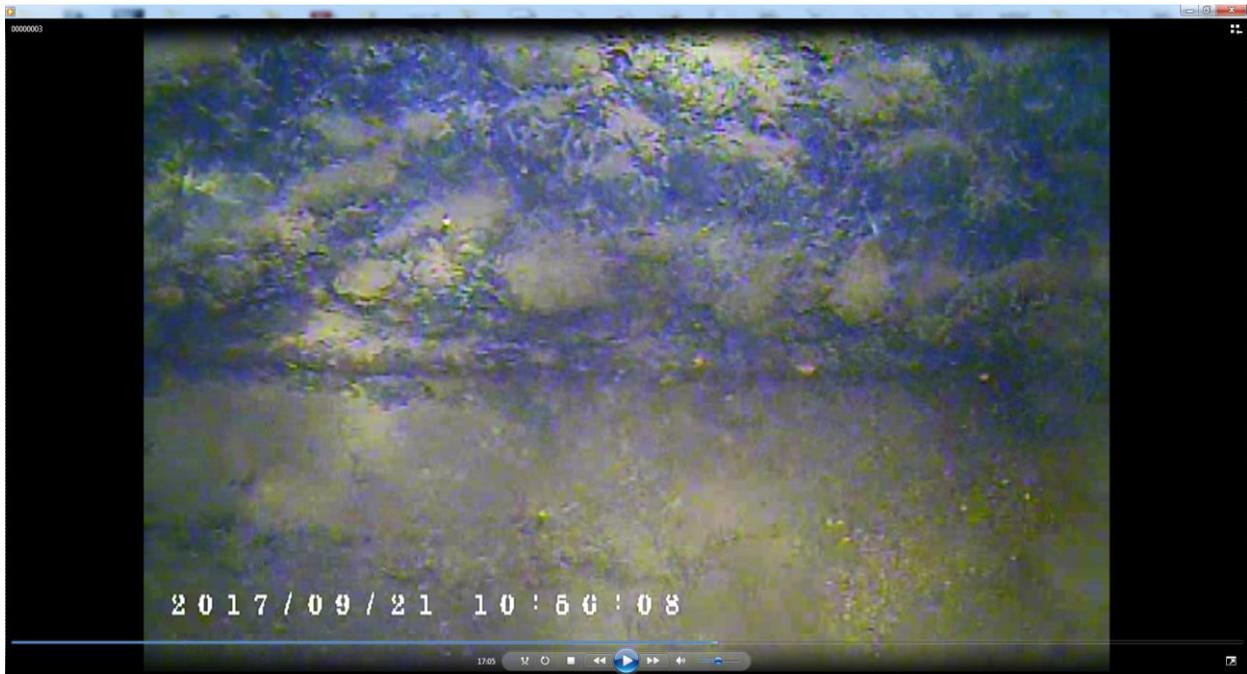
Exposed rebar above silt

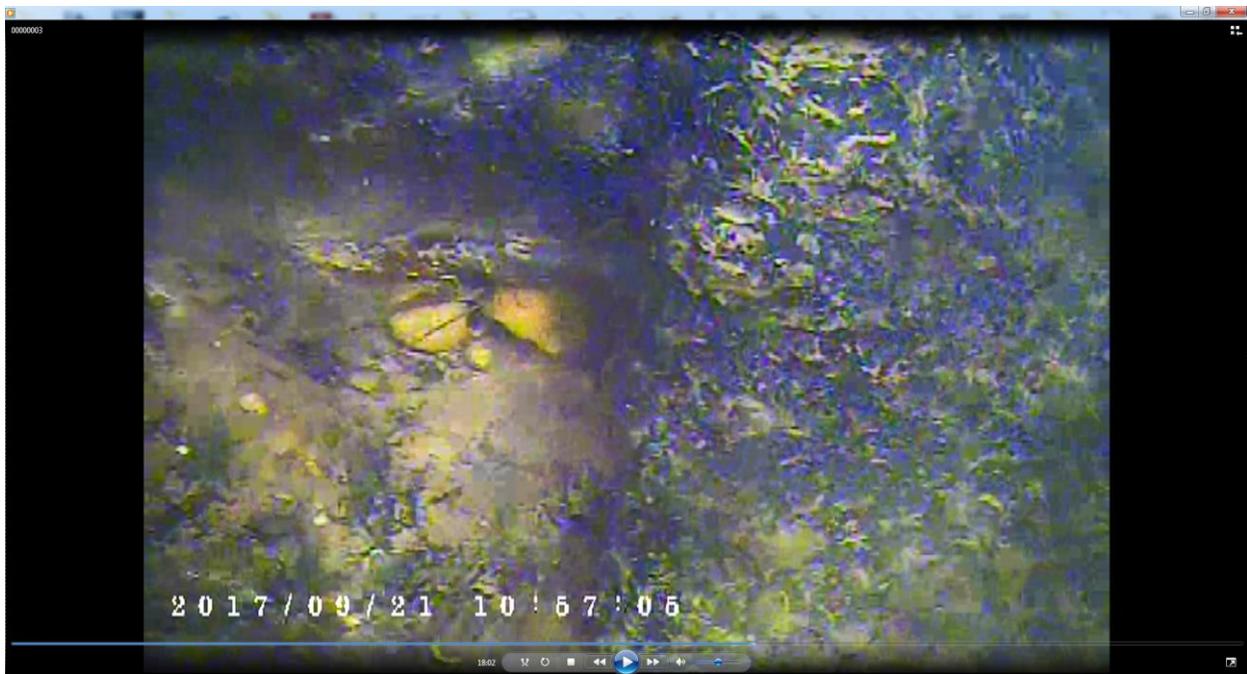
Spalling 1' x 1' x 10" depth and rebar exposed

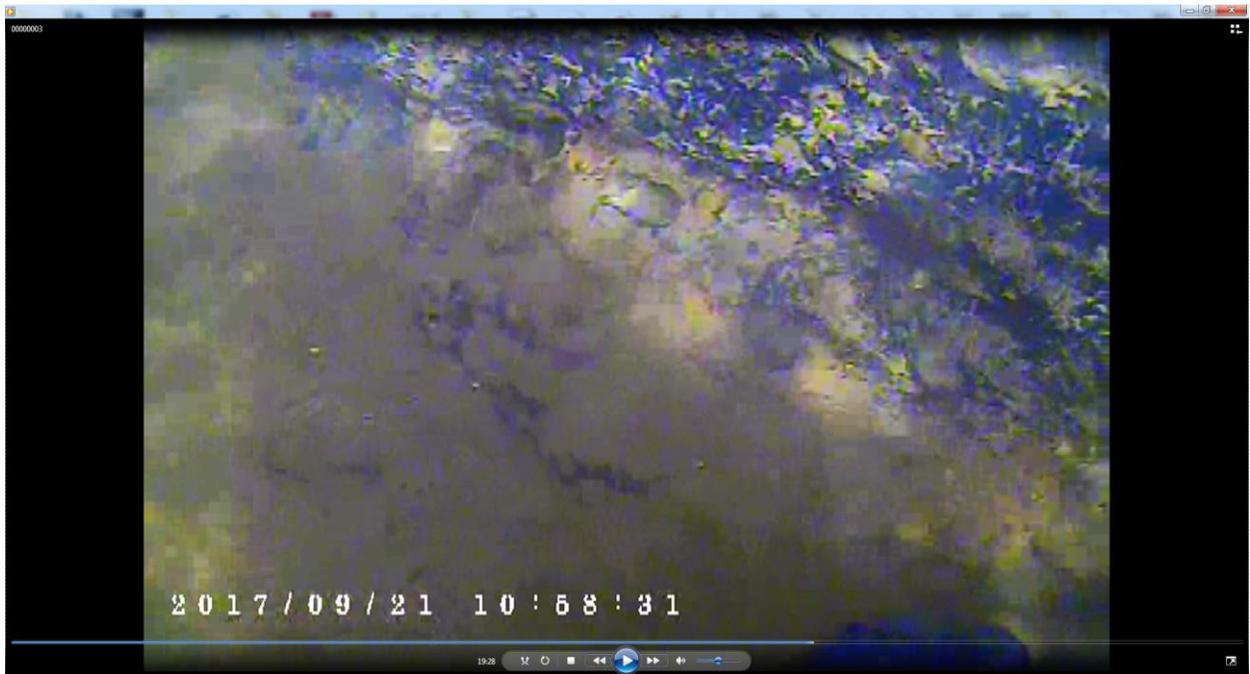
Small undercut approx. 4" depth

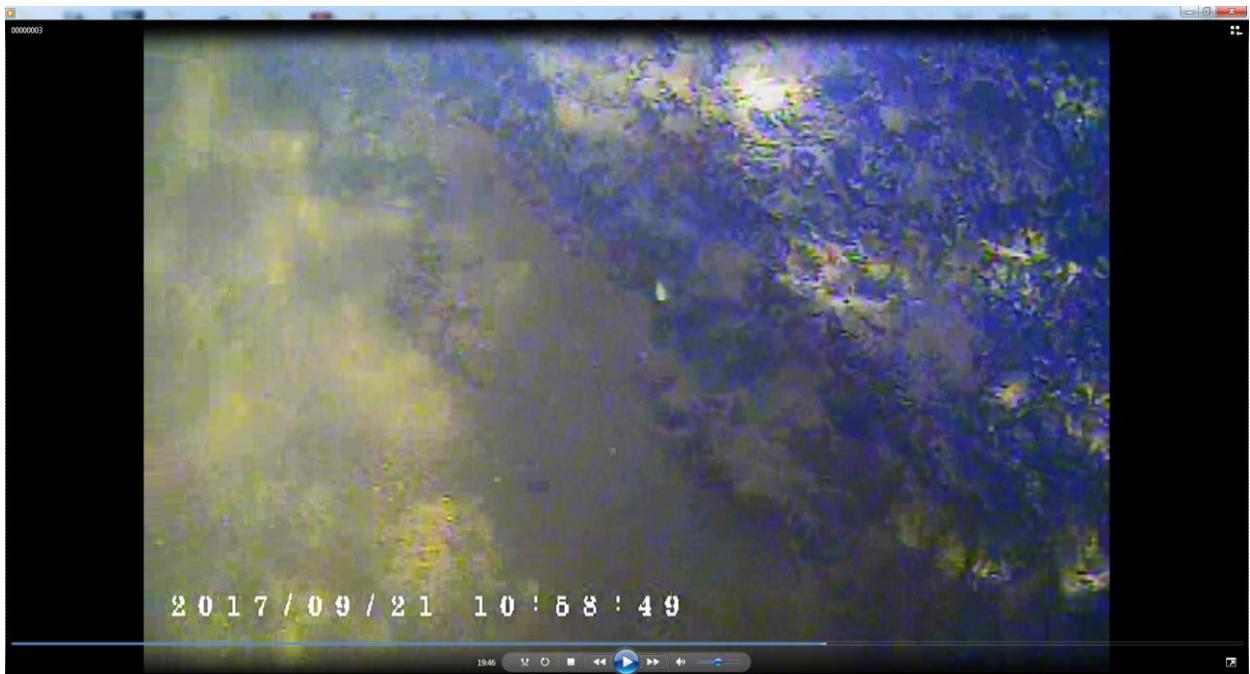
Spalling along toe

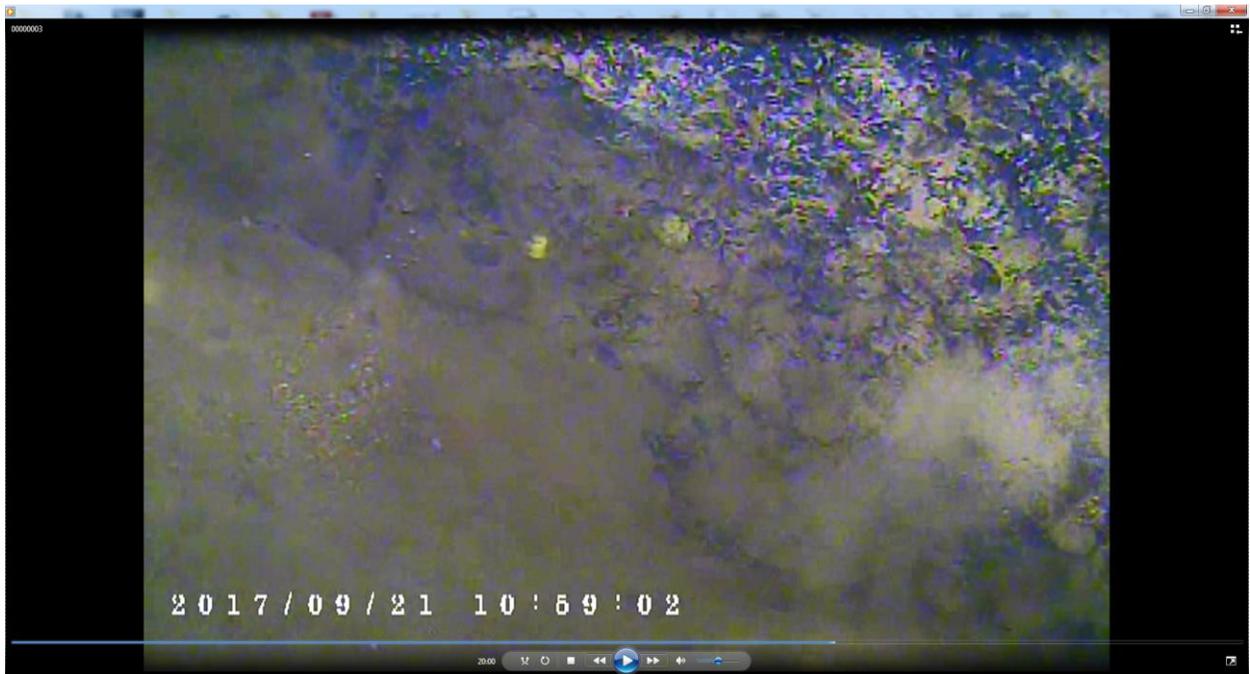
Spalling and undercutting at toe

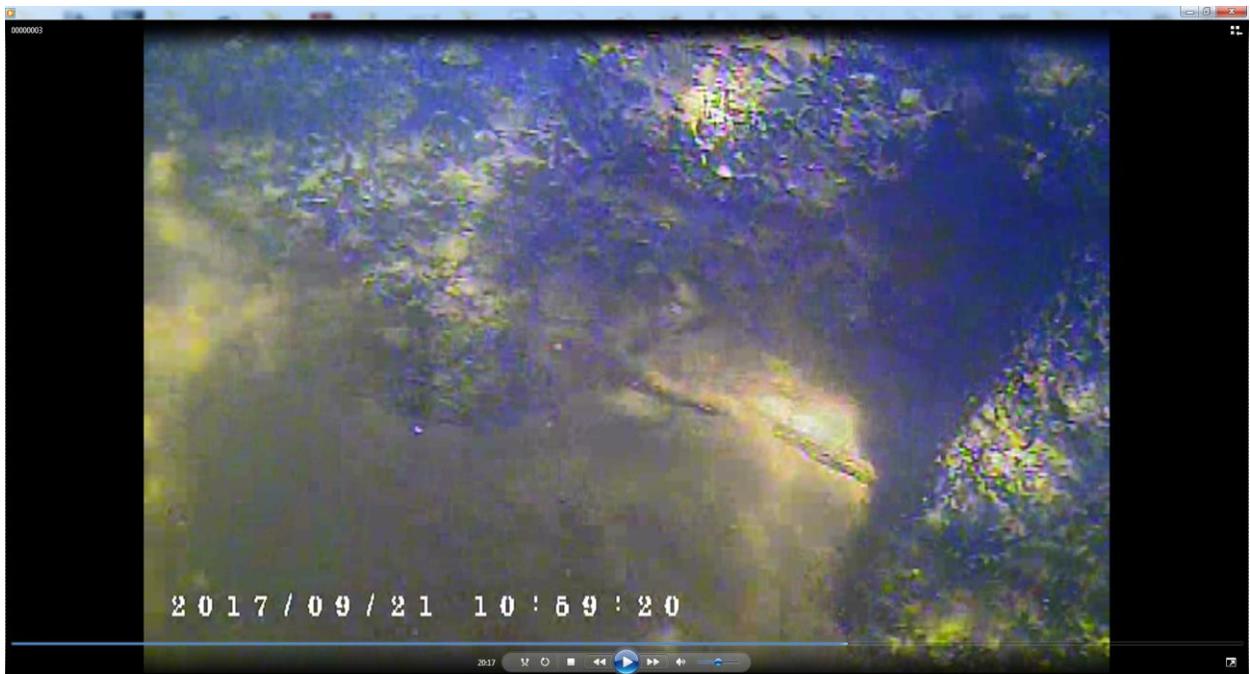
Spalled area with rebar exposed

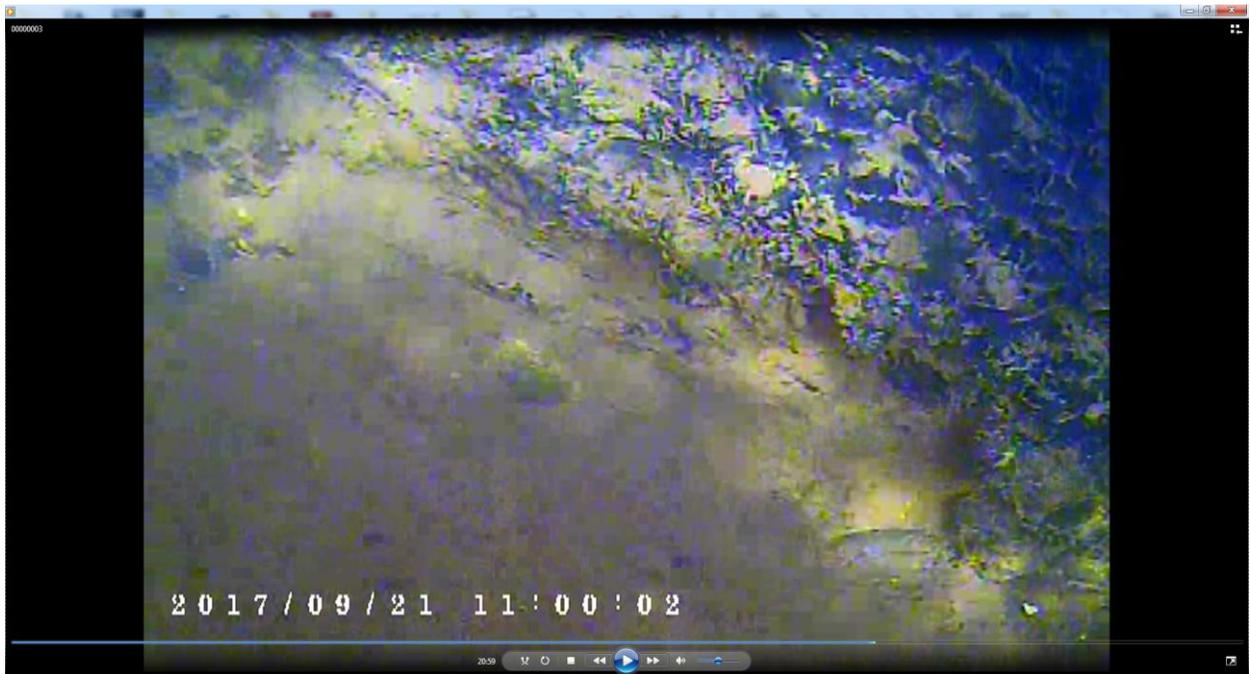
Wood formwork in concrete

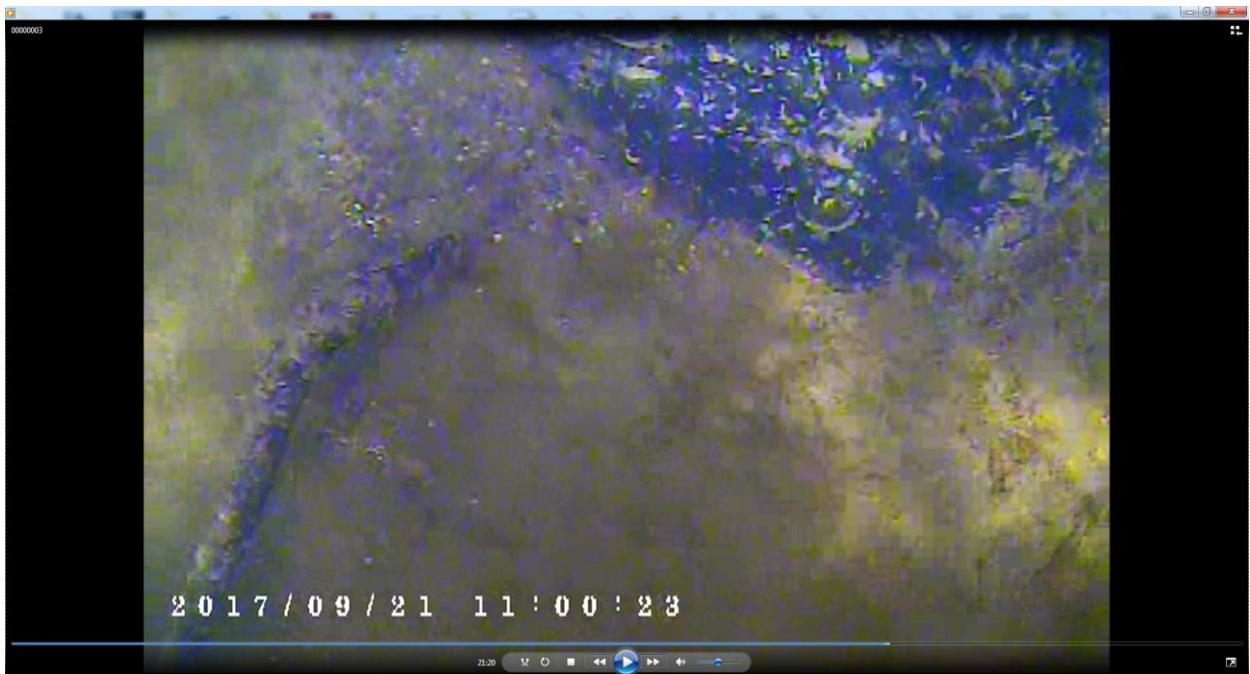
Exposed rebar at toe

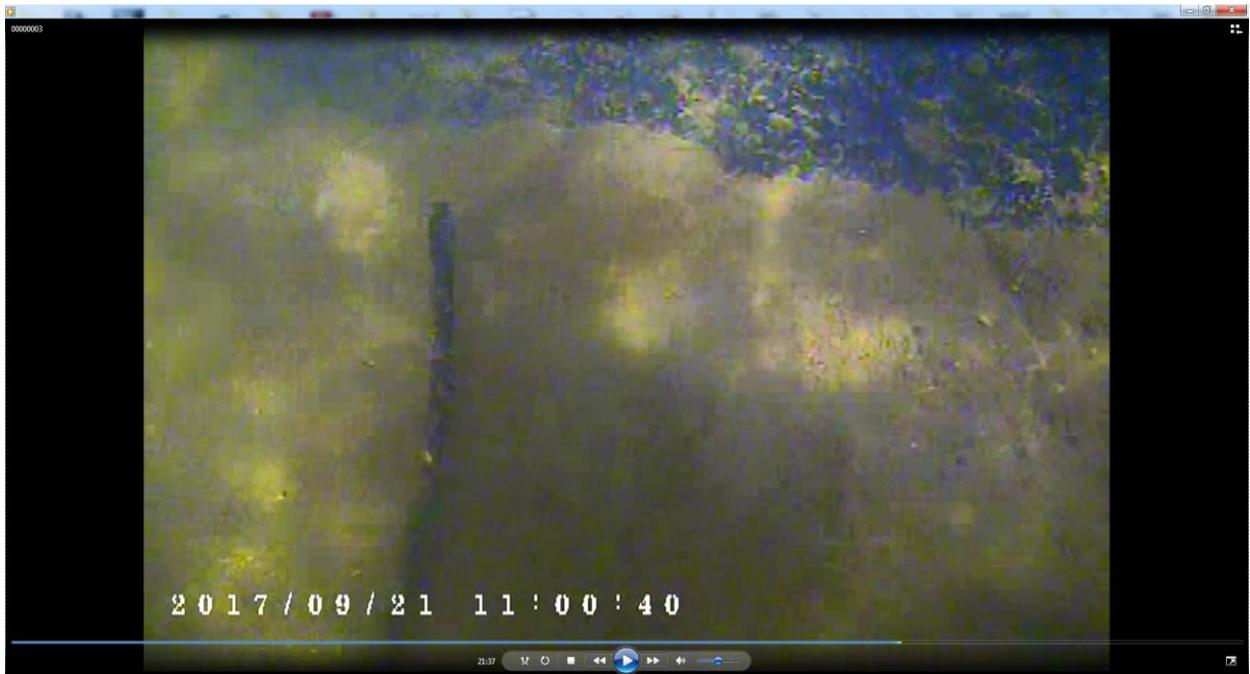
Exposed rebar at toe

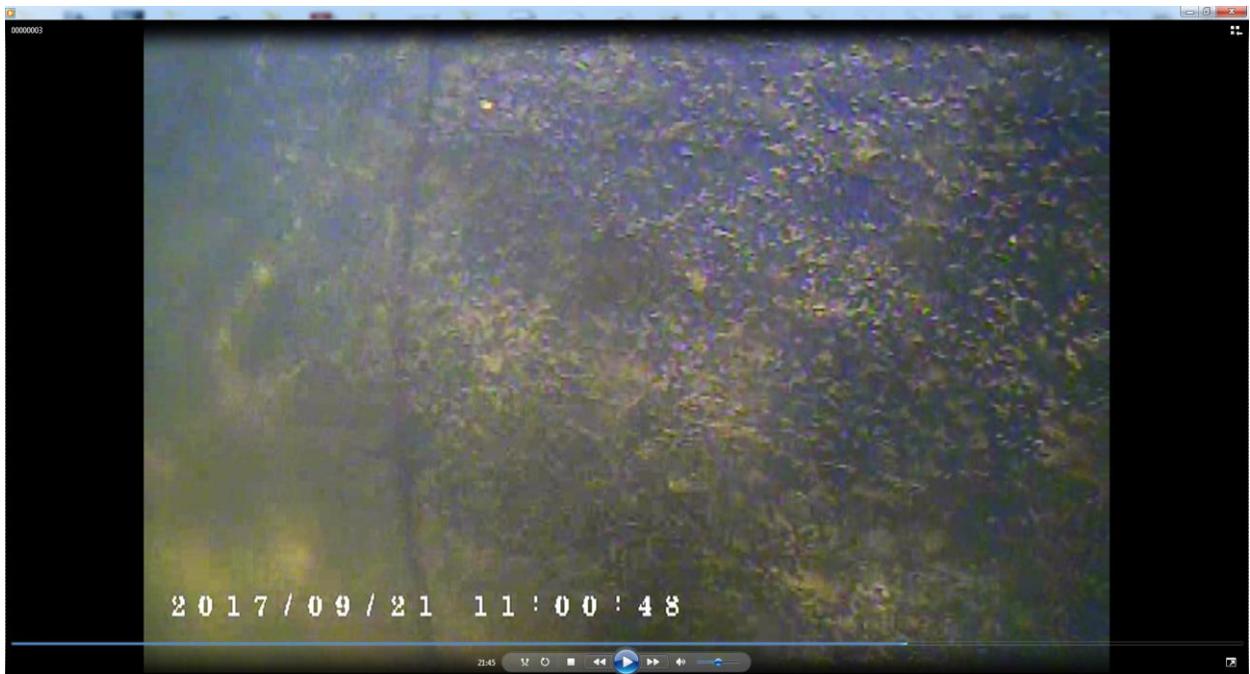
Exposed rebar at toe

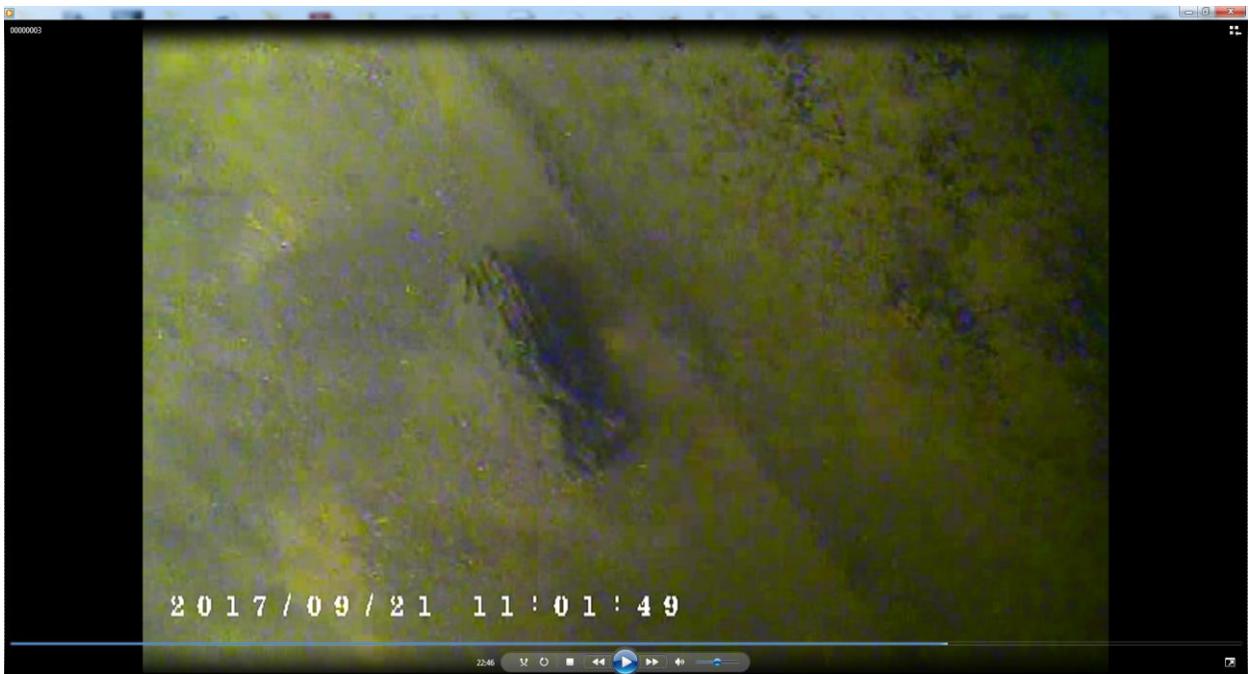
Formwork along toe

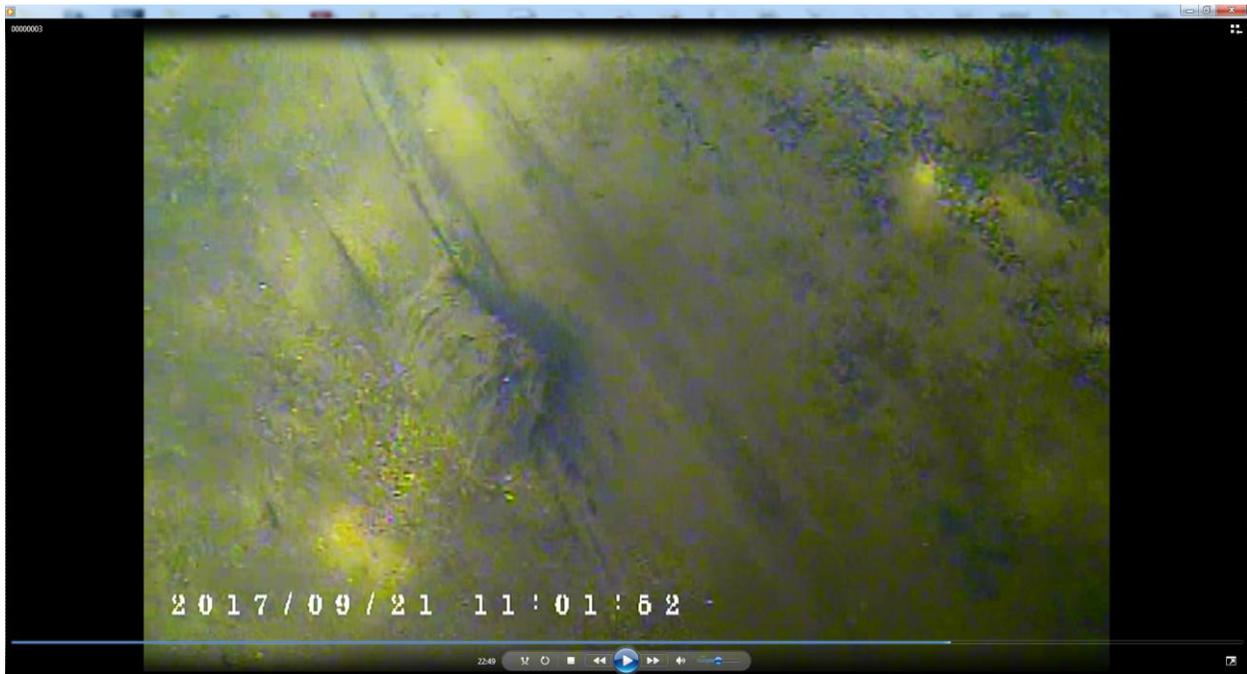
Formwork and rebar along toe

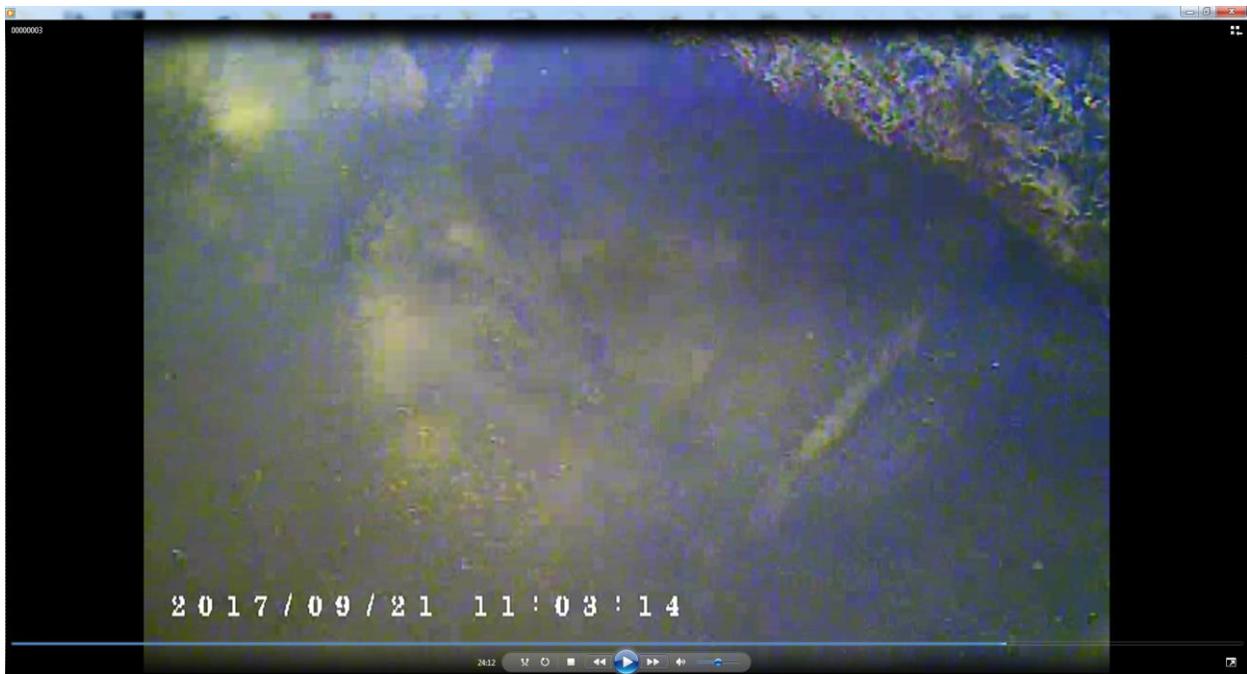
Square opening 12" depth with exposed rebar – 20' from left abutment

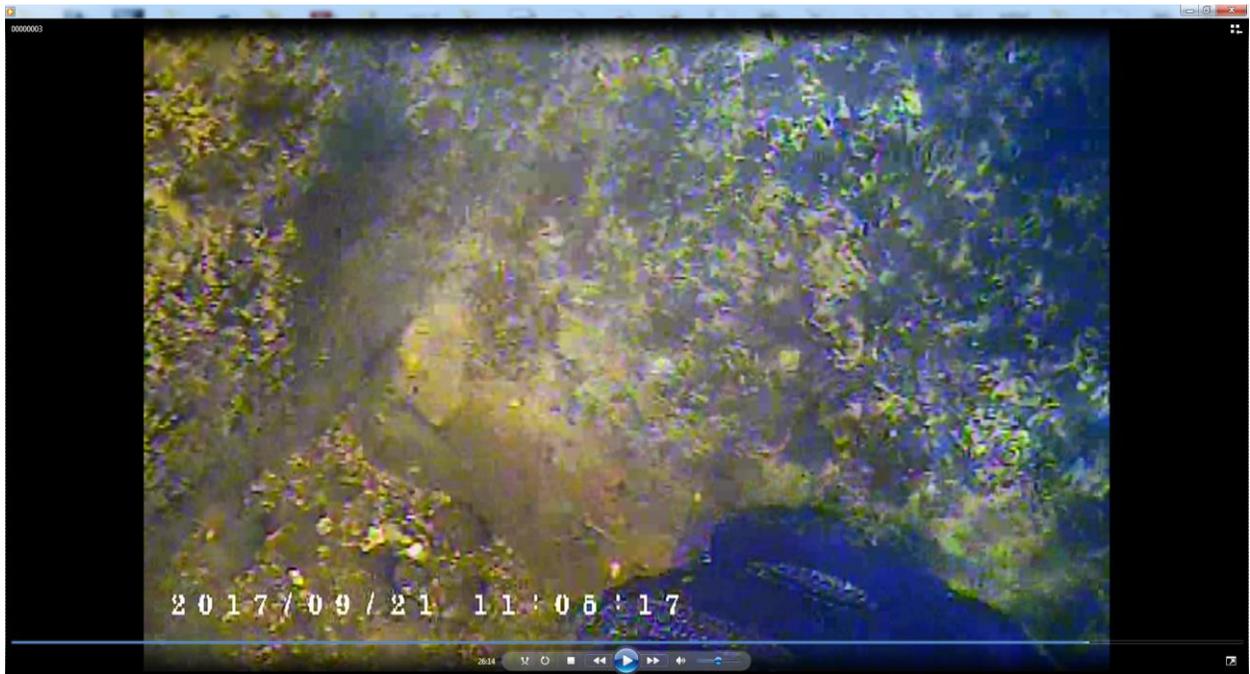
Spalling at dam left abutment and wall connection

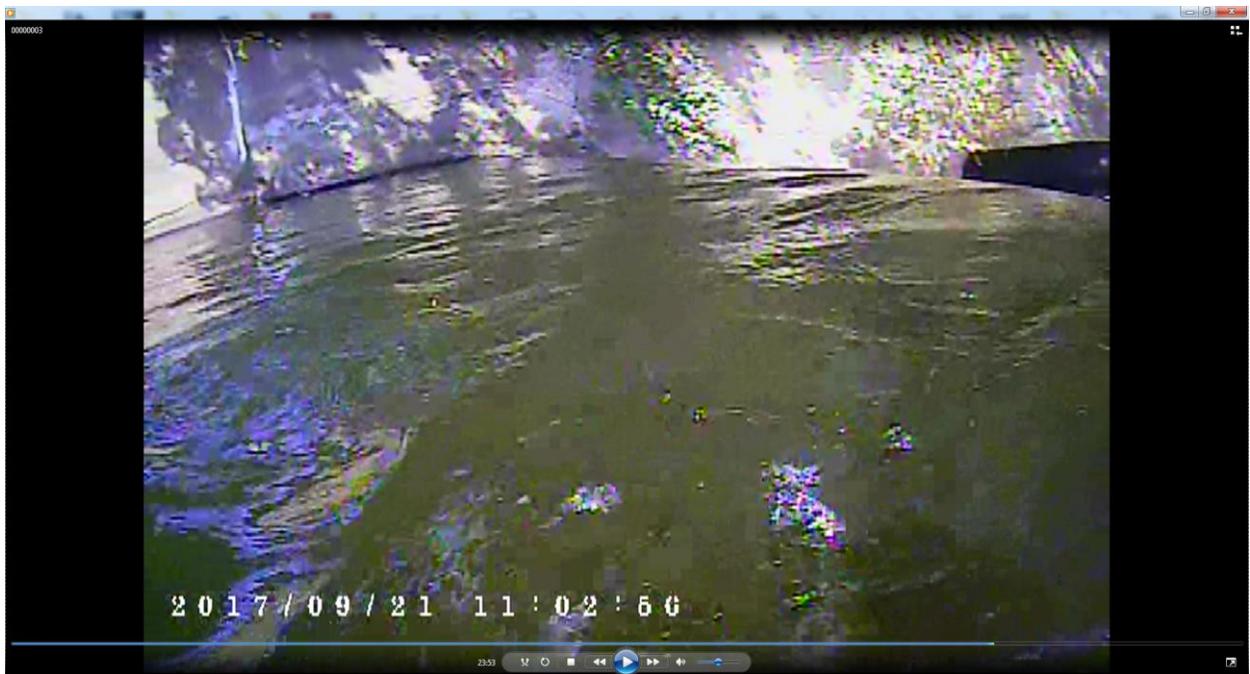
Left dam abutment at overflow section

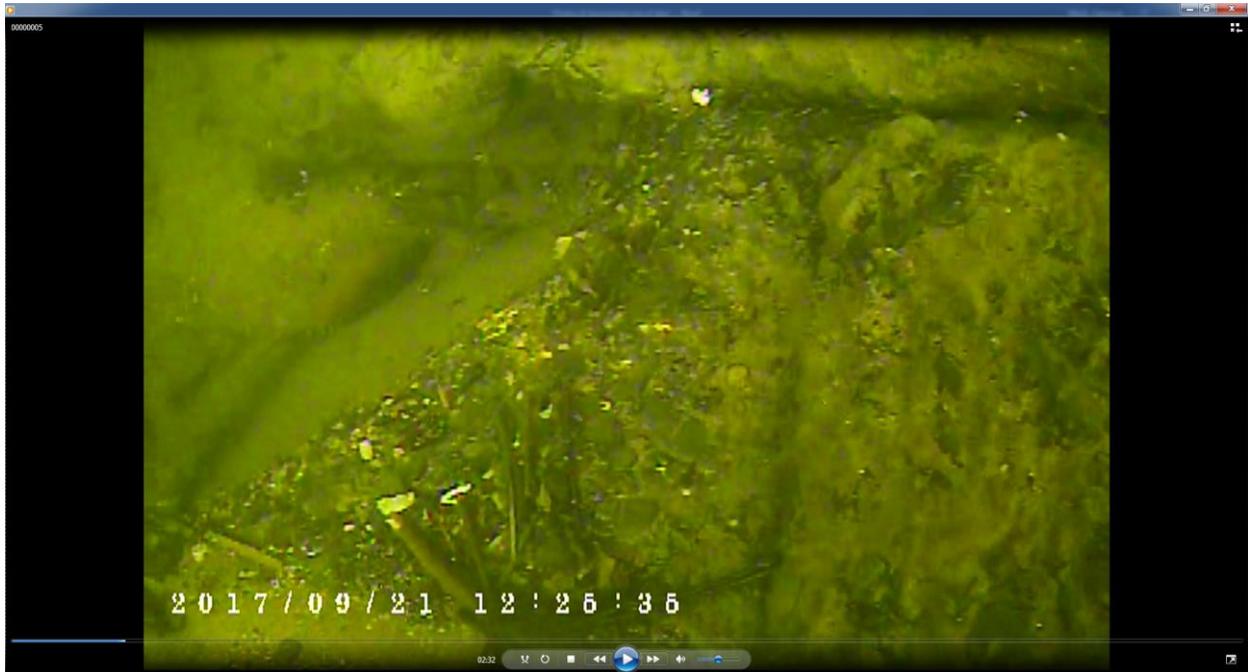
Dam cold joint deterioration at toe of apron near left abutment

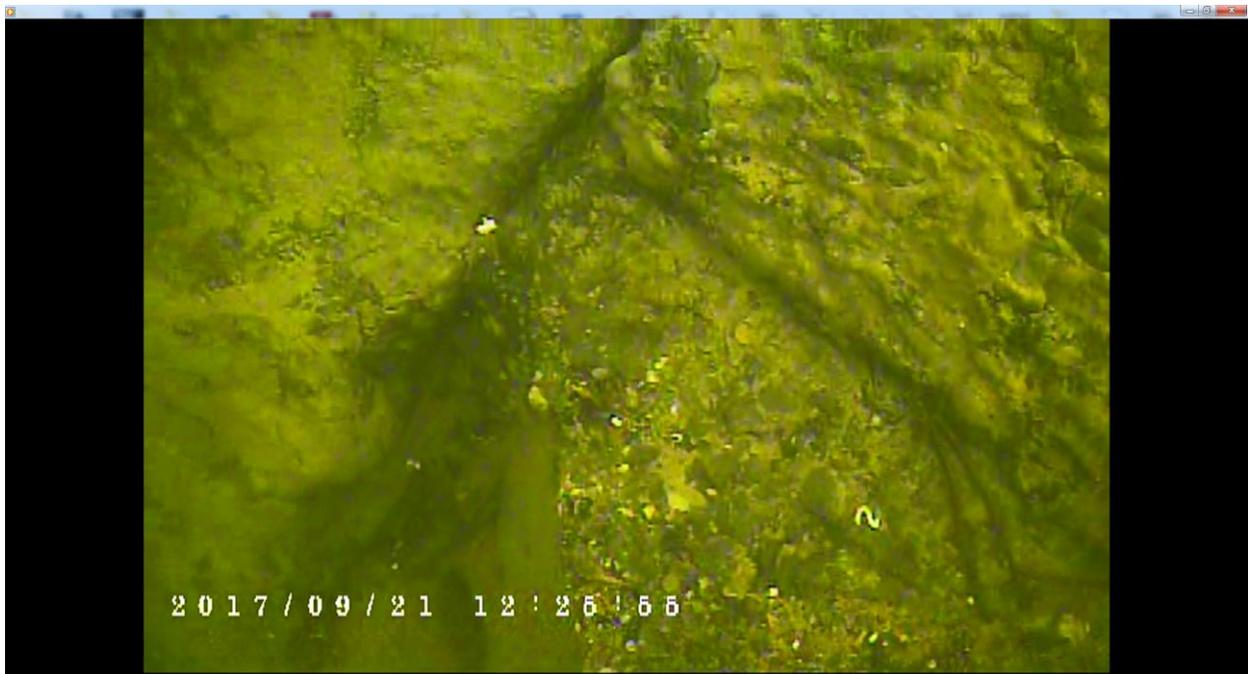
Dam cold joint deterioration at toe of apron near left abutment

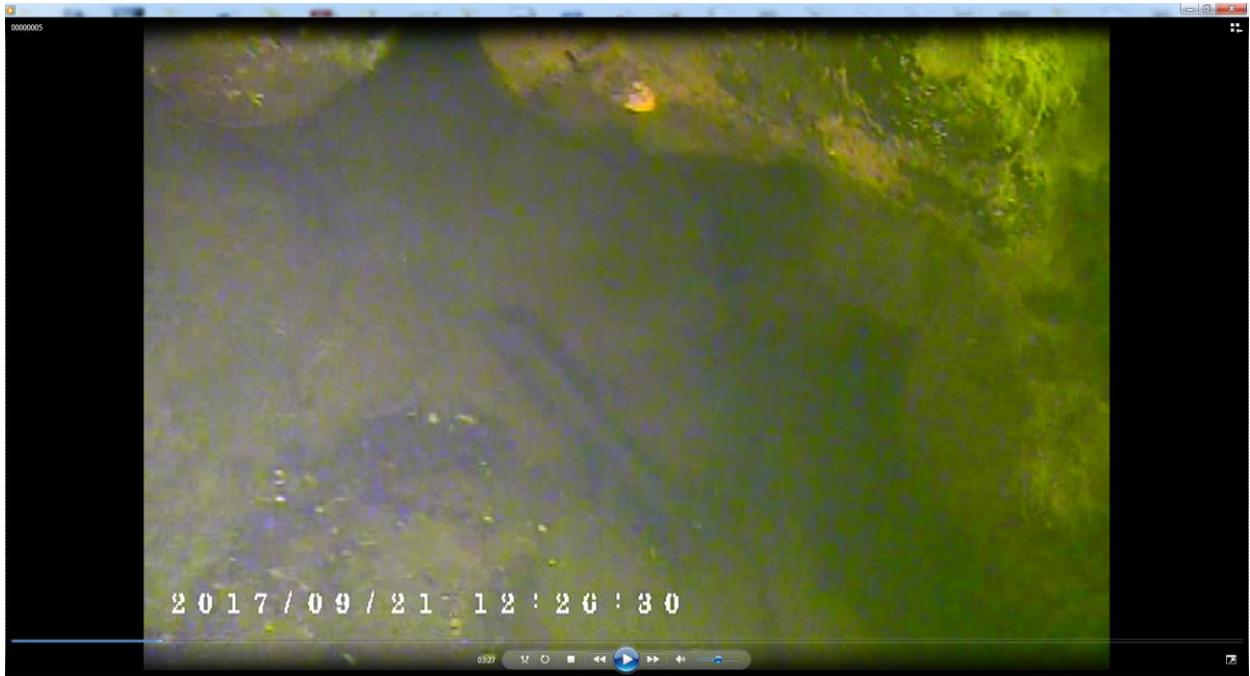
Under cutting of toe of apron – 4' depth

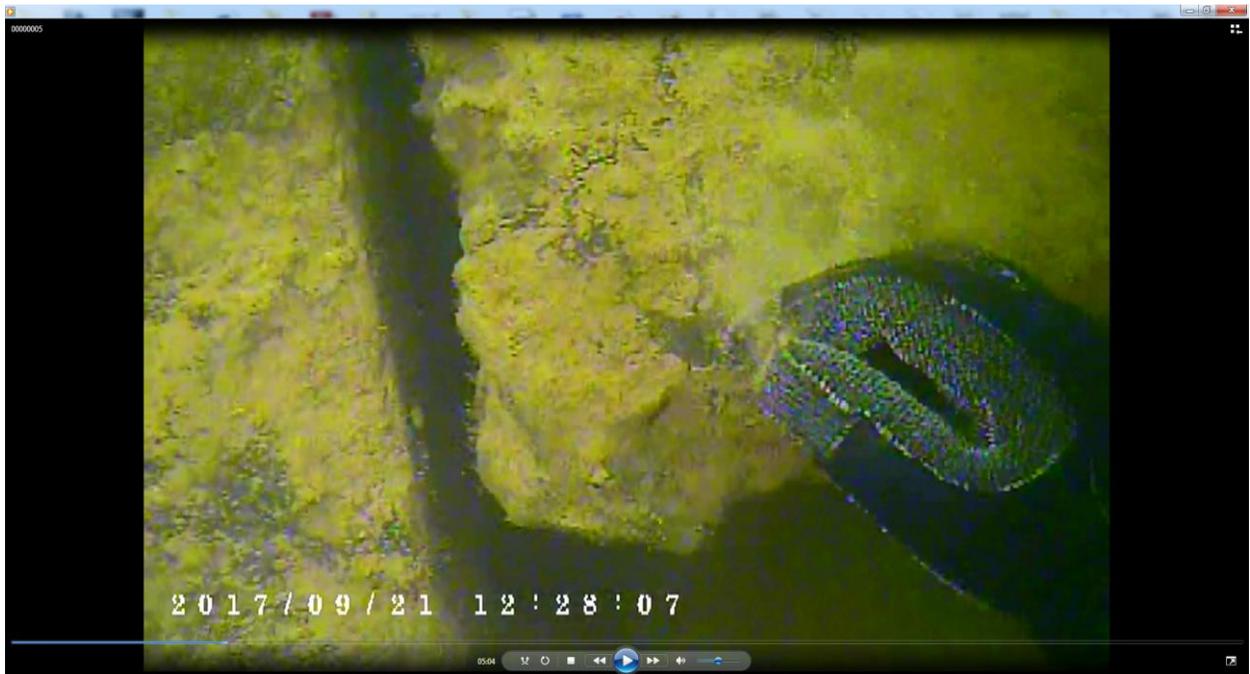
Cold joint deterioration and undercutting at toe of apron

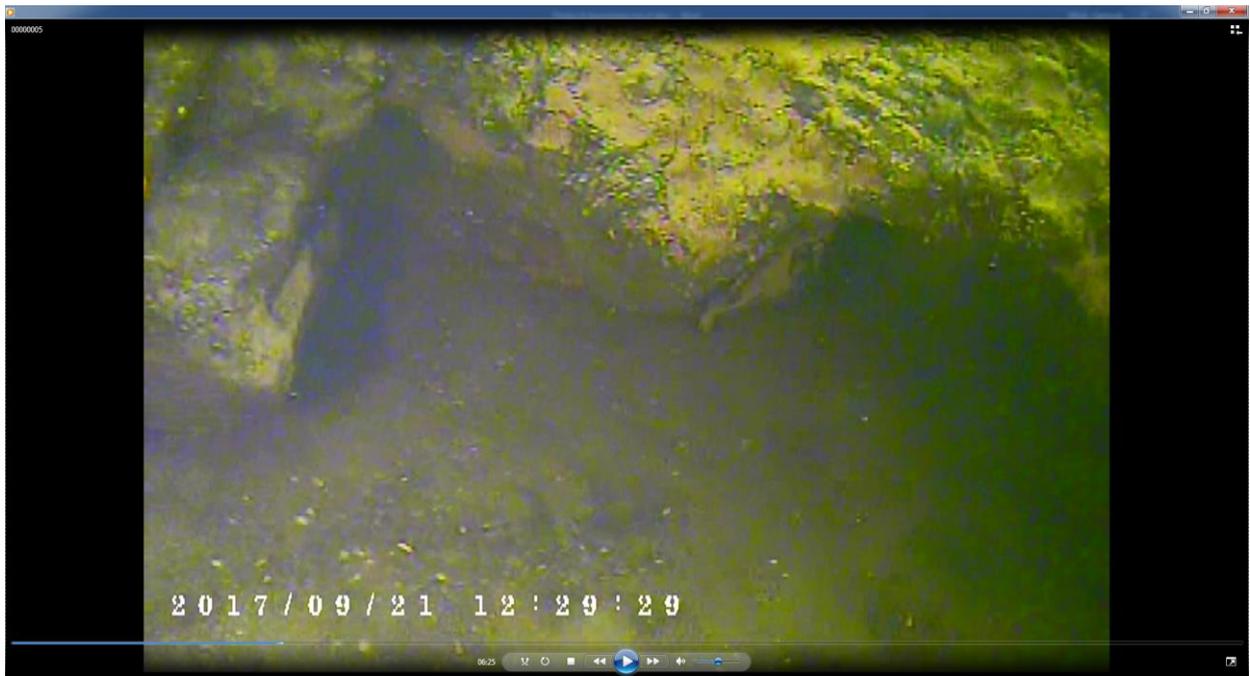
Undercutting of toe of apron

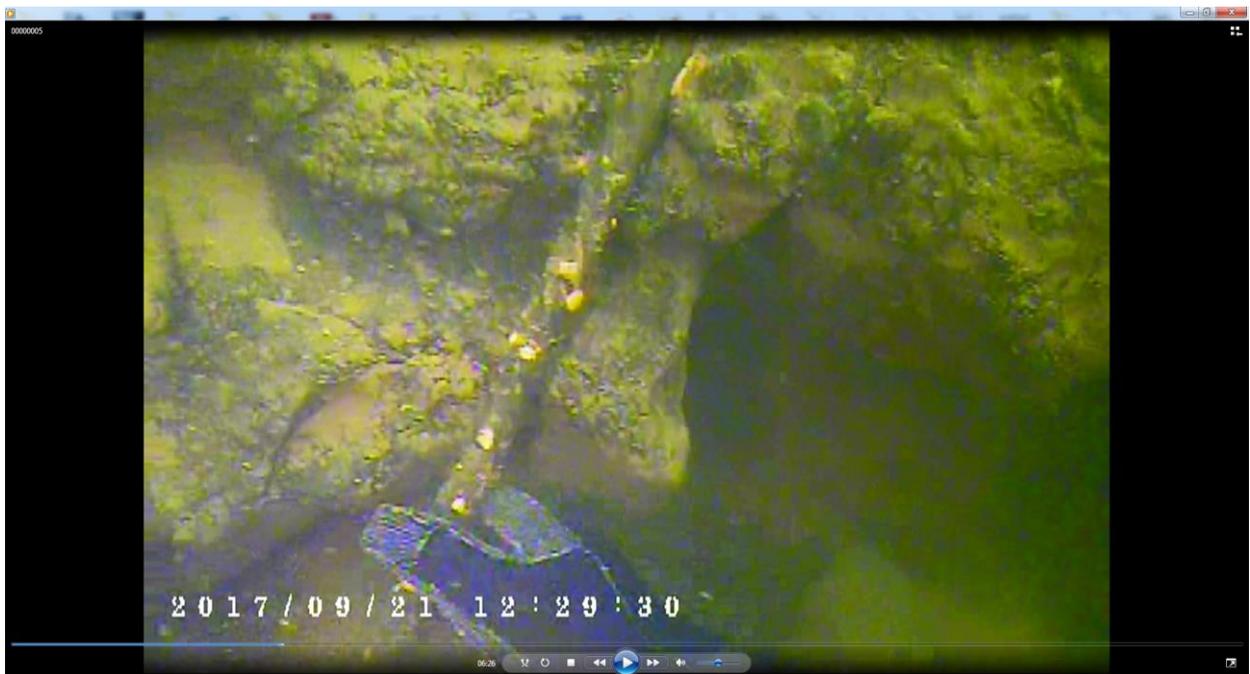
Exposed rebar, deterioration and undercutting at toe of apron

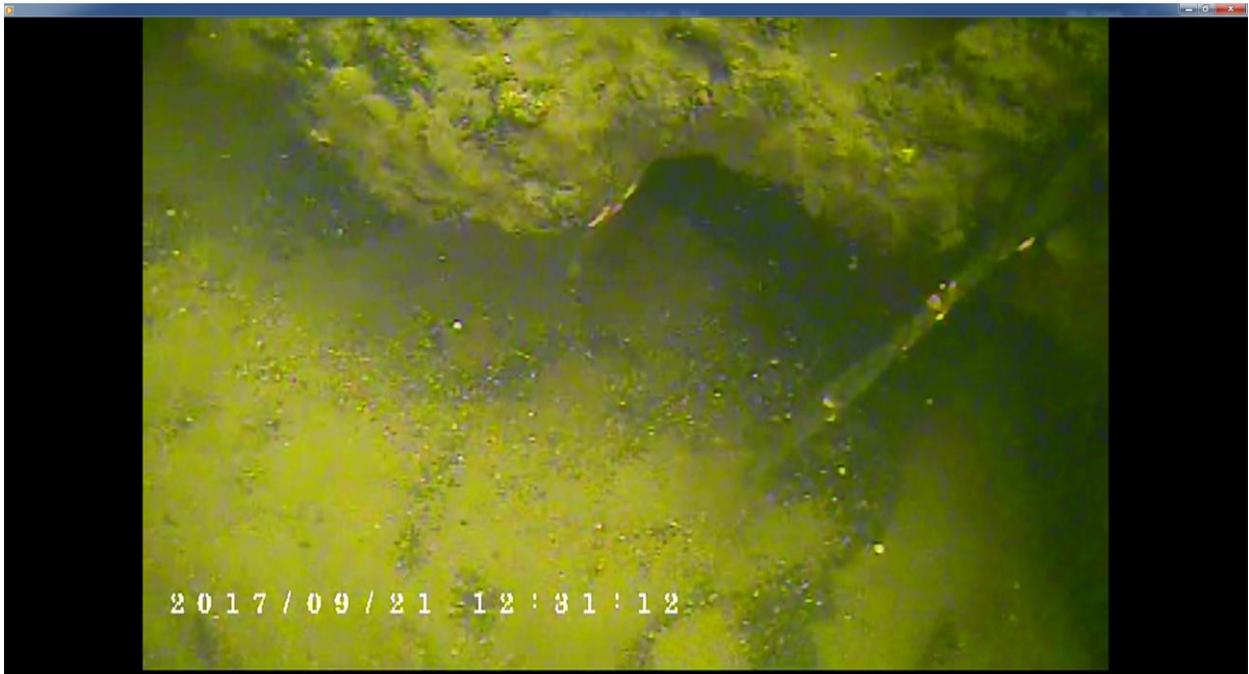
Exposed rebar, deterioration and undercutting at toe of apron
