APPENDIX C

APPENDIX D

APPENDIX E

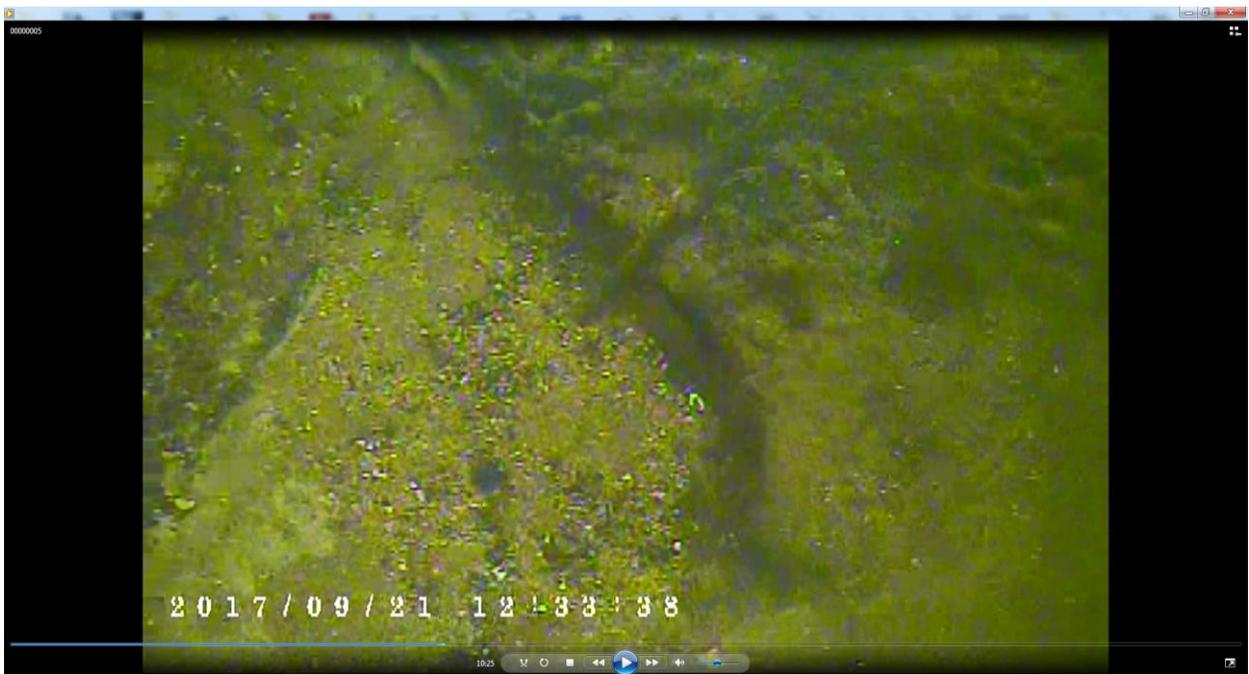
Exposed rebar, deterioration and undercutting at toe of apron

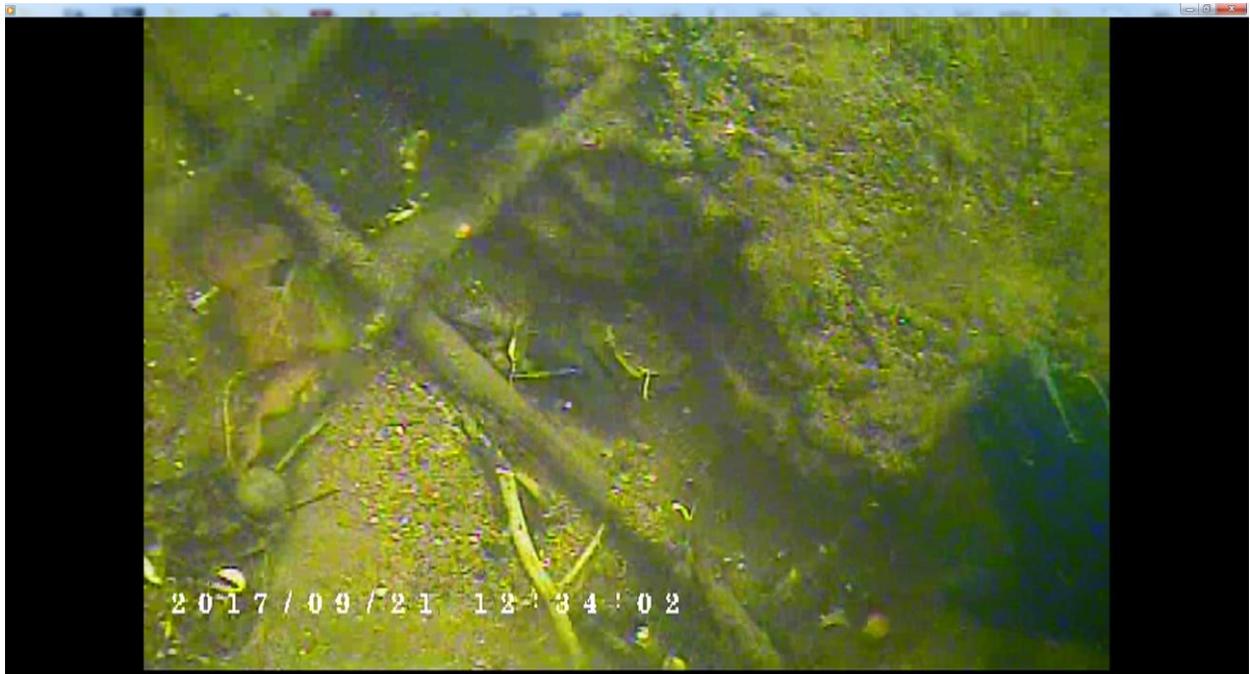
Exposed rebar, deterioration and undercutting at toe of apron

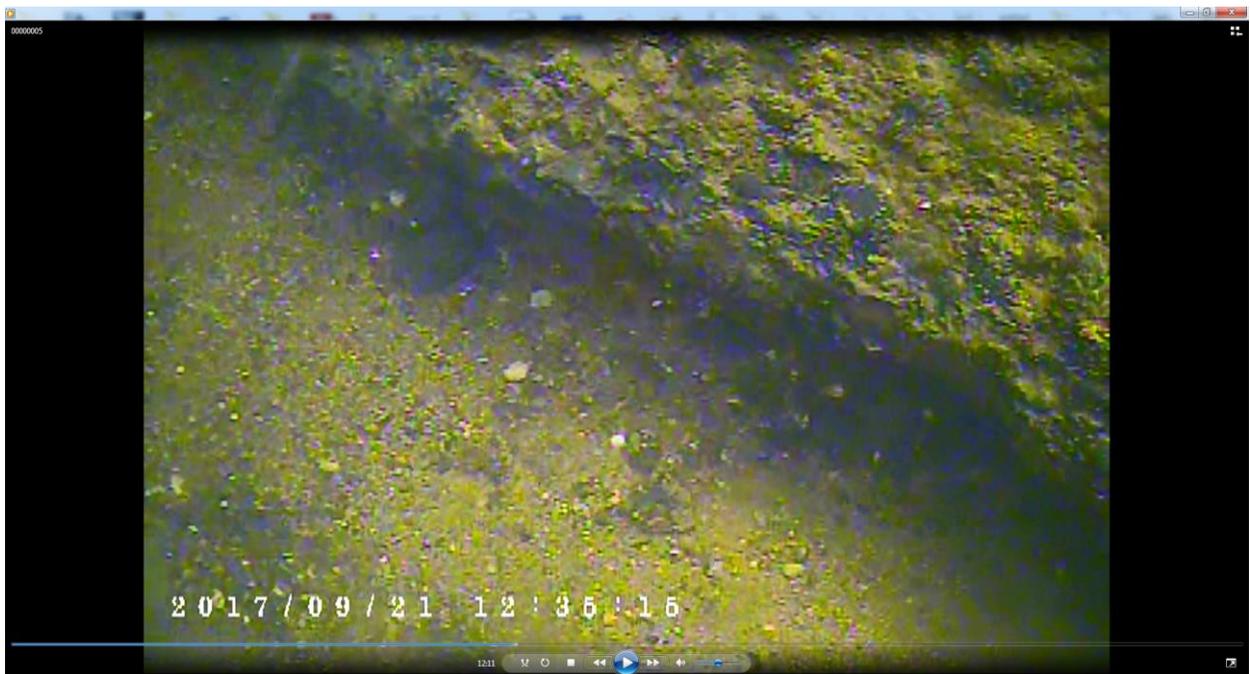
Exposed rebar, deterioration and undercutting at toe of apron

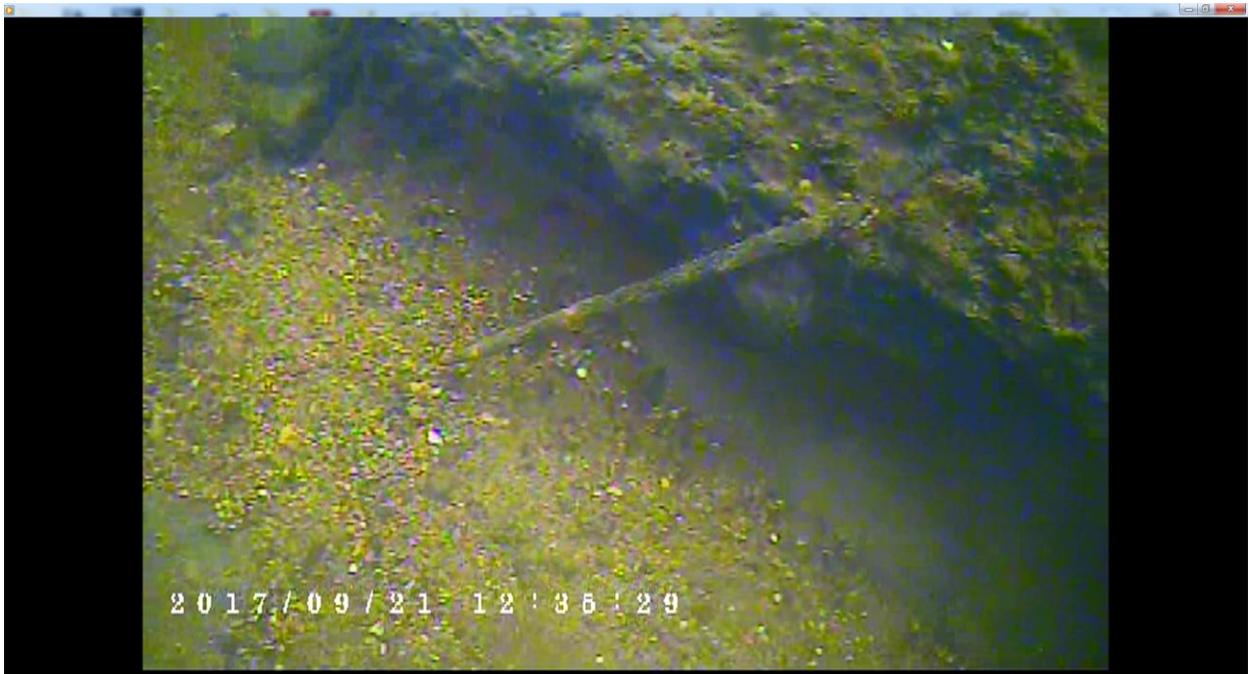
Exposed rebar, deterioration and undercutting at toe of apron

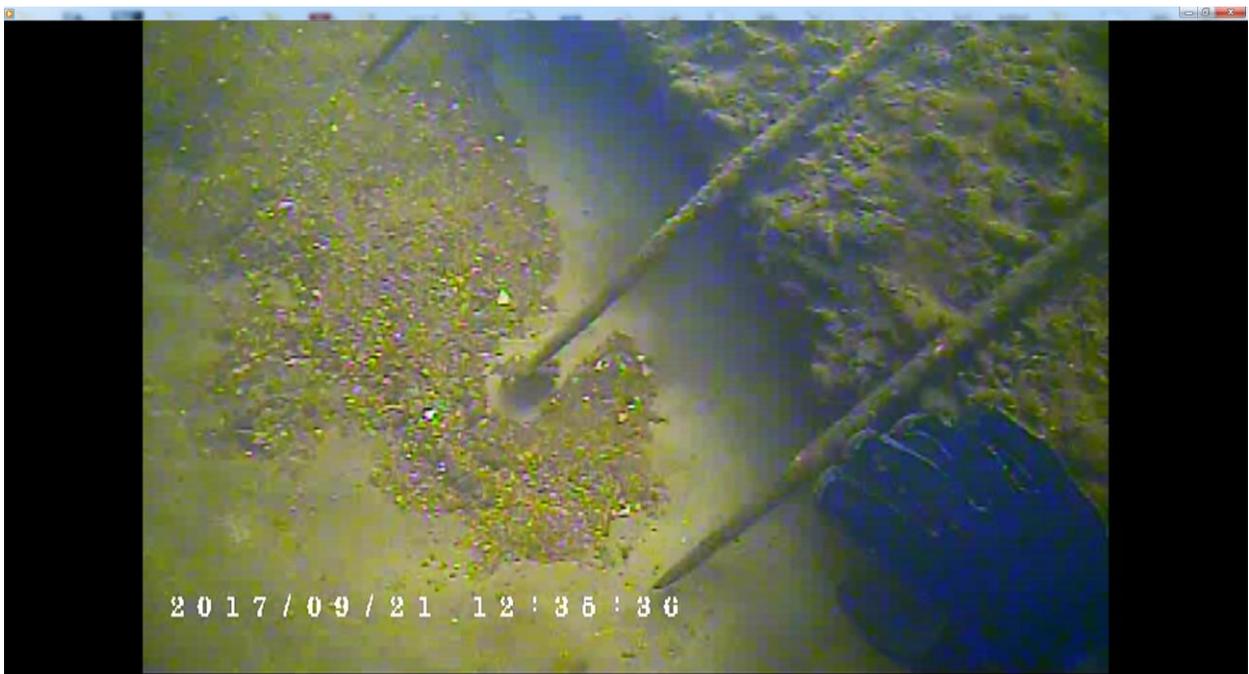
Exposed rebar, deterioration and undercutting at toe of apron

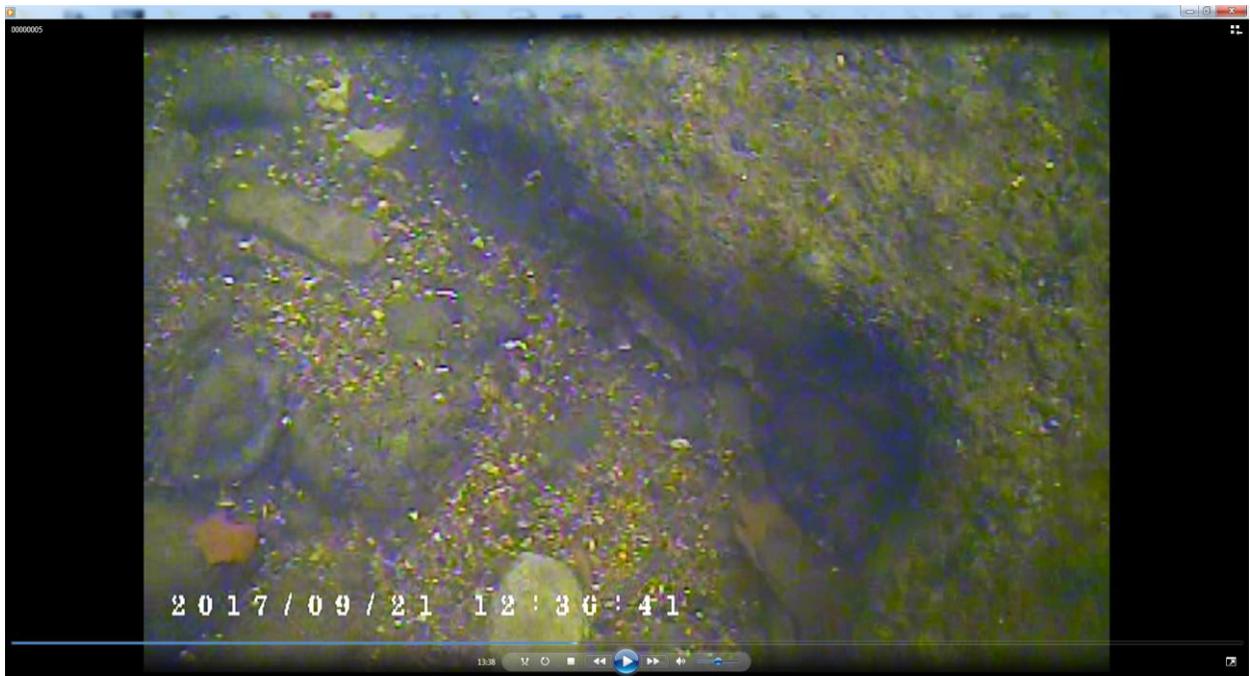
Deterioration and undercutting at toe of apron

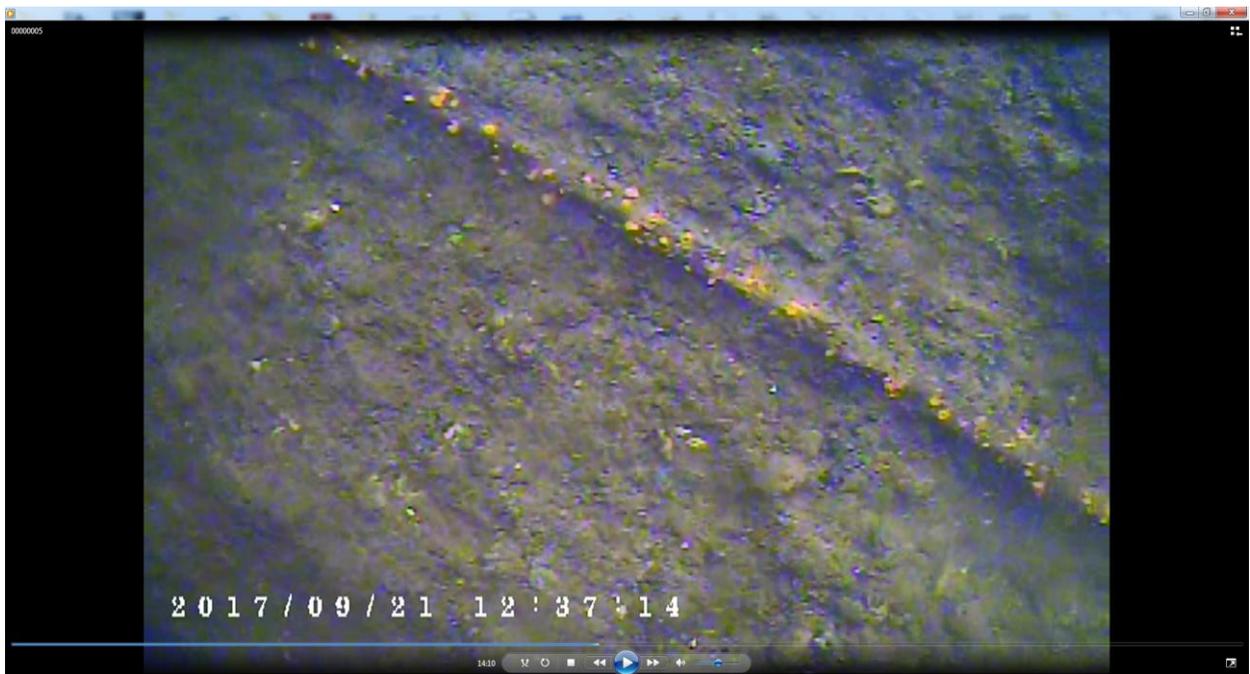
Exposed rebar on dam apron

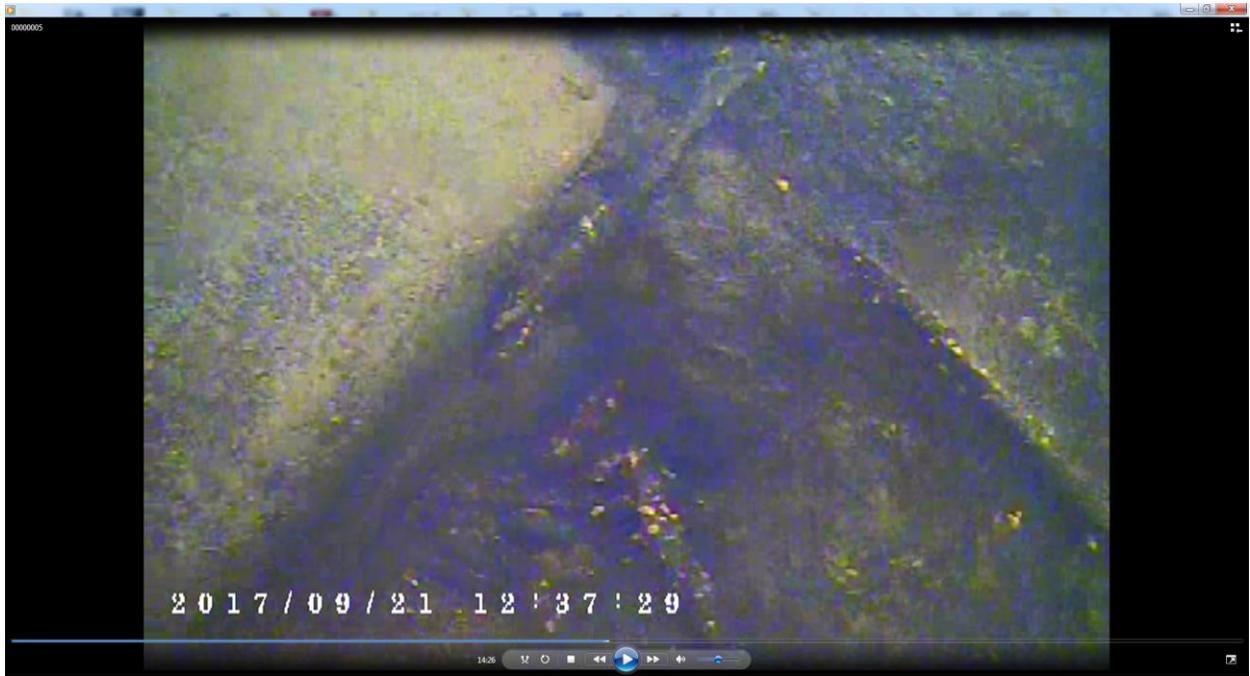
Exposed rebar, deterioration and undercutting at toe of apron

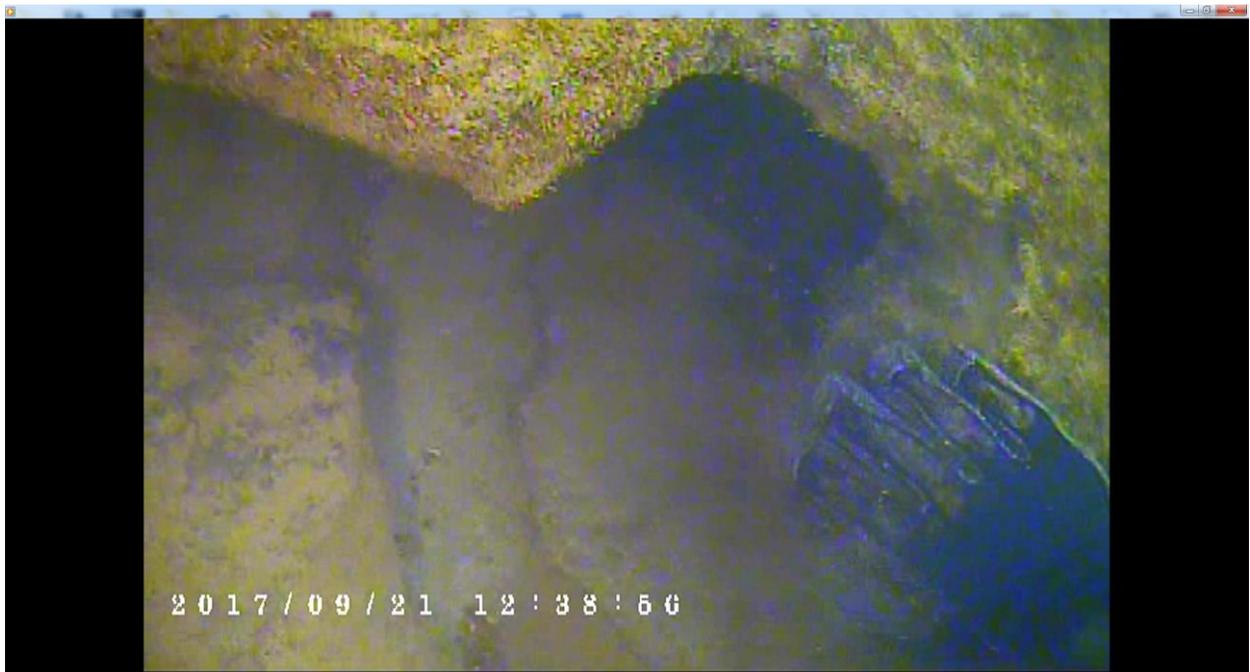
Deterioration and undercutting at toe of apron

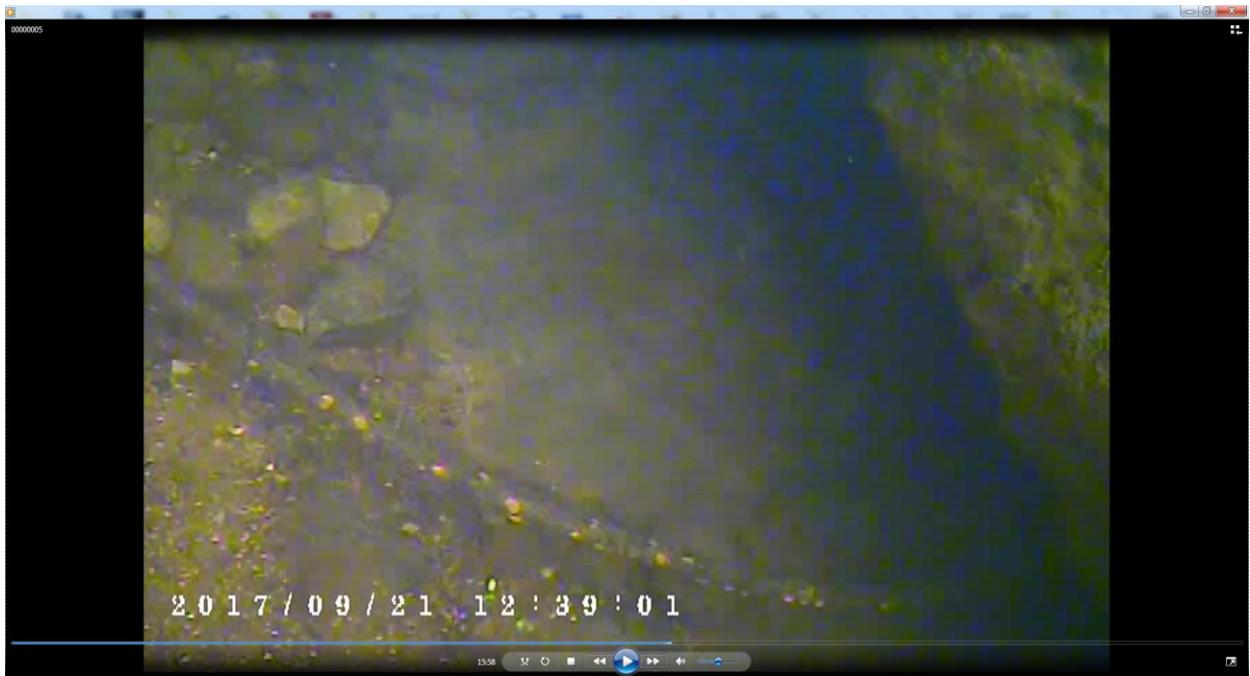
Exposed rebar, deterioration and undercutting at toe of apron

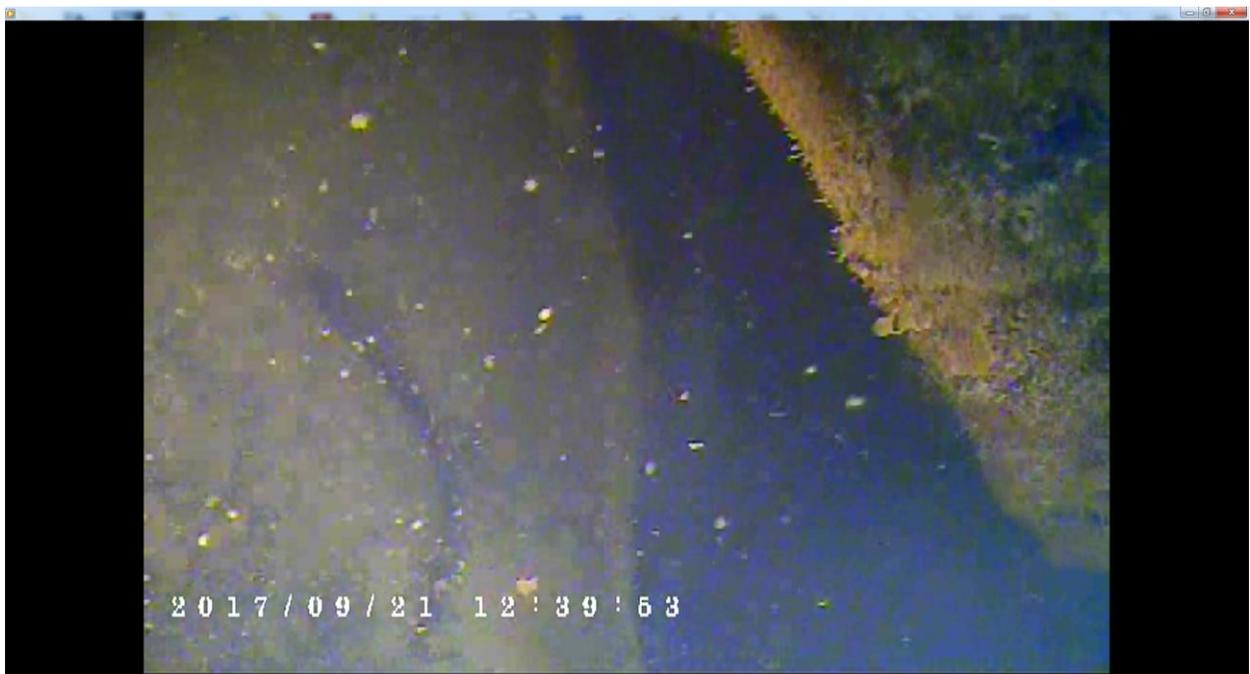
Undercutting below vertical wall at old access location on dam

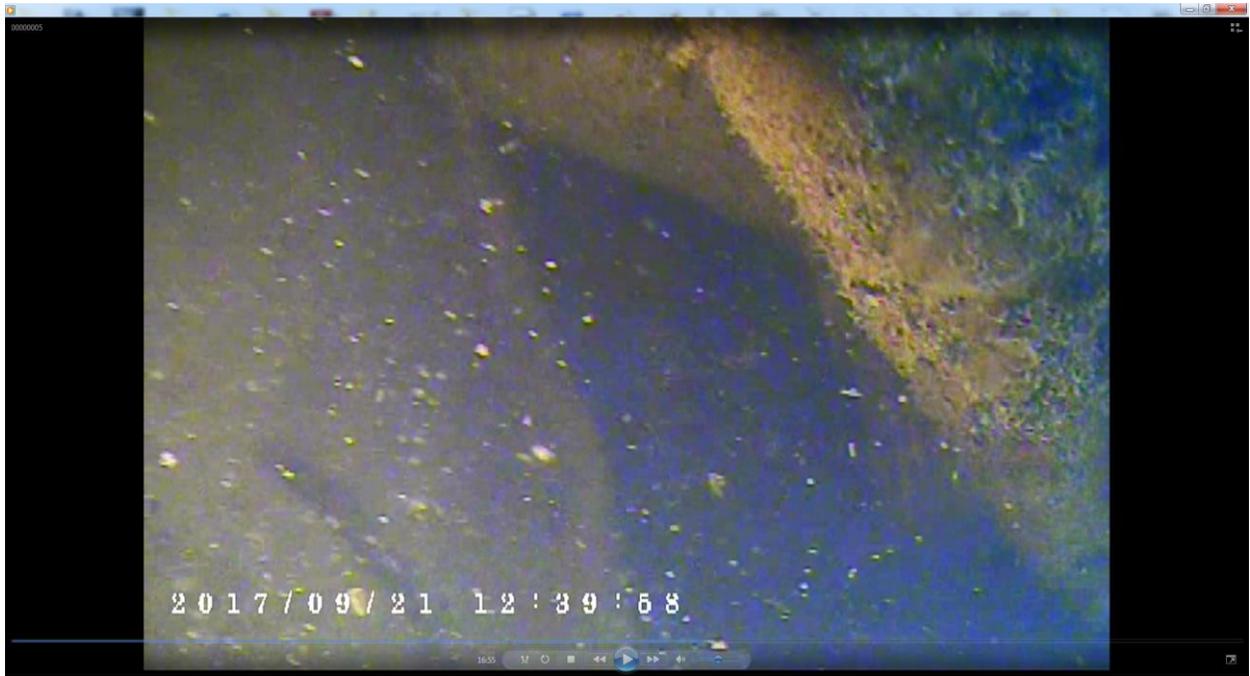
Undercutting below vertical wall at old access location on dam – timber noted

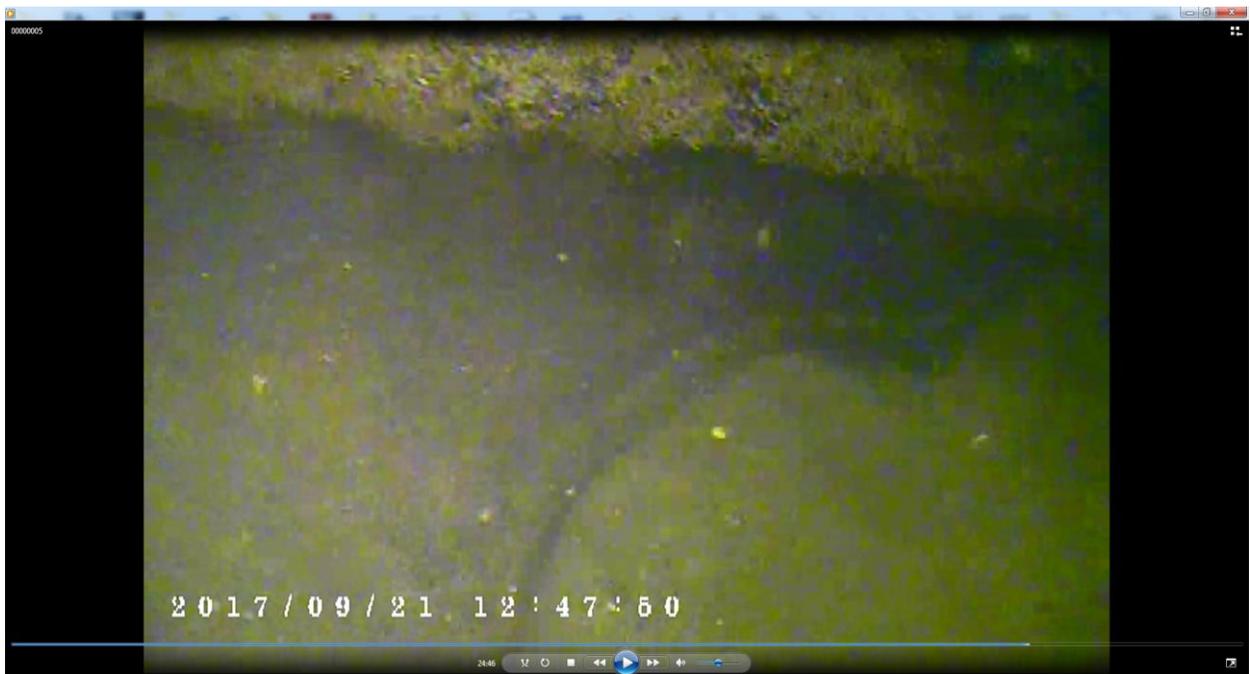
Undercutting of toe of apron

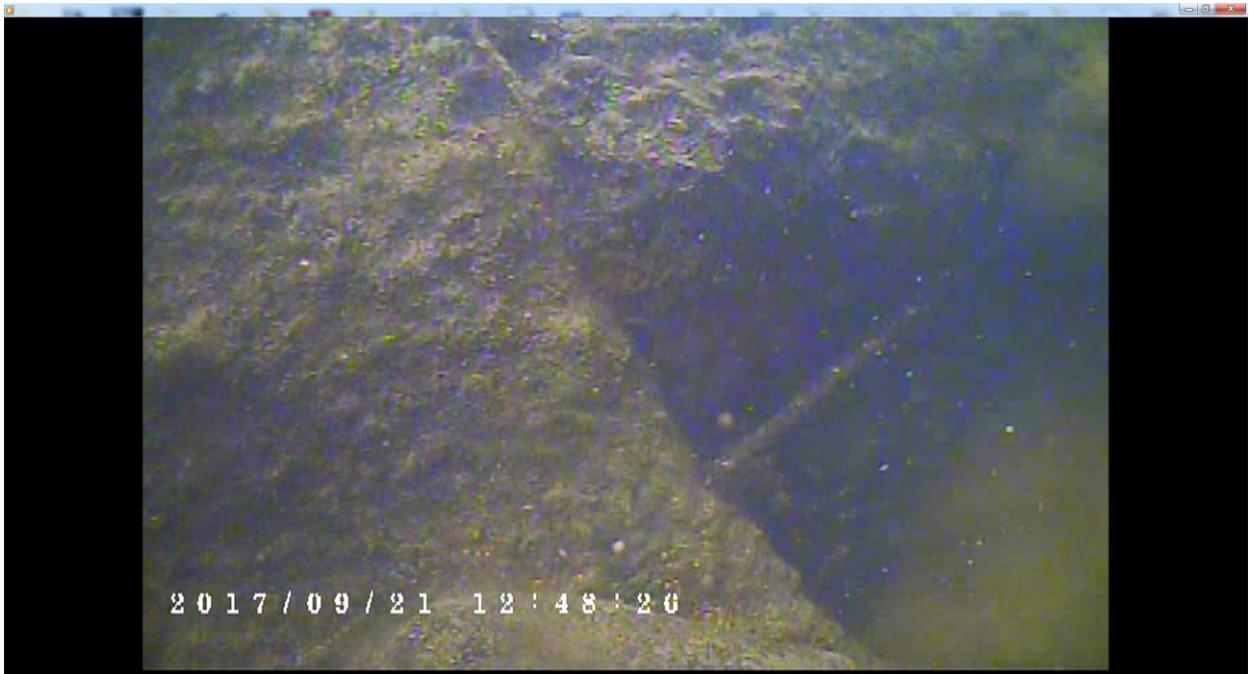
Exposed rebar, deterioration and undercutting at toe of apron

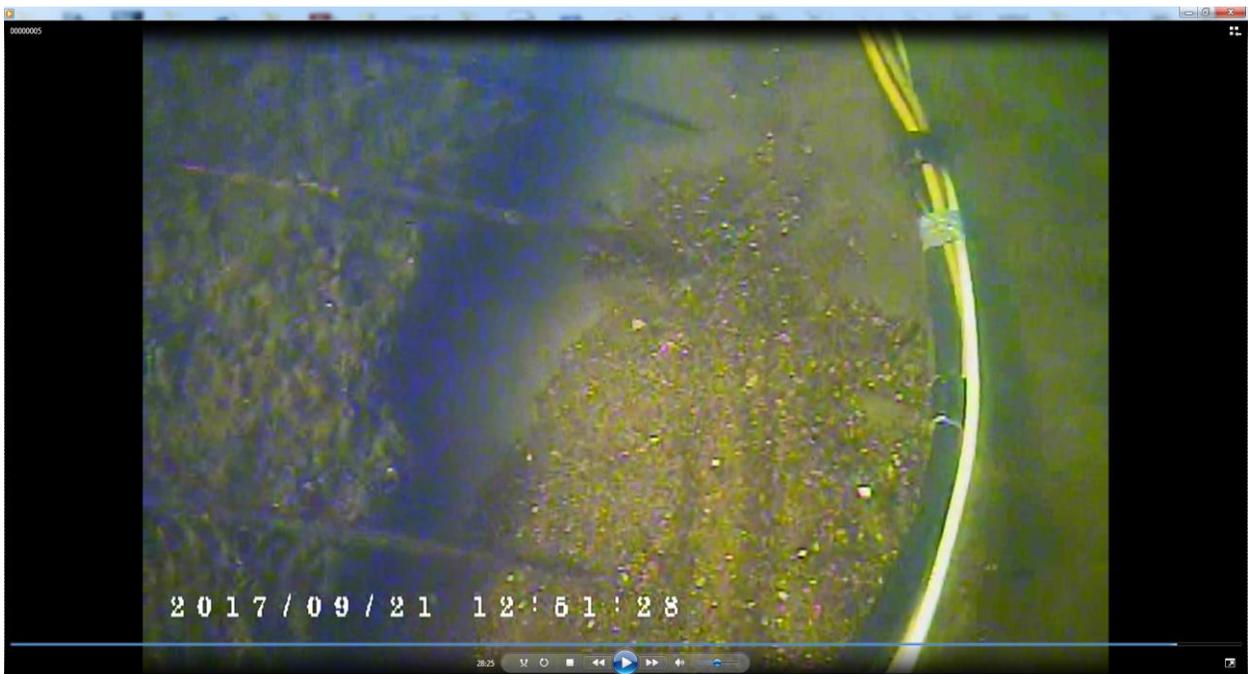
Exposed rebar, deterioration and undercutting at toe of apron

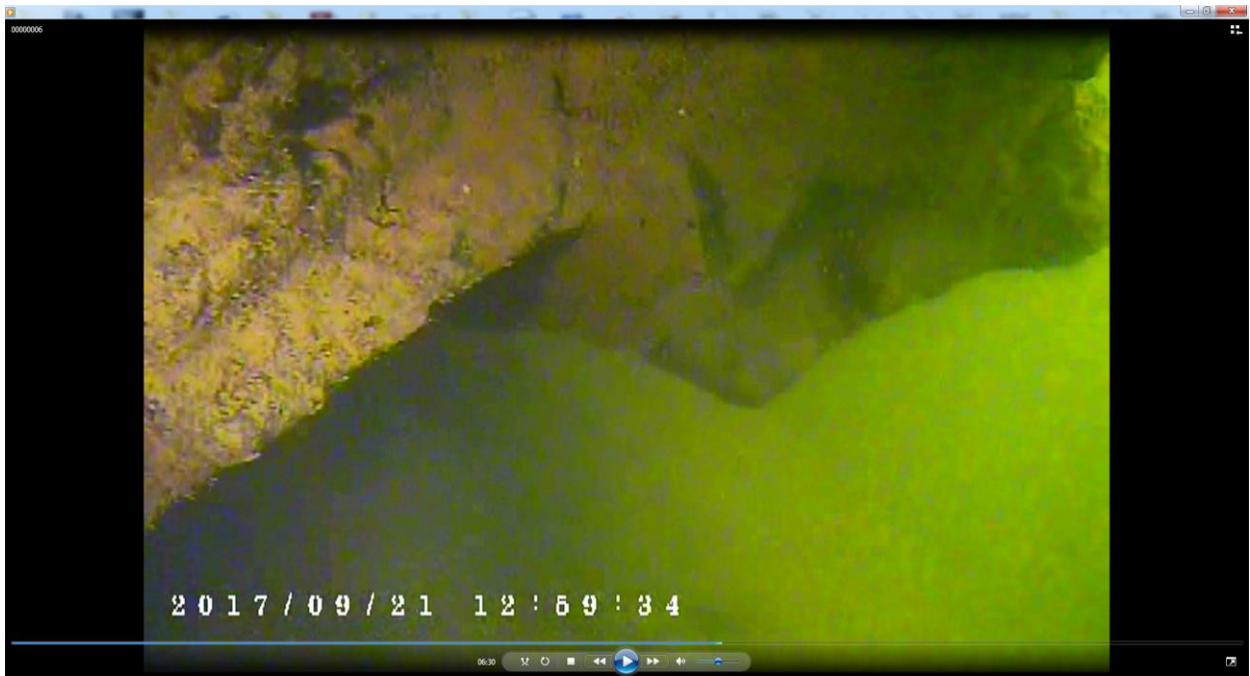
Undercutting under 3-foot protrusion of concrete 6-foot width from apron

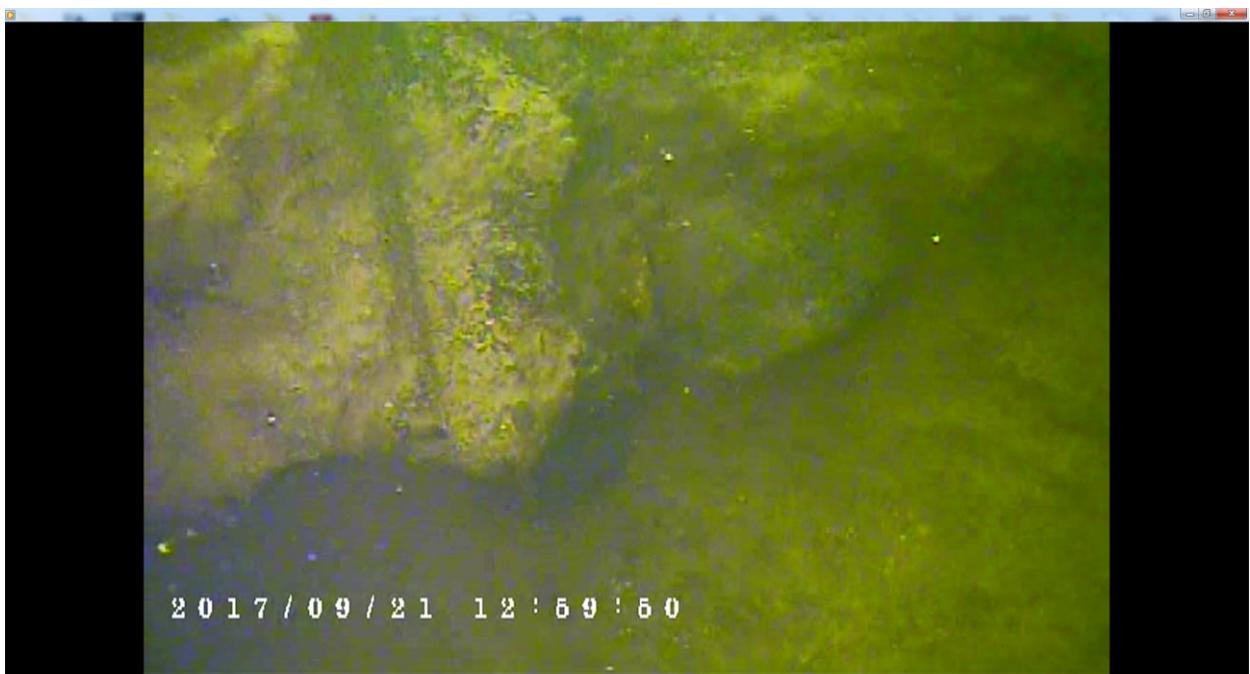
Undercutting under apron on WTP side of protrusion

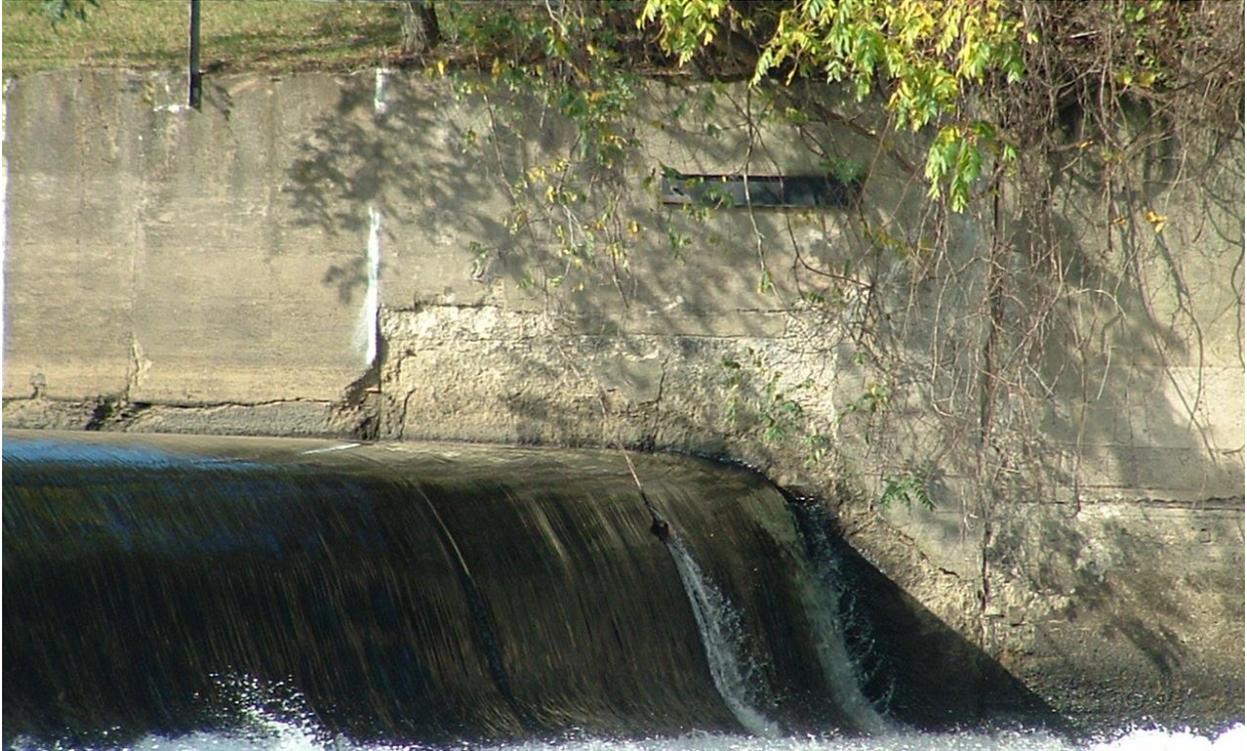
Left abutment wall spalling

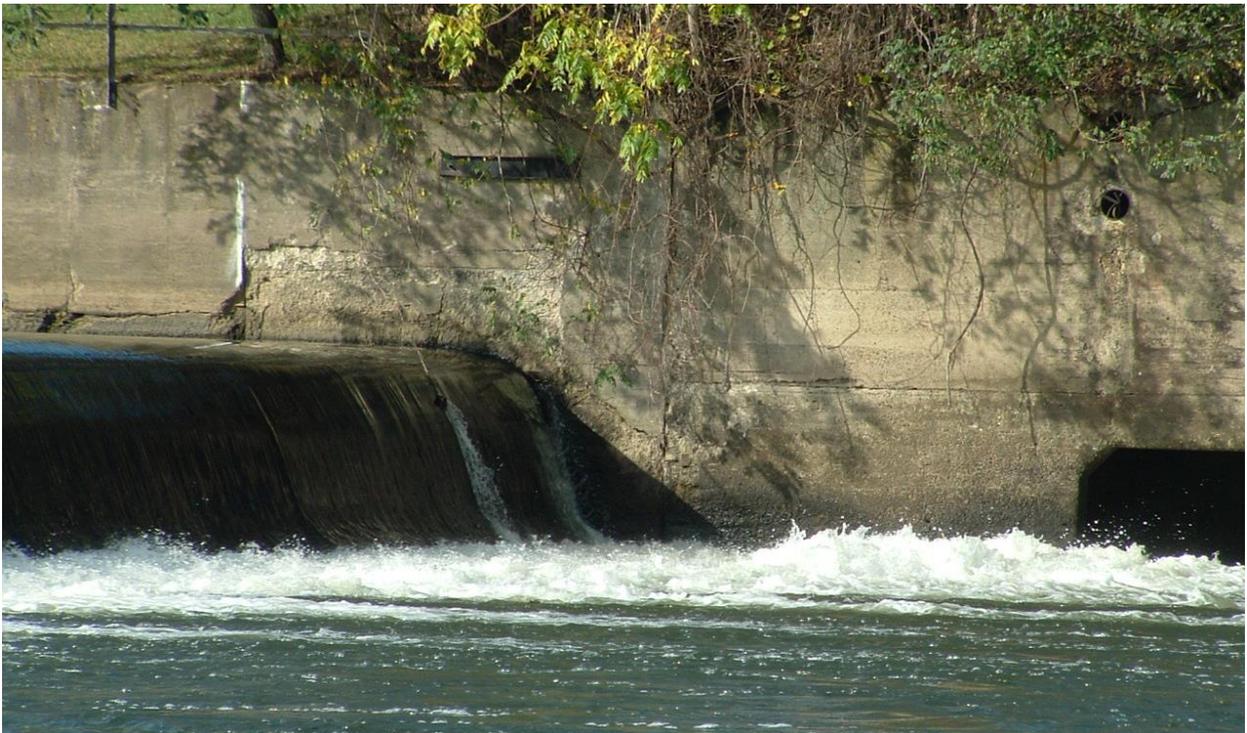
Left abutment wall and tunnel outlet

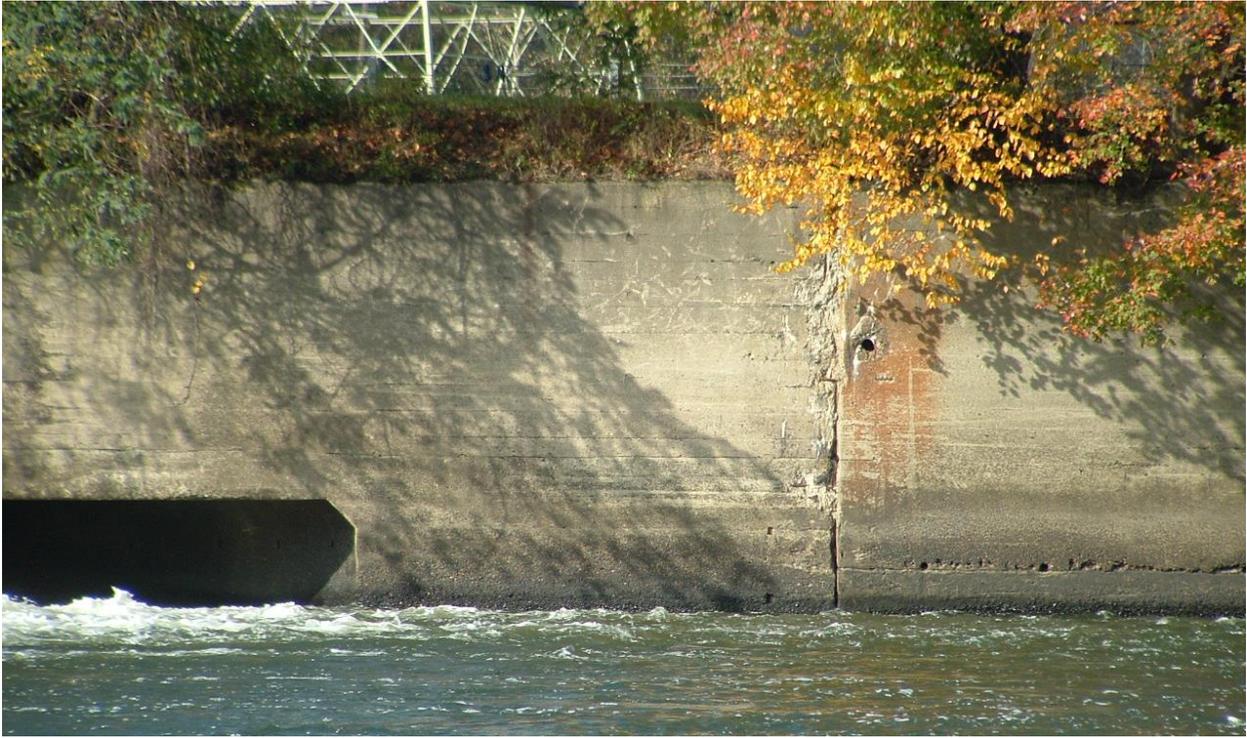
Left abutment wall downstream of Dam (match above)

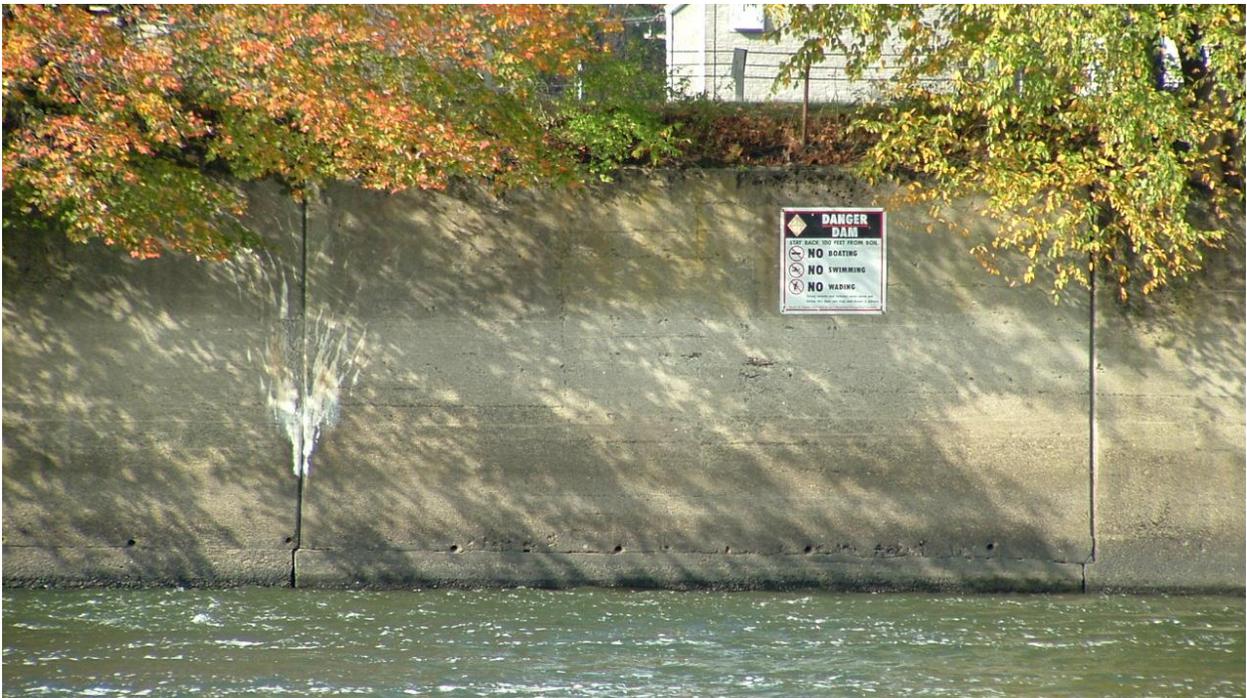
Left abutment wall downstream of Dam (match above)

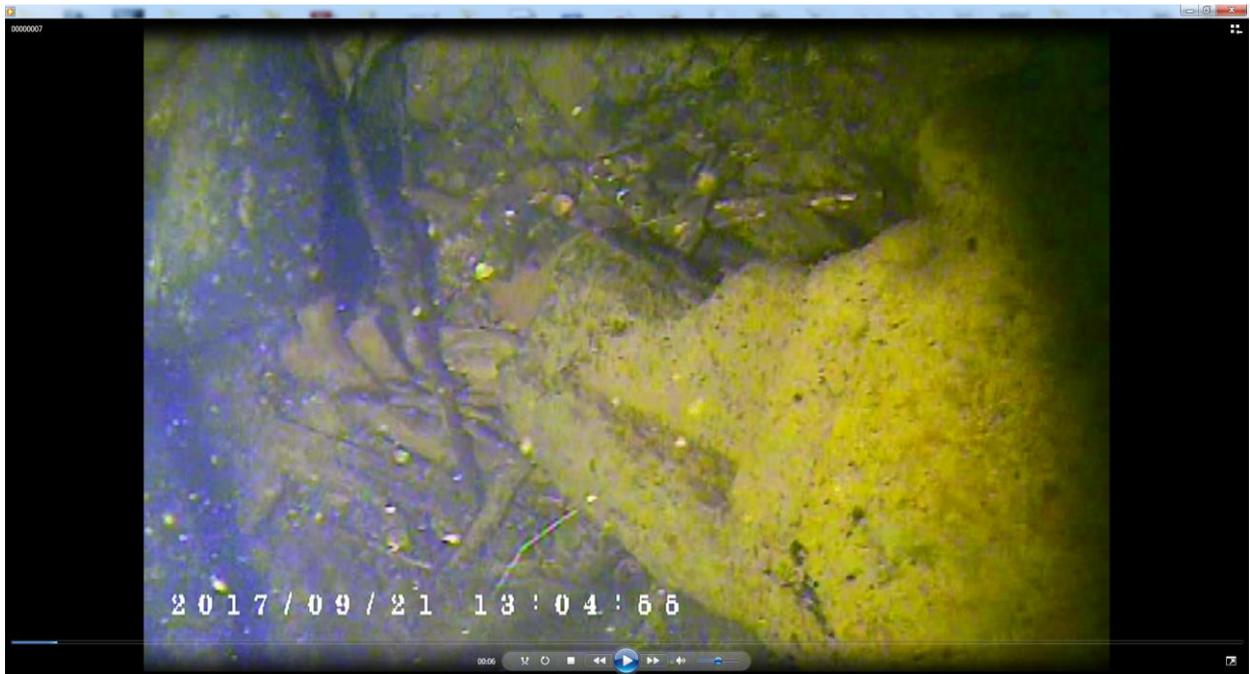
Undercut at left abutment wall at toe of apron of dam

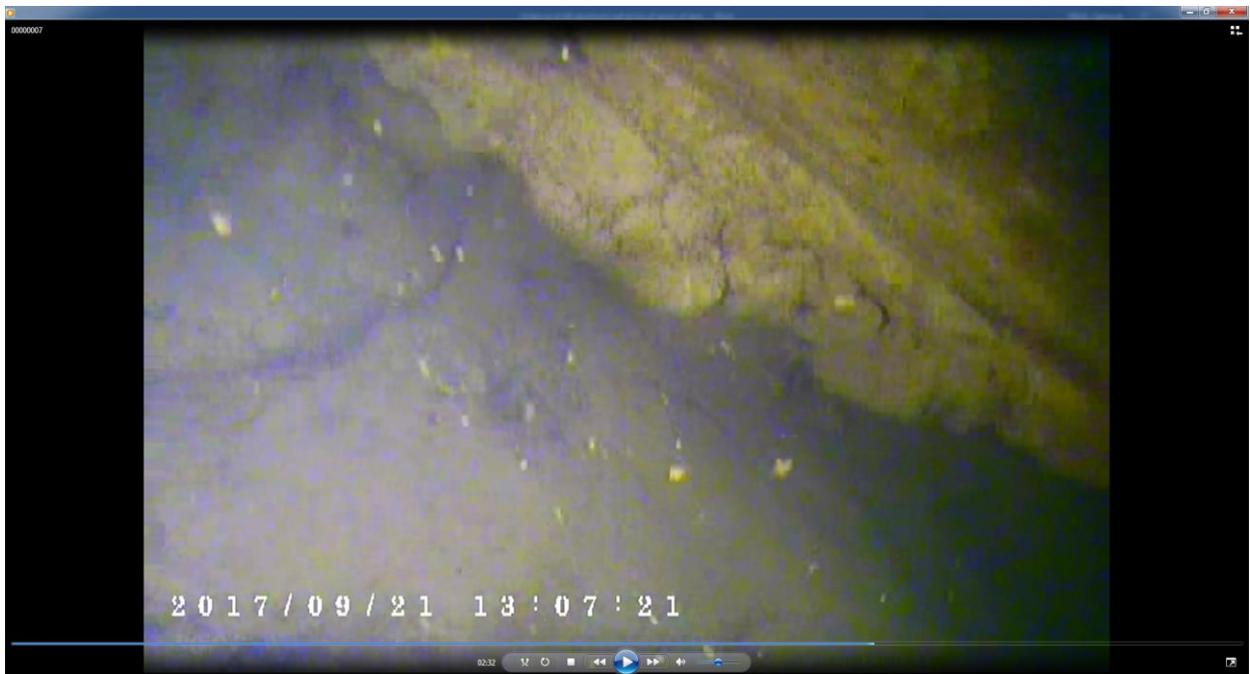
River wall undercutting – left abutment downstream of dam
