**Final
Hazardous, Toxic, and Radioactive Waste (HTRW)
Site Inspection Report
DERP-FUDS Site IO2PR006800
Former Lower Camp Debris Site
Culebra Island, Puerto Rico**

July 2012

Former Lower Camp Debris Site
Culebra Island, Puerto Rico

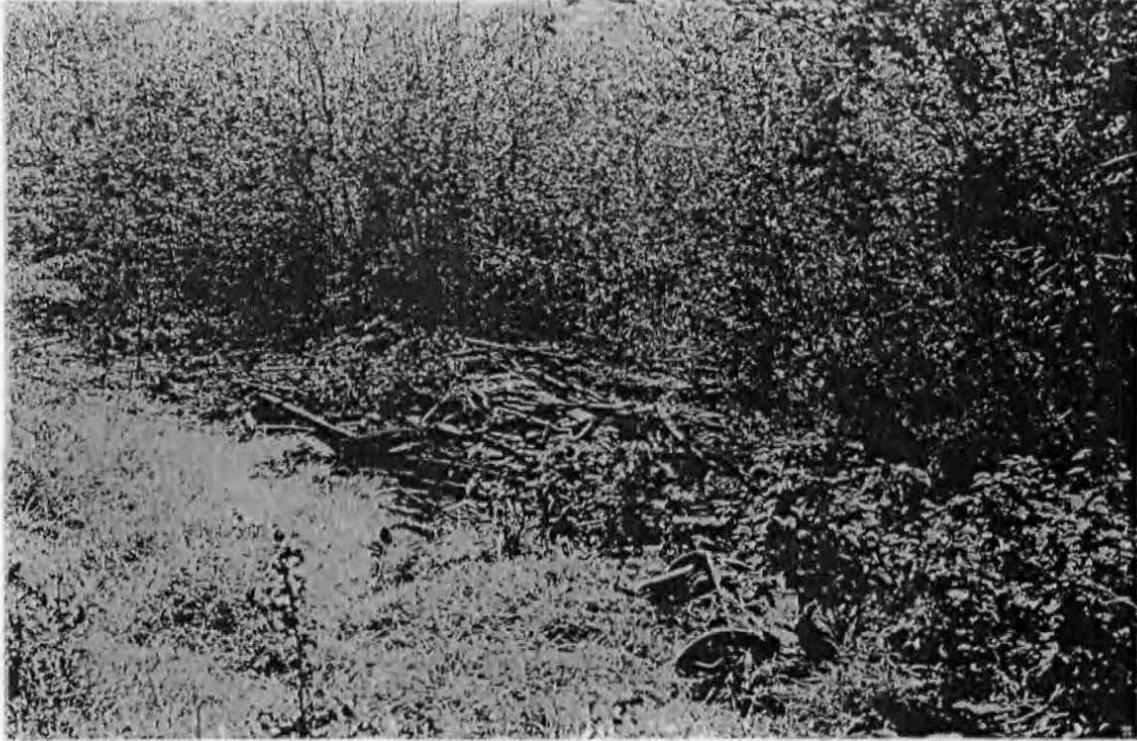
3. Culebra Island NWR (metal debris in wetland area)

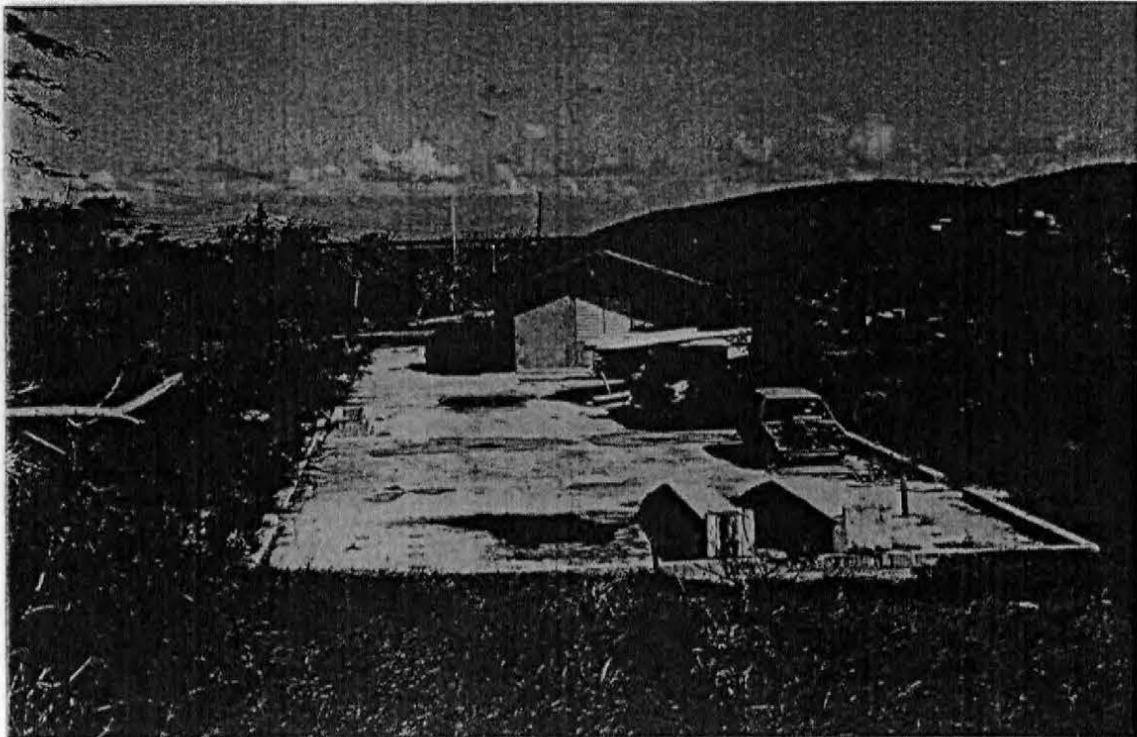
2. Culbra Island NWR (former bathroom foundation and auto shop)

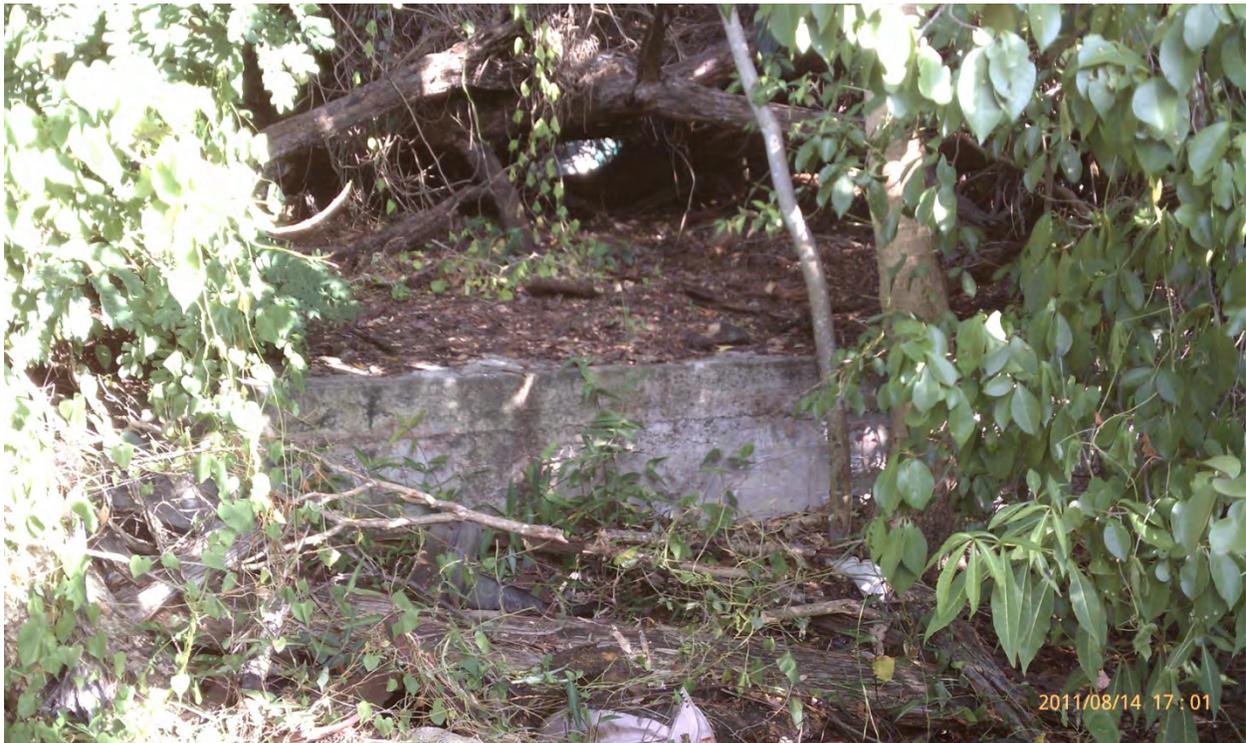
Photograph #1

The septic tank is concrete with a flat, aboveground top 18.5 feet wide by 28 feet long and located approximately 75 feet west of the concrete pad used for the former Navy restroom facility. No outfall could be visually observed. A photograph of the septic tank is included in **Appendix C**.

Septic Tank:

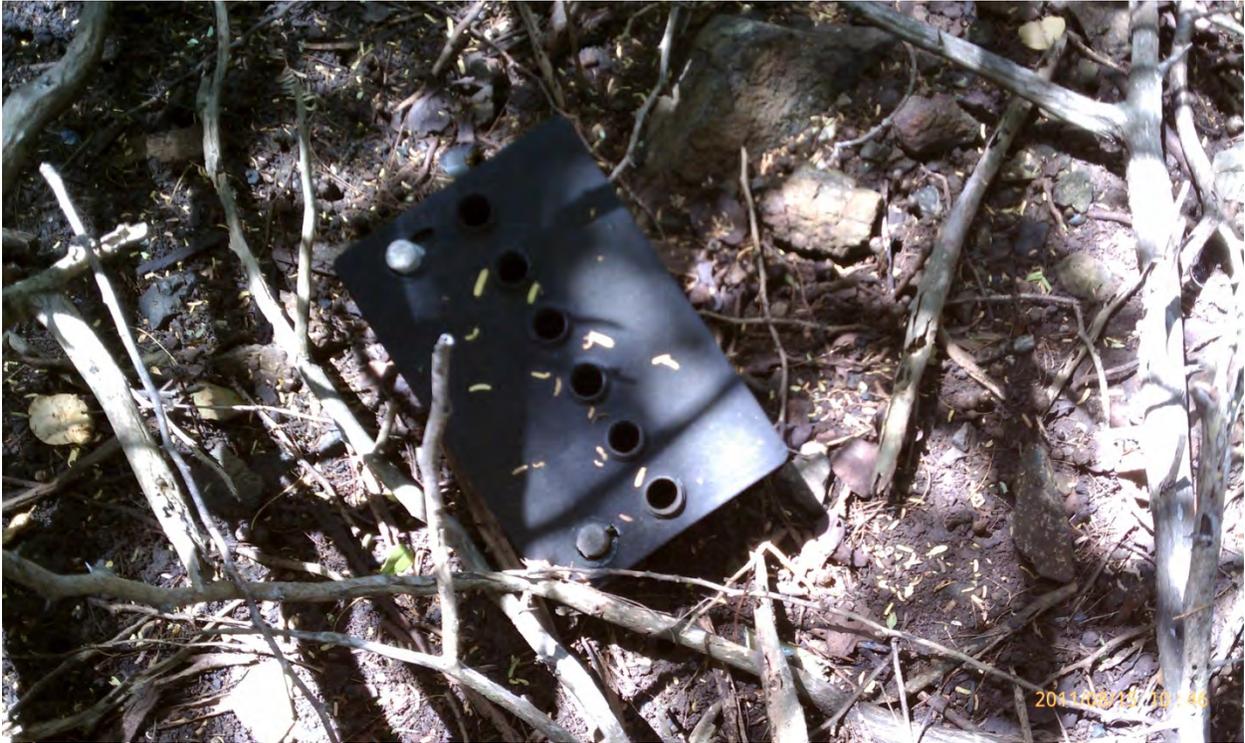
Photograph #2

Battery:

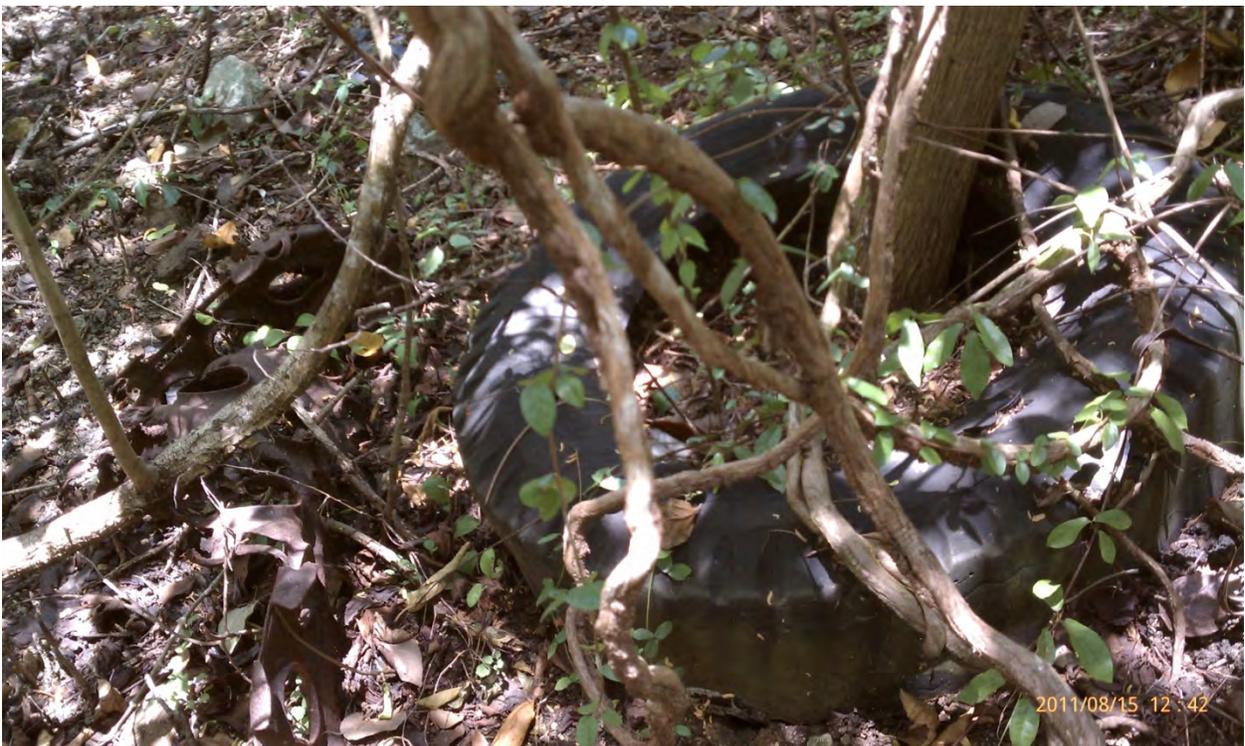
Photograph #3

Old Tires:

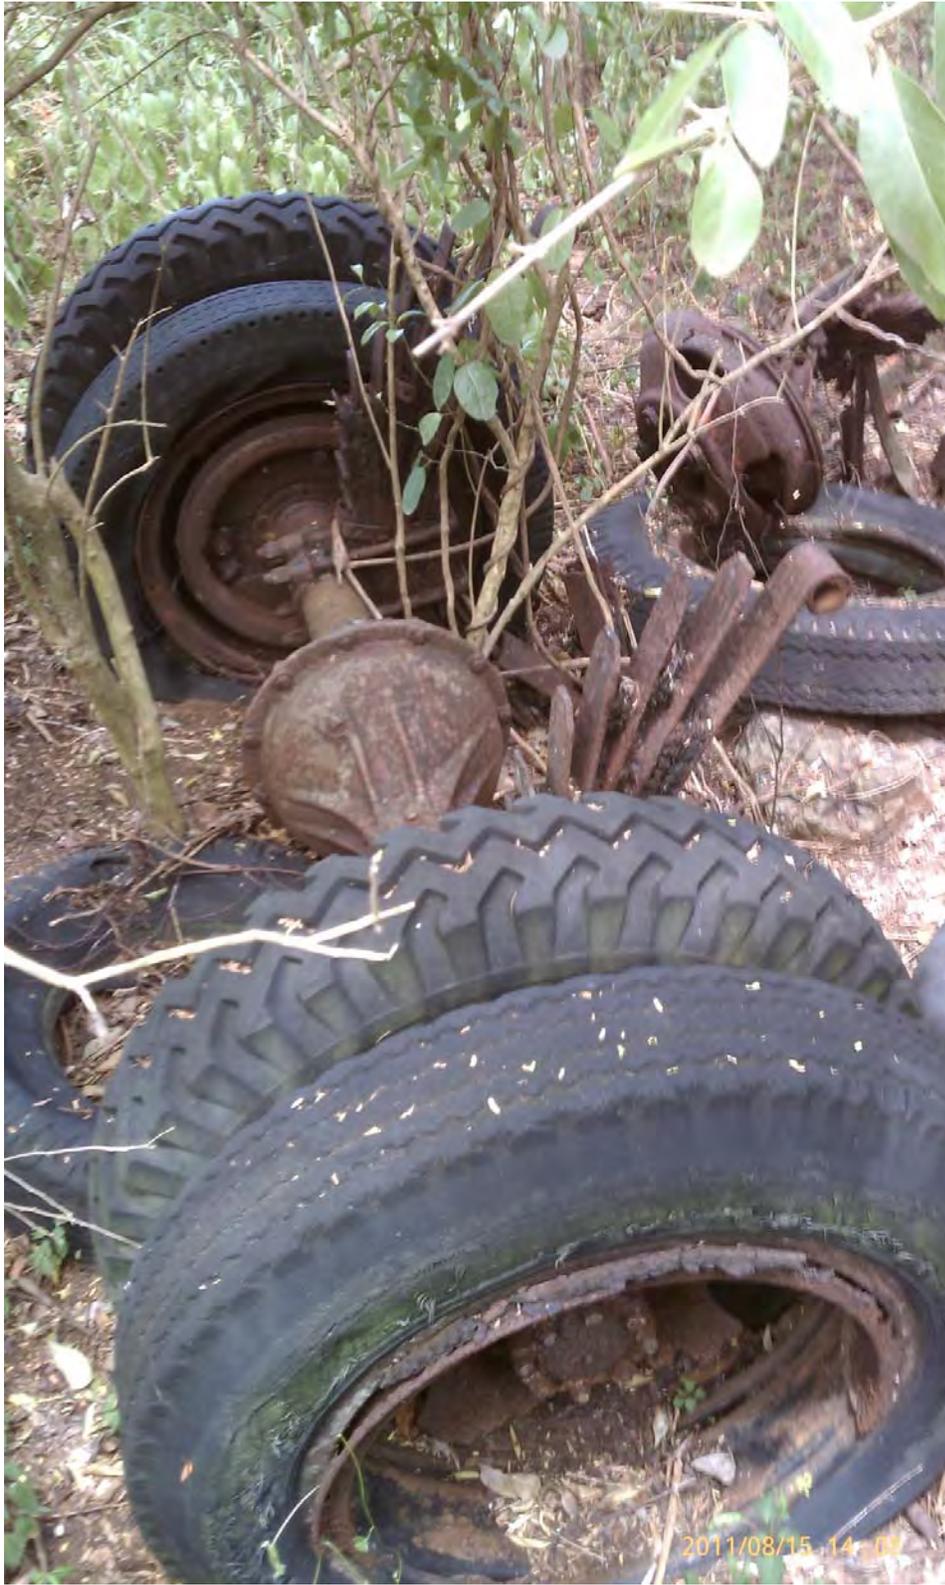
Photograph #4

Vehicle Axle and Tires:

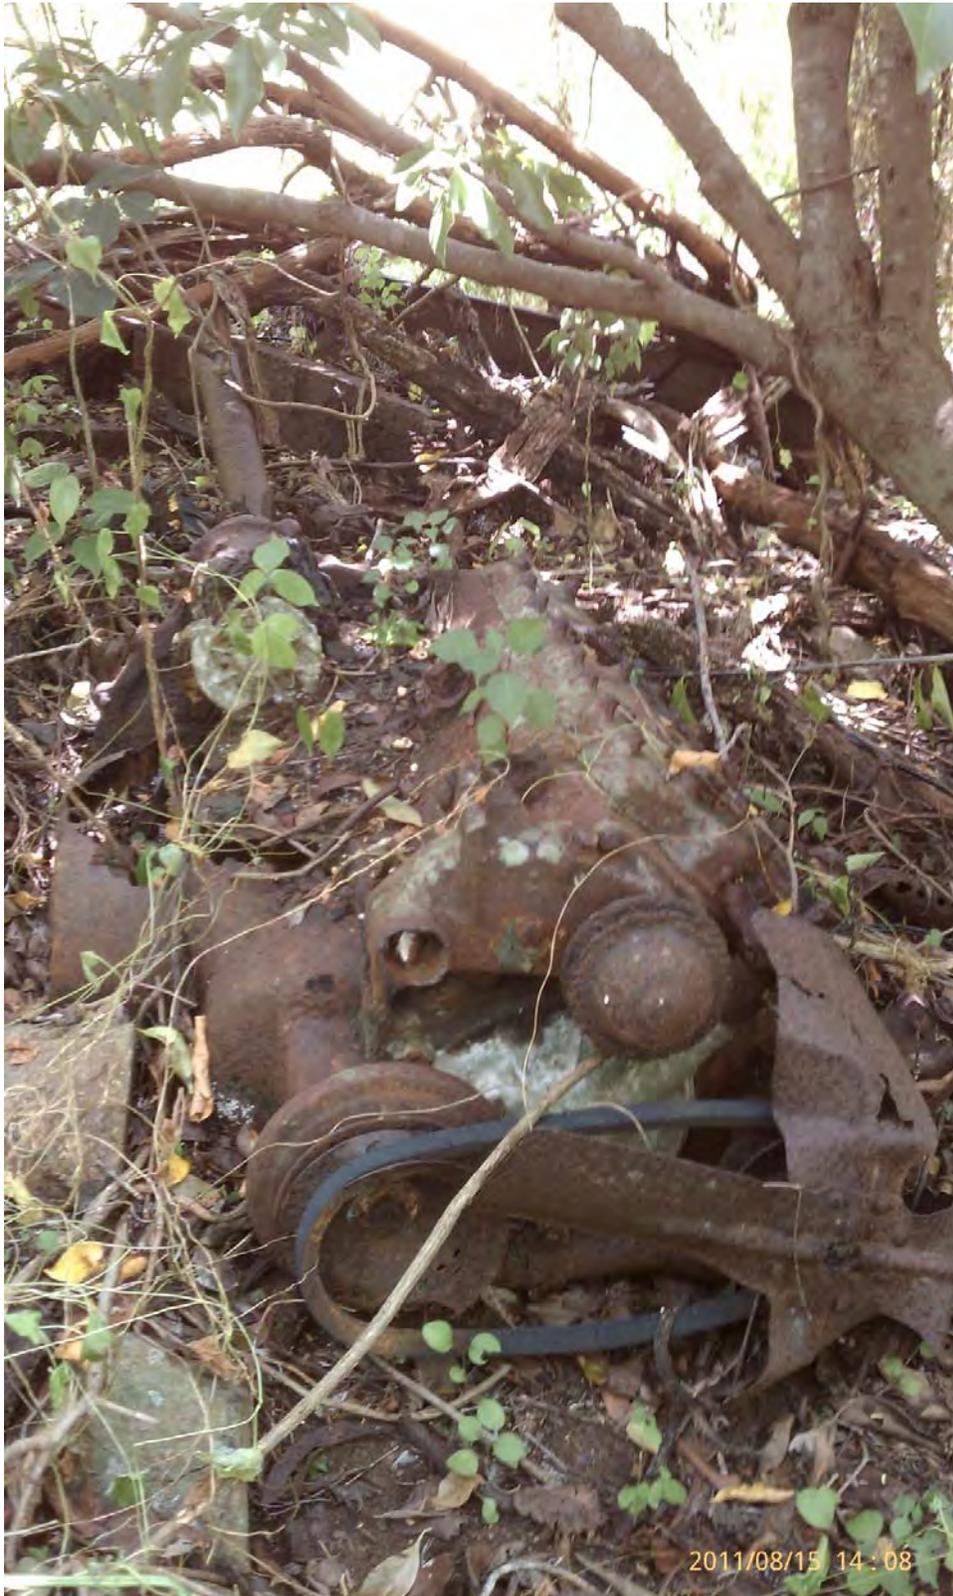
Photograph #5

Vehicle Engine, Transmission, and Frame:

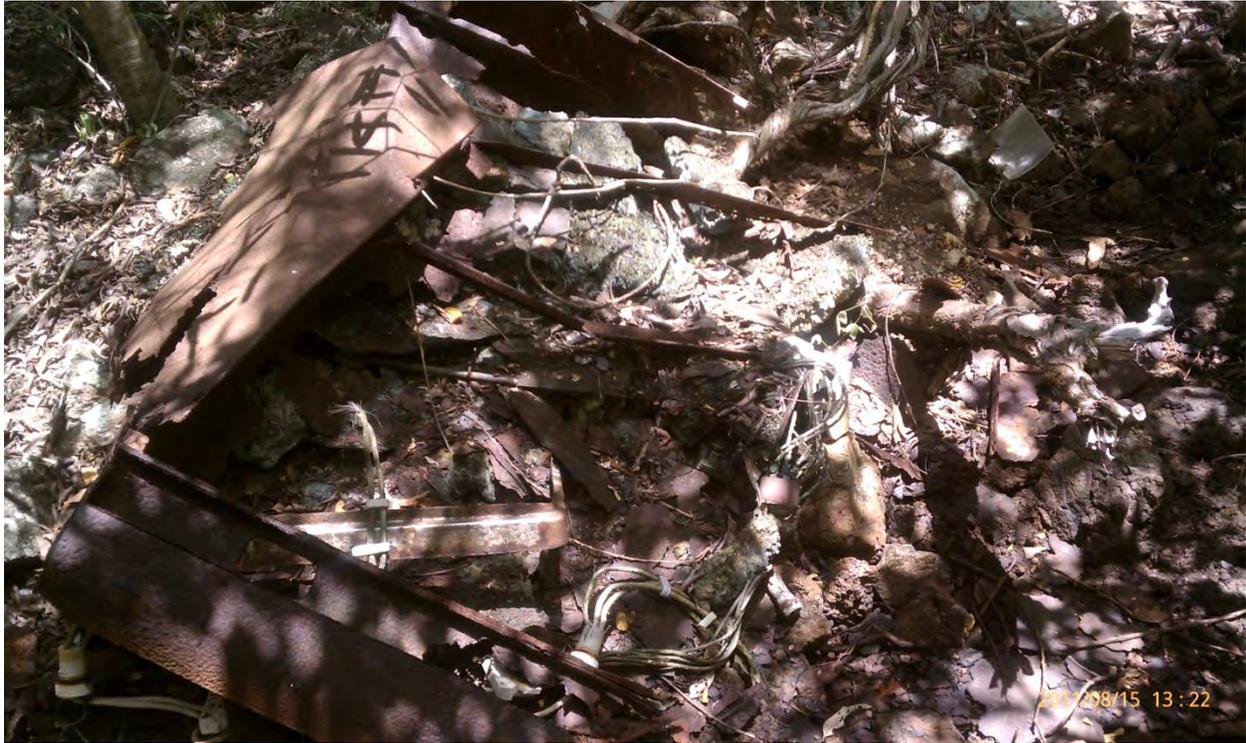
Photograph #6

Refrigerator or Other Type Appliance:

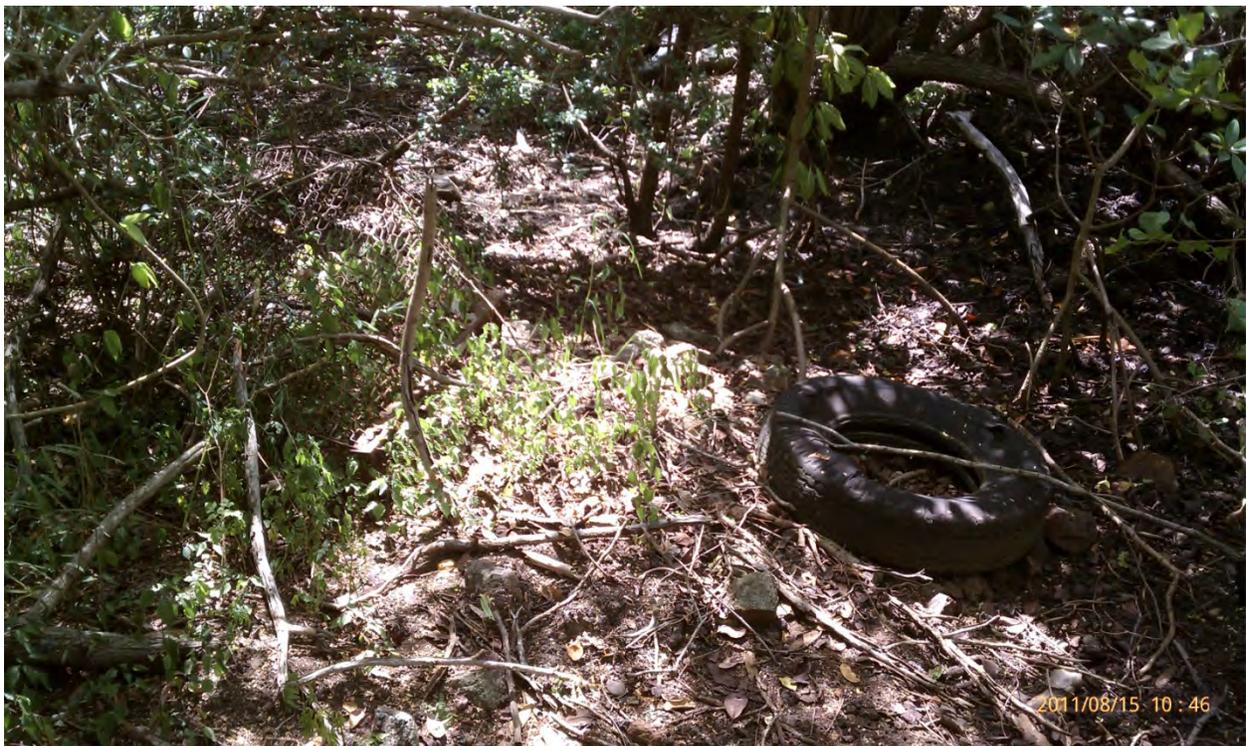
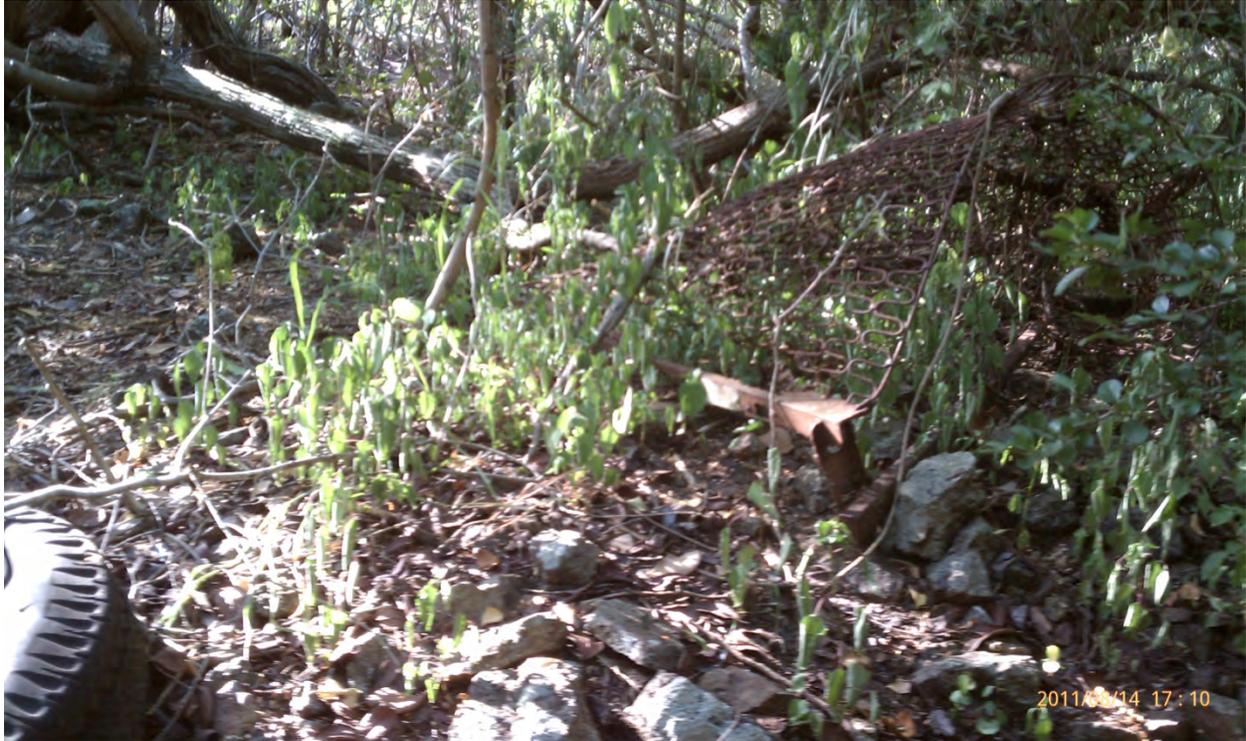
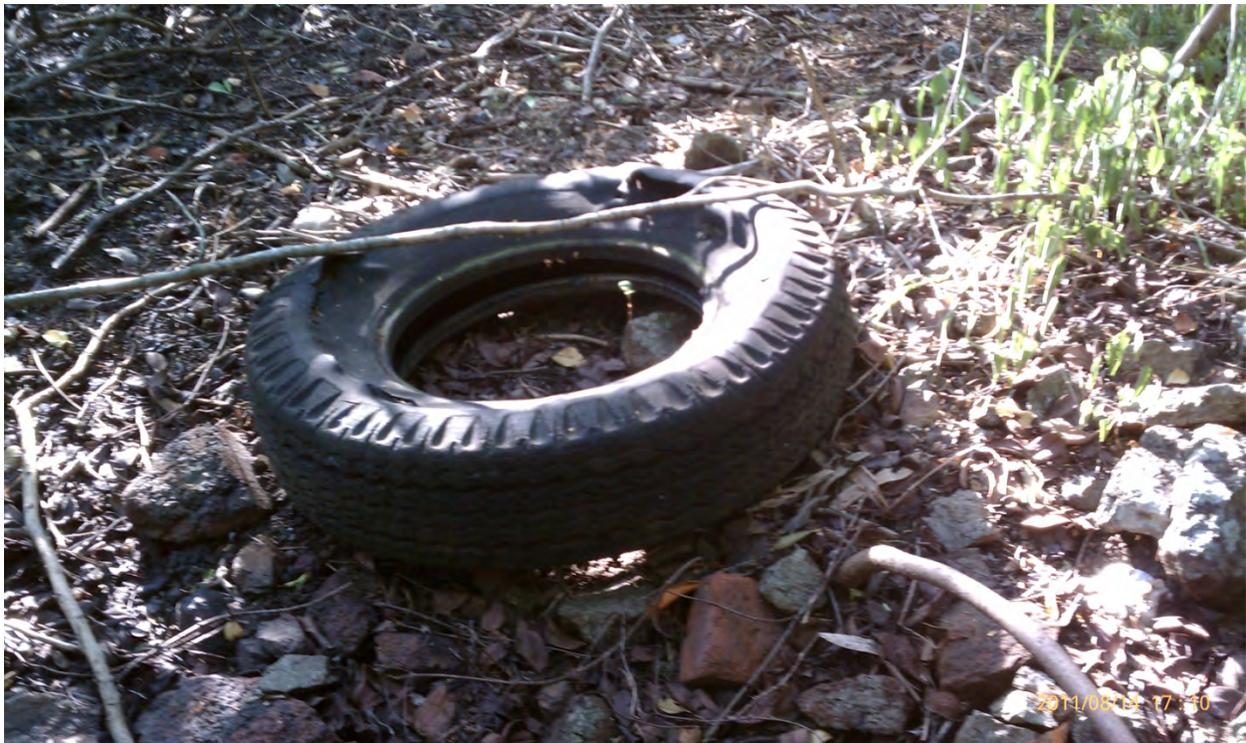
Old Tire, Mattress Spring, Building Material:

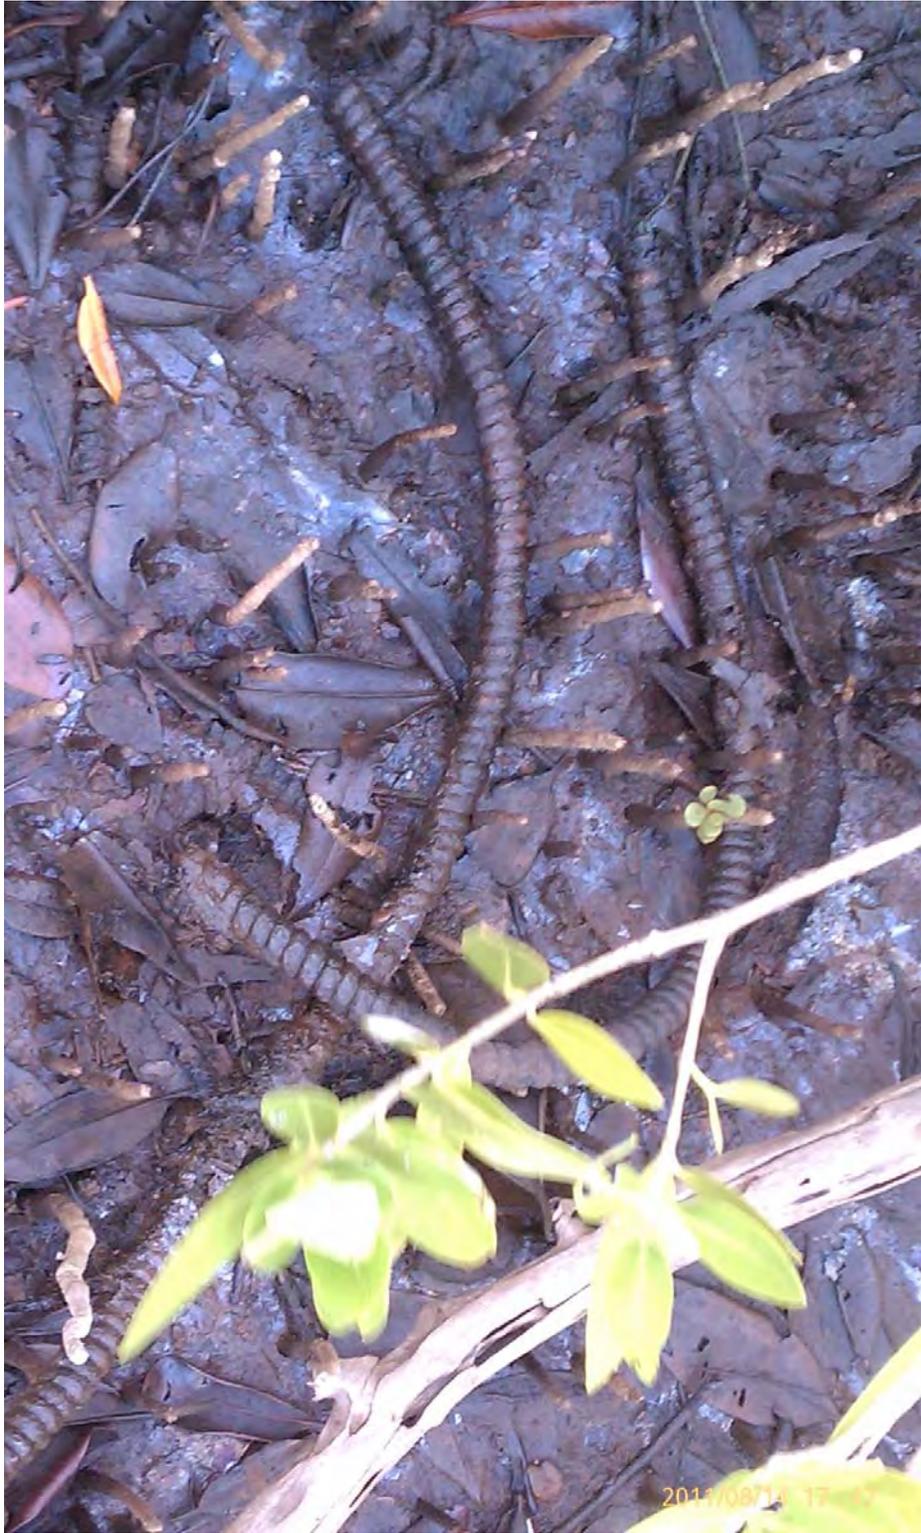
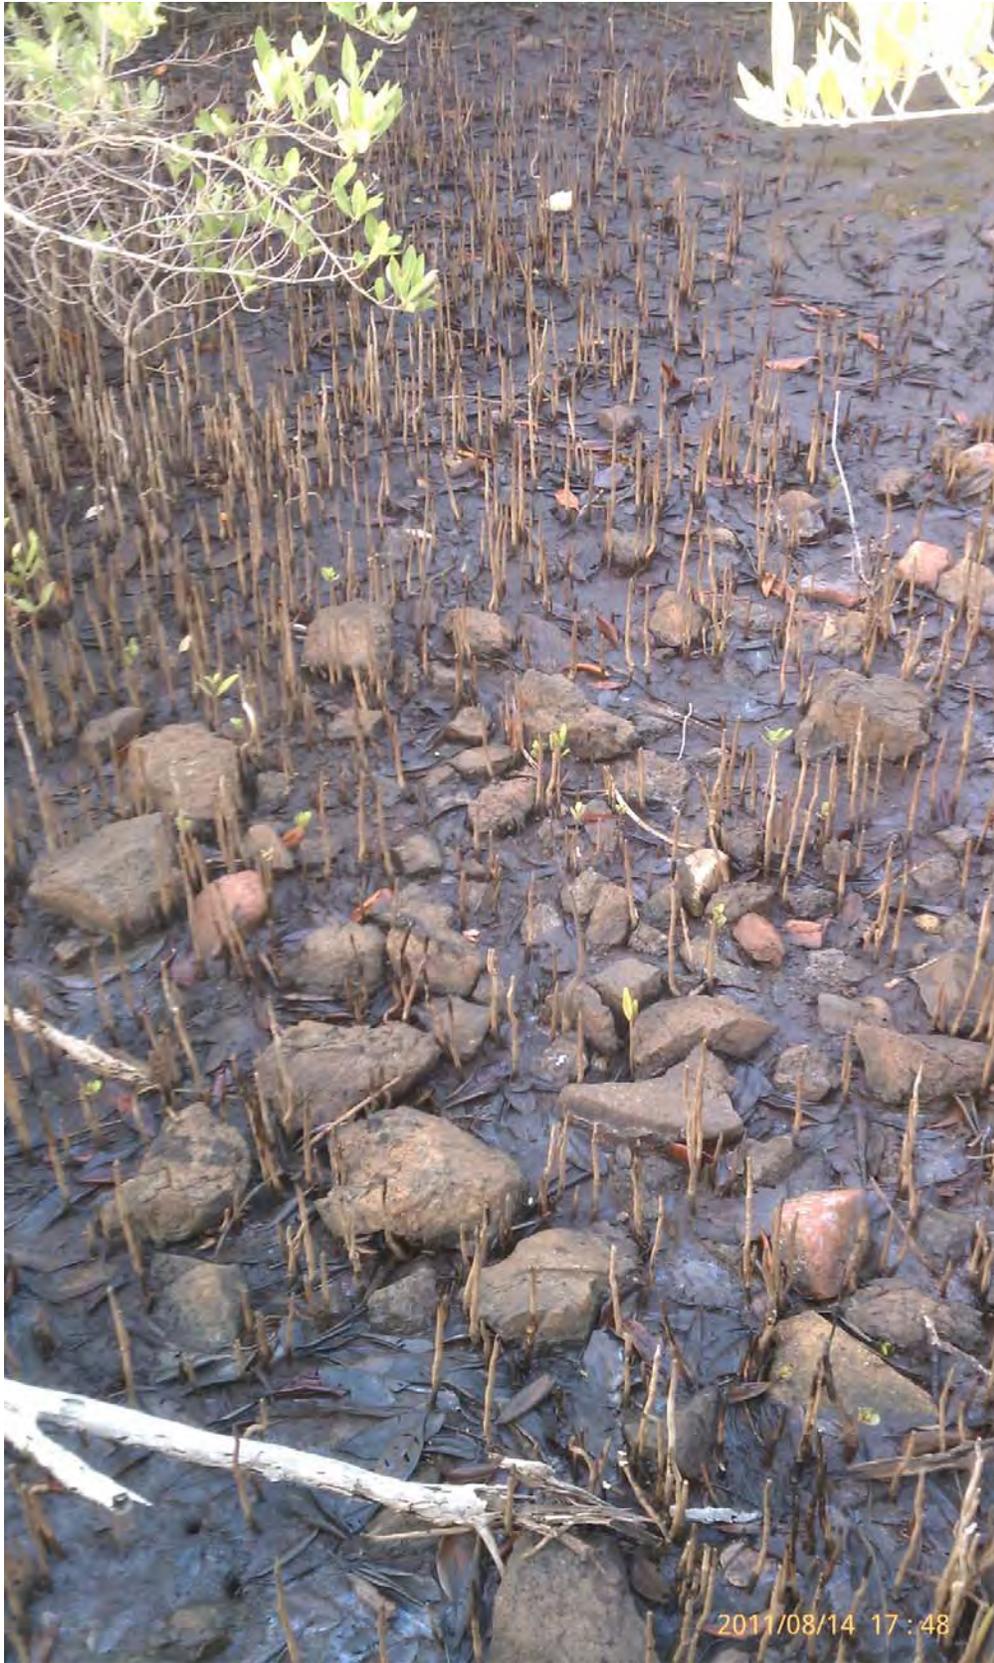
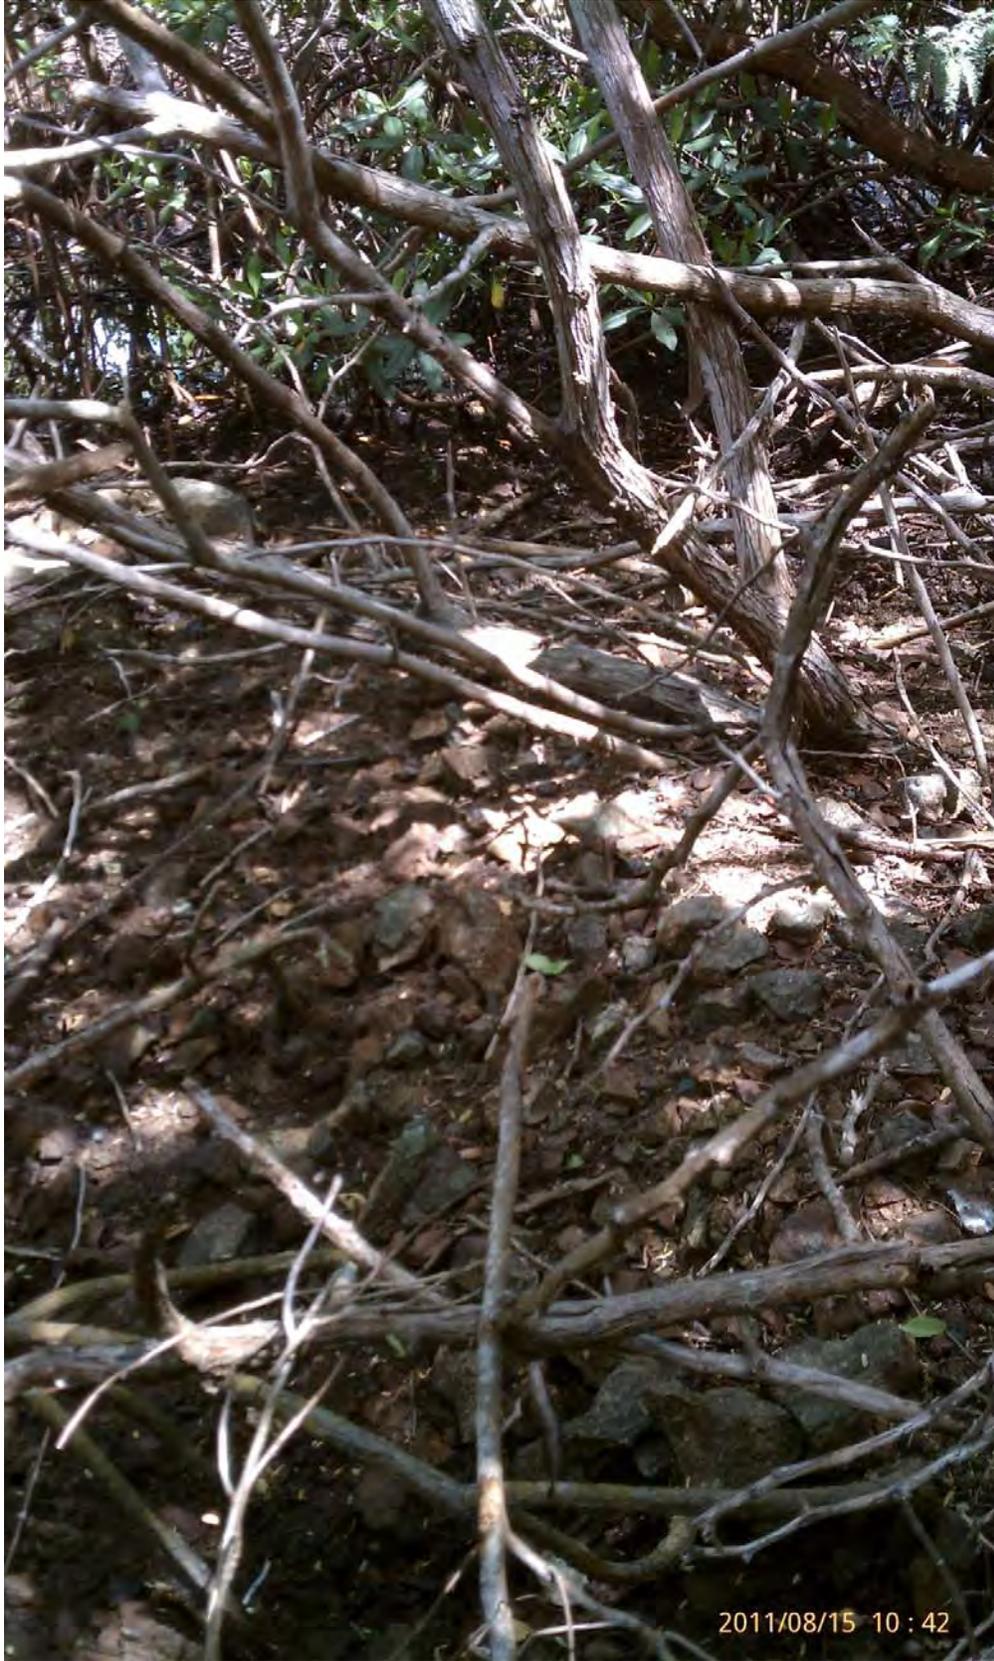
Building Materials:

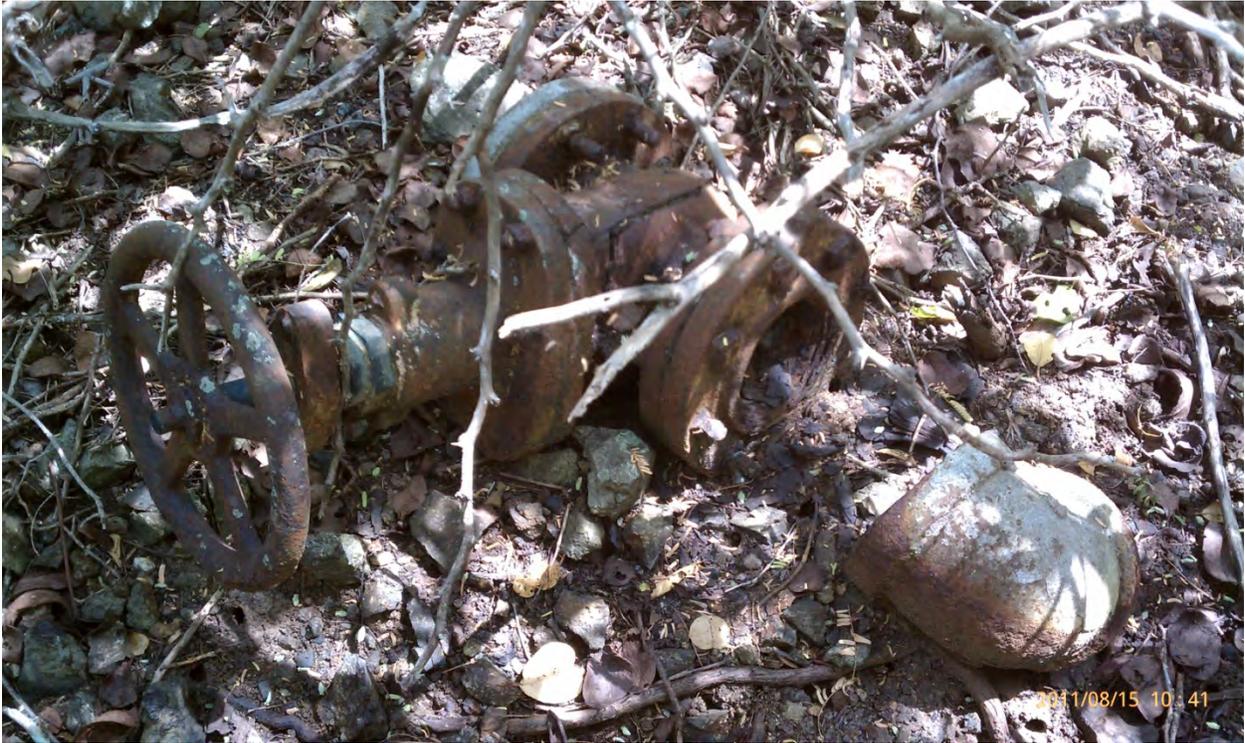
Photograph #13

Water Valve:

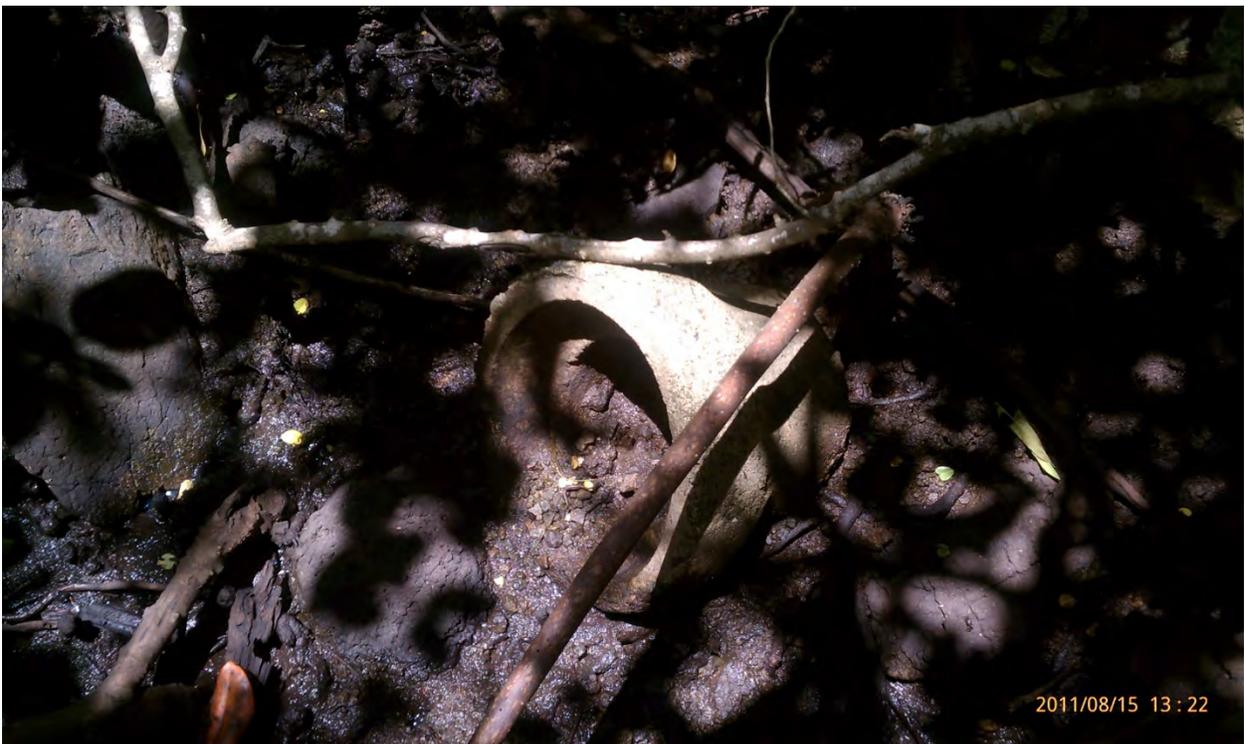
Photograph #14

Concrete Pipe:

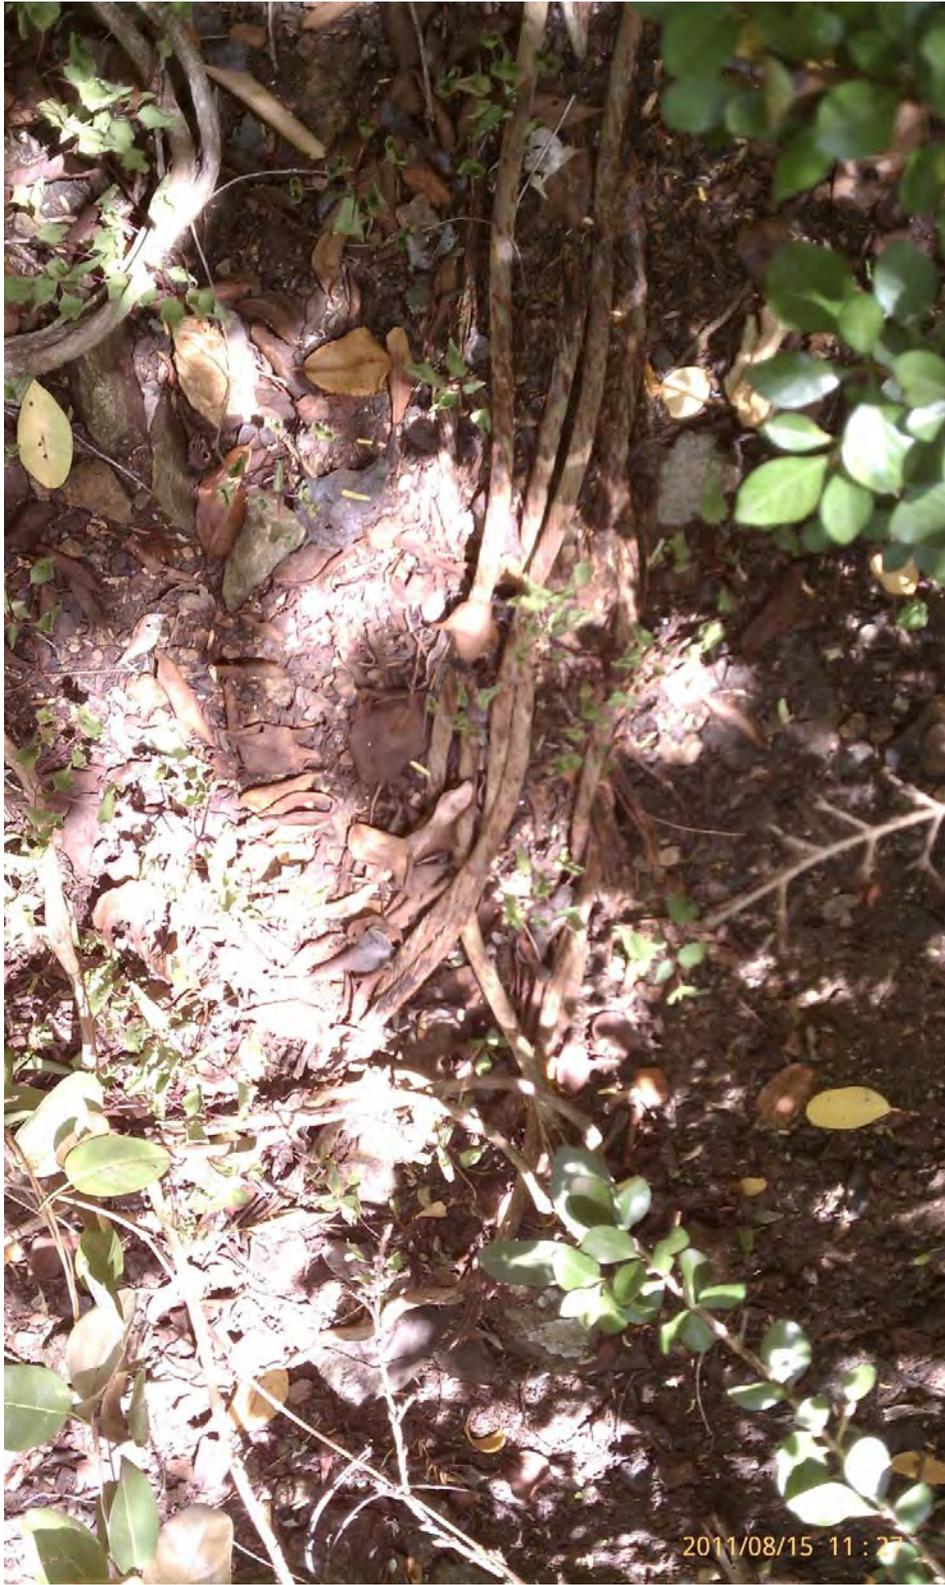
Photograph #15

Metal Braided Cables:

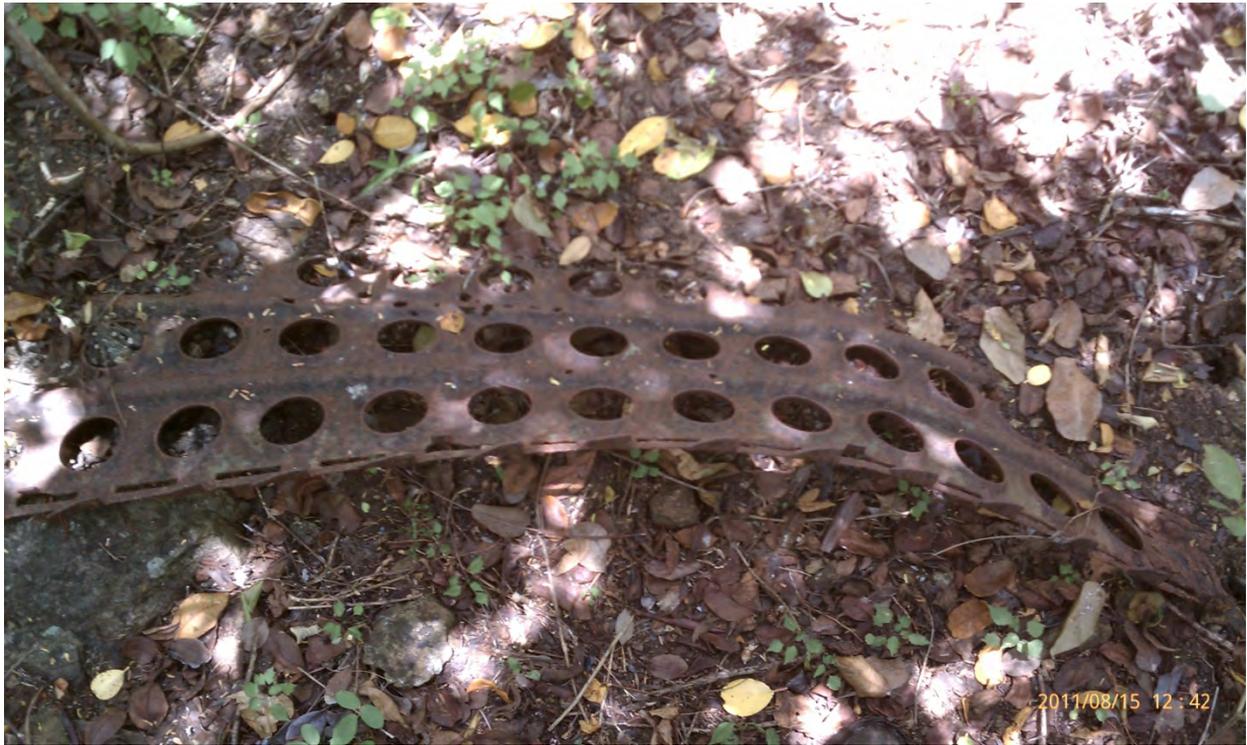
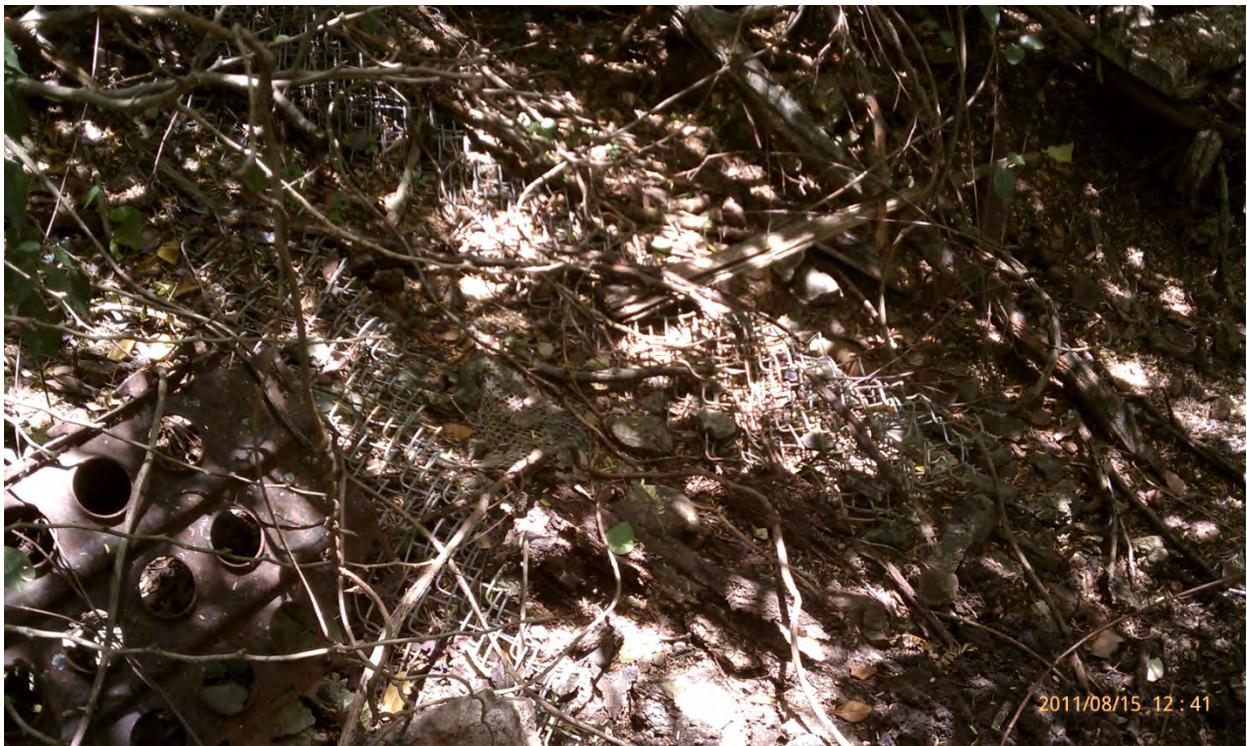
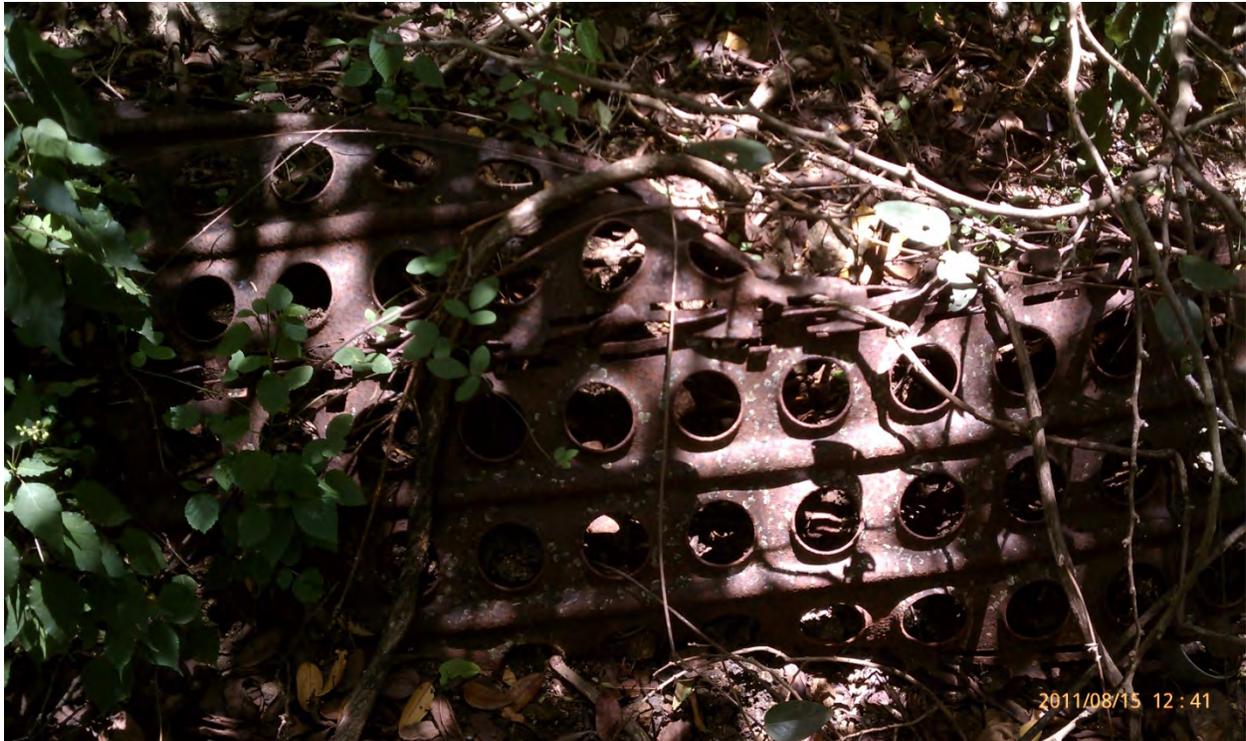
Metal Walkway:
