**Final
Hazardous, Toxic, and Radioactive Waste (HTRW)
Site Inspection Report
DERP-FUDS Site IO2PR006800
Former Lower Camp Debris Site
Culebra Island, Puerto Rico**

July 2012

Former Lower Camp Debris Site
Culebra Island, Puerto Rico

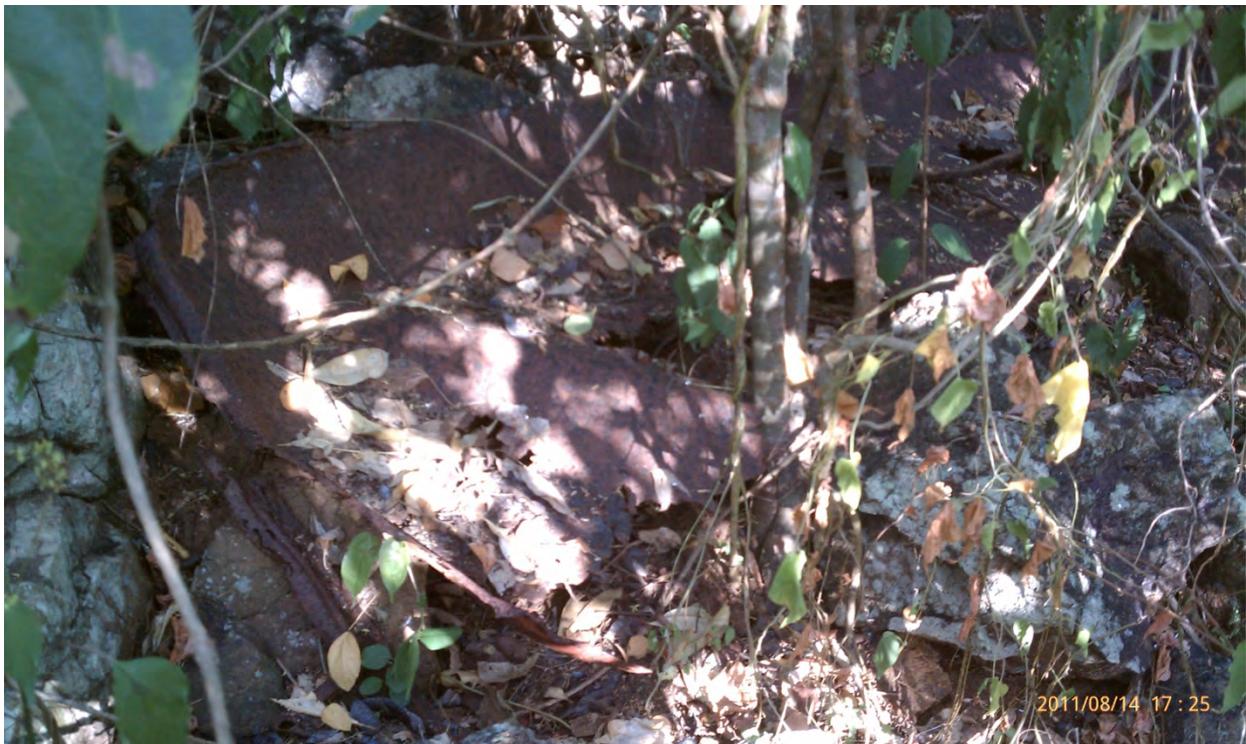
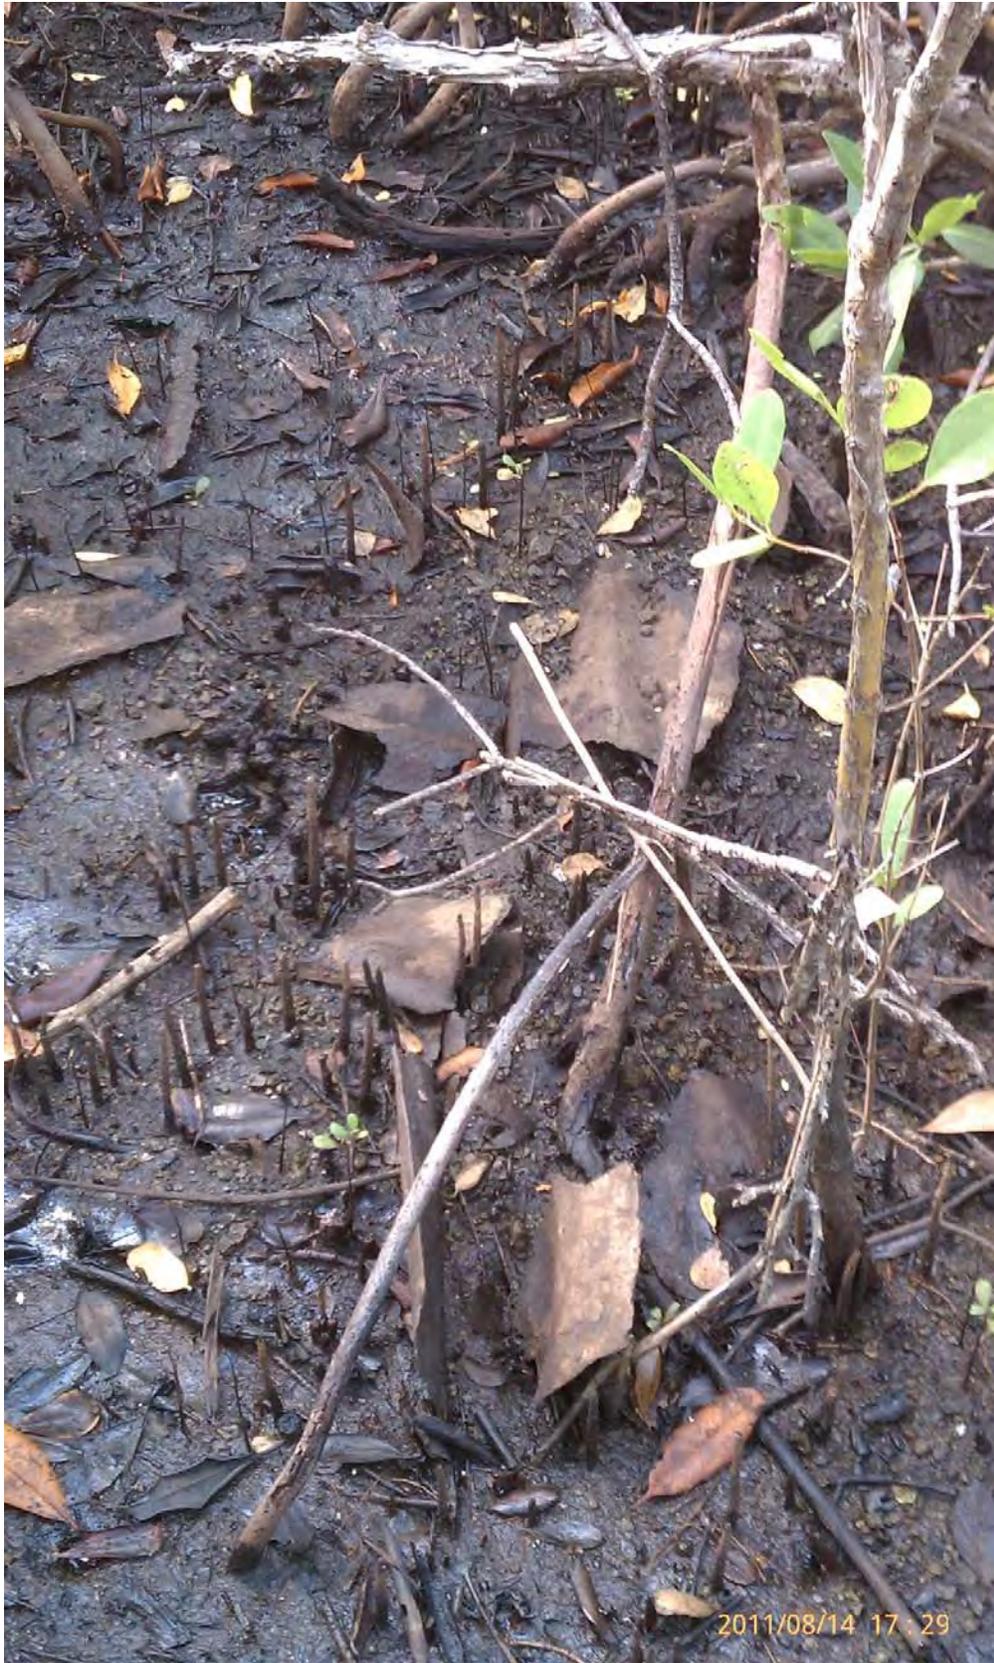
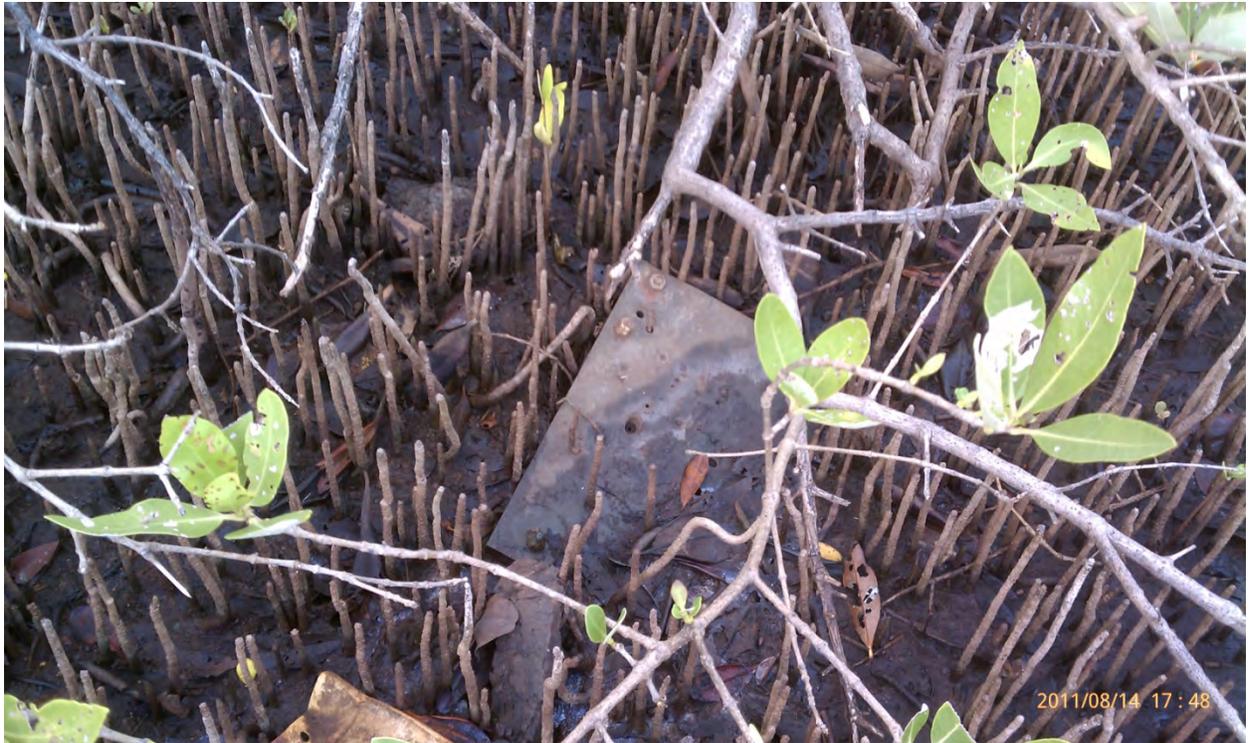
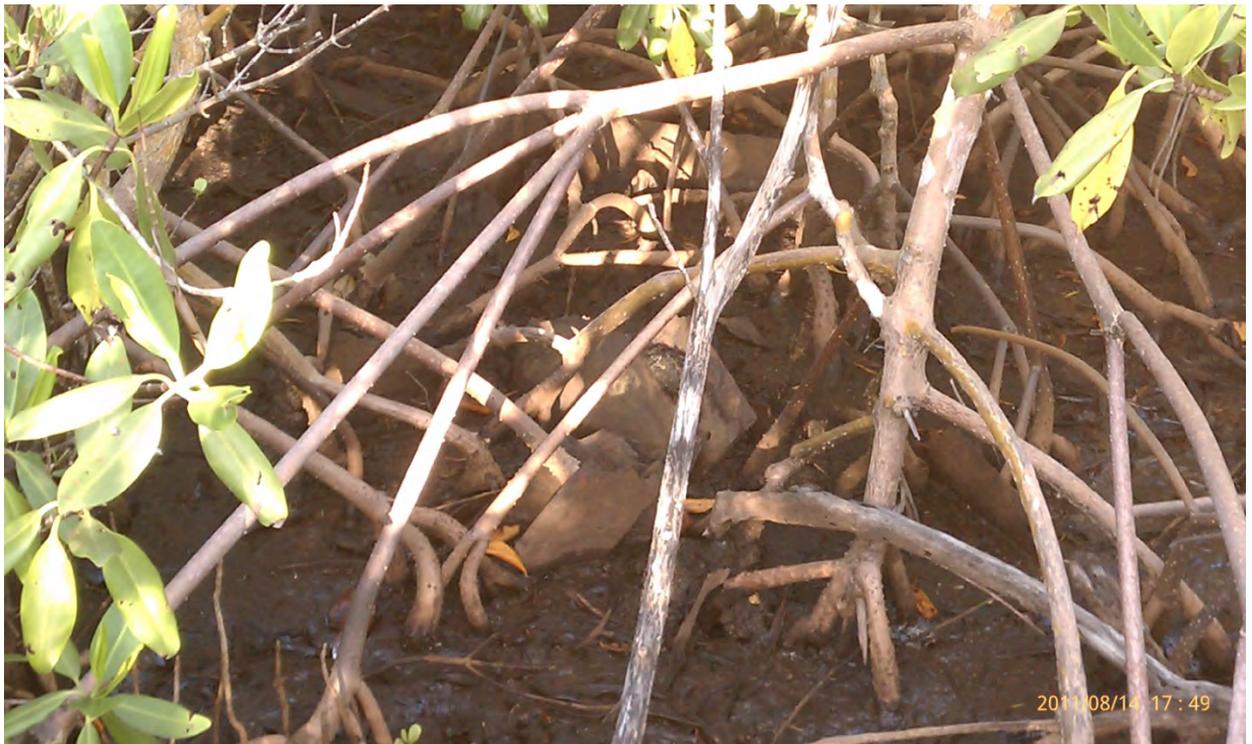
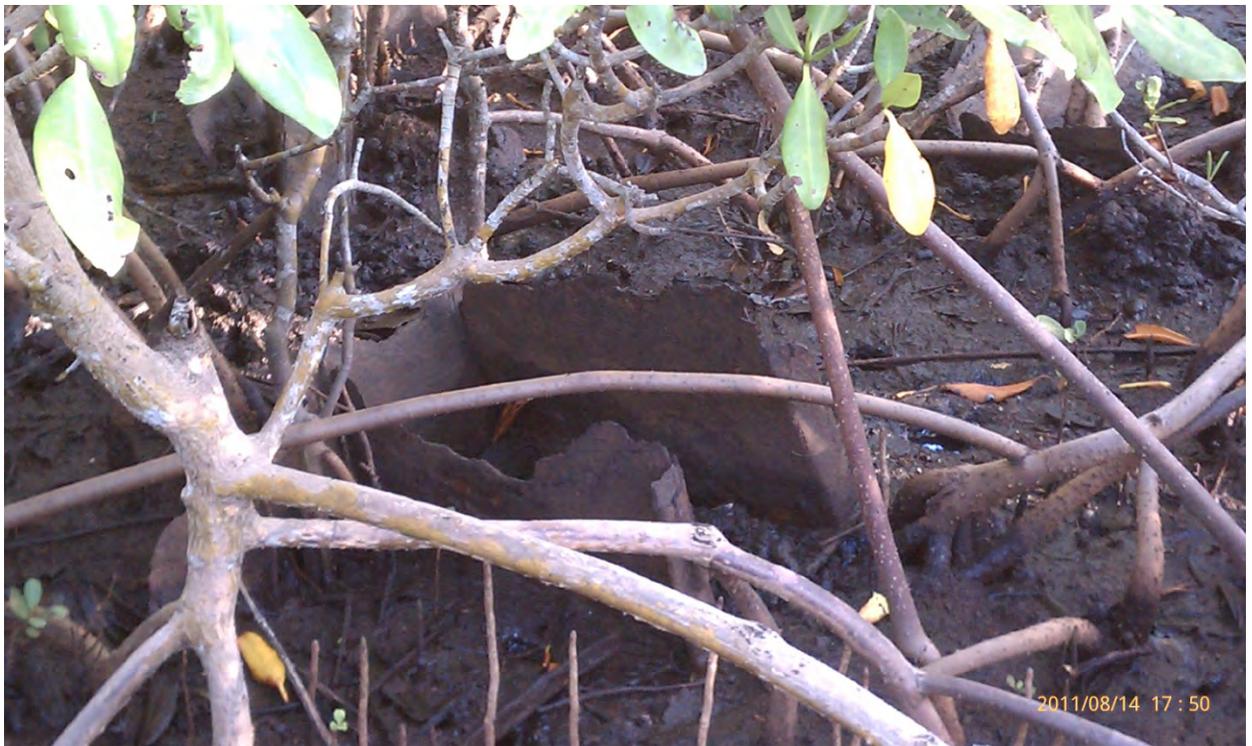
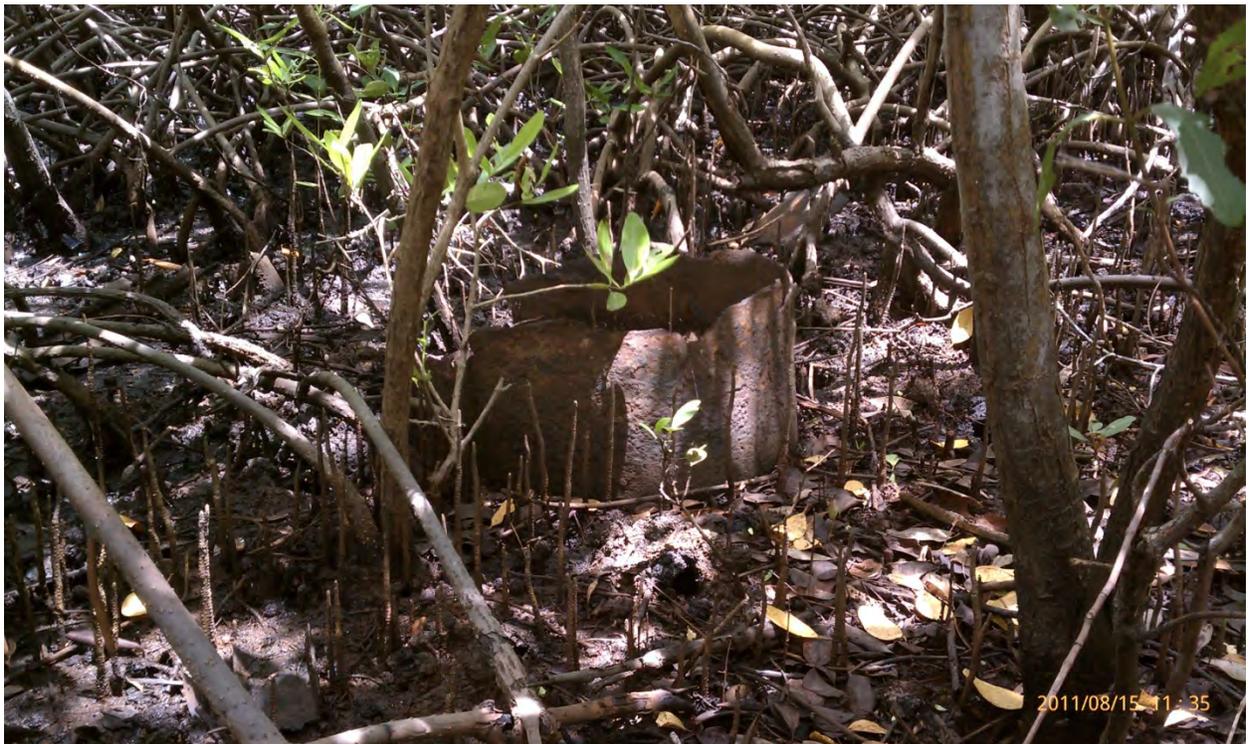
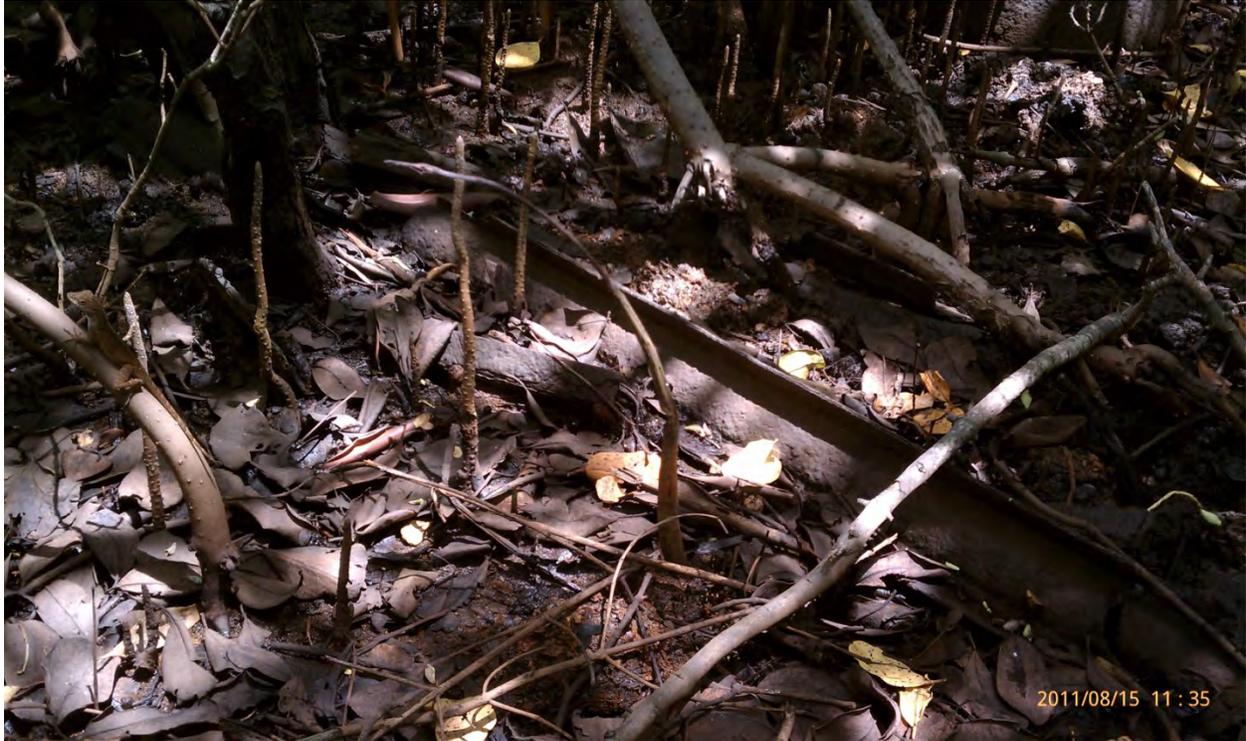
Highly Deteriorated Oxidized Metal:

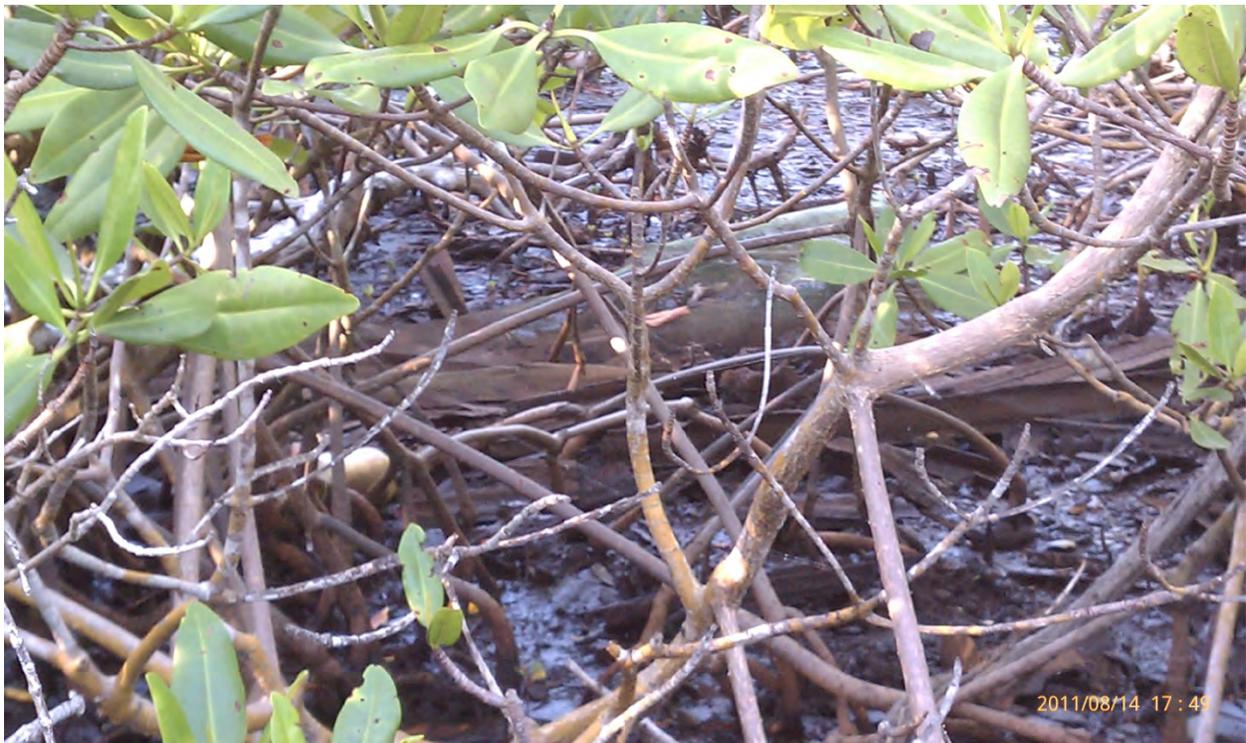
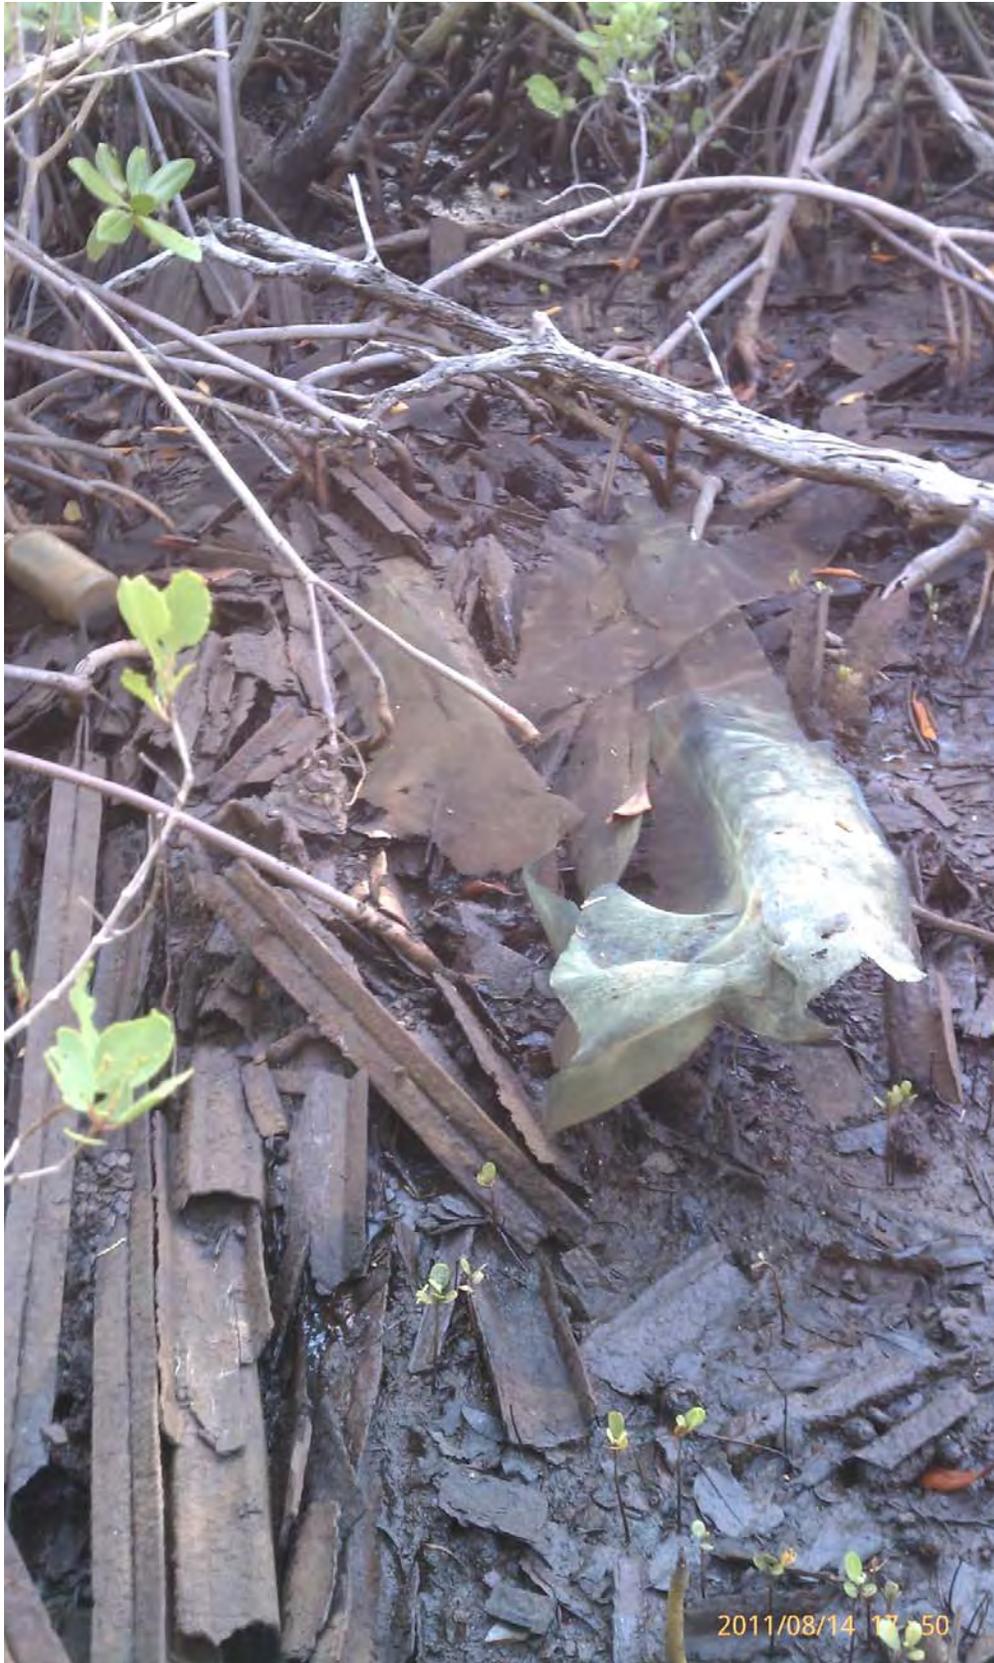
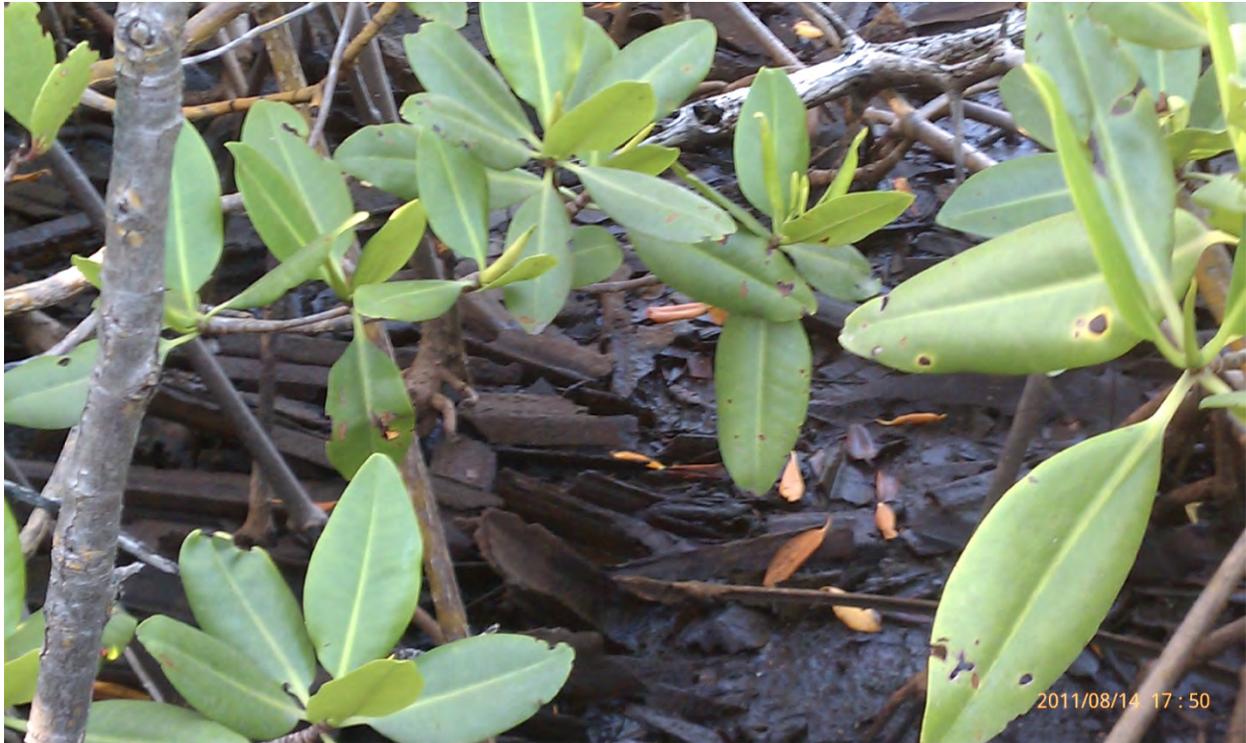
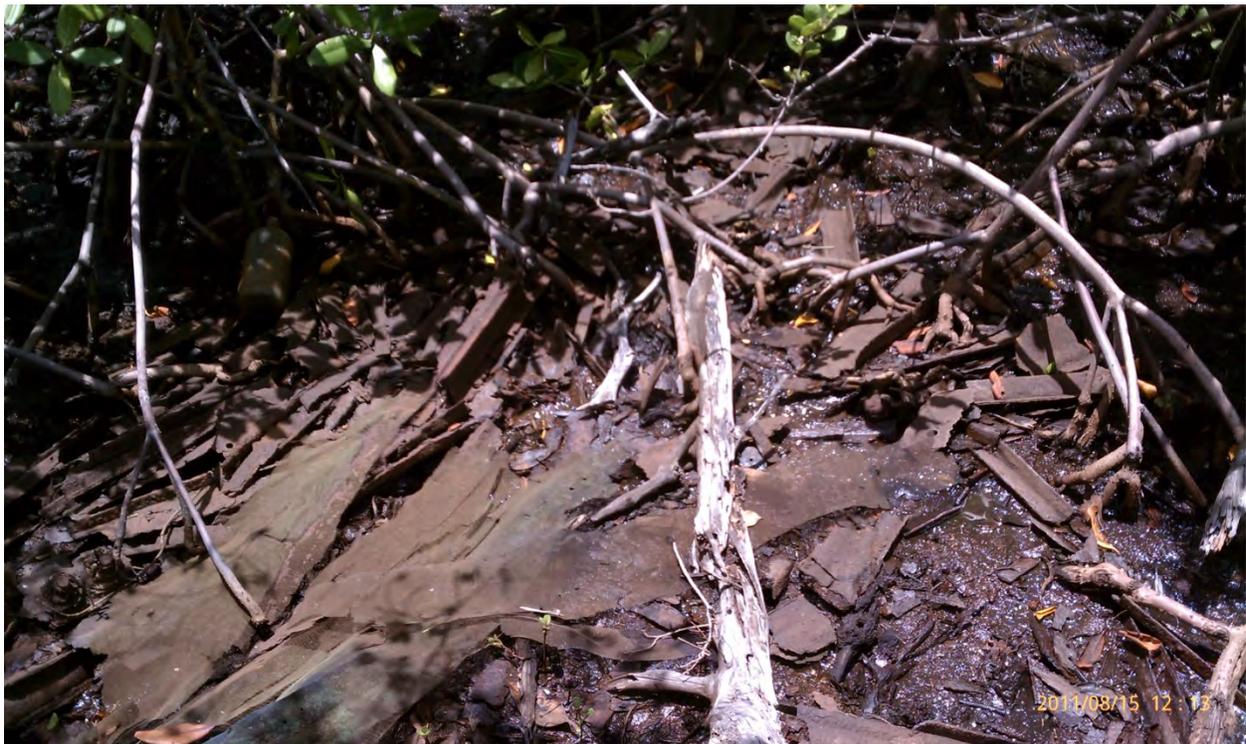
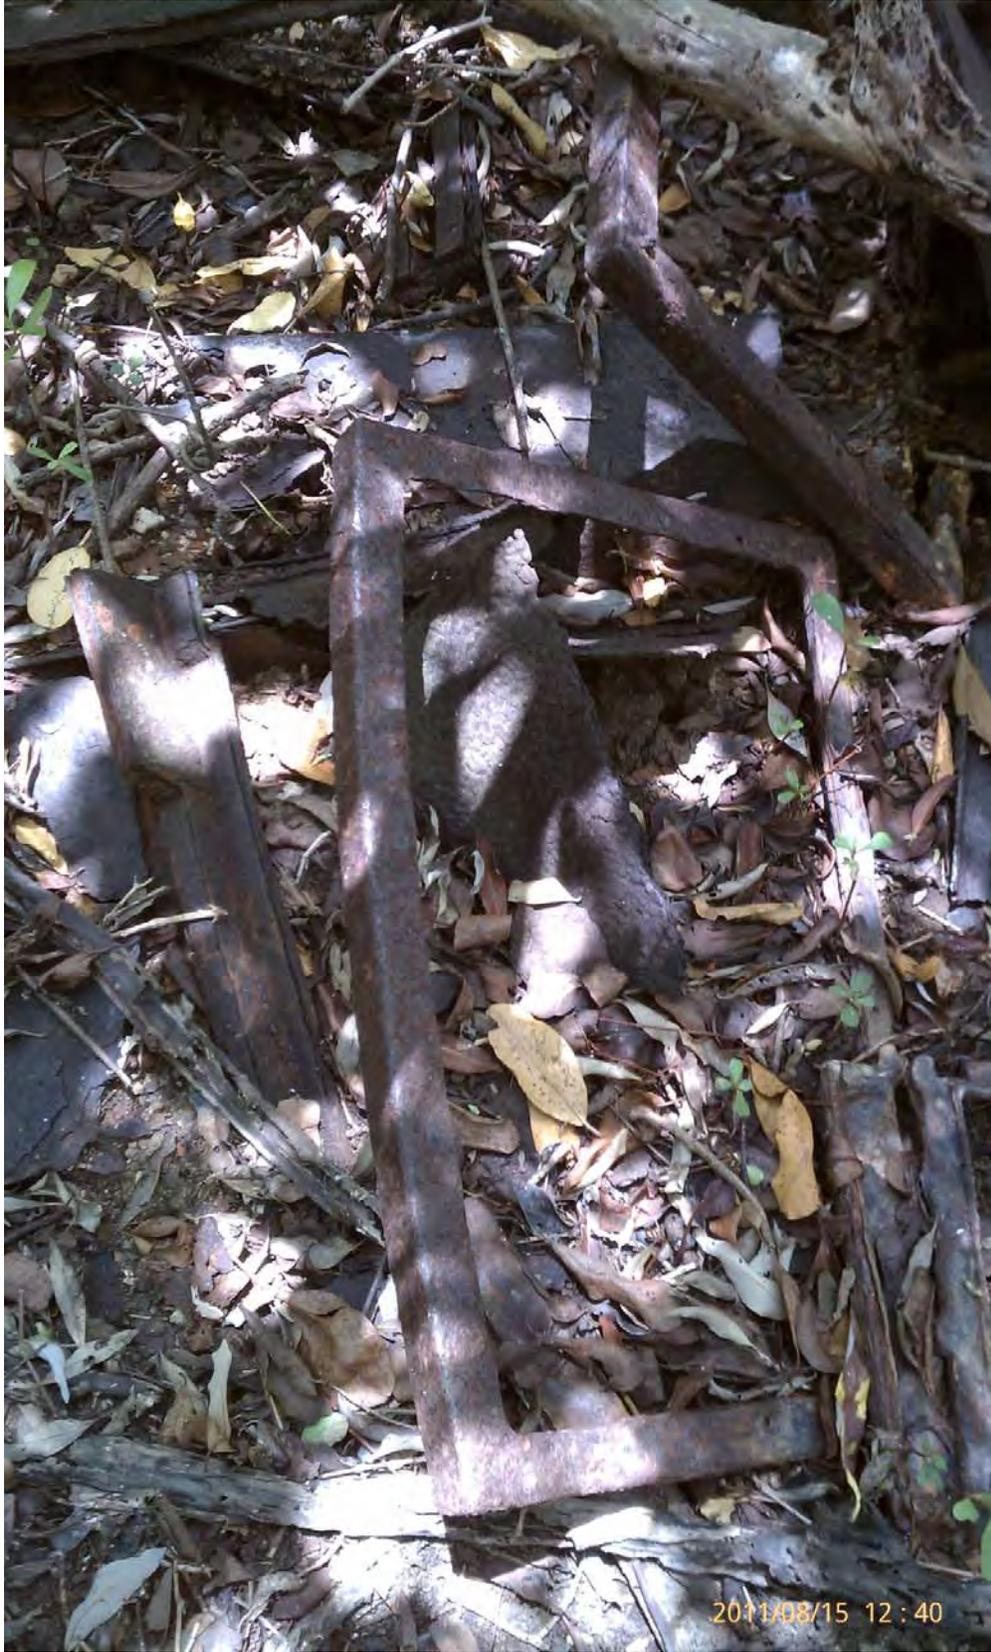
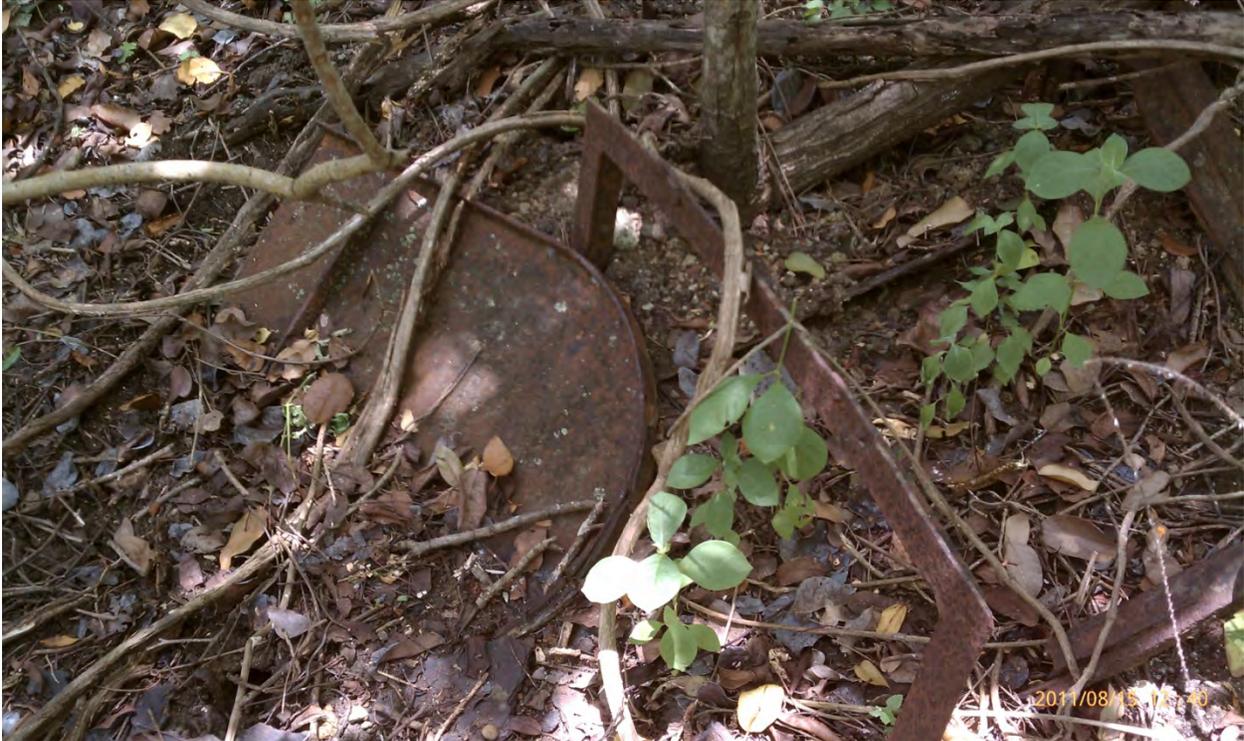
Highly Deteriorated Oxidized Metal Pile:

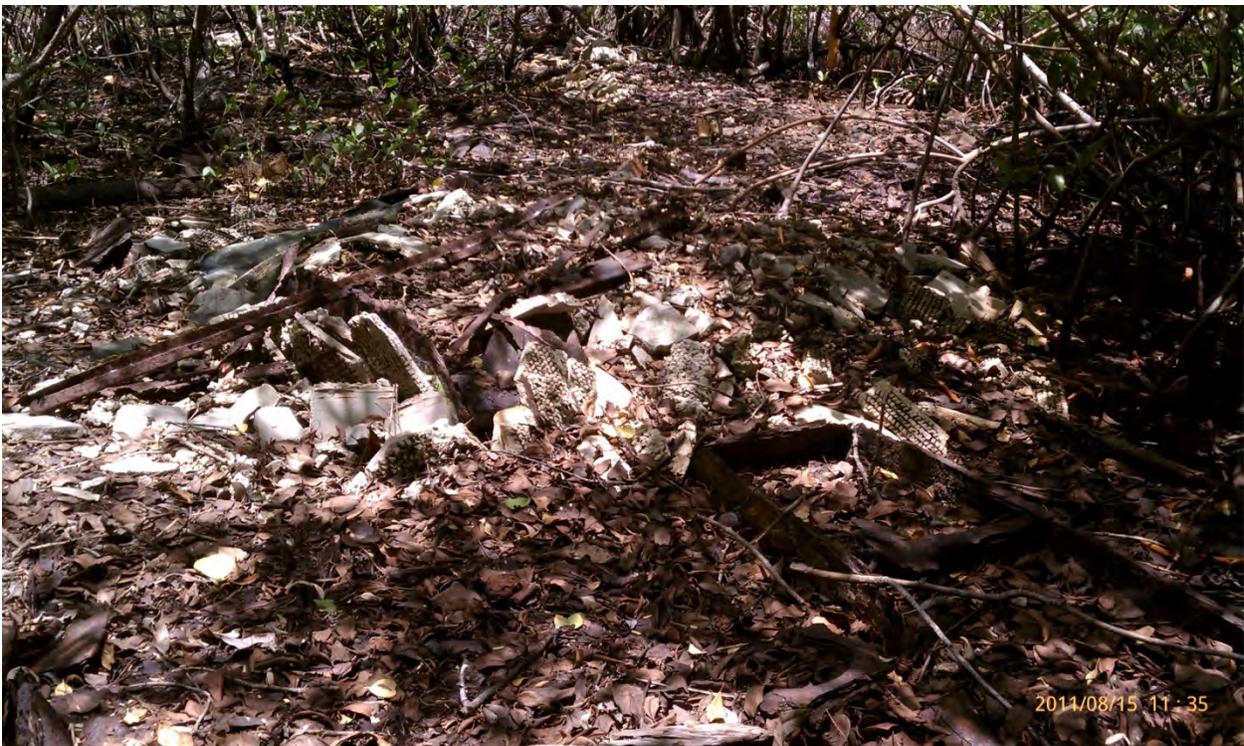
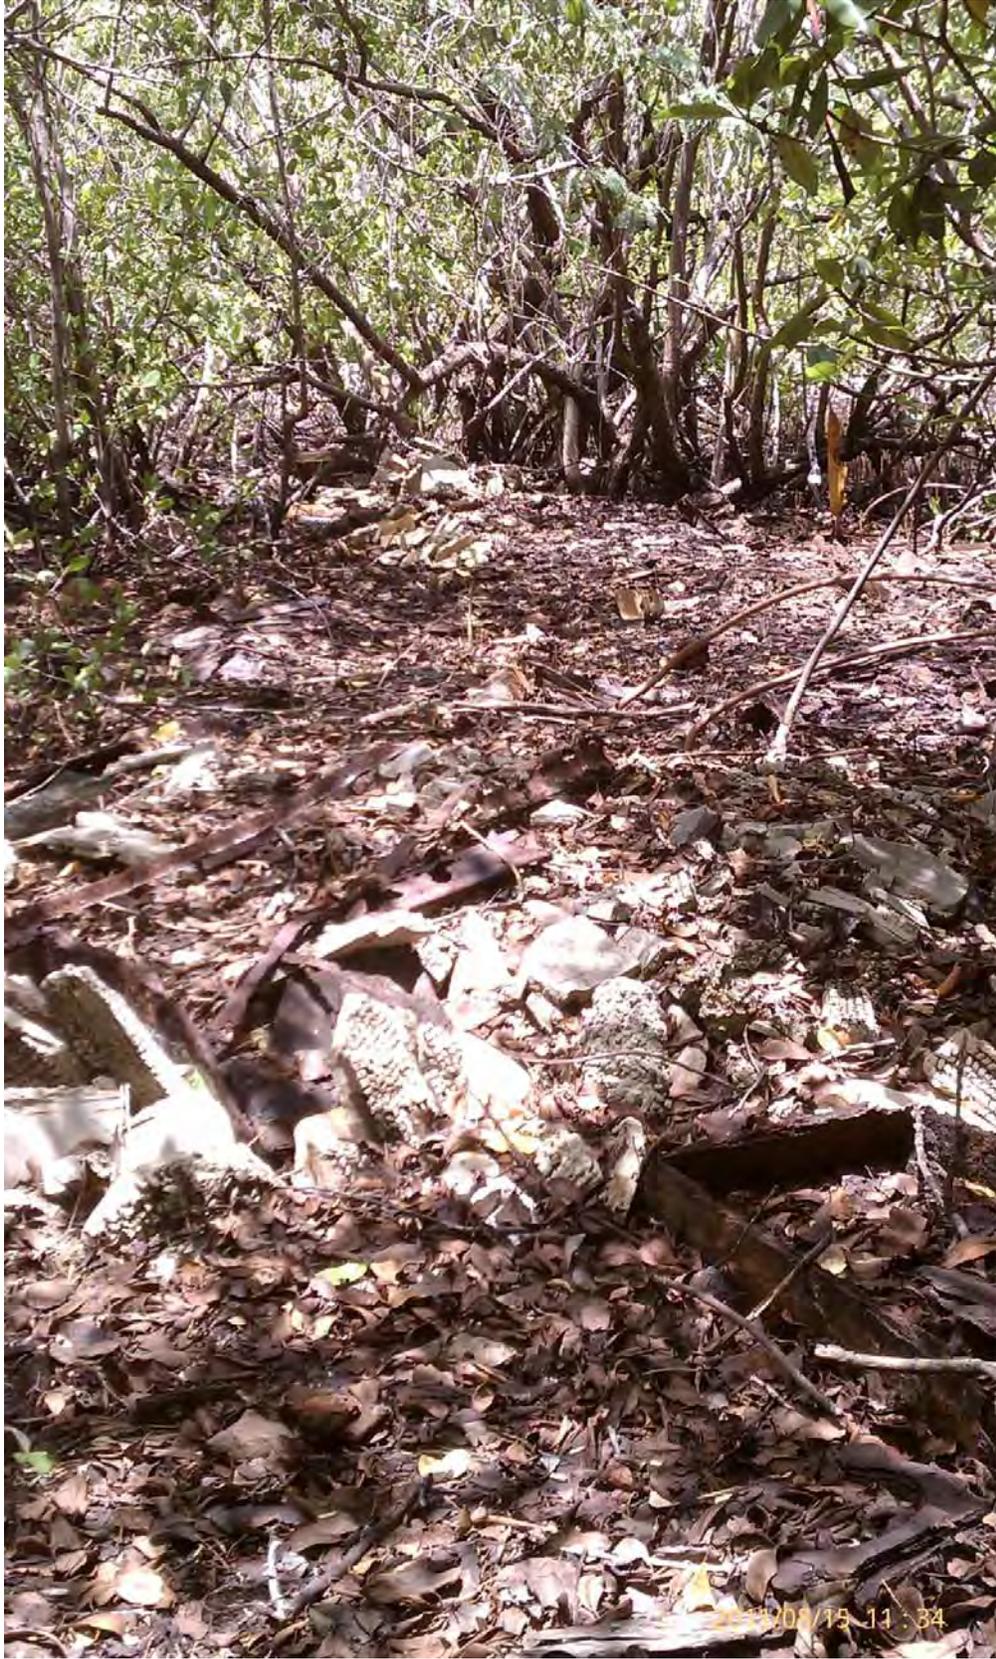
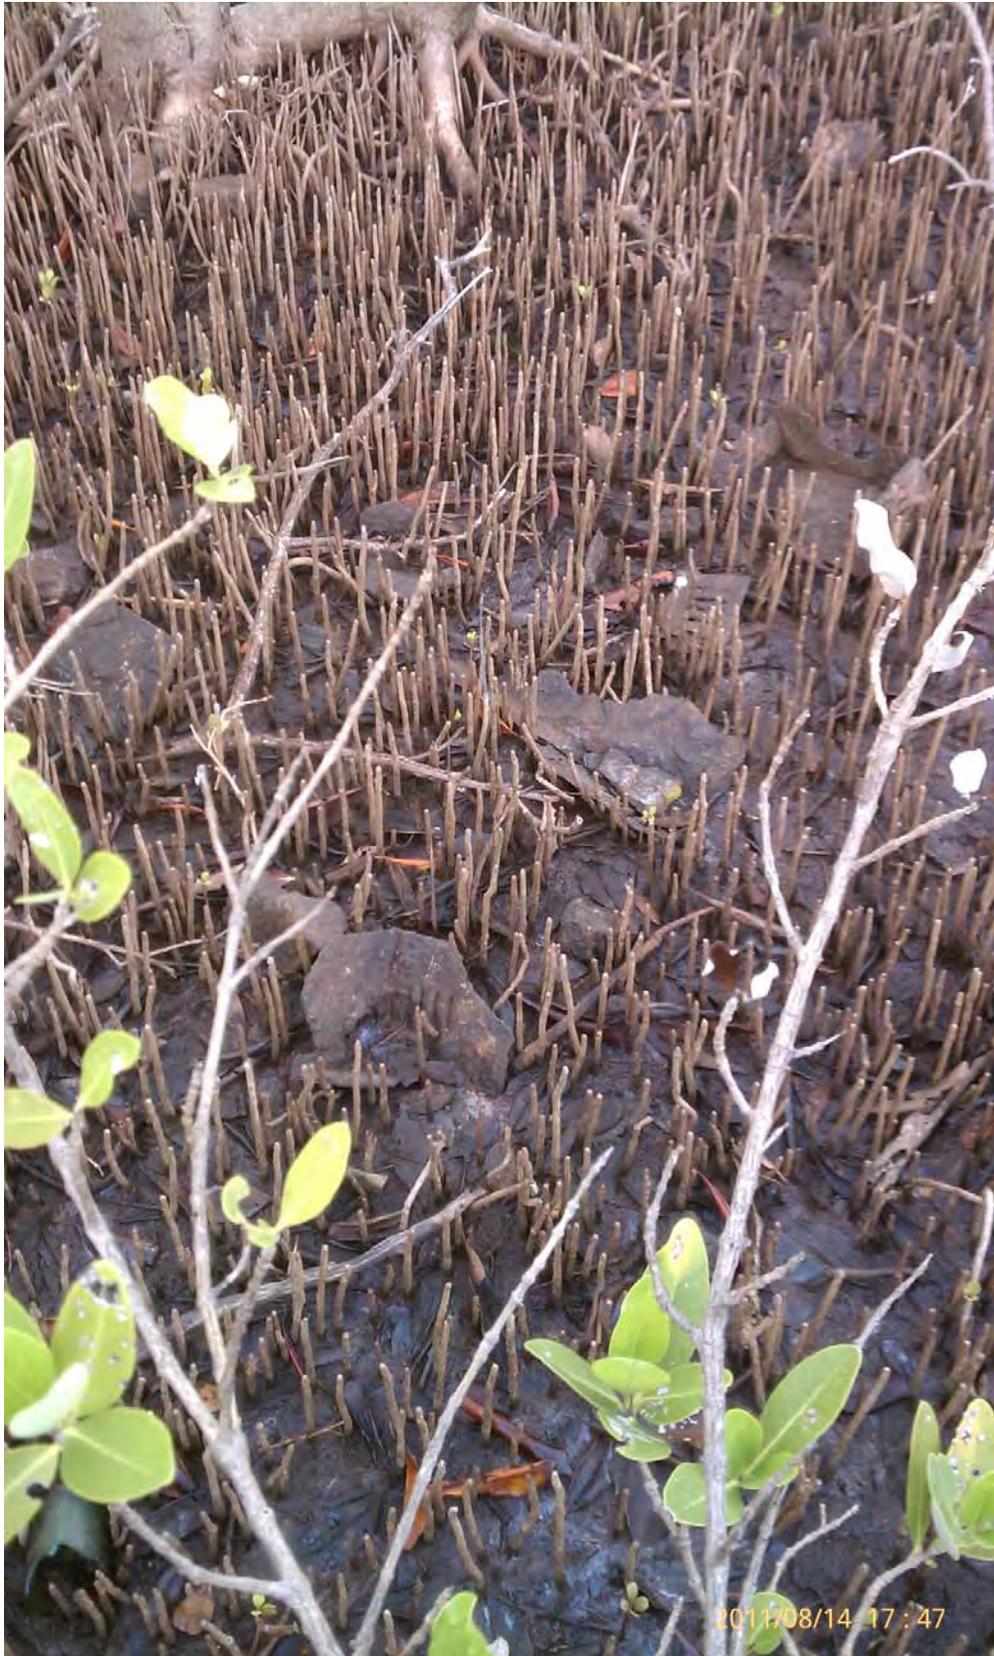
Highly Deteriorated Oxidized Metal and Building Material:

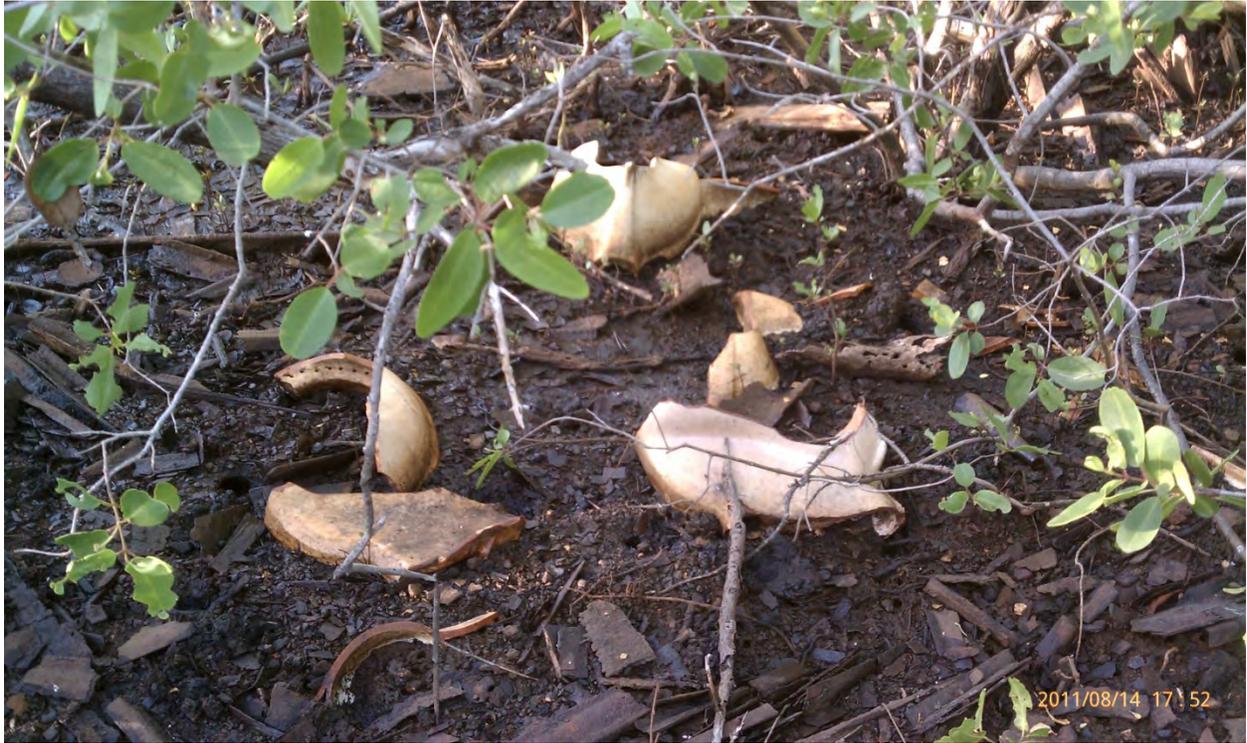
Photograph #35

Broken Porcelain and Highly Deteriorated Oxidized Metal:
