**Final
Hazardous, Toxic, and Radioactive Waste (HTRW)
Site Inspection Report
DERP-FUDS Site IO2PR006800
Former Lower Camp Debris Site
Culebra Island, Puerto Rico**

July 2012

Former Lower Camp Debris Site
Culebra Island, Puerto Rico

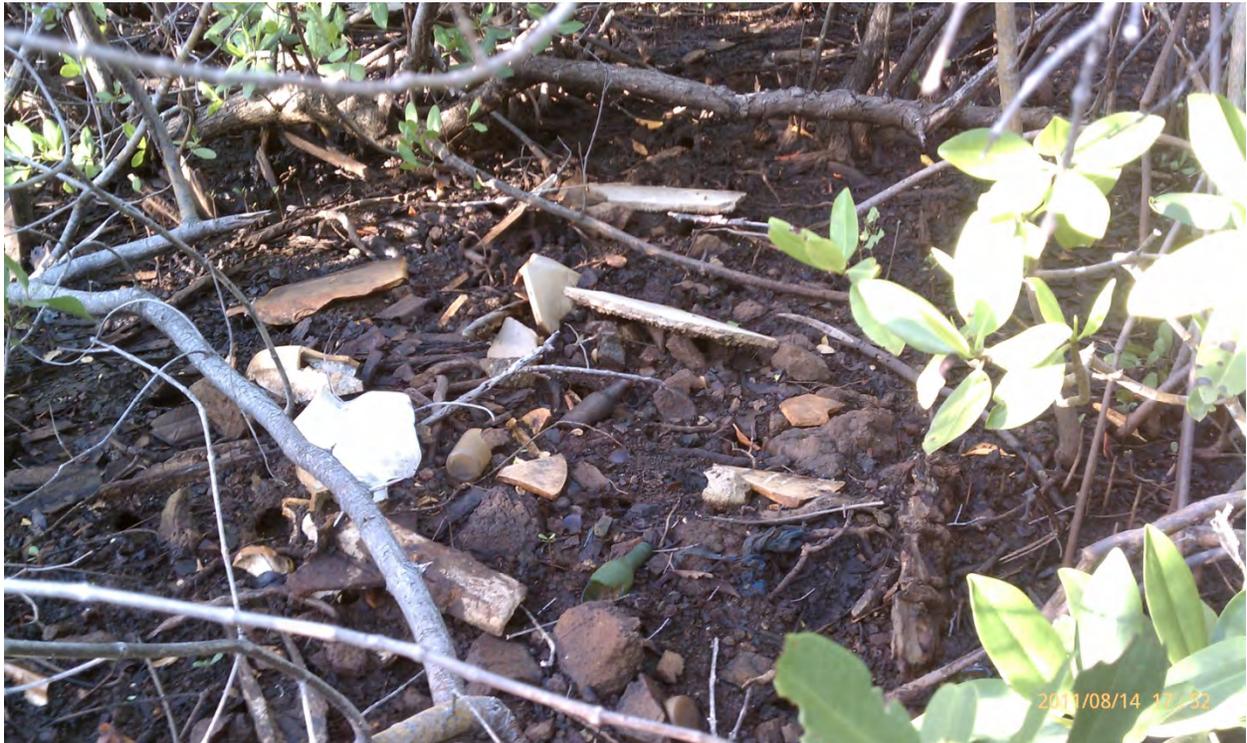
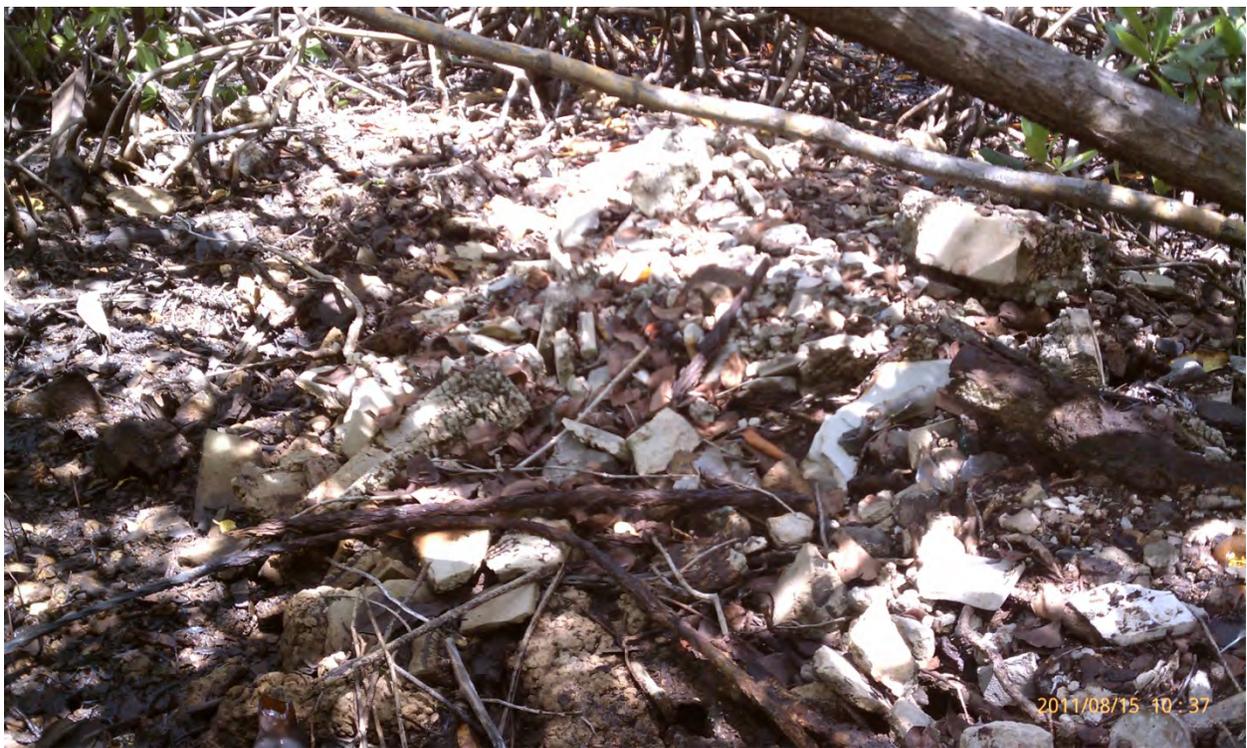
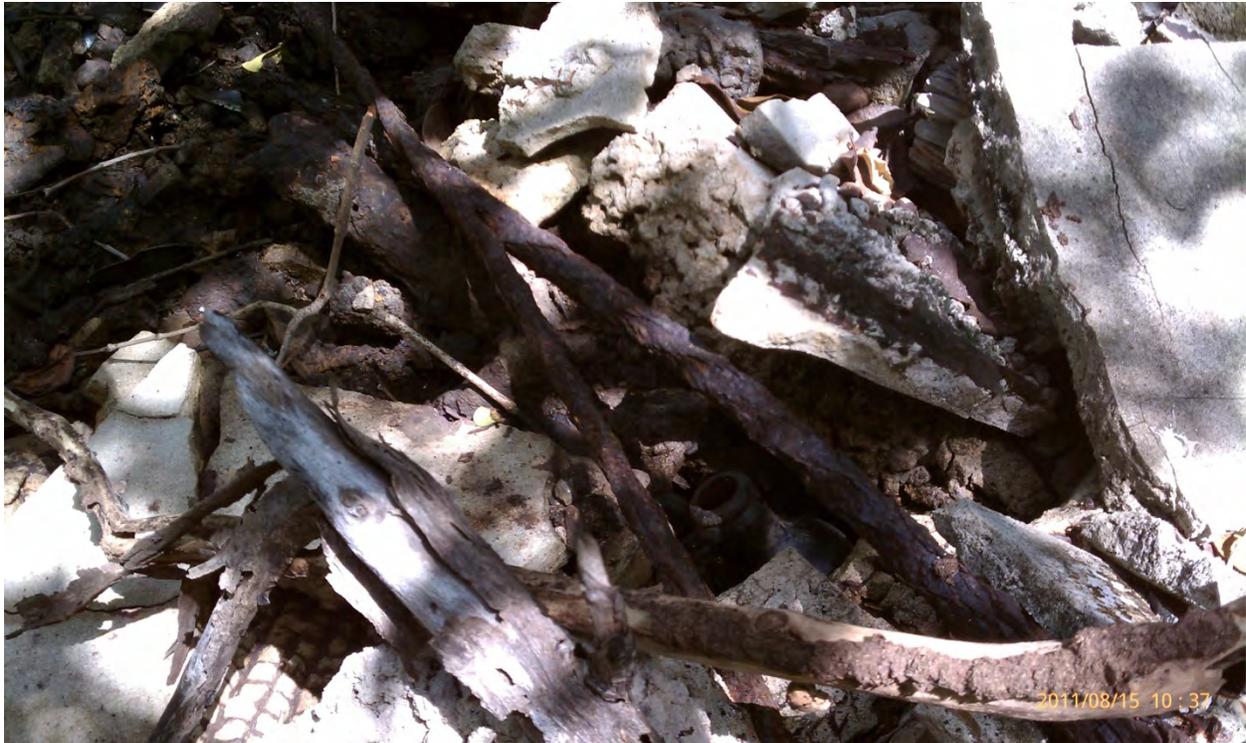
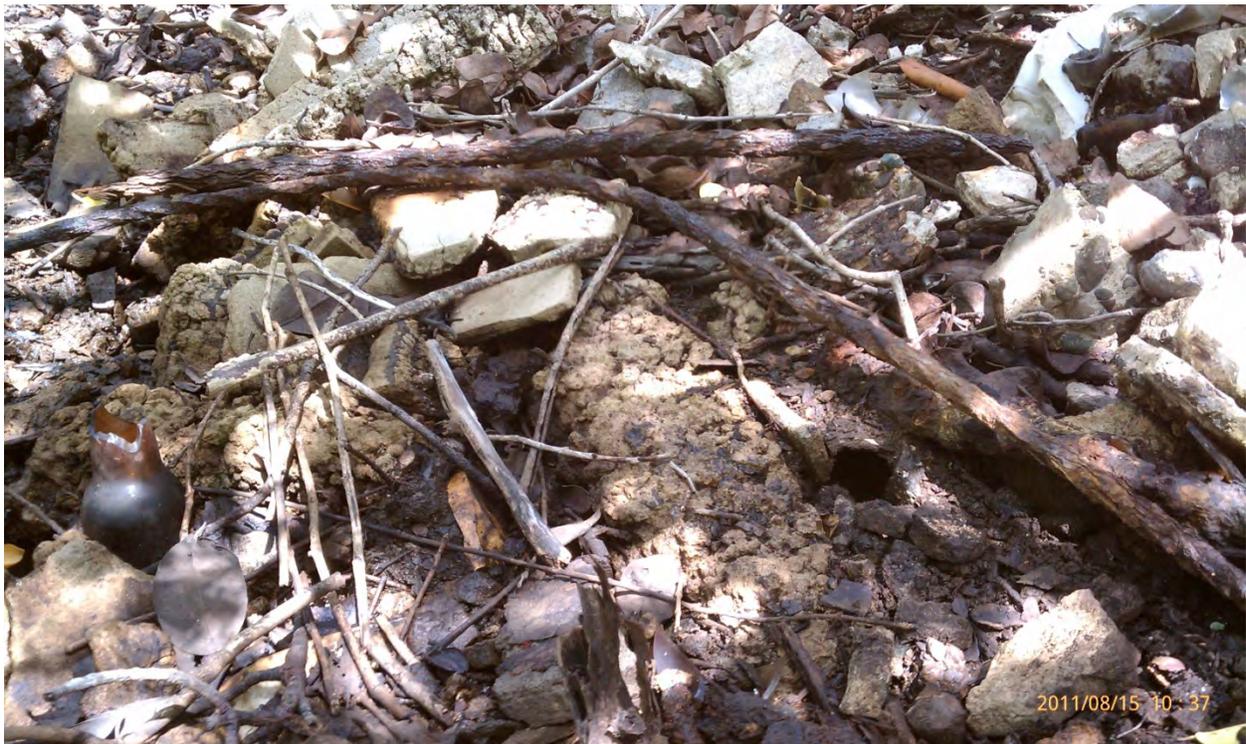
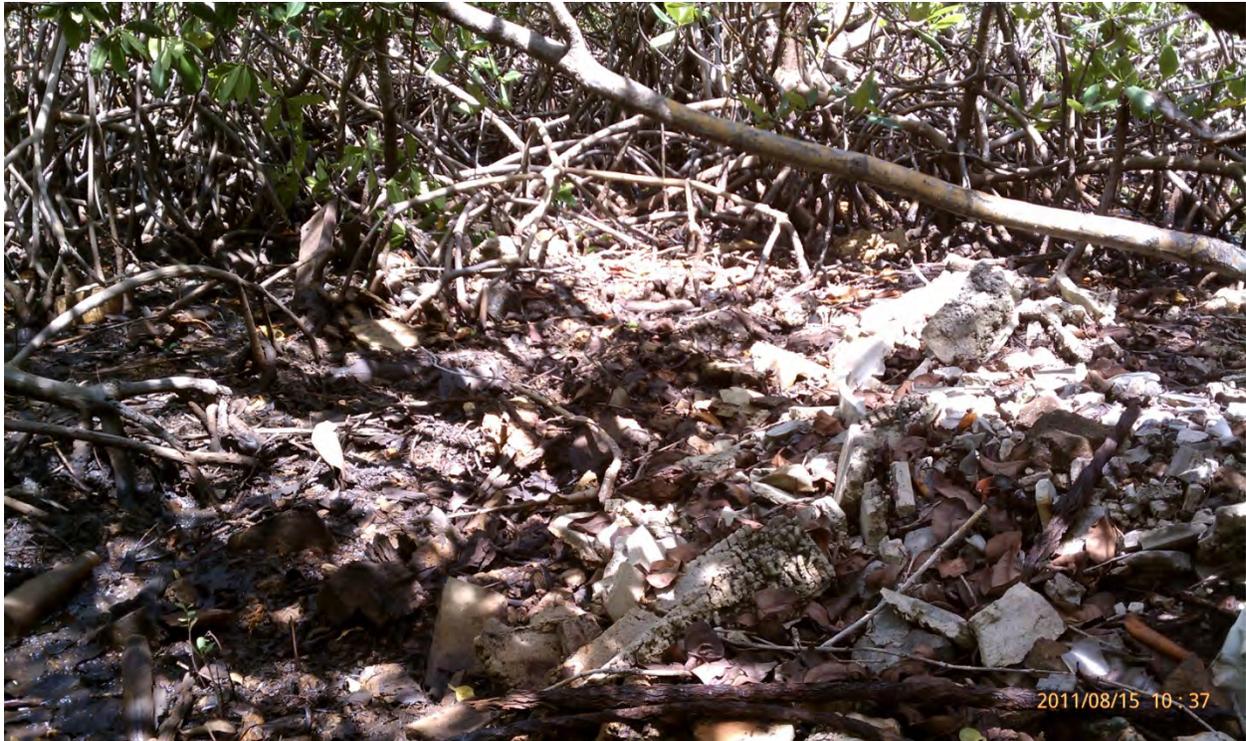
Broken Porcelain, Highly Deteriorated Oxidized Metal, Building Materials, and Broken Bottles:

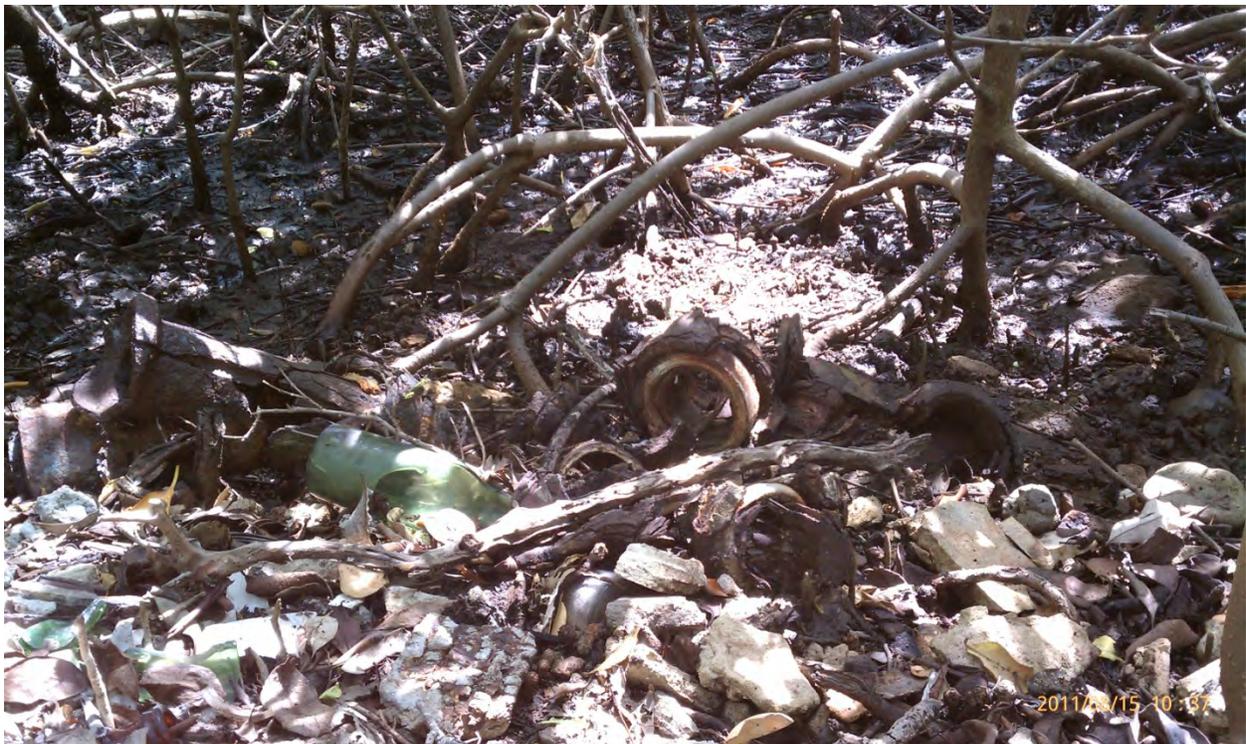
Photograph #41

Metal Pipes:

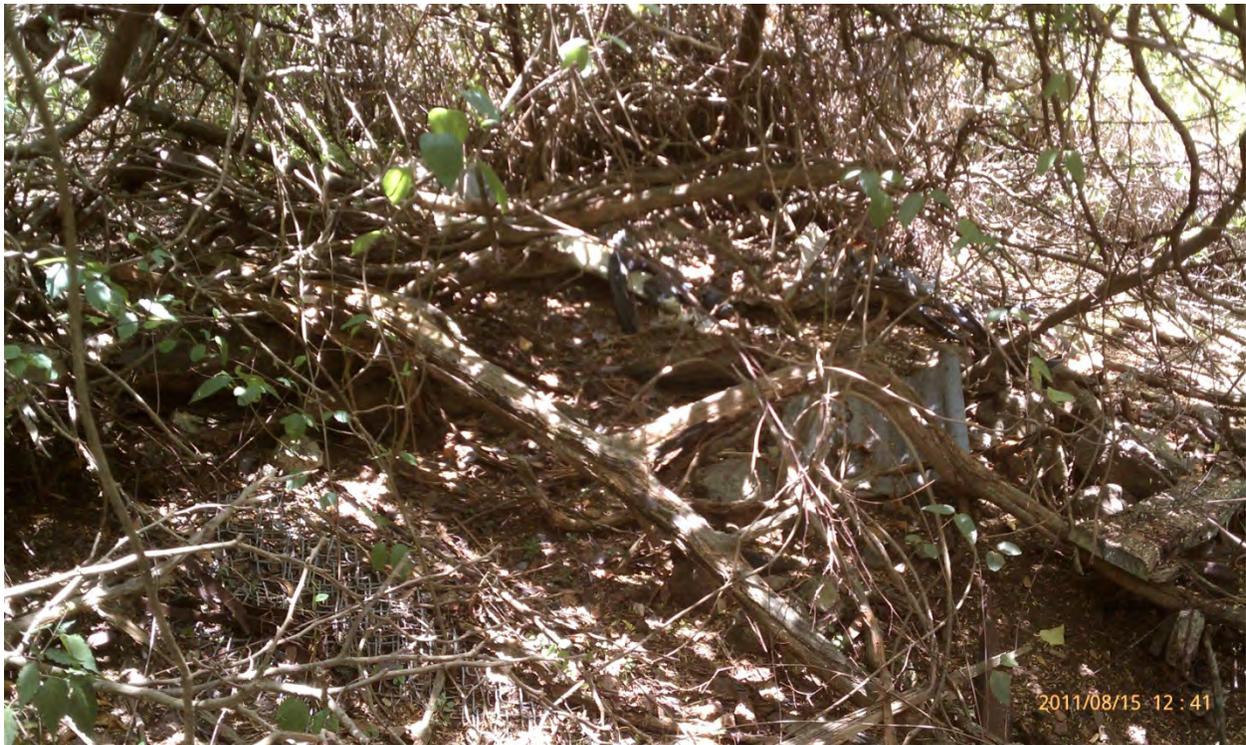
Photograph #43

Metal Chain Linked Fencing, Corrugated Sheets, Building Materials:

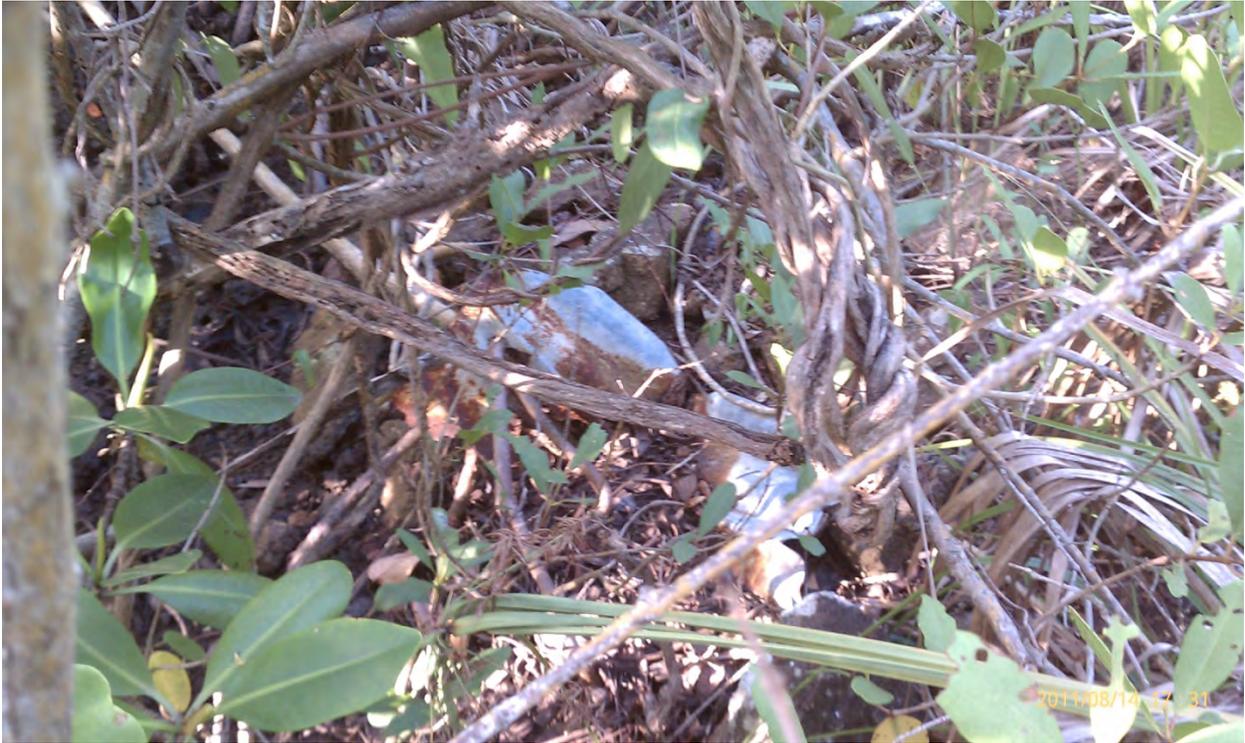
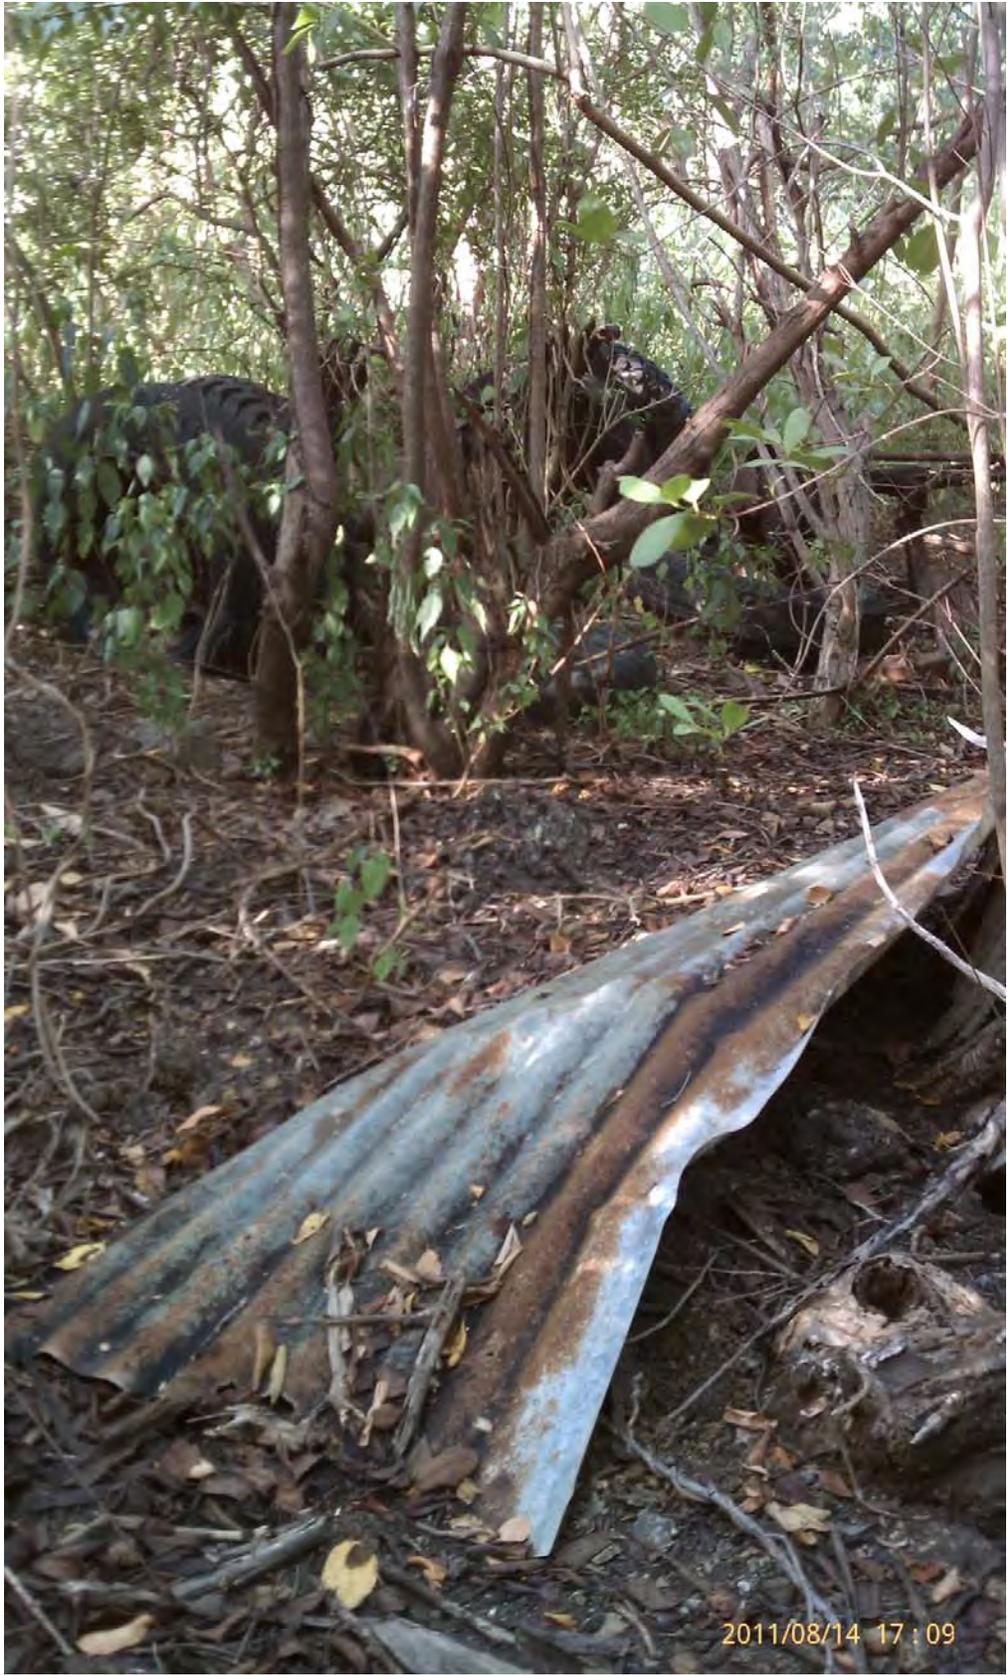
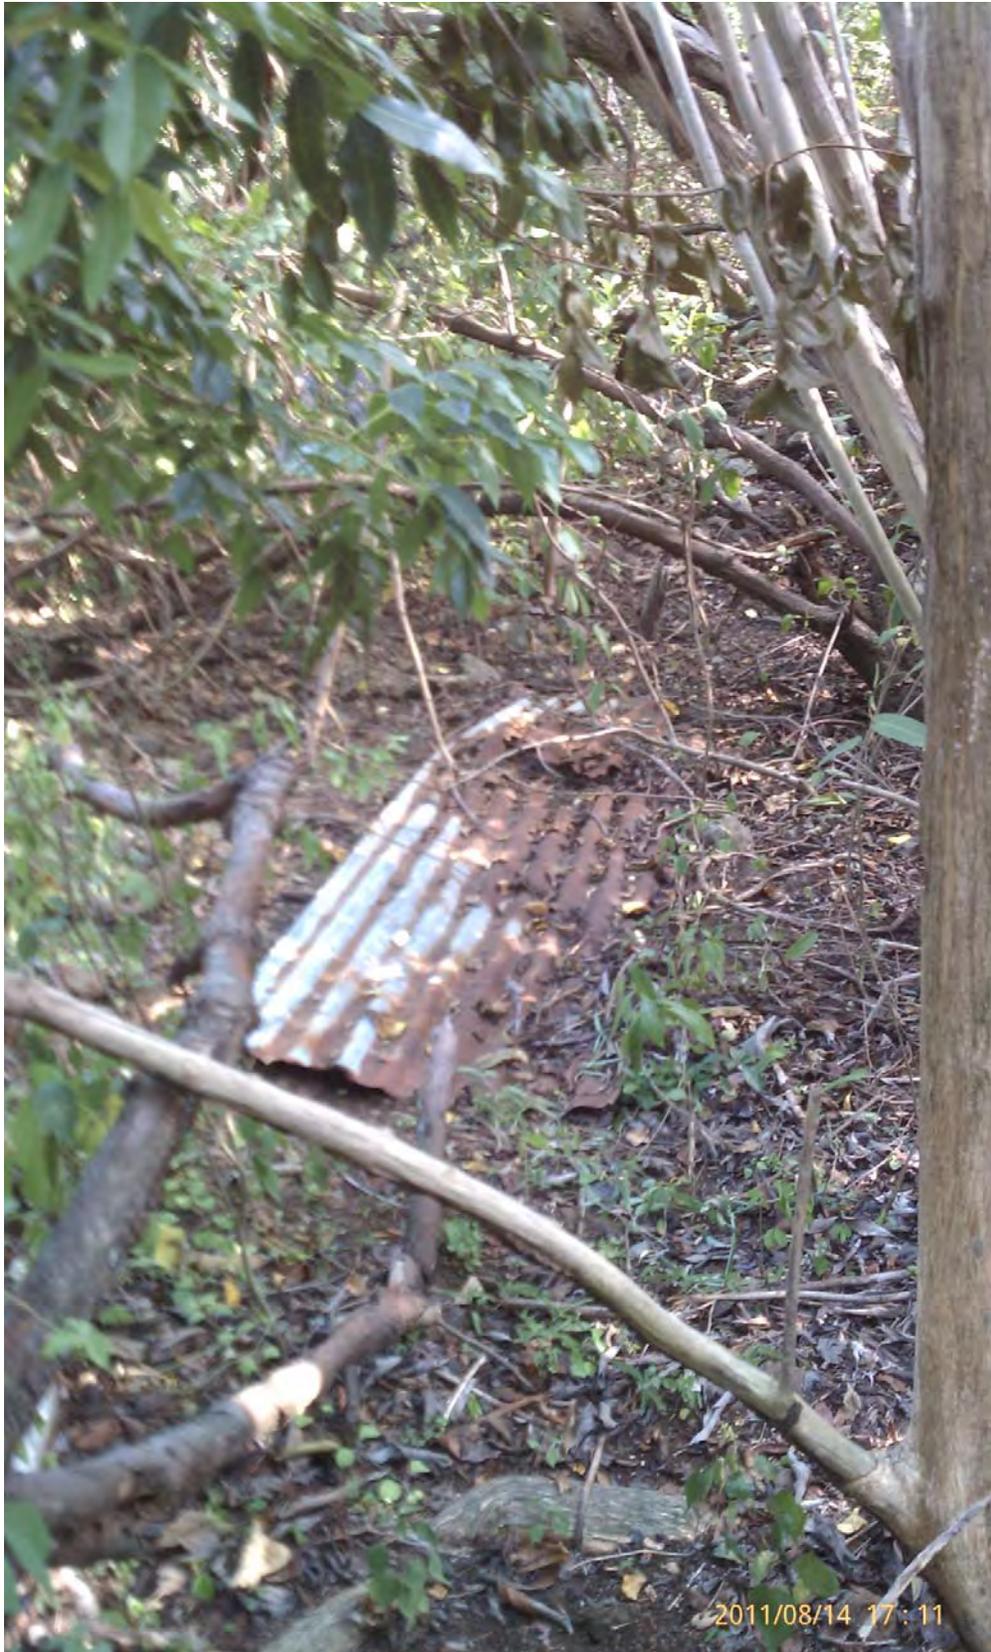
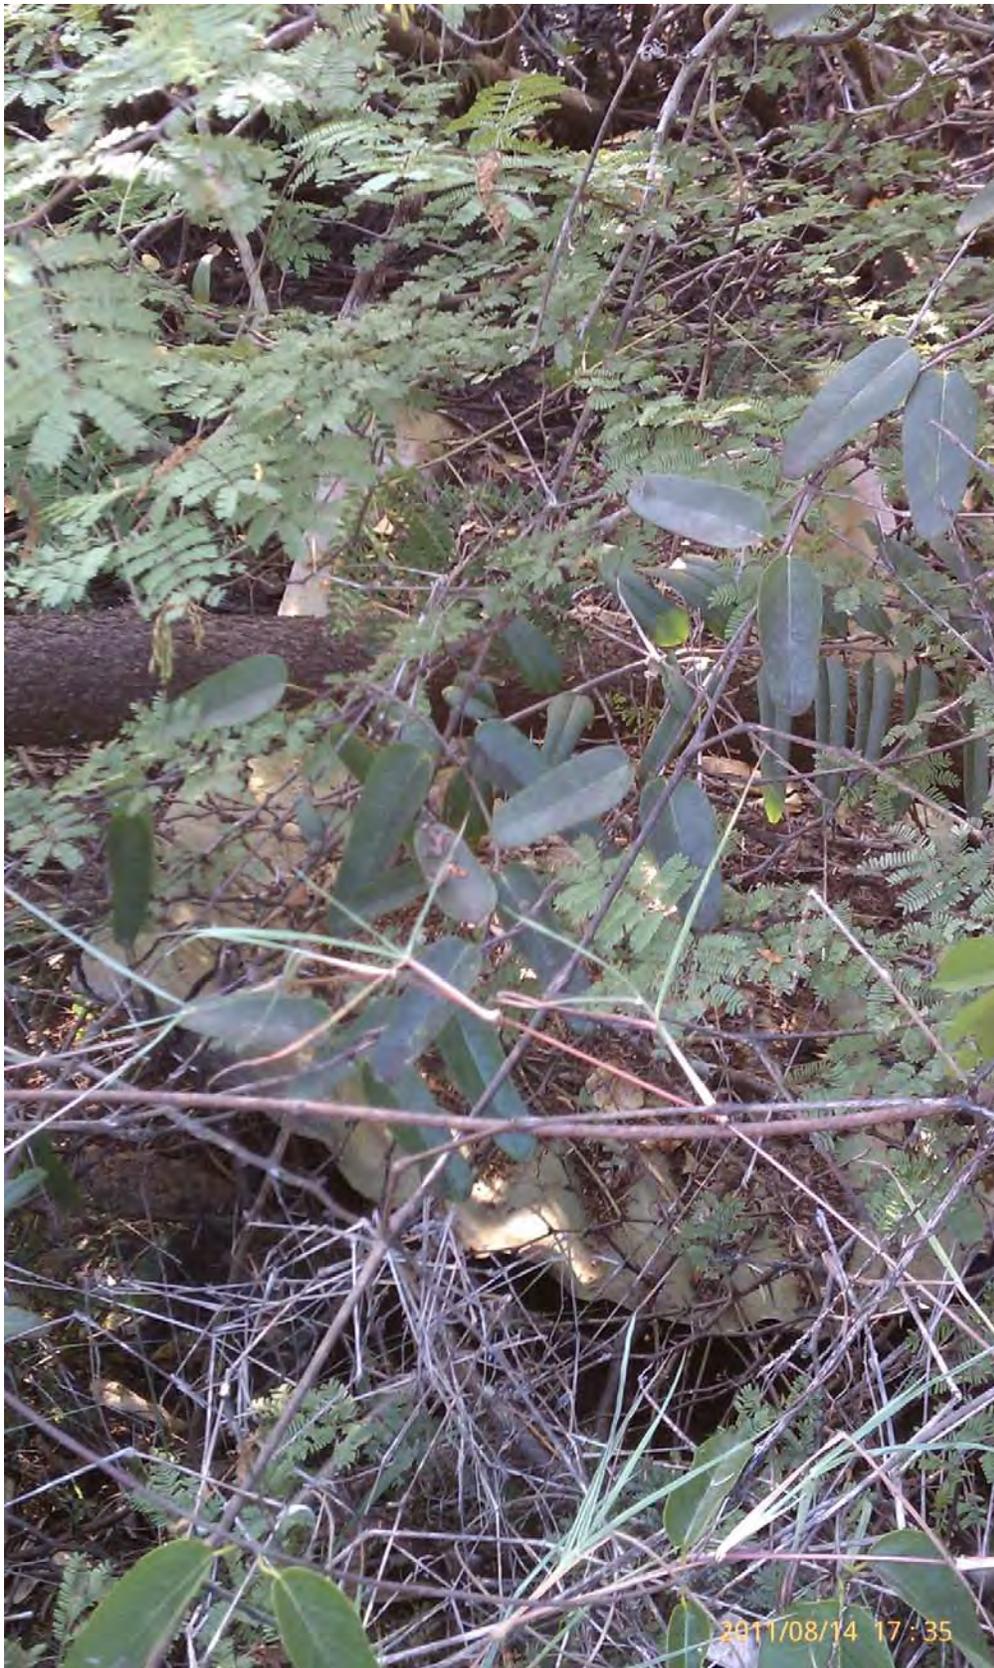
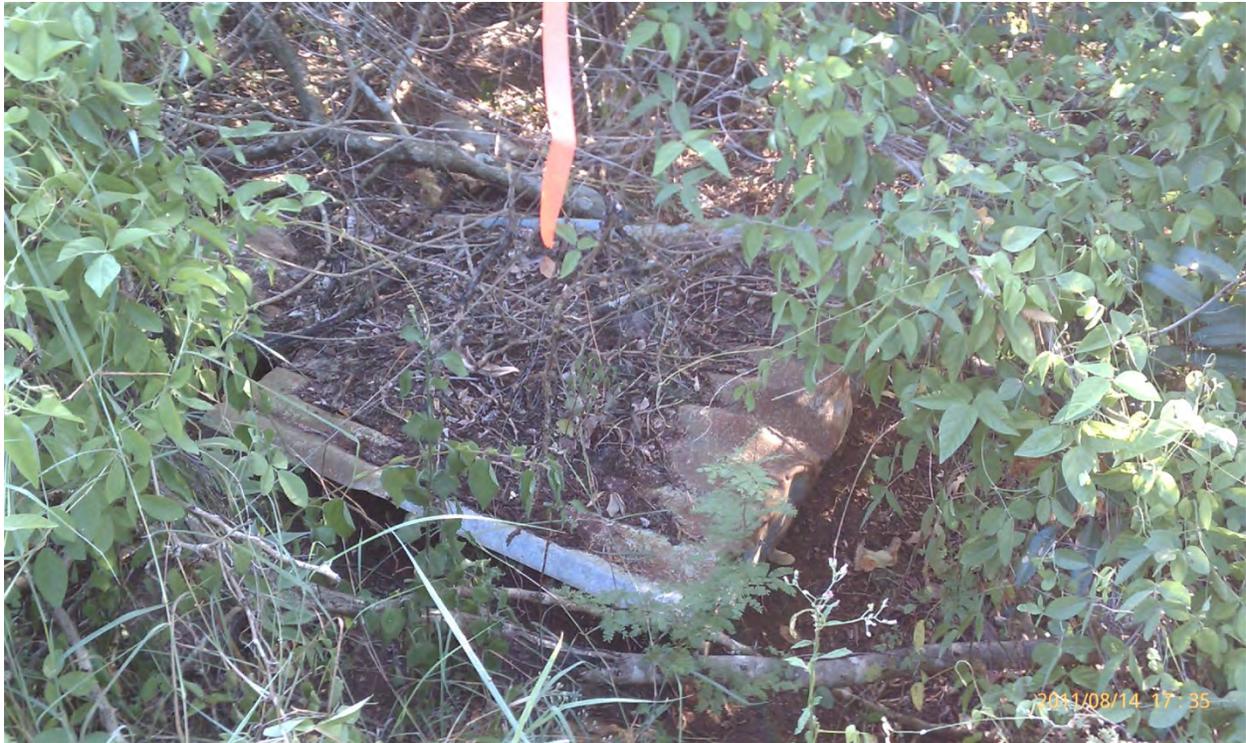
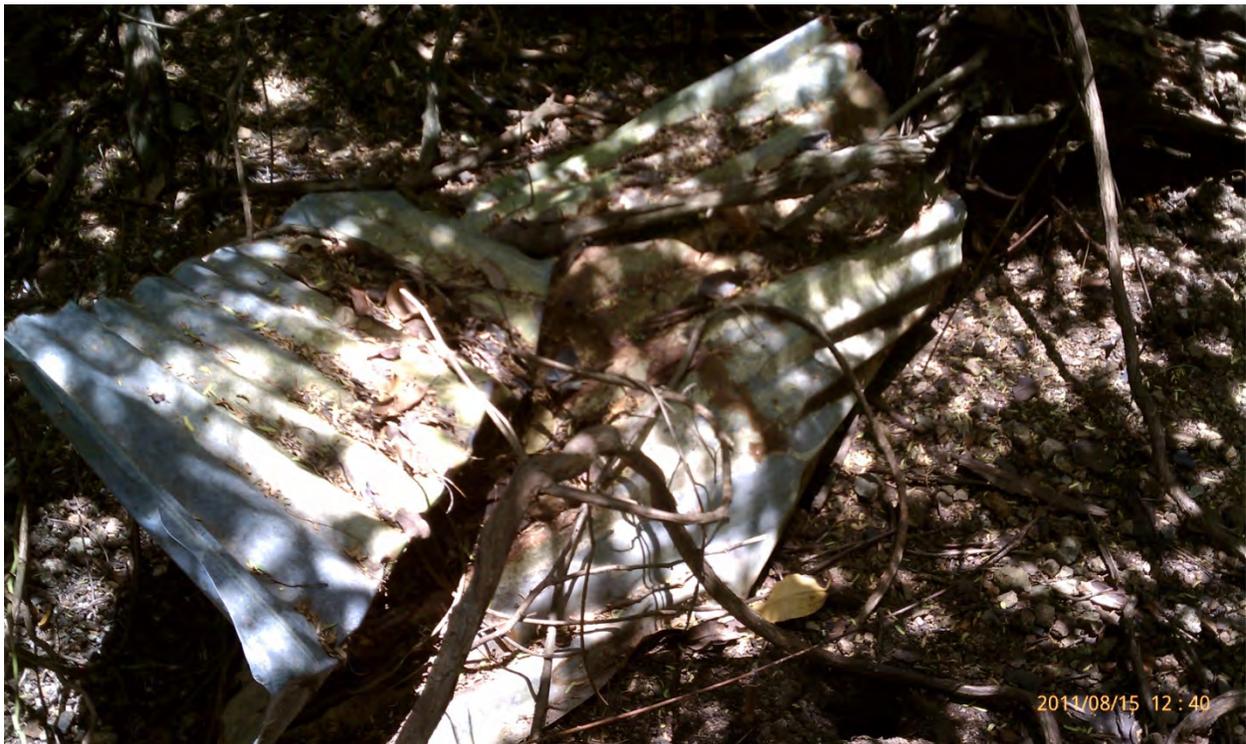
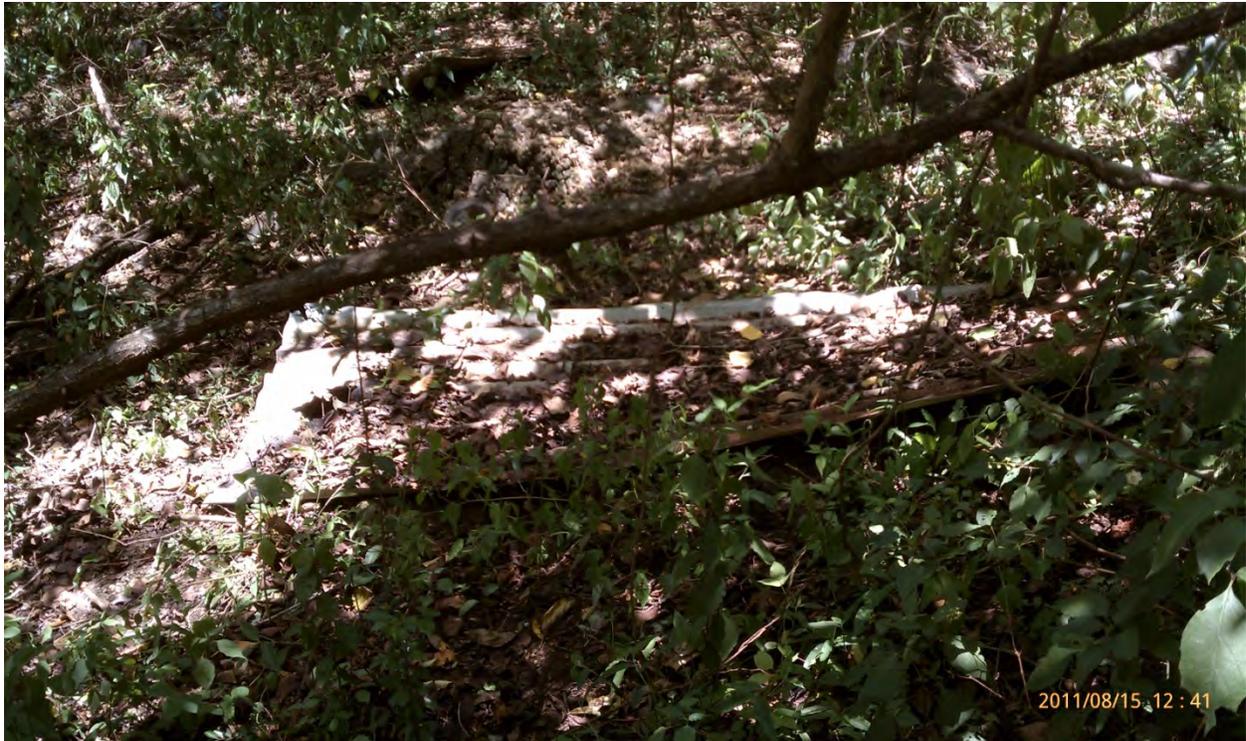
Corrugated Sheet:

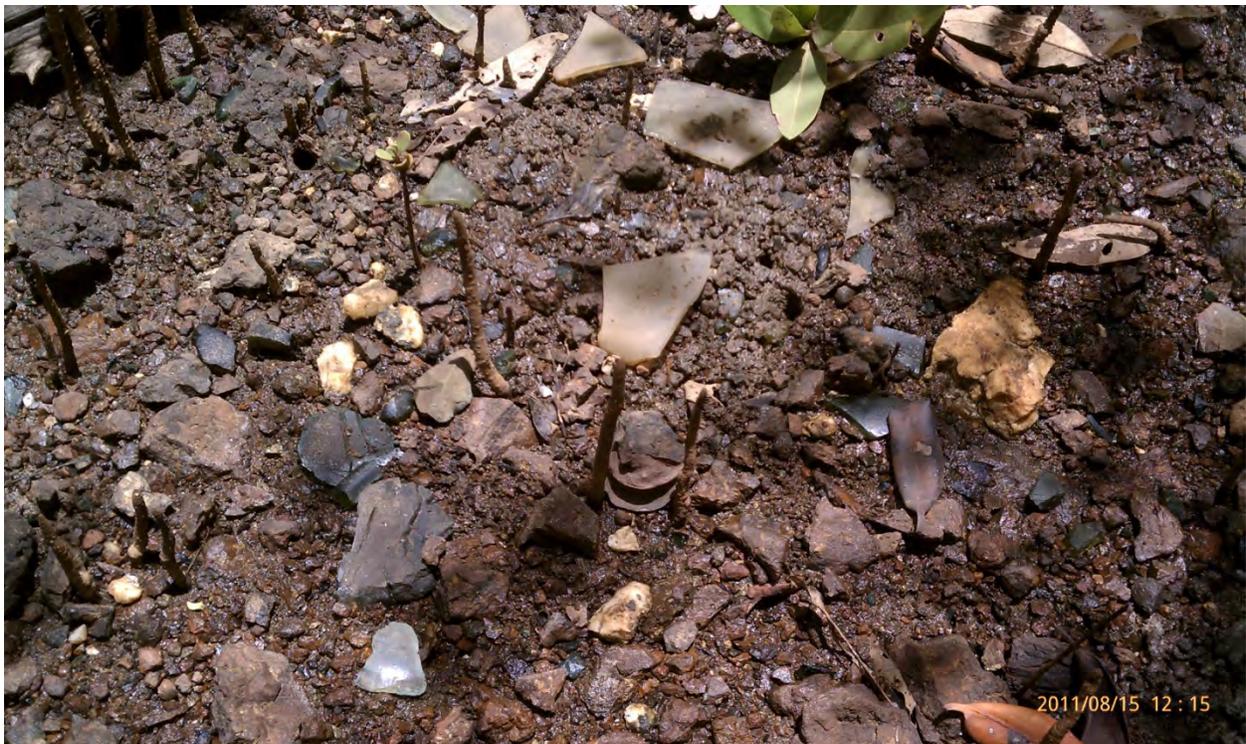
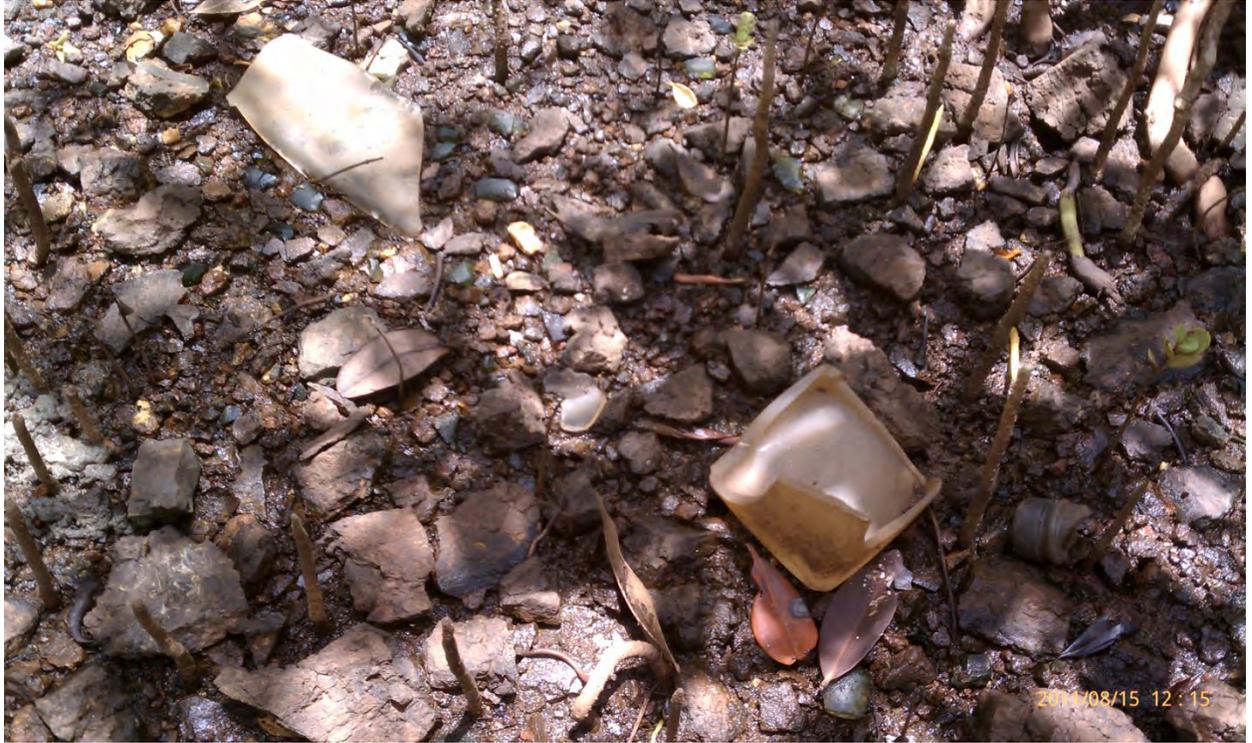
Broken Glass:
