RECURRING REVIEW REPORT
Former Jefferson Barracks Post Dumping Grounds
St. Louis County, Missouri

Defense Environmental Restoration Program
Formerly Used Defense Site
Site ID: B07MO0143

September 2014

U.S. Army Corps of Engineers
Kansas City District
Kansas City, Missouri

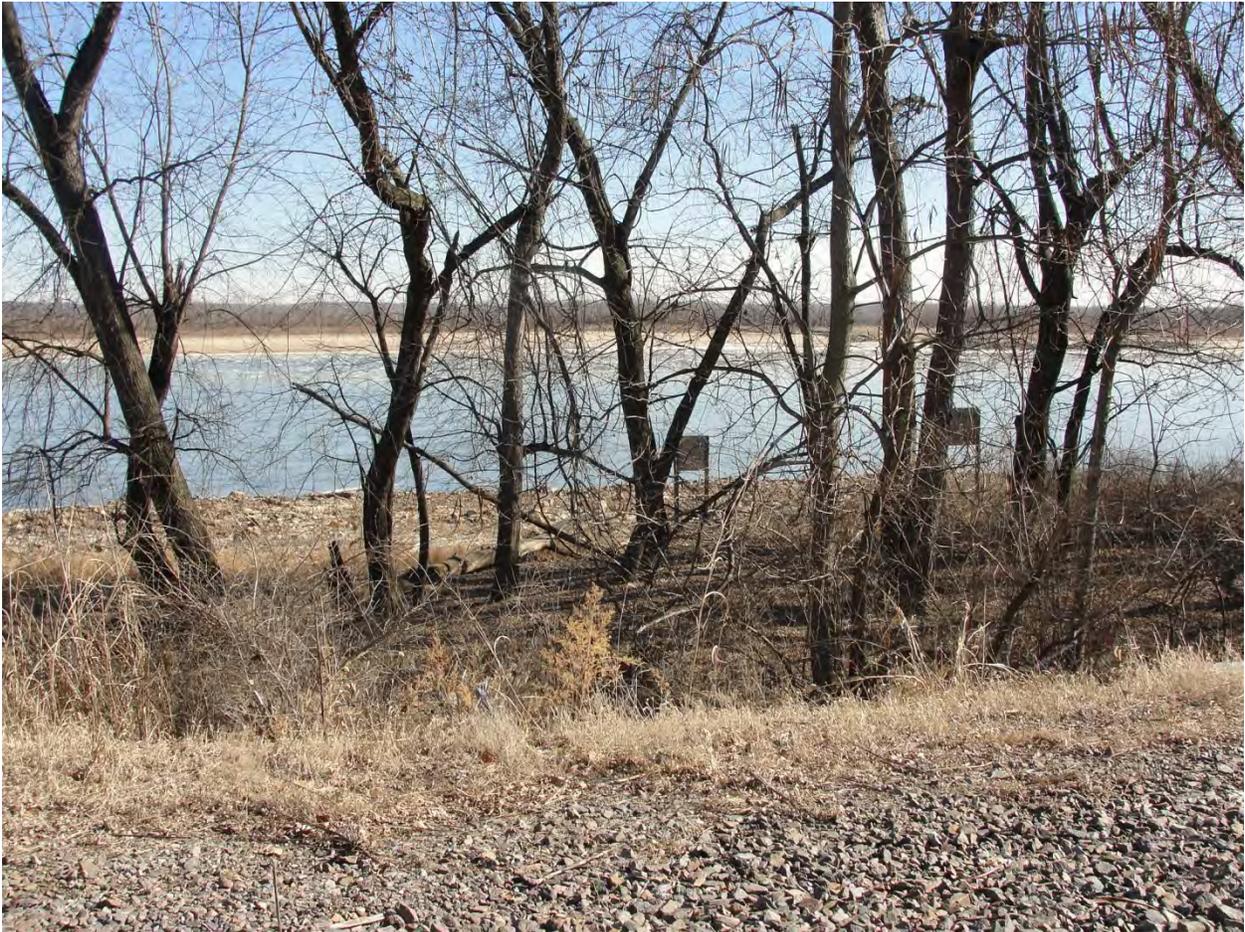
Date: January 28, 2014

Description: View is to the east, from east-side of railroad tracks; Warning Sign No. 8 is visible; the original Warning Sign No. 8 is severely undercut and its replacement has already been erected; riprap is visible between the river and the tree line.

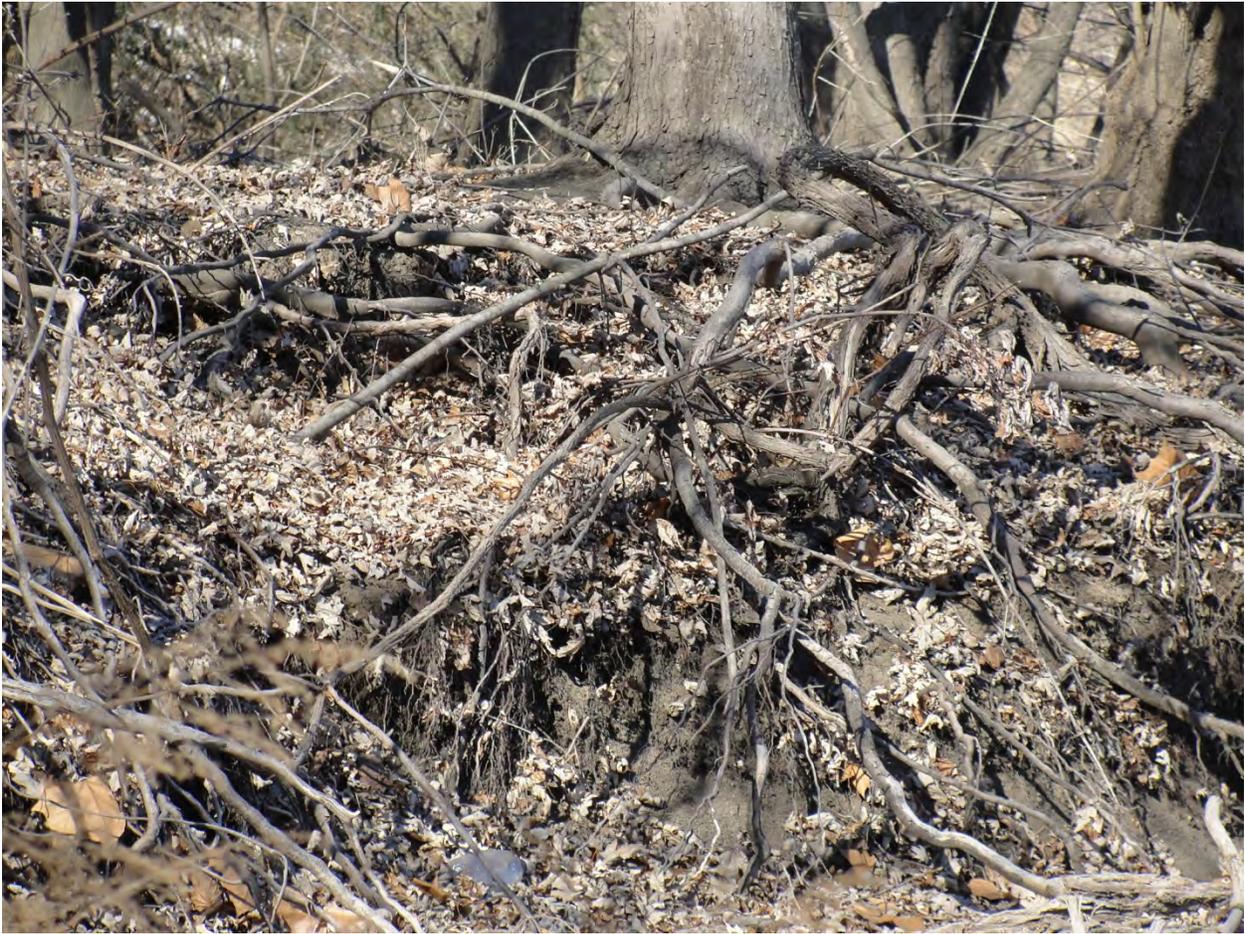
Date: January 28, 2014

Description: Zoomed photo of tree root mass which is located approximately in the center of Photo No. 12.

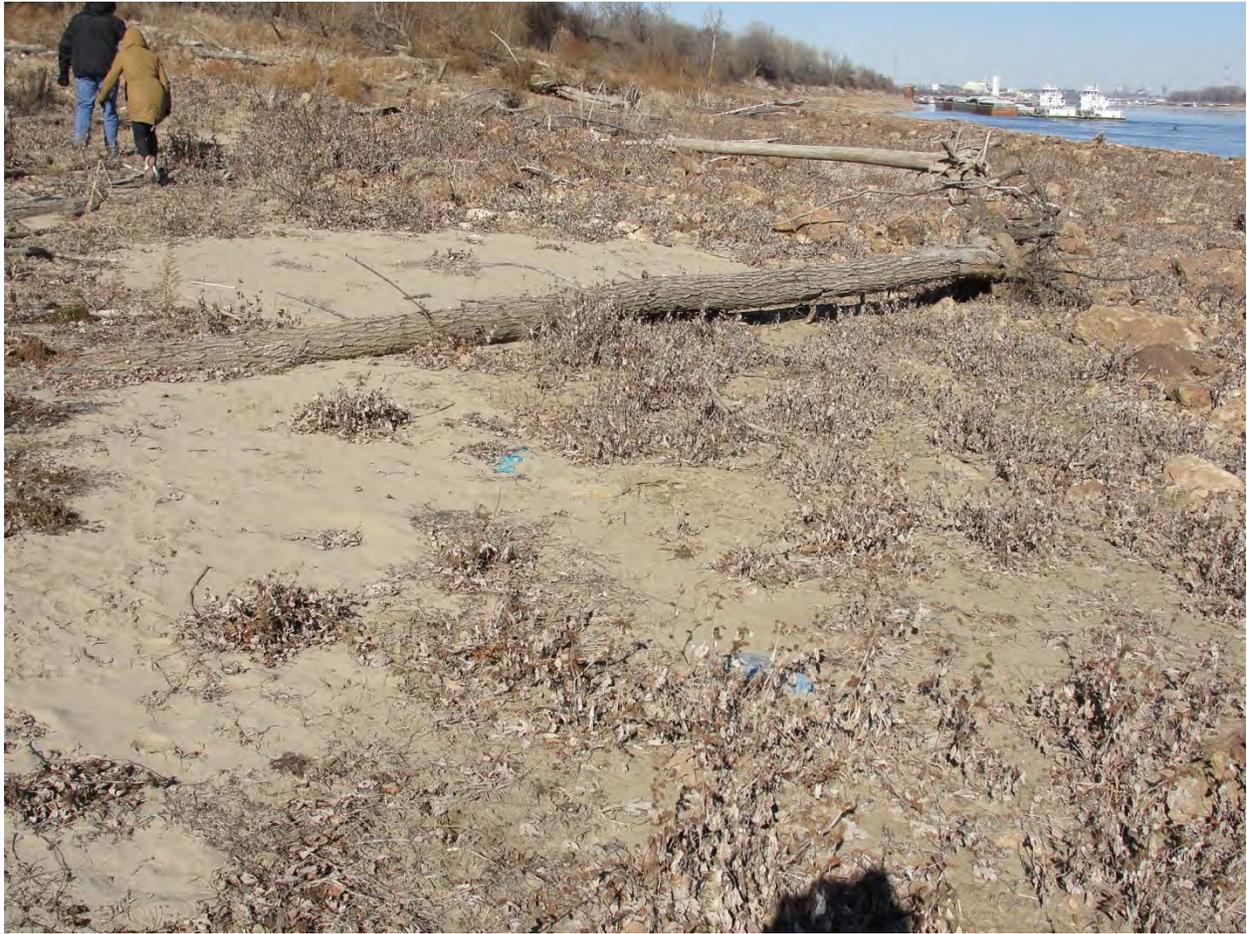
Date: January 28, 2014

Description: View is towards the north and is focused upon an area where sediment is a more predominant feature; subject matter is the center left edge of Photo No. 14.

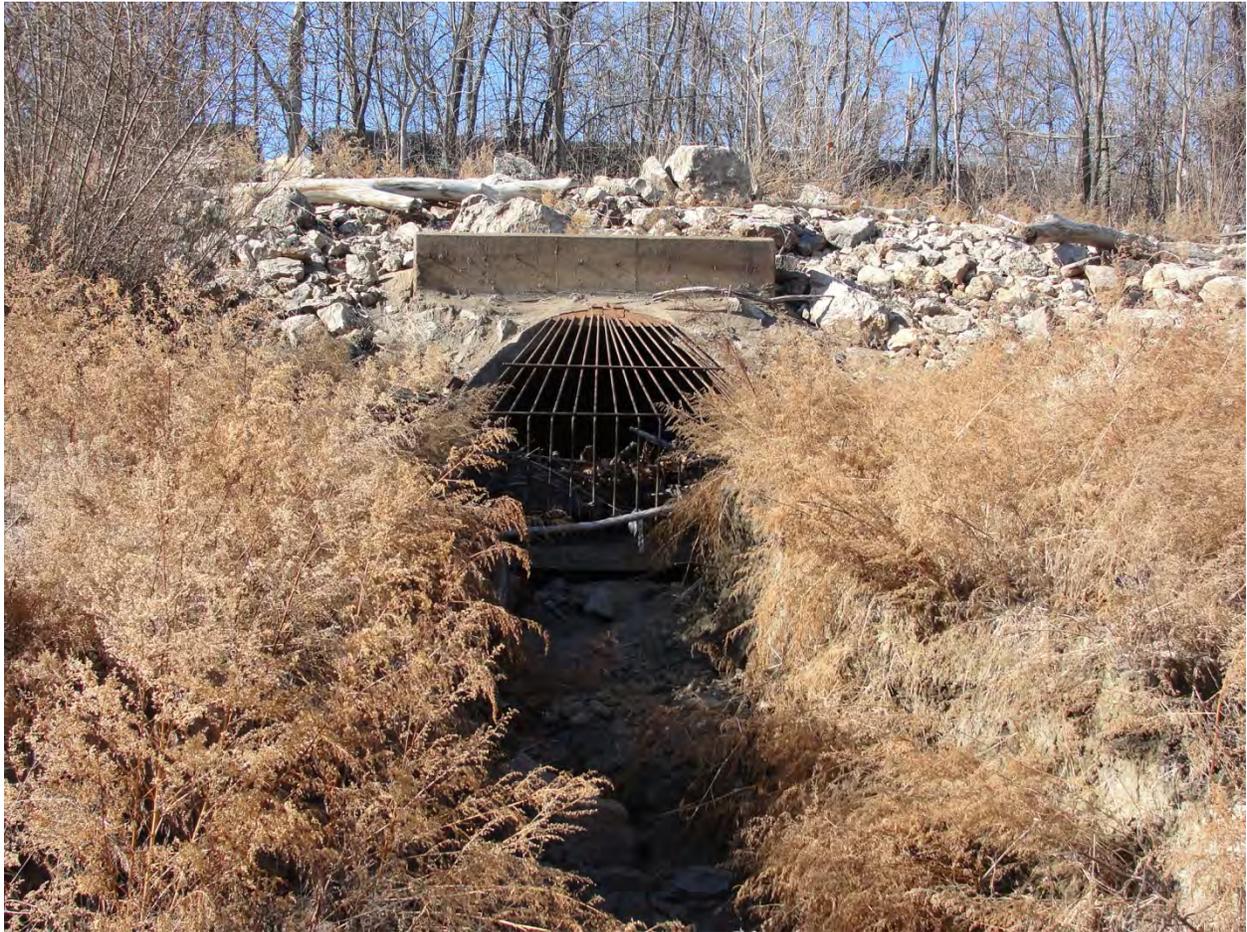
Date: January 28, 2014

One surface water collection system drainage outlet structure is present at the east edge of the escarpment, approximately in alignment with Kearney Street. Photos 28 through 30 depict this outlet and its discharge channel. The photos document that this outlet's drainage channel has been rock lined, is relatively shallow, and that no significant erosion is present. The second outlet is a combined storm drain that is depicted in Figure 2 as the 4-ft diameter concrete storm sewer. This outlet was replaced in September 2008 with a 52-inch outlet (Appendix I). The discharge channel for this outlet is lined with geotextile and riprap. Photos 18 through 21 depict the condition at this outlet during the Recurring Review Site inspection. A Site inspection conducted in April 2014, provided in Appendix I, further depicts conditions resulting from this outlet's discharges.

Description: Storm drain outfall, believed to be in alignment with Kearney Street.

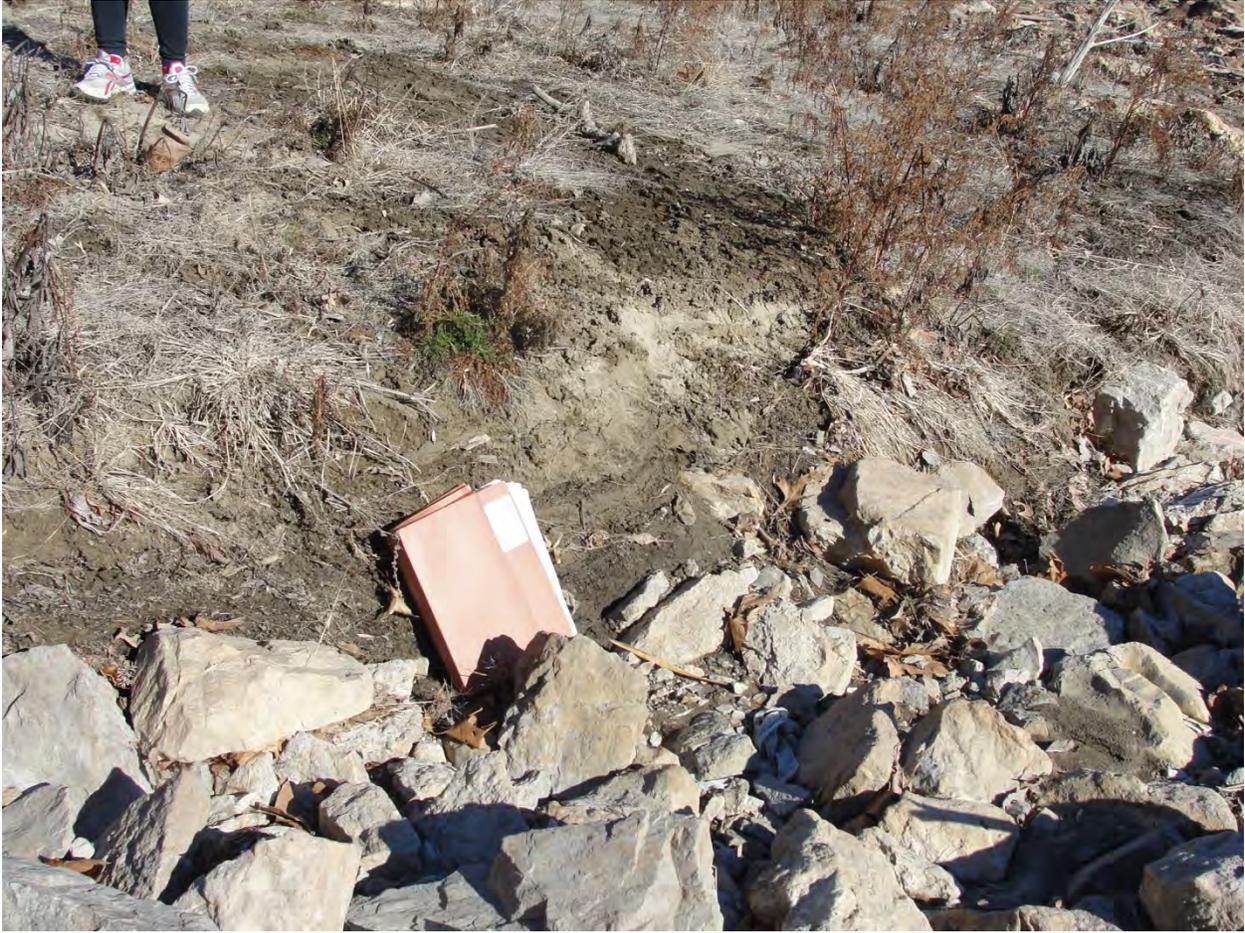
Date: January 28, 2014

Description: Drainage ditch depicted in Photo No. 29.

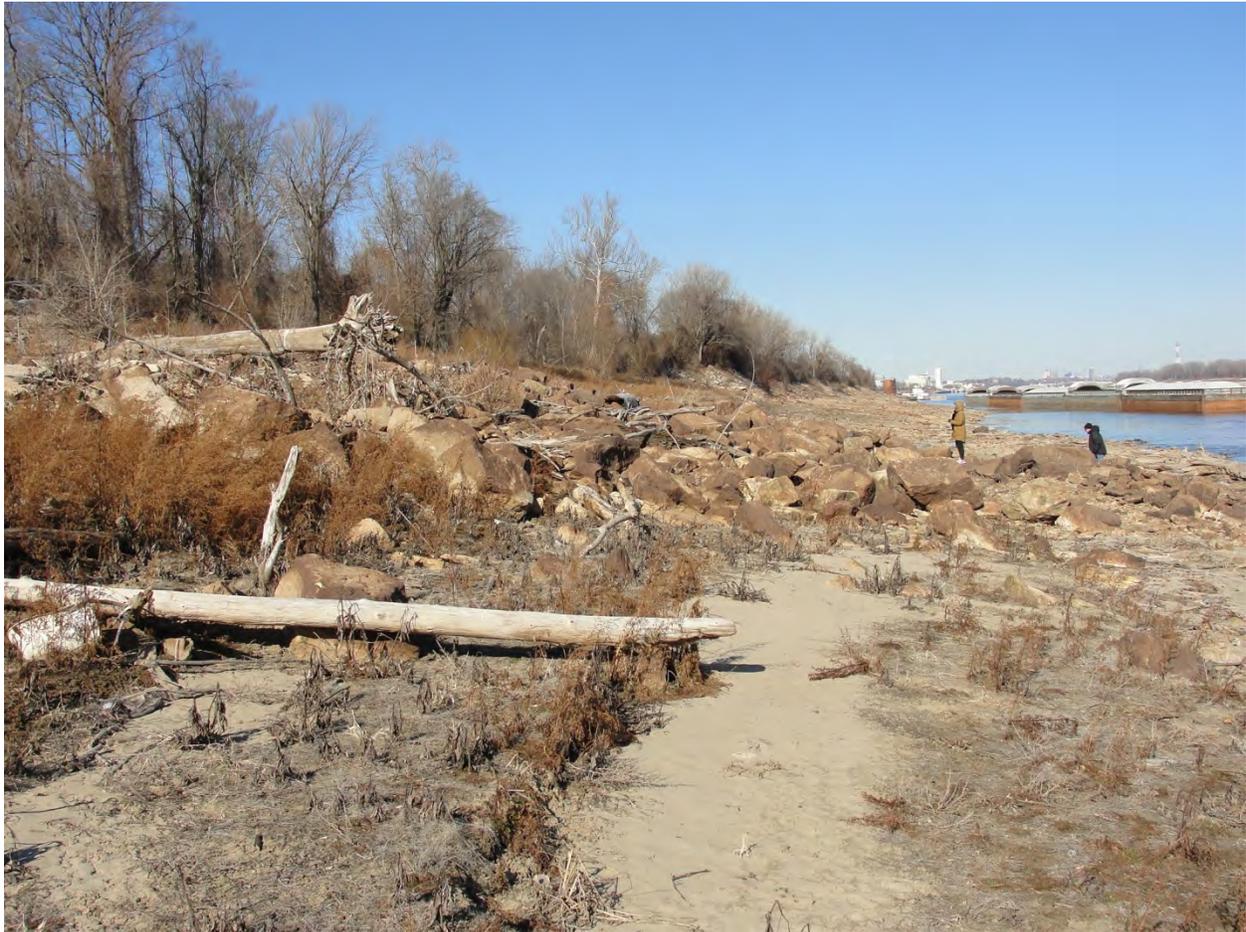
Date: January 28, 2014

Description: Photo taken from an area that has less visible surface riprap than adjacent and surrounding area – view is to the north; Photo No. 39 is a second photo taken from this location, which is panned towards the river (eastward).

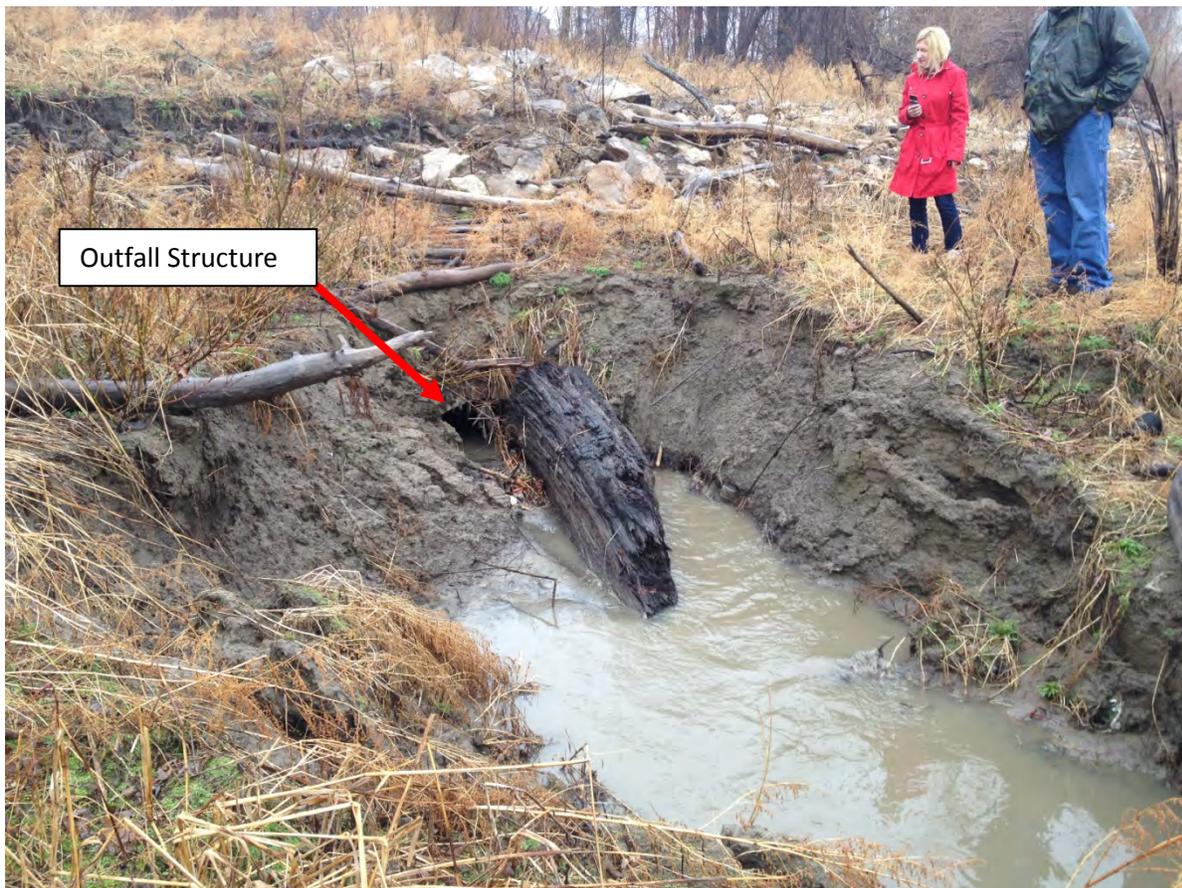
Erosion issues are directly related to an MESD outfall structure buried in the bankline. Only a small portion of the outfall structure was visible above the water line flowing out of the pipe from recent storms. It is estimated that it is a 54" concrete outfall pipe.

The drainage channel for the outfall appeared to have filled in and the outfall pipe was no longer exposed and was forgotten. It is assumed that the original outfall channel was lined with stone but

during subsequent flooding events it has filled in with sediment. During a January 28, 2014 inspection, it was observed that some erosion was occurring but the forgotten outfall pipe did not become exposed until recent storm events. The outfall channel was thought to be bankline erosion possible in need of repair.
