Re: Response to Comments for LOMR for Brickhouse Gully;
City of Houston
Brickhouse Gully (E115-00-00)

Below are our responses to the third HCFCF courtesy review comments to the LOMR for Brickhouse Gully dated April 4, 2014.

Pine Crest Golf Course – Dynamic Flood Depths at Base Flood Event (100 Year Flood)

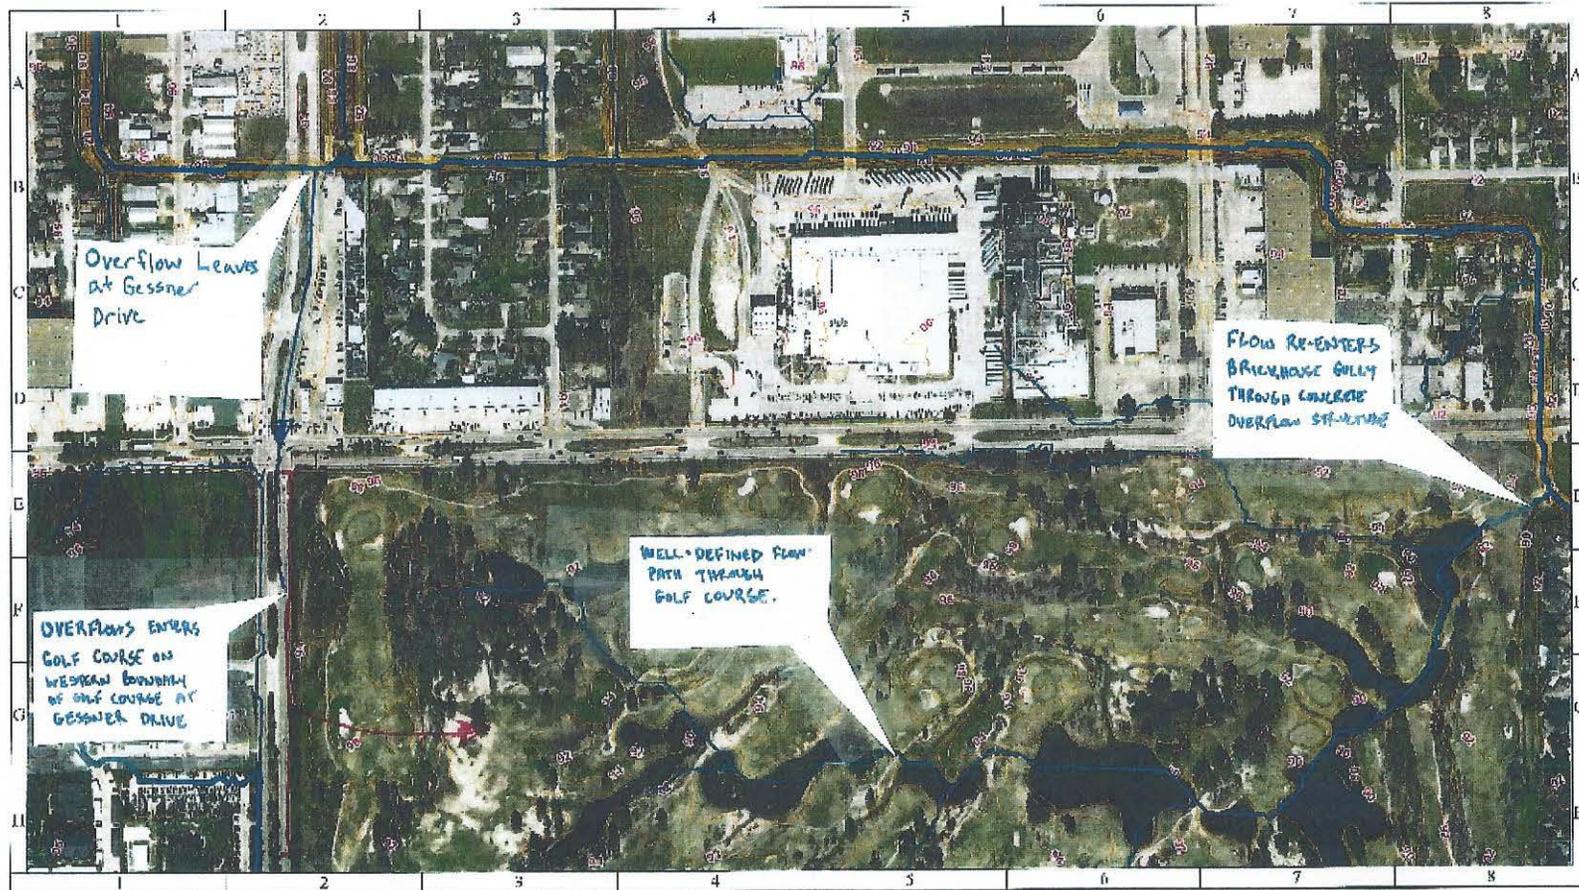
Overflow enters
golf course on
western boundary
of golf course at
Gessner Drive

Overflow Leaves
at Gessner
Drive

Well-defined flow
path through
golf course.

Flow re-enters
Briarhouse Gully
through concrete
overflow structure

All annotation on image is as received from HCFCD. This is the only image found with overflow entering from Gessner as narrative states. Image was supplied as support to 2nd review response.

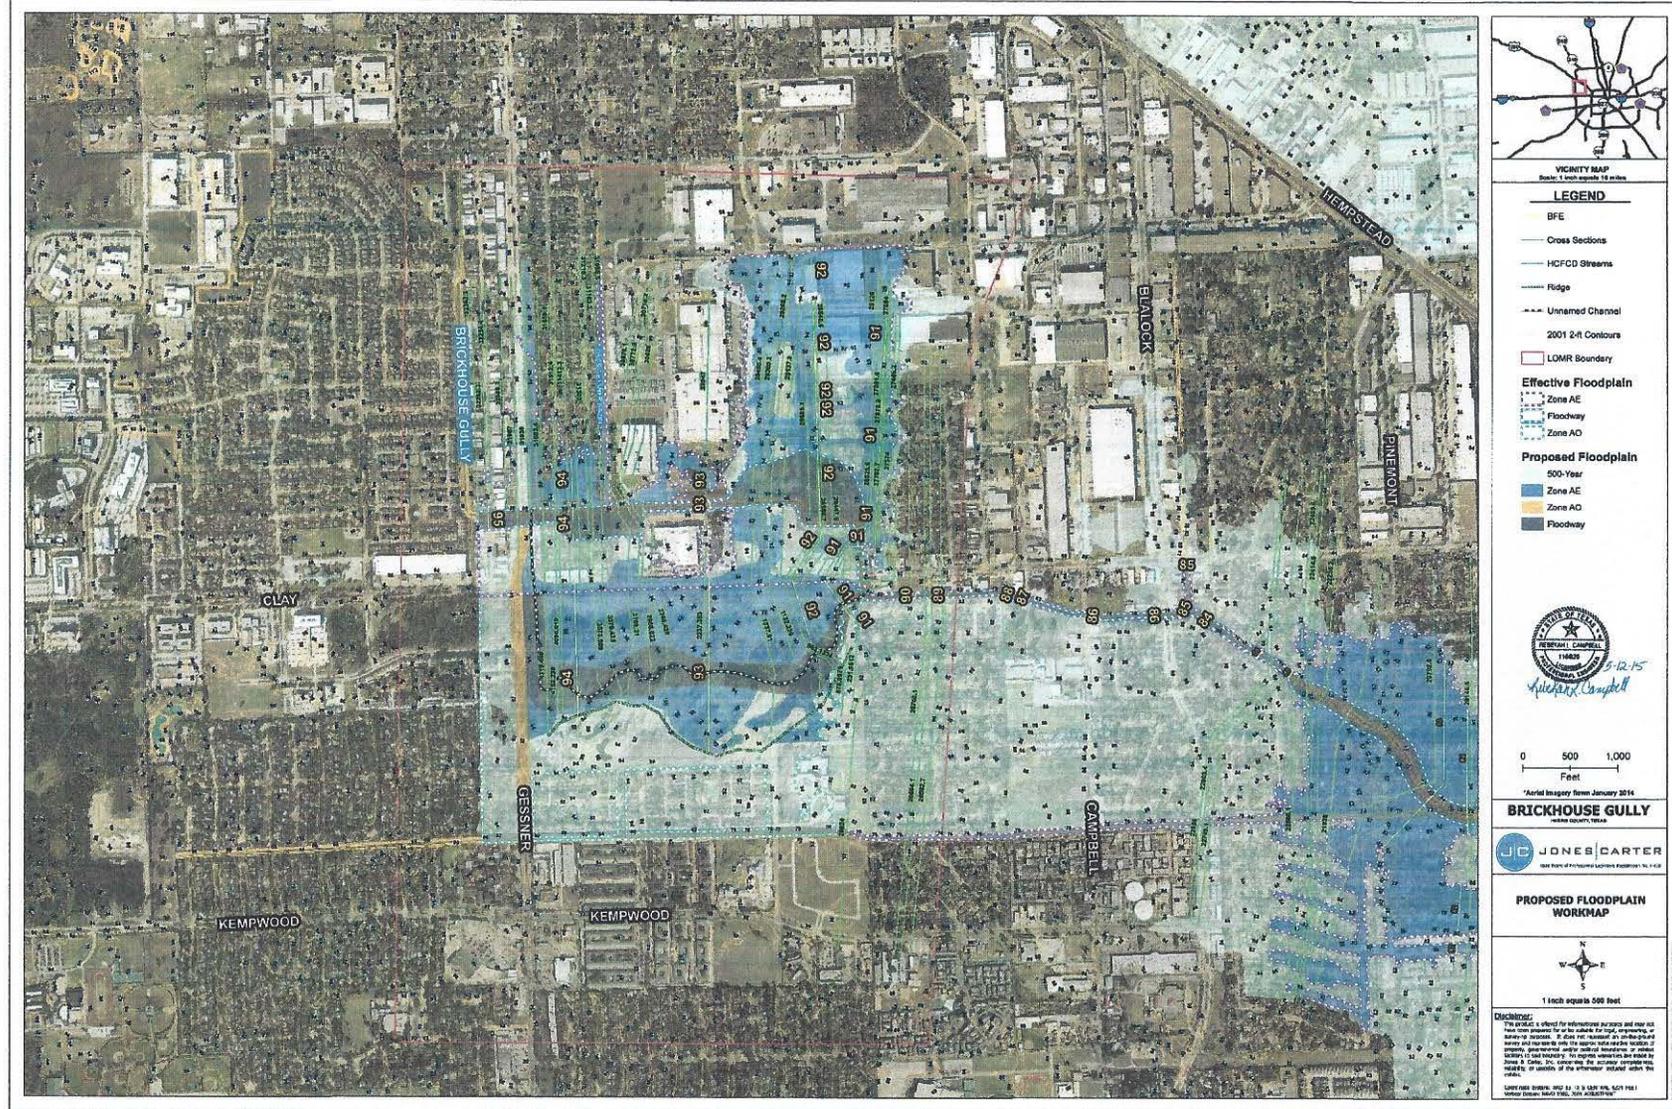
Signed topographic work map showing impossible flow path.

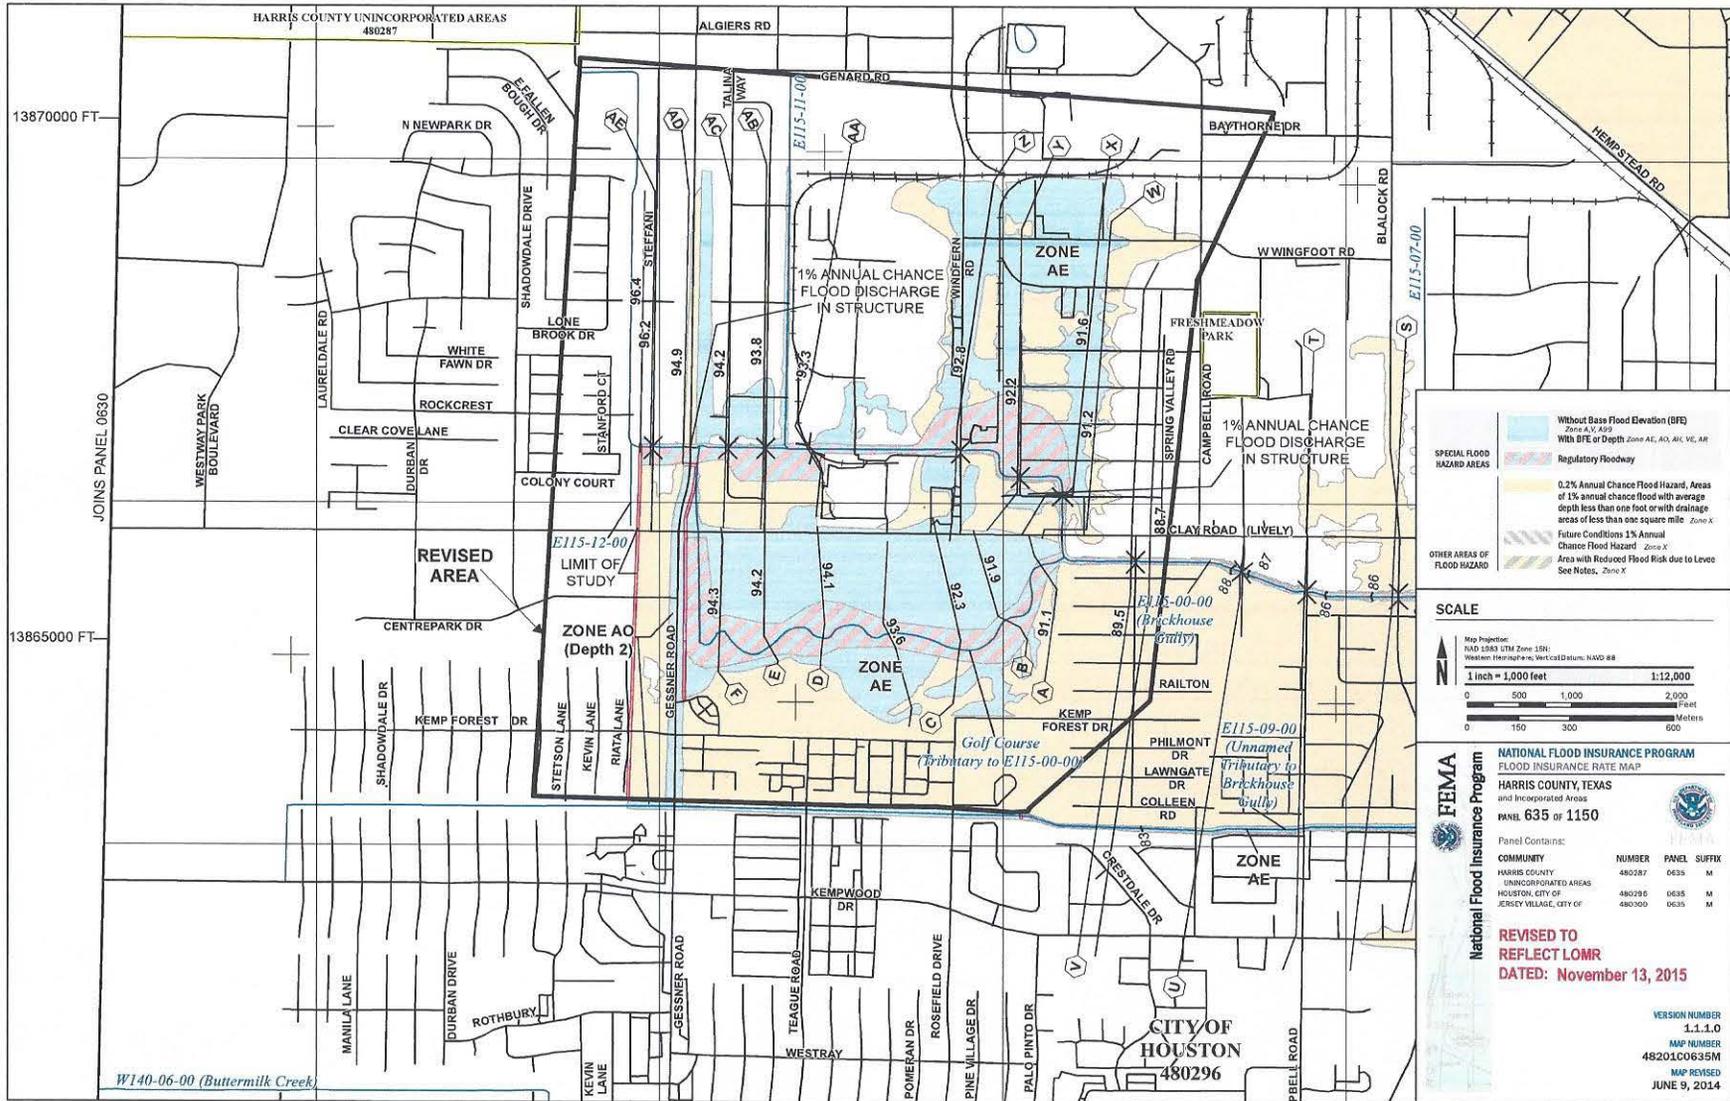
Impossible flow path shown on the LOMR

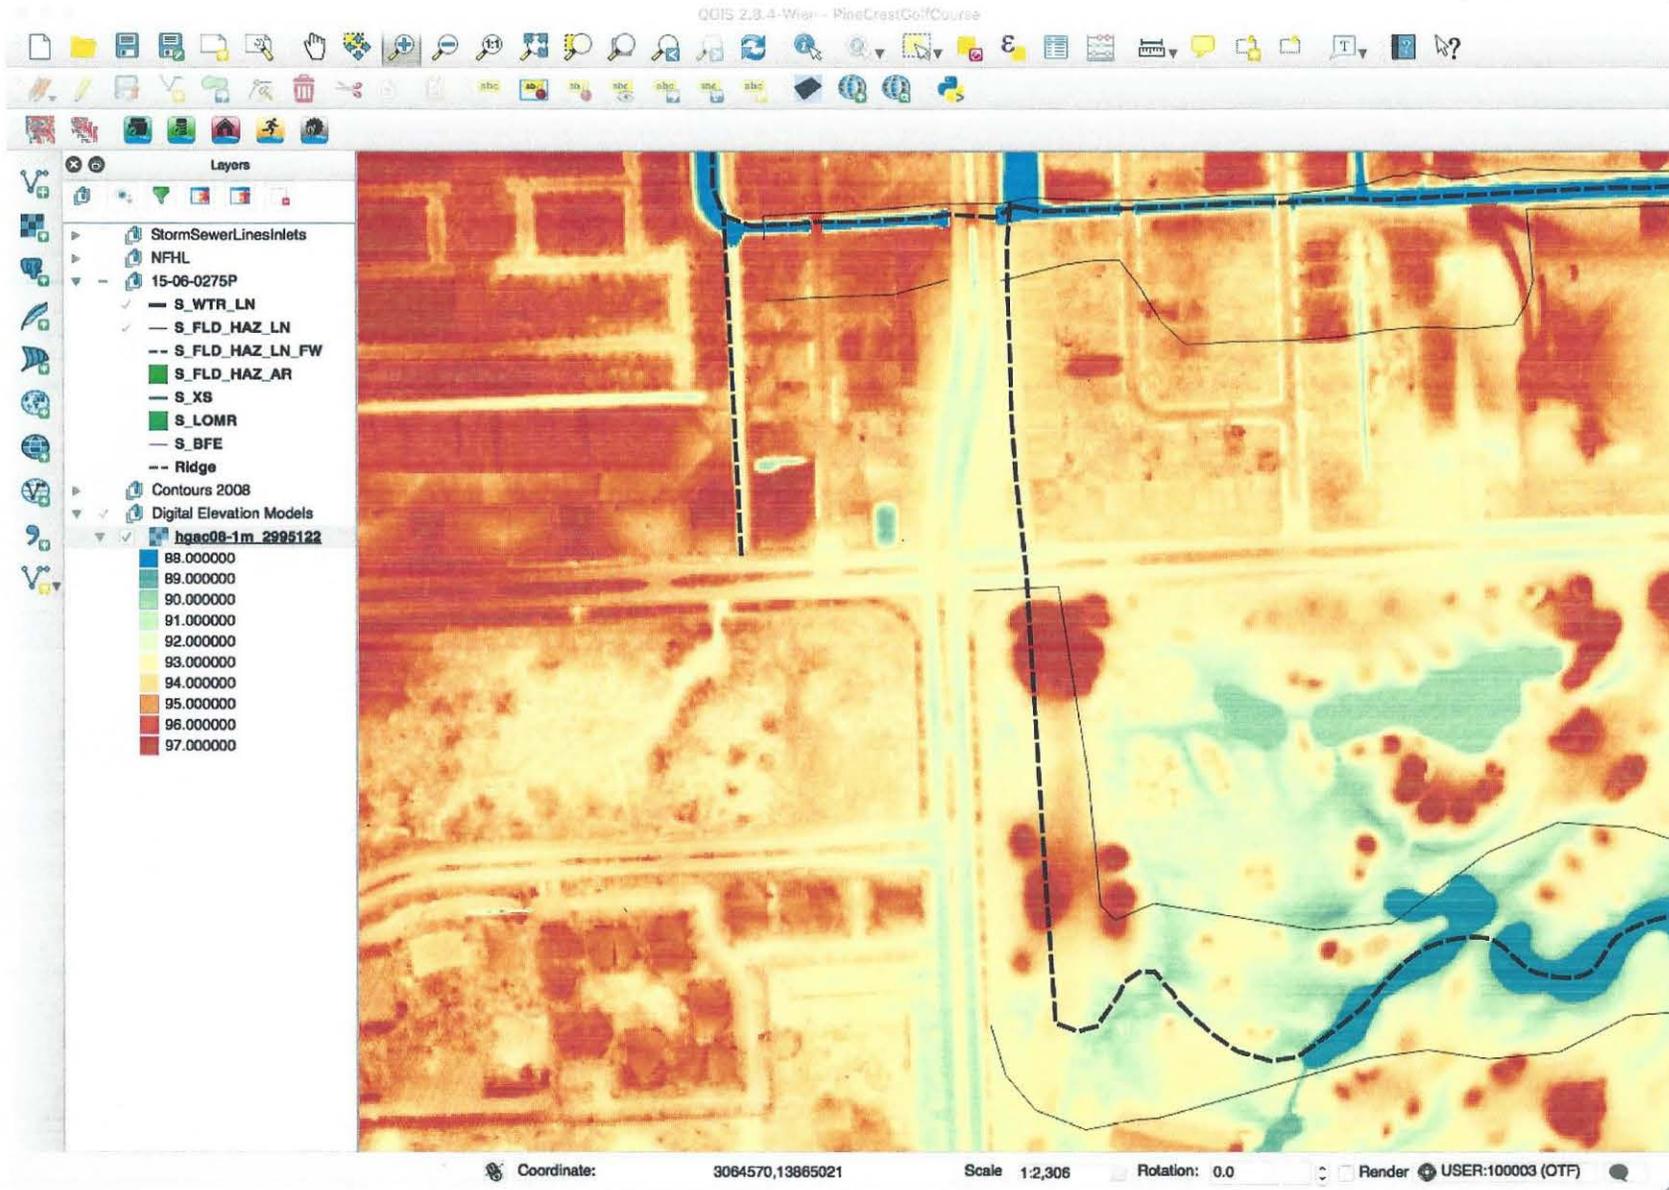
The impossible flow path shown on topographic work maps and the LOMR.

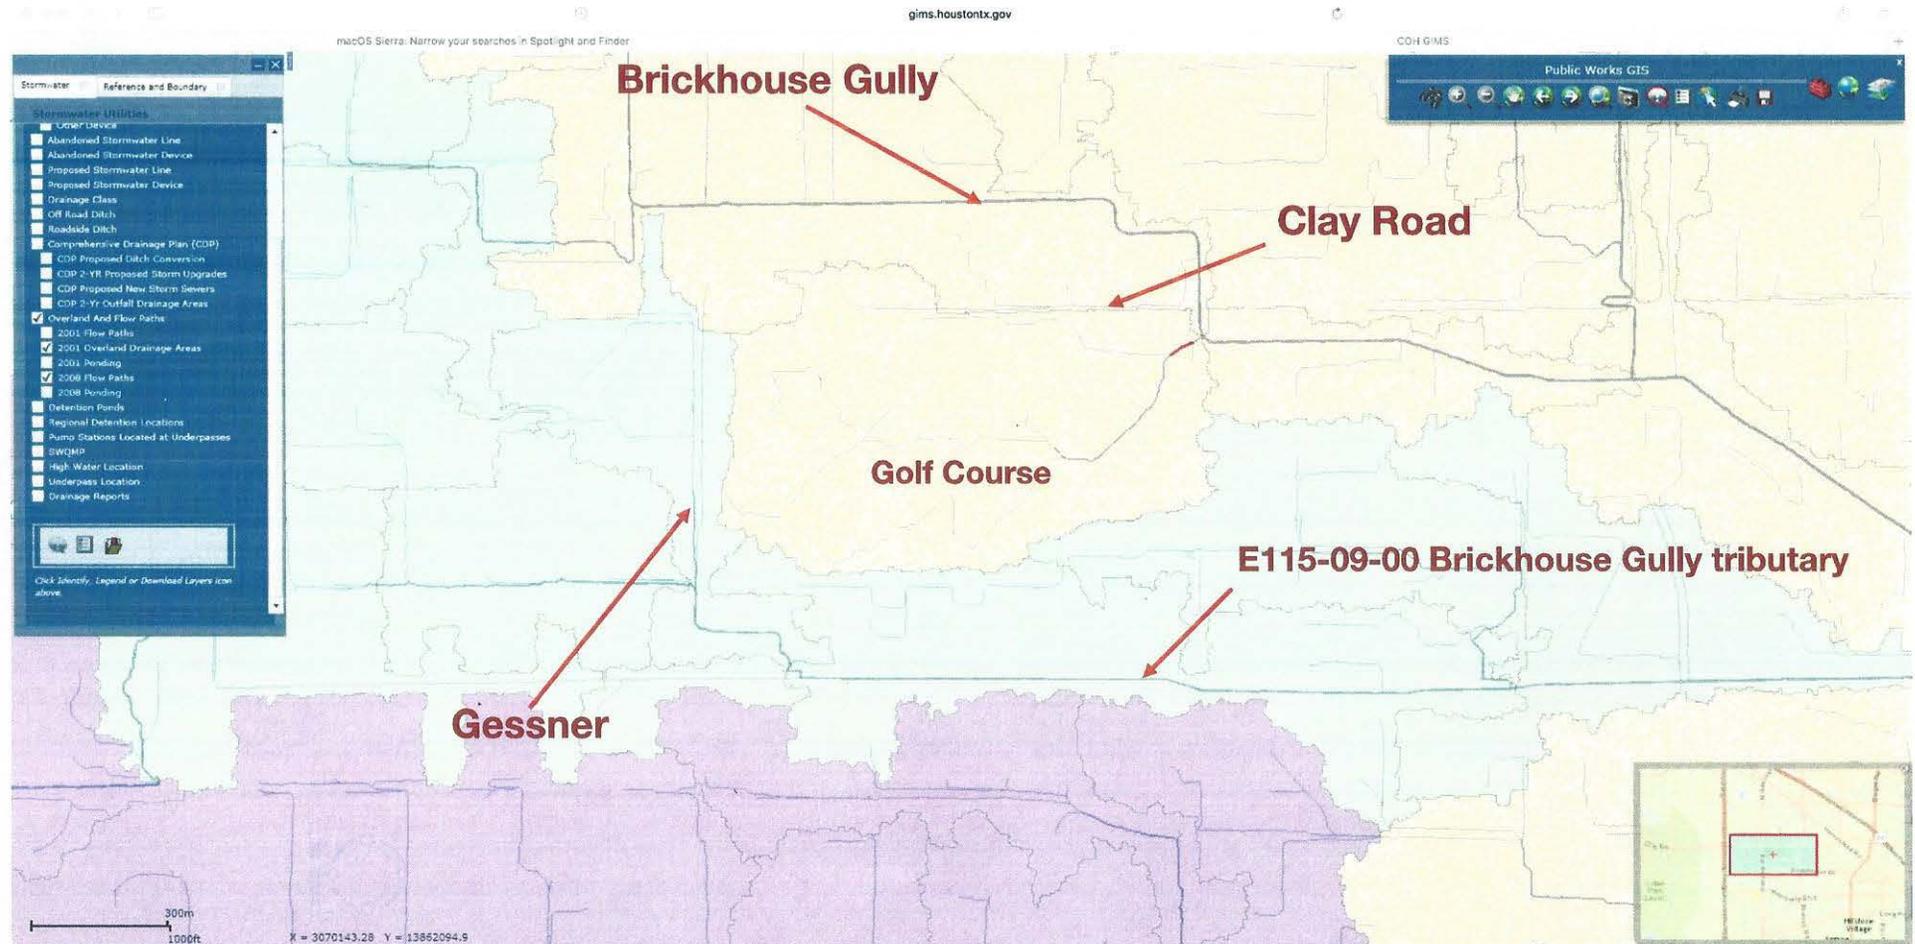
The LOMR arguments seem to conflict with City of Houston GIMS layers of Overland Drainage Areas and Sheet Flow. How does water enter the property from the west off Gessner? All of the Gessner sheet flow is shown going to the E115-09-00 tributary.

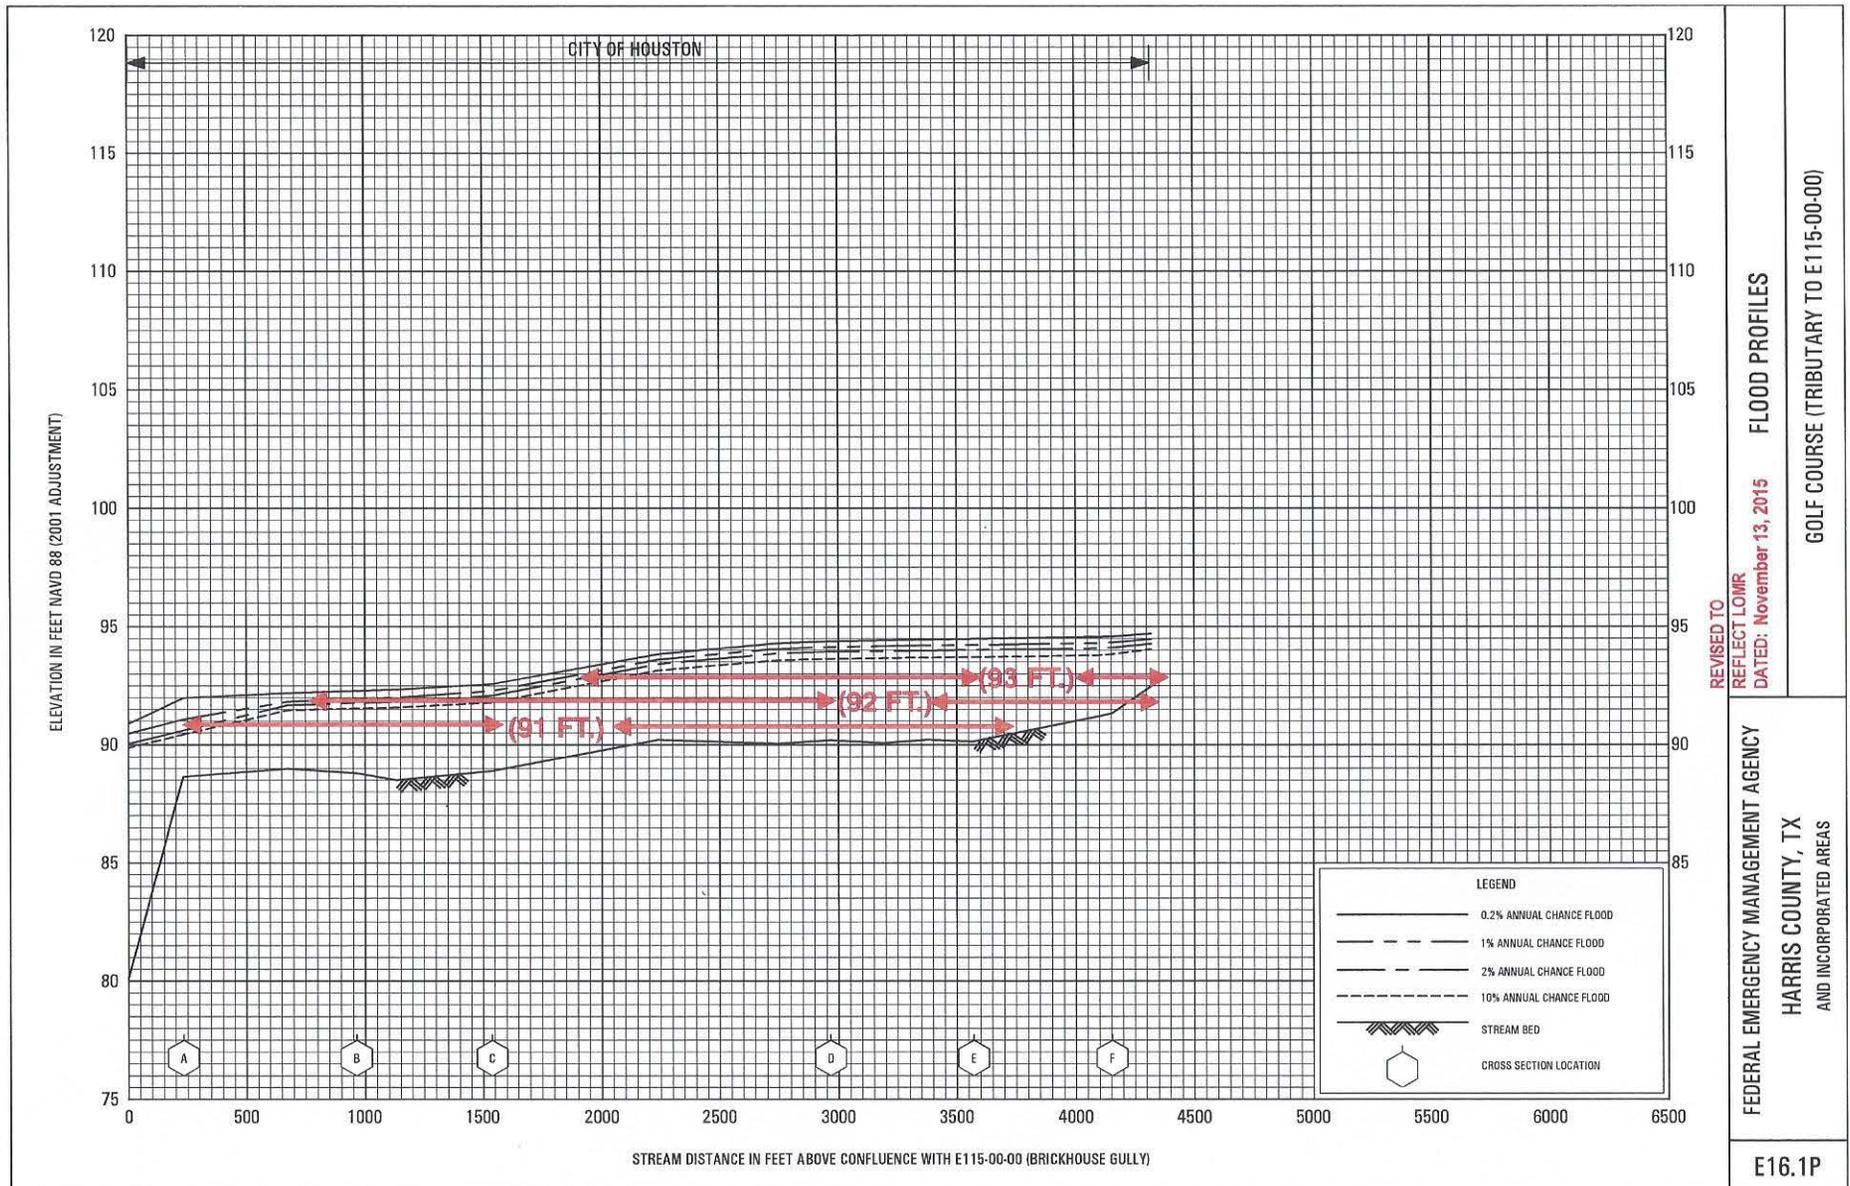
Golf Course Floodway profile - where is the model that connects the golf course to the alleged overflow from Brickhouse Gully?

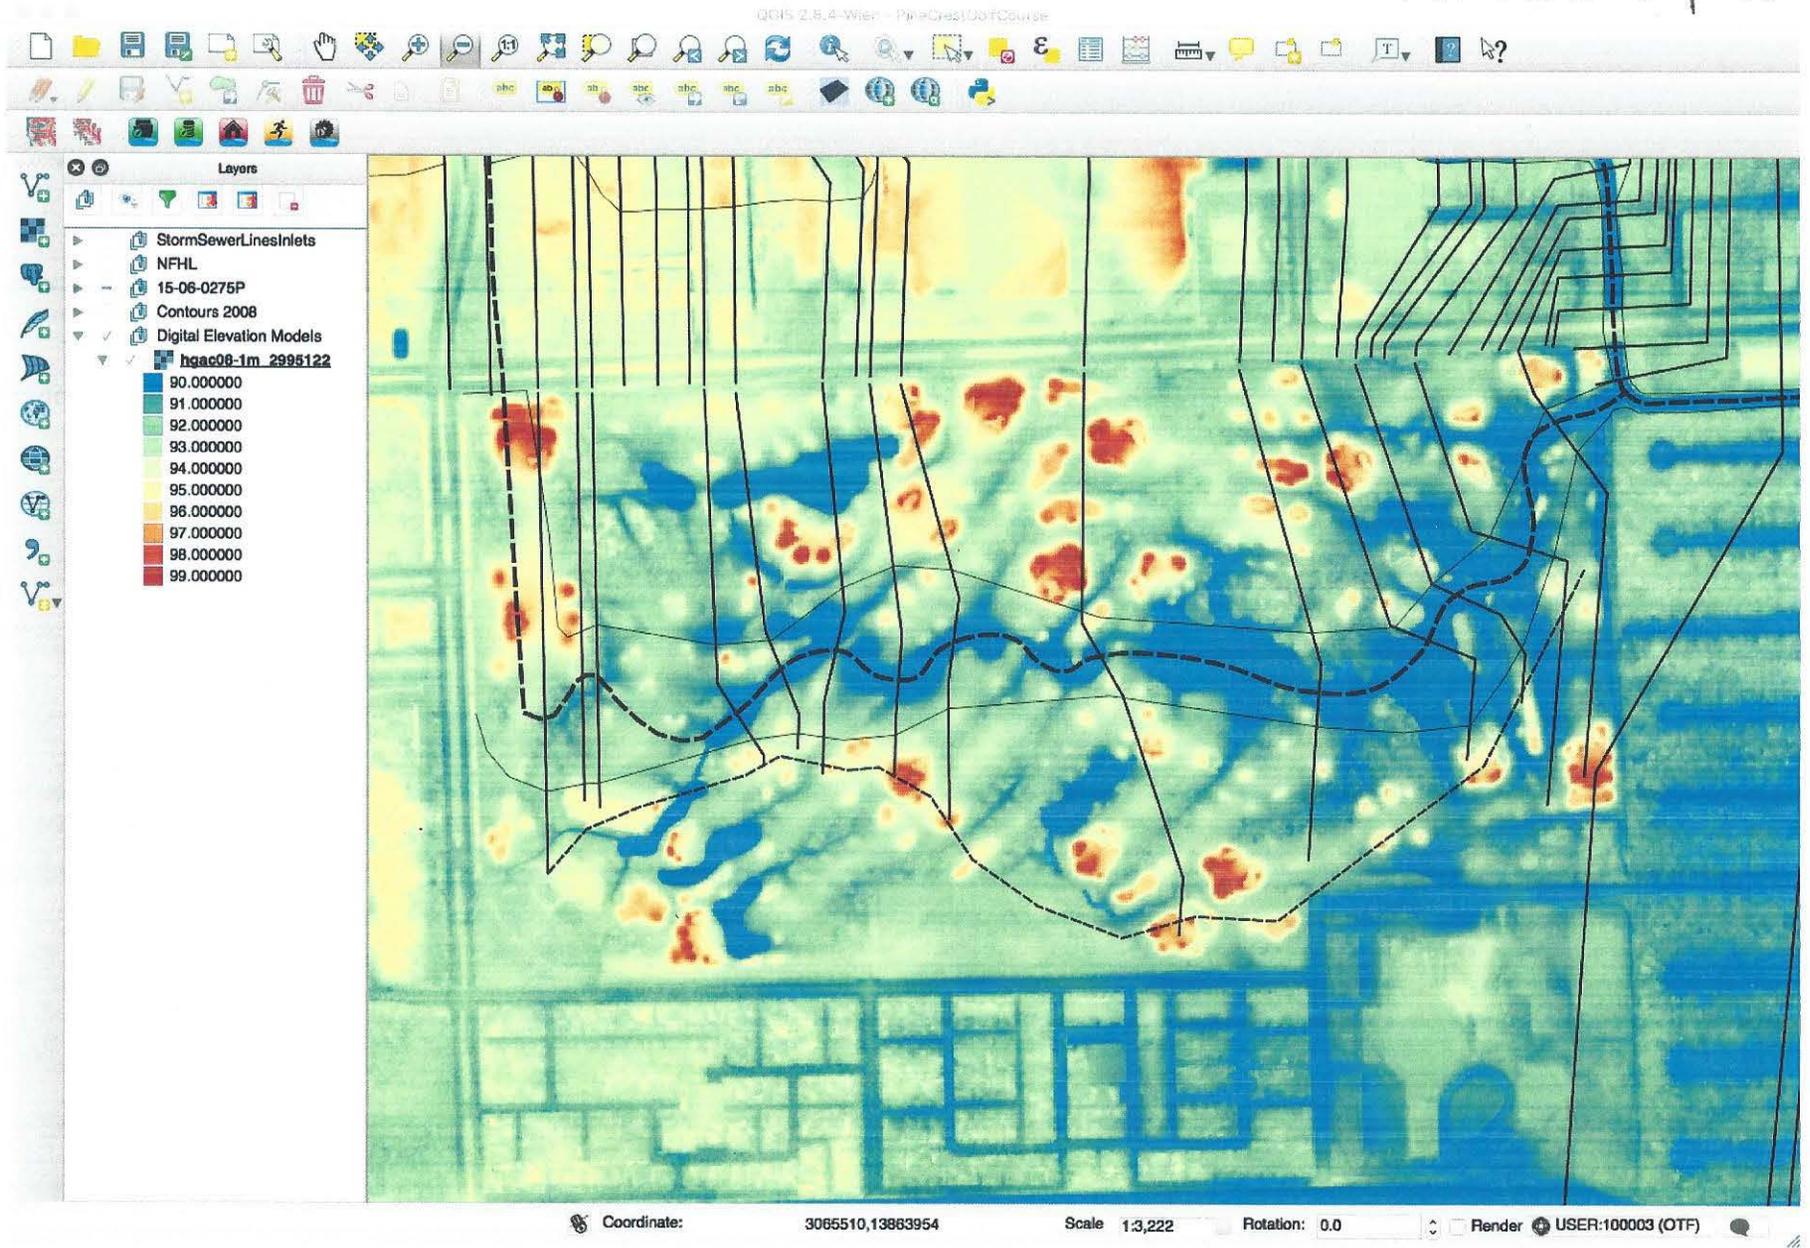
Inundation at 90 feet. The proposed channel and ridge would not hold water.

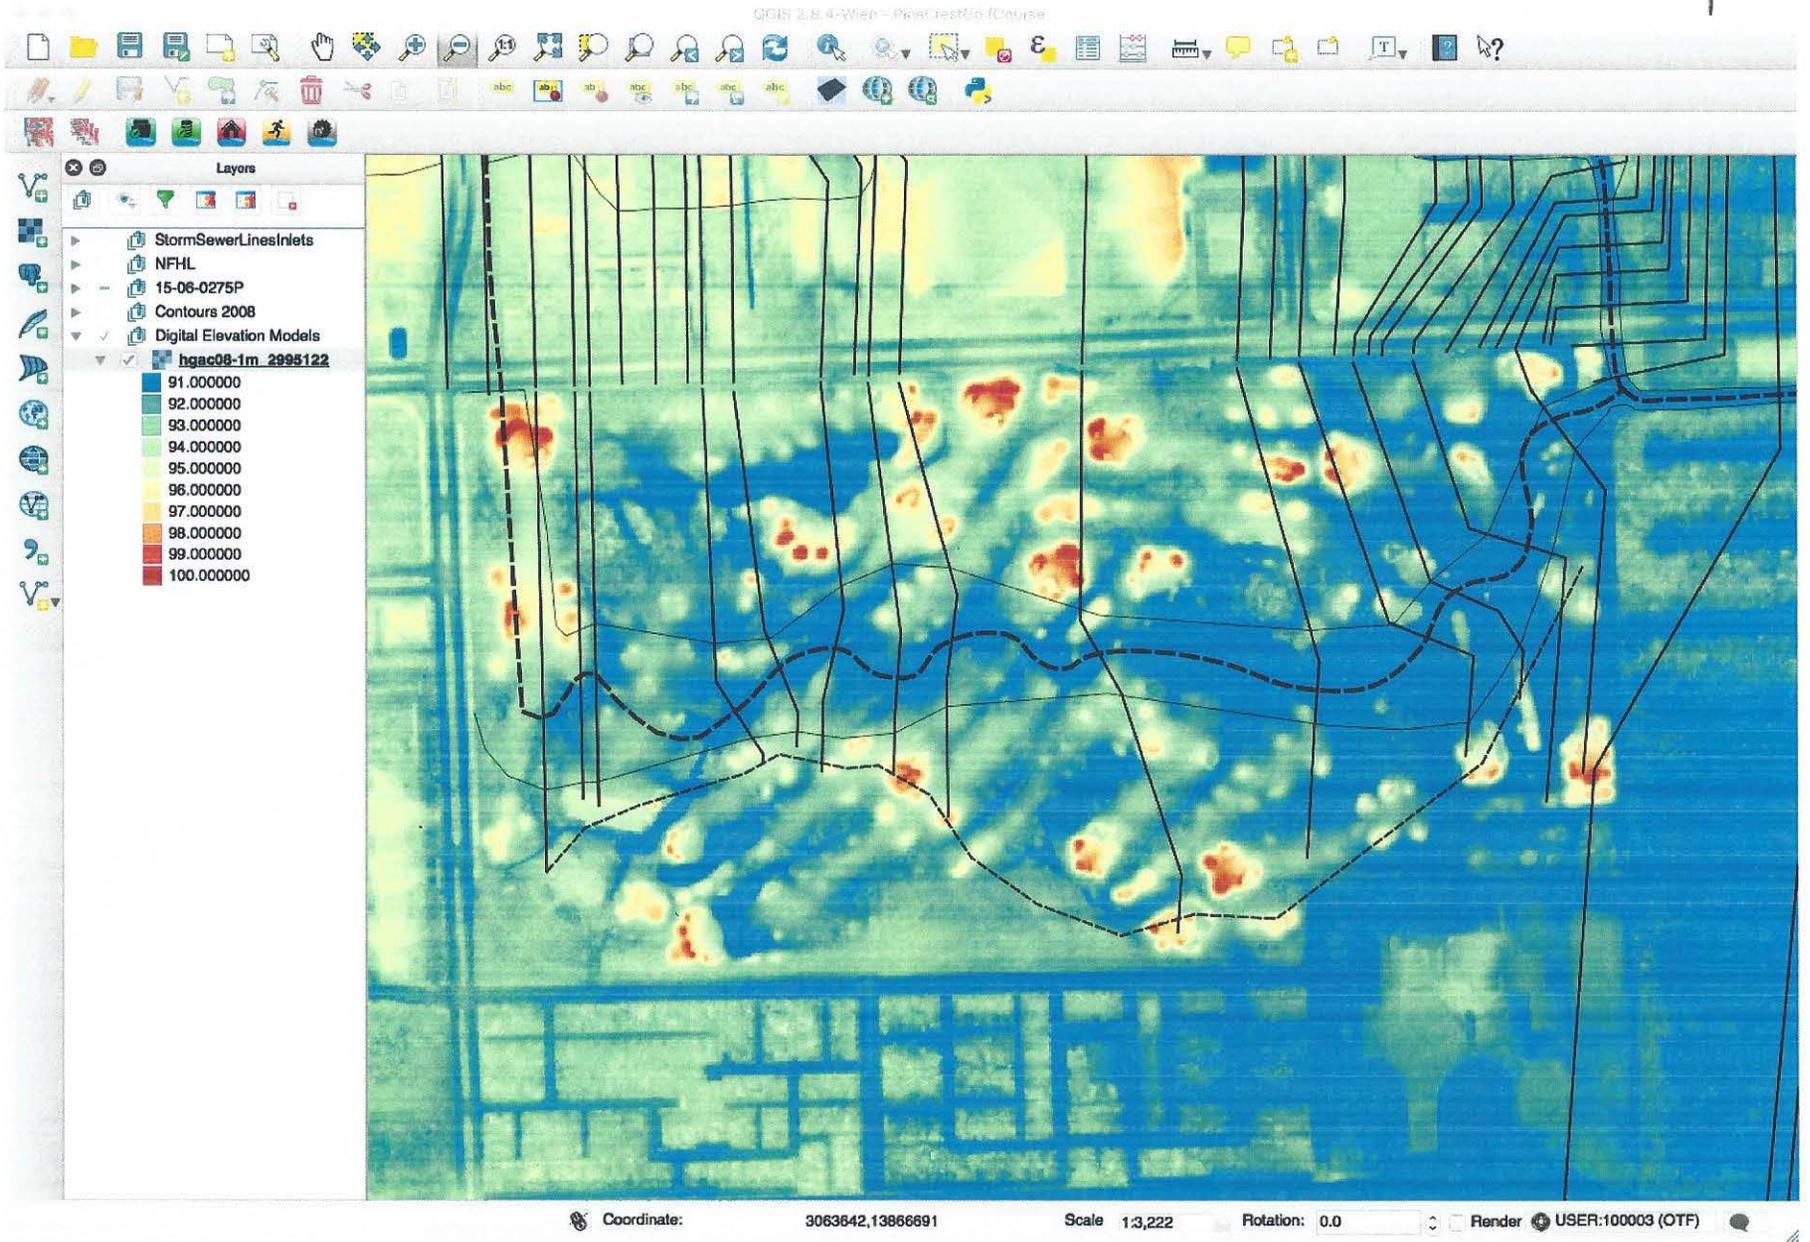
Inundation at 91 feet. The proposed channel and ridge would not hold water.

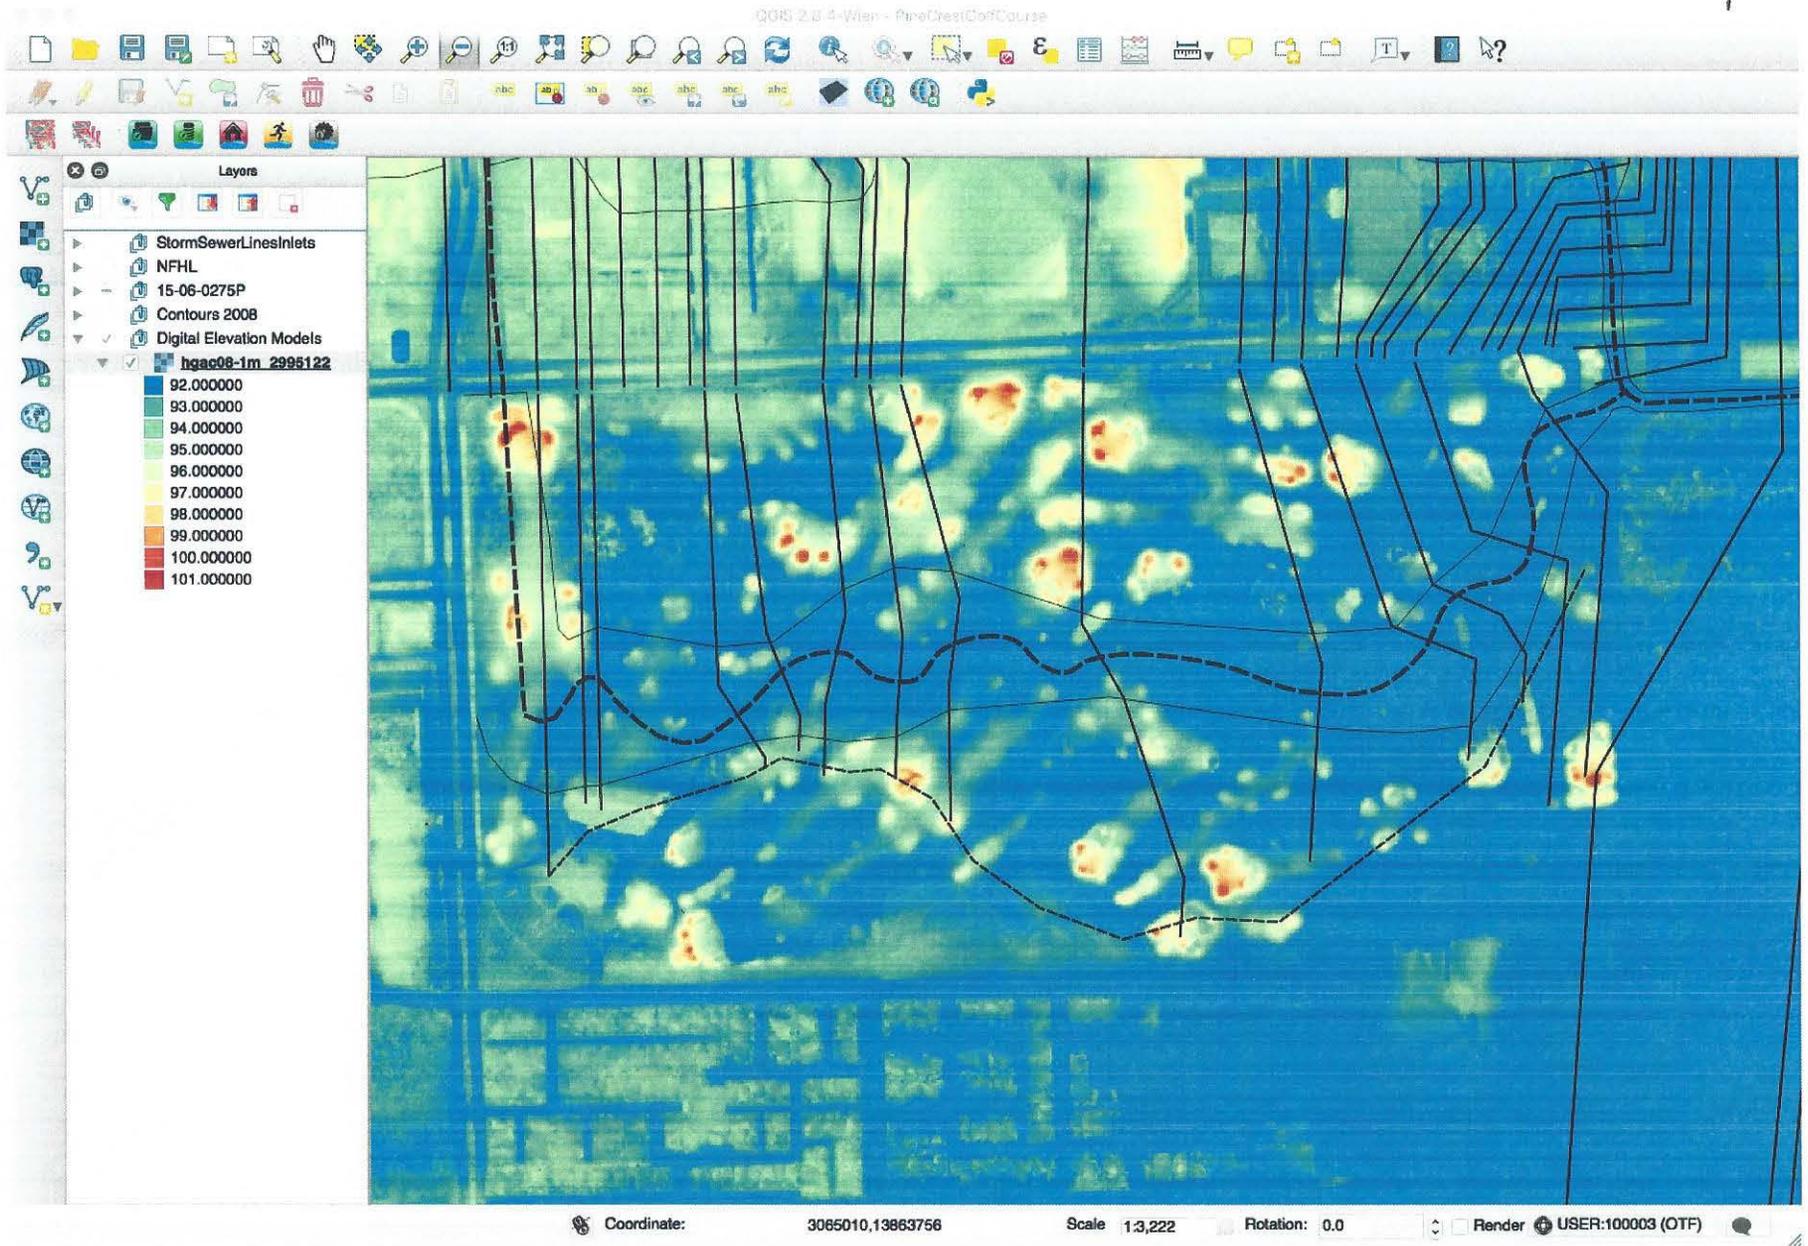
Inundation at 92 feet. The proposed channel and ridge would not hold water.

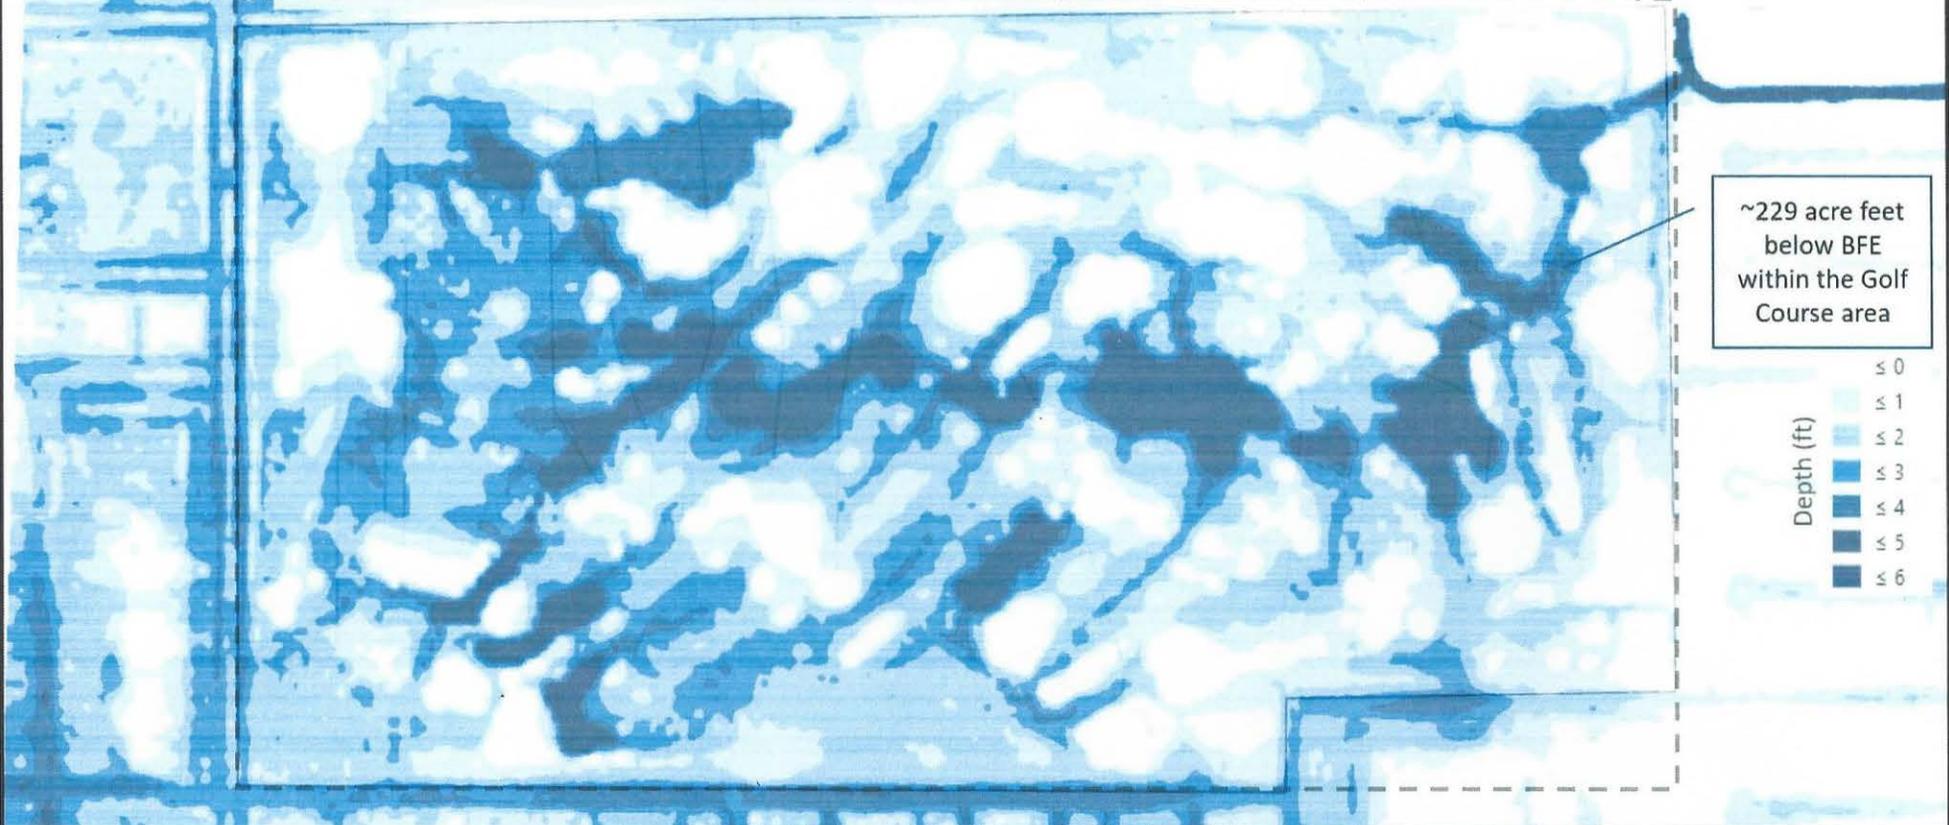
**Pine Crest Golf Course: Flood Mitigation Potential
Base Flood Detention Volume Calculation***

Area (sq ft)	Acres	Acre ft	Average depth
5,420,745	124	-229	-1.8

* Volume Calculation based on the difference between the dynamic BFE flood water surface from LOMAR 0275 and LIDAR elevations from the HGAC08 survey.

This highly-sculpted, golf course property accommodated approximately 229 acre feet of floodwater volume during a 100 year flood event. The developers are bringing in fill dirt, elevating the property and saving approximately 86 acre feet of detention volume. That leaves 143 acre feet of flood water volume which cannot be detained on the property. The surrounding properties will be forced to accommodate this extra flood water during the next 100 year flood event.

In addition, the new housing development will cover a high percentage of the area with impervious surface. This surface is not offset with any detention volume (as required in Fort Bend County), further increasing the flood risk to local residents.
