B. DISTRICT OFFICE, FILE NAME, AND NUMBER:SAJ-RD-SP, BHT Jurisdictional Determination, SAJ-2019-01815(JD-RHF)

C. PROJECT LOCATION AND BACKGROUND INFORMATION: The project is a 25.1 acre parcel located adjacent to 3800 Selvitz Road, Section 32, Township 35 South, Range 40 East, Fort Pierce, Florida. The site is a part formerly permitted citrus farming facility (FDEP File No: FLA140392). The site is adjacent to Ten Mile Creek. St. Lucie County Property Control Number 2432-122-0001-000-5.

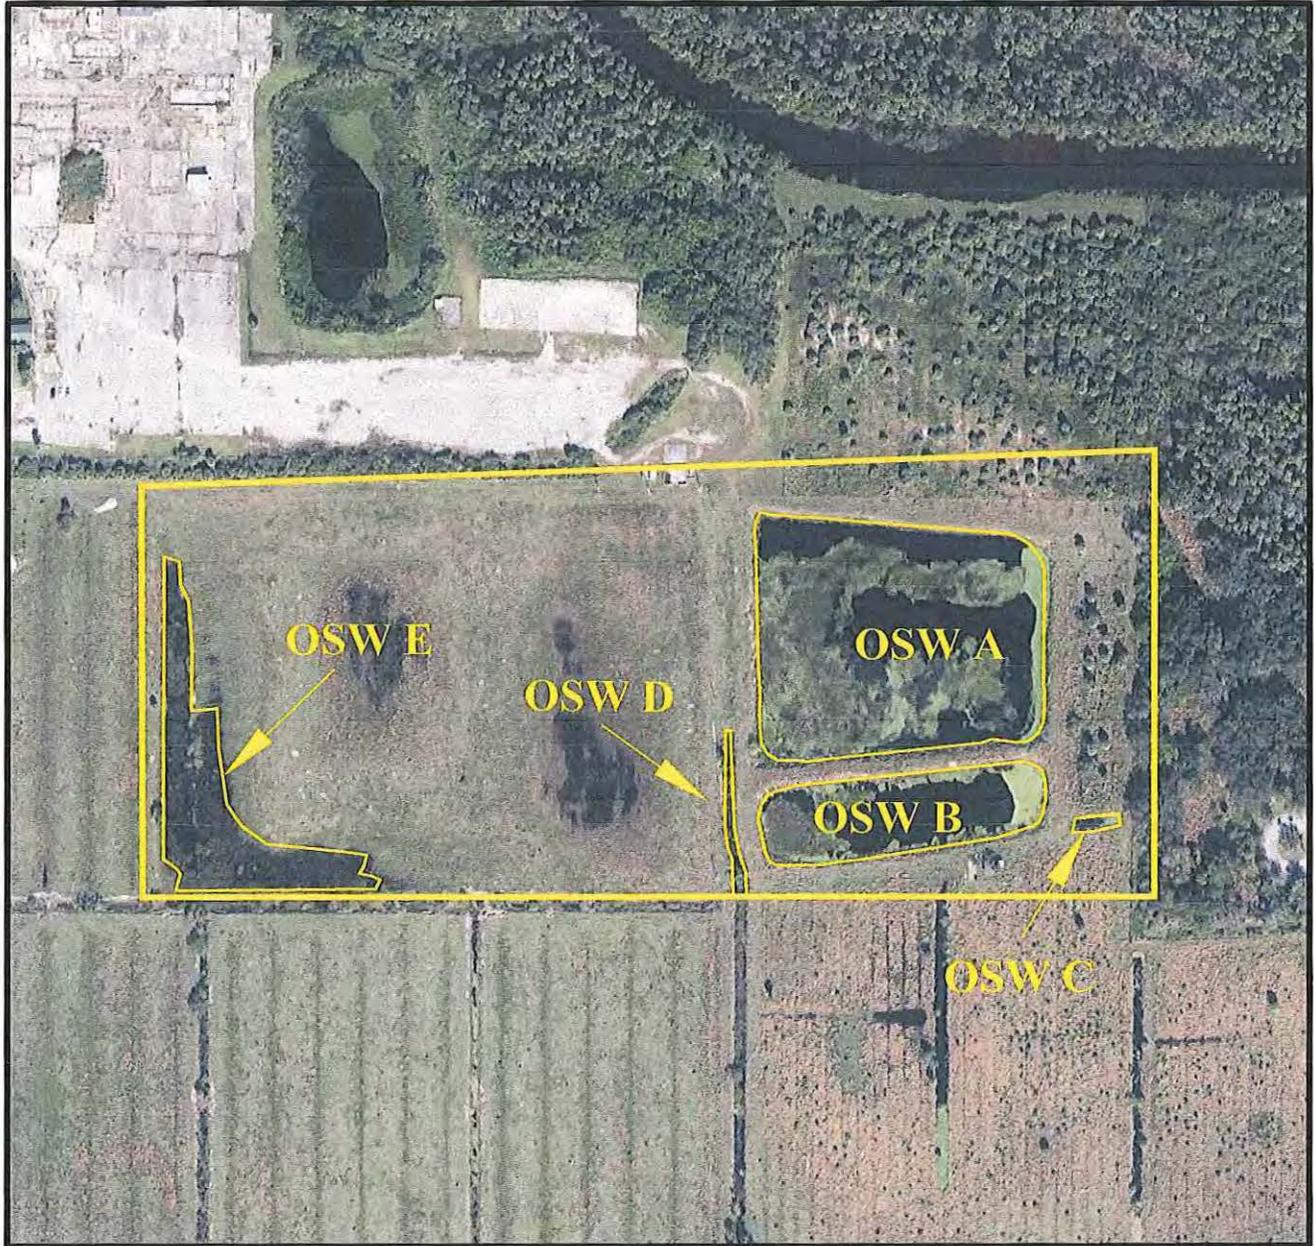
SOURCE: 2018 AERIAL PHOTOGRAPH, FDOT

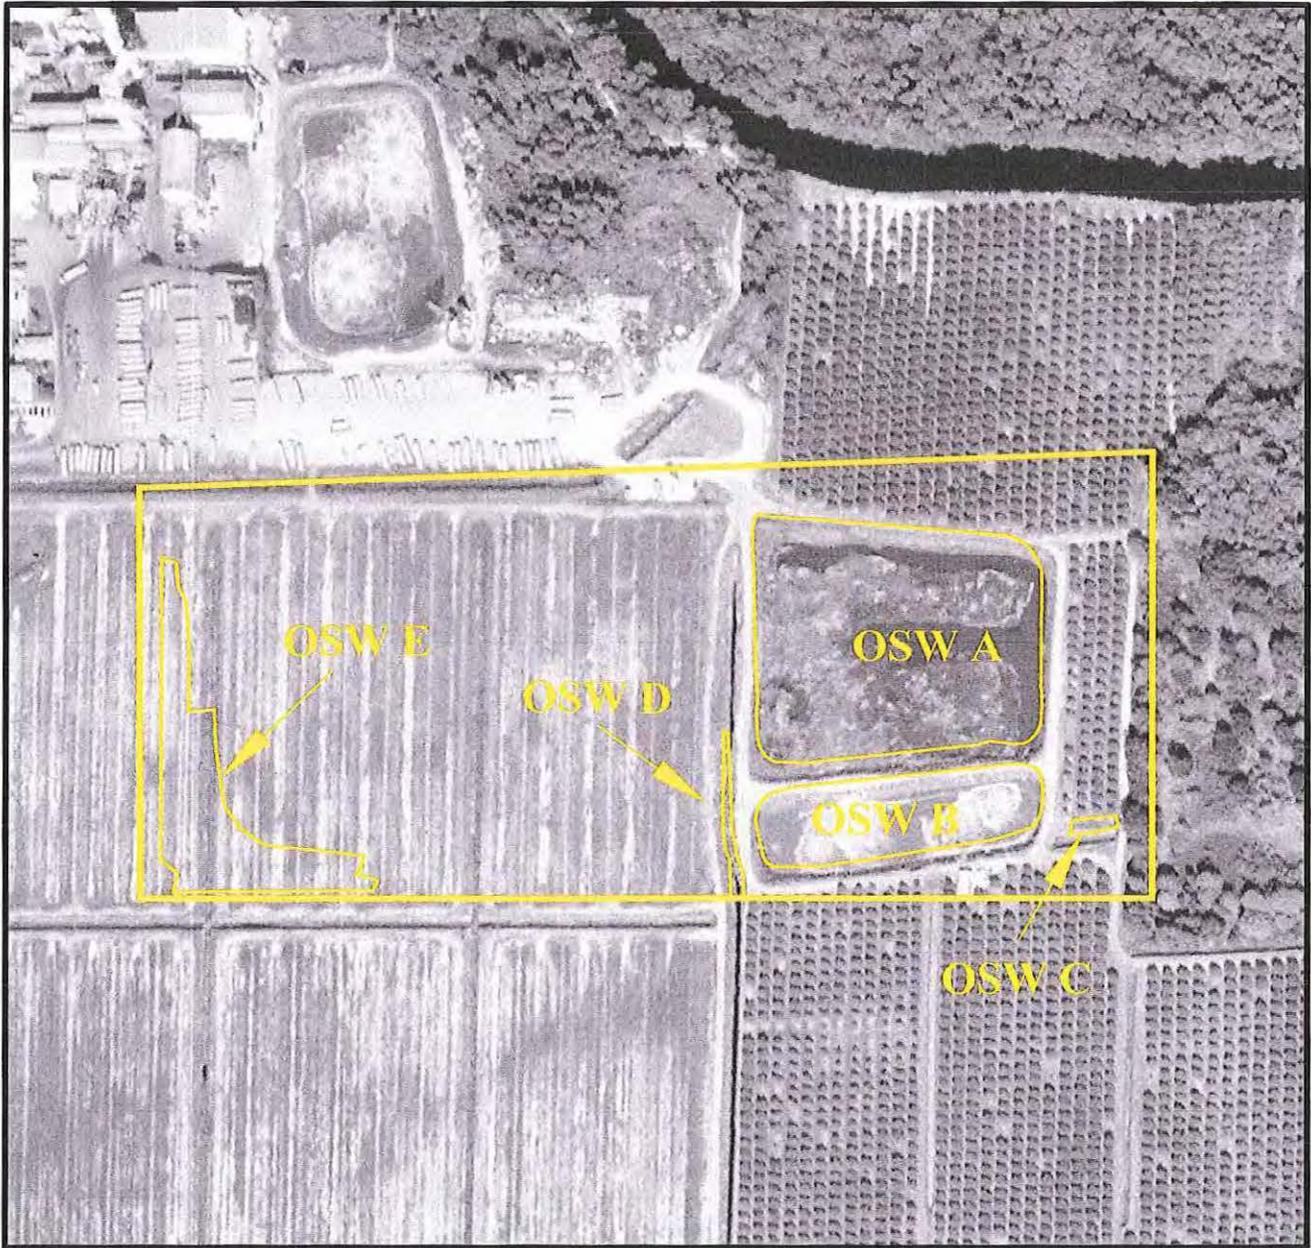
SOURCE: 1992 FDOT ORTHO AERIAL PHOTOGRAPH

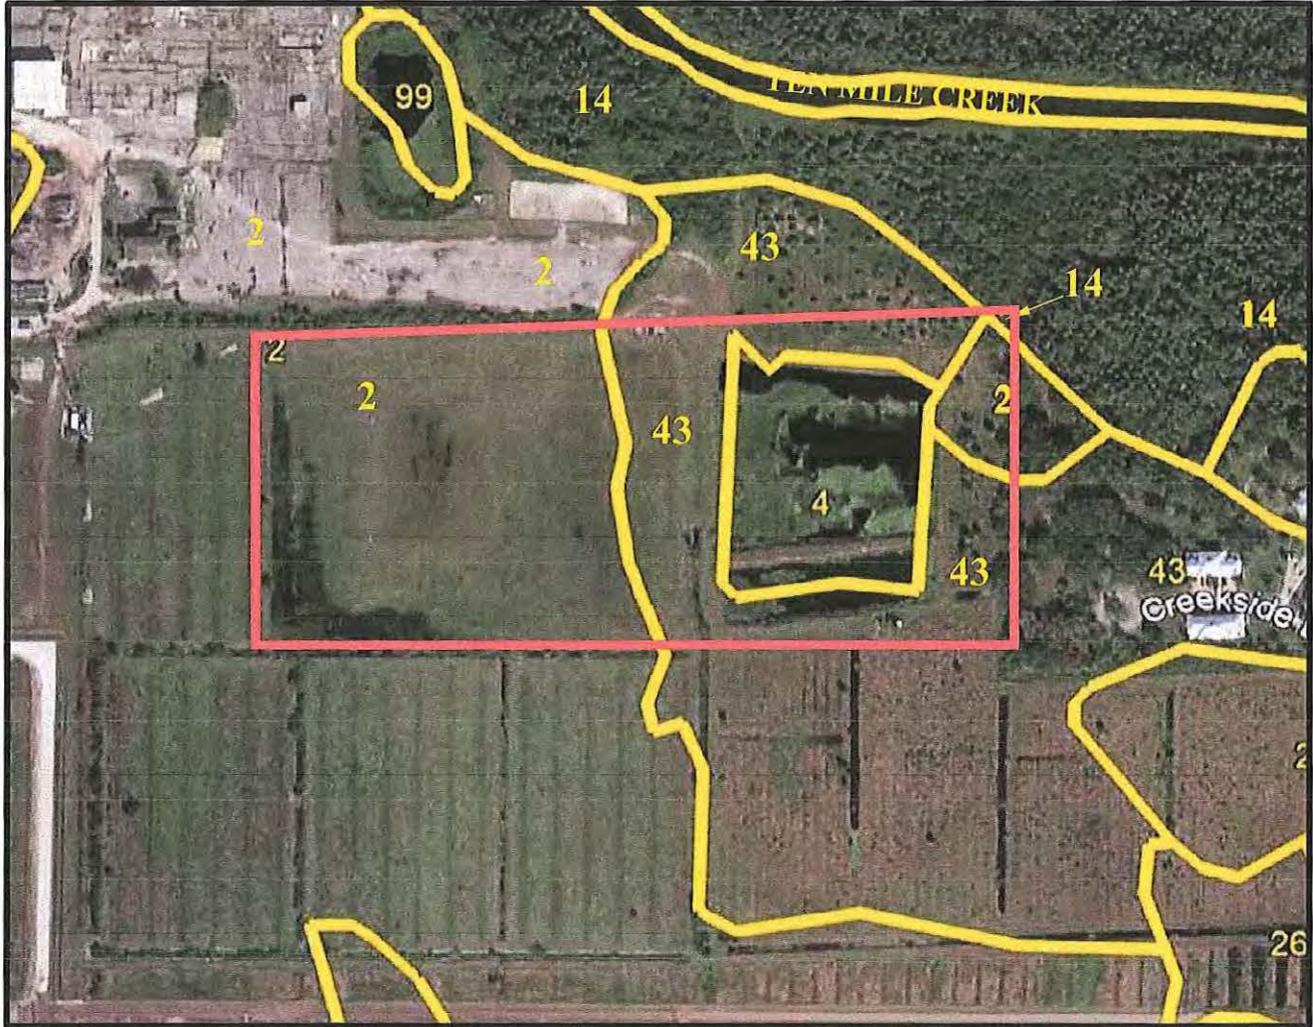
- 2 - ANKONA AND FARMTON SANDS (NOT HYDRIC 0%)
- 4 - ARENTS, 0 TO 5 PERCENT SLOPES (NOT HYDRIC 0%)
- 14 - FLUVAQUENTS, FREQUENTLY FLOODED (HYDRIC, 100%)
- 43 - SUSANNA AND WAUCHULA SANDS (HYDRIC, 1 TO 32%)

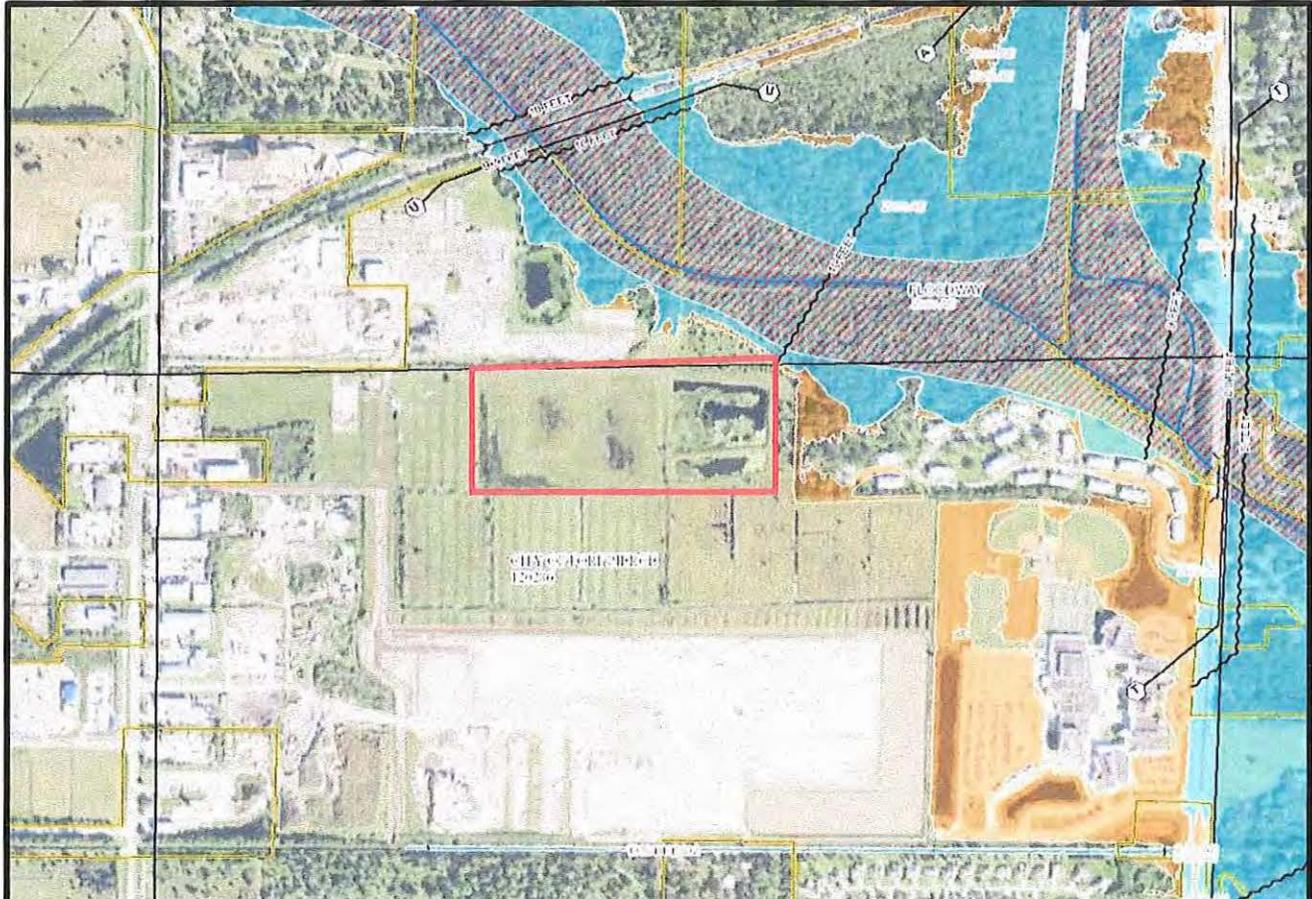
SPECIAL FLOOD HAZARD AREAS	Without Base Flood Elevation (BFE) (Zone A, V, AE)	OTHER AREAS OF FLOOD HAZARD	Regulatory Floodway	NO SCREEN	Area of Minimal Flood Hazard (Zone X)	OTHER FEATURES	Unit of Study Jurisdiction Boundary
	0.2% Annual Chance Flood Hazard, Areas of 1% annual chance flood with average depth less than one foot or with drainage areas of less than one square mile (Zone B)		Future Conditions 1% Annual Chance Flood Hazard (Zone C)	Area of Unflooded Flood Hazard (Zone D)	GENERAL STRUCTURES		Channel, Culvert, or Storm Sewer
	Area with Reduced Flood Risk due to Levee (Zone E)		Area with Flood Risk due to Levee (Zone F)		Levee, Dike, or Floodwall		Canal Transverse
					Canal Transverse Baseline		Canal Transverse Baseline
					Hydrographic Feature		Hydrographic Feature
					Base Flood Elevation Line (BFE)
