PRELIMINARY ASSESSMENT

Naval Air Station Banana River Off-Base Disposal Area

FUDS Property Number – I04FL0027

FINAL REPORT

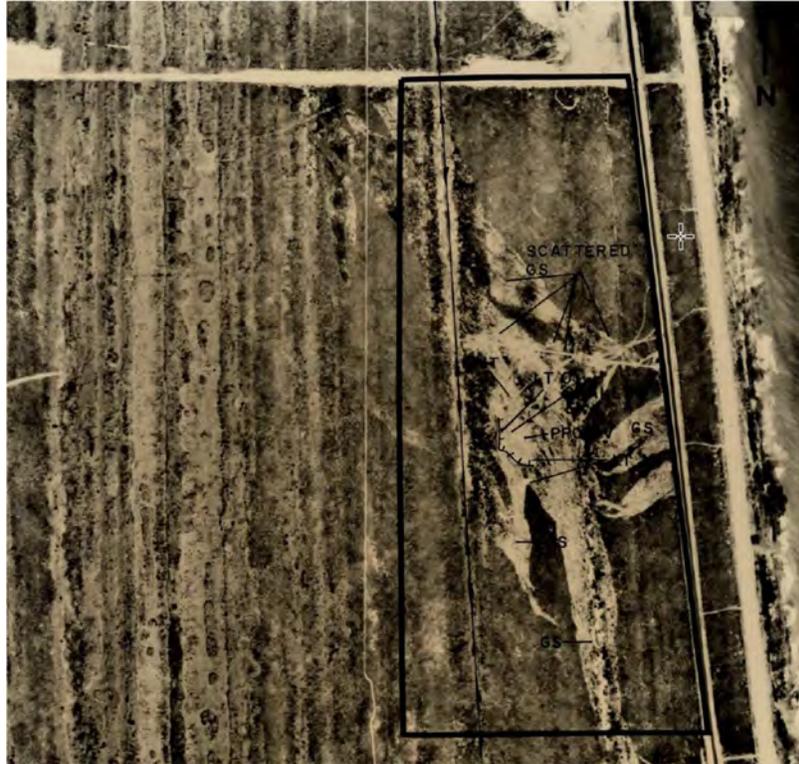
Figure 2 – EPA EPIC Analysis Aerial Imagery from 14 February 1943¹¹ⁱⁱ

Aerial imagery from 14 February 1943 revealed a series of north-south parallel drainage channels south of the air station and an area of scattered ground scars of devegetated or sparsely vegetated areas in an otherwise vegetated environment. The analysis also noted the presence of a series of access roads and a shallow excavation containing a pit, a light-toned object, a probable vehicle, and light-toned material completely devoid of vegetation (see *Figure 2*).

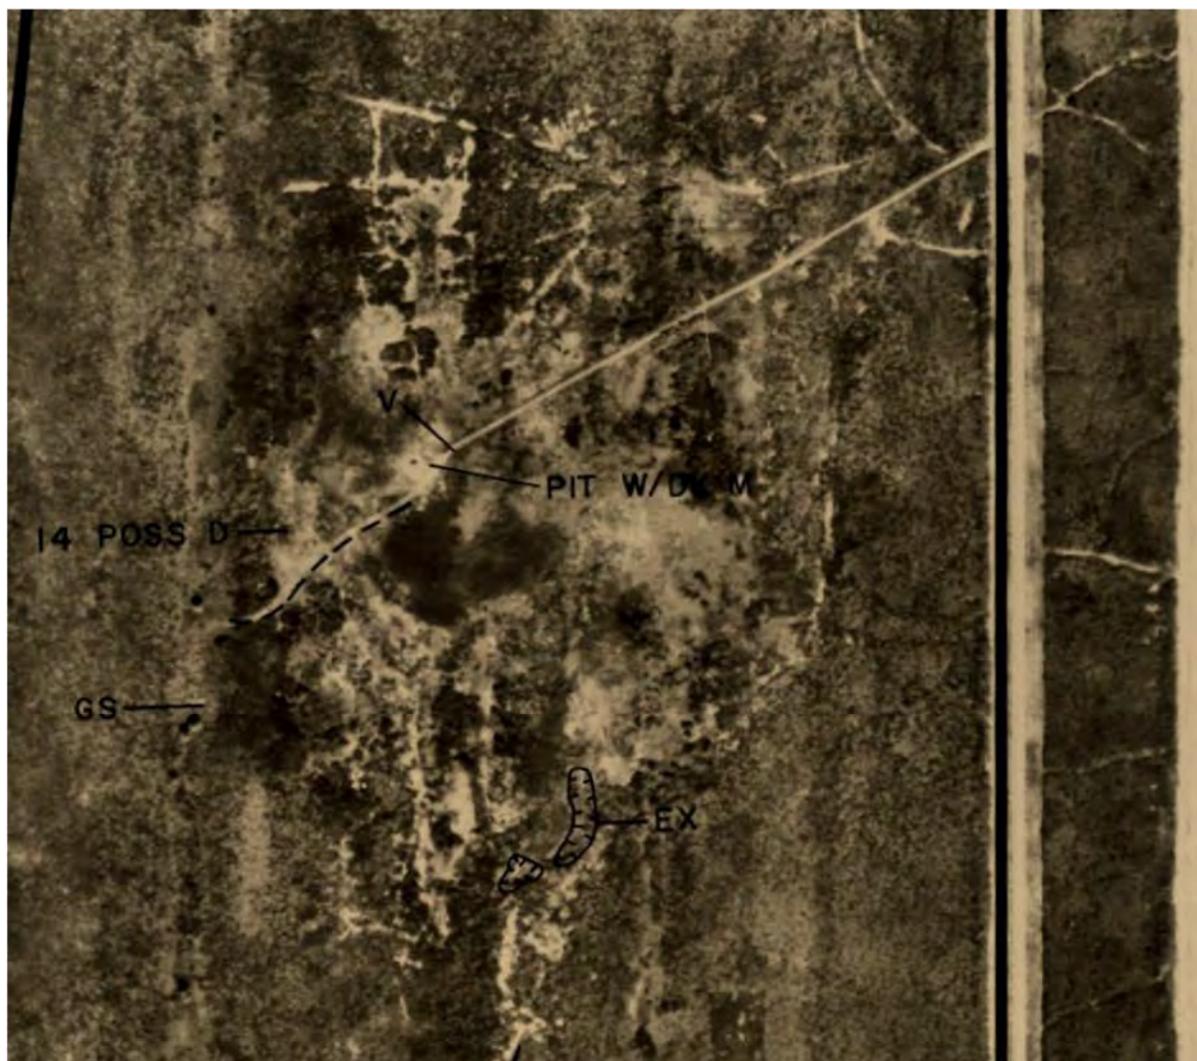
Figure 5 – EPA EPIC Analysis Aerial Imagery from 7 November 1954¹⁴

Imagery from 1951, 1953, and 1954 did not indicate an increase in the extent of the area. Analysis of the 7 November 1954 imagery revealed the presence of a vehicle, probably a truck, on an access road adjacent to a pit with dark toned material, along with approximately 14 possible drums near the access road and excavations (see **Figure 5**). These features were not evident on earlier imagery and potentially indicate post-Navy activities.

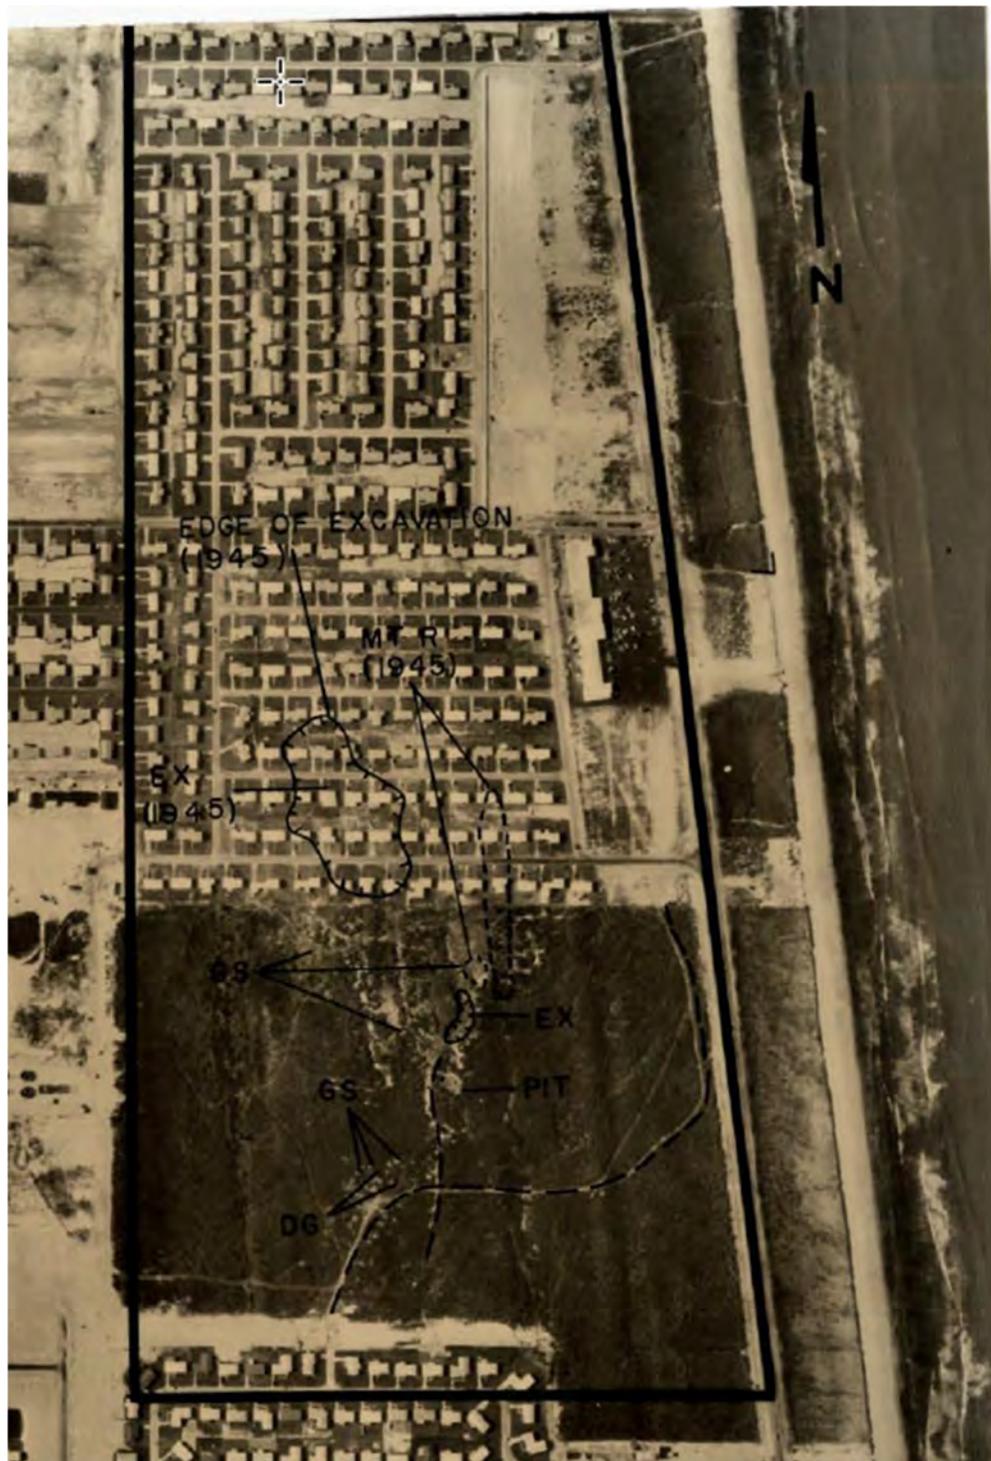
Figure 6 – EPA EPIC Analysis Aerial Imagery from 23 April 1958¹⁵

By 1958, a subdivision appears on the northern portion of the previous ground scarring, and the southern portion has revegetated, though the previous disturbances are still somewhat evident. Another pit is located south of a previous excavation, potentially indicating post-Navy use as well.

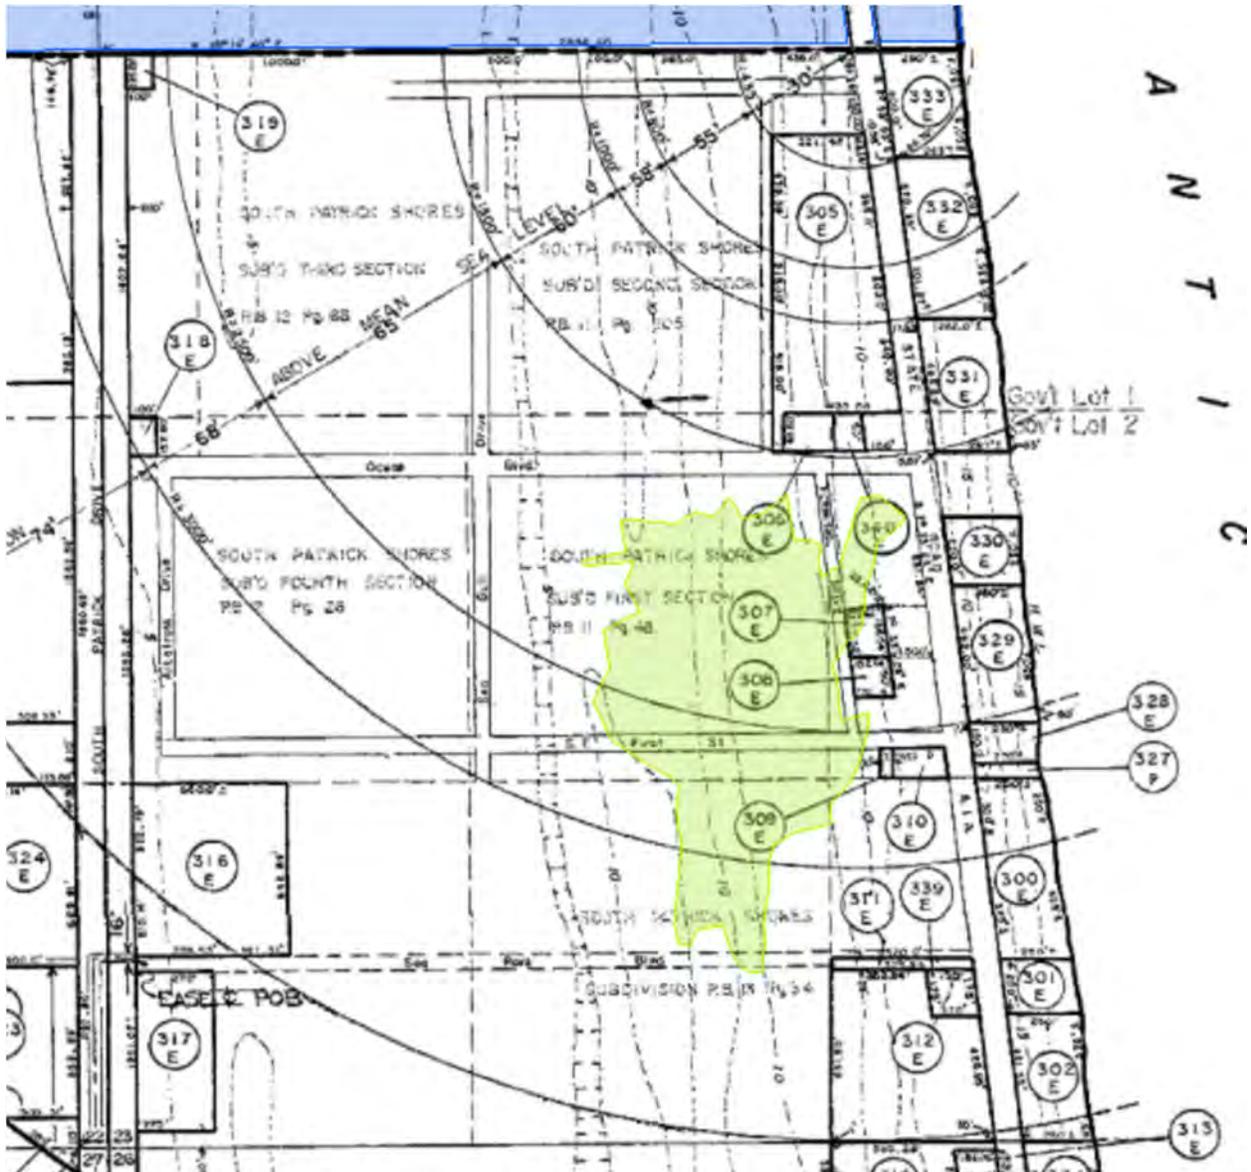
Figure 10 – Perpetual Restrictive Height Easements NASBROBDA Real Estate Tracts – September 1974²⁹

1970-71, Patrick AFB acquired perpetual restrictive height easements on a few dozen tracts of property in South Patrick Shore, including Tract 307E, limiting items on the tract to 65 feet above mean sea level. This easement partially overlaps the FUDS eligible property (see *Figure 10*). While these easements represent a real estate interest by the military, it does not affect FUDS eligibility either positively or negatively, as it does not indicate the DoD is exercising jurisdictional control over the land or indicate a ground based use.

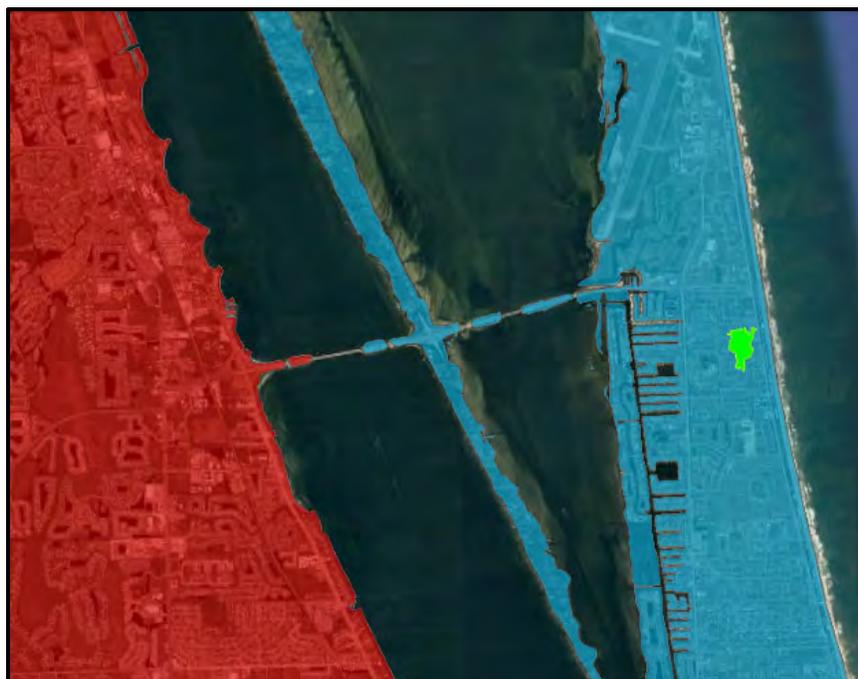
Figure 14 – Geologic Boundaries by Epoch in Vicinity of South Patrick Shores⁴¹

comprising the Eocene layer. Overlying the aforementioned strata is the Suwannee Limestone, which characterizes the Oligocene Epoch. The Hawthorn Group, which overlies the Suwannee Limestone, constitutes the Miocene Series. The Pleistocene to the most recent sedimentation is characterized by undifferentiated sediments. The geologic boundaries for areas within and in the vicinity of South Patrick Shores can be grouped by their respective epochs (see **Figure 14**).⁴⁰

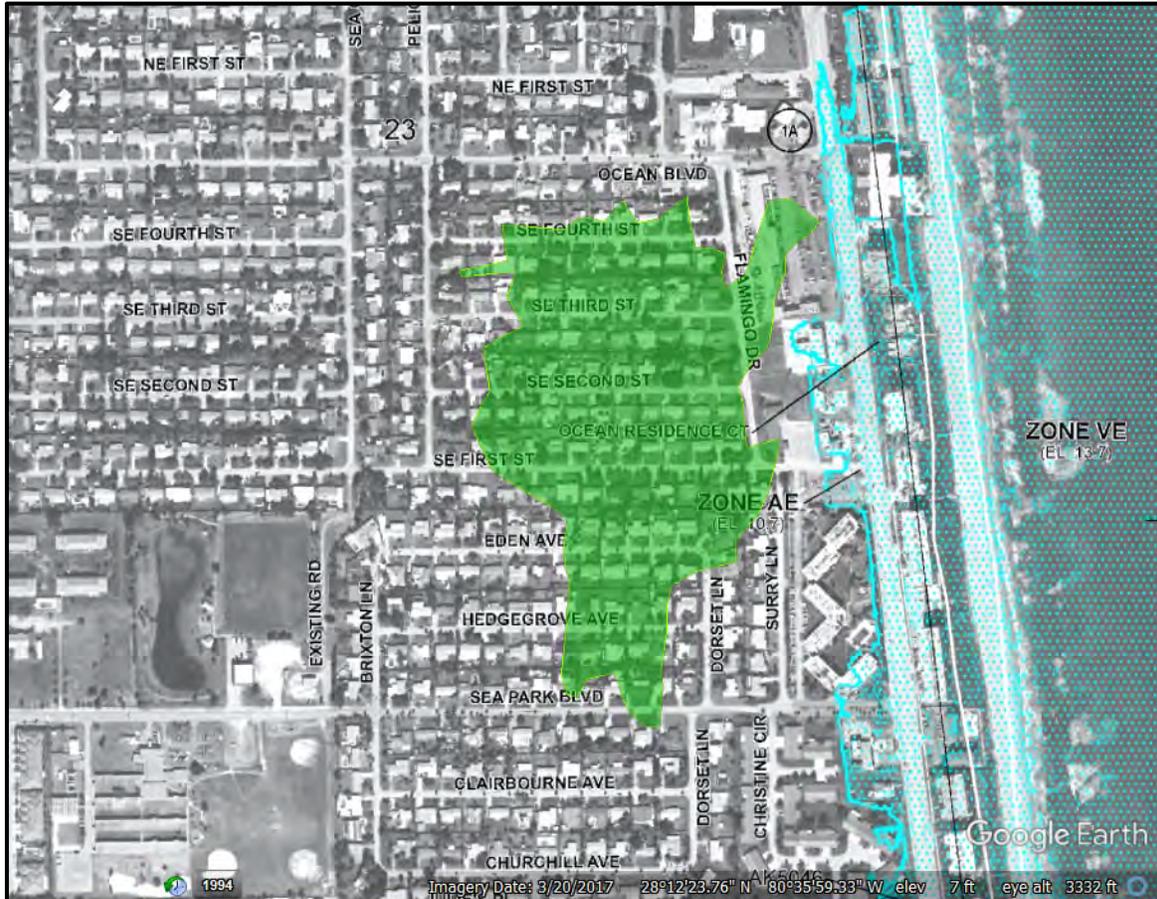
Figure 17 – March 2014 FEMA Flood Insurance Rate Map for NASBROBDA⁴⁴

The Banana River is an integral part of the Indian River Lagoon Estuary, which includes the Mosquito Lagoon, Banana River Lagoon, and North and South Indian River Lagoons. The Banana River is a designated Aquatic Preserve, and therefore there are substantial regulations regarding various activities including effluent discharges and drilling. *Figure 17* depicts the 100-year flood hazard areas along the shoreline of NASBROBDA, as determined on the FEMA Flood Insurance Rate Maps. The 100-year flood, also known as the 1% annual chance flood or the base flood, is the flood that has a 1% chance of being equaled or exceeded in any given year. The Special Flood Hazard Area is the area subject to flooding by the 1% annual chance flood. Areas of Special Flood Hazard include Zones A, AE, AH, AO, AR, A99, V, and VE, however, only Zones VE and AE are found within the boundaries of NASBRODA. The Base Flood Elevation is the water surface elevation of the 1% annual chance flood.

Note: Approximate 25 Acre FUDS boundary in green added for clarity.

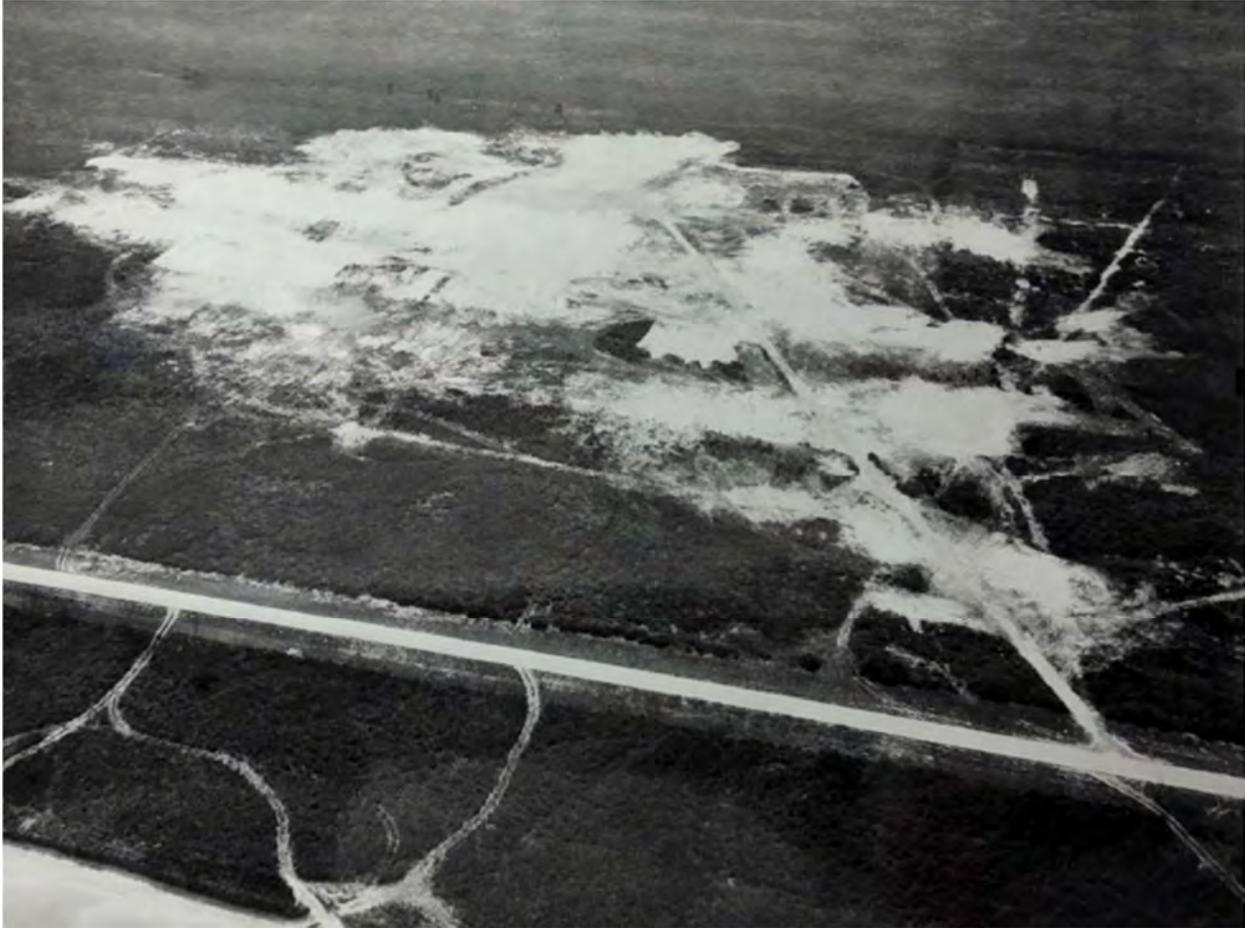
Figure 22 – Aerial Oblique looking southwest at solid waste disposal area, 13 March 1948⁸⁸

Vernon C. Fry, visited the property for a visual inspection of the completed “restoration” of the site. They both expressed their satisfaction; however, Mr. Fry later requested the Navy compensate him for the use of the property. The Navy took photographs of the site a month later (see *Figure 22, Figure 23, Figure 24, Figure 25, and Figure 26*).⁸⁷

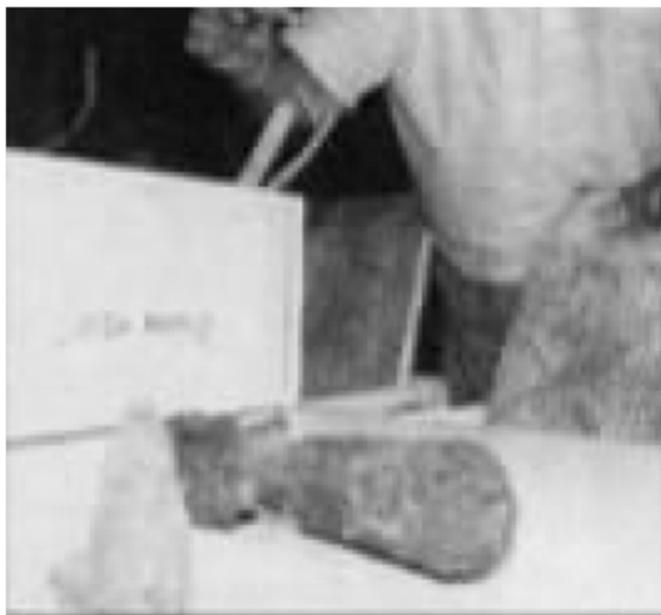
Figure 32 – Munition found in soil from a pool excavation on Second Street, May 2003¹¹⁷

In May 2003, Brevard County Sherriff’s Office responded to an incident in West Melbourne when an item was found in soil excavated from a backyard on Second Street in South Patrick Shores. The Sheriff’s office speculated it was a “1950s-era mortar.”¹¹⁶ From the photo accompanying the newspaper article, specific munition identification is not possible; however, the item more closely resembles a Mk 23 practice bomb than a mortar, which would be an aberration at a Navy facility (see **Figure 32**). It does not appear that the 45 CES EOD responded to this incident.

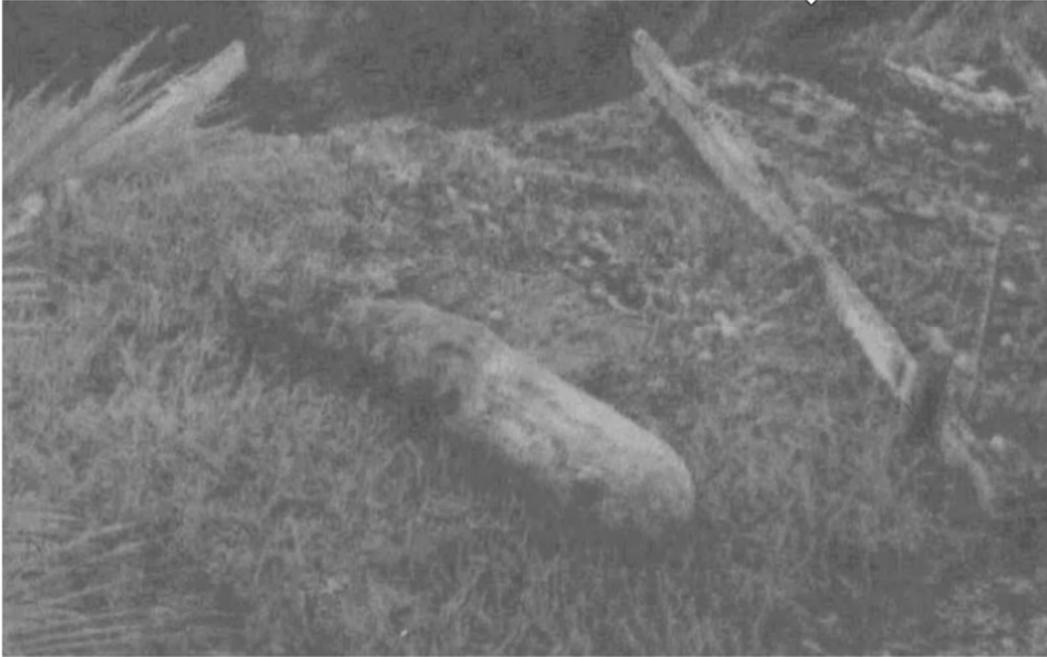
Figure 33 – Practice Concrete Bomb found on SE First Street, September 2009¹²¹

During excavation for a swimming pool in a yard on SE First Street, workers found a large, cylindrical object that reportedly weighed more than 100 pounds. On 26 September 2009, Patrick Air Base bomb squad identified the item as a “harmless” “training bomb.”¹¹⁹ The 45 CES EOD reported it as “a practice concrete filled bomb” and did not denote a spotting charge associated with it.¹²⁰

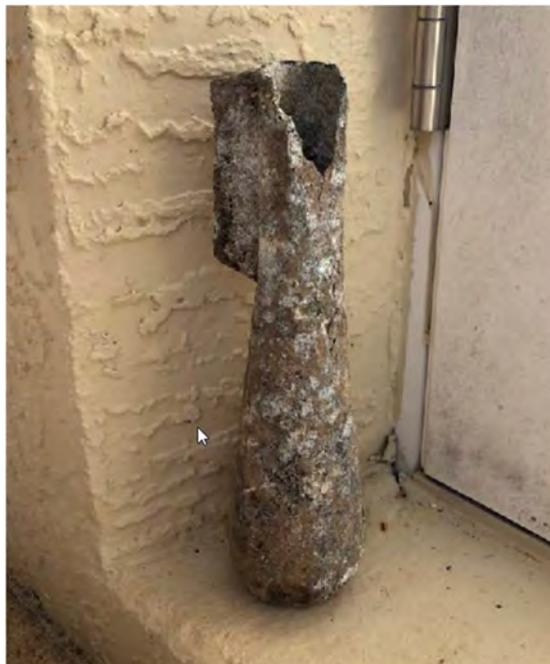
Figure 34 – Mk 43 Miniature Practice Bomb found in yard on SE First Street, September 2018¹²³

On 30 September 2018, the 45th CES EOD unit identified an Mk 43 Mod 1 bomb (i.e., miniature practice bomb made of lead-antimony alloy) found in a yard on SE First Street within the boundaries of NASBROBDA (see *Figure 34*). The EOD unit determined the item was non-hazardous and removed the item for disposal.¹²²

In the fall of 2018, residents dug up an Mk 23 and an Mk 43 miniature practice bomb (one each). There have been at least two earlier accounts in 1971 and in 2003 of items the public described as "mortars." It is more likely the items were miniature practice bombs that have a similar shape as a mortar. This conclusion is based on photographs of the 2003 item (see *Figure 32*) and that mortars are not standard munitions for the Navy. During construction of a pool in 2009, a resident located a concrete M85, 100-pound practice bomb. Other residents have found expended small arms casings, and there are at least two accounts of small arms ammunition.

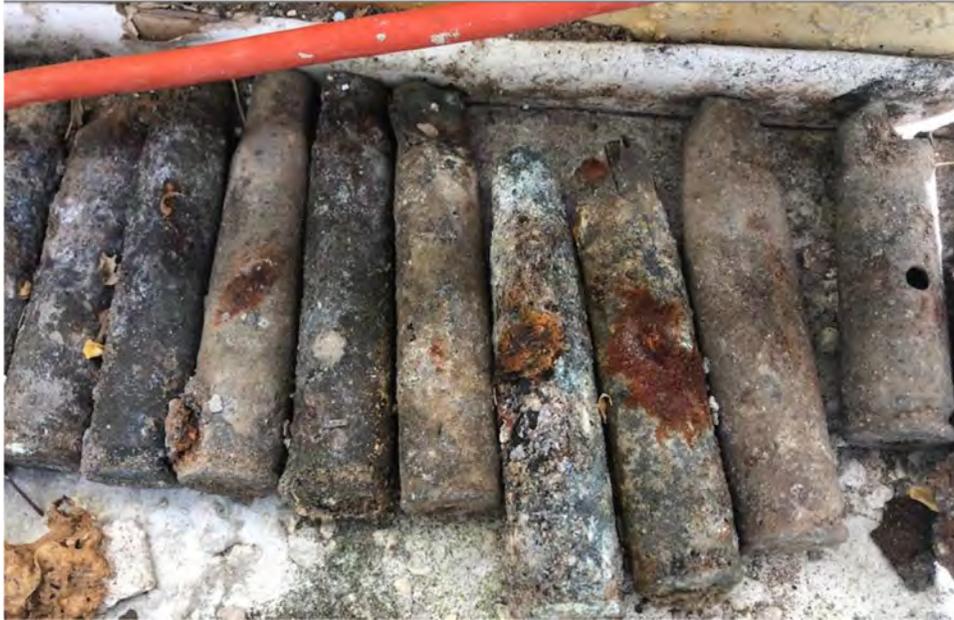
Figure 35 – Expended small arms cartridge cases from a yard on SE First Street, September 2018¹²⁴

Also in the fall of 2018, a resident on SE First Street posted a picture of expended cartridge cases (see *Figure 35*), and a resident on Dorset Lane posted on social media finding a “mortar” shell (see *Figure 36*). The former appear to be expended .50 caliber small arms casings, and the later item appears to be an Mk 23, 8¼ inch long, miniature practice bomb made of iron.

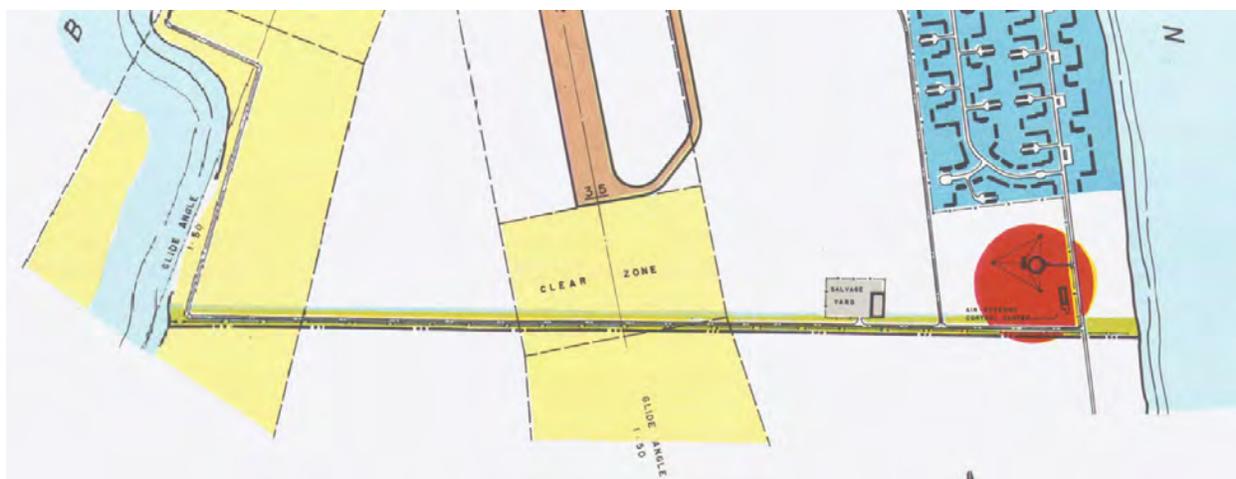
Figure 38 – Patrick AFB Salvage Yard, 13 March September 1952¹²⁹

By 1952, Patrick AFB site plans denote the location of a salvage yard along the southern border of the installation with road access to the southern perimeter road (see *Figure 38*).

Review of aerial imagery indicates that operations of a salvage yard, or something else, began at this location between April and October 1945 (see Appendix O NASBROBDA HPA).

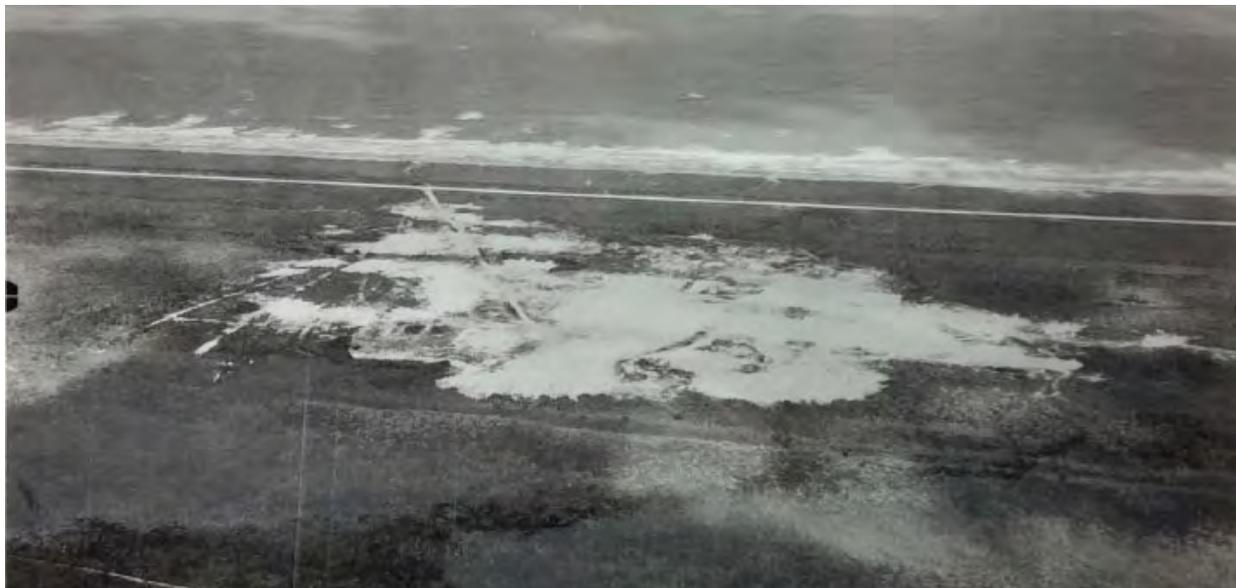
Figure 39 – Aerial Oblique looking east at solid waste disposal area, 13 March 1948¹³³

The NASBR off-site solid waste disposal operations occurred about half a mile south of the NASBR southern boundary (see **Figure 39**). Section 4.1.2 discusses additional details regarding use and operation. The Navy used the FUDS for the disposal of “wrecked planes, motors, flying jackets, lime, cement, tin cans and every kind of rubbish except lumber, which had been disposed of by fire”¹³⁰ by 1942. The NASBR Public Works Department cleared and restored the area in 1947. The restoration “process consisted of burning and burying all rubble, trash, etc. to a depth of 8-10 feet and covering it with 6 feet of soil. The surface was restored to a comparative level by bulldozing the eight acres more or less.”¹³¹ During that clean up, “junk wagons” hauled “considerable material” from the area.¹³²

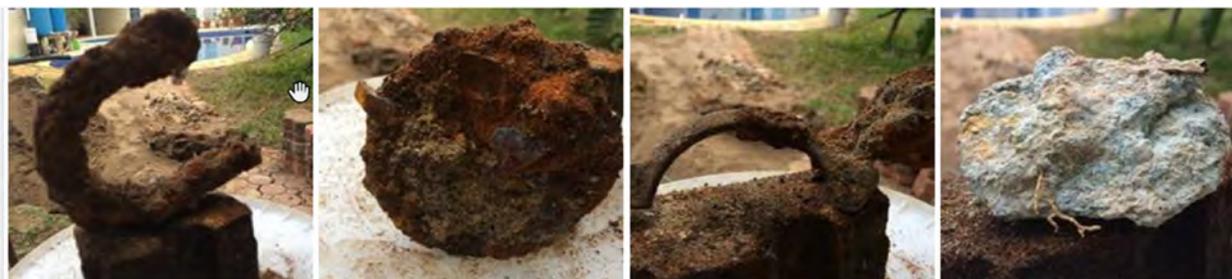
Figure 41 – Heavily corroded material found in a yard on SE First Street within NASBROBDA, September 2018¹⁴⁷

Local television news and social media in the fall of 2018 included a number of accounts of material dug up by local homeowners. Although cutlery, glass dishware, and bottles are recognizable, ferrous items found in the ground in 2018 are heavily corroded without a clear indication of their original shape and purpose (see **Figure 41**).

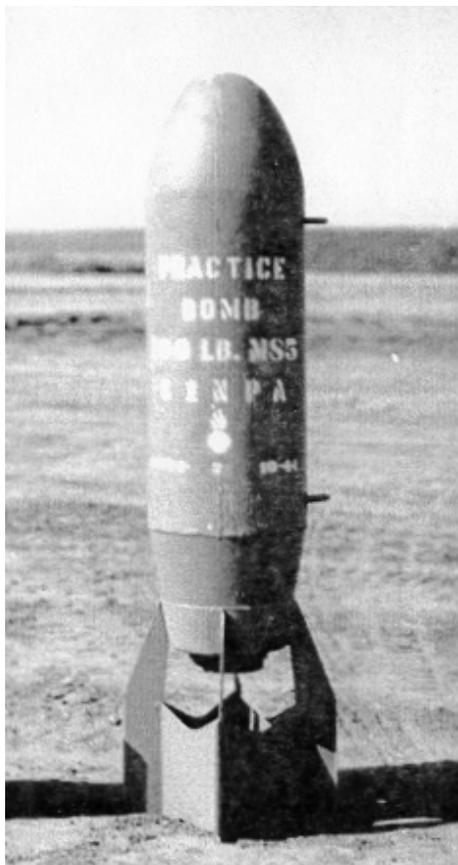
BOMB, PRACTICE, 100 POUND, M85

Description. The M85 is a round-nosed cylindrical type bomb constructed completely (except for fin assembly and spotting charge) of reinforced concrete. It simulates the M38A2 in general shape and employs the same spotting charges as the M38A2.

Over-all length..... 38.25 inches
Diameter 8.13 inches
Weight sand loaded & spotting charge 103.5 pounds

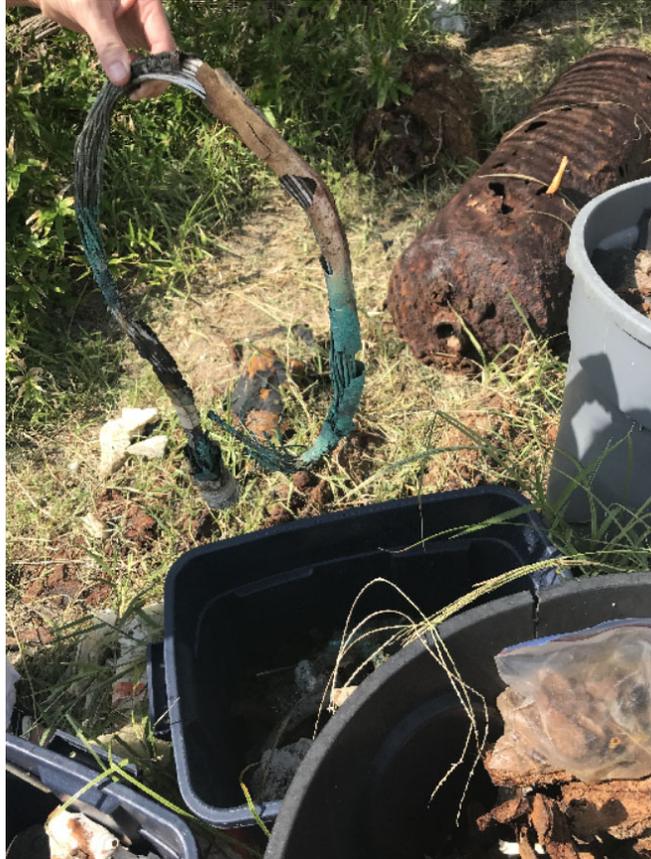
Photo 1 – Miscellaneous material dug up by the resident at 165 Dorset Lane, 30 September 2019

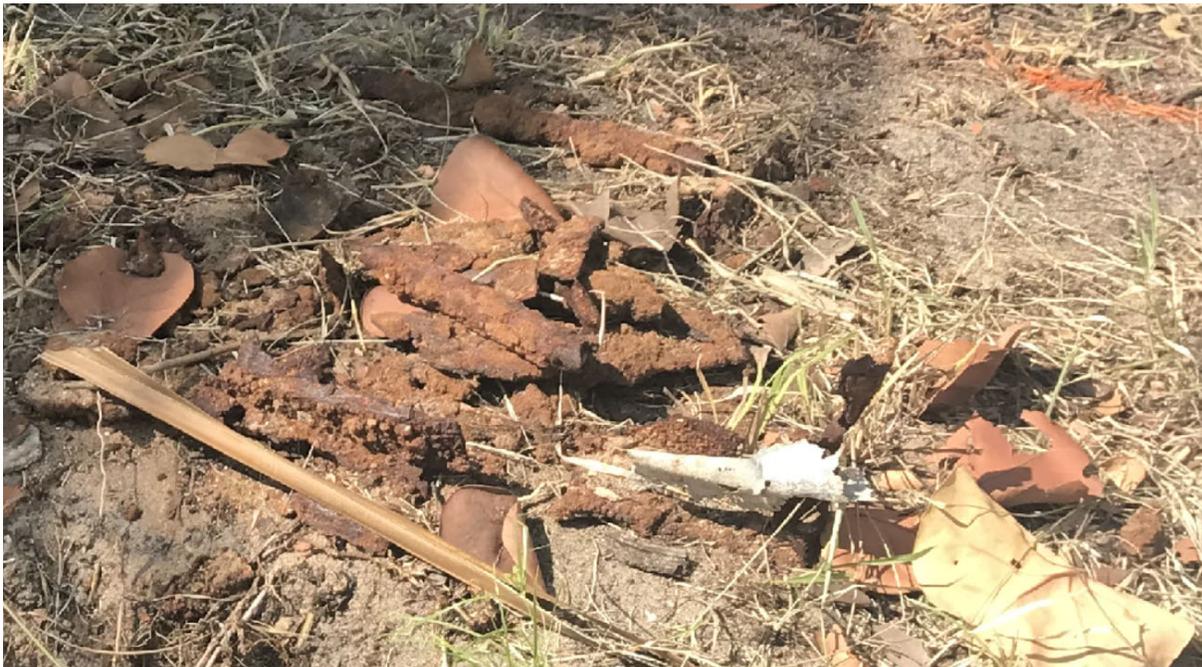
Photo 2 – Heavily corroded material dug up by the resident at 165 Dorset Lane, 30 September 2019

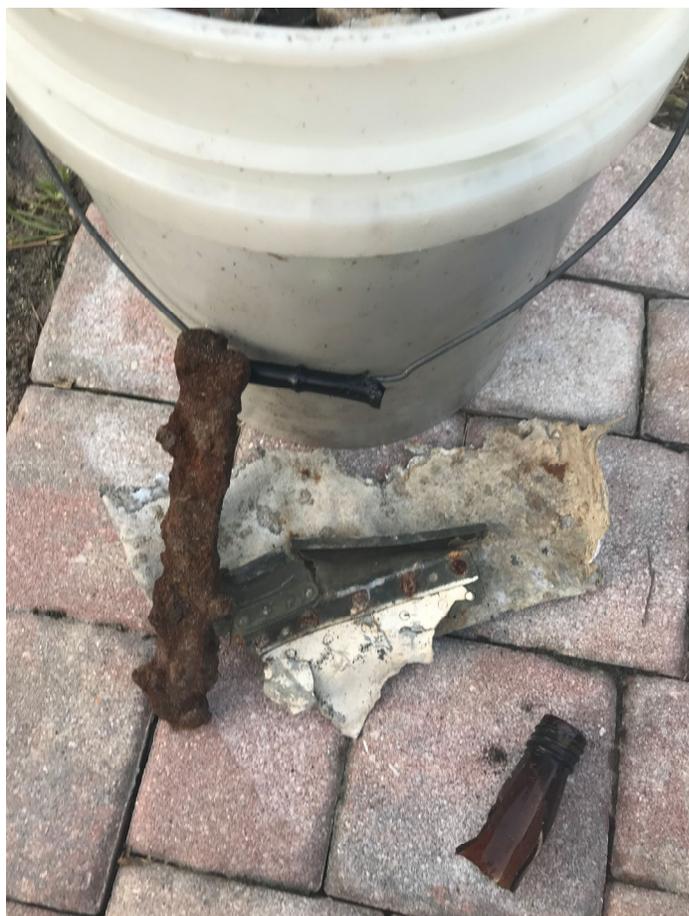
Photo 3 – Representative Debris next to Bucket Full of Glass and Metal Debris found at 113 SE First Street, Photo taken at 165 Dorset Lane 30 September 2019

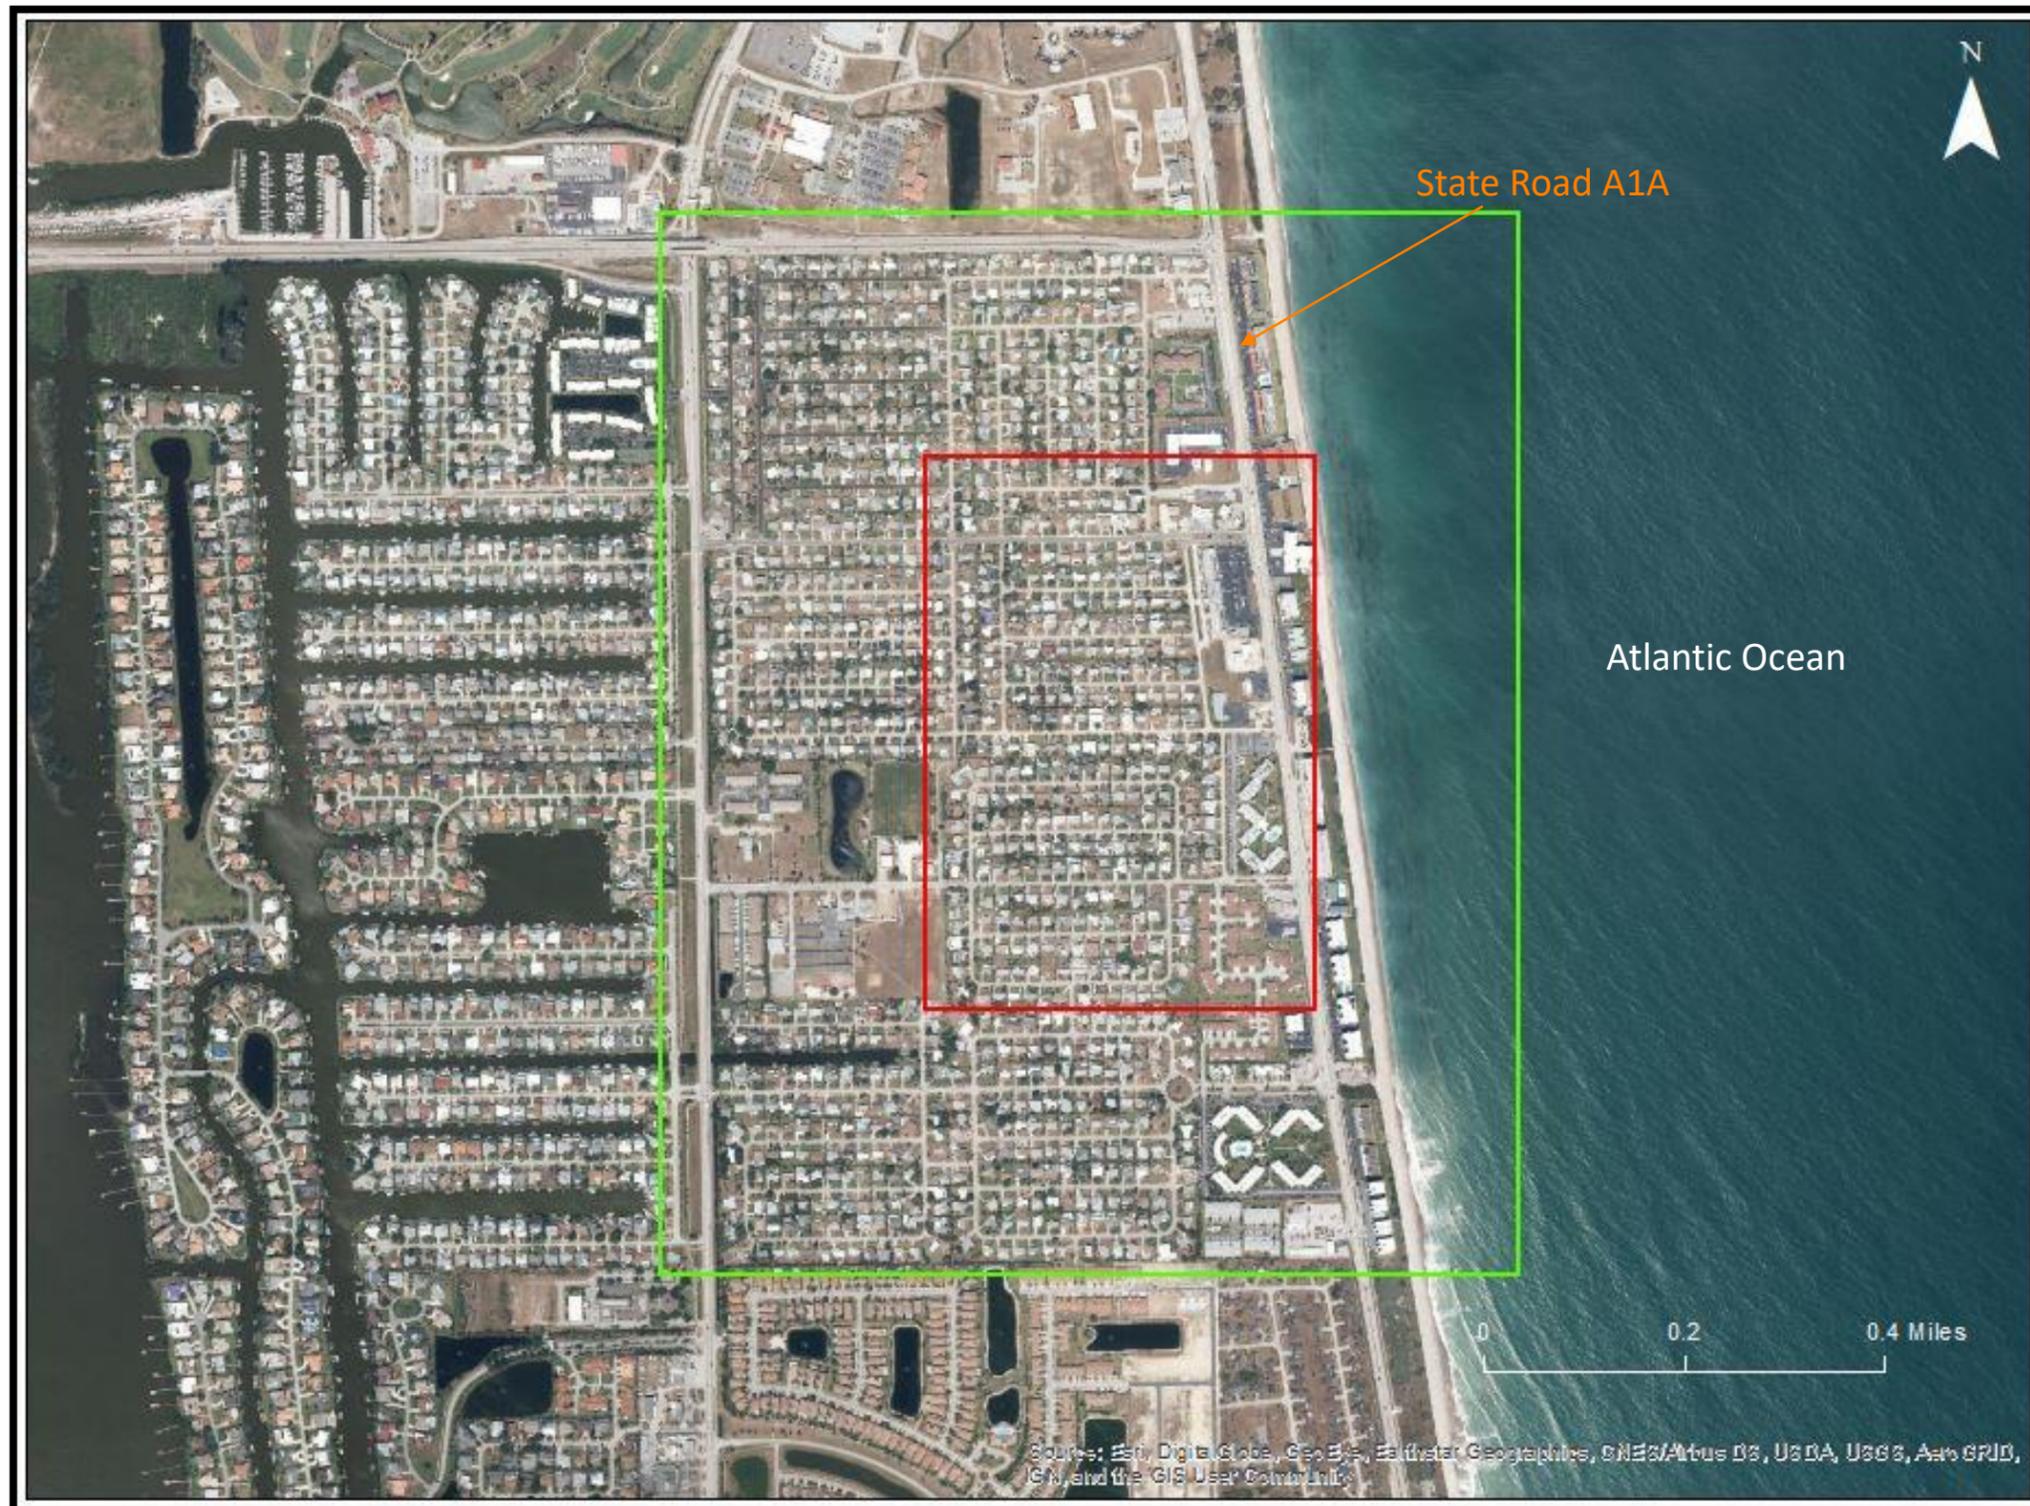
HPA STUDY AREA

The study area boundary shown in red was chosen to insure a complete overview of potential impacted area. The area boundary shown in green was selected to provide an overview of the surrounding area for select years. These boundaries do not indicate areas of activity, but areas of study used only for this historical photographic analysis.

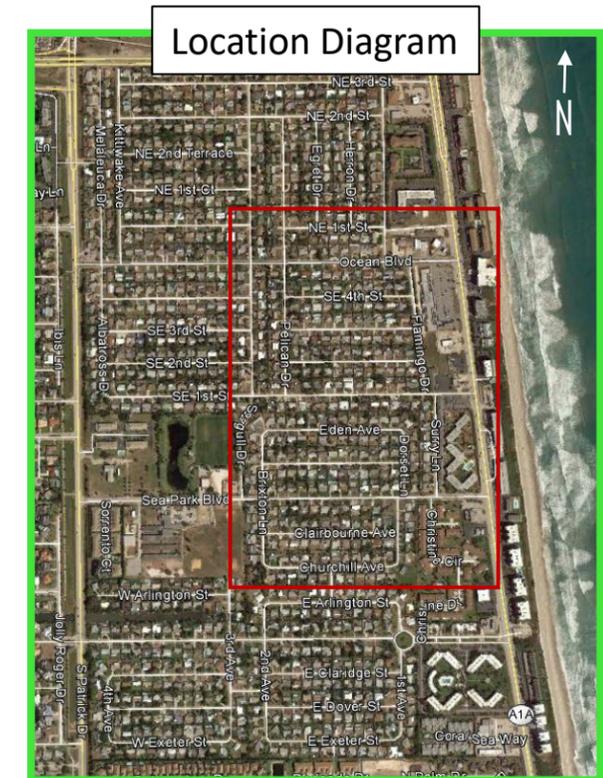
This 26 February 1944 overview shows the extent of disposal activity. The surface disturbance area is no longer visible.

NOTE: This photograph has multiple scan lines, or banding, that run from north to south and are not natural features. The lines are errors created during the scan of the aerial film.

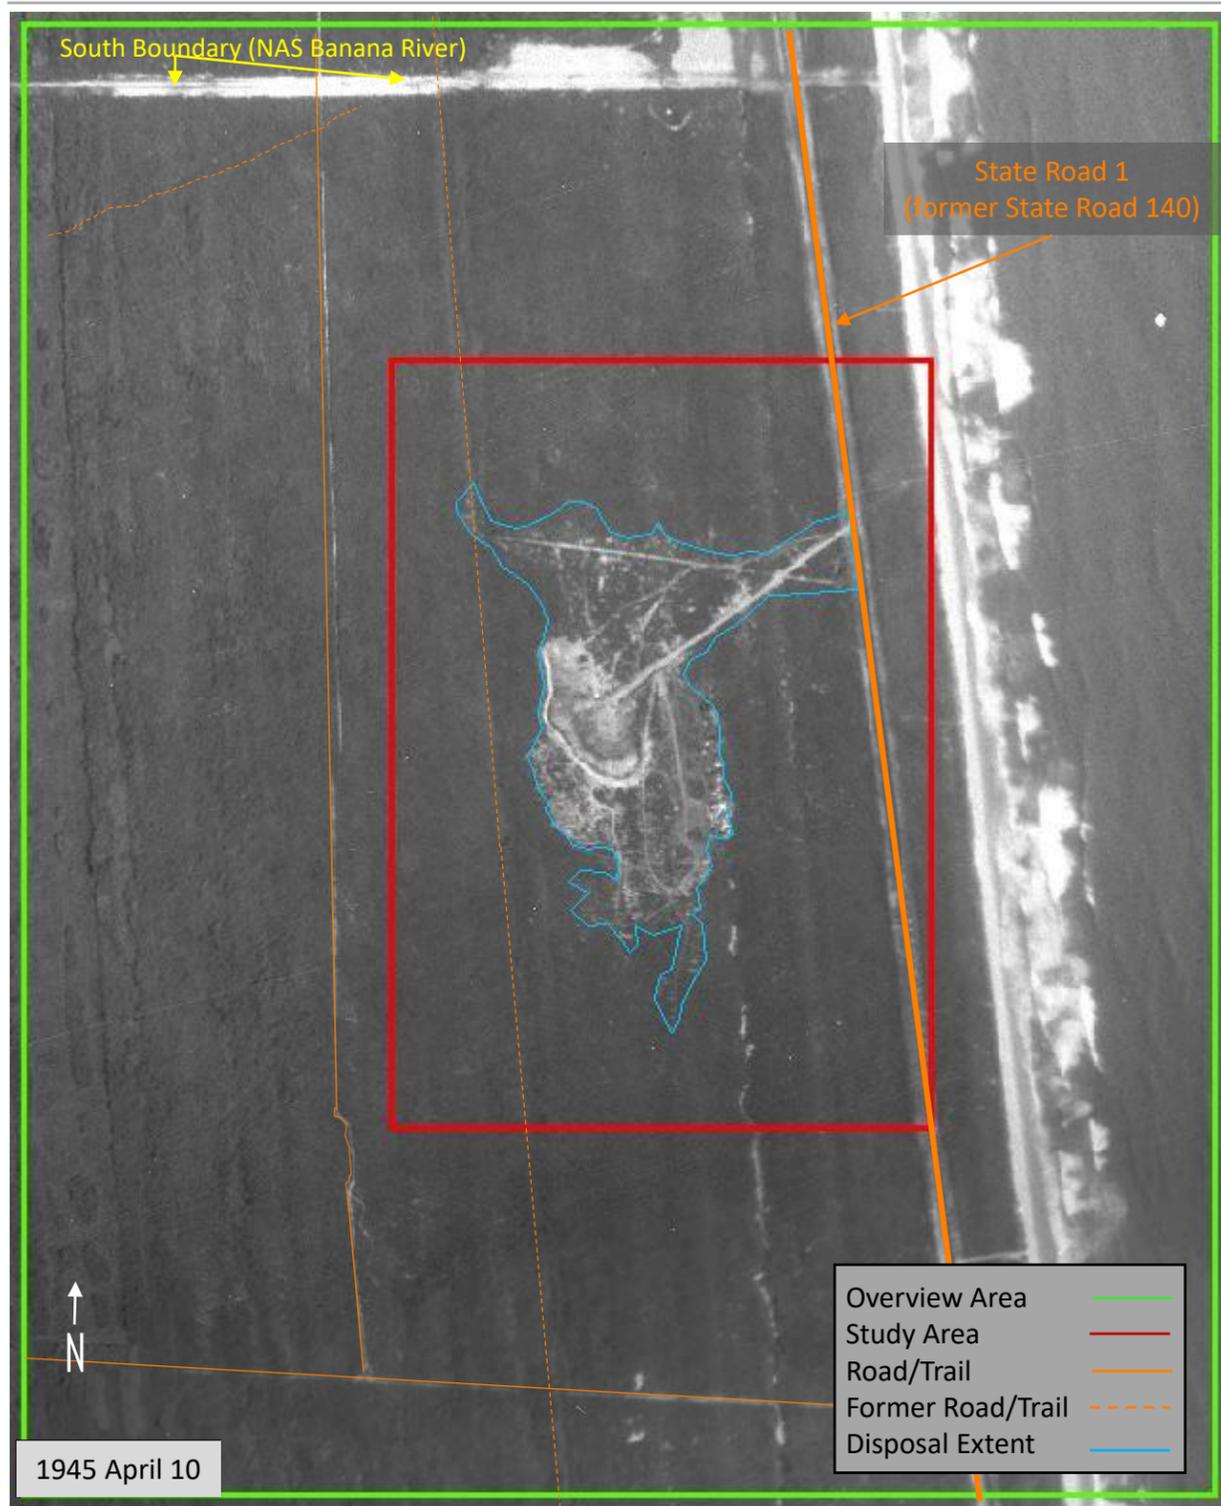
PHOTOGRAPHIC ANALYSIS – 10 April 1945

This 10 April 1945 overview shows the extent of disposal activity. The road/trail west of the off-base disposal area appears to have limited use or is relegated to a walking path.

NAS Banana River was a designated salvage point for scrap material. The amount sent to this station increased just after the war ended due to other stations closing. Disposal and burn areas are mentioned numerous times within historical documents, but locations are not specified.

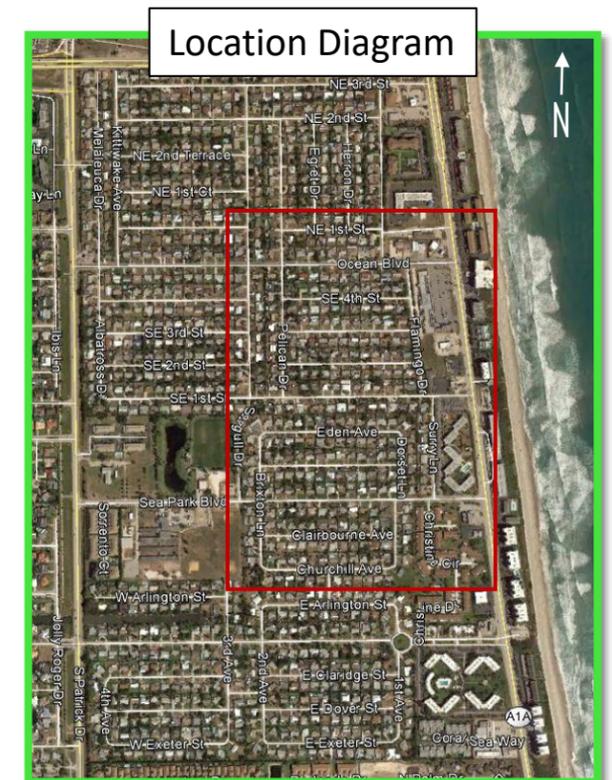
This 10 October 1945 overview shows the extent of disposal activity. The former road/trail immediately west of the off-base disposal area appears subject to erosion.
