PRELIMINARY ASSESSMENT

Naval Air Station Banana River Off-Base Disposal Area

FUDS Property Number – I04FL0027

FINAL REPORT

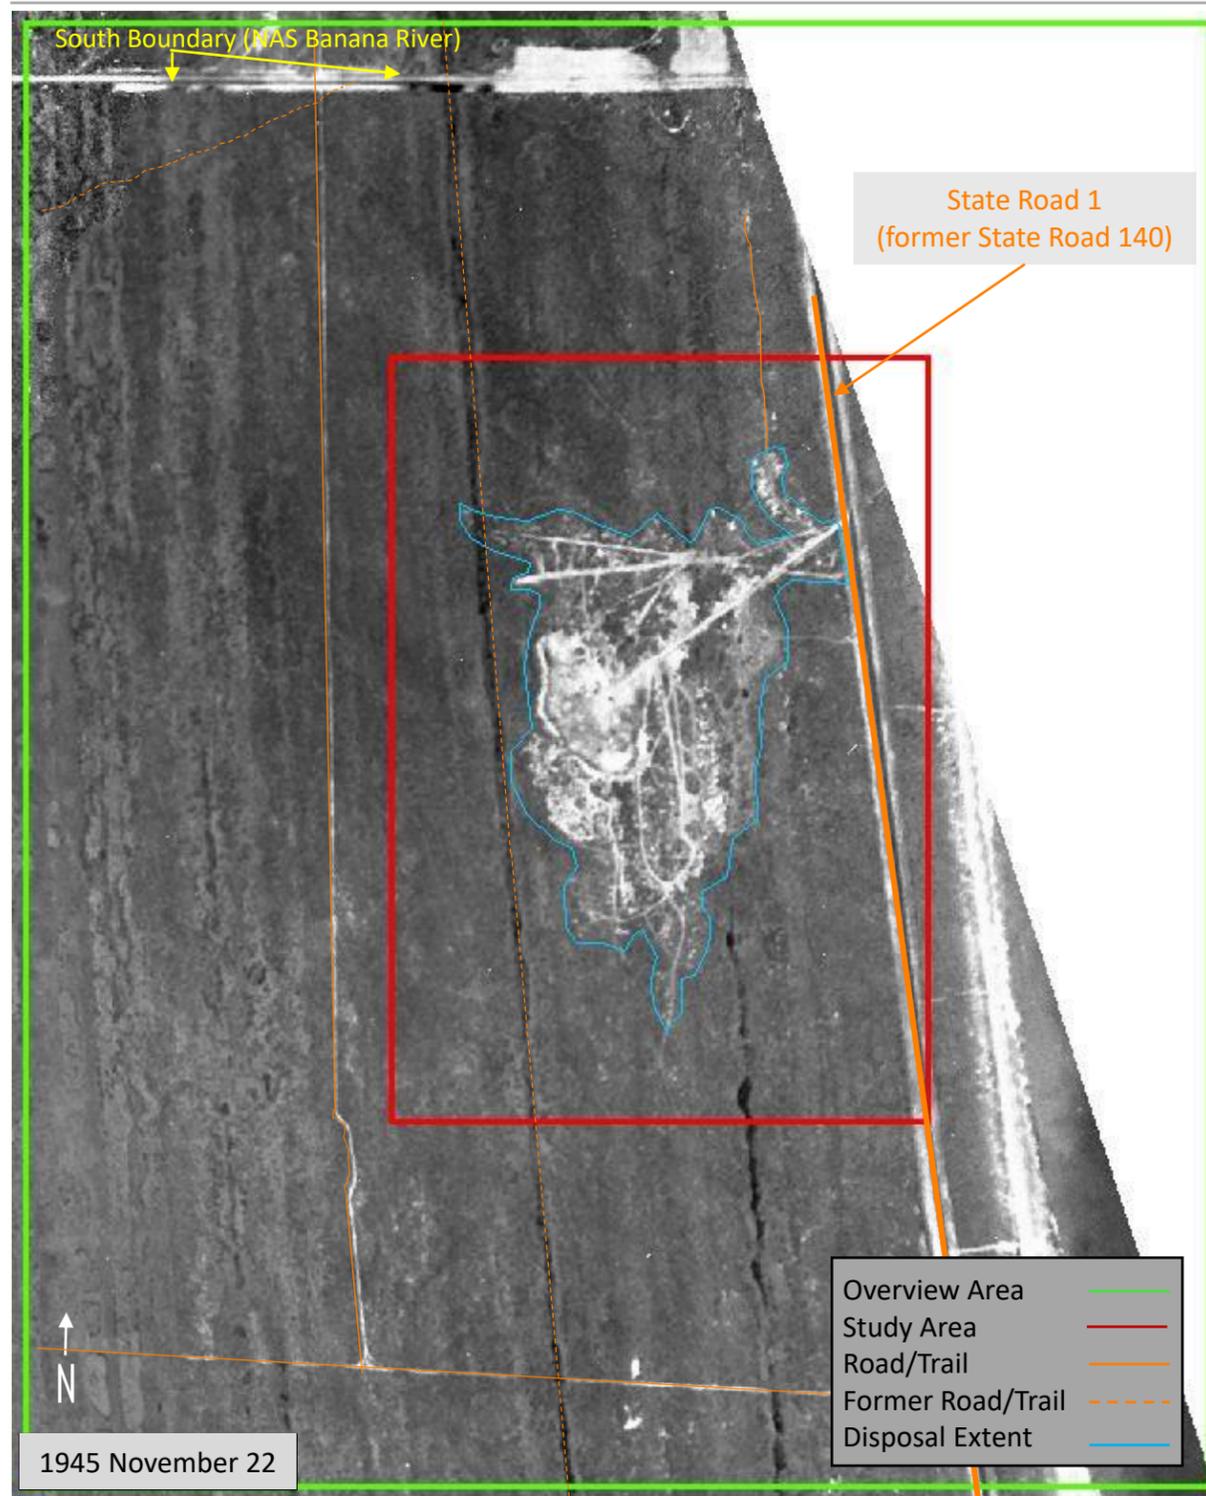
PHOTOGRAPHIC ANALYSIS – 22 November 1945

This 22 November 1945 overview shows the extent of disposal activity. Little change is observed between 10 October and 22 November 1945.

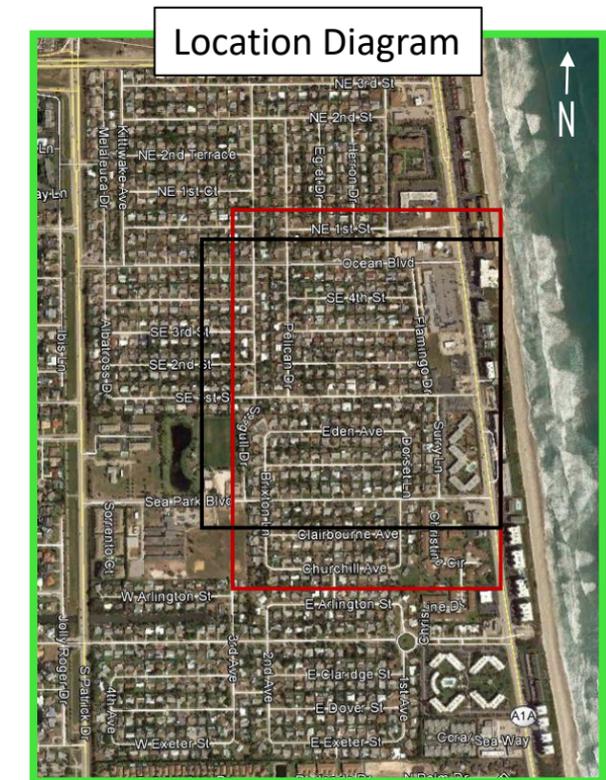
This 22 November 1945 subset from the larger overview on the previous page shows detailed activity of the main off-base disposal area. Roads leading north and south of the site are still active, along with an increase in the number of mounds of material around those access roads.

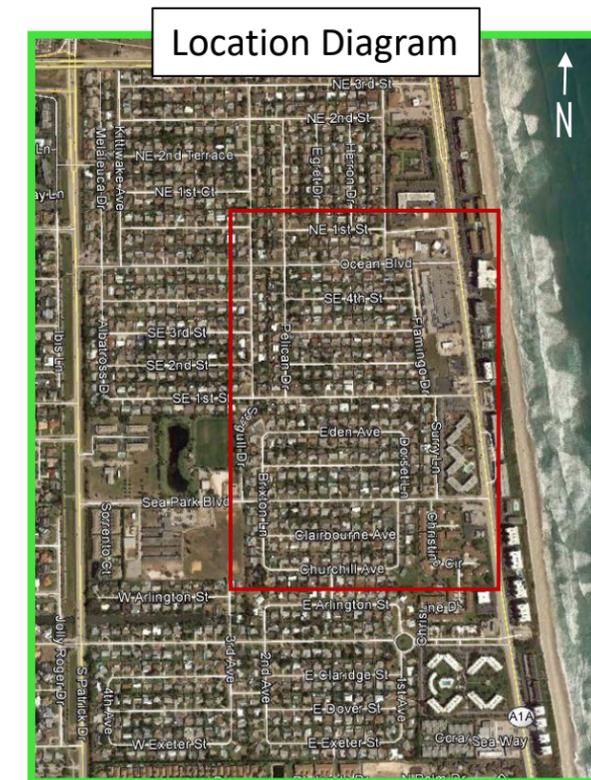
This 17 June 1947 overview shows the extent of disposal activity. There are new trail additions leading away from the existing road/trail west of the disposal area and roads extending north and south from the off-base disposal area.

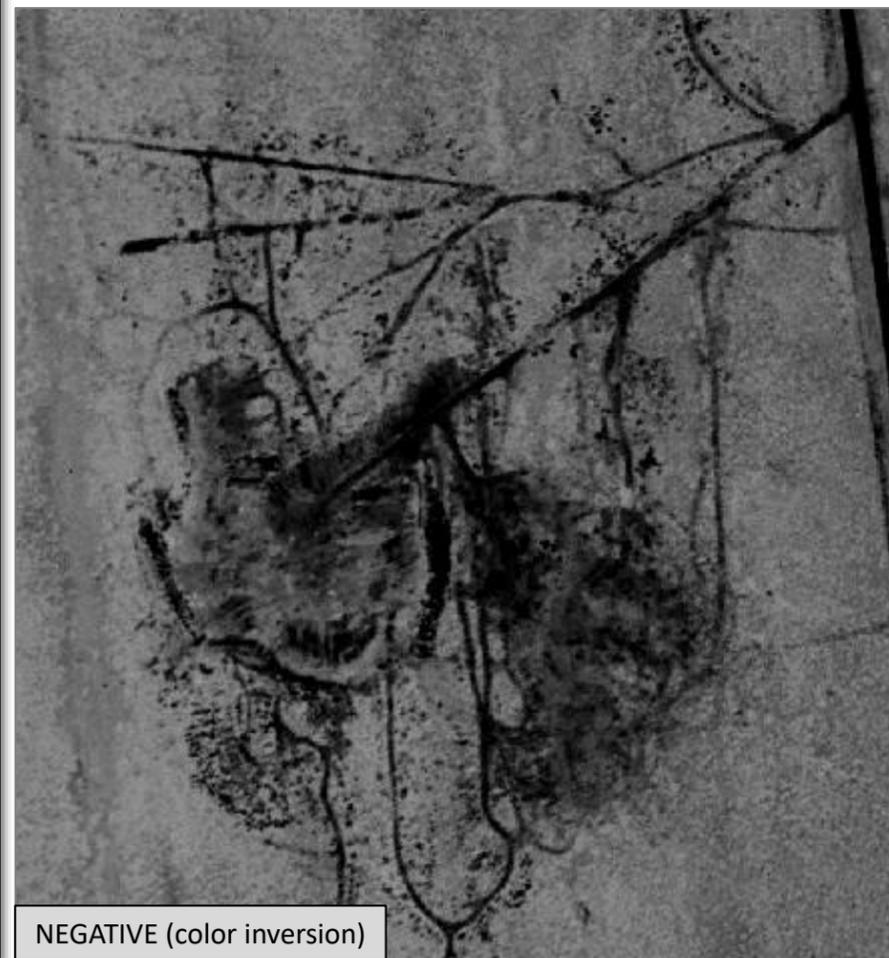
This 17 June 1947 subset from the larger overview on the previous page shows detailed activity of the main off-base disposal area. There are no significant changes between the area visible in February and June 1947.

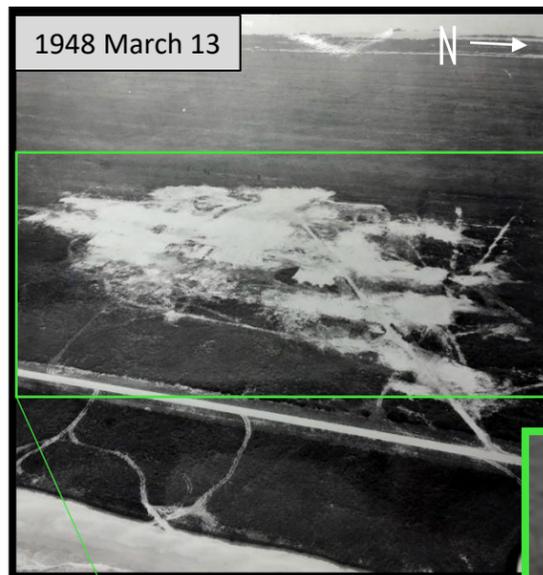
NO. JACK 47482 DATE 3-13-48
N. A. S. JACKSONVILLE, FLORIDA
SUBJECT Dump Area Oblique
west 800'
MADE FOR Com 7

This oblique photograph taken on 13 March 1948 shows the former off-base disposal area mostly leveled by fill and/or grading.

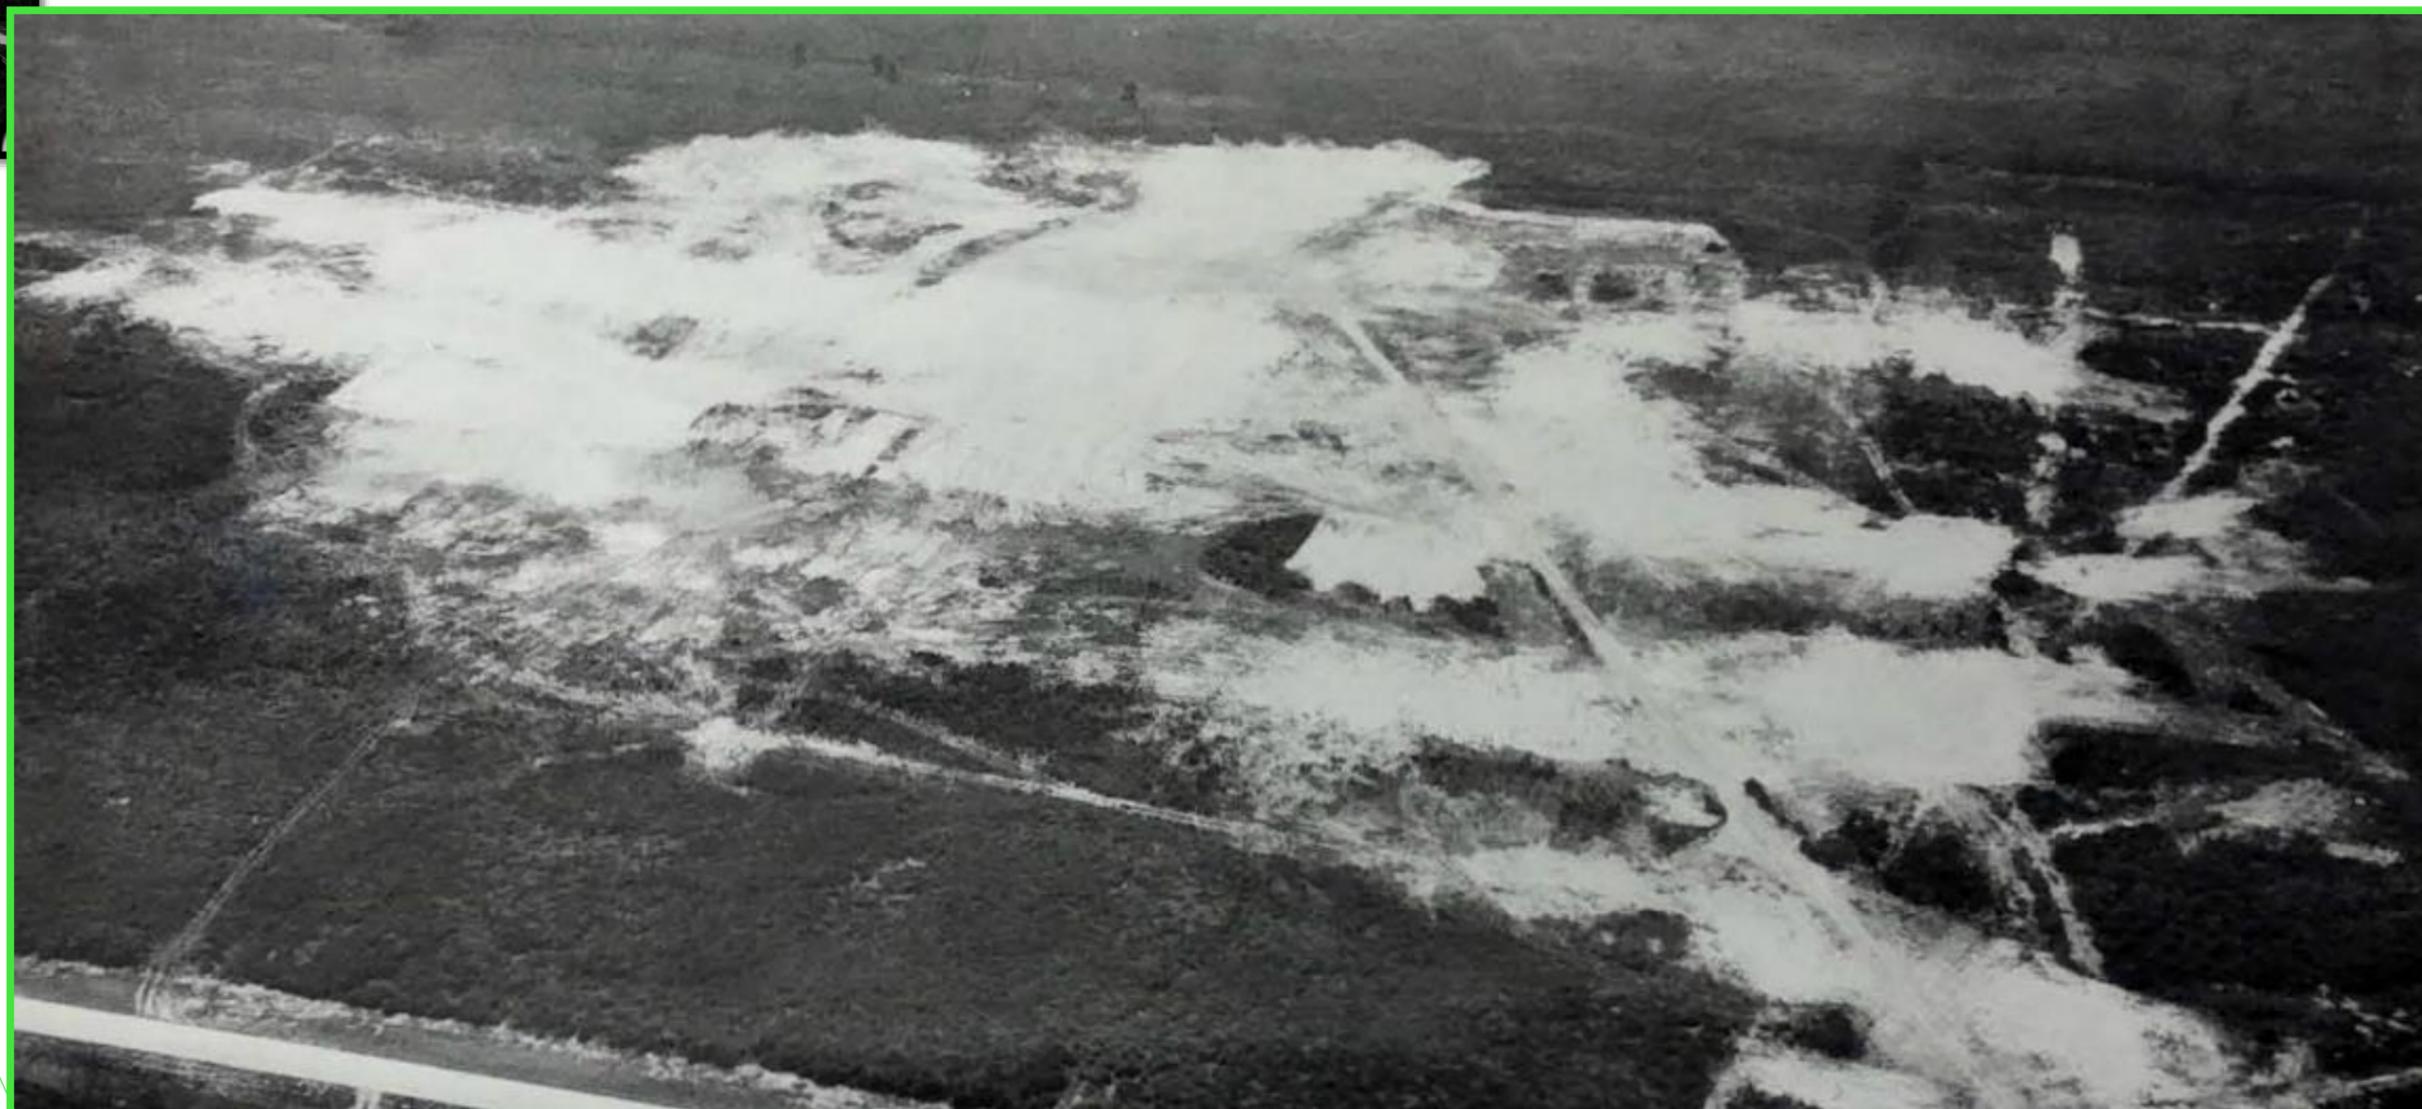
NO. JACK 47482 DATE 3-13-48
N. A. S. JACKSONVILLE, FLORIDA
SUBJECT Dump Area Oblique
West 800'
MADE FOR Com 7

This oblique photograph taken on 13 March 1948 shows another view of the former off-base disposal area after restoration efforts.

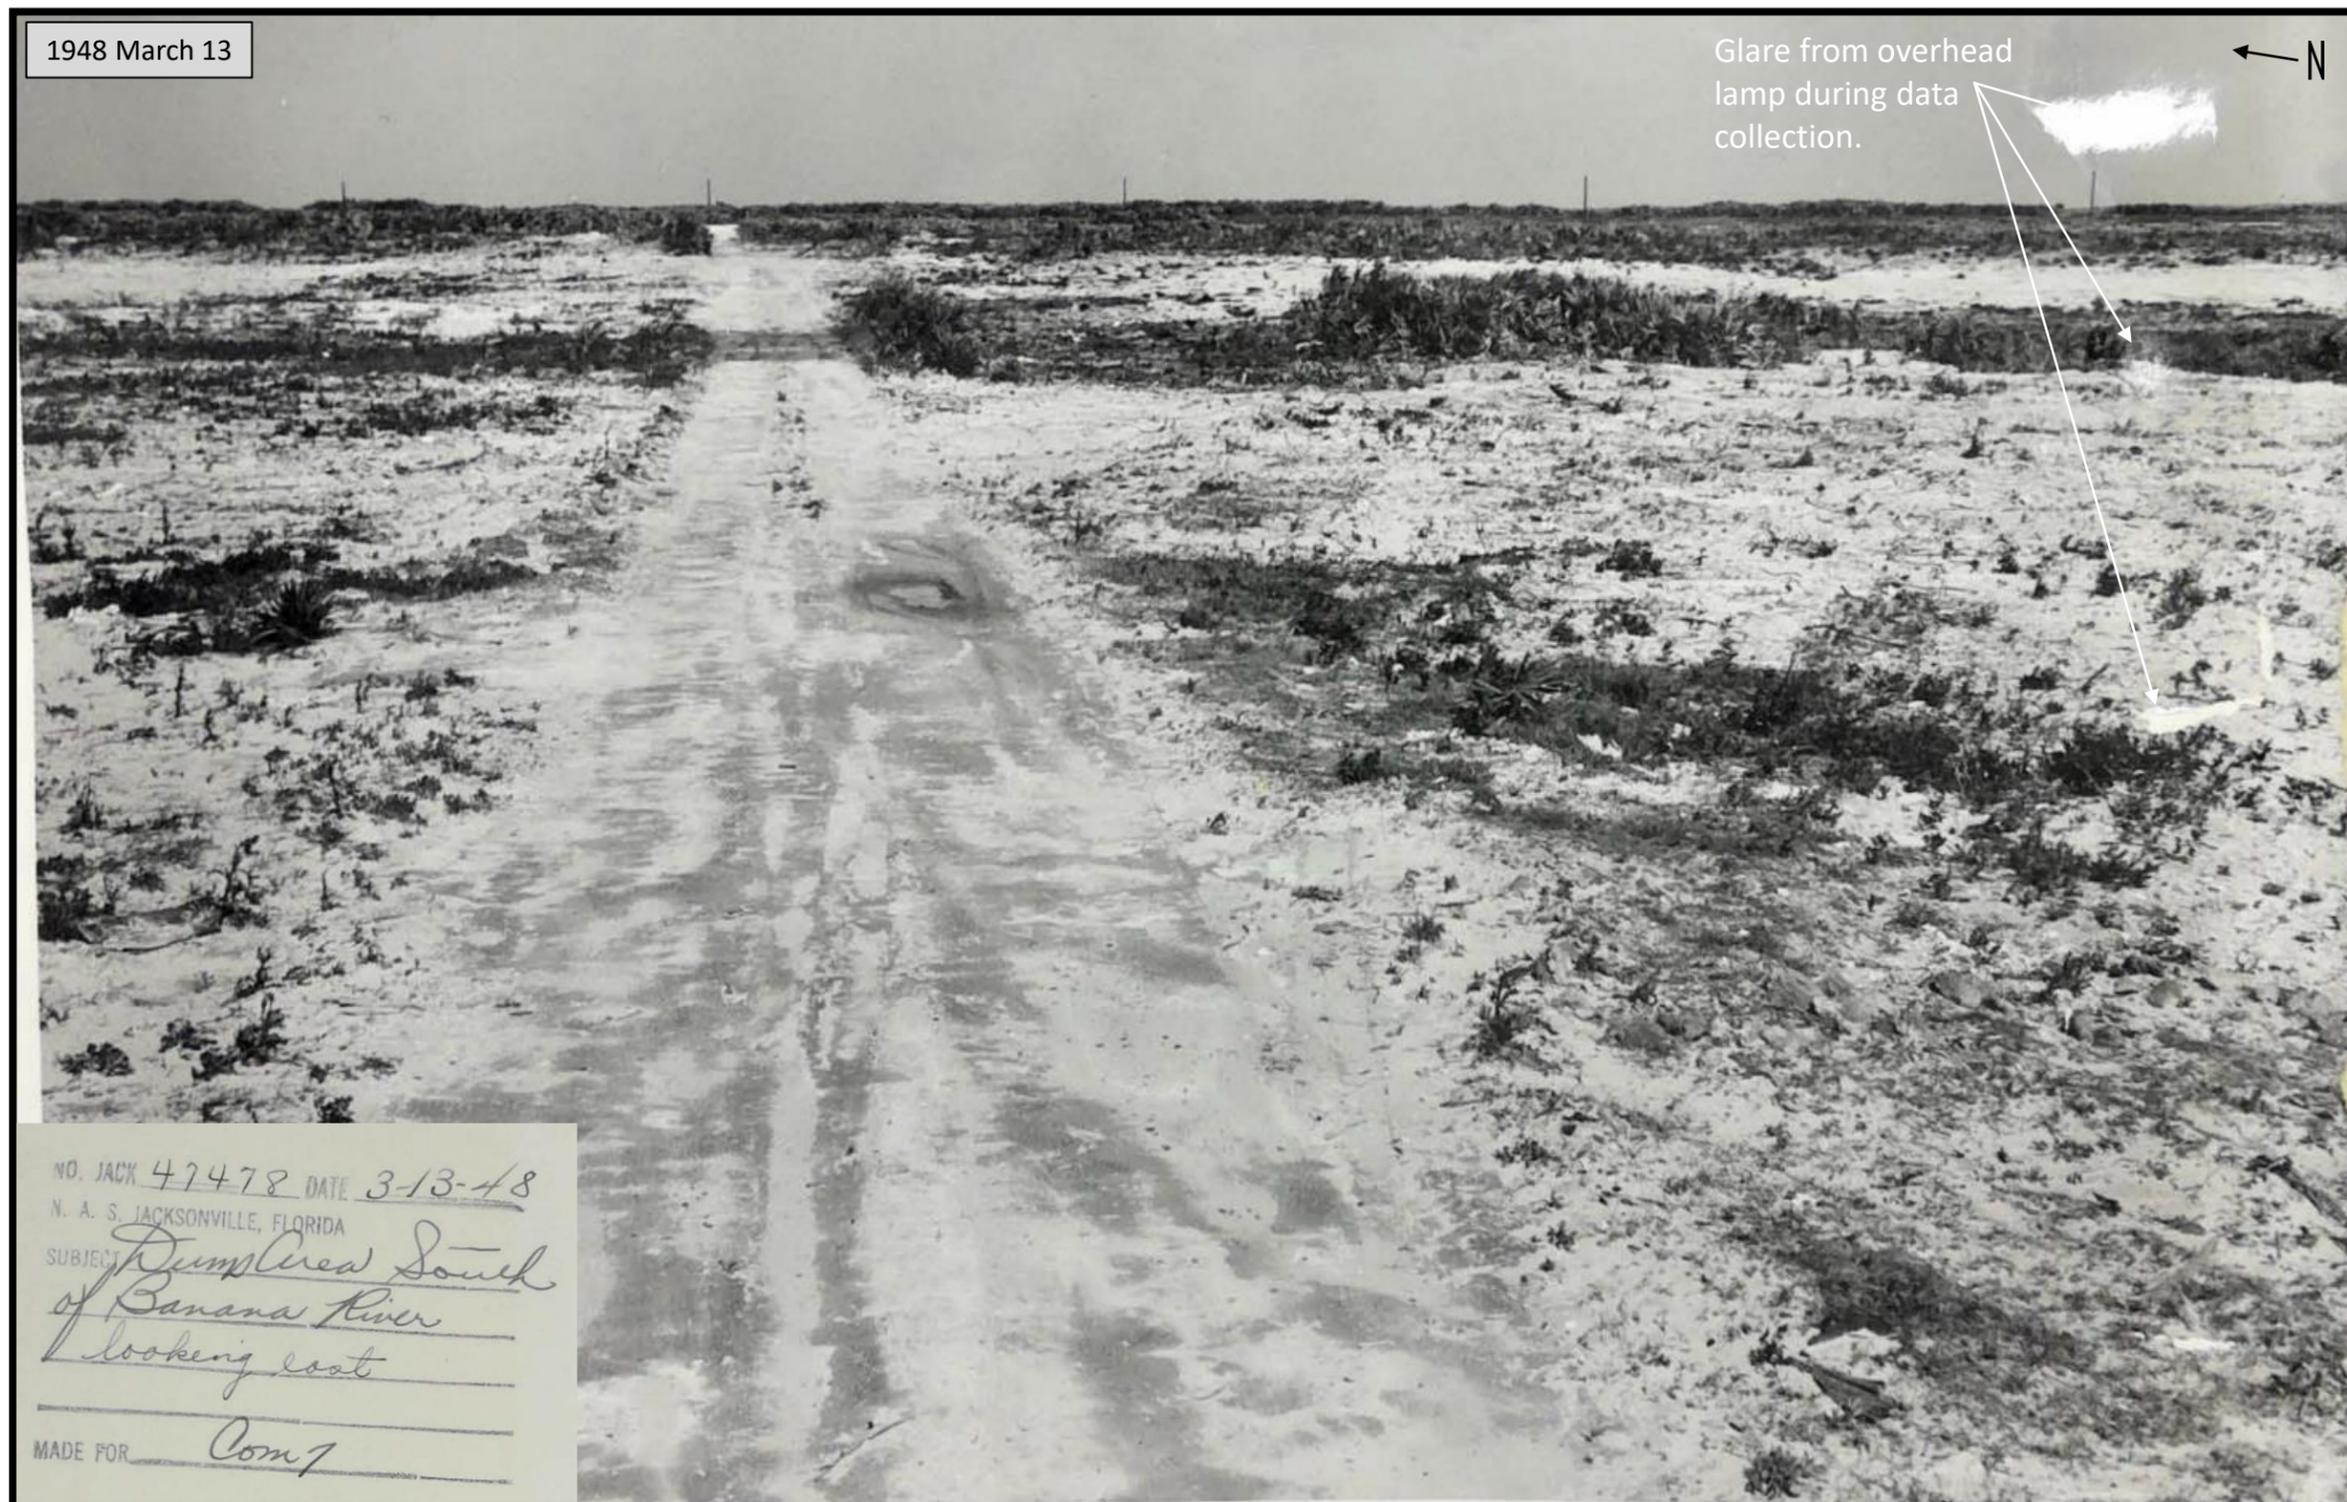
PHOTOGRAPHIC ANALYSIS – 13 March 1948

This ground photograph, taken 13 March 1948, shows a view from within the former off-base disposal area on the main access road looking east toward the coastline.

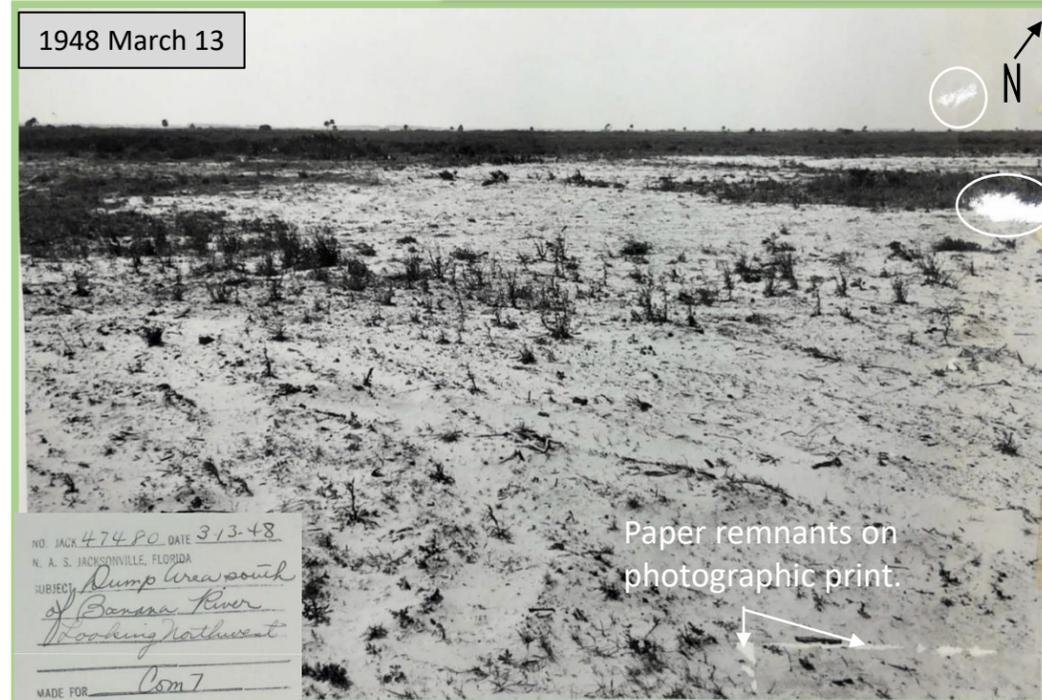
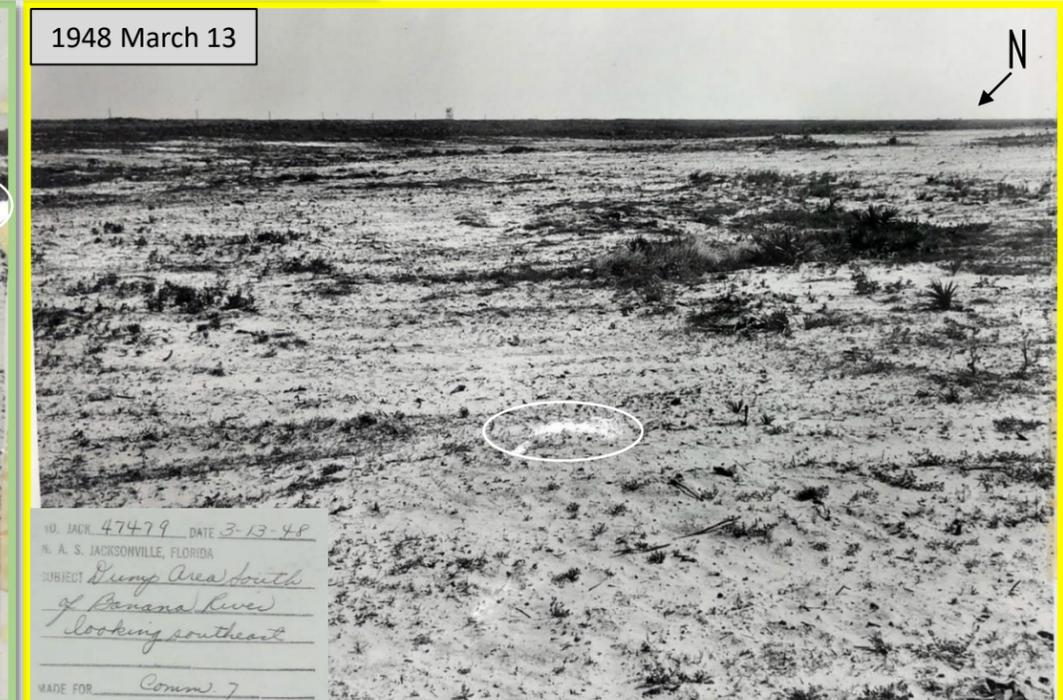
These ground photographs, taken 13 March 1948, show the former off-base disposal area after restoration efforts.

Note: Glare spots are visible on all of these photos (annotated in white). The glare came from an overhead lamp during data collection.

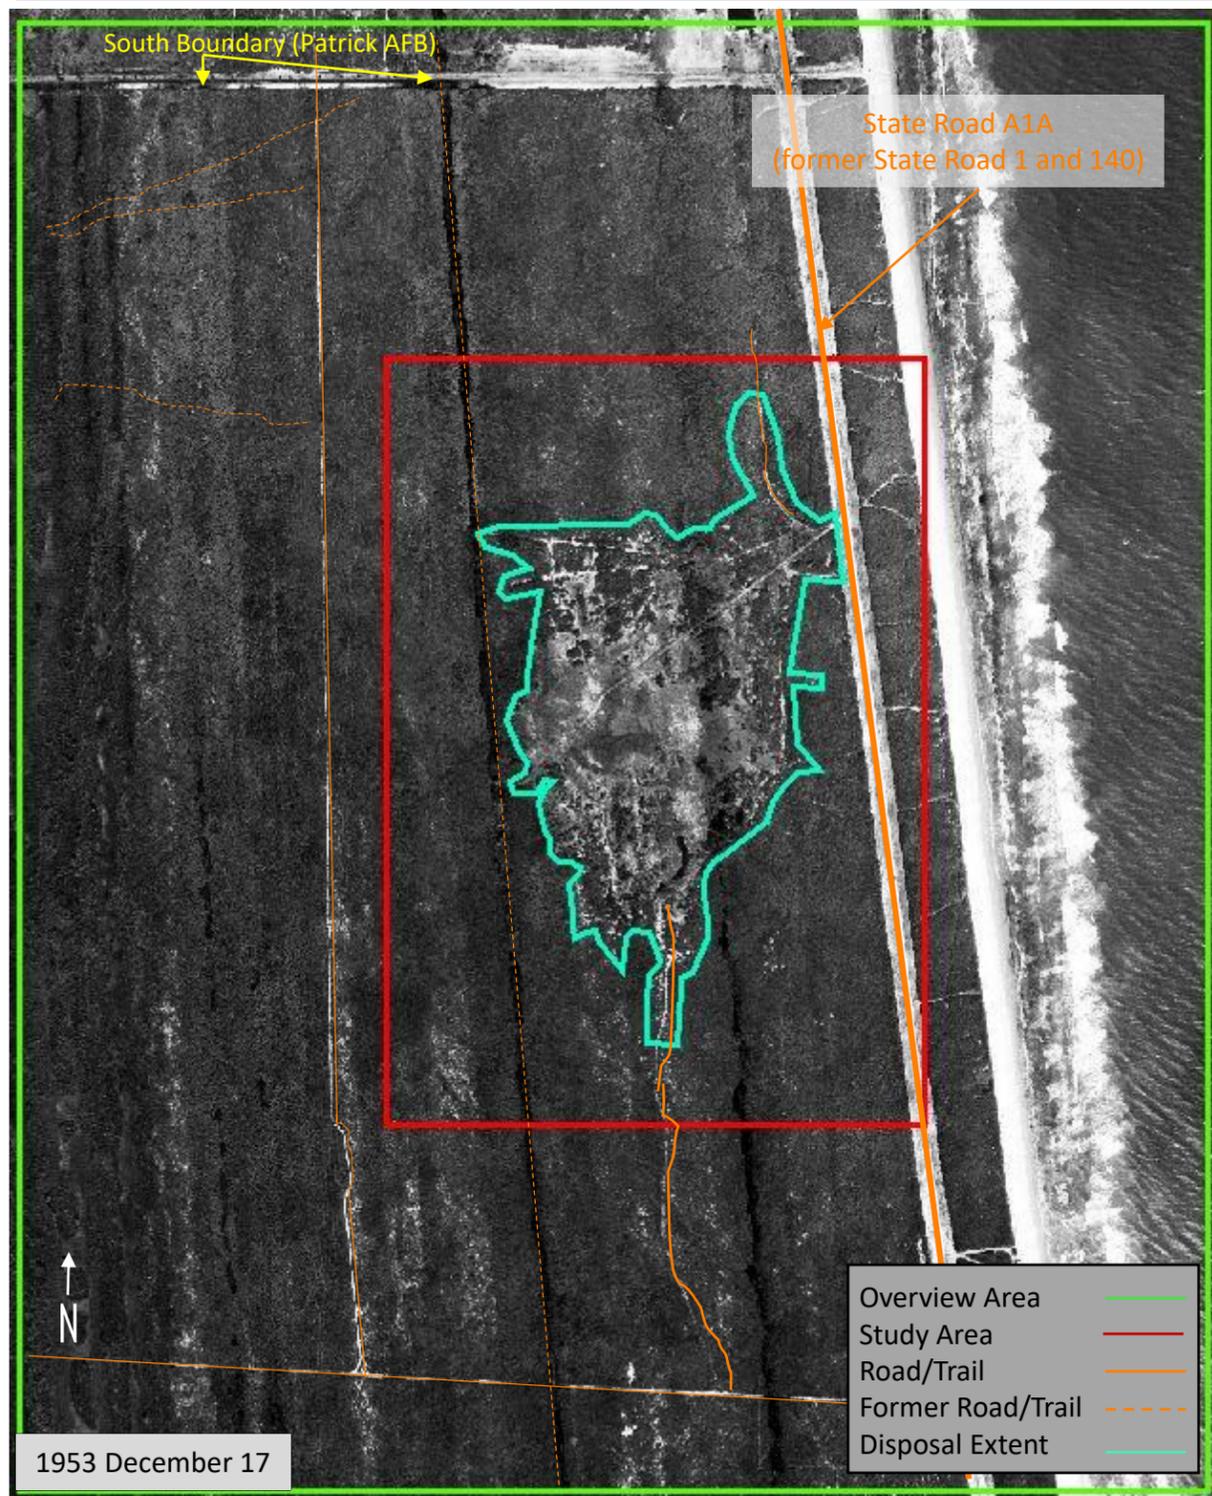
PHOTOGRAPHIC ANALYSIS – 17 December 1953

This 17 December 1953 overview shows the extent of activity within the former off-base disposal area since 02 April 1951. Continued return of vegetation is observed over much of the site, but the access road has been extended and remains active. The entry point to the south is also active. The former road/trail immediately west of the former disposal area, what was a linear depression between sand dunes, and several smaller areas within the former disposal area appear flooded, likely due to rain as the other linear depressions (or riles between sand dunes) are also filled with water.

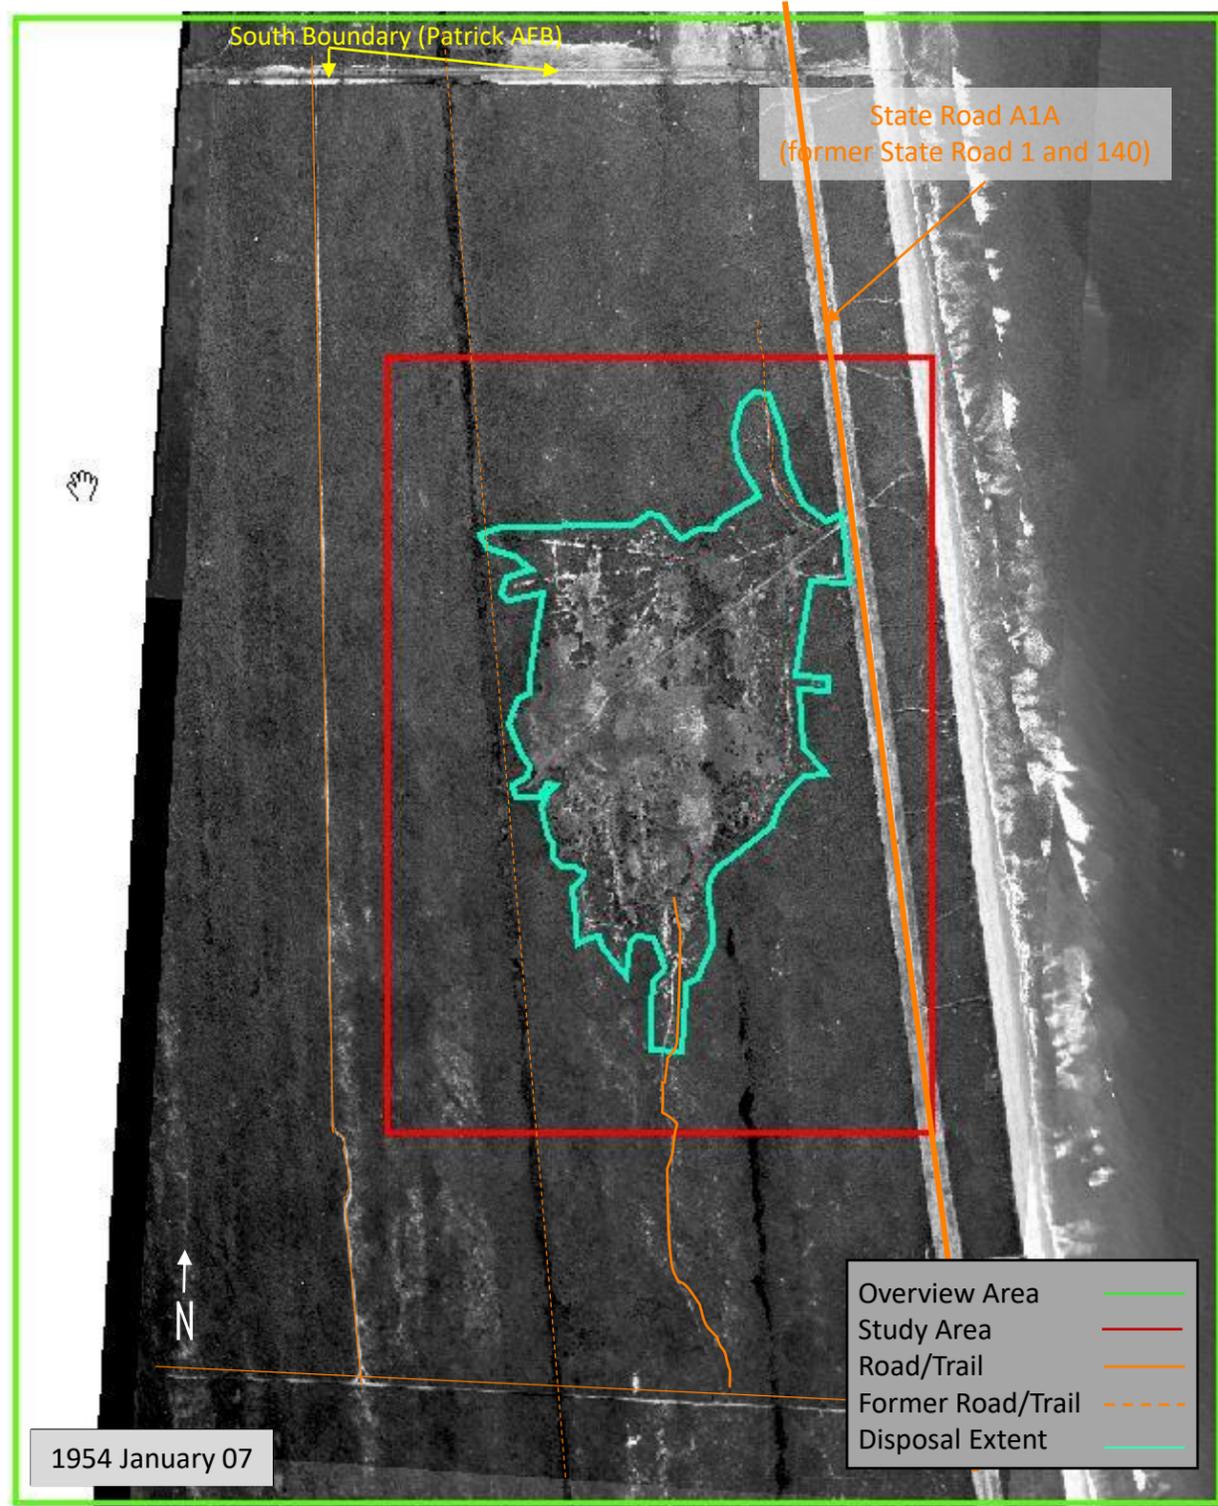
PHOTOGRAPHIC ANALYSIS – 07 January 1954

This 07 January 1954 overview shows the extent of activity within the former off-base disposal area since 17 December 1953 (three weeks prior). Little change is observed during this timeframe.

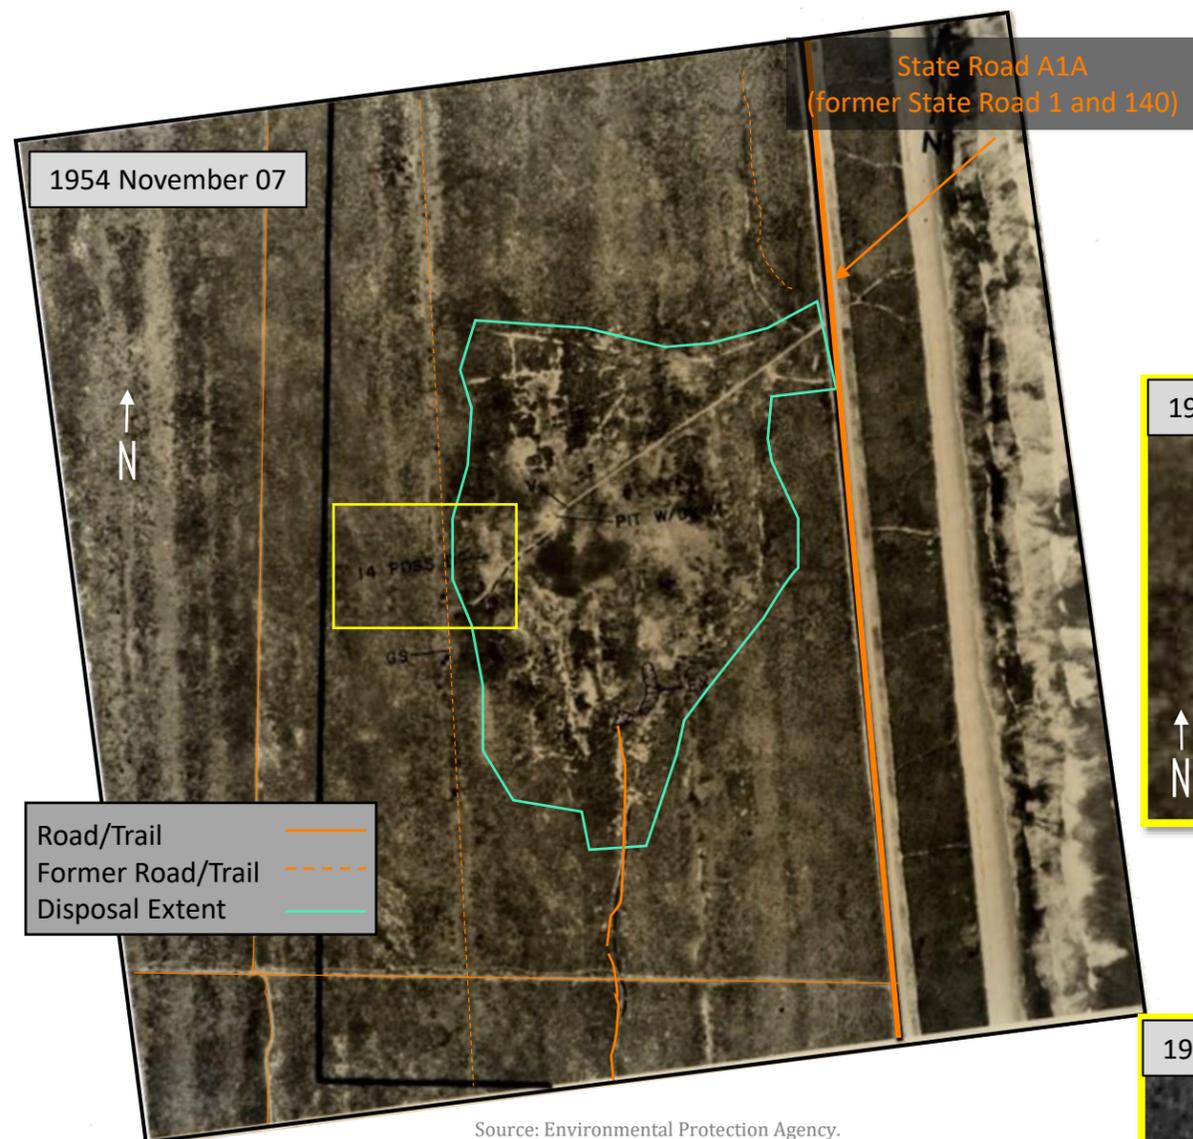
PHOTOGRAPHIC ANALYSIS – 07 November 1954

Note: This photo was not rectified for this report, so orientation is approximate.

A site analysis was performed by the Environmental Protection Agency in 1991 and revealed ‘possible’ drums based on the 07 November 1954 photograph shown here. This 1954 photograph was unavailable in its original form at the time of this report, and the resulting spatial resolution was not conducive to confirming particular features, therefore drum disposal could not be confirmed. This area is shown here in January 1954 and December 1953, to include the scale of a traditional 55 gallon metal drum (23 inches wide by 34.5 inches tall).

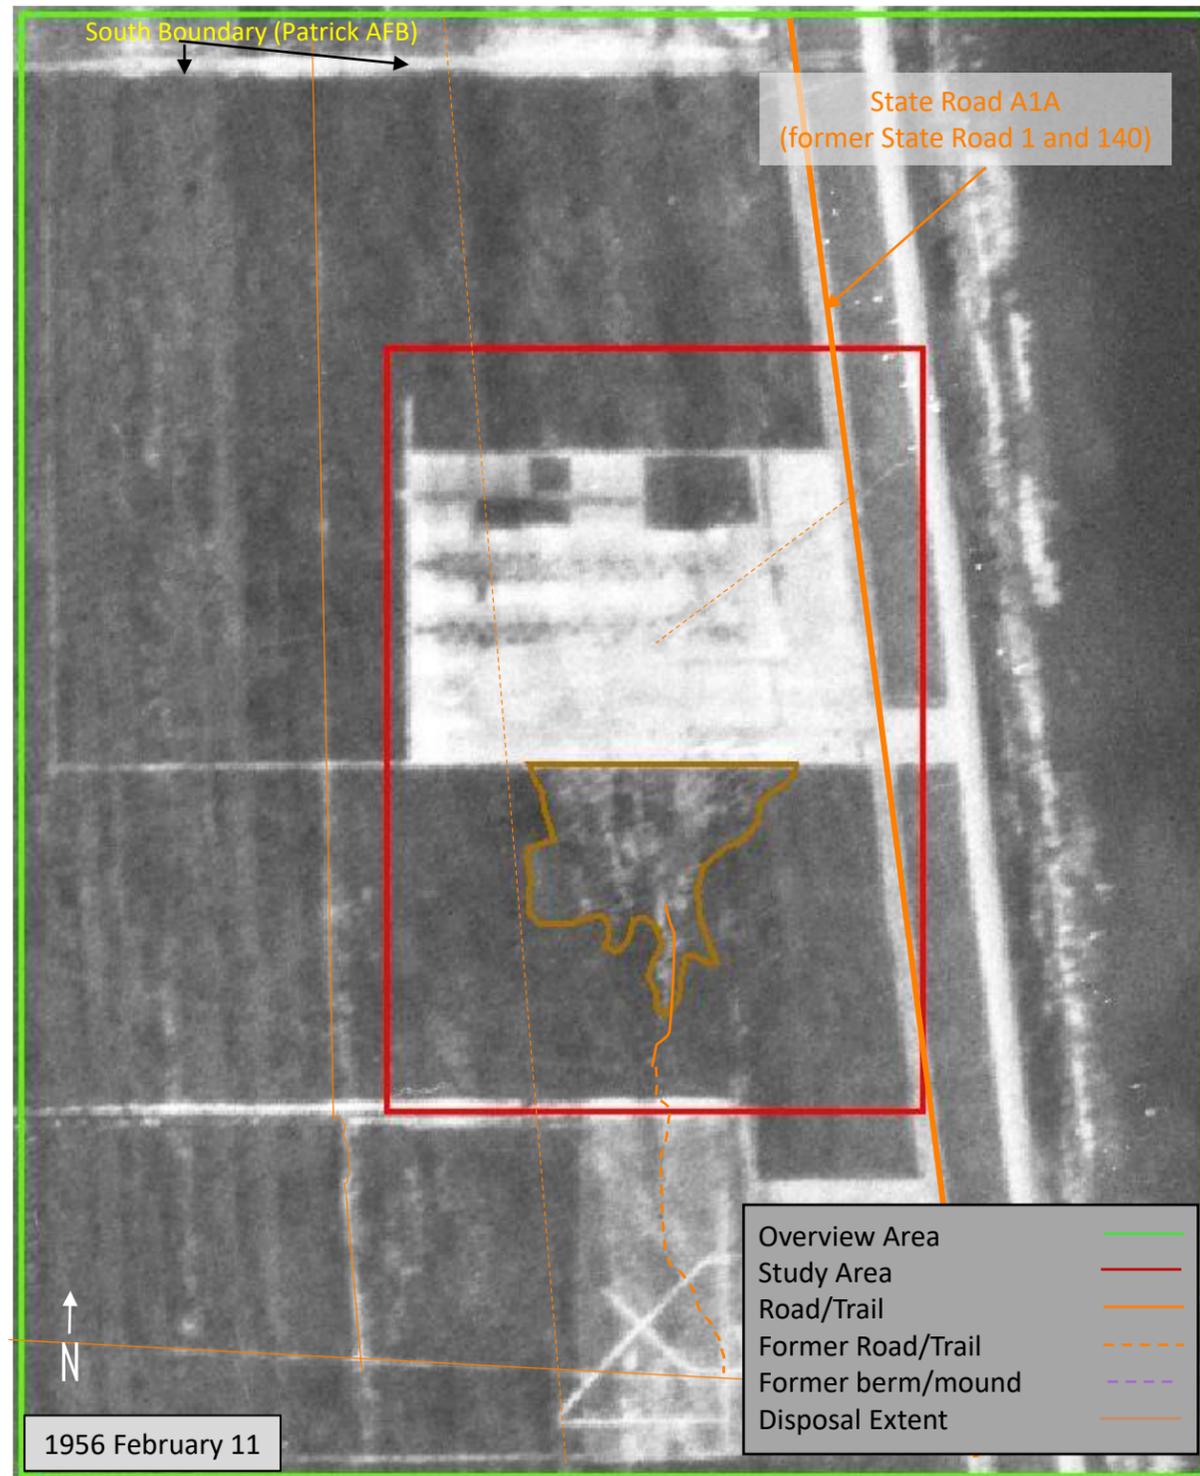
PHOTOGRAPHIC ANALYSIS – 11 February 1956

This 11 February 1956 photograph shows the extent of activity within the former off-base disposal area. The construction of the South Patrick Shores development has begun and has been graded with the potential addition of fill material. New roads connecting to the development as well as tracks going through the southern half of the former disposal area are visible. The subset from the larger image shows the former tracks, roads (one that is still visible in this image), and larger mounds from previous years.

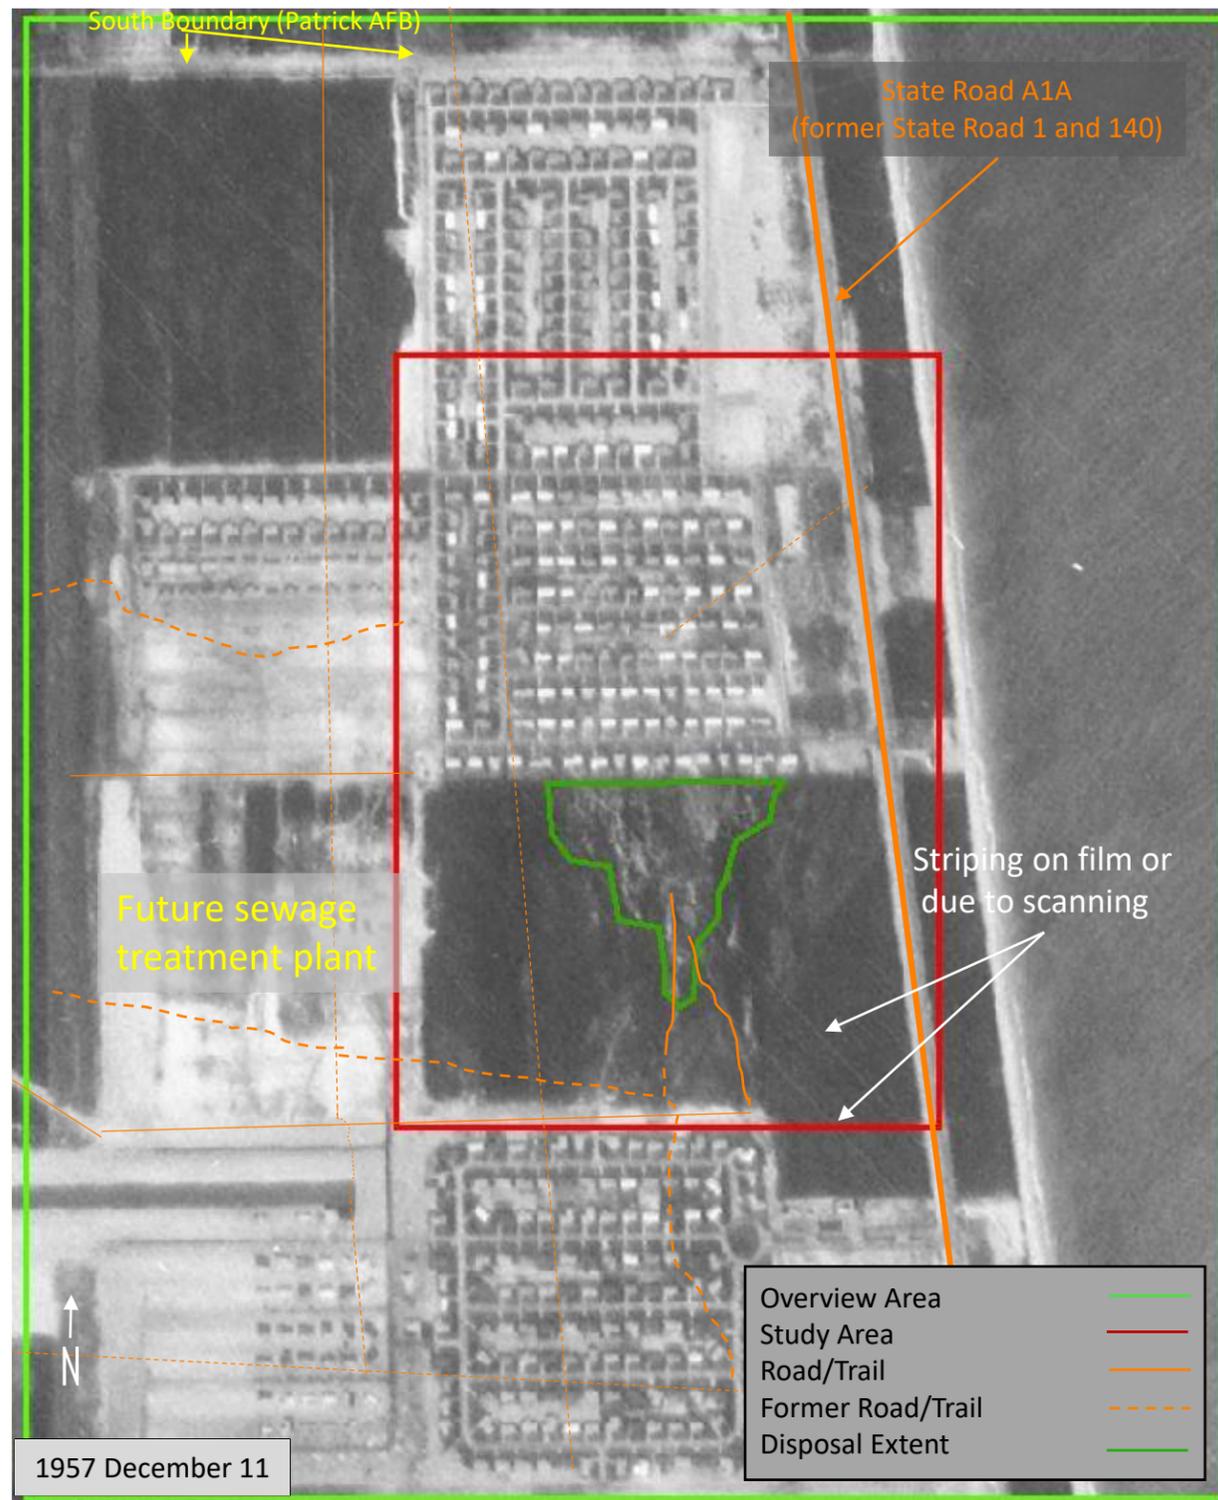
PHOTOGRAPHIC ANALYSIS – 11 December 1957

This 11 December 1957 photograph shows the extent of activity within the former off-base disposal area. The construction of the South Patrick Shores development continues along with associated utilities (sewage treatment plant). Additional development is observed north, west and further south of the former disposal area (and beyond the extent of earlier disposal operations). The southern part of the former disposal area is still visible, but appears inactive. The spatial resolution of this photograph is considered poor.
