PRELIMINARY ASSESSMENT

Naval Air Station Banana River Off-Base Disposal Area

FUDS Property Number – I04FL0027

FINAL REPORT

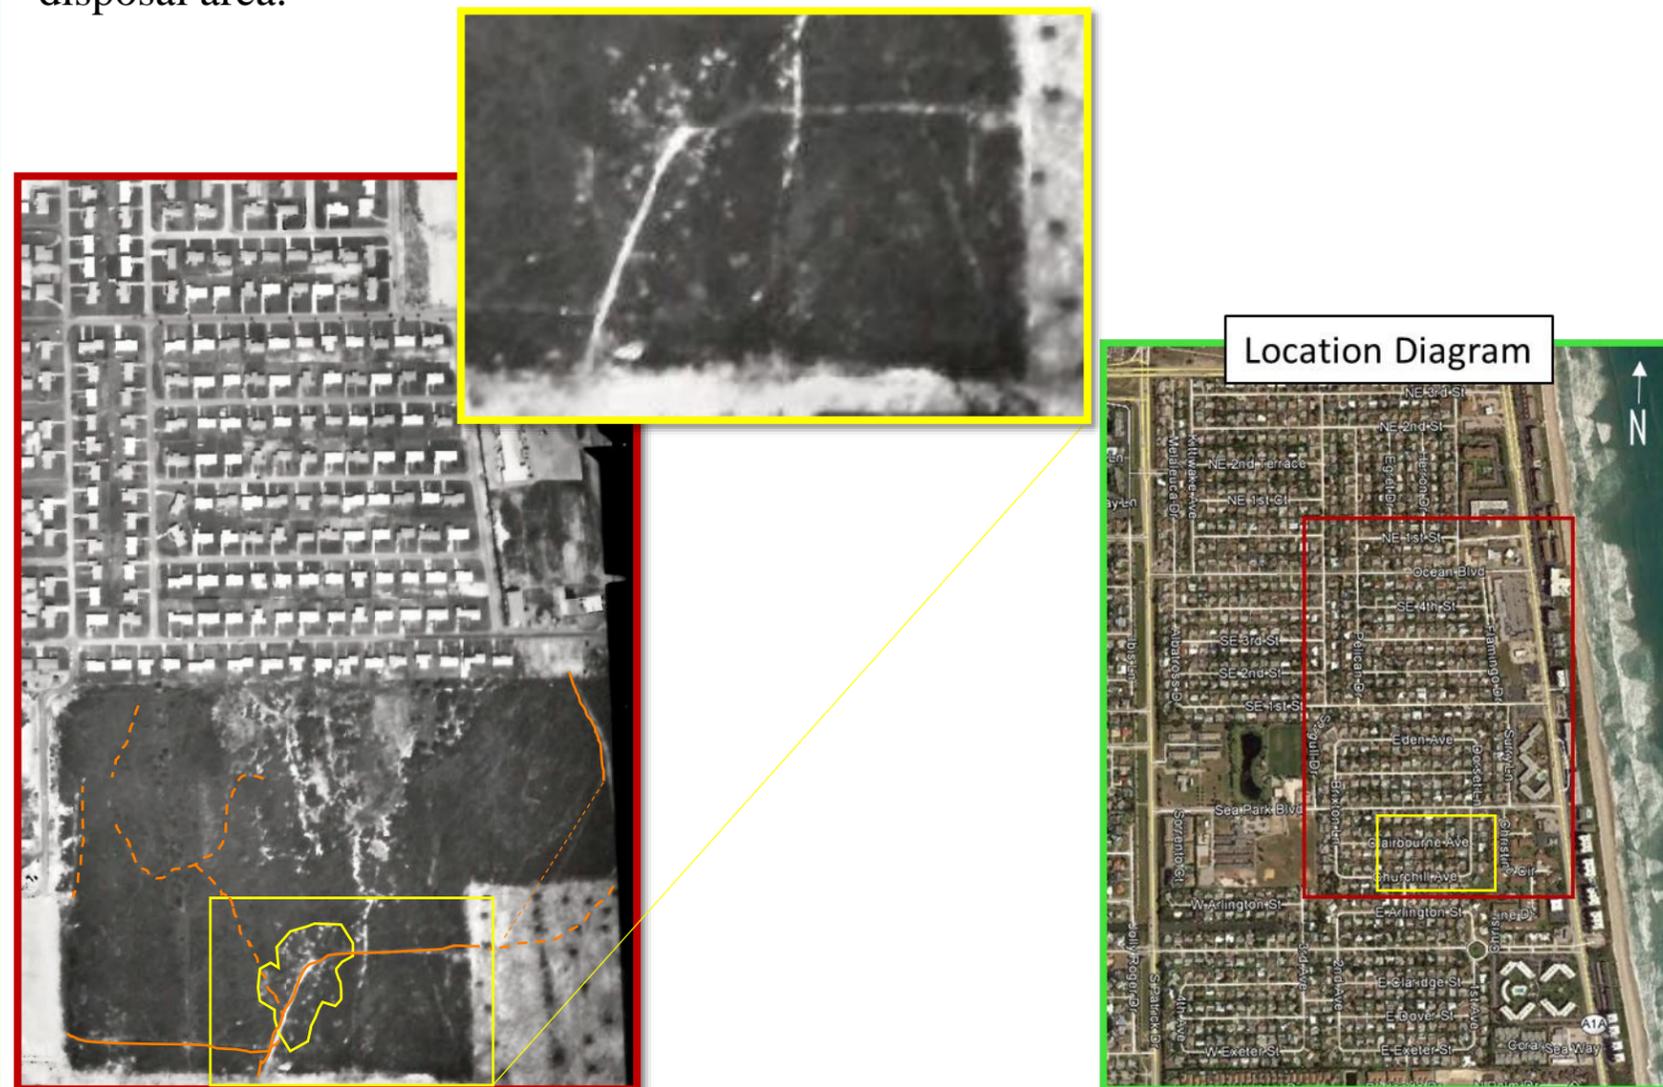
This 03 November 1958 photograph shows the extent of activity within the former off-base disposal area since 23 April 1958. Continued development of the South Patrick Shores area, sewage treatment plant and development extending outside of the study area is observed. The southern half of the former off-base disposal area is still visible and appears inactive. No new activity is visible in the area of recent debris disposal (see yellow inset box). Development is starting southeast of the southern half of the former disposal area.

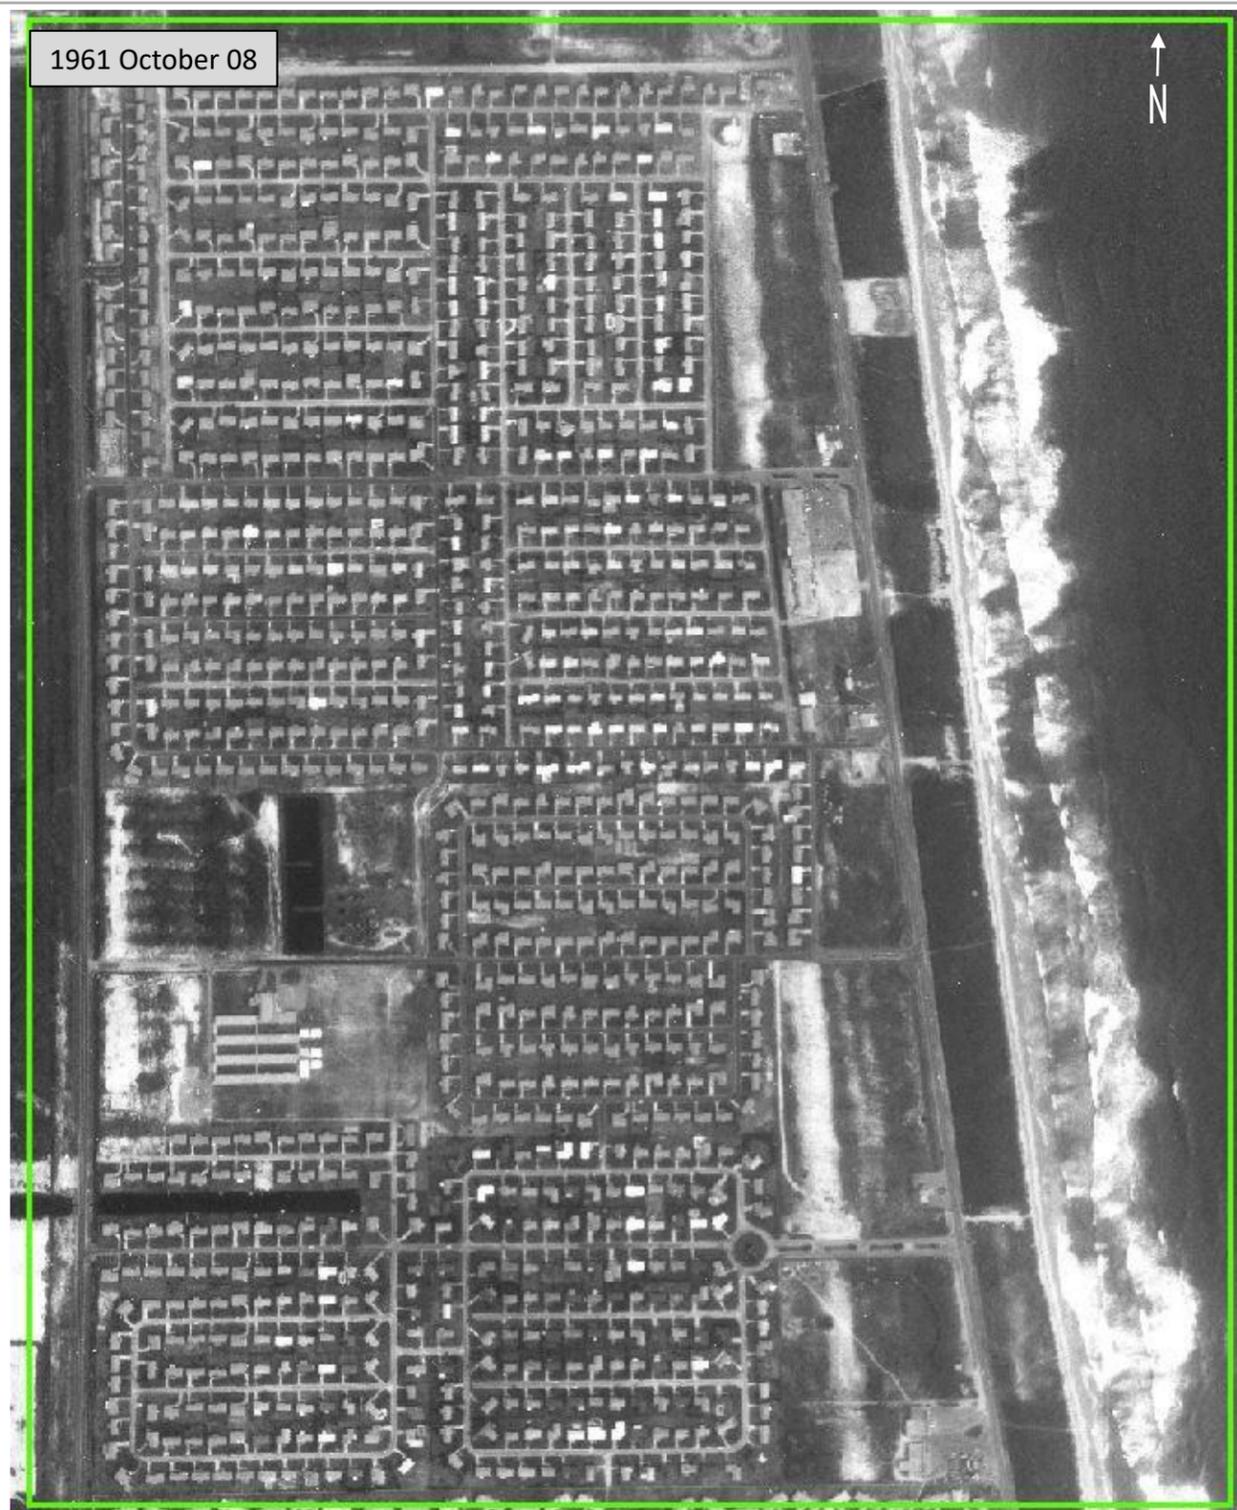
PHOTOGRAPHIC ANALYSIS – Overview 1961

This 08 October 1961 photograph shows an overview of the former off-base disposal area. The disposal area is no longer visible. Residential and commercial properties make up the land use for the entire former off-base disposal area.

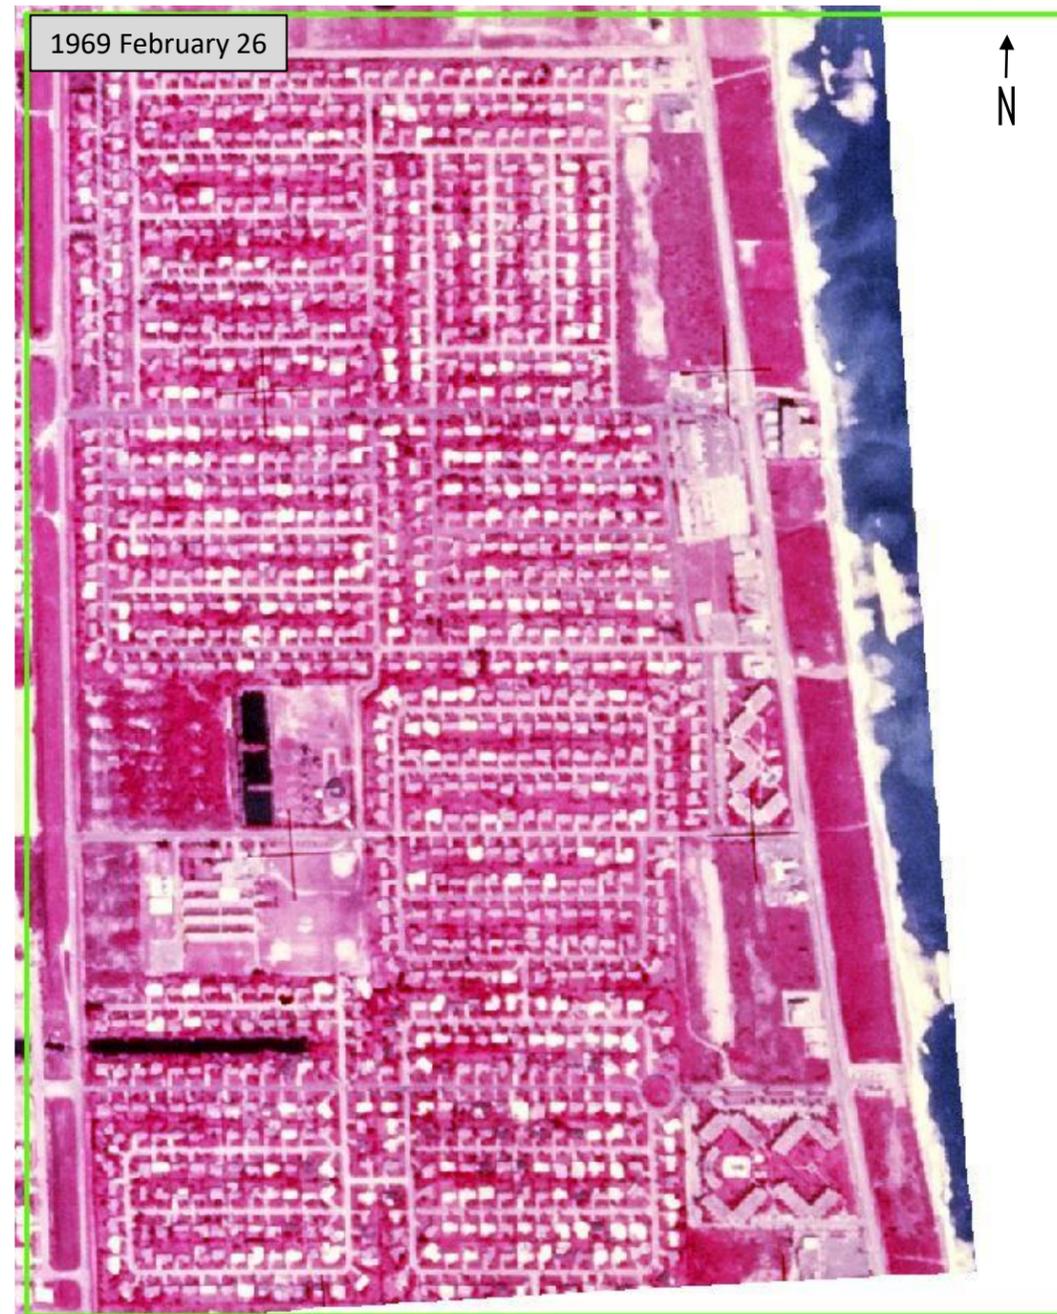
Note: This is a Color-infrared (CIR) aerial photograph (false color photography). The red tone is usually associated with healthy vegetation.
