APPENDIX I
JURISDICTIONAL RESOURCE IMPACT DETAILS

SELECT ENGINEERING DETAILS

JAMES RIVER WATER PROJECT
 JAMES RIVER WATER AUTHORITY - FLUVANNA COUNTY, VIRGINIA
SELECT ENGINEERING DETAILS - IMPACTS 1 AND 2

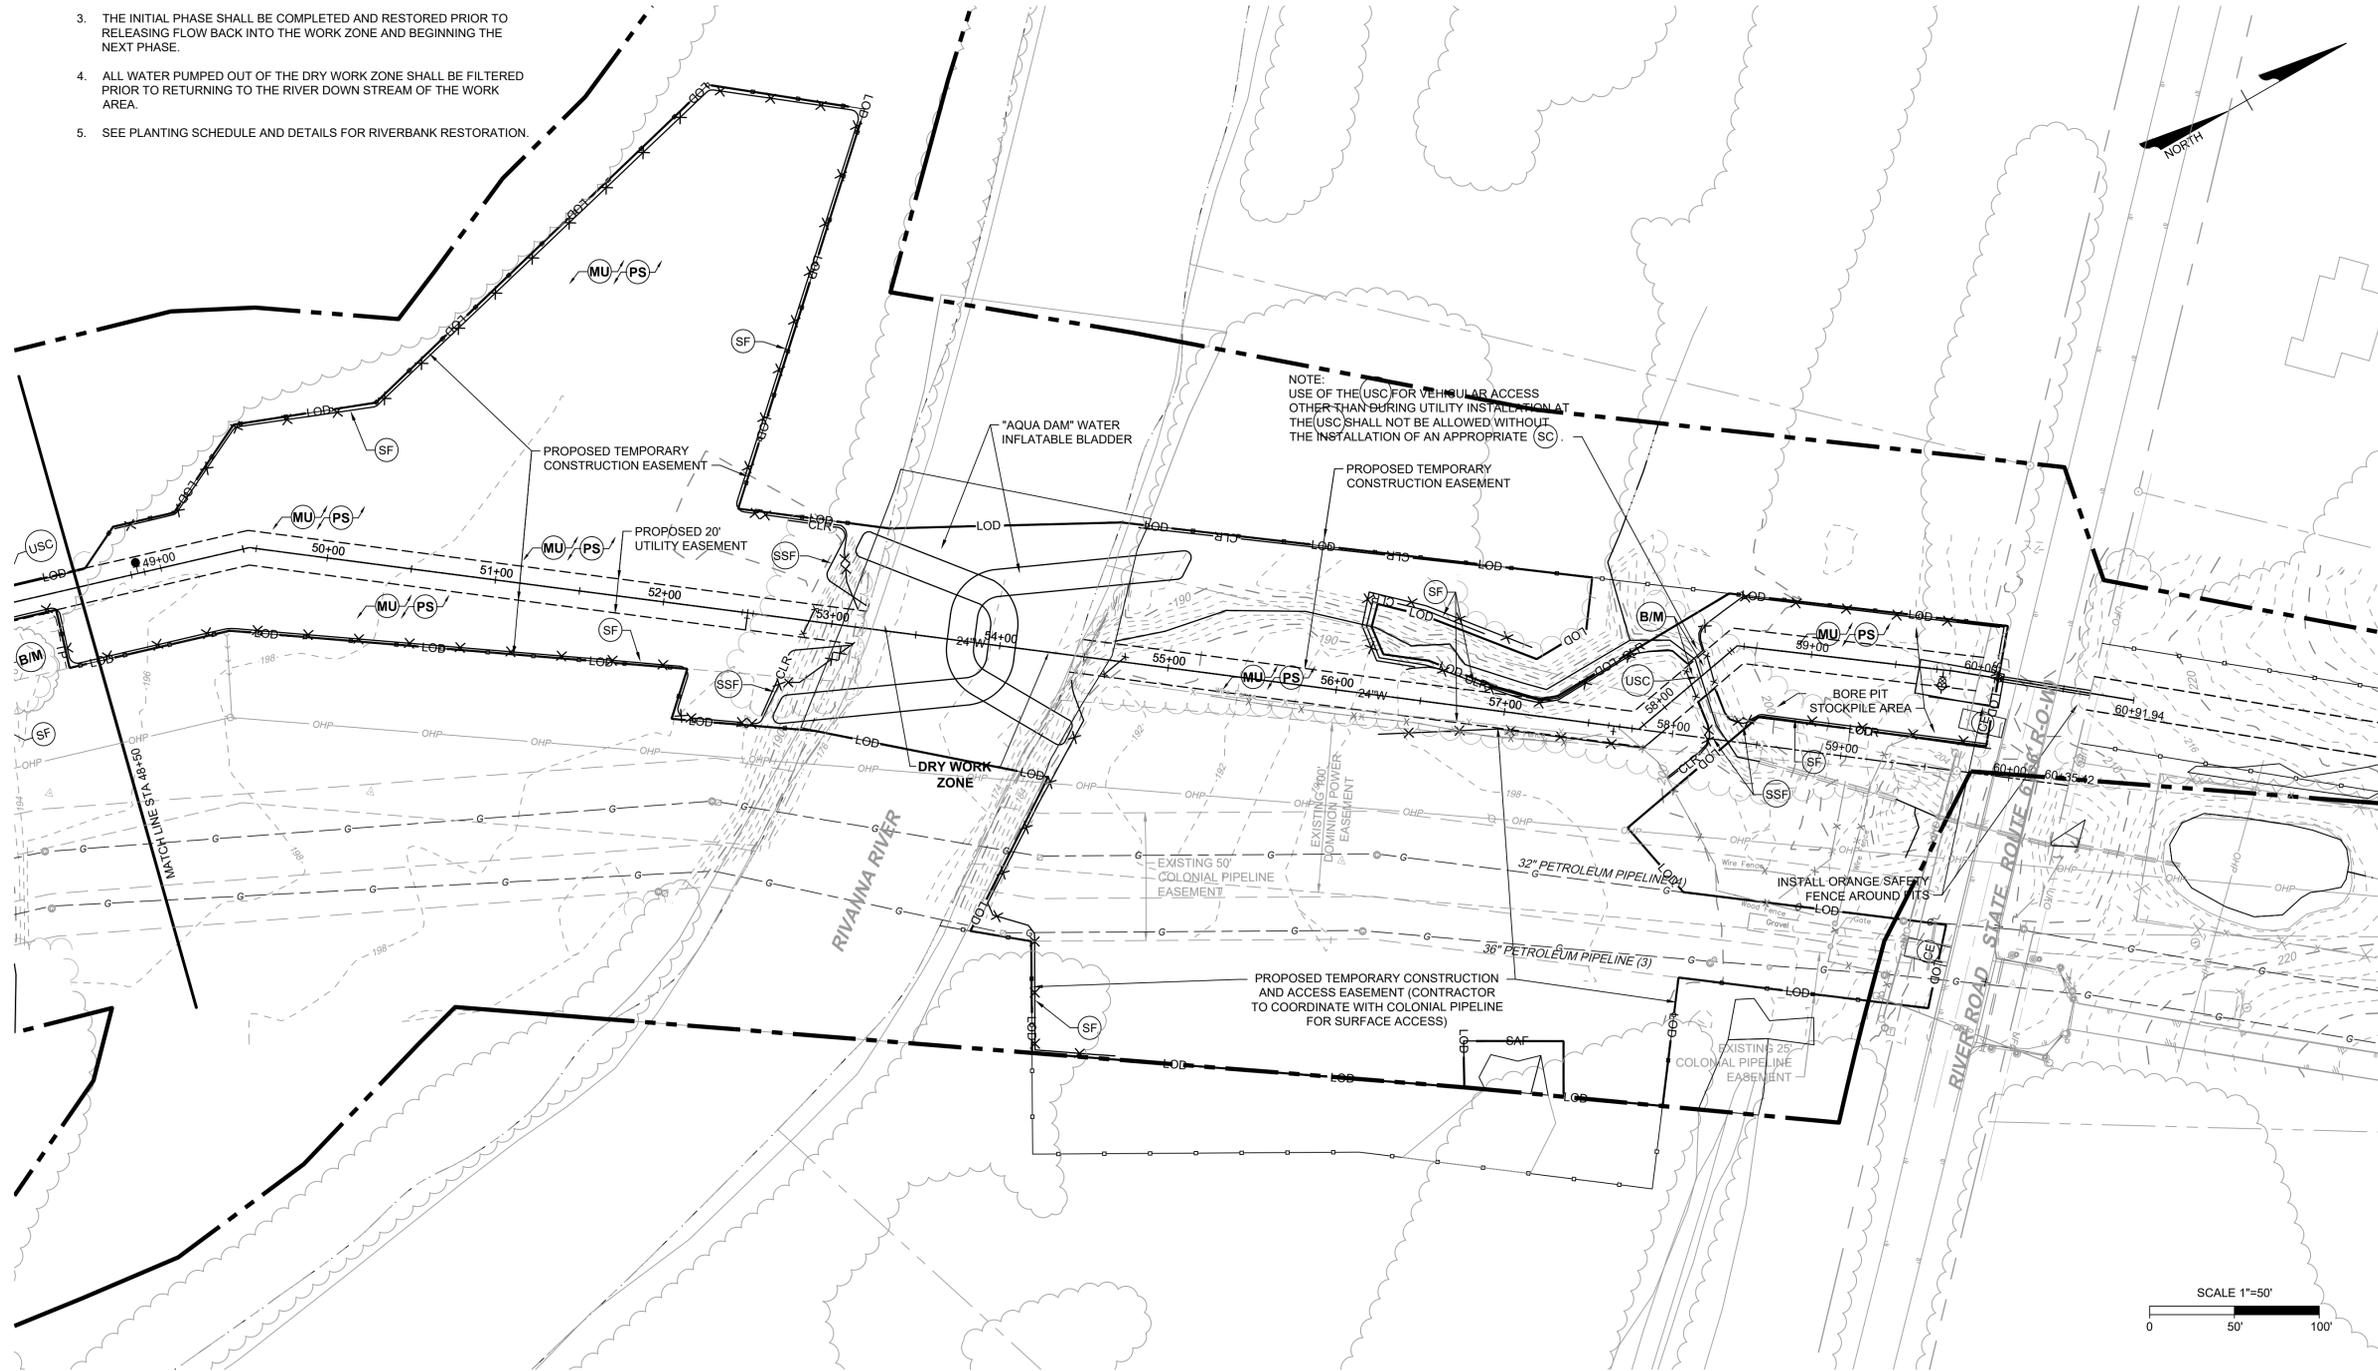
RIVER CROSSING NOTES:

1. CONTRACTOR SHALL INSTALL BLADDER AND PUMP OUT THE WORK AREA PRIOR TO ANY EXCAVATION WITHIN THE RIVER BANK OR RIVER BOTTOM.
2. RIVER CROSSING TO BE COMPLETED IN 2 (TWO) PHASES.
3. THE INITIAL PHASE SHALL BE COMPLETED AND RESTORED PRIOR TO RELEASING FLOW BACK INTO THE WORK ZONE AND BEGINNING THE NEXT PHASE.
4. ALL WATER PUMPED OUT OF THE DRY WORK ZONE SHALL BE FILTERED PRIOR TO RETURNING TO THE RIVER DOWN STREAM OF THE WORK AREA.
5. SEE PLANTING SCHEDULE AND DETAILS FOR RIVERBANK RESTORATION.

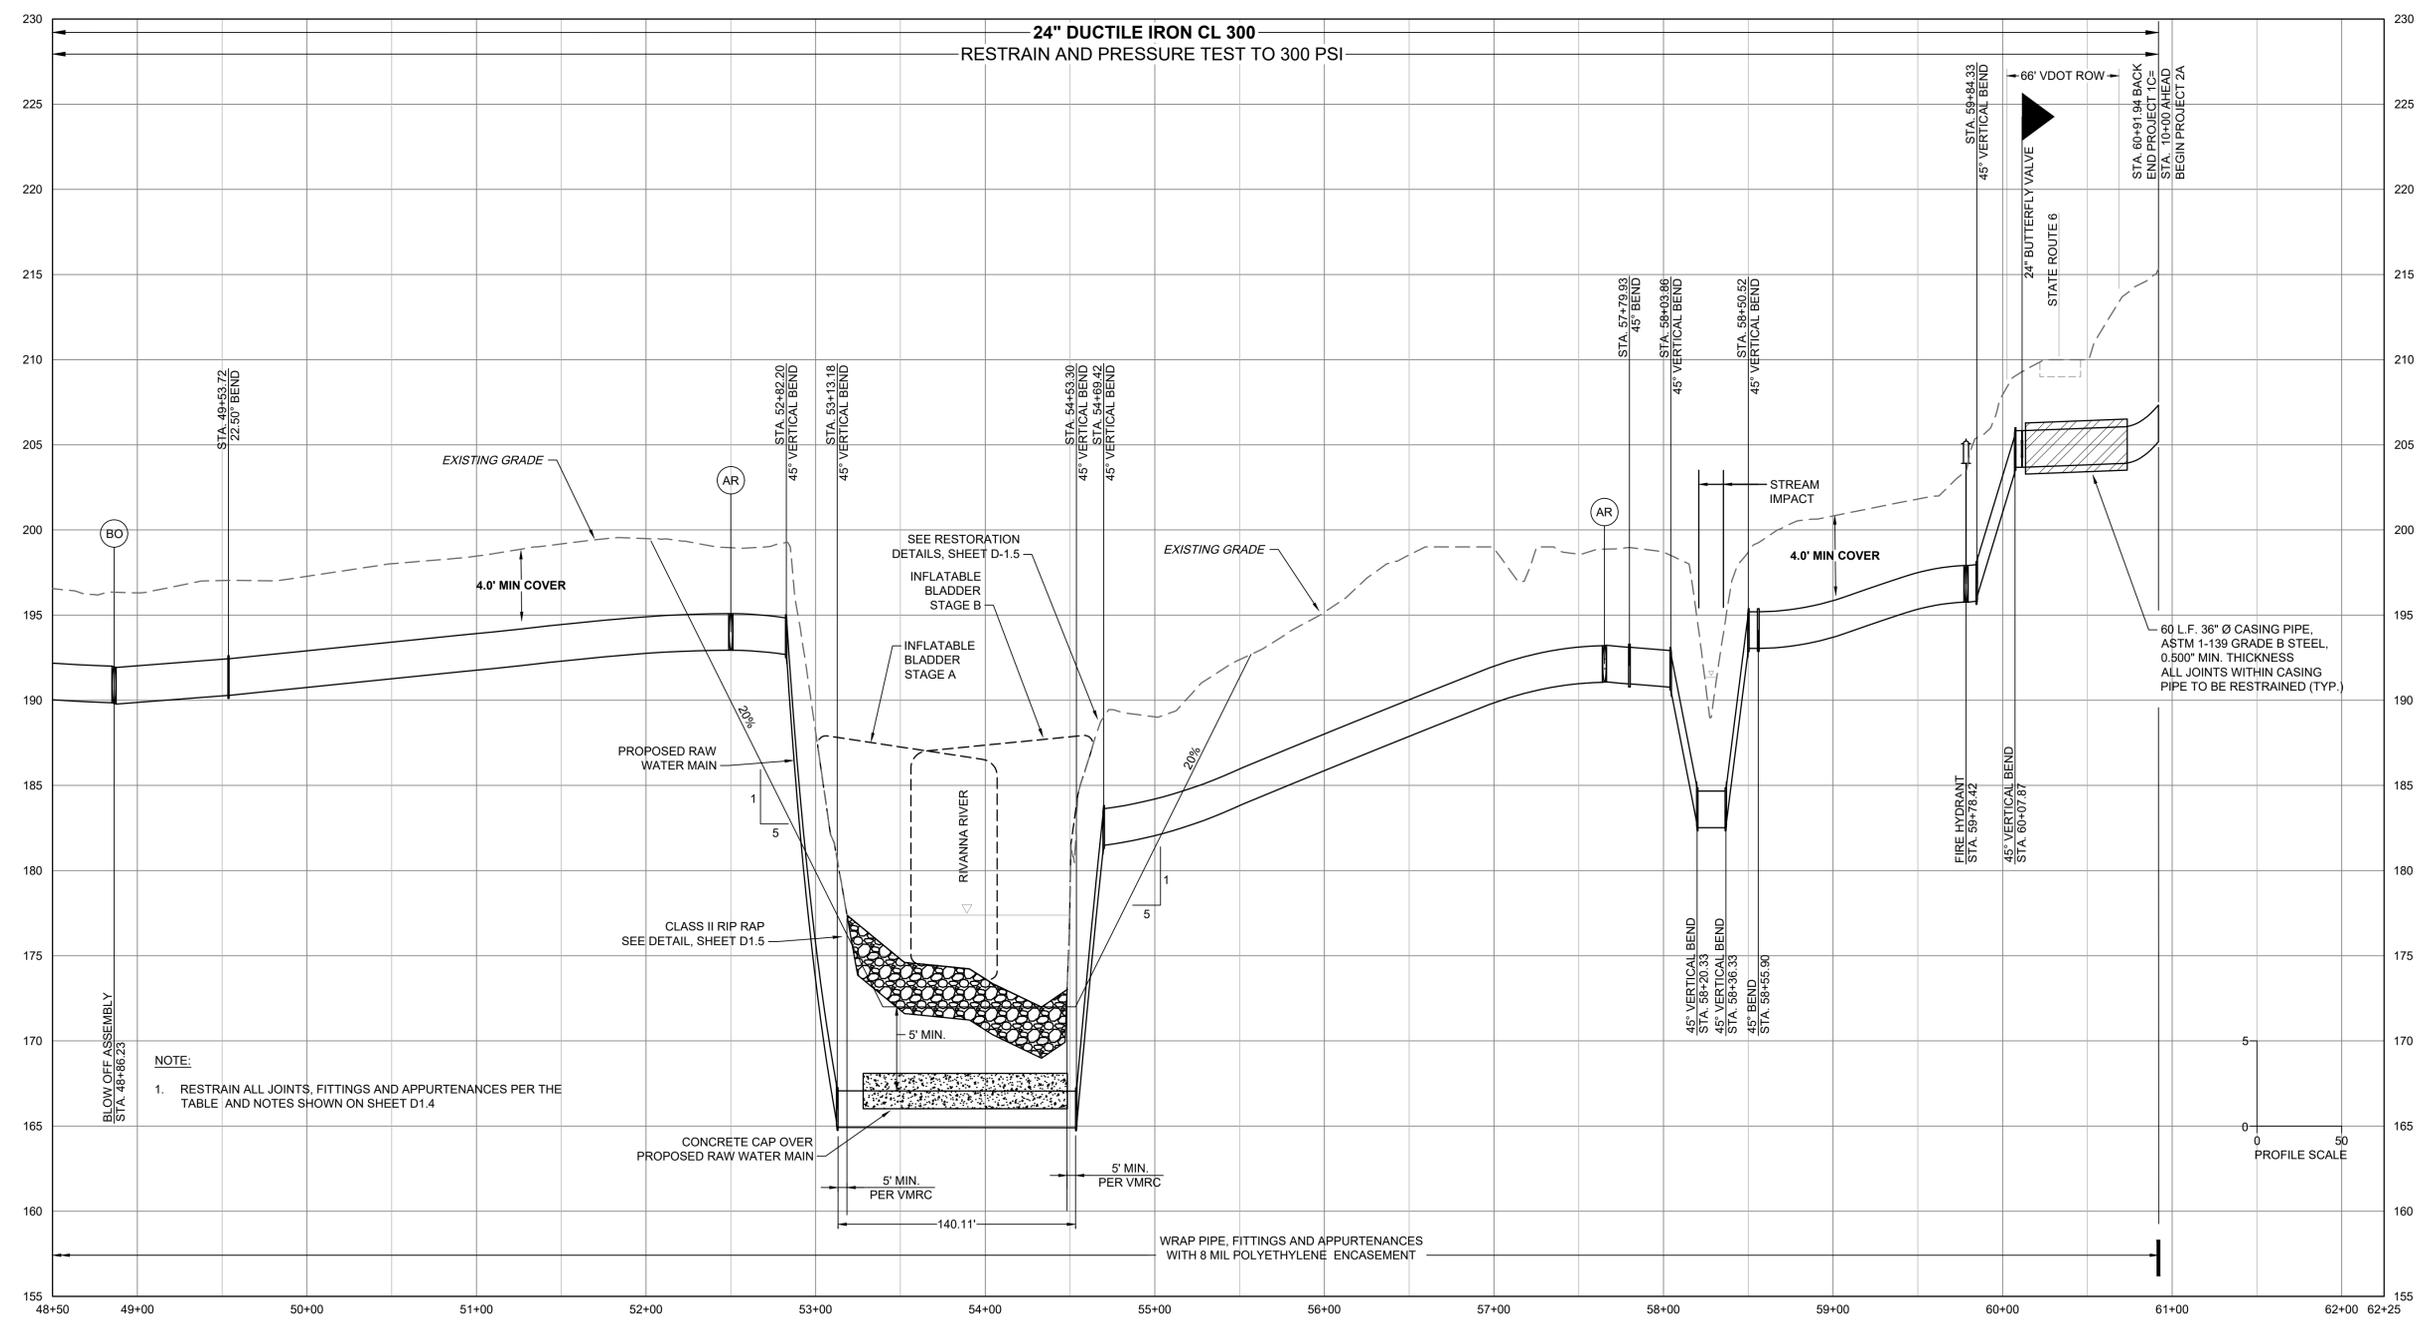
- RIVER CROSSING NOTES:
- CONTRACTOR SHALL INSTALL BLADDER AND PUMP OUT THE WORK AREA PRIOR TO ANY EXCAVATION WITHIN THE RIVER BANK OR RIVER BOTTOM.
 - RIVER CROSSING TO BE COMPLETED IN 2 (TWO) PHASES.
 - THE INITIAL PHASE SHALL BE COMPLETED AND RESTORED PRIOR TO RELEASING FLOW BACK INTO THE WORK ZONE AND BEGINNING THE NEXT PHASE.
 - ALL WATER PUMPED OUT OF THE DRY WORK ZONE SHALL BE FILTERED PRIOR TO RETURNING TO THE RIVER DOWN STREAM OF THE WORK AREA.
 - SEE PLANTING SCHEDULE AND DETAILS FOR RIVERBANK RESTORATION.

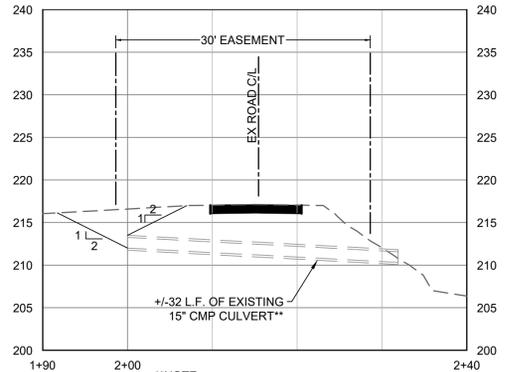
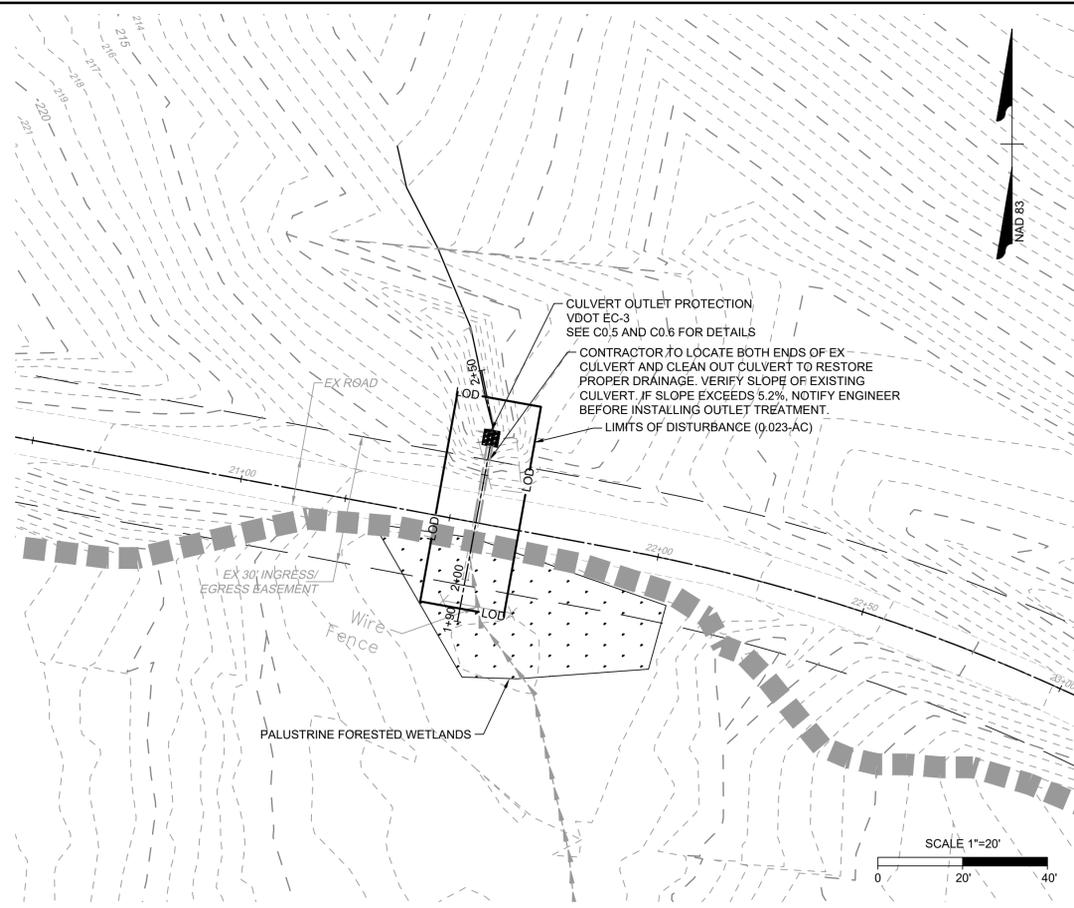
IMPACT # 200
SCALE: 1"=20'

****NOTE:**
CONTRACTOR TO LOCATE BOTH ENDS OF EXISTING CULVERT AND CLEAN OUT CULVERT TO RESTORE PROPER DRAINAGE. VERIFY SLOPE OF EXISTING CULVERT - IF SLOPE EXCEEDS 5.2%, NOTIFY ENGINEER BEFORE INSTALLING OUTLET TREATMENT.

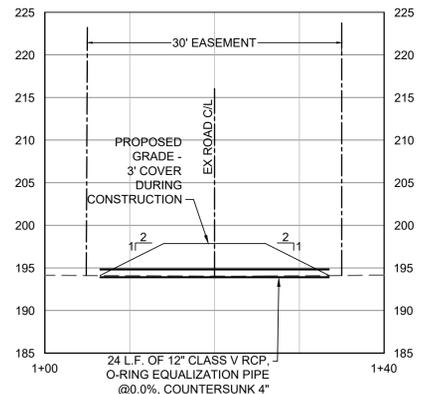
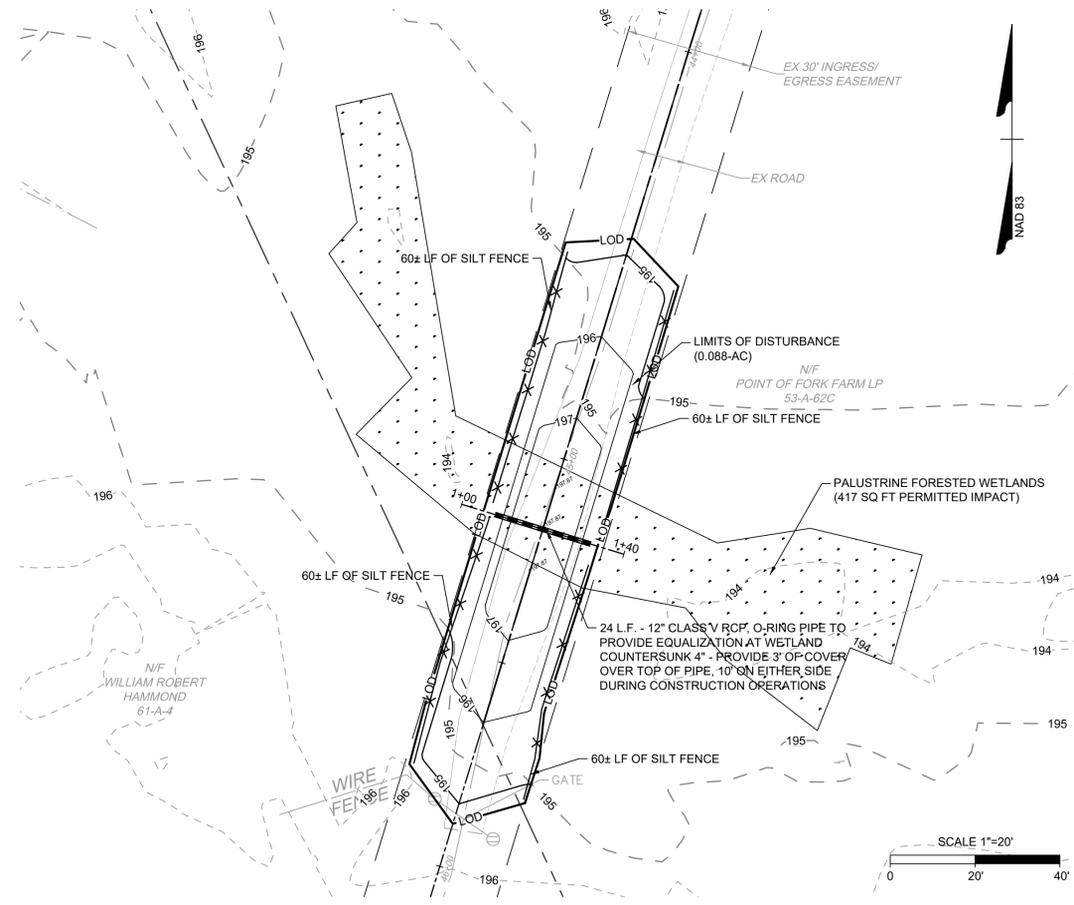
IMPACT # 202
SCALE: 1"=20'

24 L.F. OF 12" CLASS V RCP, O-RING EQUALIZATION PIPE @0.0%, COUNTERSUNK 4"

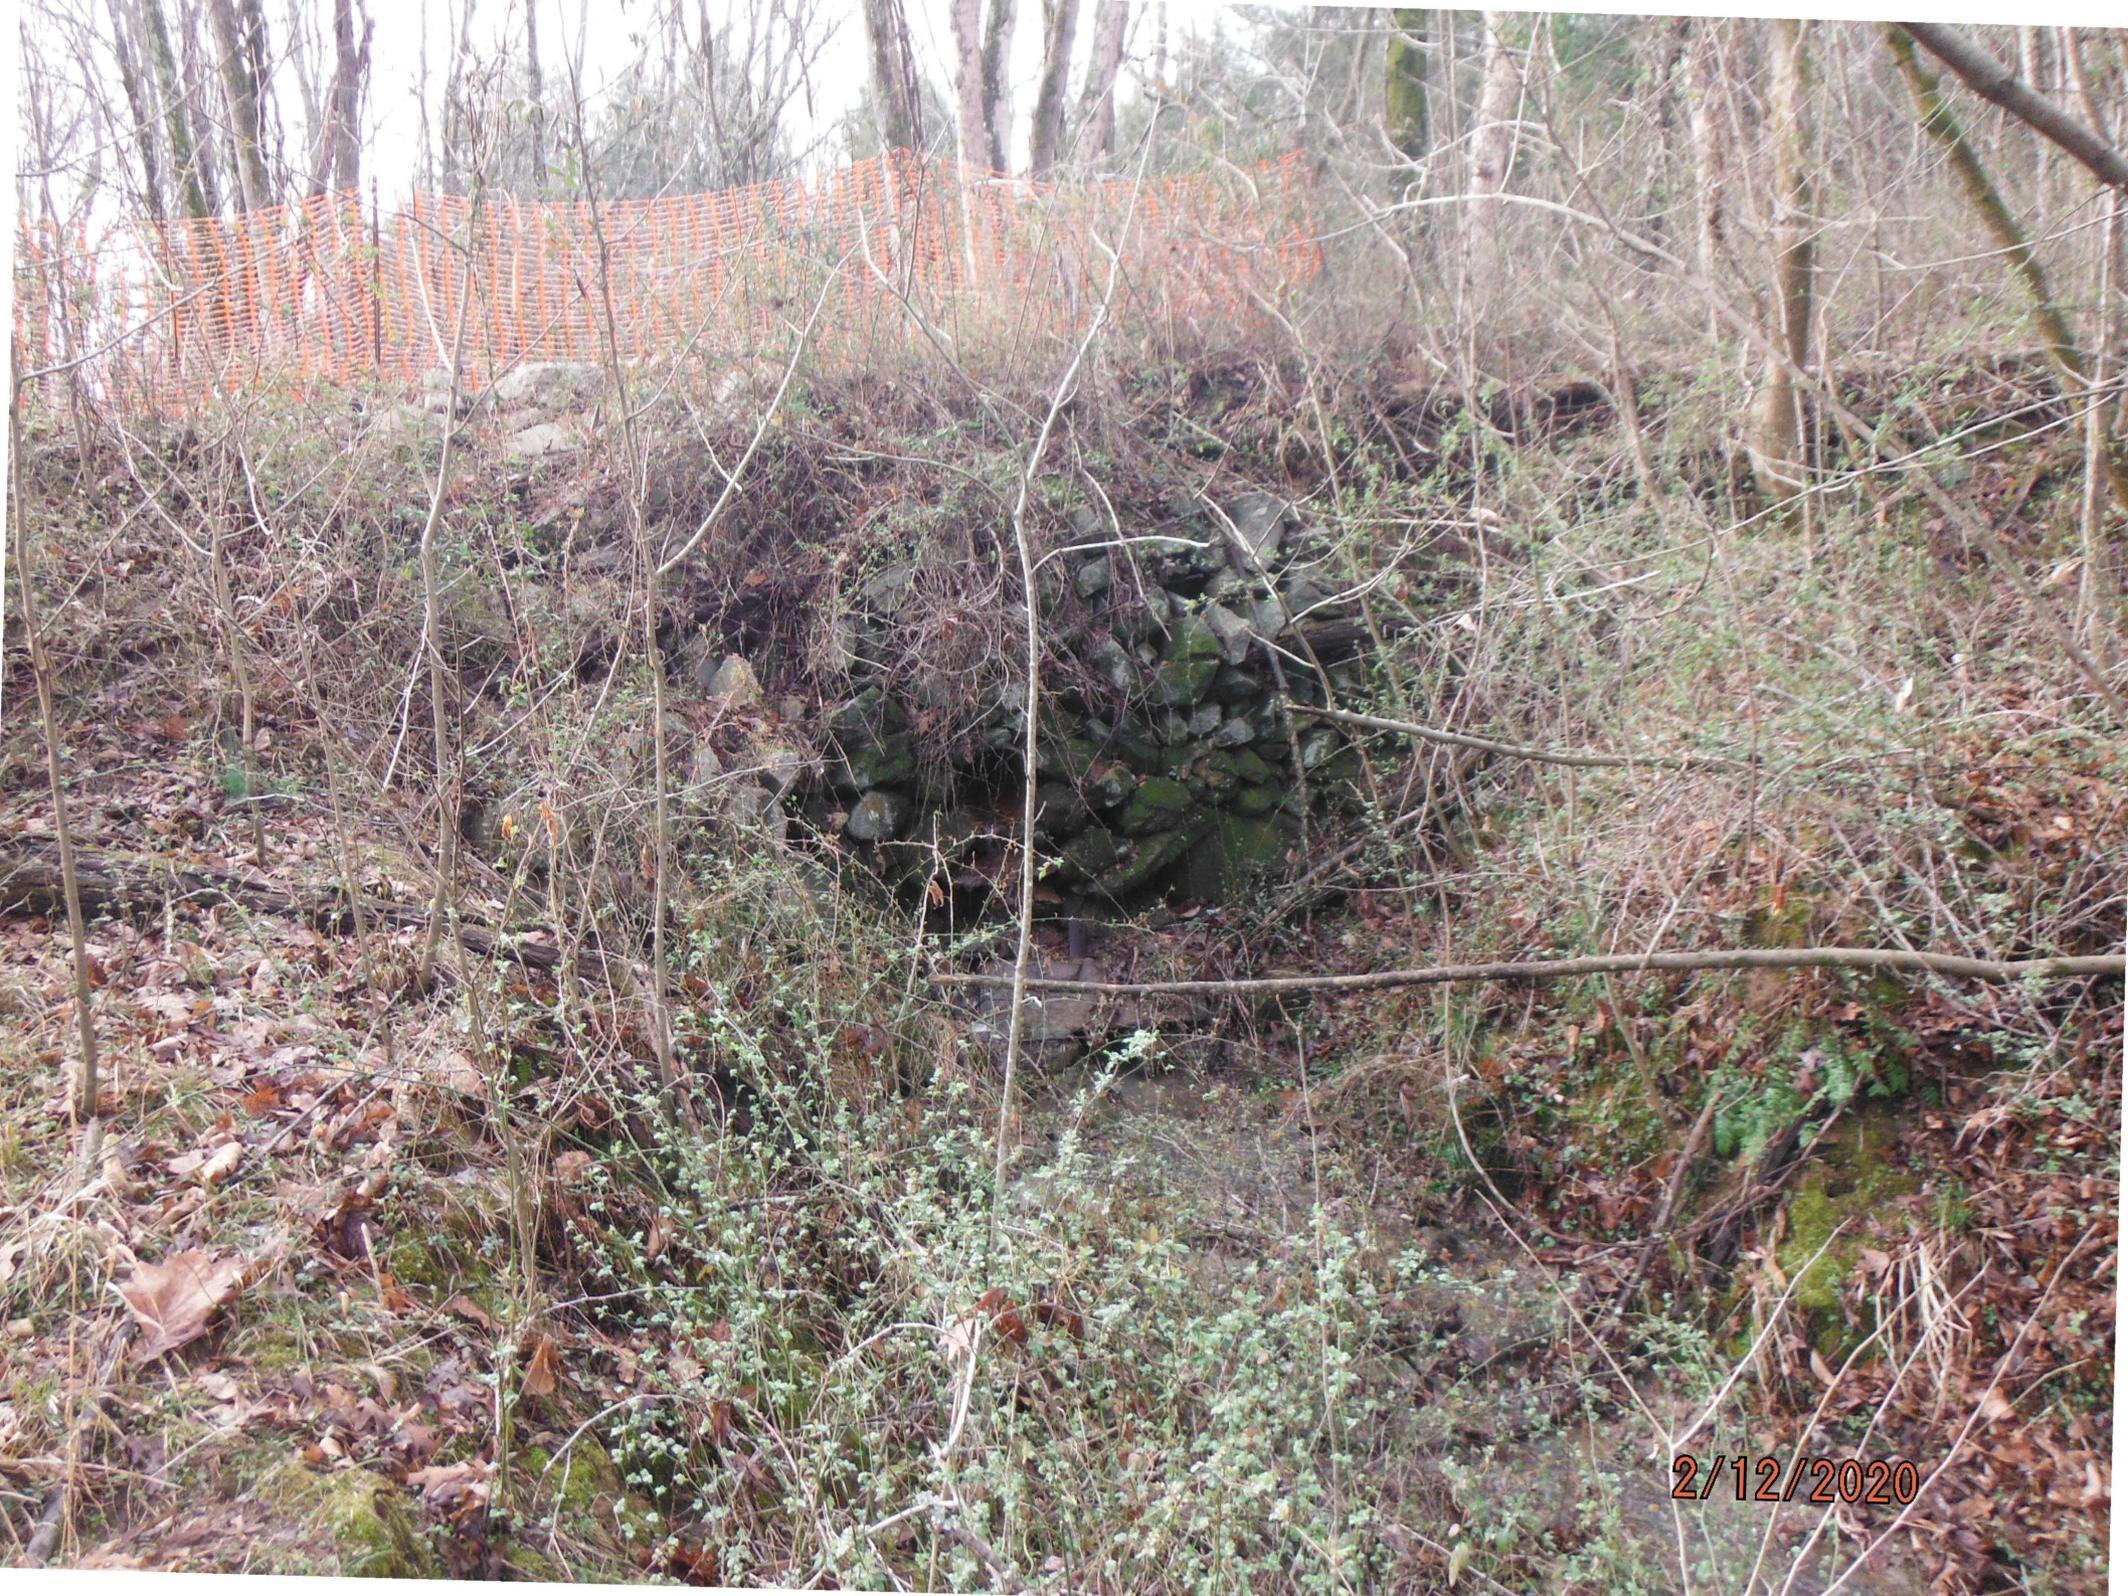
INSERT PHOTOS:

DESCRIBE PROPOSED IMPACT:

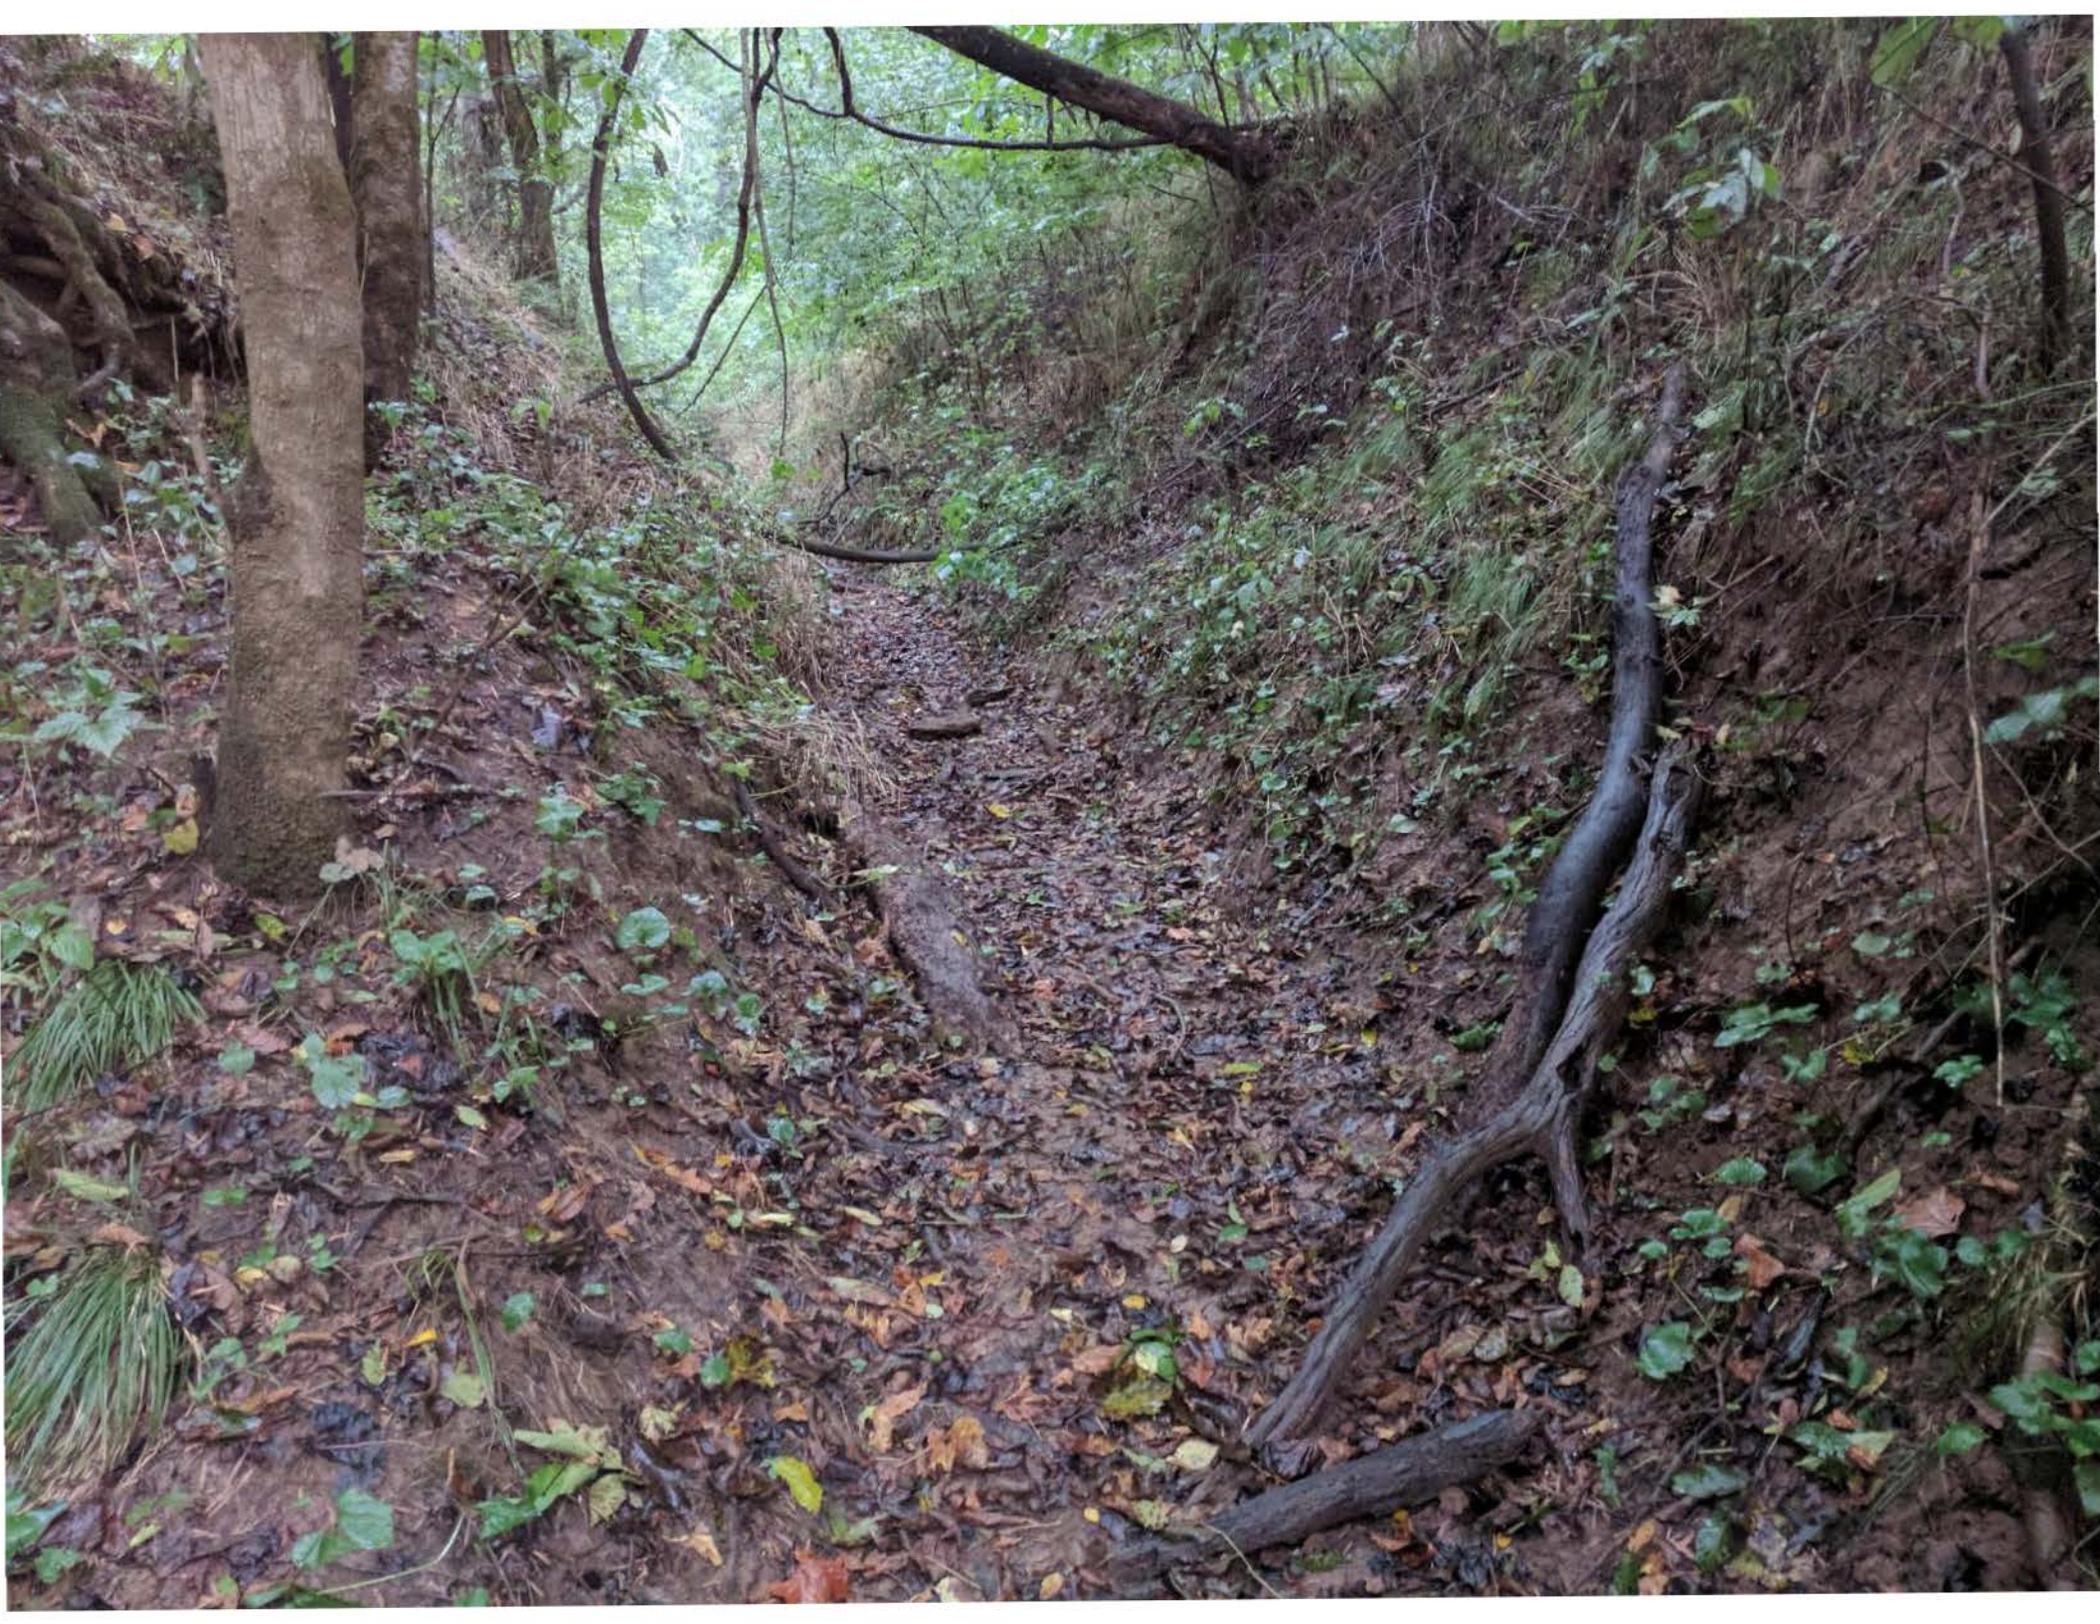
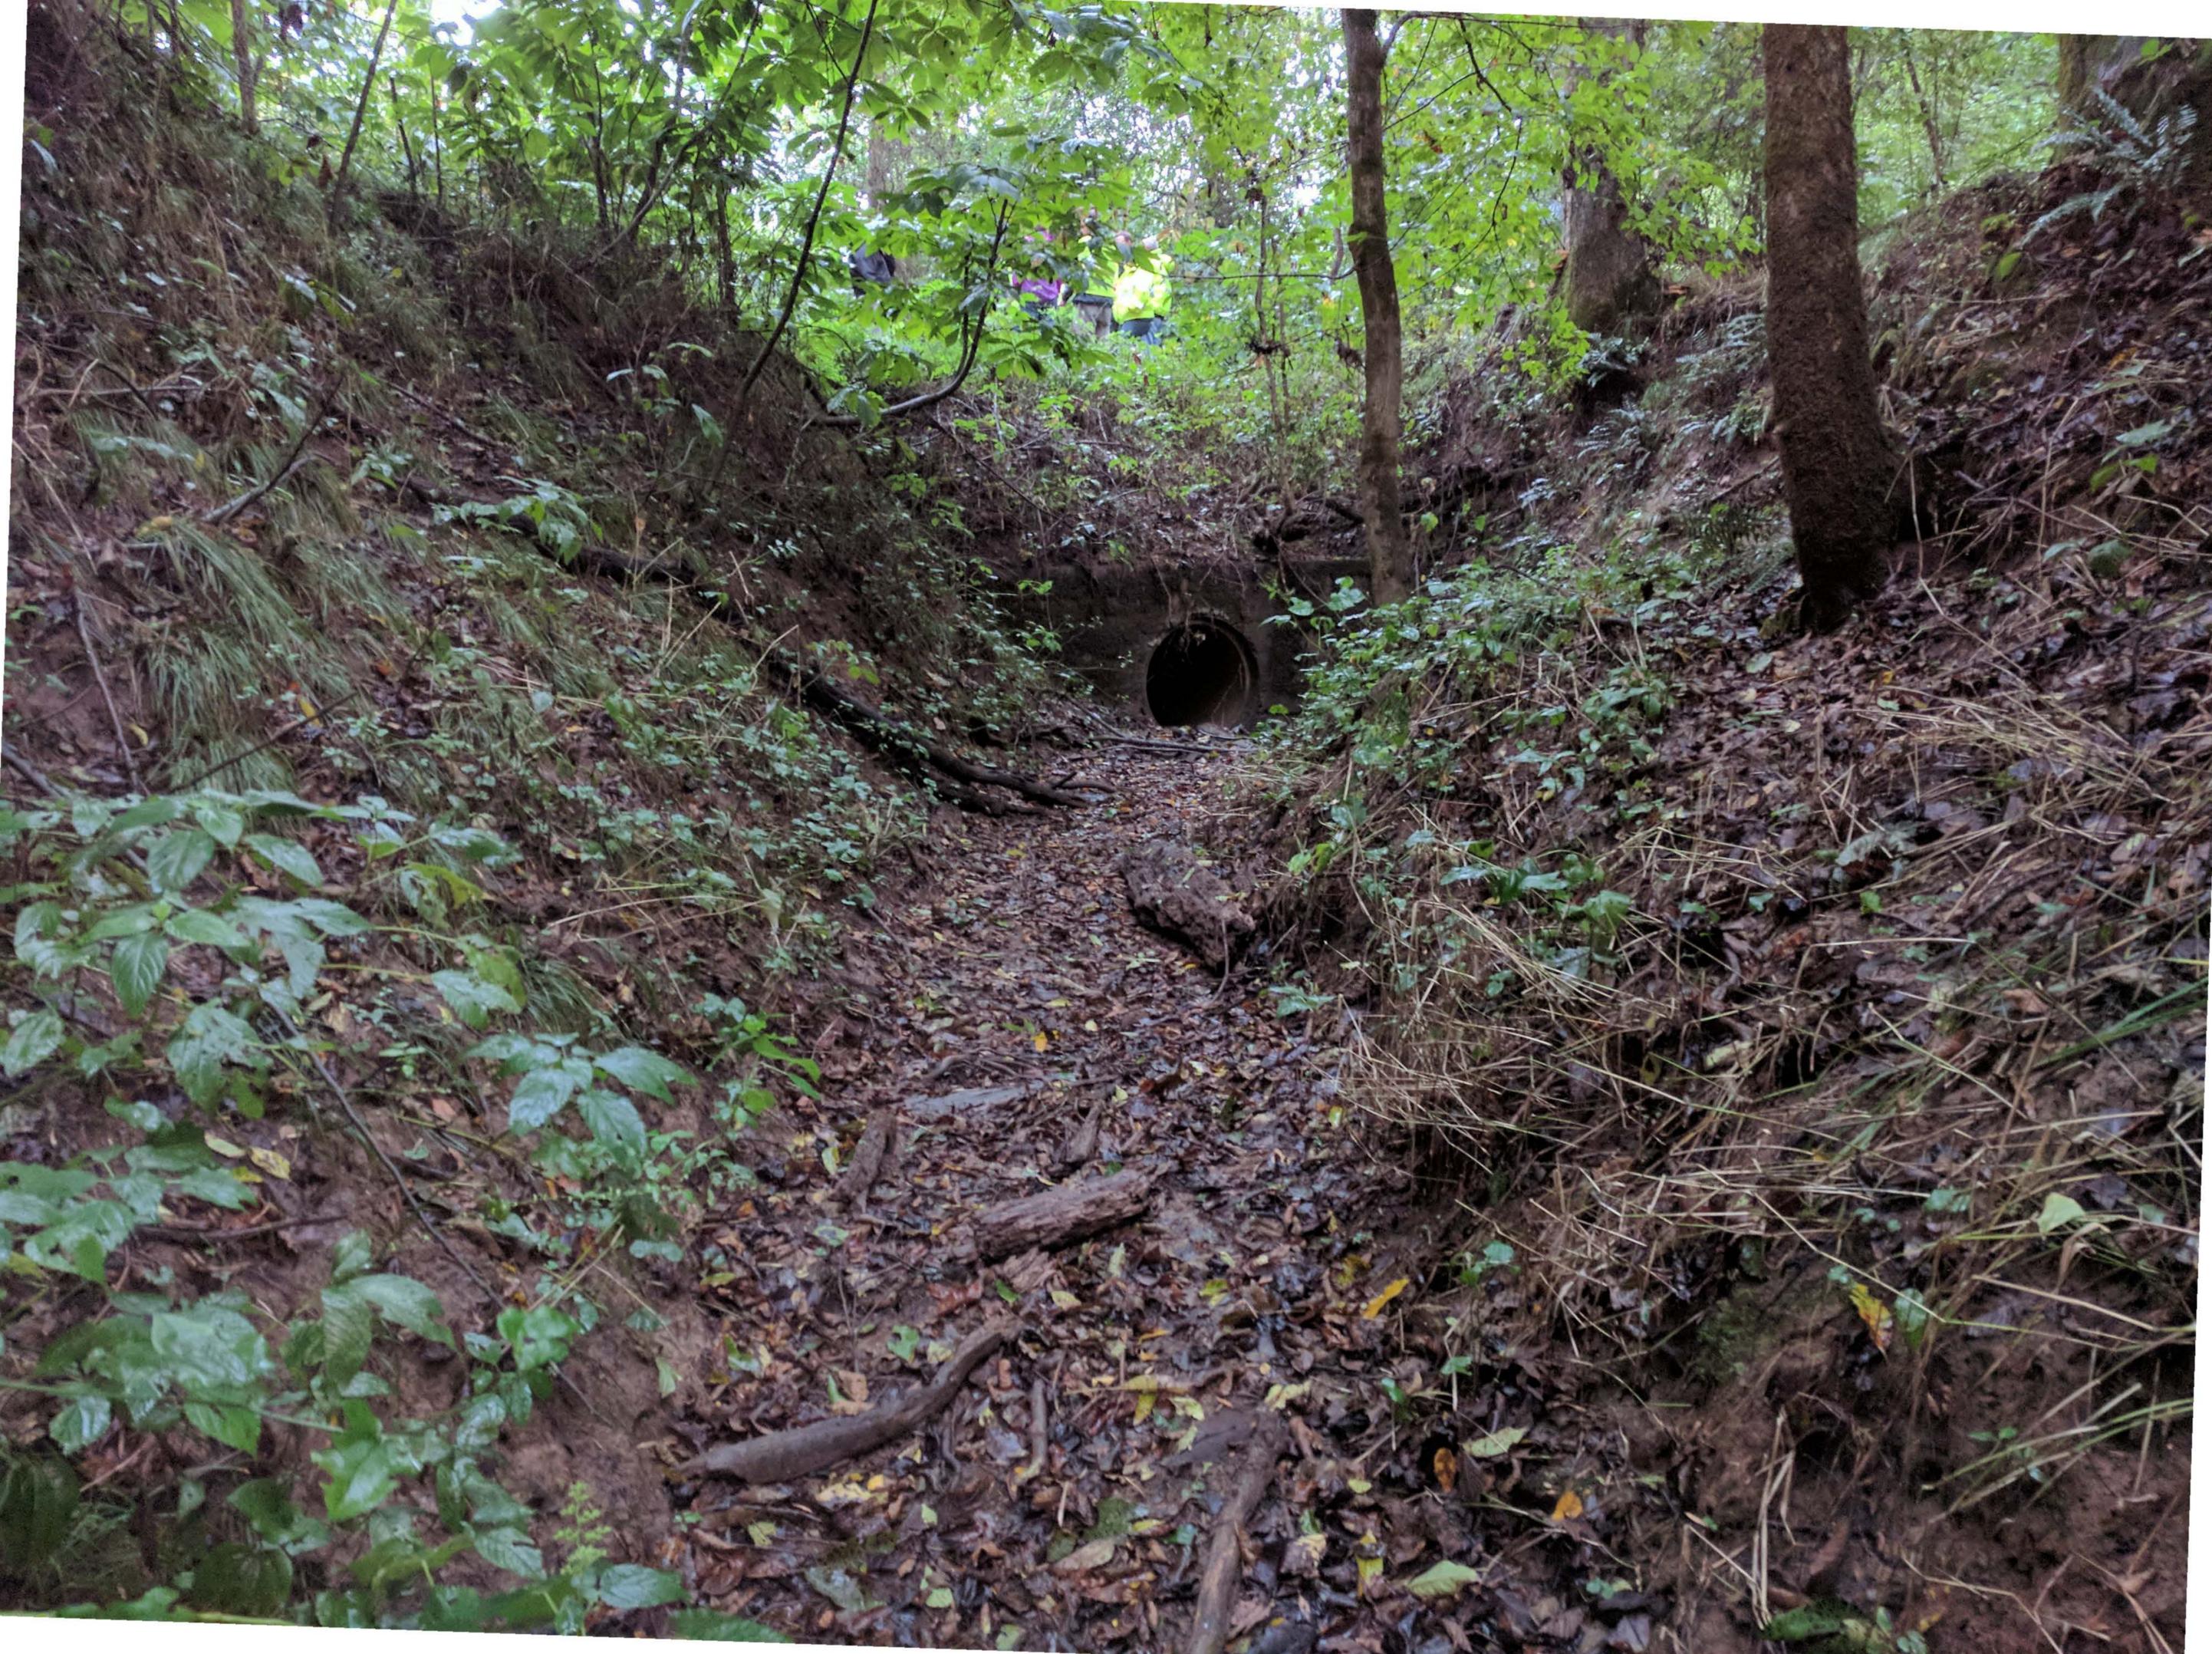
4. CHANNEL ALTERATION: Stream crossings, riprap, concrete, gabions, or concrete blocks, straightening of channel, channelization, embankments, spoil piles, constrictions, livestock							NOTES>> channel has been straightned - existing culvert present at crossing
Conditional Category							
Channel Alteration	Negligible	Minor		Moderate		Severe	
	Channelization, dredging, alteration, or hardening absent. Stream has an unaltered pattern or has naturalized.	Less than 20% of the stream reach is disrupted by any of the channel alterations listed in the parameter guidelines.	20-40% of the stream reach is disrupted by any of the channel alterations listed in the parameter guidelines.	40 - 60% of reach is disrupted by any of the channel alterations listed in the parameter guidelines. If stream has been channelized, normal stable stream meander pattern has not recovered.	60 - 80% of reach is disrupted by any of the channel alterations listed in the parameter guidelines. If stream has been channelized, normal stable stream meander pattern has not recovered.	Greater than 80% of reach is disrupted by any of the channel alterations listed in the parameter guidelines AND/OR 80% of banks shored with gabion, riprap, or cement.

INSERT PHOTOS:

DESCRIBE PROPOSED IMPACT:
