**Soil Excavation and Removal Completion Report
TCCREF Parcel B Areas (FNOD AOCs 6, 11, and 20)**

Tidewater Community College Real Estate Foundation
Tidewater Community College
Green District Administration Building
121 College Place, Suite 624
Norfolk, VA 23510

July 2019

Project Number: 64543
Revision Number: 0

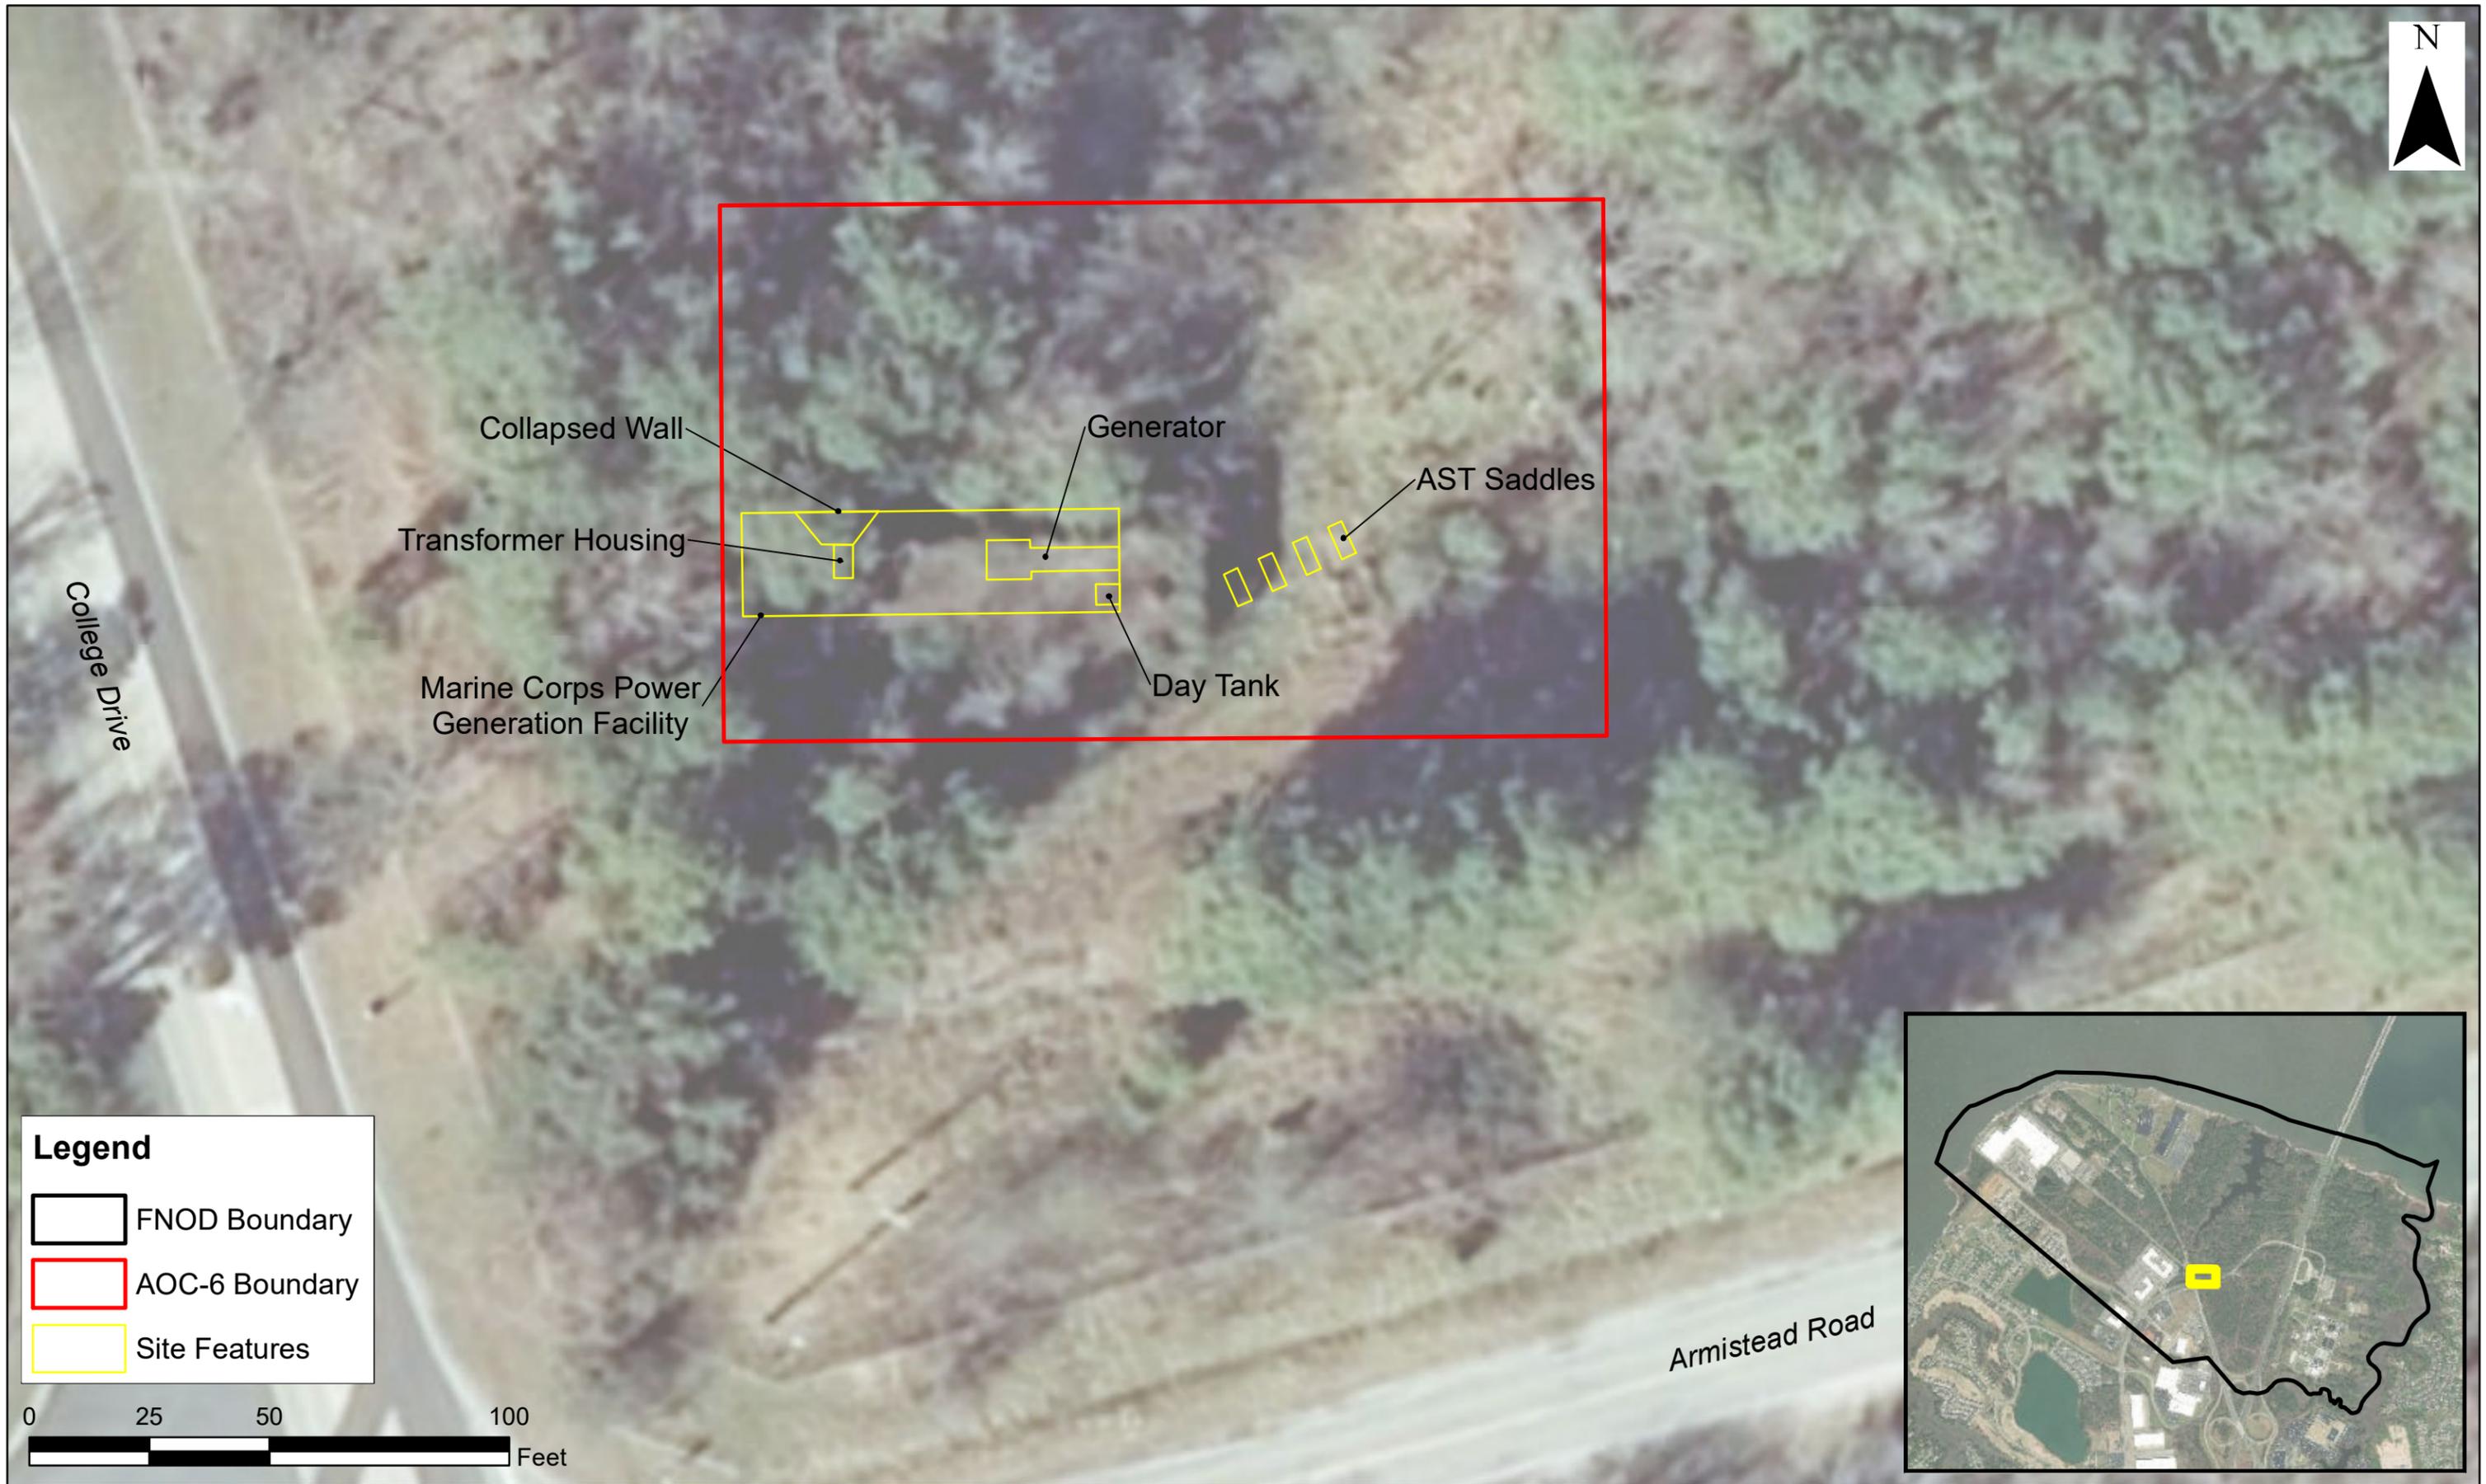
Figure: 2

AOC-6 Location and Features

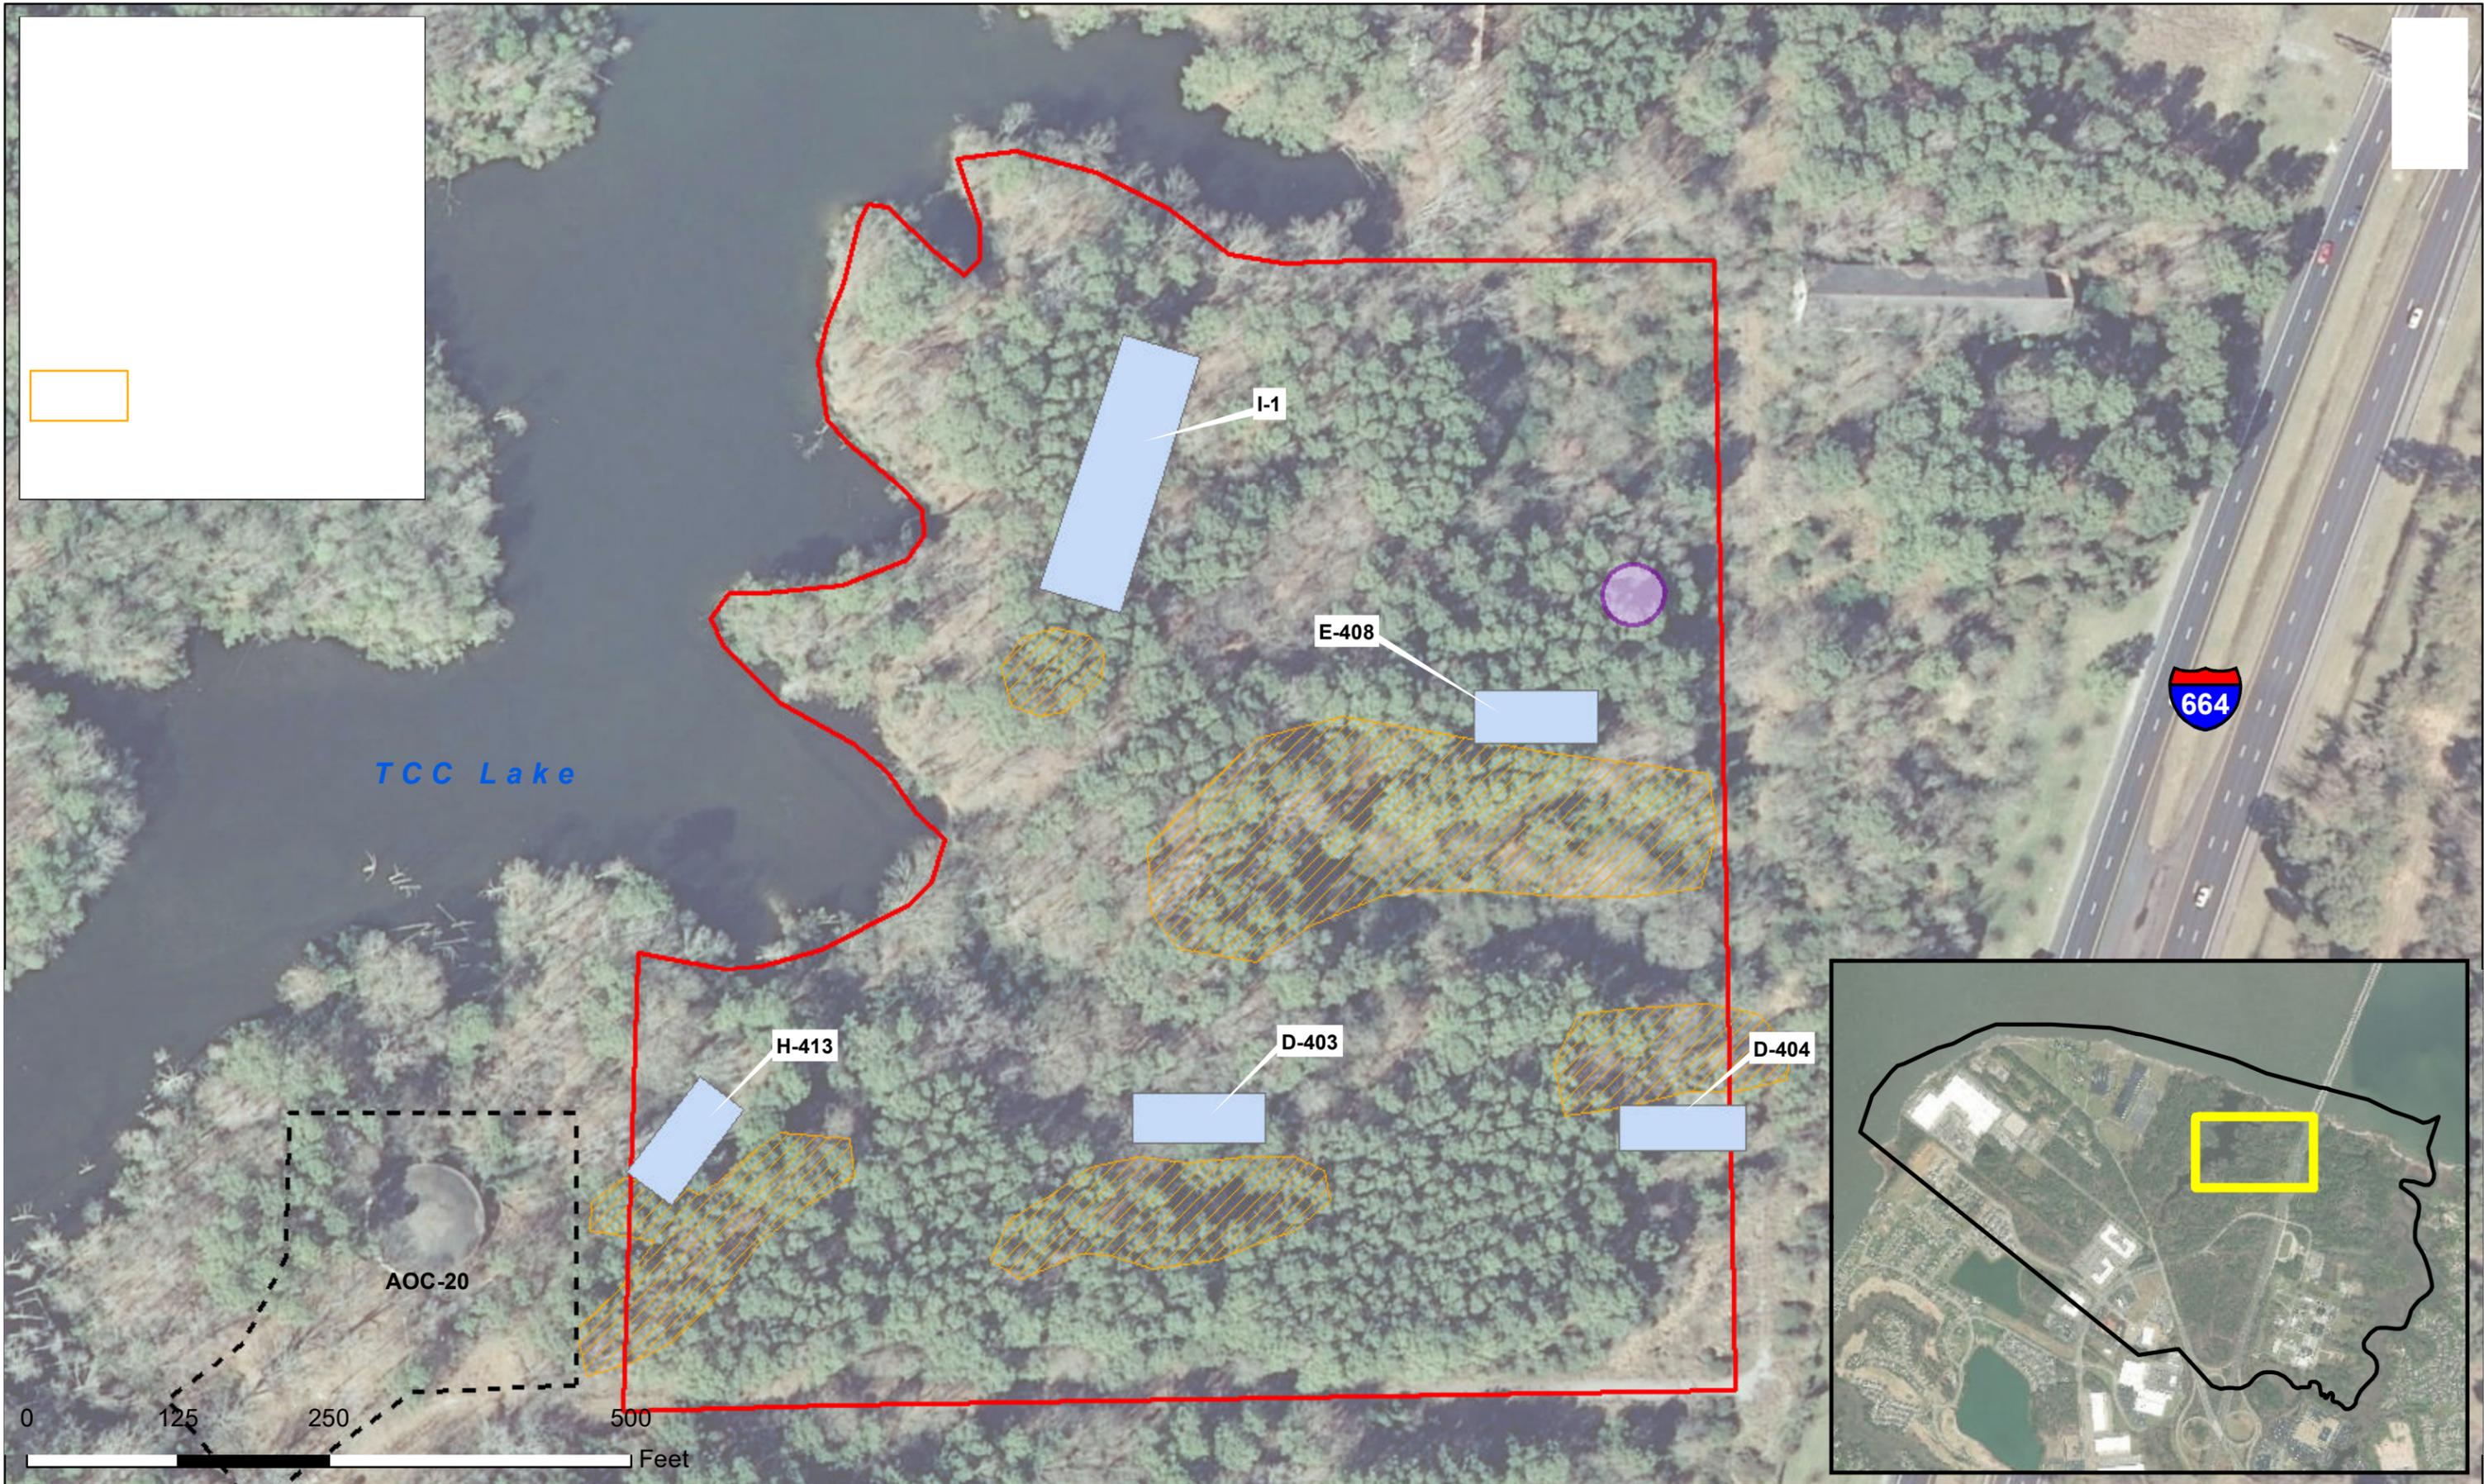
Figure: 3

AOC-11 Location and Features

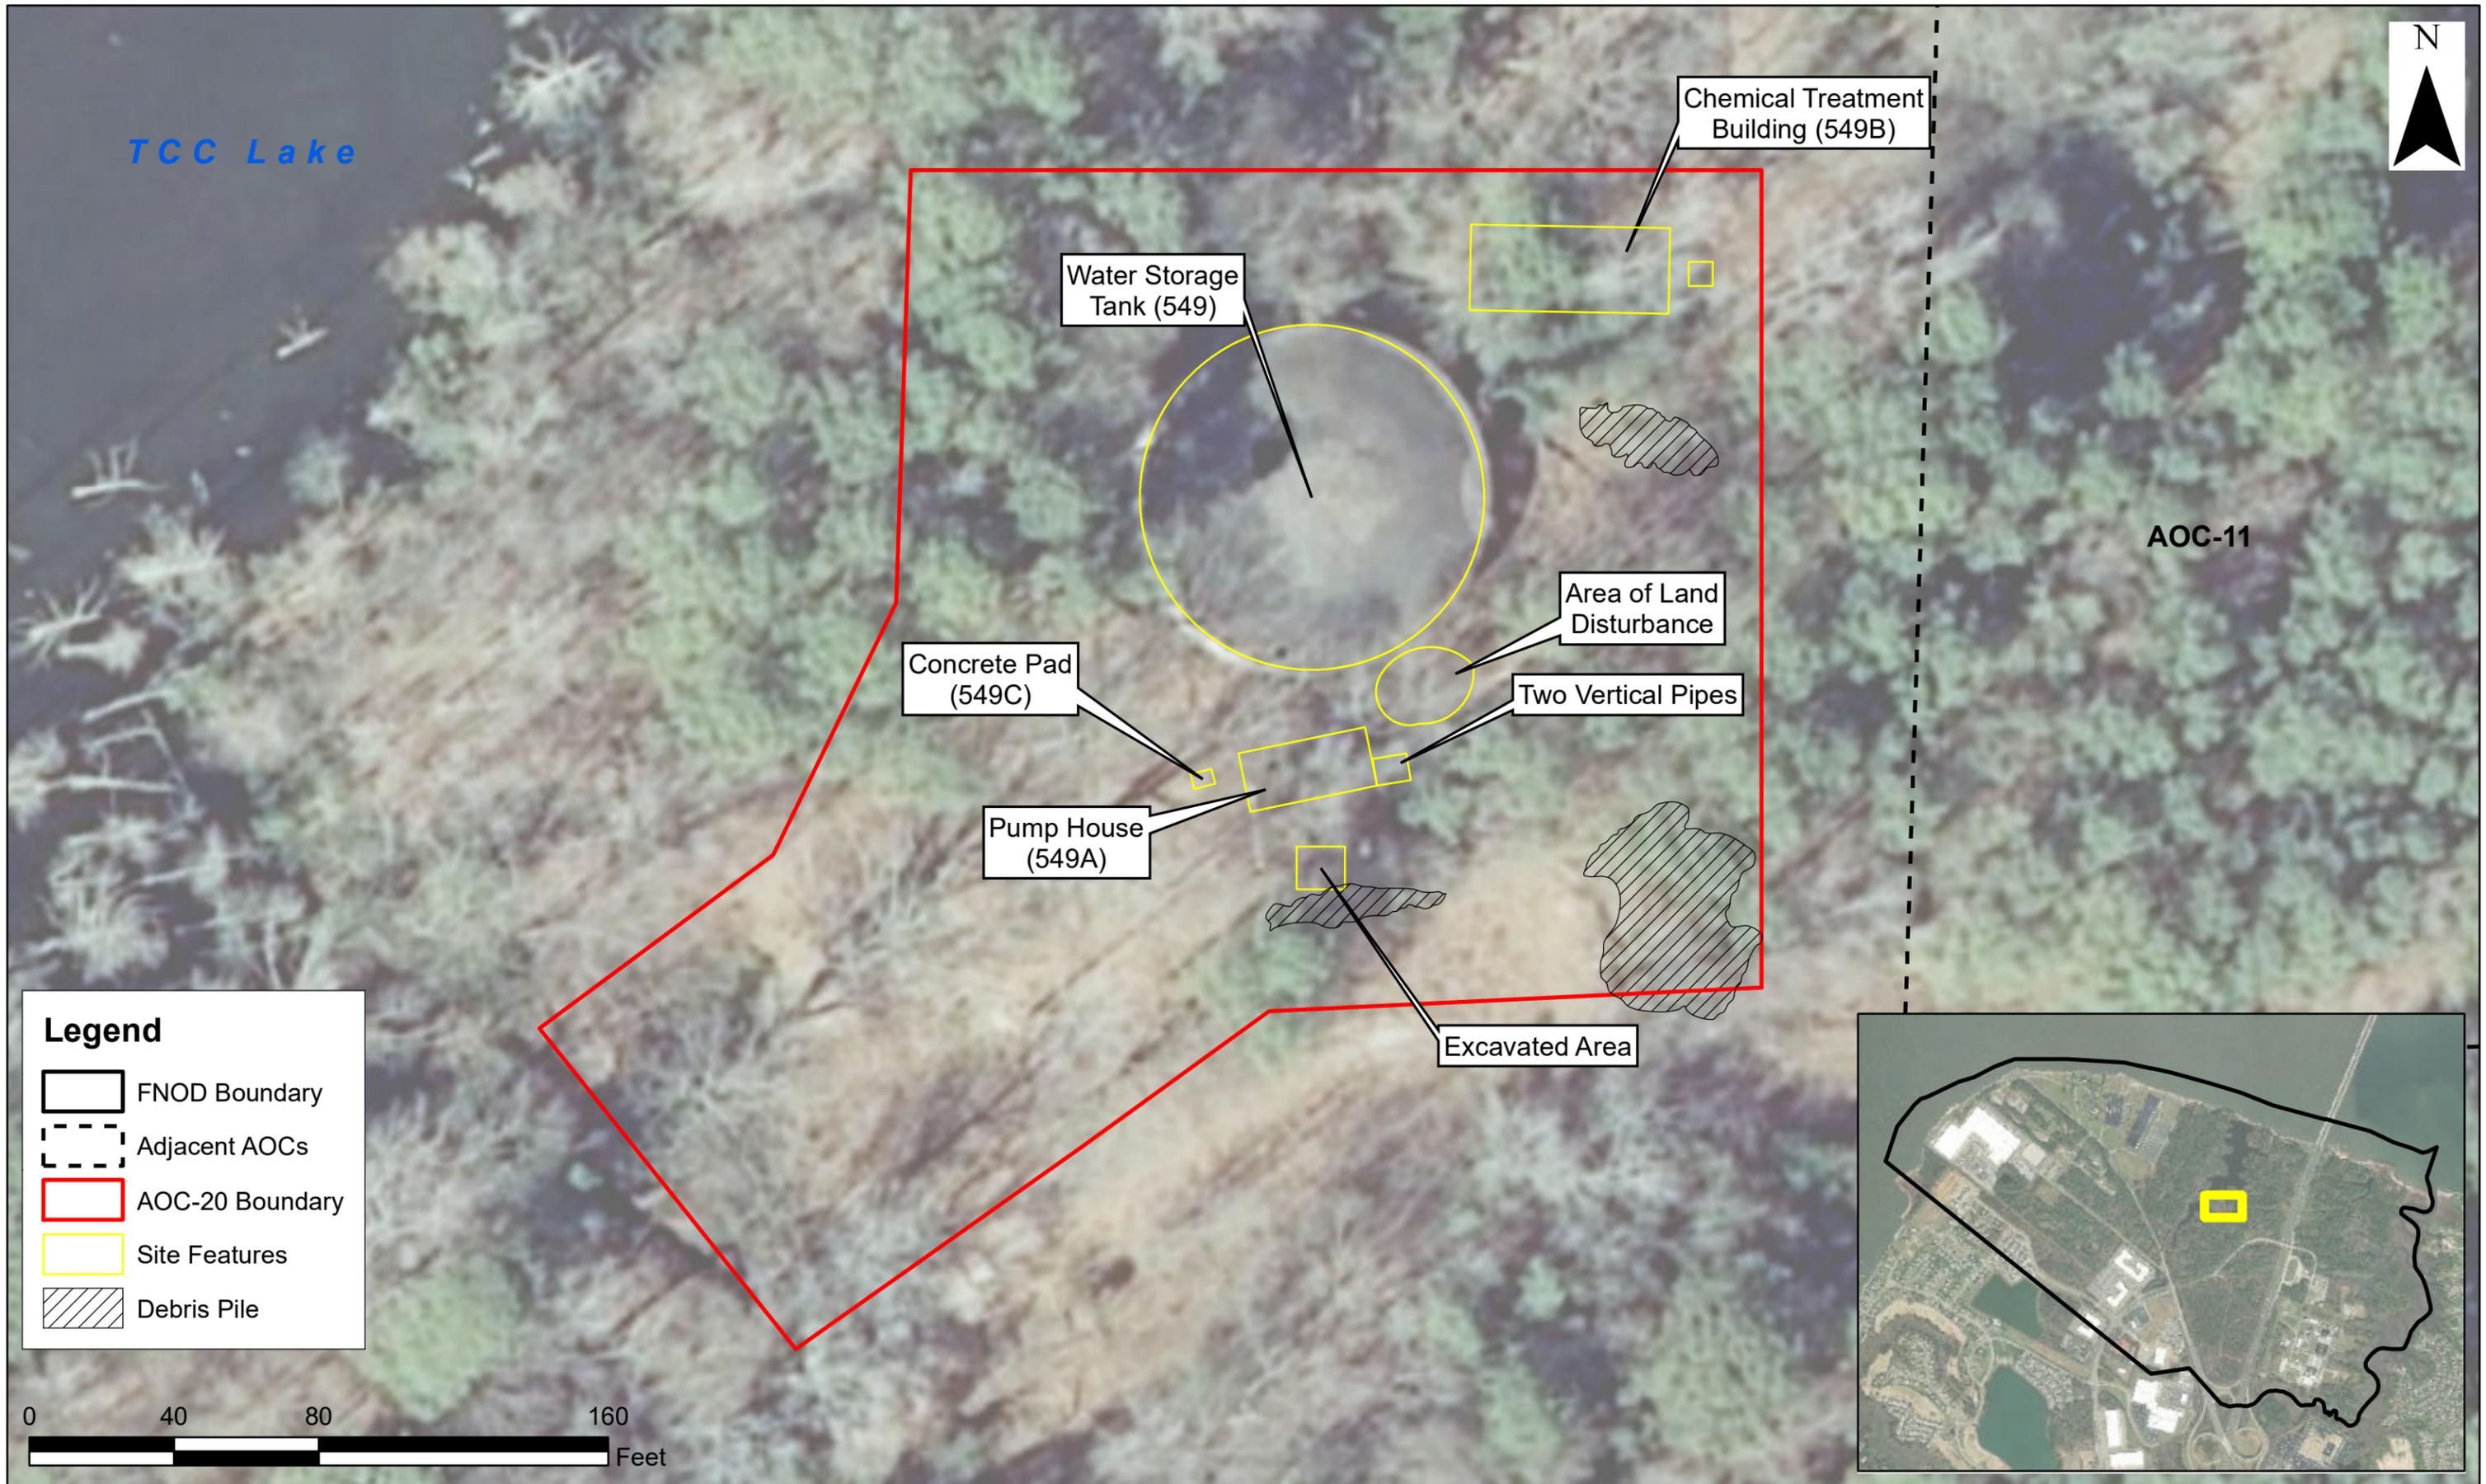
AOC-20 Location and Features

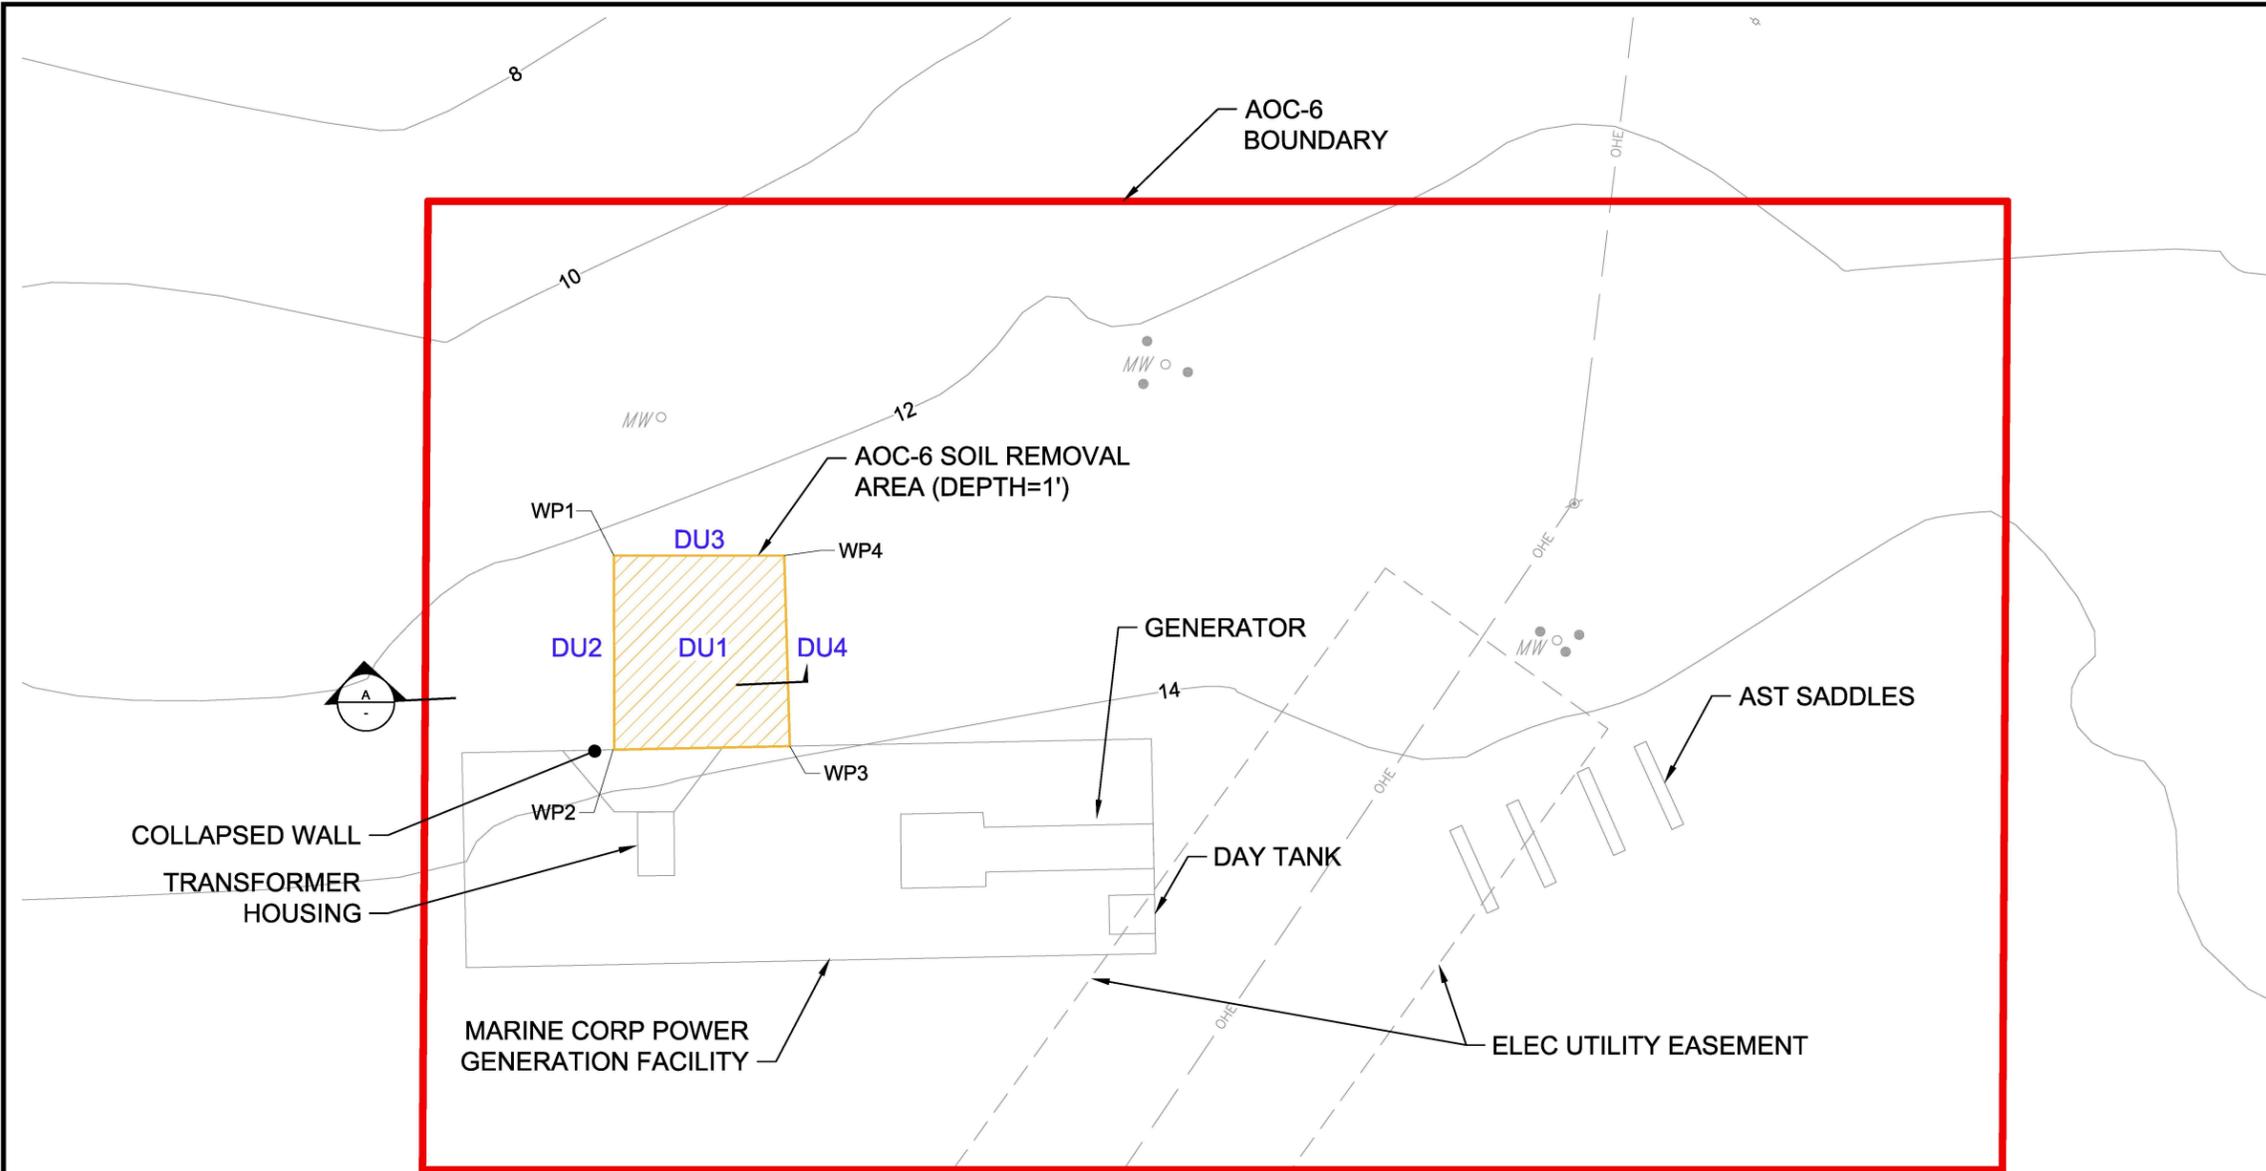
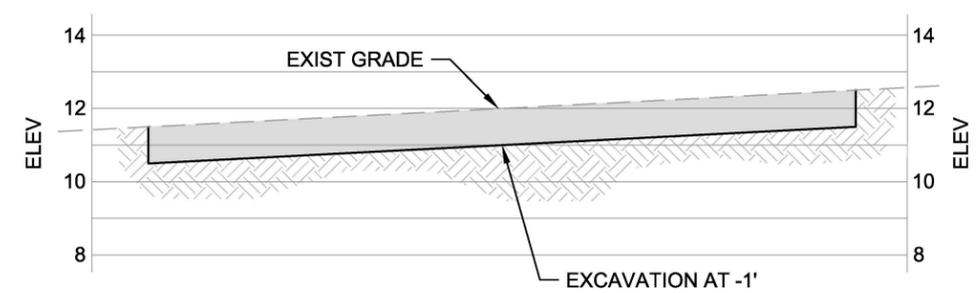
Filename: 64543-TCCREF SRCR-FIG05-AOC06.DWG Plotted: 3/23/2015 1:57:15 PM

1. HORIZONTAL DATUM IS NAD83 VA STATE PLANE SOUTH ZONE.
2. SOUTH WALL NOT SAMPLED DUE TO PRESENCE OF CONCRETE FOUNDATION FOR MCPG FACILITY.

PROFILE A
SCALE: 1" = 10' HORIZ, 1" = 5' VERT

Samples collected from decision unit 1 (bottom) slightly exceeded the residential RSL for Aroclor-1260 in two of three samples. Samples collected from decision unit 4 (east wall) slightly exceeded the residential RSL for Aroclor-1254 in one of two samples and for Aroclor-1260 in both samples. Potential human health risk was approximated through a risk ratio approach for these two PCBs, using the maximum detections. For Aroclor-1254, a noncarcinogen, the calculated hazard quotient was 0.1, which is below the non-carcinogenic residential risk standard. For Aroclor-1260, a carcinogen, the calculated incremental carcinogenic risk was 1.4×10^{-6} , which is within the EPA target risk range of 1×10^{-6} to 1×10^{-4} . Based on these results, it was determined that no additional excavation at AOC 6 was warranted. EPA Region 3 concurred with this determination.

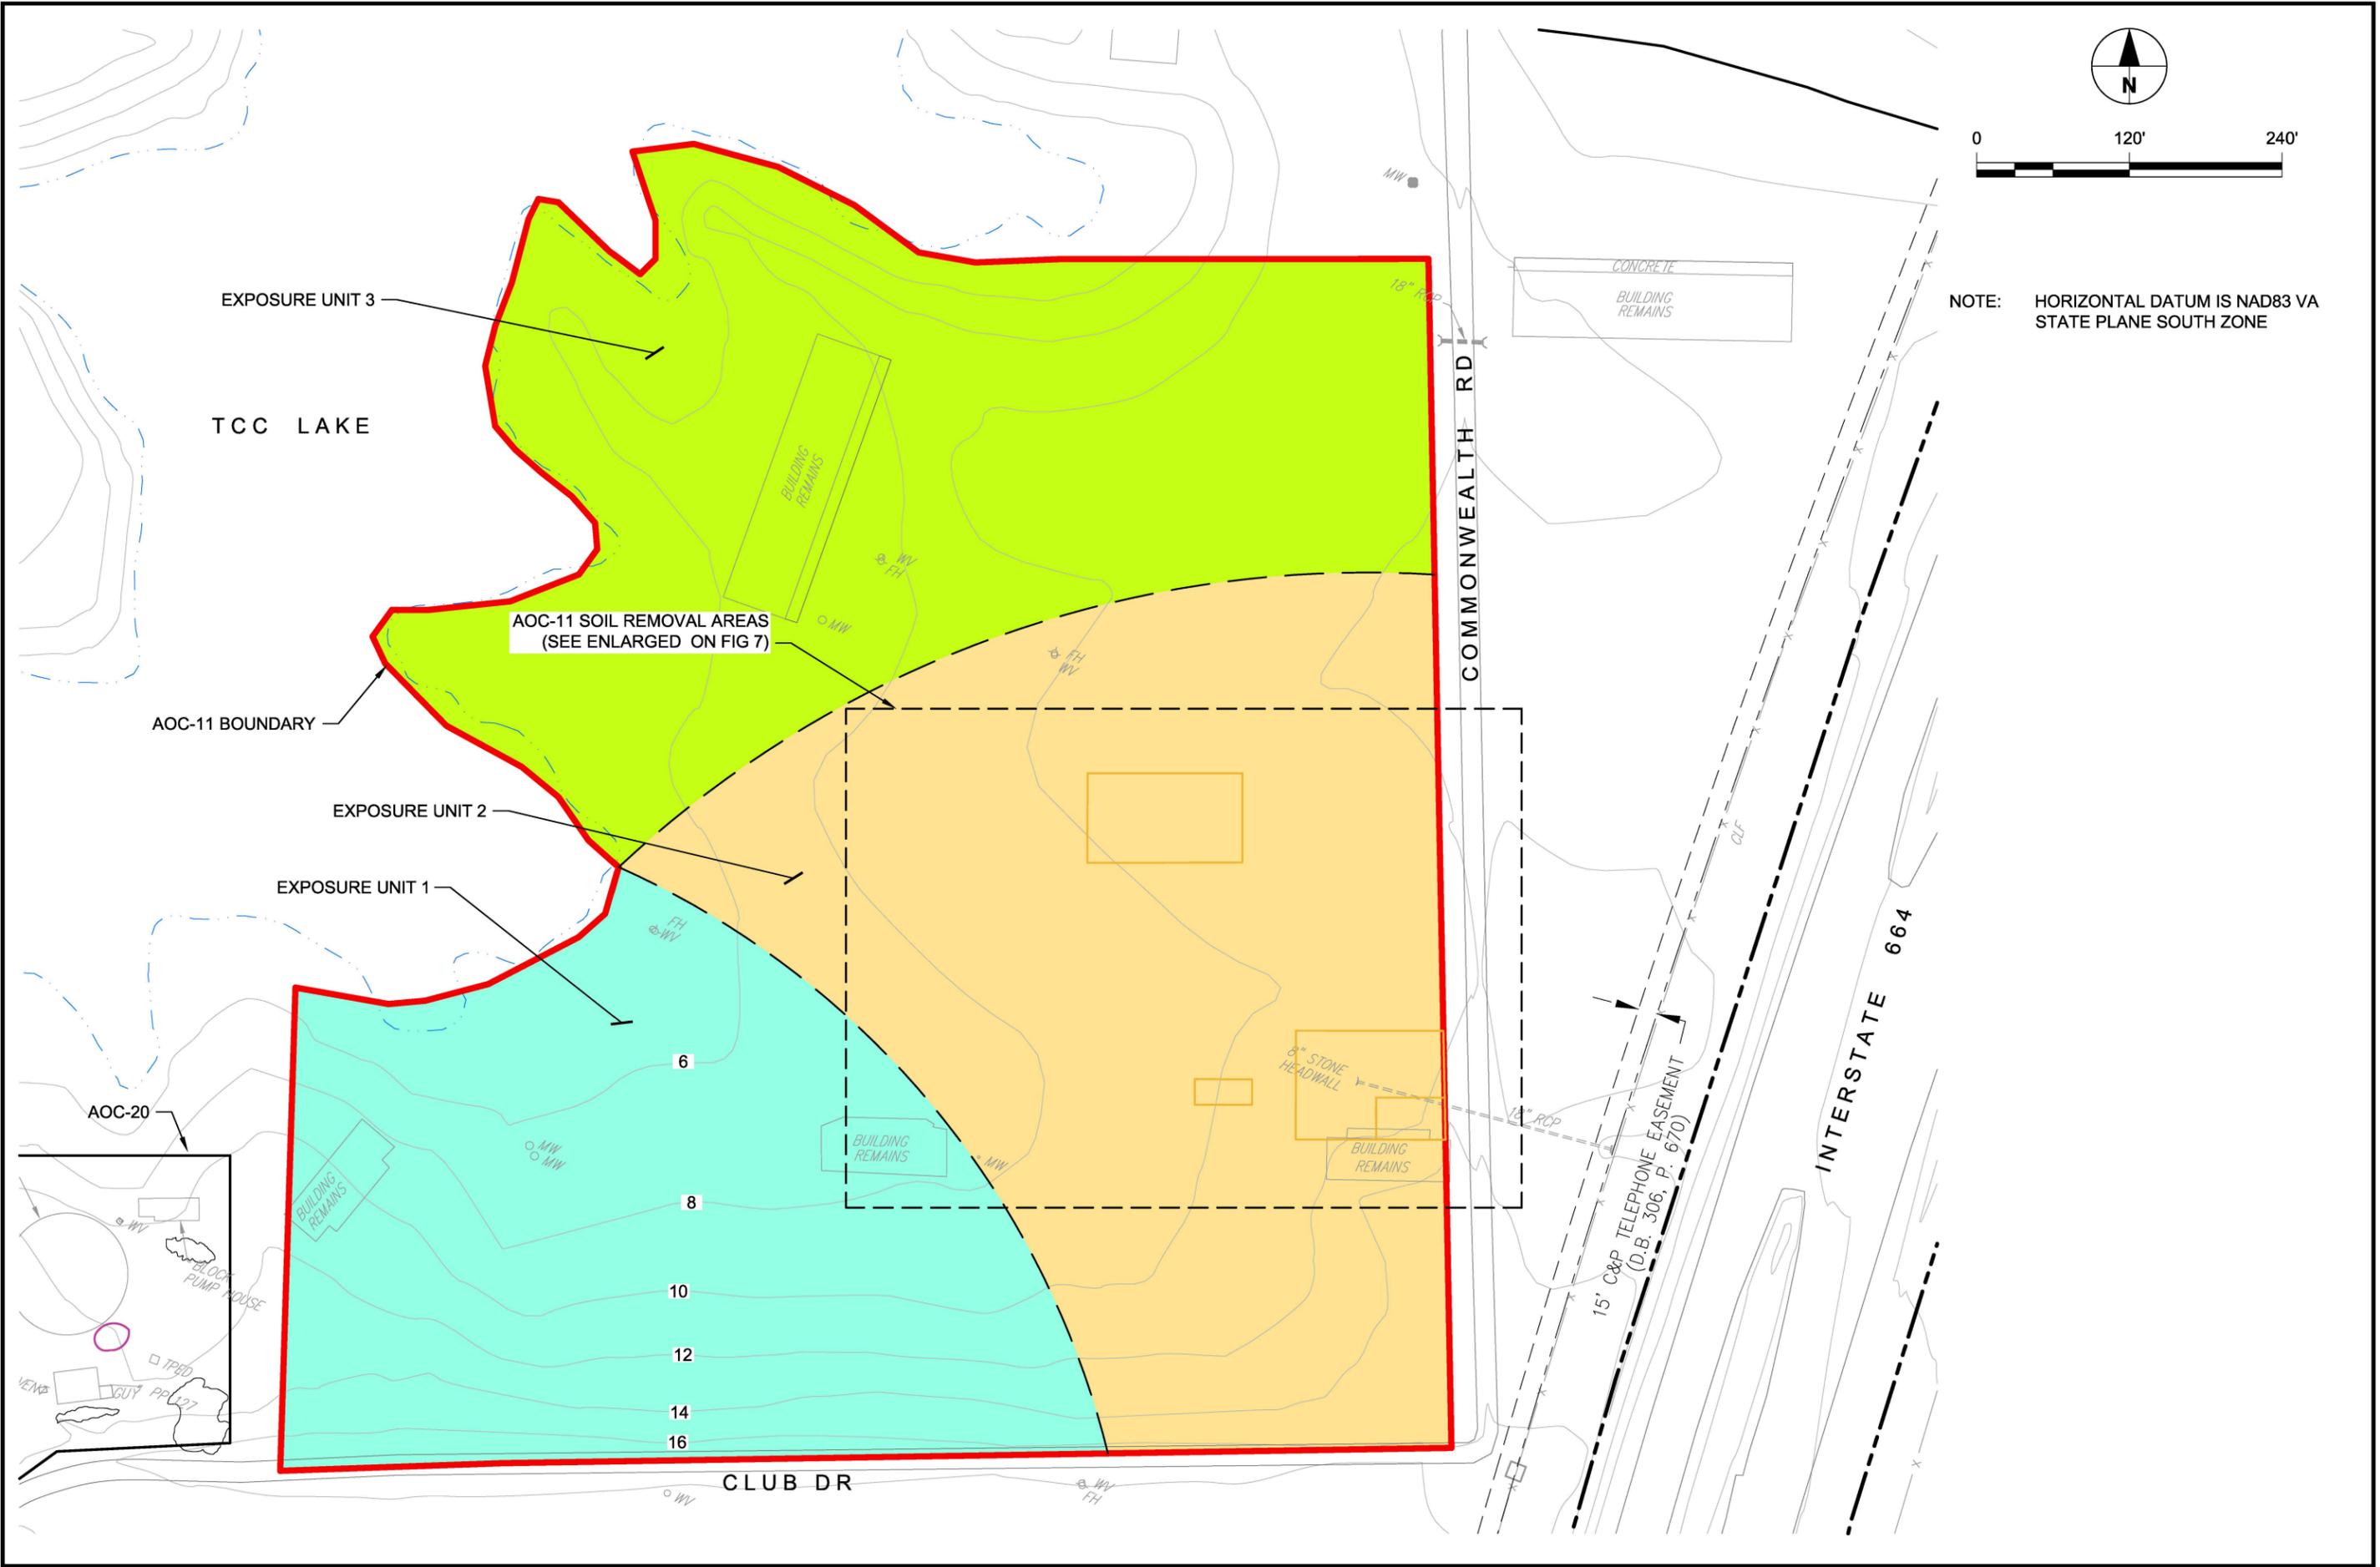
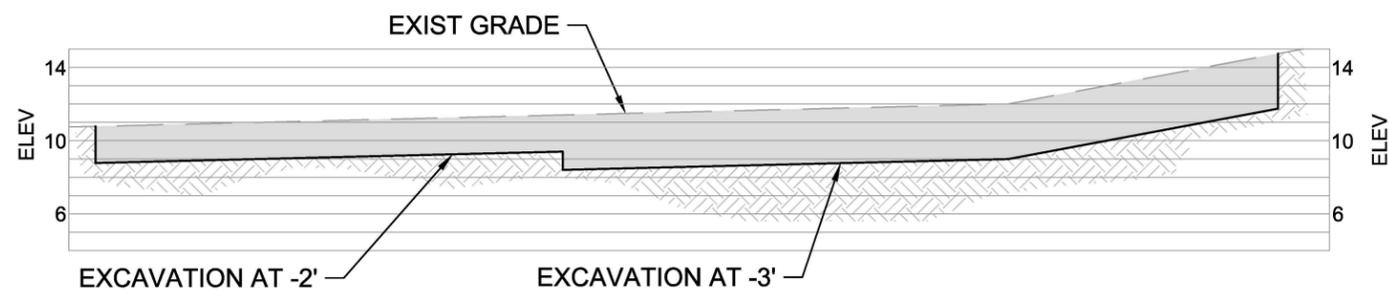
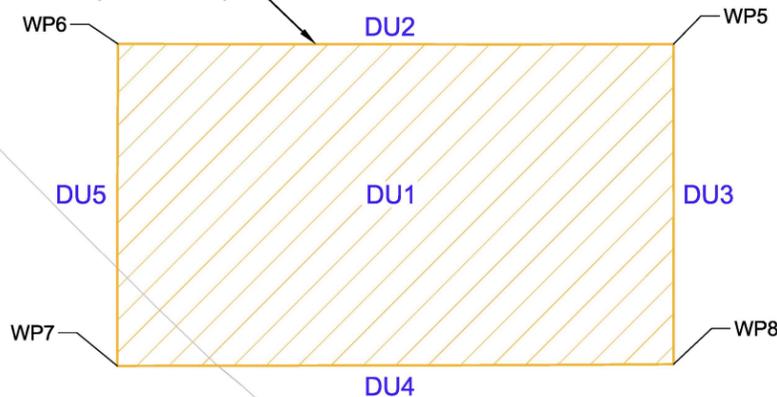
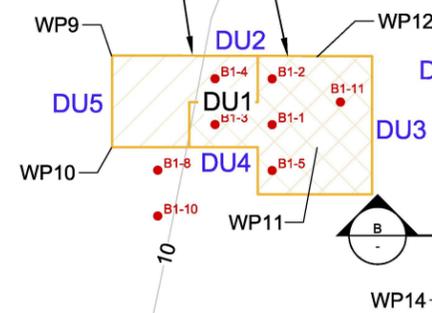
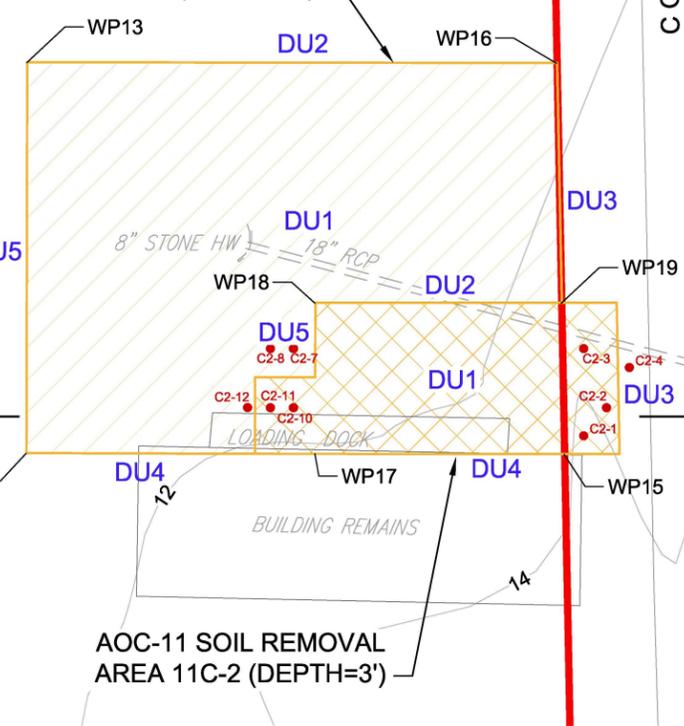
Filename: 64543-TCCREF SRCR-FIG06-AOC11.DWG Plotted: 6/8/2018 11:43:15 AM

PROFILE B

AOC-11 SOIL REMOVAL AREA 11A-1 (DEPTH=1')

AOC-11 SOIL REMOVAL AREA 11B-1 (DEPTH=3')

AOC-11 SOIL REMOVAL AREA 11B-1 (DEPTH=2')

AOC-11 SOIL REMOVAL AREA 11C-1 (DEPTH=2')

AOC-11 SOIL REMOVAL AREA 11C-2 (DEPTH=3')

Several rounds of confirmation sampling and additional over-excavation were completed at AOC-11 excavation areas B-1, C-1 and C-2. The process for confirmation sampling and over-excavation is generally described in the sections below. Additional detail can be found in three memorandums presented in **Appendices H.1, H.2 and H.3**.
