PUBLIC NOTICE

Permit Application No. SAJ-2019-04155(SP-MMT)

WATERWAY AND LOCATION: The project would affect waters of the United States associated with C-13 Canal. The project site is located at Oakland Park Boulevard Bridge (No. 860139), over C-13 Canal (FPID 441474-1-52-01), Broward County, Florida.

Overall: To install scour countermeasure protection at the Oakland Park Boulevard Bridge (No. 860139), over C-13 Canal in Broward County.

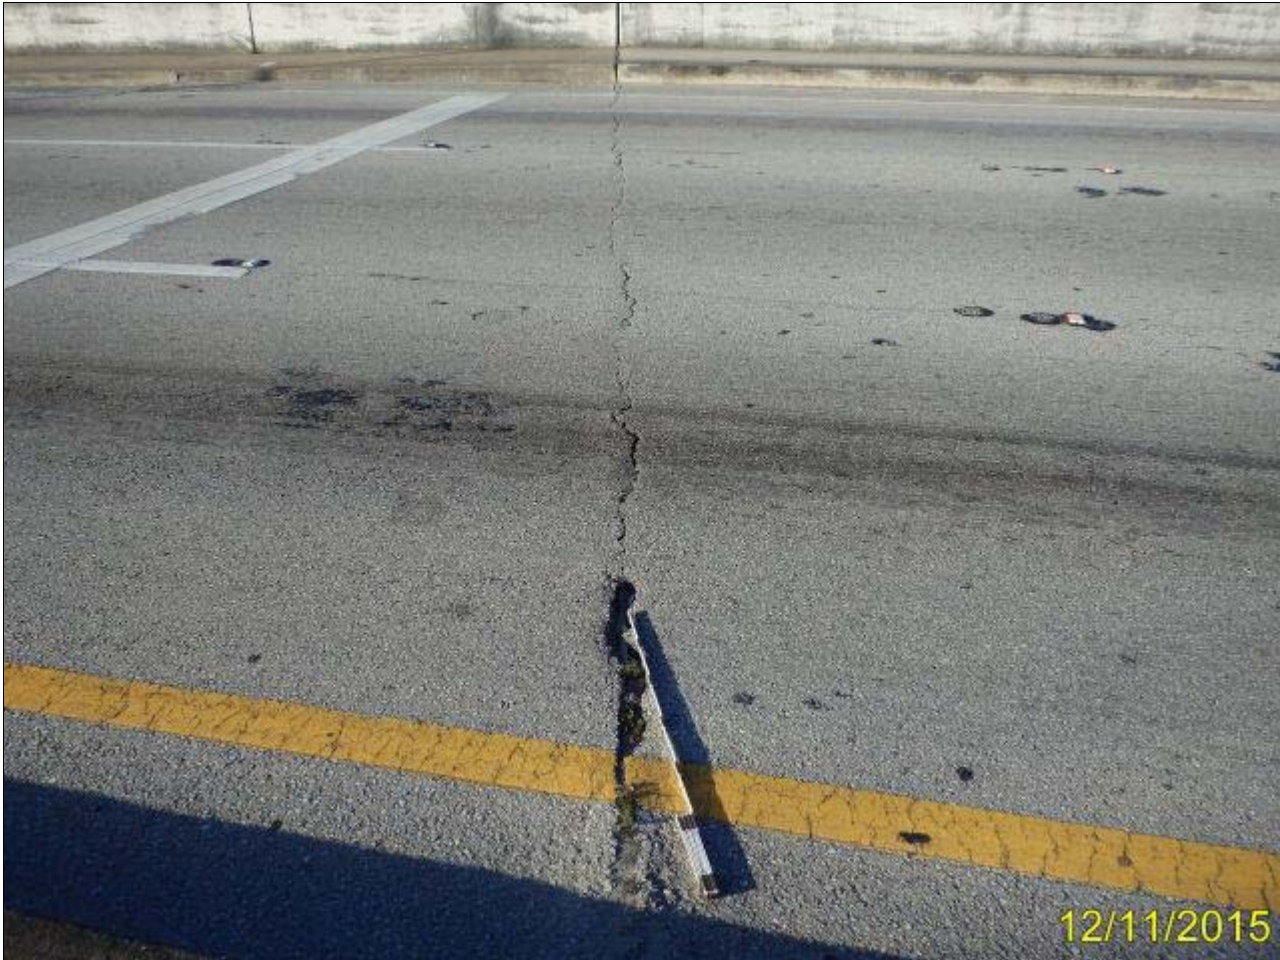
Photo 1 - Element 99 PS Conc Slab

The asphalt over the expansion joints has full roadway width x 1/2in. wide transverse cracks – INCREASE. Refer to photo 1.

Transverse crack and pothole over Abutment 1 joint eastbound

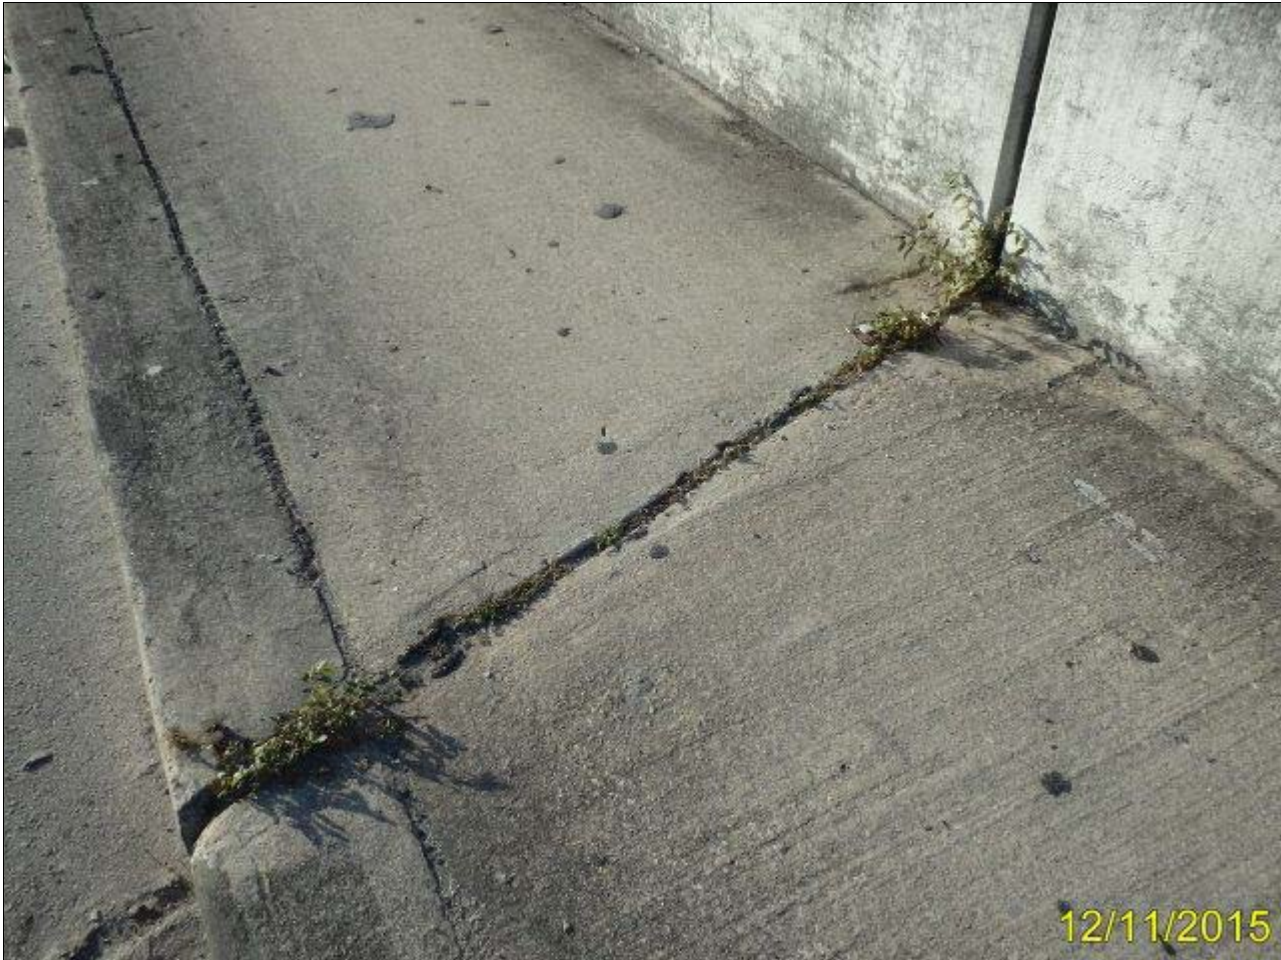
Photo 2 – Element 301 Pourable Joint Seal

Bent 3 left (north) sidewalk joint filled with dirt and vegetation

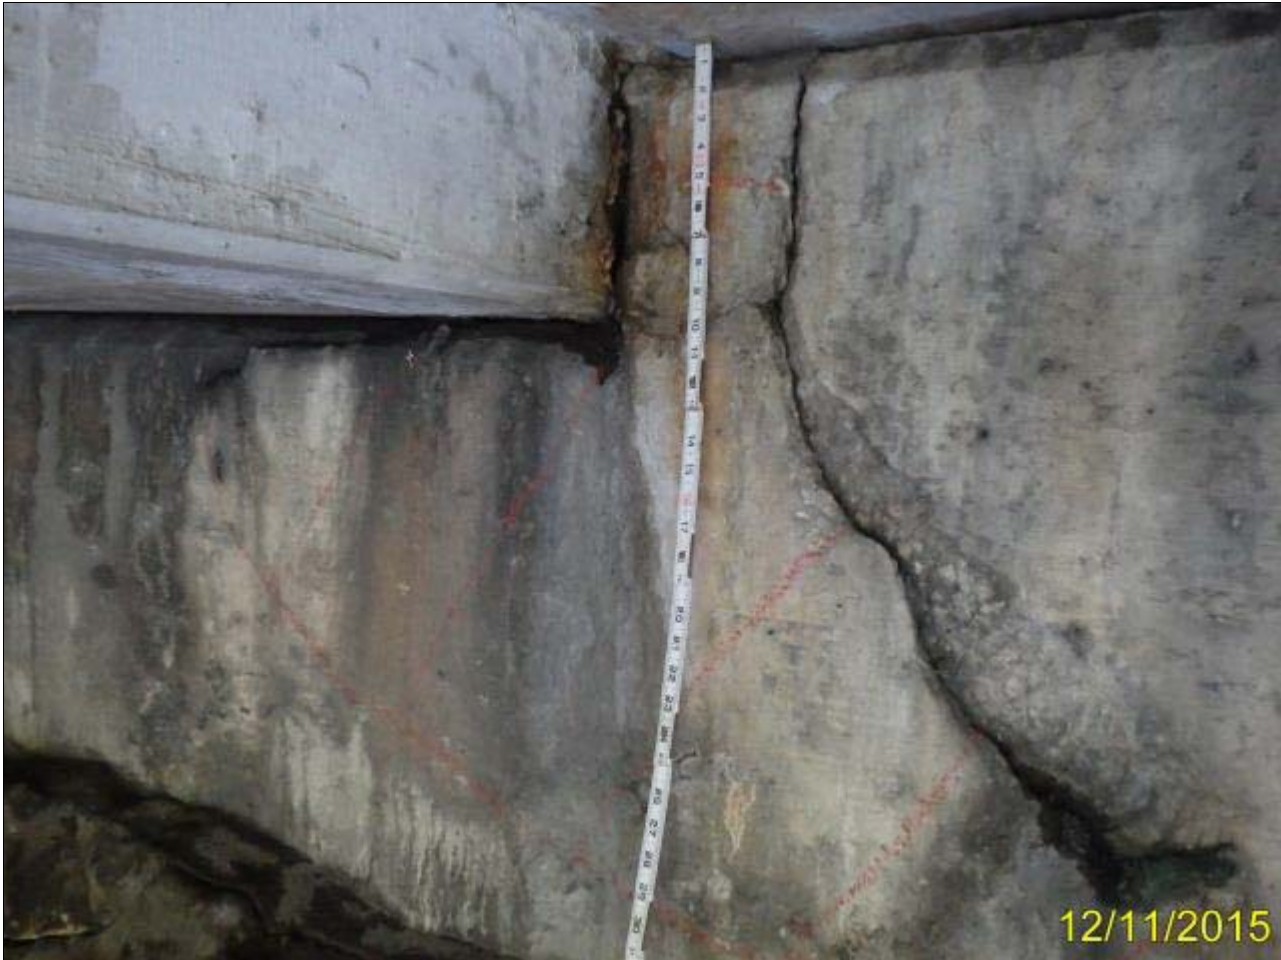
Photo 3 - Element 215 R/Conc Abutment

Abutment 1 cap has a 3-1/2ft. x 30in. x 1-1/2in. spall/delamination under Slab Units 1-2 and 1-3 – INCREASE. Refer to photo 3.

Spall/delamination in Abutment 1 cap under Slab Units 1-2 and 1-3

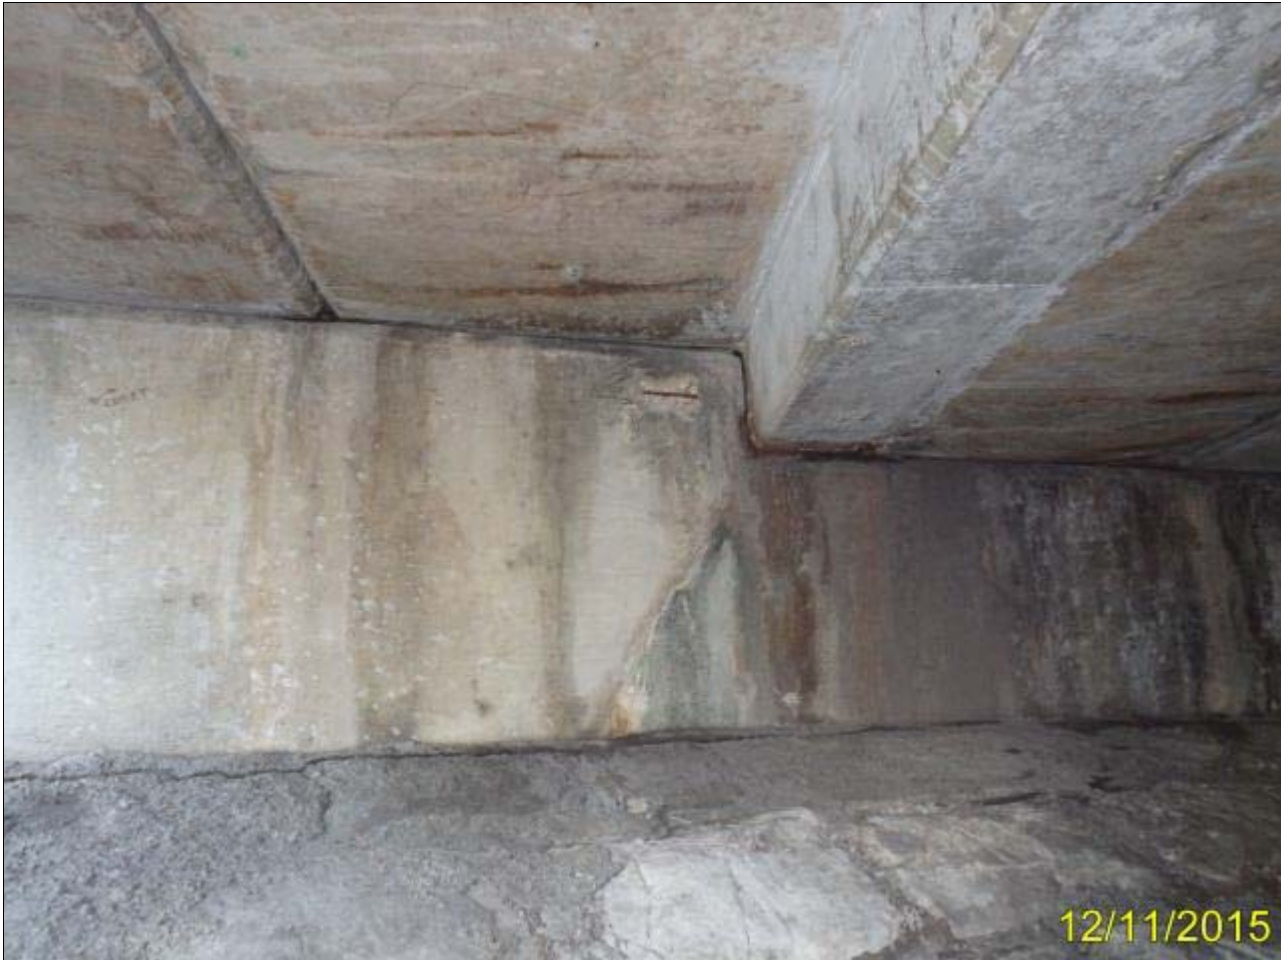
Photo 4 - Element 215 R/Conc Abutment

Abutment 4 cap has a 5in. x 3in. x 1in. spall with 5in. of exposed rebar below Slab Unit 3-2 – NO CHANGE. Refer to photo 4.
