**DEPARTMENT OF THE ARMY
JACKSONVILLE DISTRICT CORPS OF ENGINEERS
COCOA REGULATORY FIELD OFFICE
400 HIGHPOINT DRIVE, SUITE 600
COCOA, FLORIDA 32926**

PUBLIC NOTICE

Permit Application Number SAJ-1992-01224 (JMB)

WATERWAY AND LOCATION: The Sebastian Inlet Sand Bypassing and Channel Maintenance Project is located along the shoreline of the Atlantic Ocean from Sebastian Inlet from Department of Environmental Protection (FDEP) monuments R-3 to R-17, in Sections 20 and 29, Township 30 South, Range 39 East, Sebastian Inlet, Indian River County, Florida.

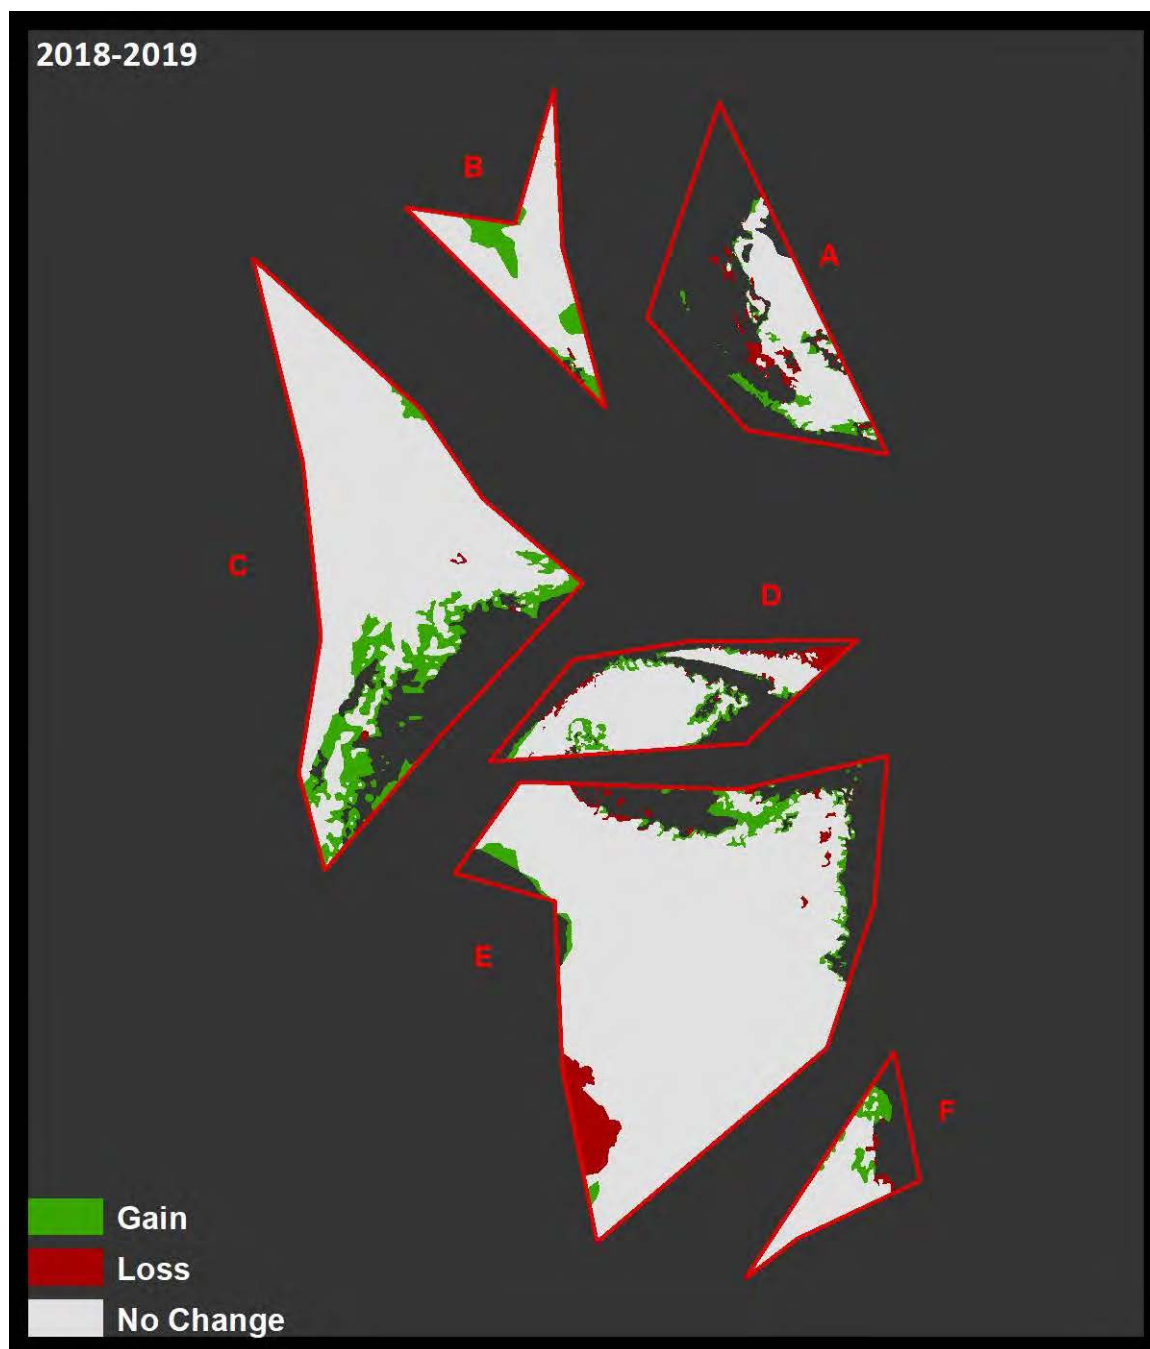
Figure 2-3 Spatial distribution of inter-year change in seagrass coverage within the mitigation boundaries. Gains are depicted as - green, losses - red, and areas consistent between years - gray. Analysis included 2018 and 2019 data.

To estimate changes in the distribution of seagrass within the flood tidal shoal, finalized seagrass coverage feature classes were compared between 2018 and 2019 for regions of “Gain” and “Loss.” ESRI ArcGIS 10.5.1 was used to cut the areas of non-overlap from alternating comparisons of the two datasets, leaving a remaining portion as a static region of “No Change.” A visual depiction of these changes can be seen in Figure 2-3.

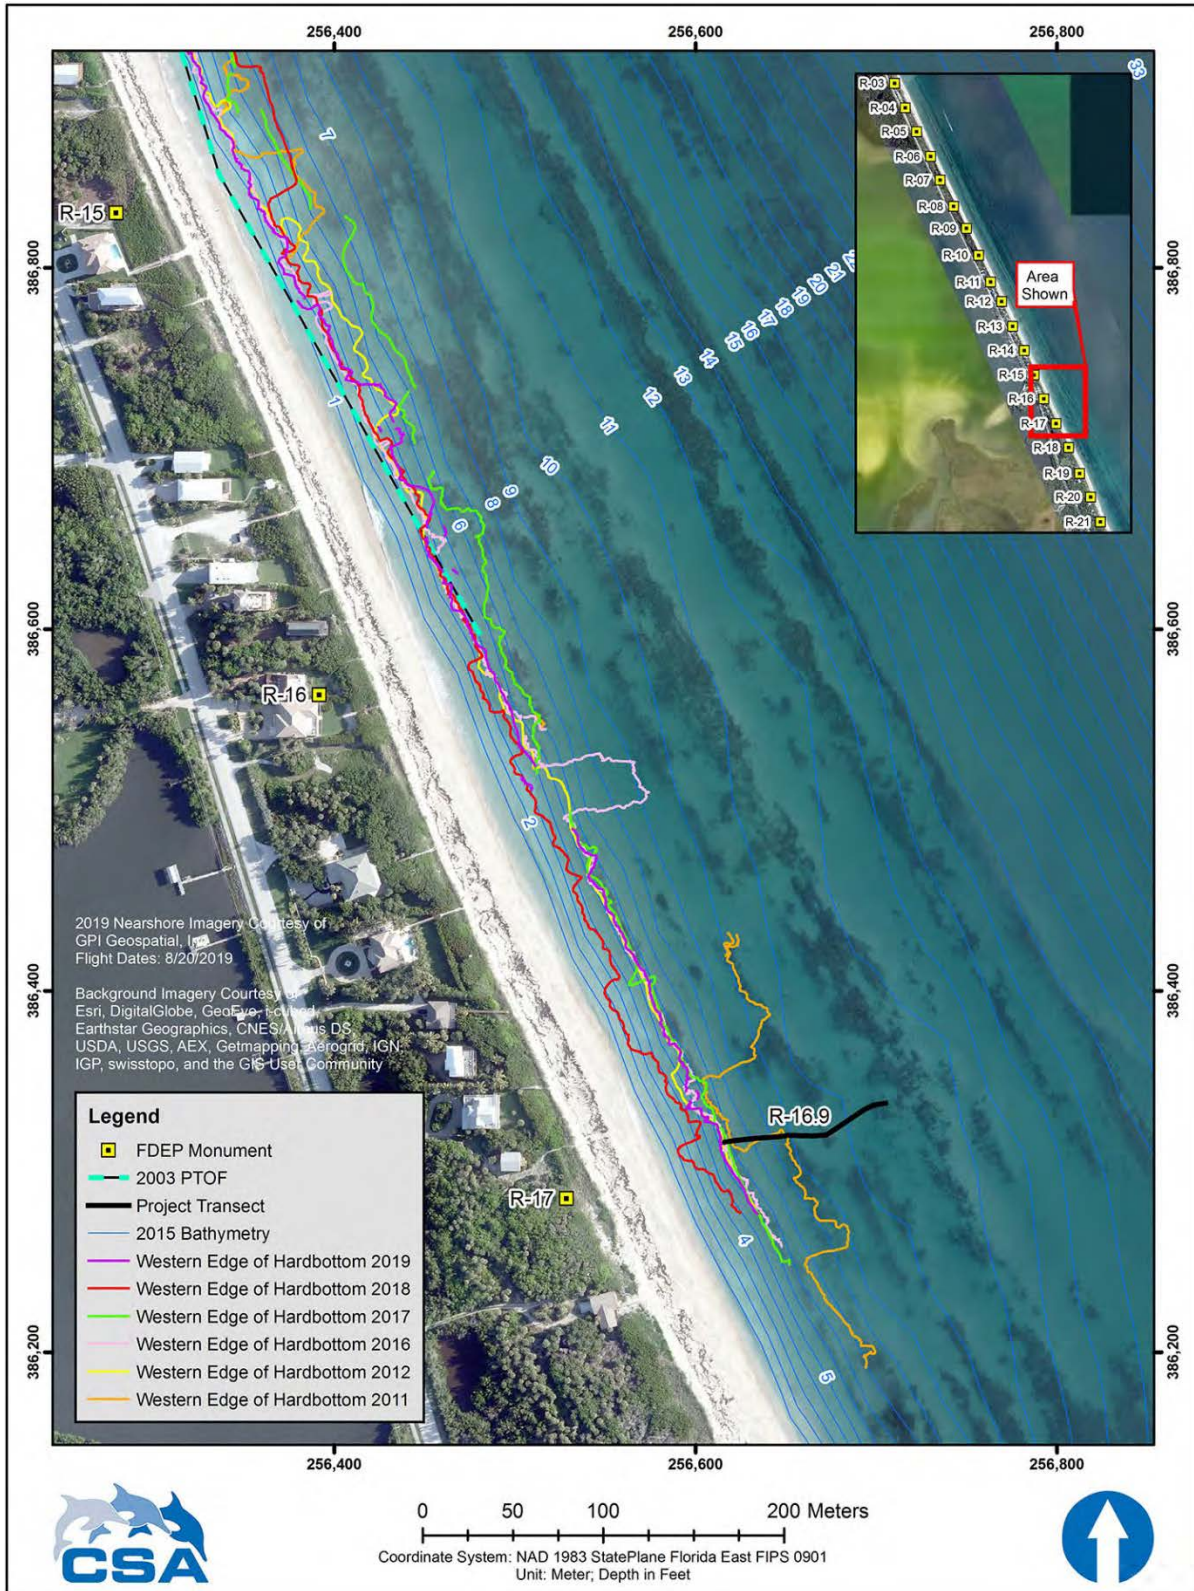
Figure 15. Portion of the nearshore (western) edge of hardbottom edge from R-15 to R-17.5 mapped in 2018 and 2019 for the Sebastian Inlet District Sand Bypassing Projects. PTOF = permitted toe of fill.

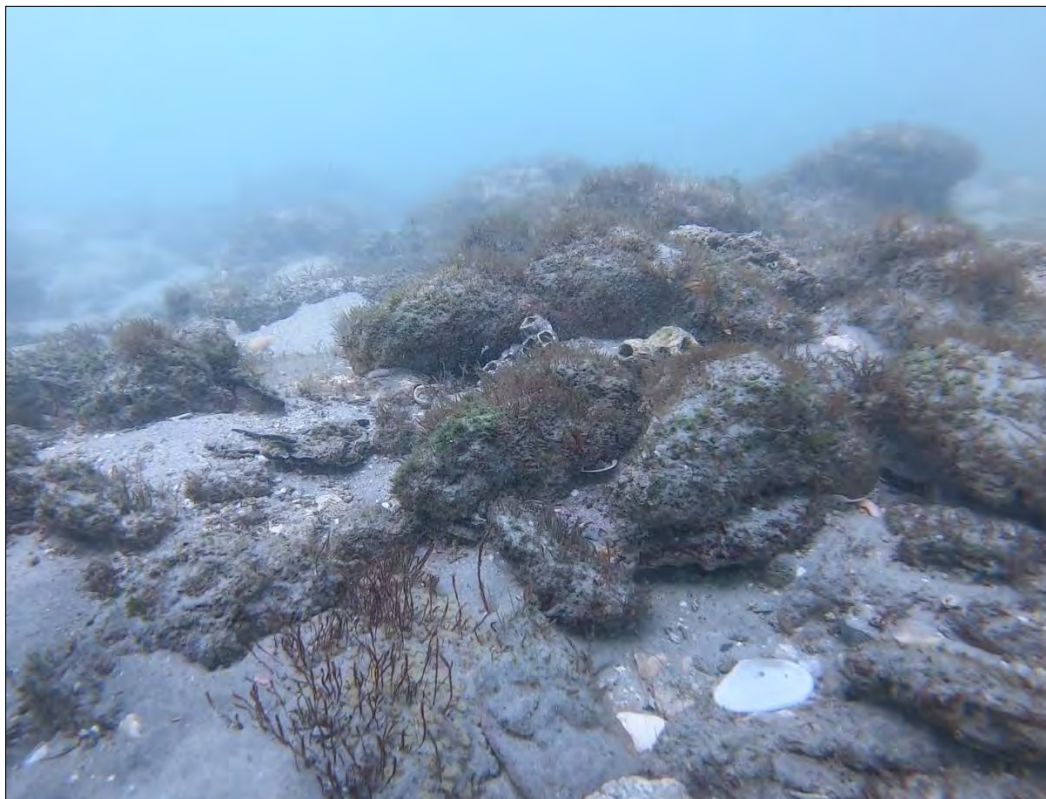
Photo 3. Low relief portion of the patchy nearshore hardbottom edge near R-5, showing turf algae, *Bryocladia cuspidata*, *Caulerpa prolifera*, and the invasive barnacle, *Megabalanus* spp. Image scale approximately 2.5 m².

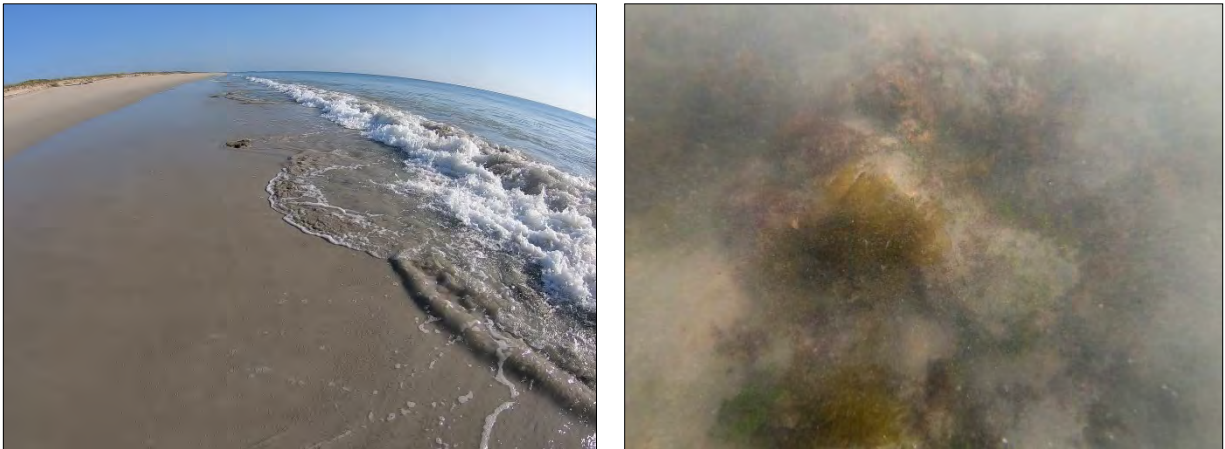
Photo 4. Location on shore (a) of low-relief, patchy, low tide exposed hardbottom near R-10, and (b) submerged hardbottom near R-9 showing brown *Spatoglossum* sp., *Ulva lactuca*, and red turf algae.

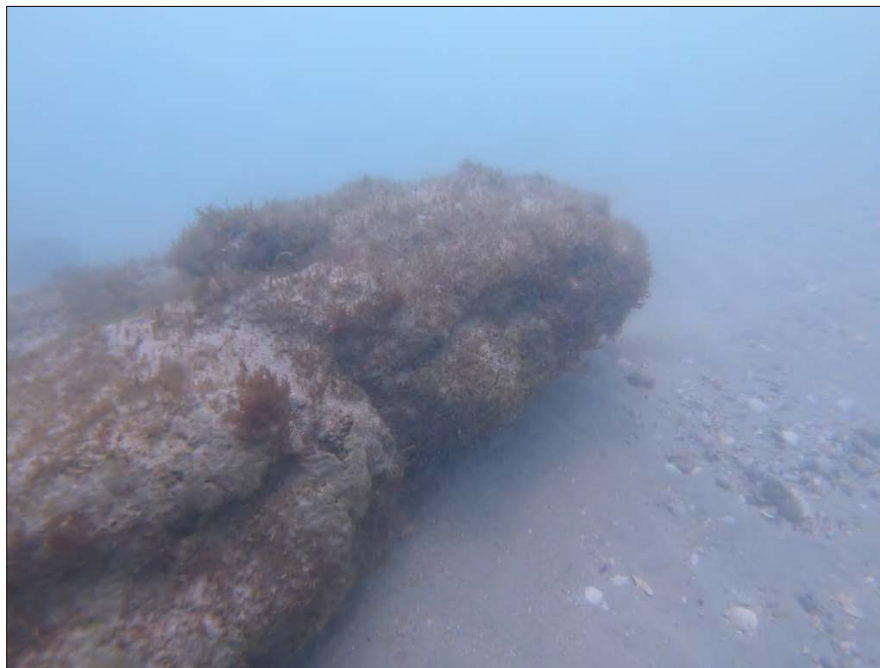
Photo 5. Medium relief (1 m), hardbottom outcrop near R-16, showing turf algae, *Bryocladia cuspidata*, unidentified red macroalgae, sand, and shell hash along the nearshore hardbottom edge.
