# **FINAL CLOSURE REPORT LEAD CONTAMINATED SOIL REMOVAL**

## **Point Vicente Interpretive Center Rancho Palos Verdes, California**

Contract No. DACA05-99-D-0014  
Task Order CQ07  
FUDS Site No. J09CA055800  
Document Control No. 02-400.03-0012

June 2003

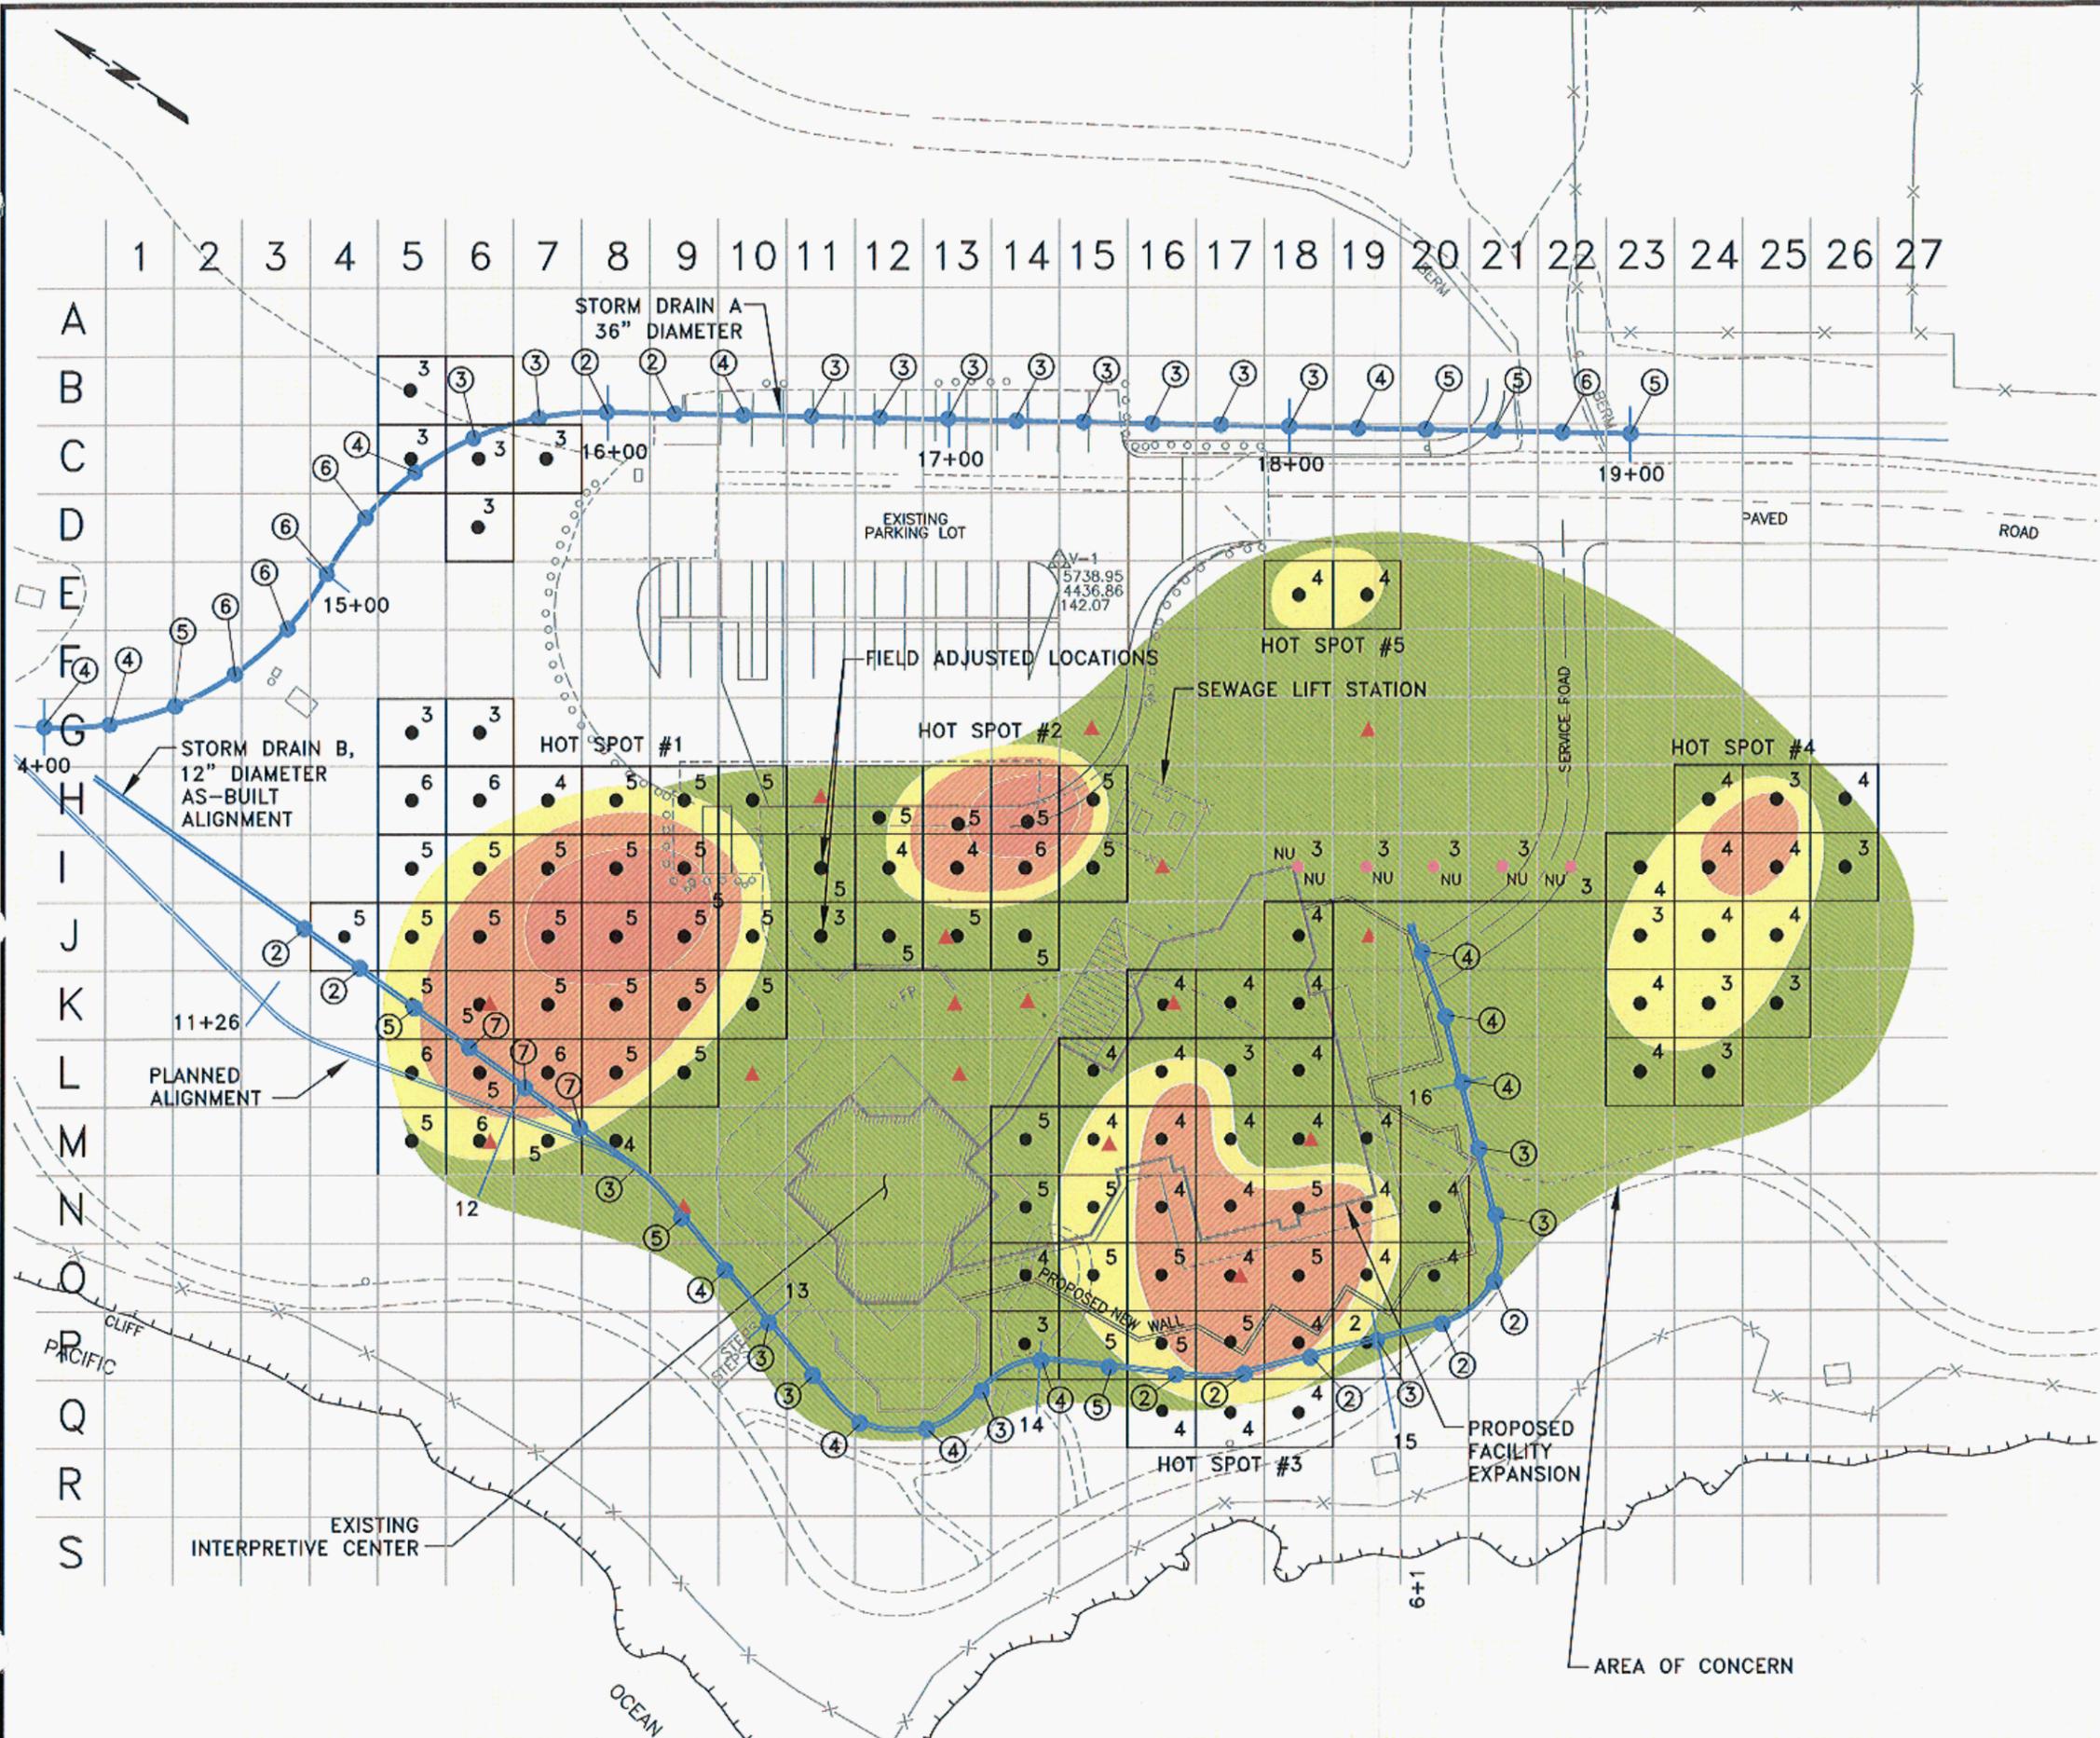
<b>FIGURE 3</b>	
<b>AS-BUILT PRELIMINARY SAMPLE LOCATIONS MAP</b>	
CLIENT: POINT VICENTE INTERPRETIVE CENTER	
LOCATION: RANCHO PALOS VERDES, CALIFORNIA	
DRAWN BY/DATE: EA 2/6/03	DRAWING NO.: 02-400.03-B1
CHECKED BY/DATE:	APPROVED BY/DATE:

Lead contamination above the remedial action level was found in the following sample locations in Hot Spot 1: HS1-J8-3, (“HS1” indicates Hot Spot 1, “J8” is the 20 by 20 grid number, as shown on Figure 3, and “3” indicates the depth of the sample in feet bgs), HS1-J8-6, HS1-I8-3, HS1-H6-4-224 HS1-J7-3, HS1-J7-3-225, HS1-J7-5-226, HS1-I6-2.5, HS1-J9-4-230, HS1-J9-8.5-234, HS1-I9-4-232, HS1-I9-9-231, HS1-J10-4-233, and HS1-I10-4. The two hundred series number at the end of some sample IDs indicates that the sample is a duplicate and was sent to either Associated Laboratories or the USACE QA laboratory.

Drilling in the area of the proposed utilities (Grids I18 through I22) extended to a depth of six feet bgs. Lead-contaminated soil above the remedial action level was not found in these samples. The locations of the utilities as shown in Figure 3 of the Final Work Plan (ITSI, 2002) were

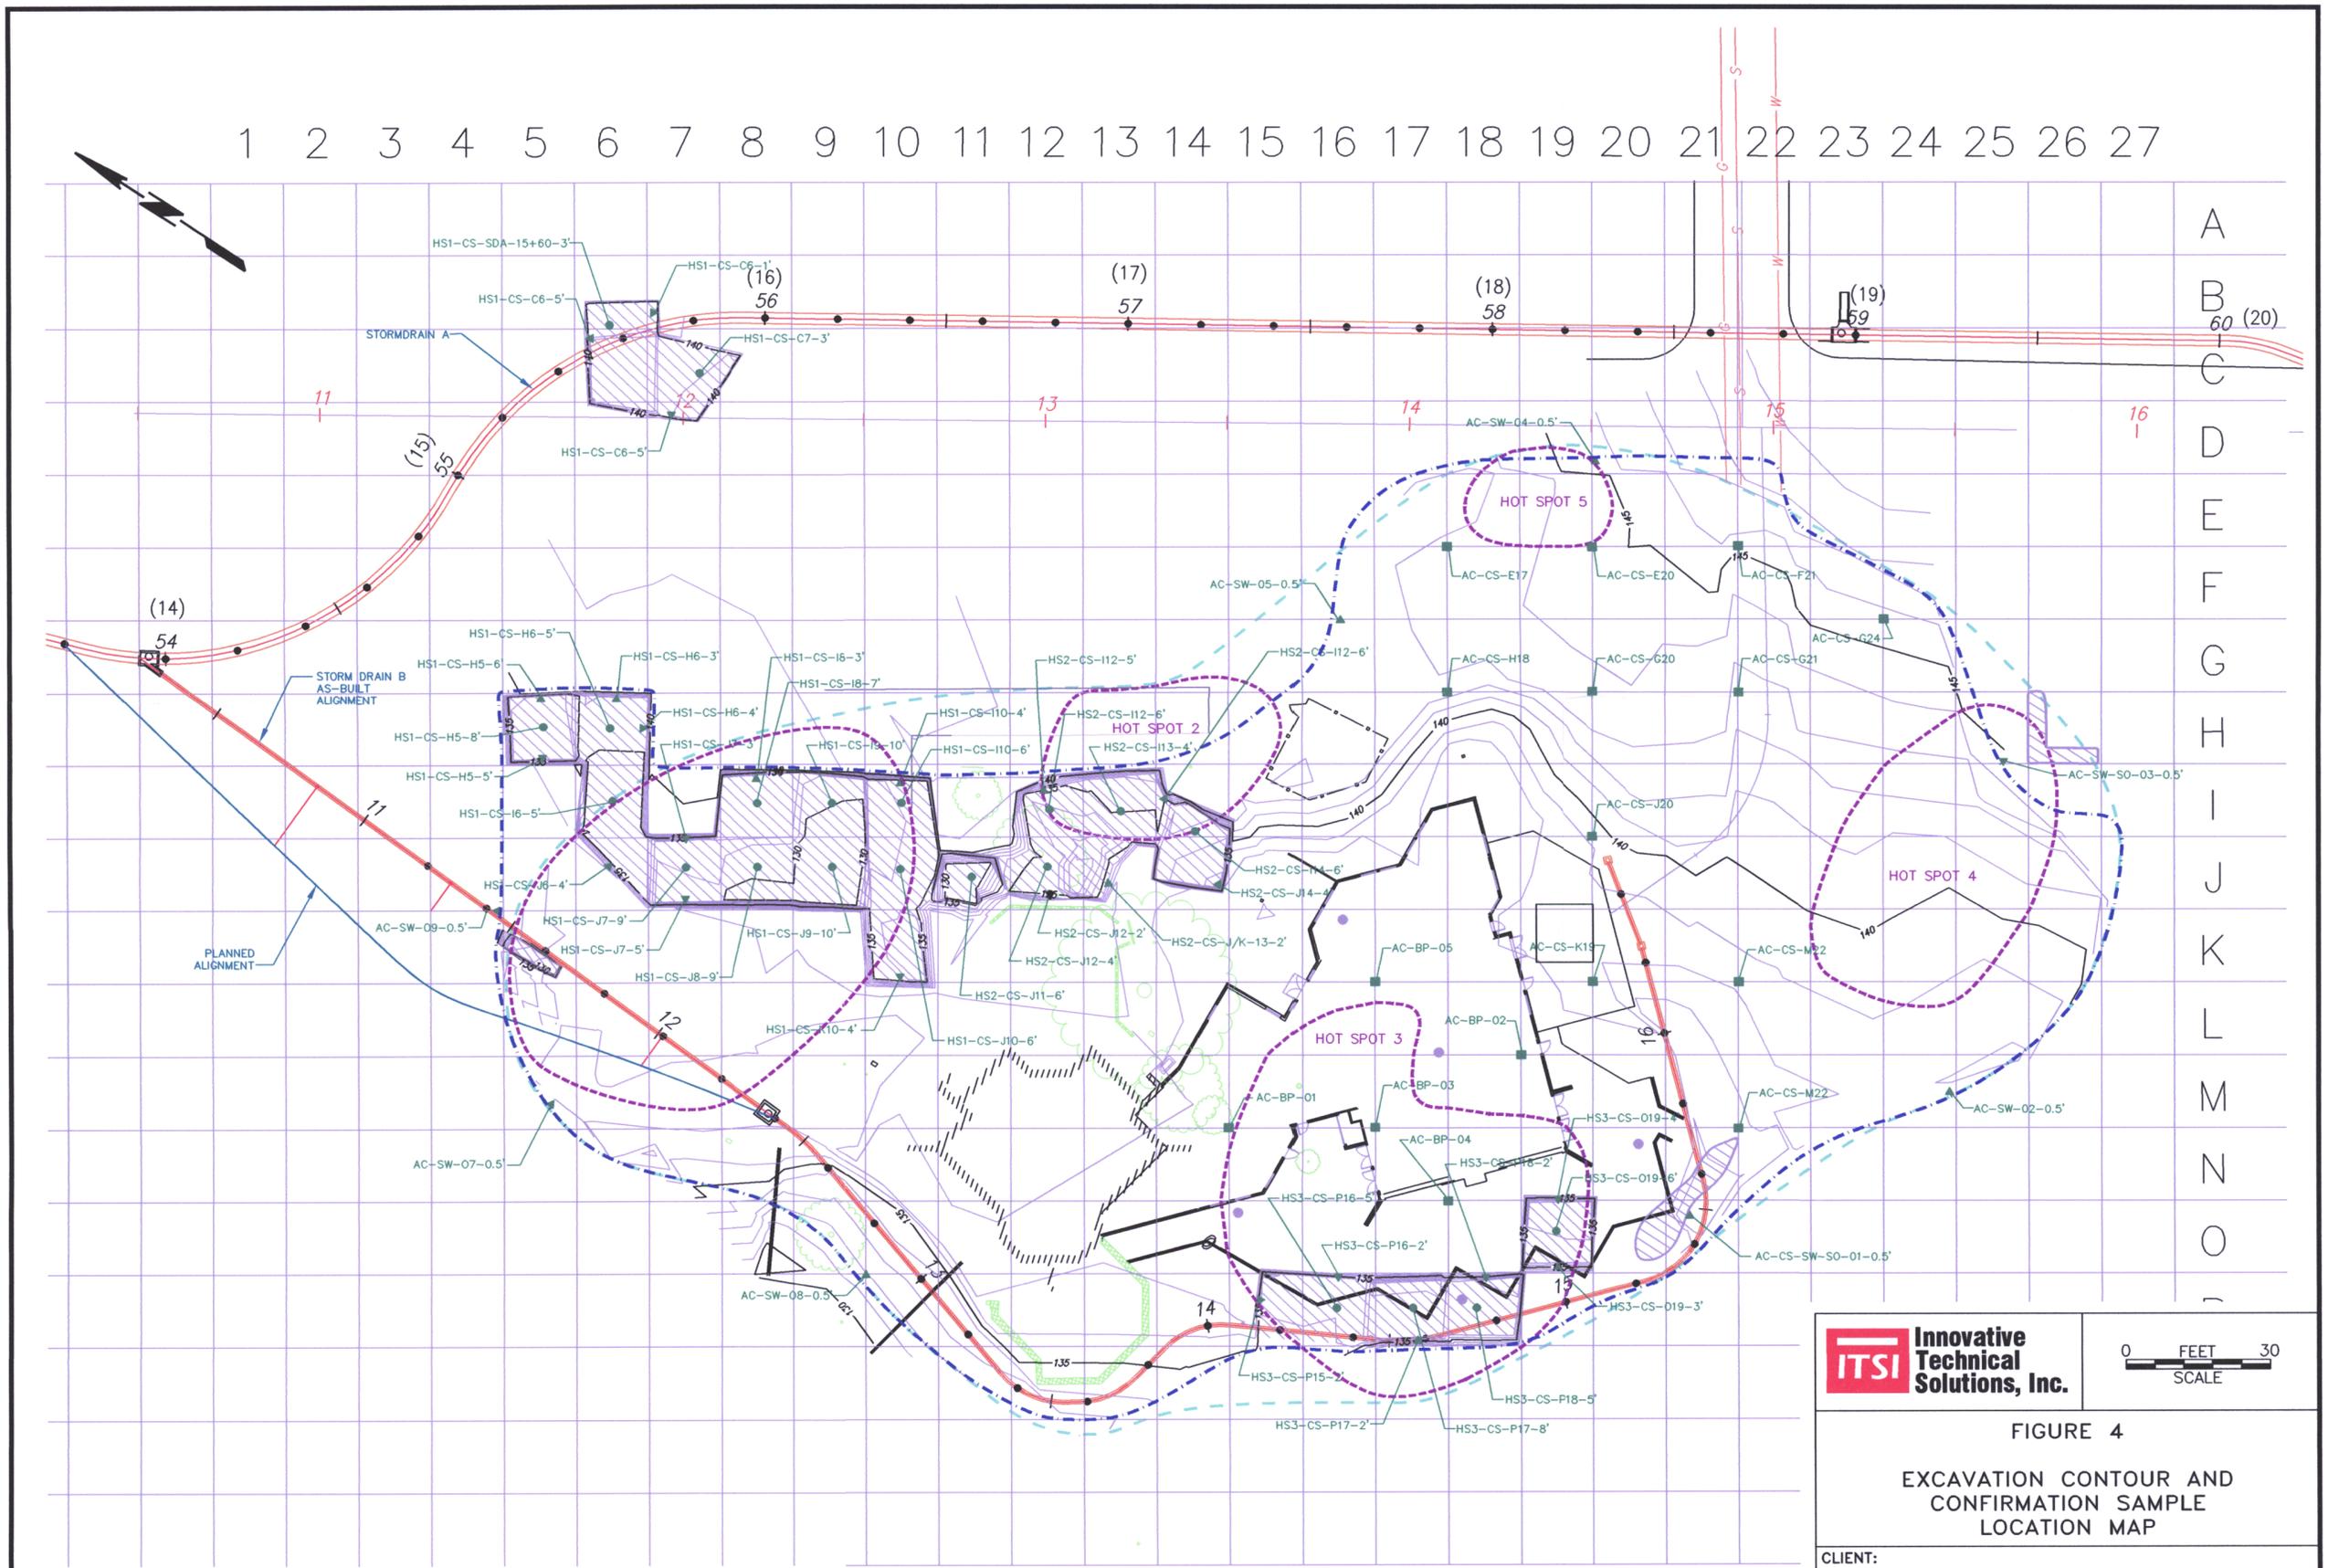
<b>FIGURE 4</b>	
<b>EXCAVATION CONTOUR AND CONFIRMATION SAMPLE LOCATION MAP</b>	
CLIENT: <b>POINT VICENTE INTERPRETIVE CENTER</b>	
LOCATION: <b>RANCHO PALOS VERDES, CALIFORNIA</b>	
DRAWN BY/DATE: <b>EA 1/16/03</b>	DRAWING NO.: <b>02-400.03-C2</b>
CHECKED BY/DATE:	APPROVED BY/DATE:

Generally, areas of high lead contamination coincide with the previous investigations in the Hot Spot areas (Figure 4). However, the vertical extent of the lead contamination was unknown, and was found to be deeper than expected in Hot Spots 1 and 2. In areas of known lead contamination, previous investigations had not reached the bedrock depth of approximately 8 to 12 feet bgs.

This section describes the excavation of the known “Hot Spot” soil areas defined as Area A. Area A includes the five hot spots, and the future proposed building pad as it coincides with Hot Spot 3. The limits of the excavations and the locations of final confirmation samples are indicated on Figure 4. Several step-outs were conducted in the areas defined as Hot Spots 1, 2, and 3. Hot Spots 4 and 5 were found to have no soil that exceeded the remedial action level.

Some areas were not excavated to the full extent of the Area B boundaries. The southeast side of the site is home to Coastal Scrub Sage, and this vegetation was protected to the fullest extent possible. An area of about 50 feet by 30 feet within the Area B was not excavated; however, some of this sage unfortunately did have to be removed because it coincided with an area of high lead-contamination that was found during confirmation sampling of the Area A sidewall. An area approximately 10 feet by 40 feet was excavated in this area (Figure 4, near sample location AC-SW-SO-3-0.5).

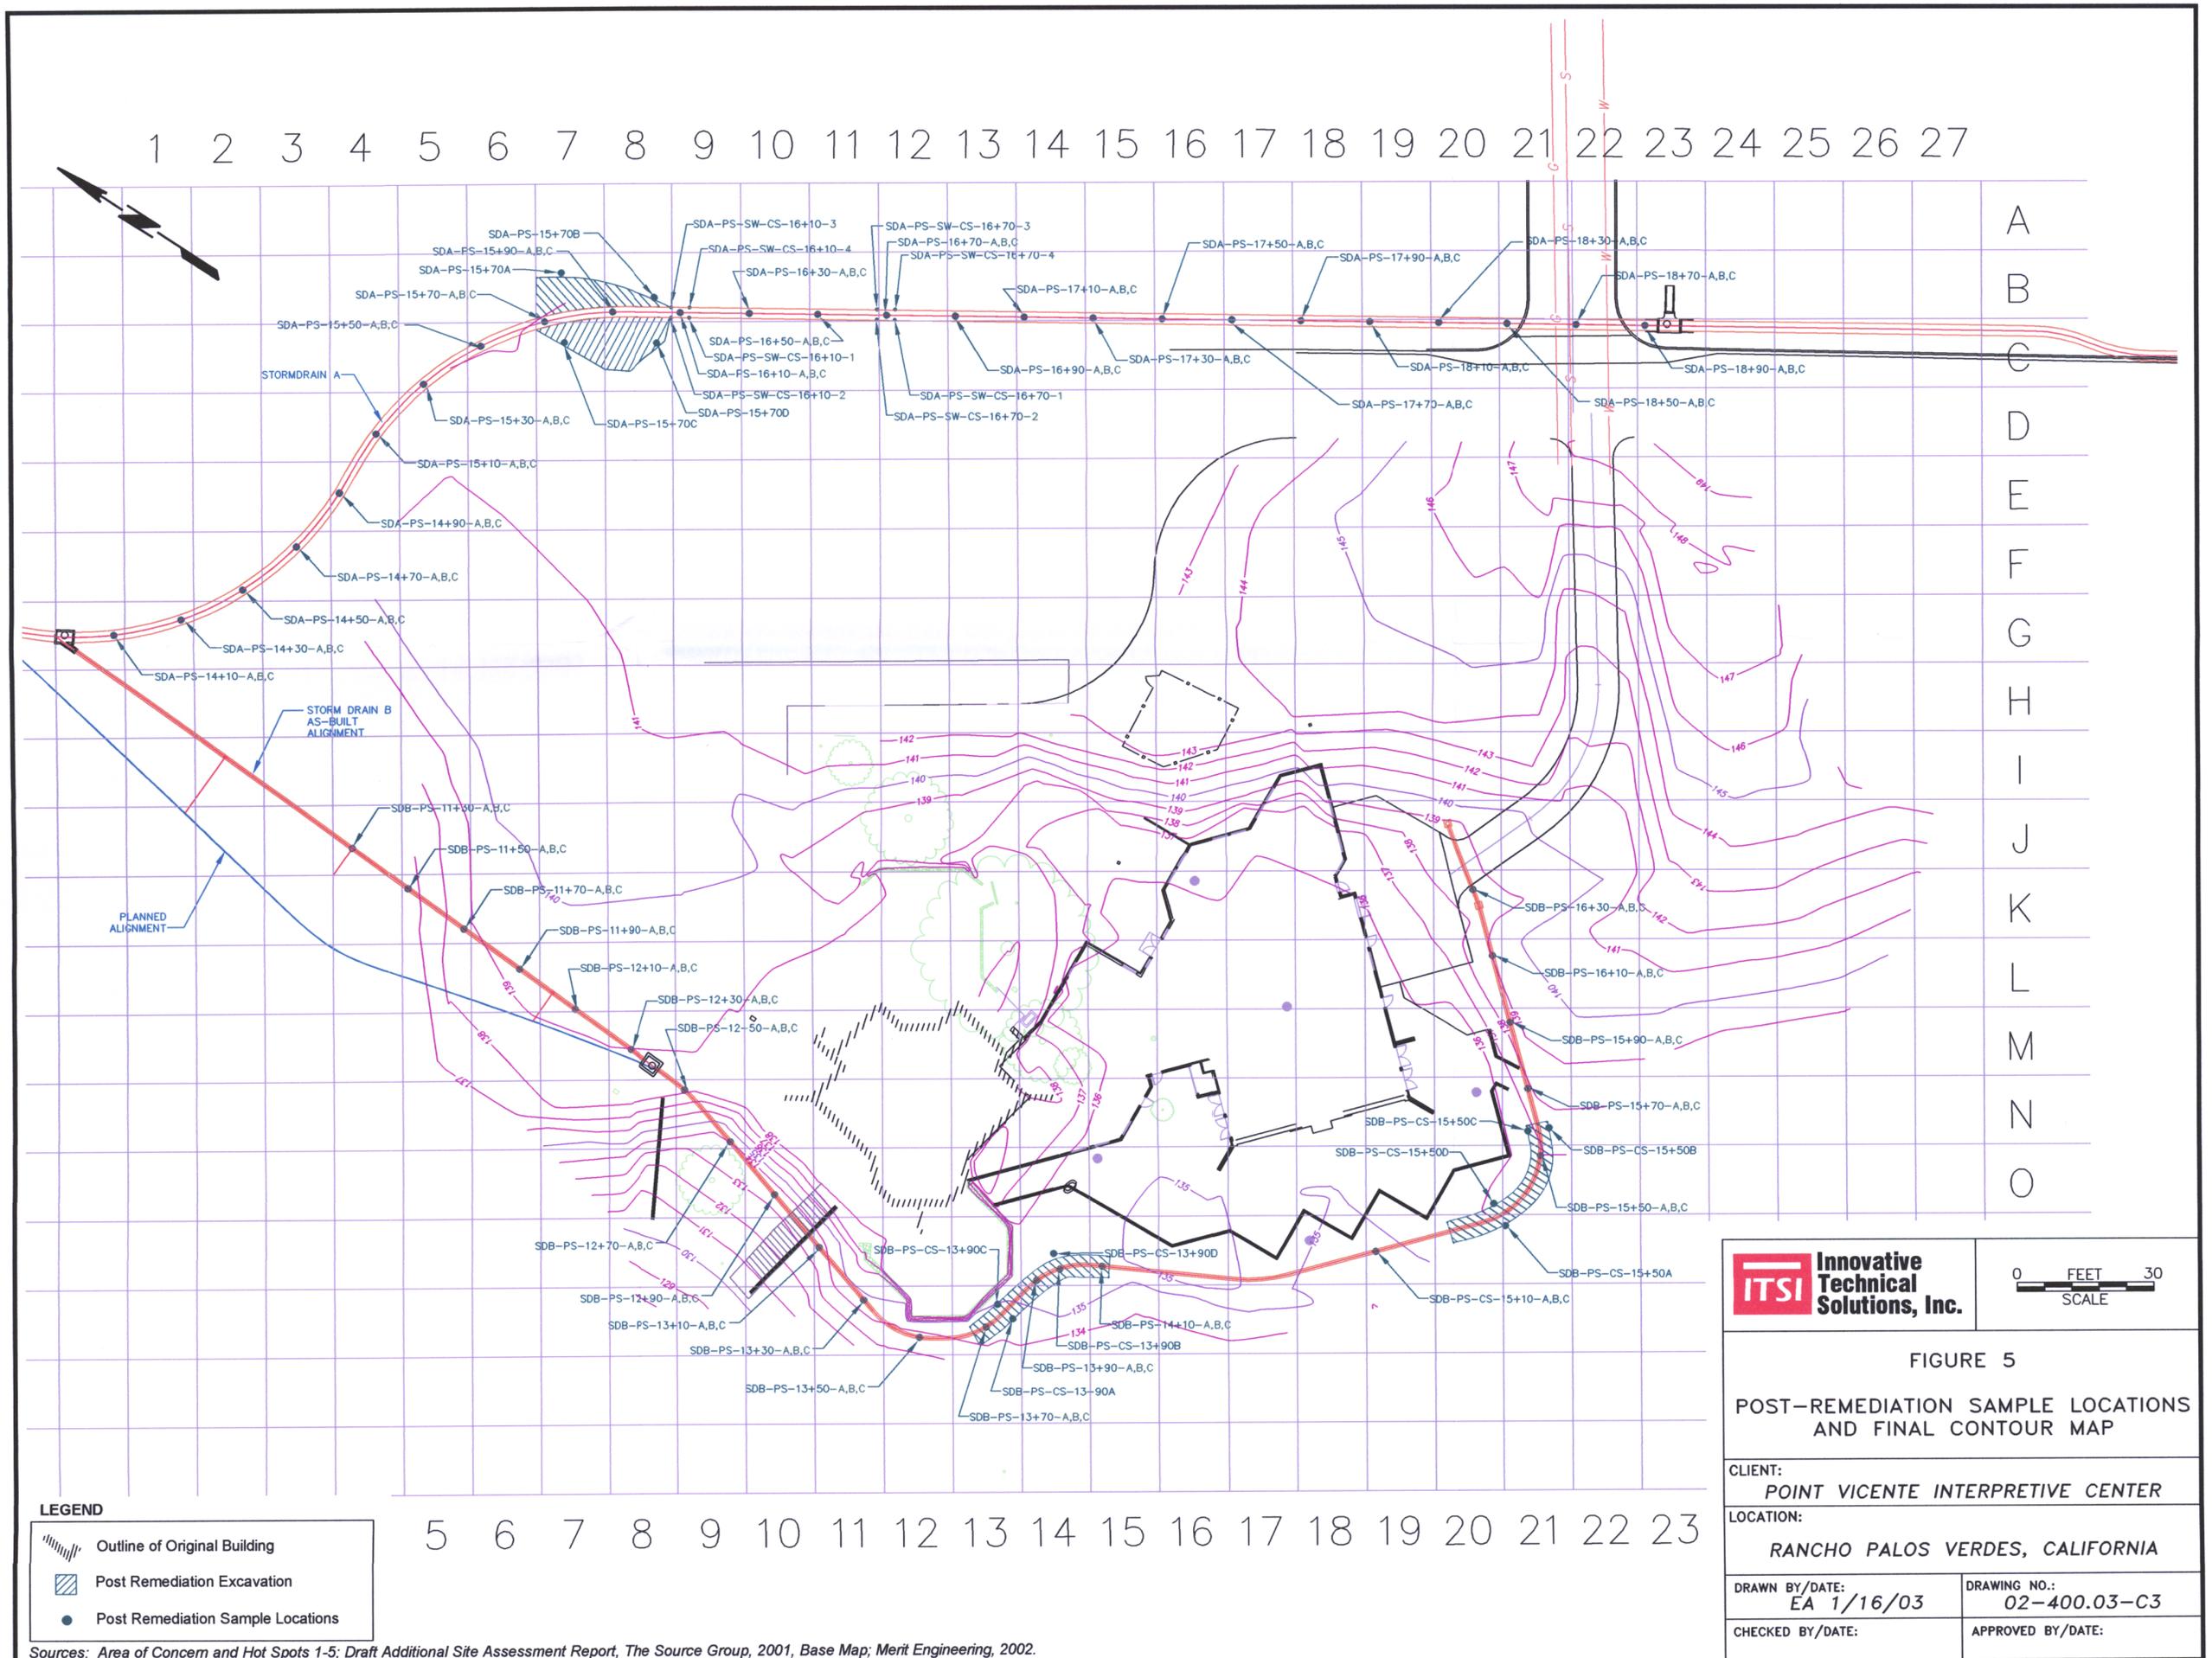
CLIENT: POINT VICENTE INTERPRETIVE CENTER	
LOCATION: RANCHO PALOS VERDES, CALIFORNIA	
DRAWN BY/DATE: EA 1/16/03	DRAWING NO.: 02-400.03-C3
CHECKED BY/DATE:	APPROVED BY/DATE:

Two areas along Storm Drain A and two areas along Storm Drain B were found to have lead concentrations in excess of the action level. In these cases, the utility contractor was ordered to stop work in the affected area. ITSI remobilized to the site, excavated and stockpiled the affected soil, collected excavation confirmation samples, and also collected waste characterization samples from the stockpiles. The stockpiles were covered with plastic and later the soil was loaded into trucks and hauled to the Bradley Landfill as Special Waste. Confirmation samples were collected on the excavation sidewalls and bottoms to insure complete removal of contaminated soil. Approximately 134 samples were collected during the post-remediation activities. The limits of the excavations and the post remediation sample locations are shown on Figure 5.

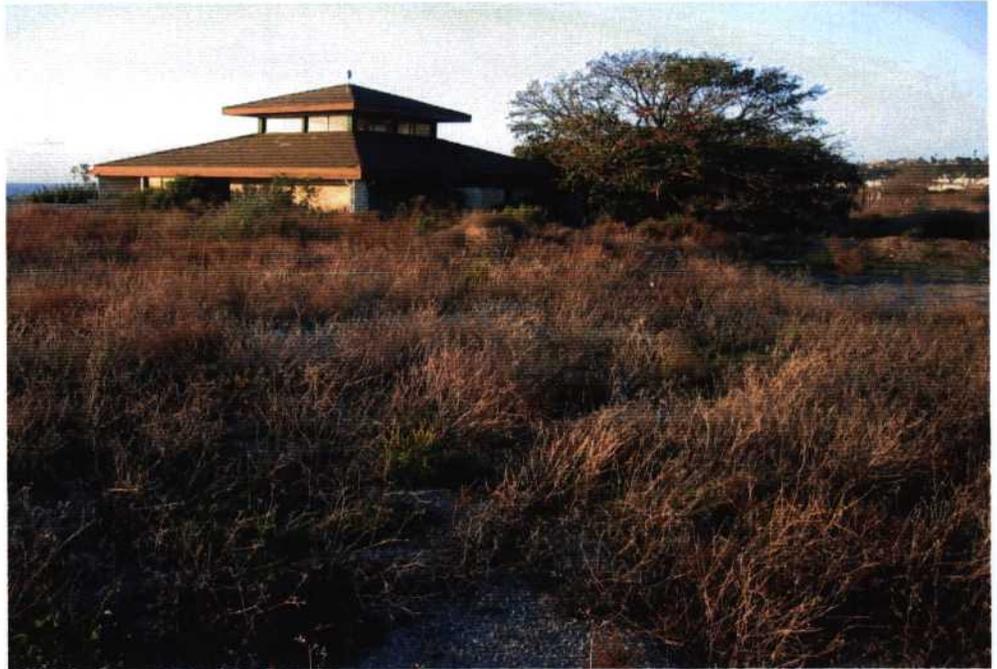
Overlooking Area of Concern.

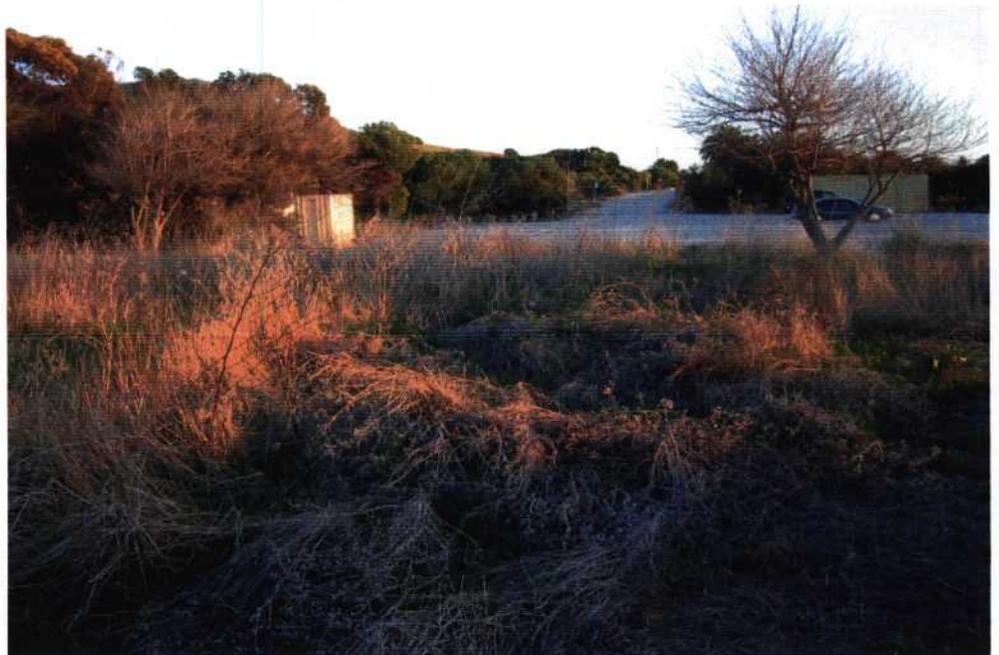
### Photograph No. 3

Storm Drain B and Area of Concern on north side of Interpretive Center.

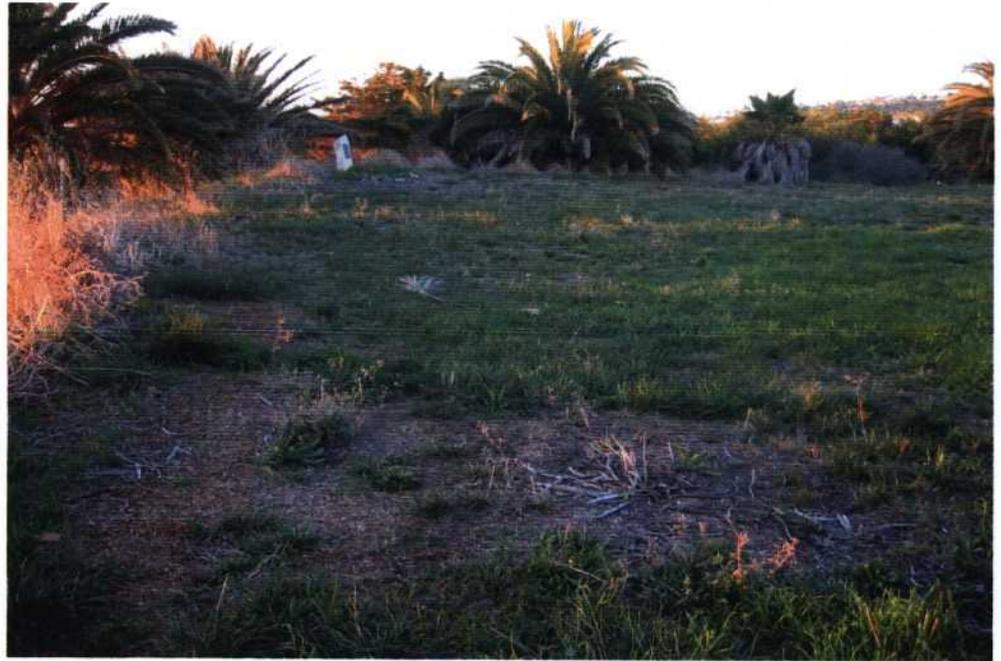
### Photograph No. 4

Storm Drain A through Area of Concern area.

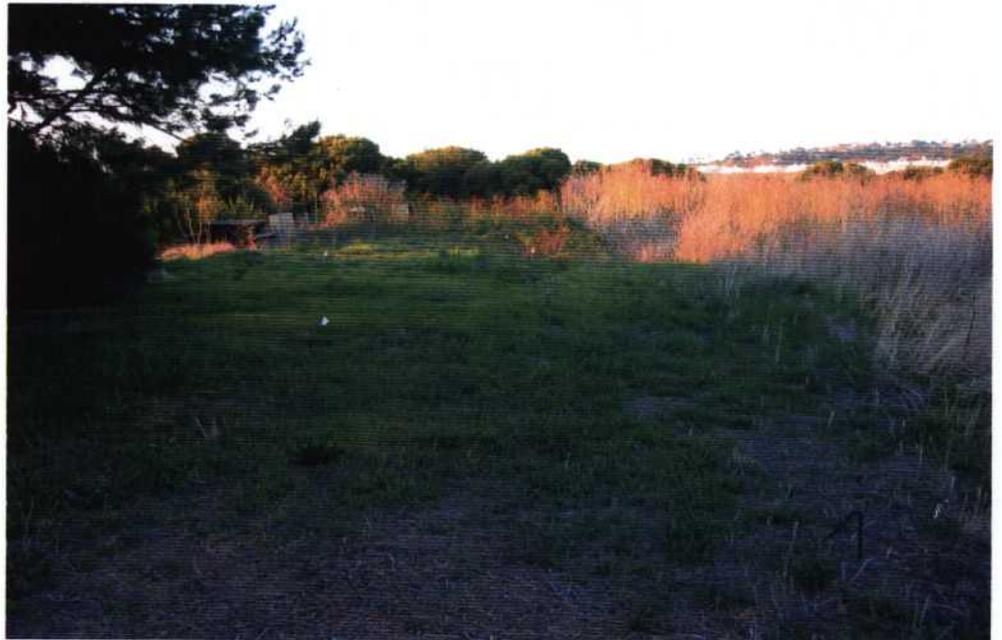
### Photograph No. 5

Tri-County Drilling, sampling  
along Storm Drain A.

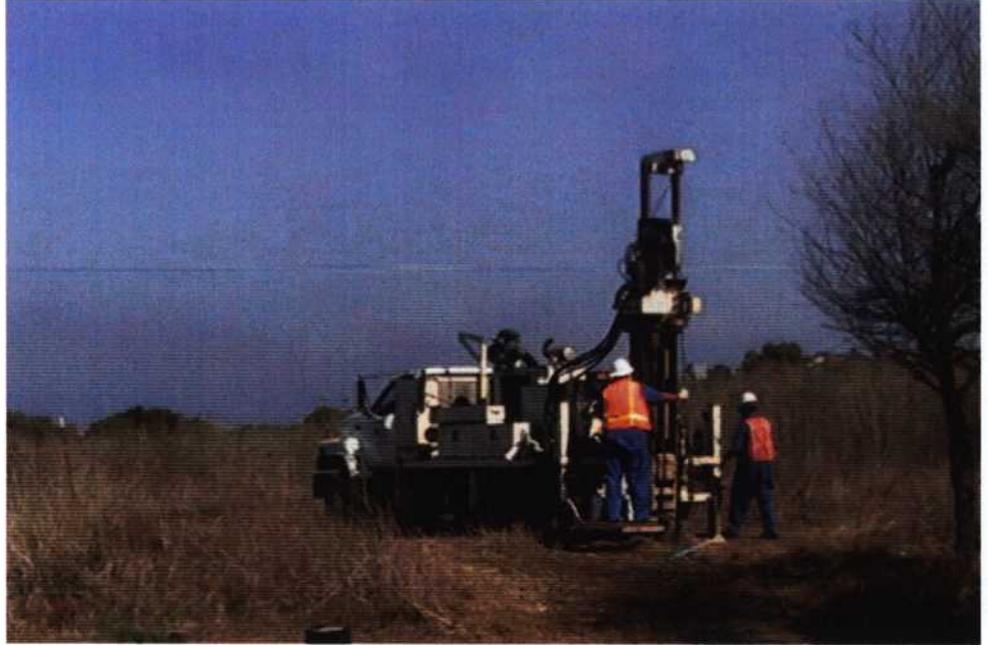
### Photograph No. 6

Tri-County Drilling sampling  
with direct push drilling probe.

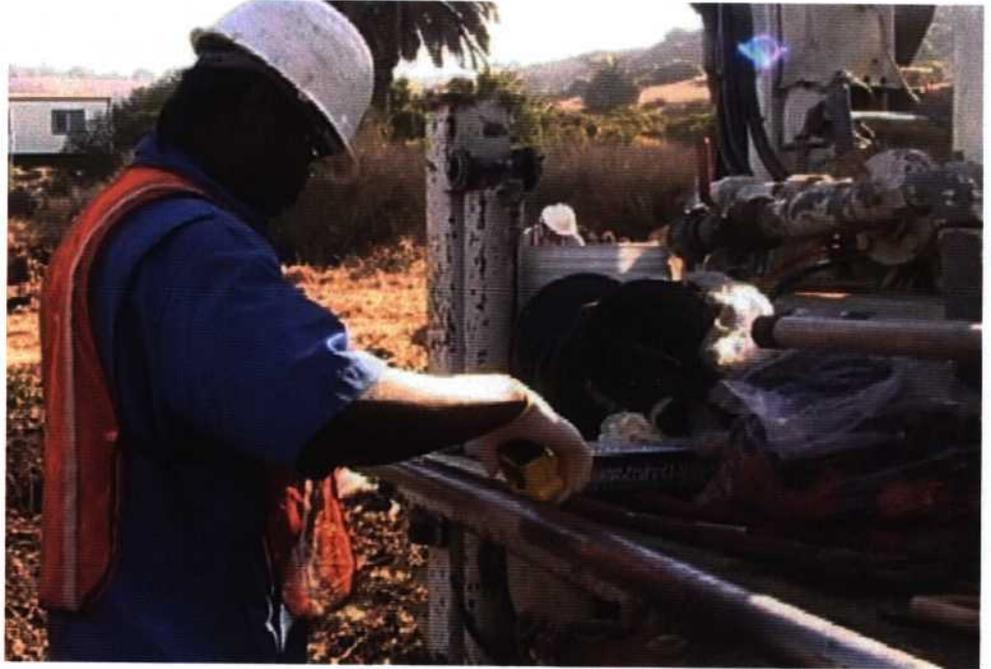
### Photograph No. 8

Gray Environmental preparing soil sample for XRF screening.

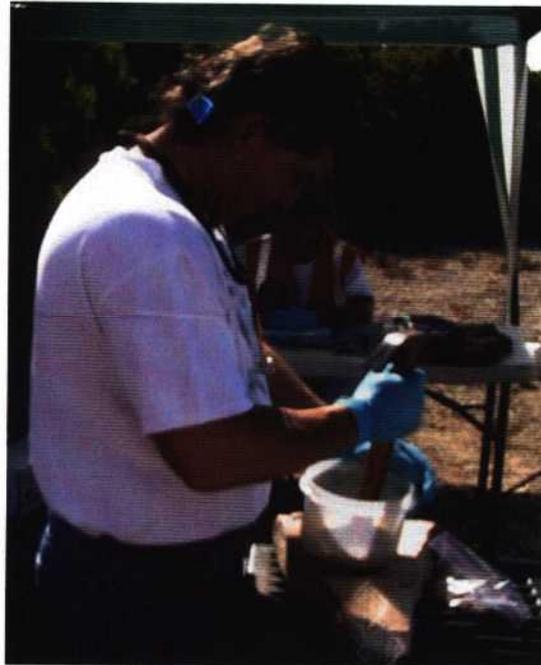
### Photograph No. 9

XRF unit screening soil sample.

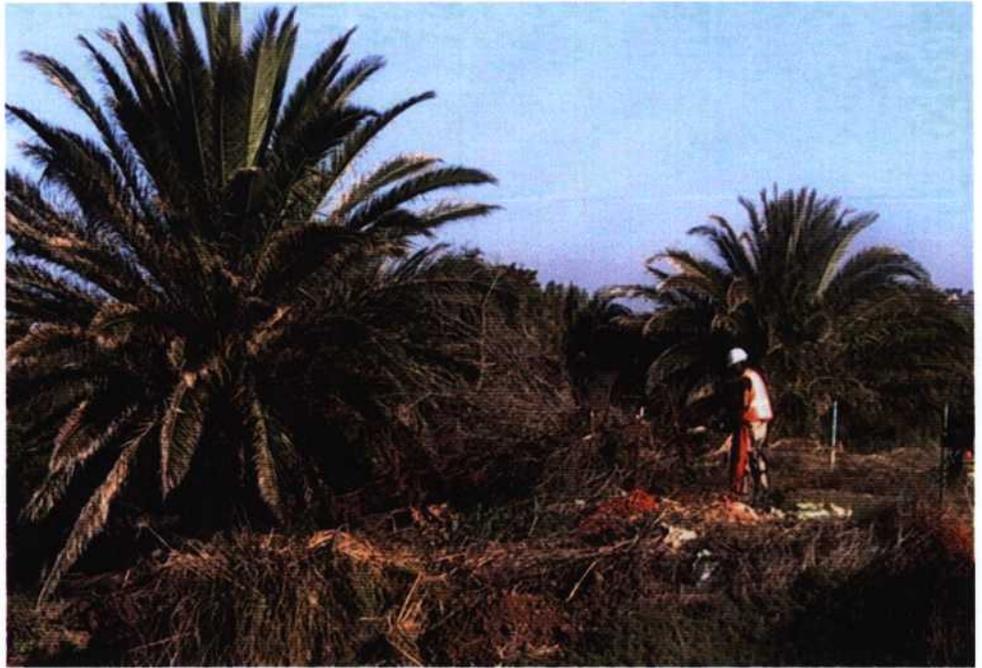
### Photograph No. 14

Clearing along Storm Drain B.

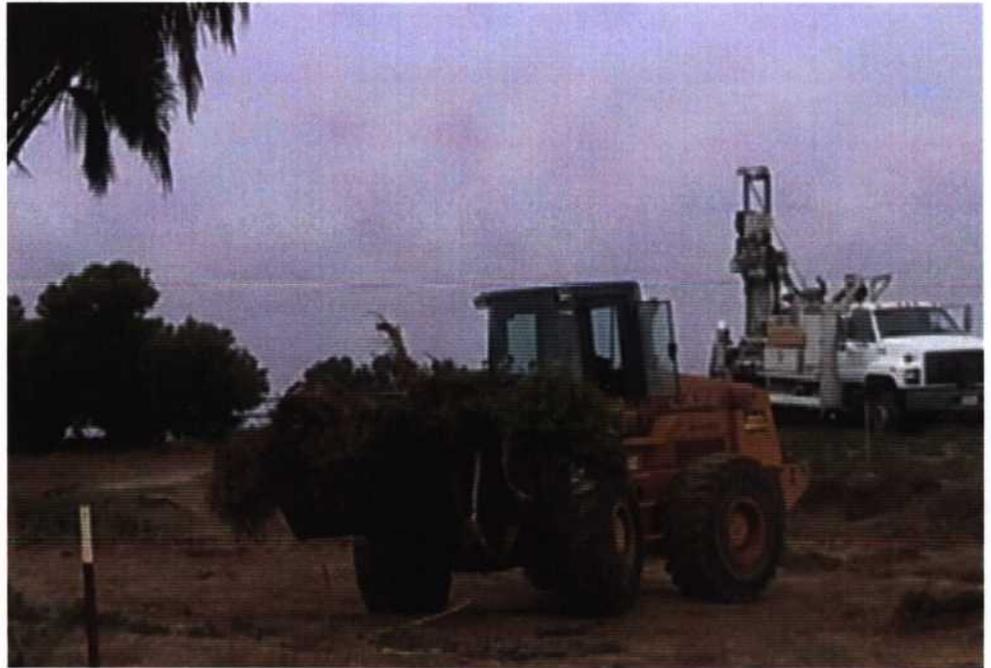
### Photograph No. 16

Removal of top one foot of material along Storm Drain B.

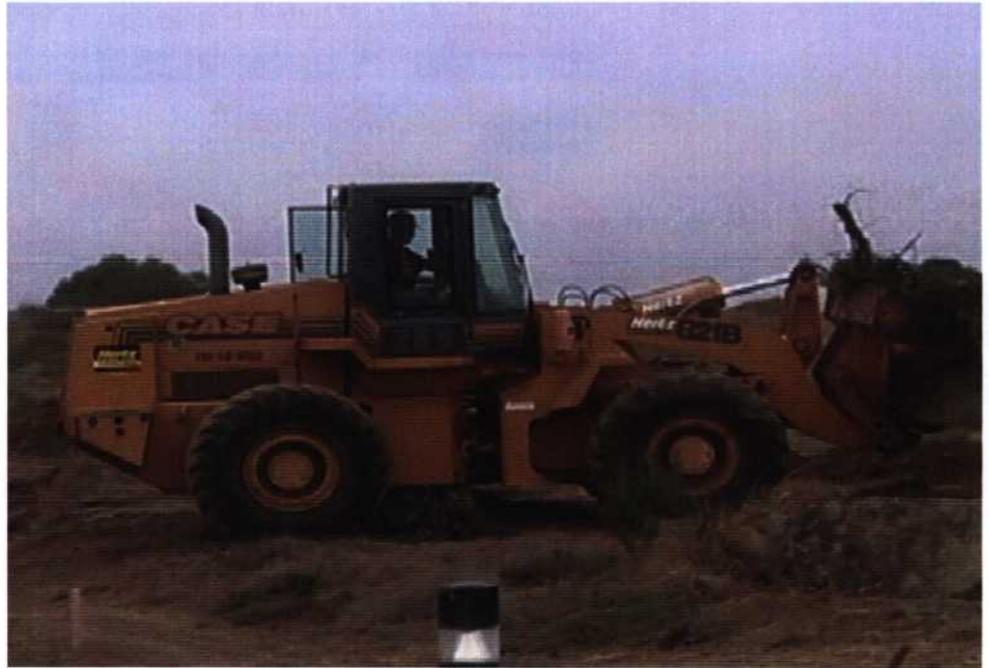
### Photograph No. 18

Removal of top one foot of soil  
in Area of Concern from  
building pad area.

Dust control being performed  
by ITSI ground labor.

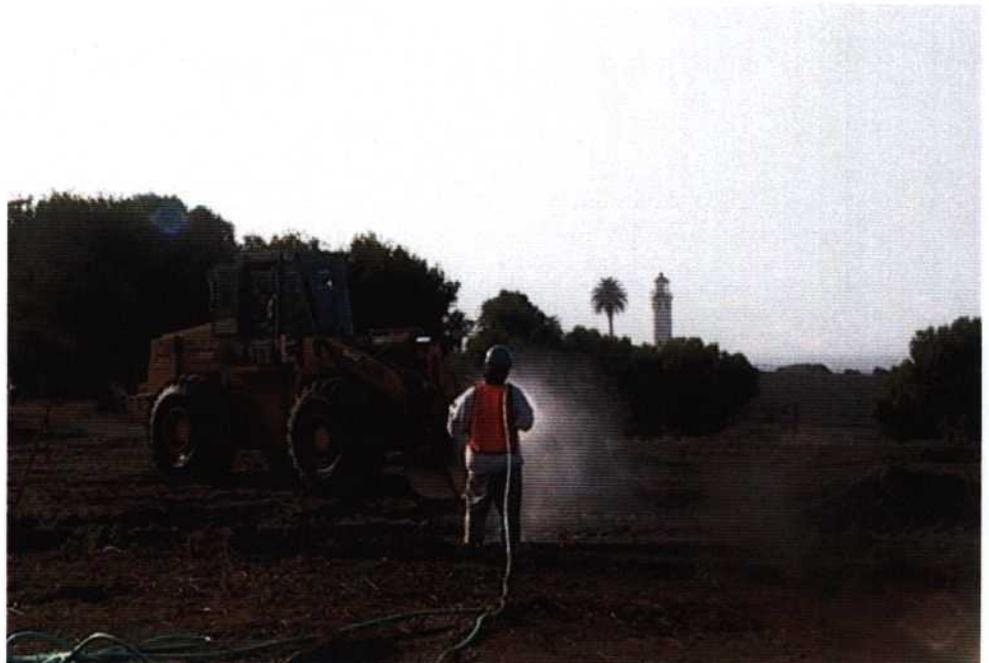
### Photograph No. 19

Start of Hot Spot 1 excavation  
at grid location H5.

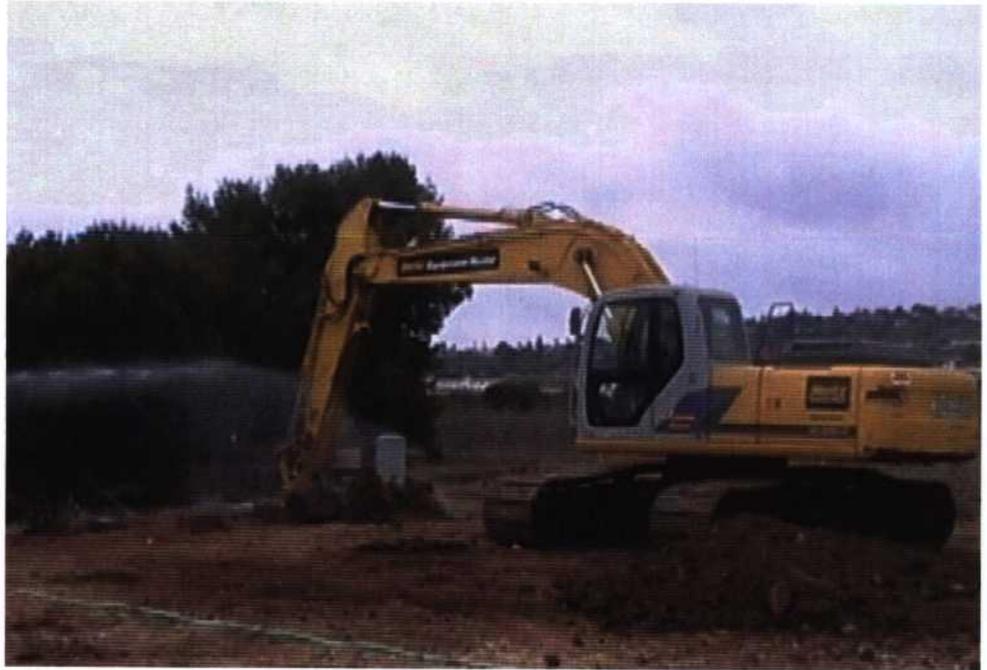
### Photograph No. 20

Excavation at Hot Spot 1.

H5 background  
I6 foreground.

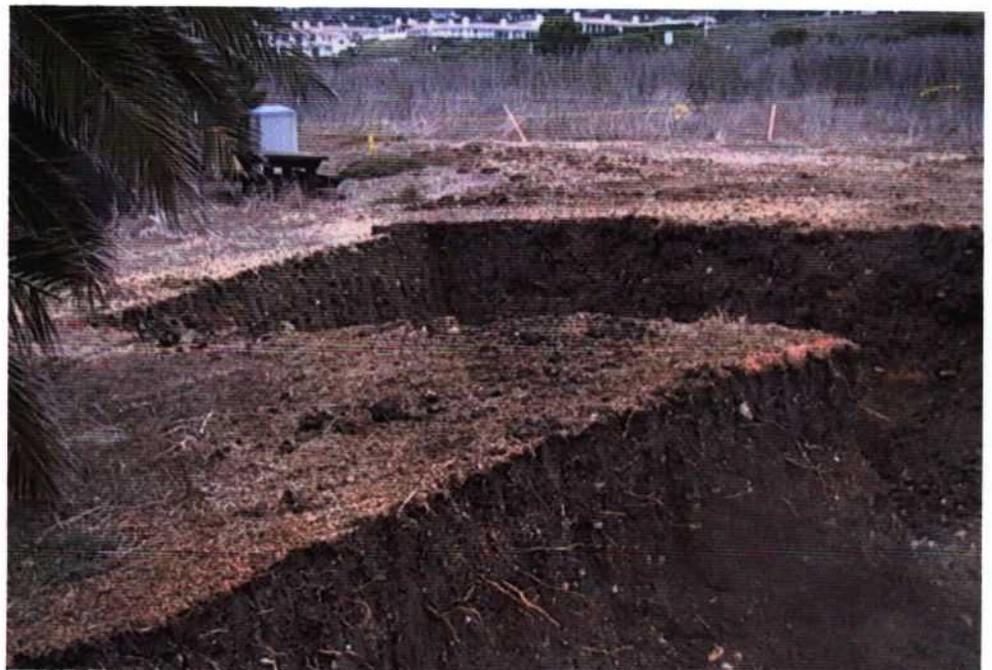
### Photograph No. 21

Excavation in Hot Spot 1  
continues into grid J10.

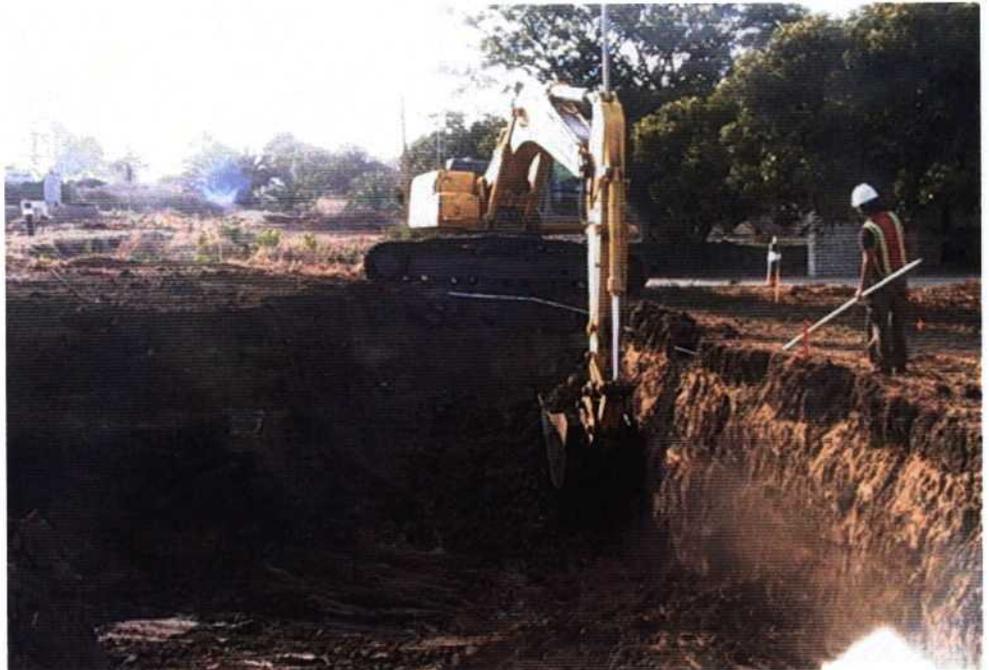
### Photograph No. 22

Repaired 6" non-potable water  
line in Hot Spot 2, at grid J12

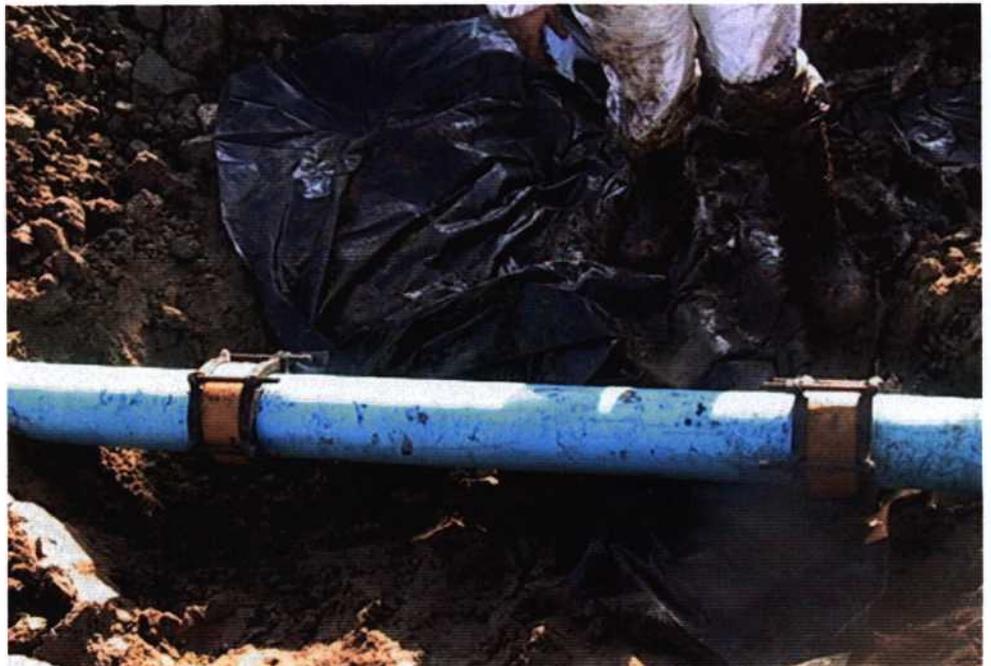
### Photograph No. 23

Backfill of Hot Spot 2 at grid I13.

Bobcat loader being used to backfill around repaired pipe in grid J12.

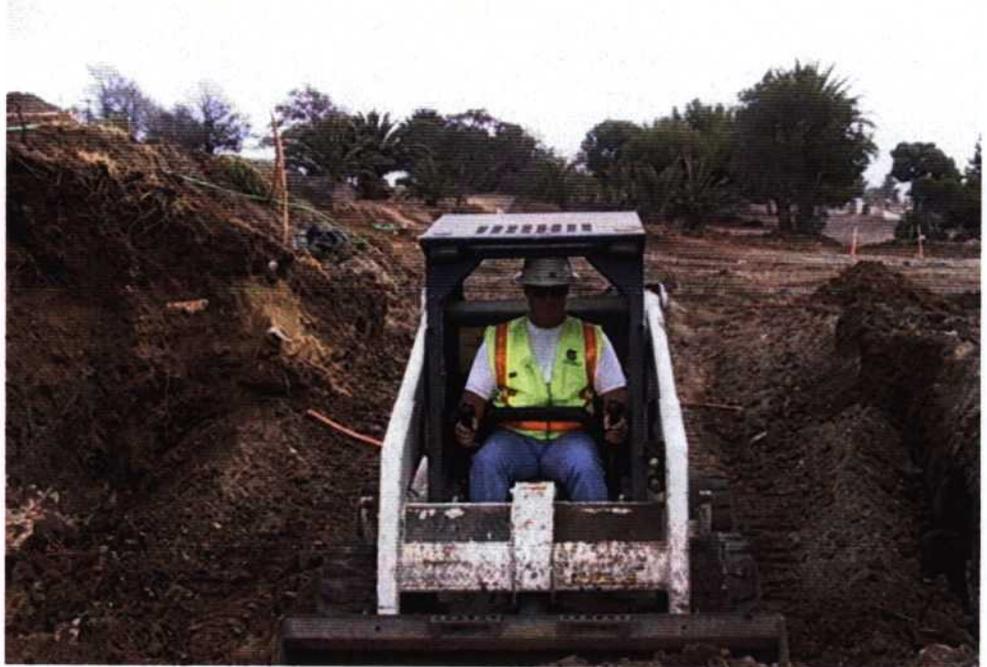
### Photograph No. 24

Excavation at Hot Spot 3.
