# **FINAL CLOSURE REPORT LEAD CONTAMINATED SOIL REMOVAL**

## **Point Vicente Interpretive Center Rancho Palos Verdes, California**

Contract No. DACA05-99-D-0014  
Task Order CQ07  
FUDS Site No. J09CA055800  
Document Control No. 02-400.03-0012

June 2003

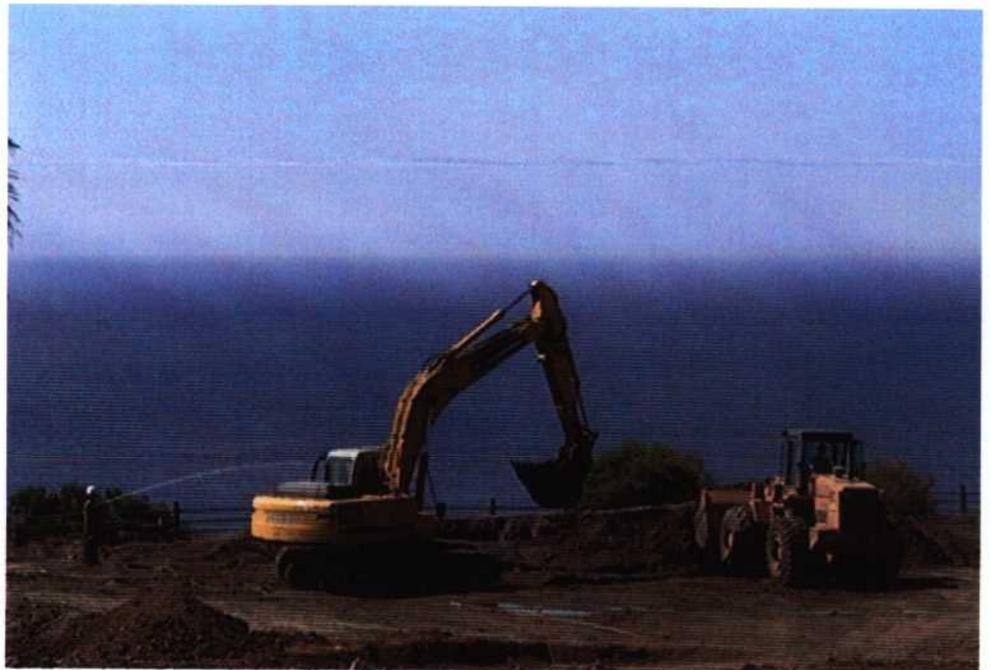
### Photograph No. 25

Backfilling of Hot Spot 3 with structural fill. Loader being used for compaction.

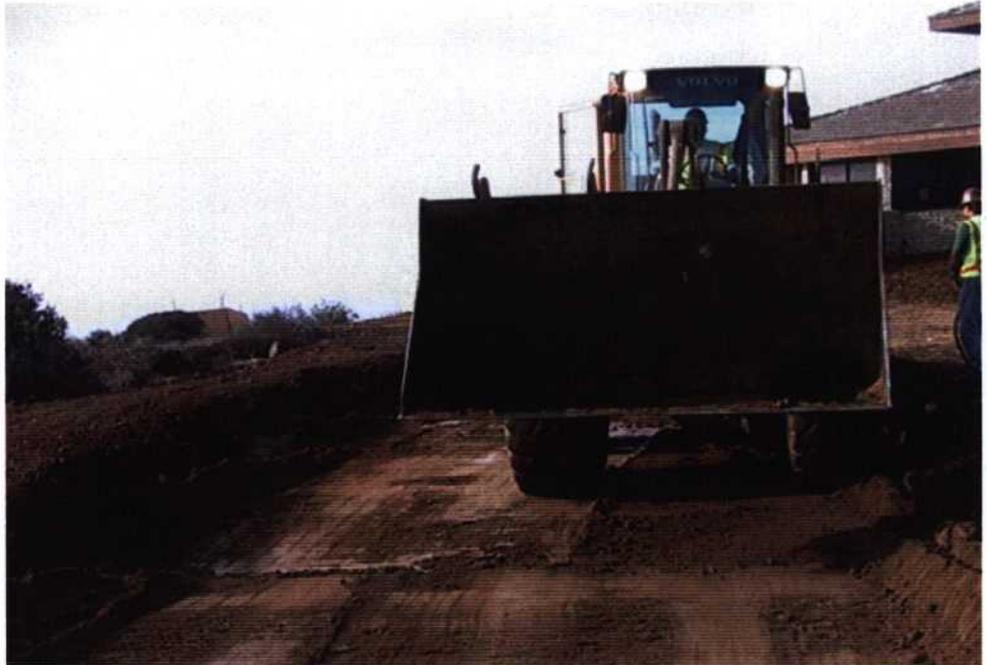
### Photograph No. 26

Backfilling of Hot Spot 3 with structural fill. Material being watered down for compaction.

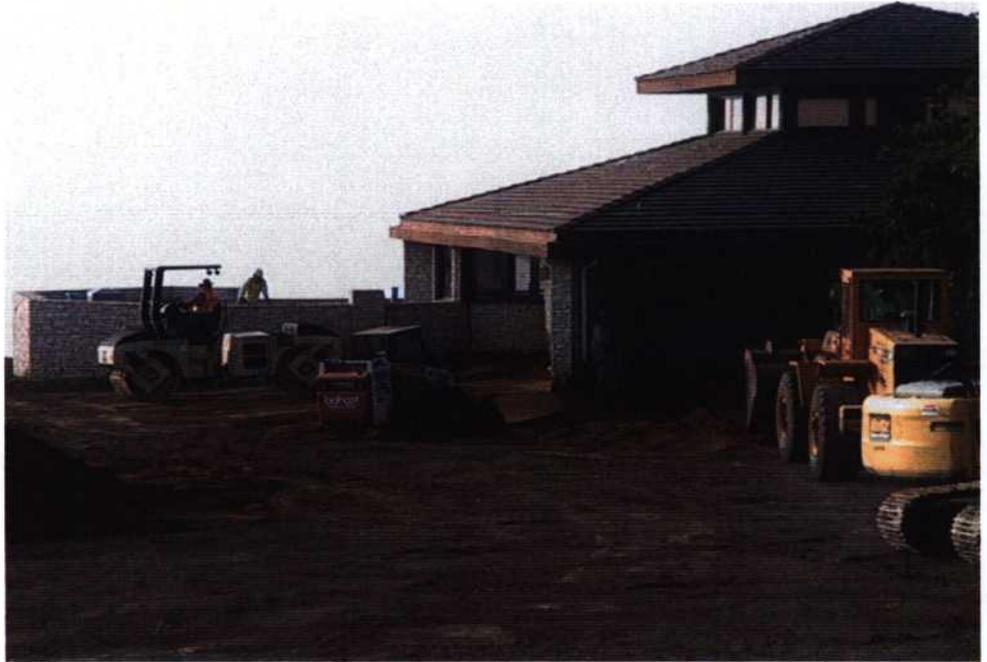
### Photograph No. 28

Compaction of Hot spot 2 with structural fill material.

Sheepsfoot compactor being used for compaction of soil.

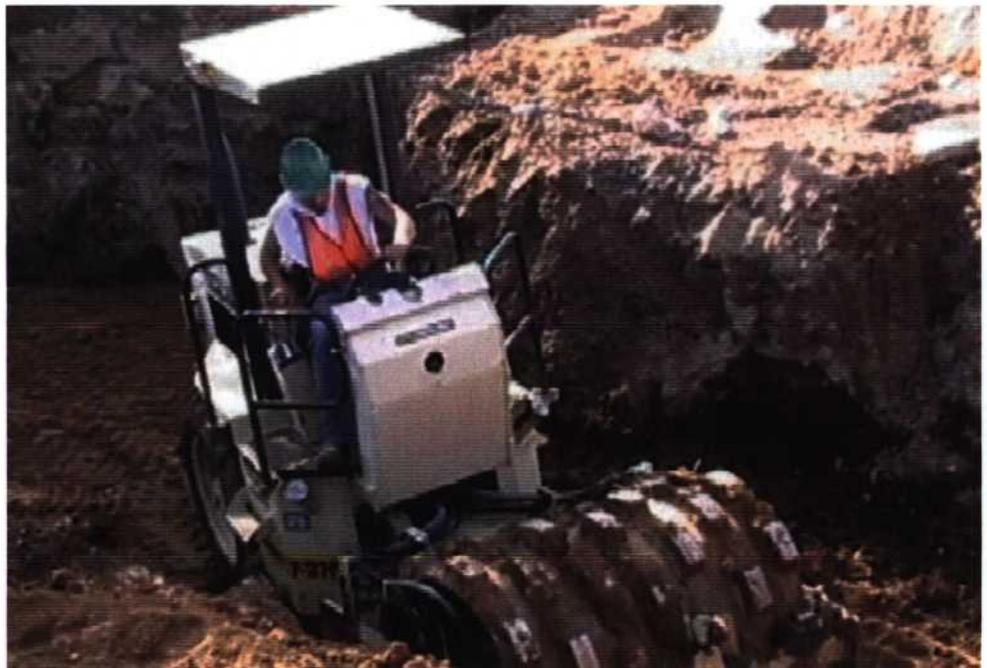
### Photograph No. 29

Compaction of Hot Spot 2 with  
Structural fill material.

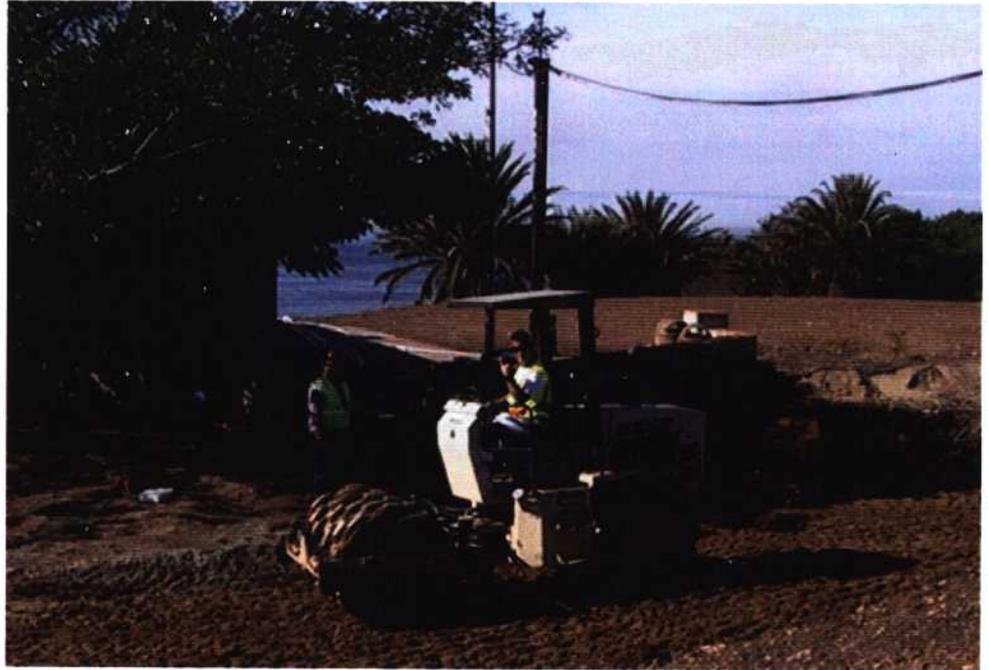
### Photograph No. 30

Compaction testing along  
south wall of Interpretive  
Center.

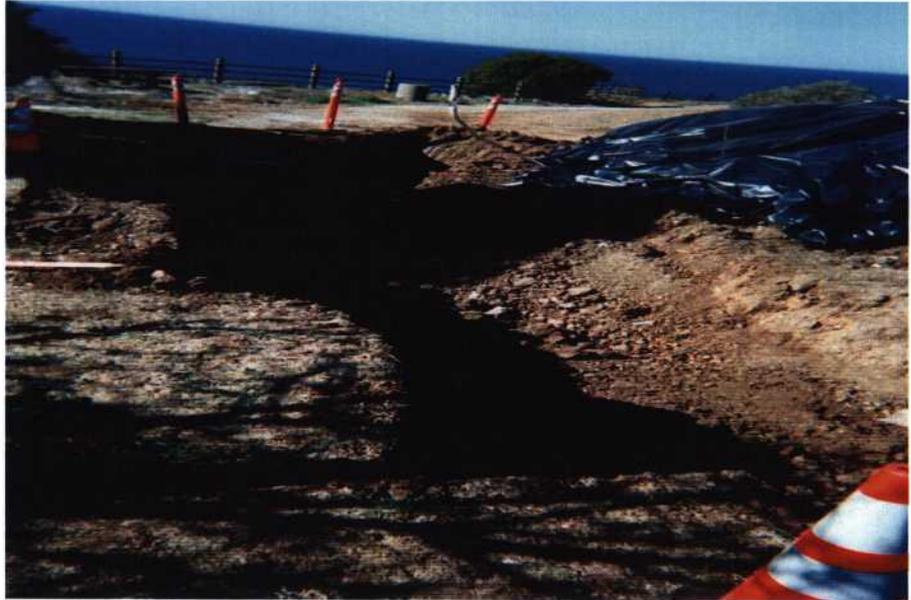
### Photograph No. 44

Post-excavation backfill of  
Storm Drain B, 13+90.

Excavation from 13+70 to 14+00

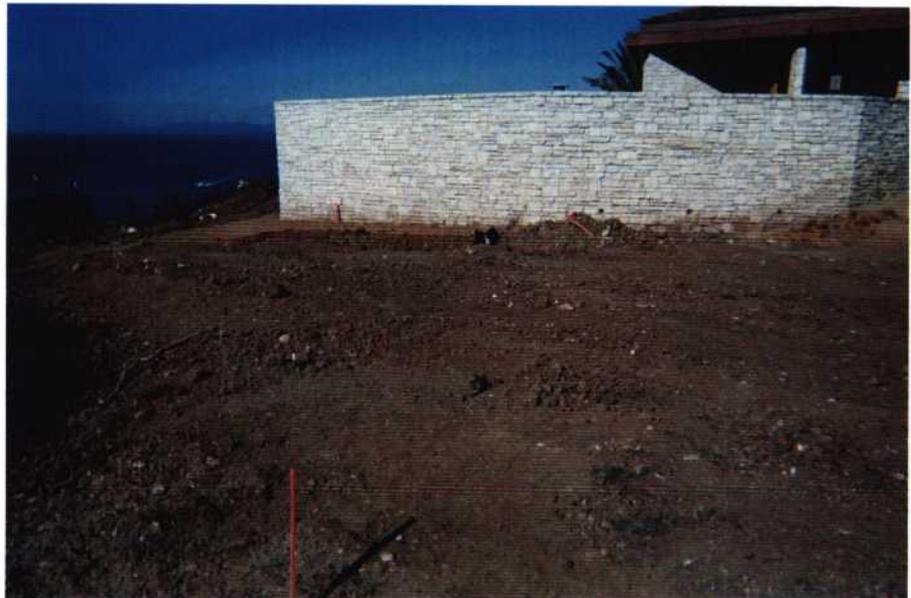
### Photograph No. 45

Post-excavation of Storm  
Drain A, 15+70.
