# **Final Remedial Investigation Report, Culebra Island Site Puerto Rico**

Artillery Firing Area (MRS 06) – Project No. I02PR006806  
Cayo Norte Impact Area (MRS 08) – Project No. I02PR006808  
Soldado Point Mortar and Bombing Area (MRS 09) – Project No. I02PR006809  
Defensive Firing Area No. 1 (MRS 10) – Project No. I02PR006810  
Defensive Firing Area No. 2 (MRS 11) – Project No. I02PR006811  
Cayo Luis Peña Impact Area (MRS 13) – Project No. I02PR006813

**FINAL**  
**Remedial Investigation Report**  
**Culebra Island Site, Puerto Rico**  
**FUDS Project No. 102PR0068**  
**Contract: W912DY-04-D-0006, Task Order: 0022**  
**April 2017**

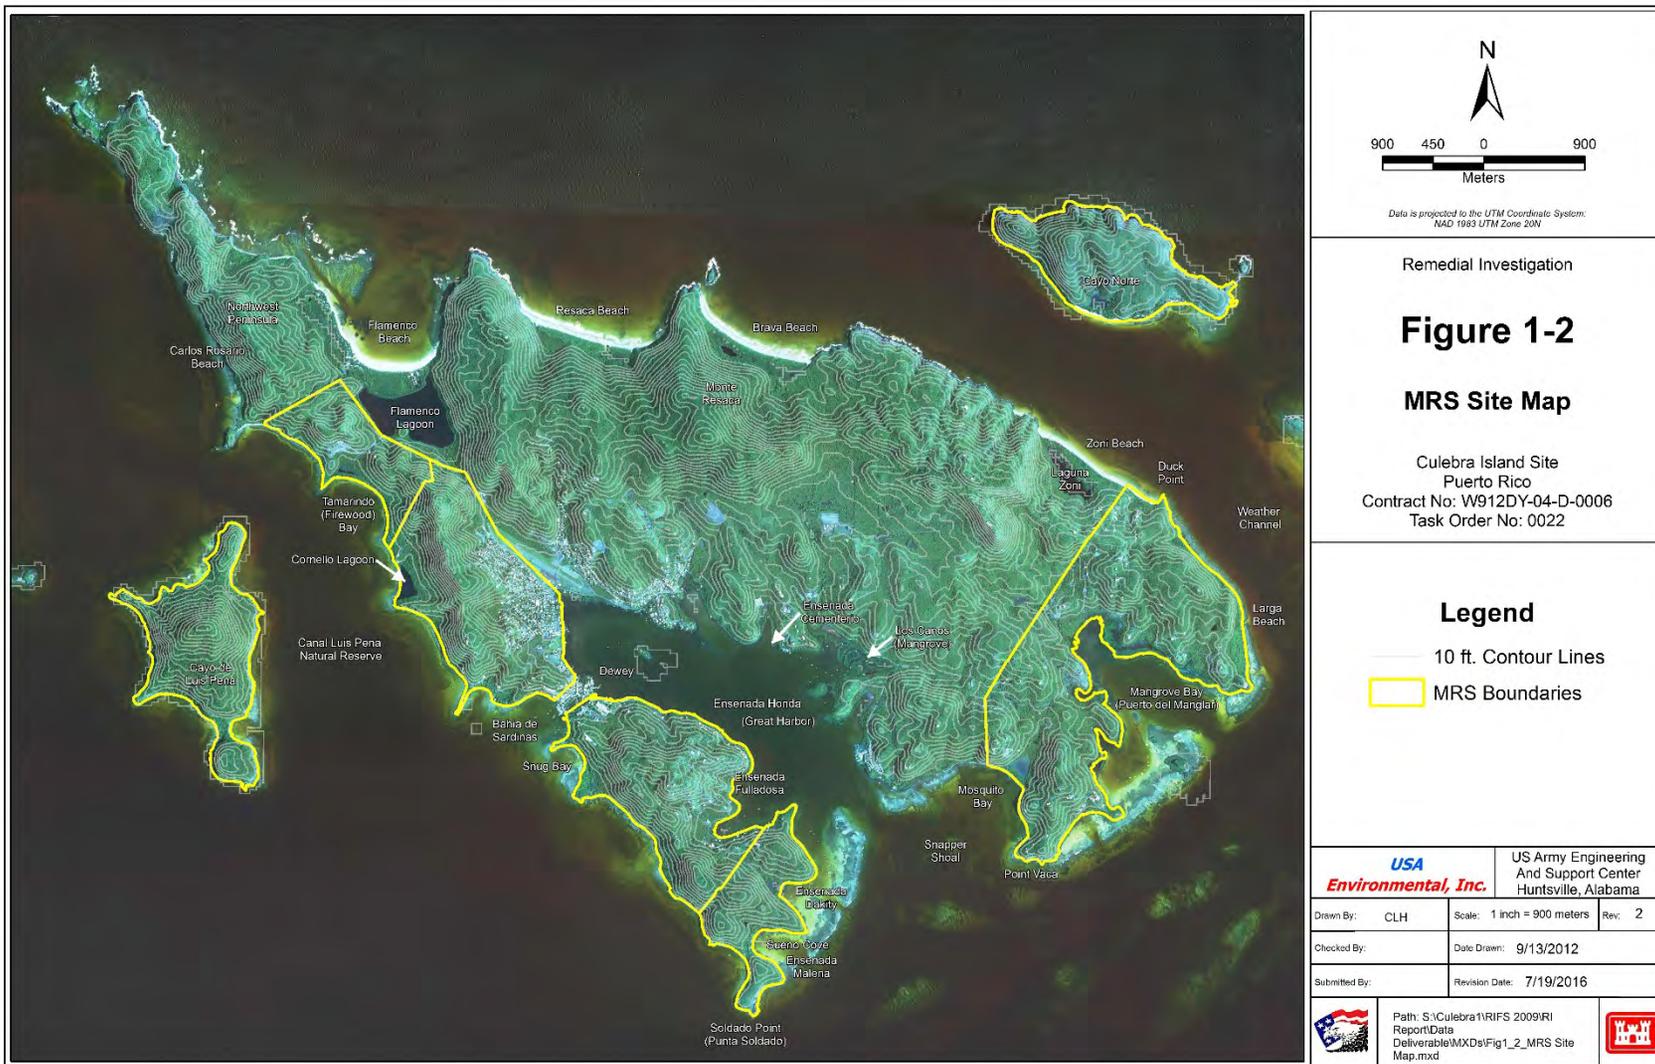
Figure 1-2: Culebra Island MRS Map

The Culebra Island MRSs included in this RI are shown in Figure 1-2. Descriptions for Culebra Island MRSs included in this RI are presented below. Further details regarding spatial relationships among MRSs, historical range activity, and findings of the MEC investigation are found on Figures A-31 through A-36.

Norte (MRS 08), located approximately one-half mile off the northeast coast of Culebra Island. Culebra Island and the surrounding cays are part of the Commonwealth of Puerto Rico. This RI addresses the terrestrial portions of the six MRSs only. The underwater portion of the MRSs is not evaluated in this document. Details of the underwater portion of the MRS are presented when relevant to support the evaluation of the terrestrial acreage. The site location is shown in Figure 1-1. MRS locations are shown on Figure 1-2. Appendix A: Figure A-1, Plate 2 from the ASR shows historical areas of DoD activity.

Culebra Island and the surrounding cays are comprised of sandy beaches, irregular rugged coastlines, lagoons, coastal wetlands, steep mountains, and narrow valleys. Ninety percent of the island is mountainous. The island contains an east-west trending ridge with an average elevation of 300 feet mean sea level (msl) in the northern part of the island. The highest point on Culebra is Mount Resaca at approximately 640 feet msl. Topographic features are shown on Figure 1-2.

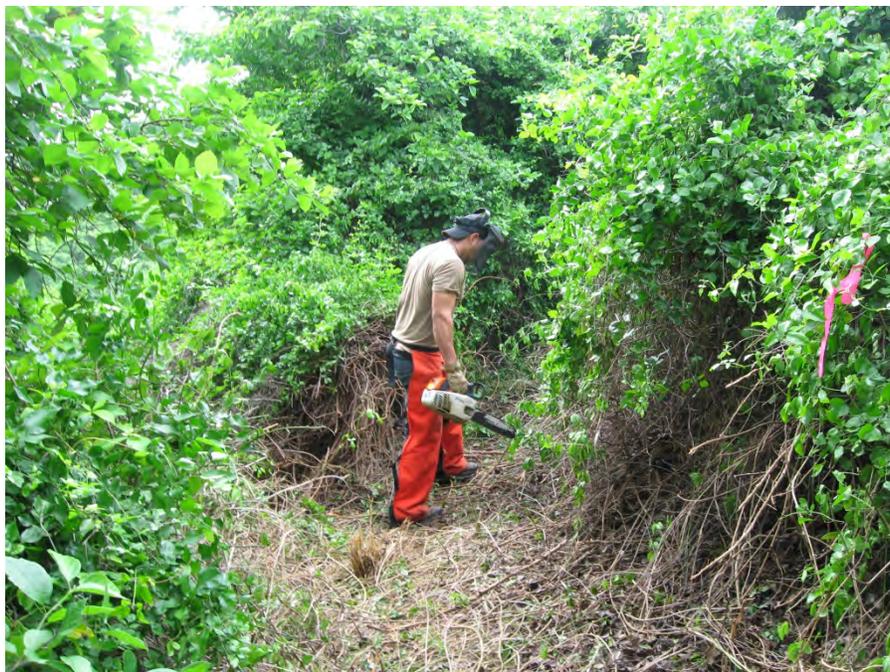
Vegetation removal activities were conducted in undeveloped areas to provide access for DGM surveys on transects and grids. Vegetation teams consisted of UXO qualified personnel and subcontracted deforester labor. Prior to commencing with vegetation removal activities, a local field biologist provided the vegetation removal teams with training in endangered species identification and mitigation procedures. This training was in coordination with the endangered species mitigation SOPs (Appendix M of the WP). The Team Leader utilized a Trimble Pro XRT Differential Global Positioning System (DGPS), or equivalent, to follow each transect, following a path of least resistance to help minimize devegetation and avoiding all properties where a ROE had not been obtained. Vegetation removal teams utilized handheld saws and cutters to clear the footprints needed, a path approximately 5 feet wide for transects and a 50-foot x 50-foot area for grids.

**Photograph 4-1: Vegetation Removal**

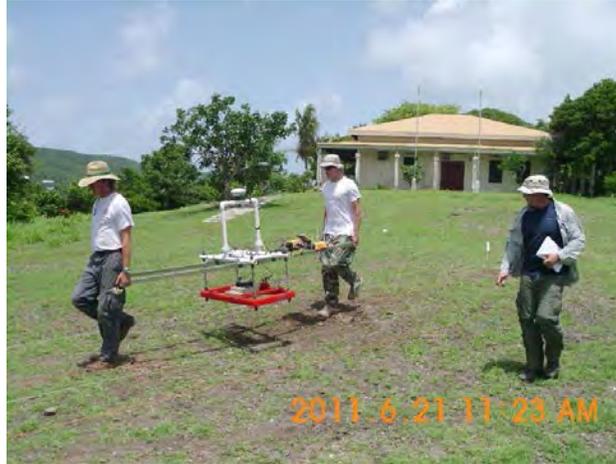
The test strip results and anomaly selection criteria were provided to the USACE Geophysicist prior to starting fieldwork. Any recommended changes to the anomaly selection criteria were discussed with USACE’s Geophysicist prior to implementing. USA documented the GSV results in a Draft and Final Geophysical System Verification letter report (the Final GSV Report is provided in Appendix K) that documented IVS setup, digital geophysical detection results, grid line spacing test results, initial grid anomaly selection criteria, and recommended final DGM performance metrics. The test strip was installed in a designated area at the USFWS facility located on Culebra.

**Photograph 4-2: Survey of IVS**

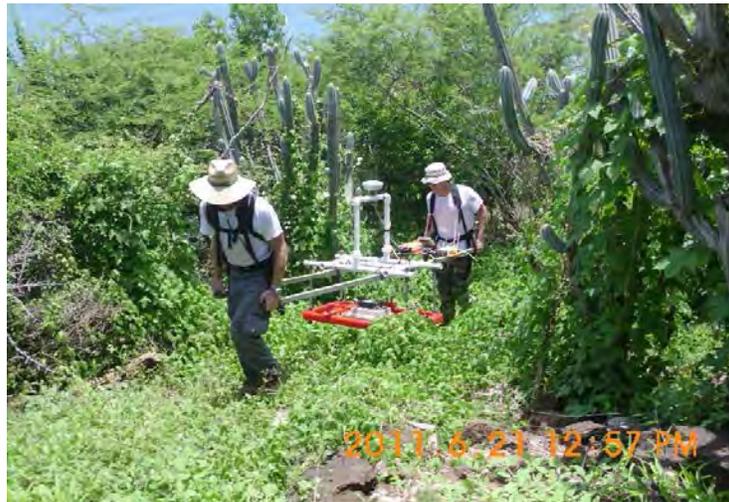
**Photograph 4-3: DGM Transect Survey**

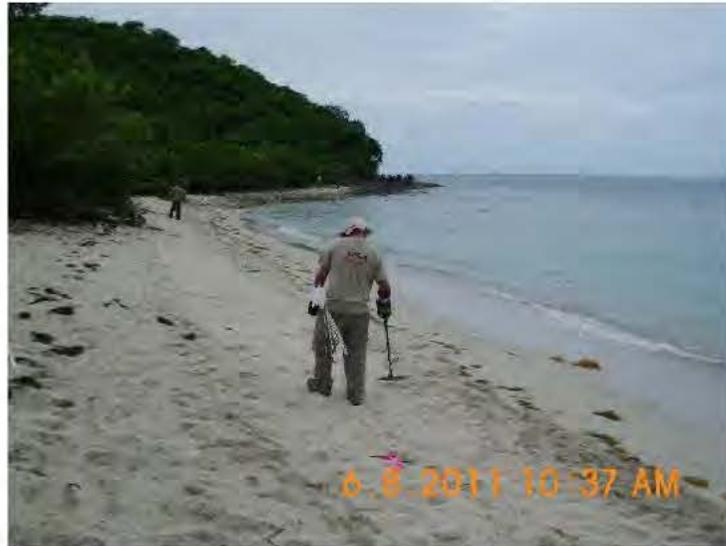
The analog mag-and-dig investigation of the trails and beach areas in MRS 13 was augmented with a surface visual reconnaissance investigation conducted during a post award site visit. The investigation occurred as directed, primarily on trail areas cleared by the team (Appendix A: Figure A-36). This investigation was conducted without an ESP in place and the observations of the items were visual; the items were not handled and were left in place. These areas investigated by visual reconnaissance were not established/accessible trails and per the DQO for MRS 13 were not surveyed.

Photograph 4-4: Beach Analog Mag-and-Dig Investigations

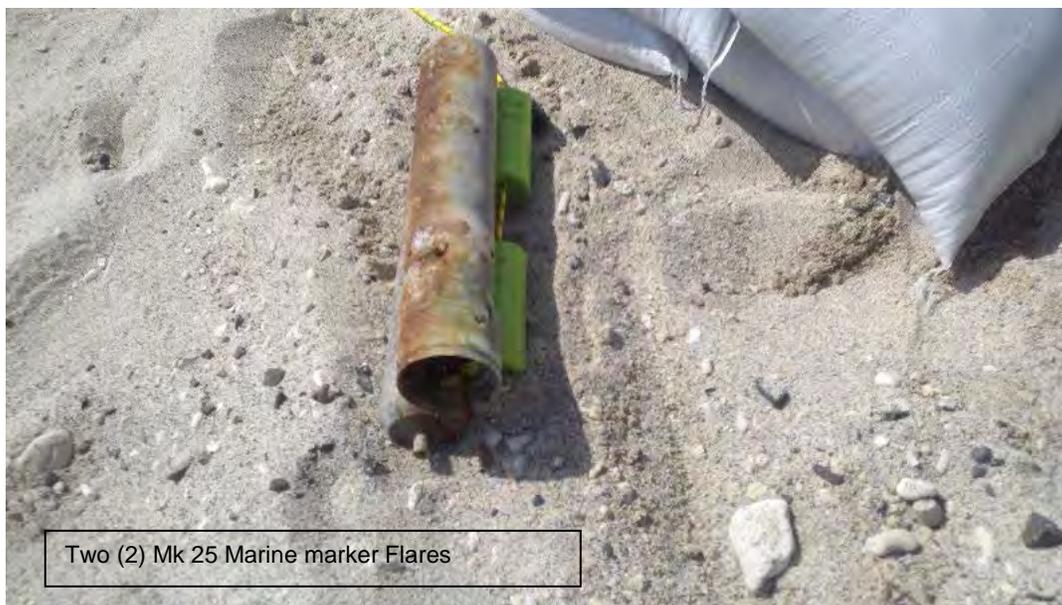
<b>Date</b>	<b>Location</b>	<b>Shot Time</b>	<b>Time Cleared</b>	<b>Munitions Destroyed</b>
26 May 2011	MRS 09	15:30 local	16:00 local	(2) Mk 25 Marine Markers
13 June 2011	MRS 09	10:30 local	11:00 local	(1) partial BDU-33

**Photograph 4-5: Disposal of MEC Items in MRS 09**

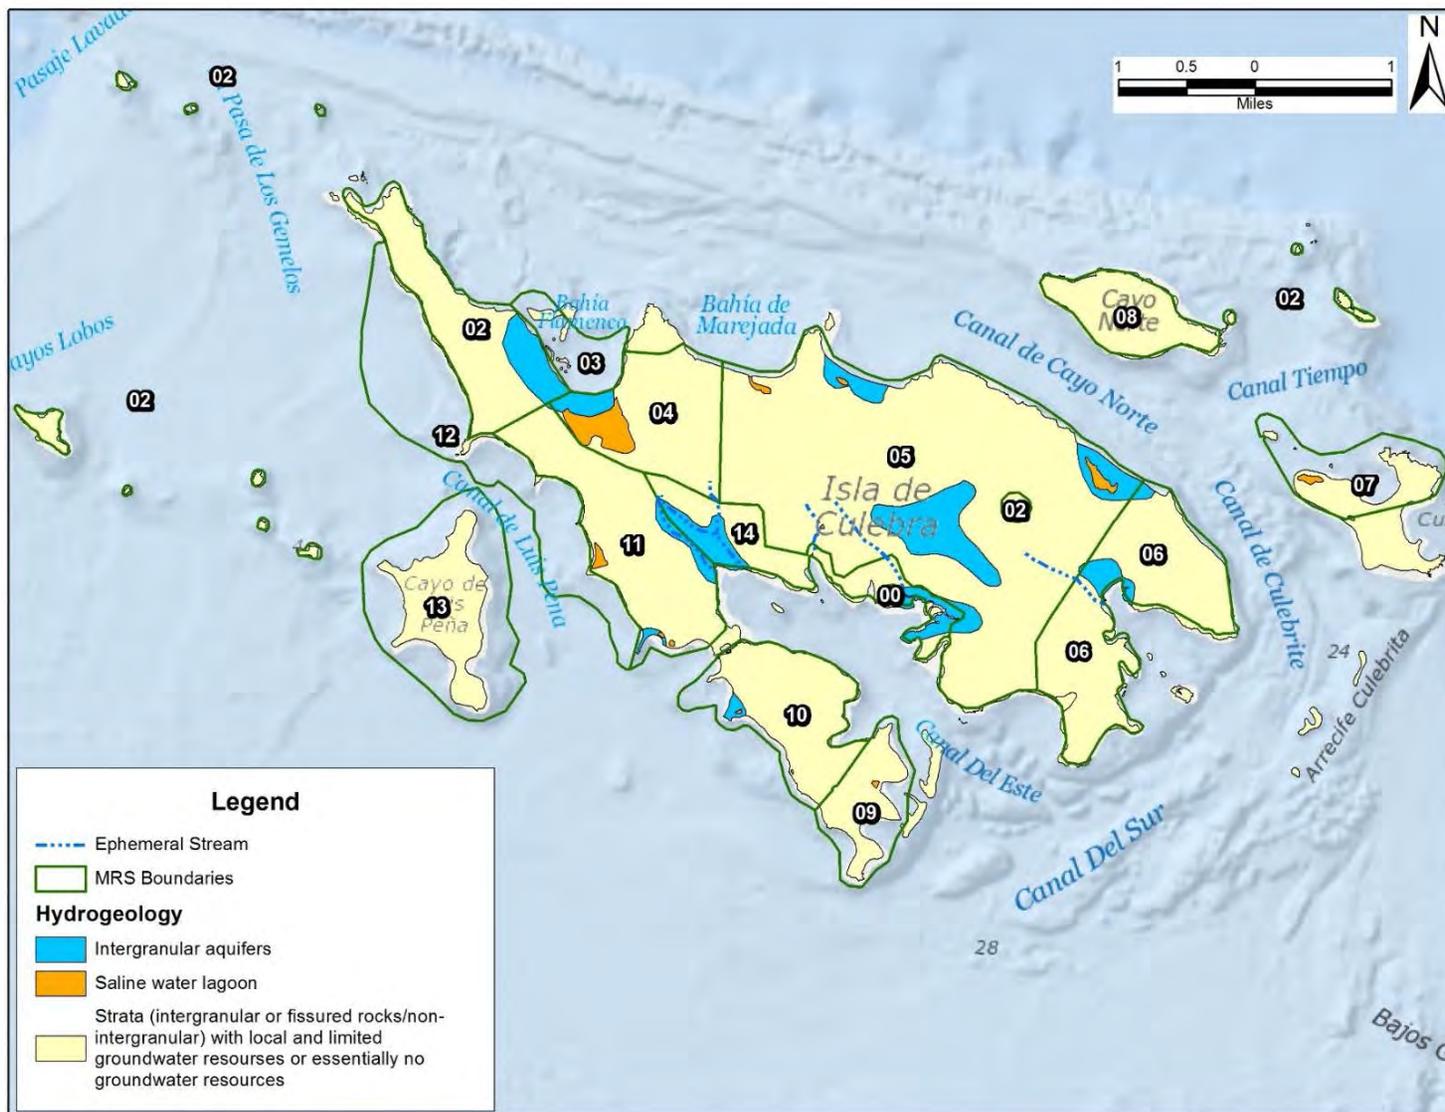
Given the impermeable nature of the volcanic rock with storage located within fracturing, the acreage of the island that would significantly be impacted by saltwater intrusion, the lack of known aquifers, minimal MD discovered, and no MC source that poses a human health risk, there is no human health risk due to exposure to groundwater. Therefore the groundwater pathway is considered incomplete.

Figure 5-1: USGS 2014, Hydrogeology of Puerto Rico and the Outlying Islands (Plate 1 with MRS Boundaries added)

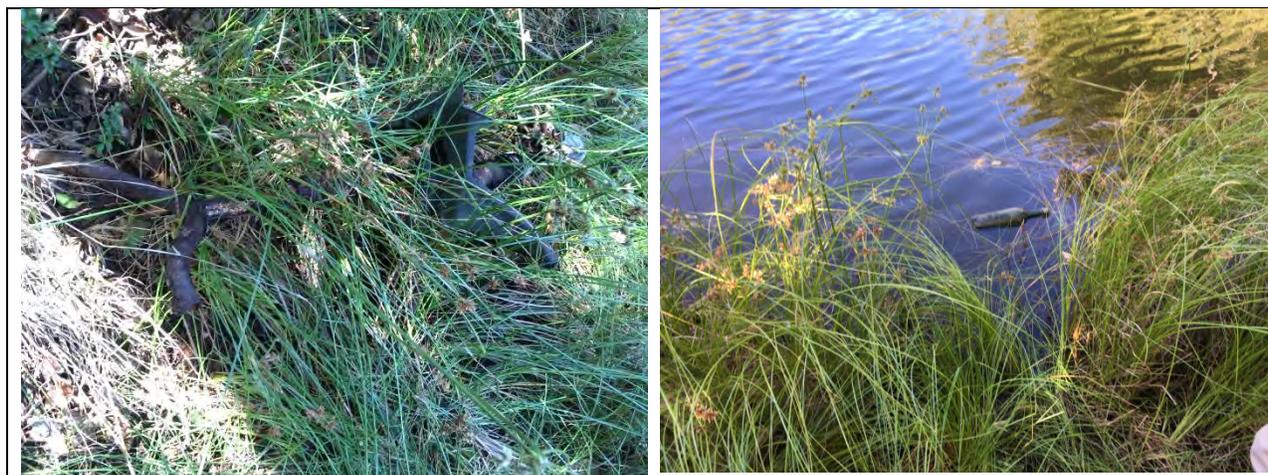
During both the 2012 and the 2016/2017 sampling events, evidence of public impacts were observed on the bank of the lagoon and in the lagoon water, as shown in the photos below. Pieces of a motorcycle were observed on the bank, and bottles were observed floating in the water. It is possible public impacts to the lagoon have contributed to localized elevated concentrations of aluminum and copper.

**Photograph 7-1: Debris on Bank and in Water of MRS 09 Lagoon**

Therefore, based on the results of sampling conducted at this site and evaluation of the surrounding area, aluminum and copper are not considered COPCs in MRS sediment resulting from former munitions use and will not be evaluated further.
