**Little Colorado River at Winslow, Navajo County, Arizona**  
**Flood Risk Management Feasibility Study**

**Phase I Environmental Site Assessment**

## Phase I Environmental Site Assessment for pertinent parts of “Little Colorado River at Winslow” Feasibility Study

Winslow, AZ and Vicinity (Navajo County)

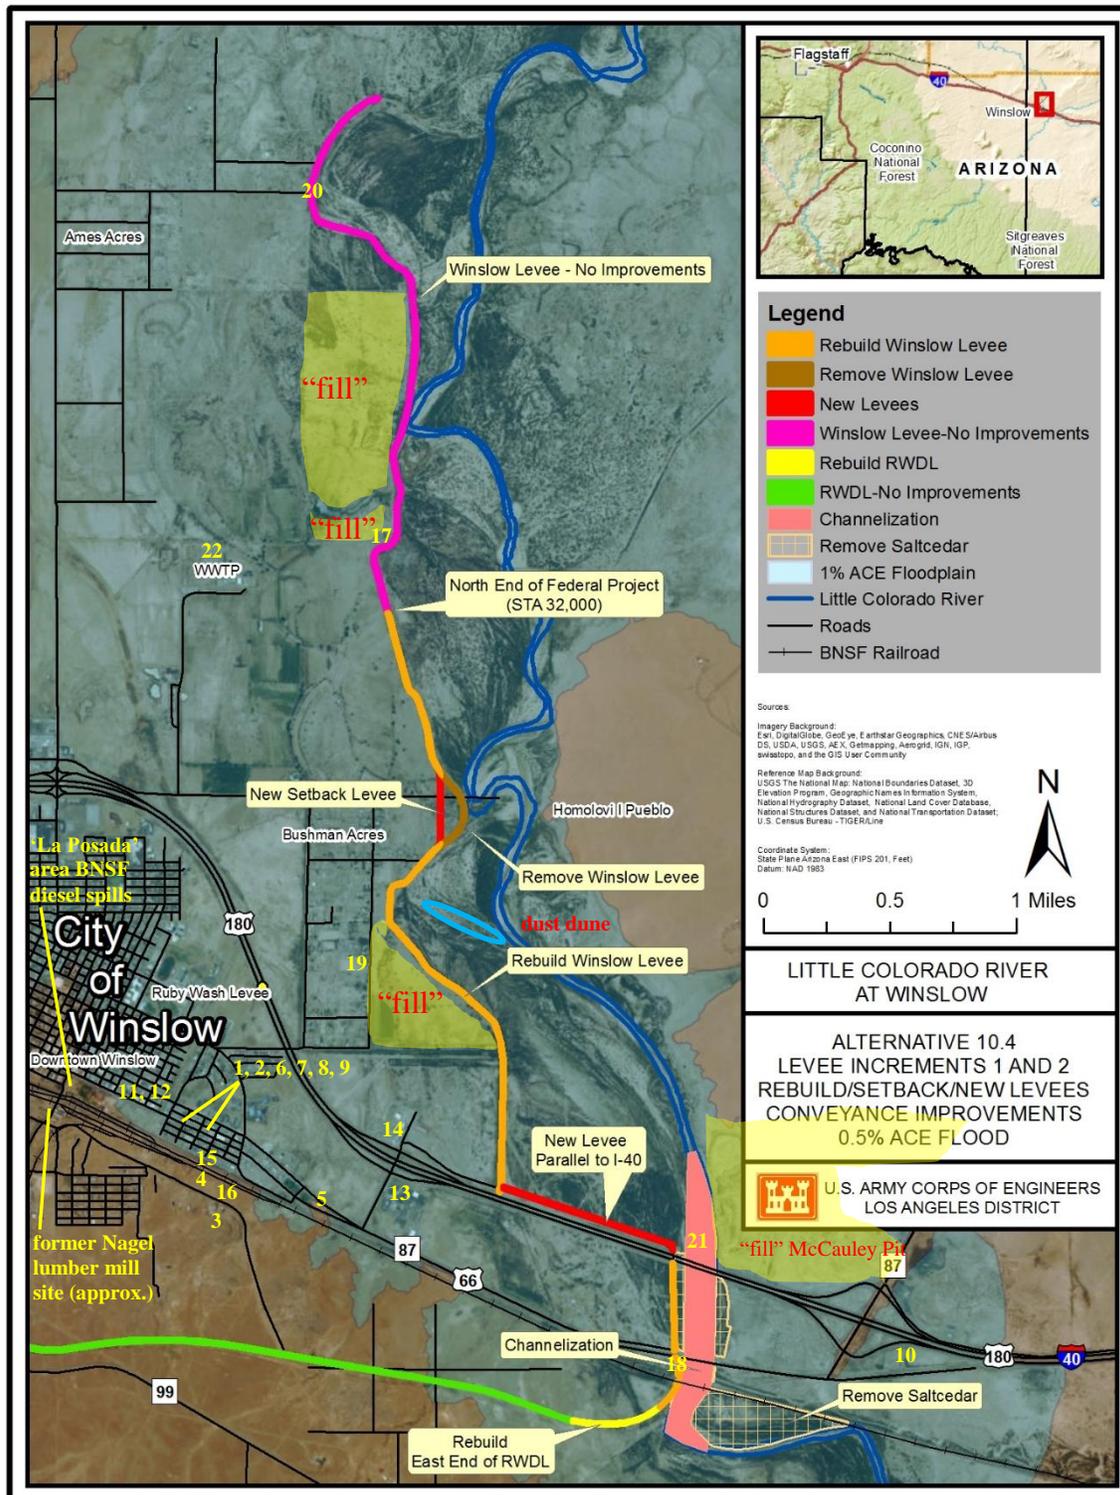
**Figure 1** — This Phase I ESA identifies potential RECs (numbered/named sites) that may impact the shown existing levee and conceptual levee improvements (purple, red, brown, yellow, orange lines, pink polygon, yellow hachured area), and potential excess earth materials disposal sites (marked “fill” and shaded yellow), as well as additional conceptual impact areas shown on Figure 2. See main feasibility report for full alternatives array.

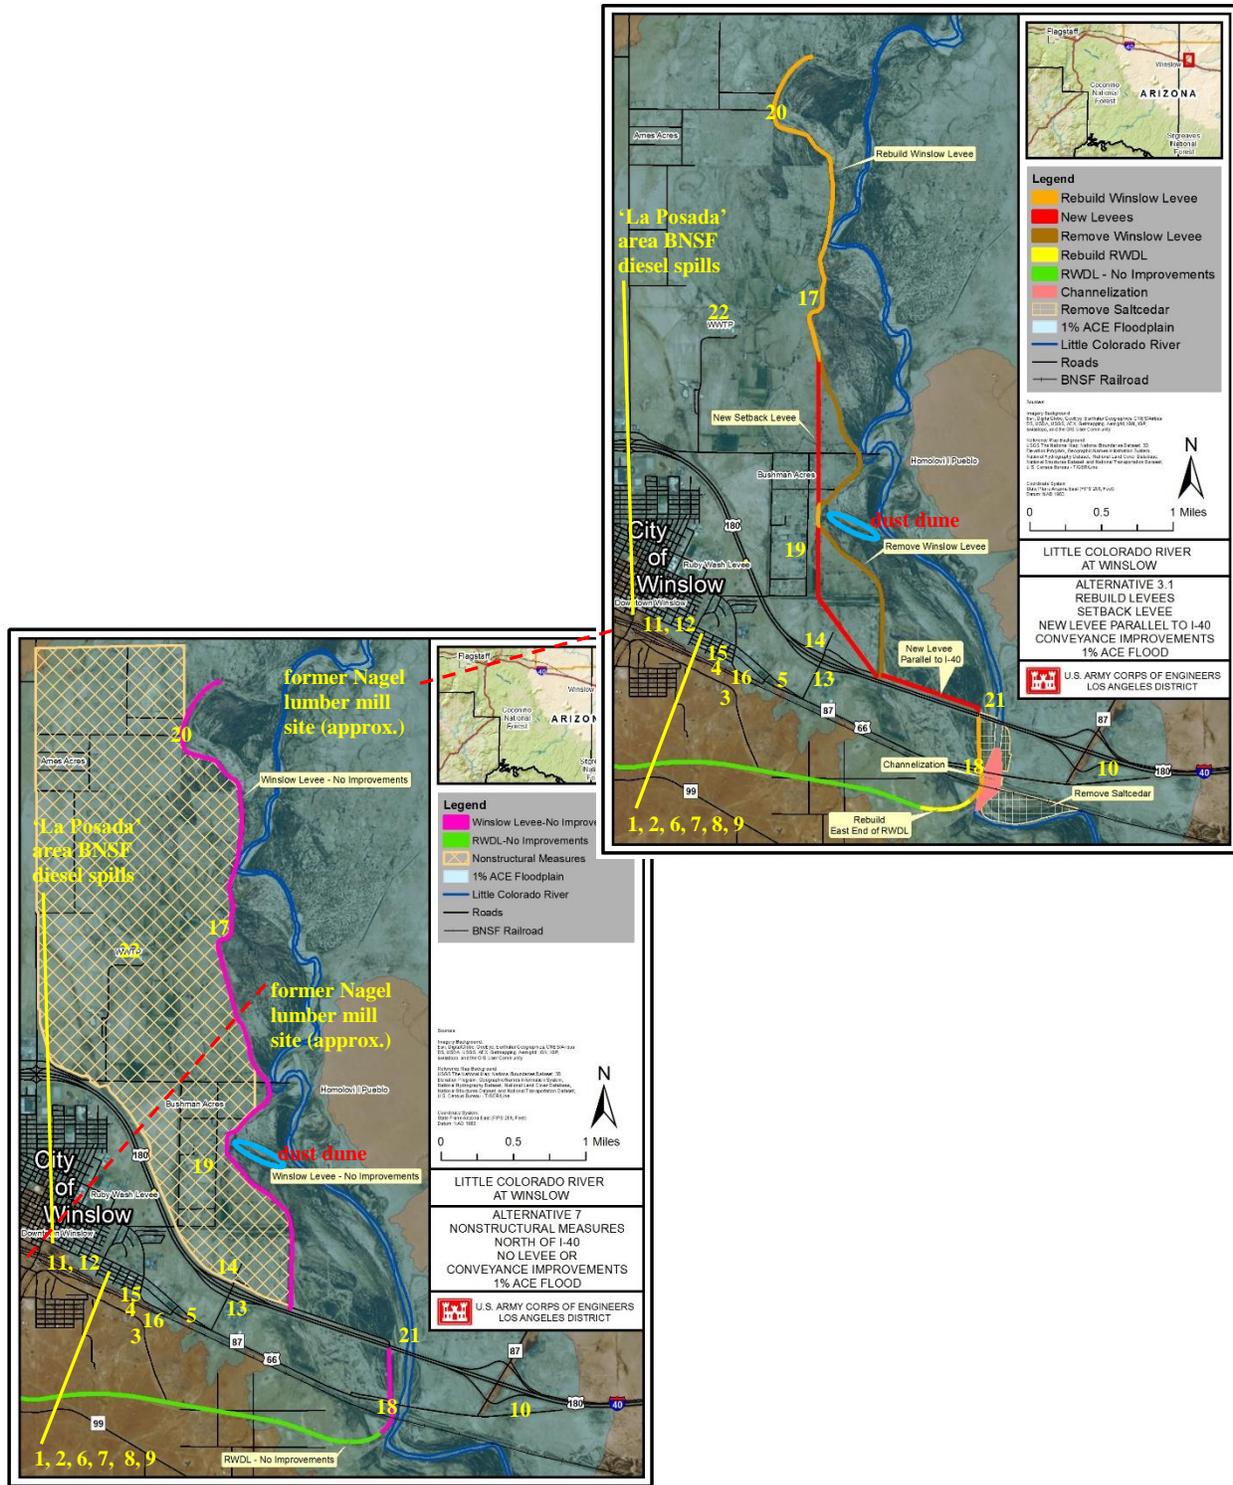
**Figure 2**—This Phase I ESA identifies potential RECs (numbered/named sites) that may impact conceptual elevation of existing structures (within zone of yellow hatching in lower left map), potential set-back levee footprint (red solid line in upper right-hand map), as well as additional conceptual impact areas shown on Figure 1. Much of the conceptual elevation of existing structures zone has no development and most existing structures are not densely concentrated. See main feasibility report for full alternatives array.

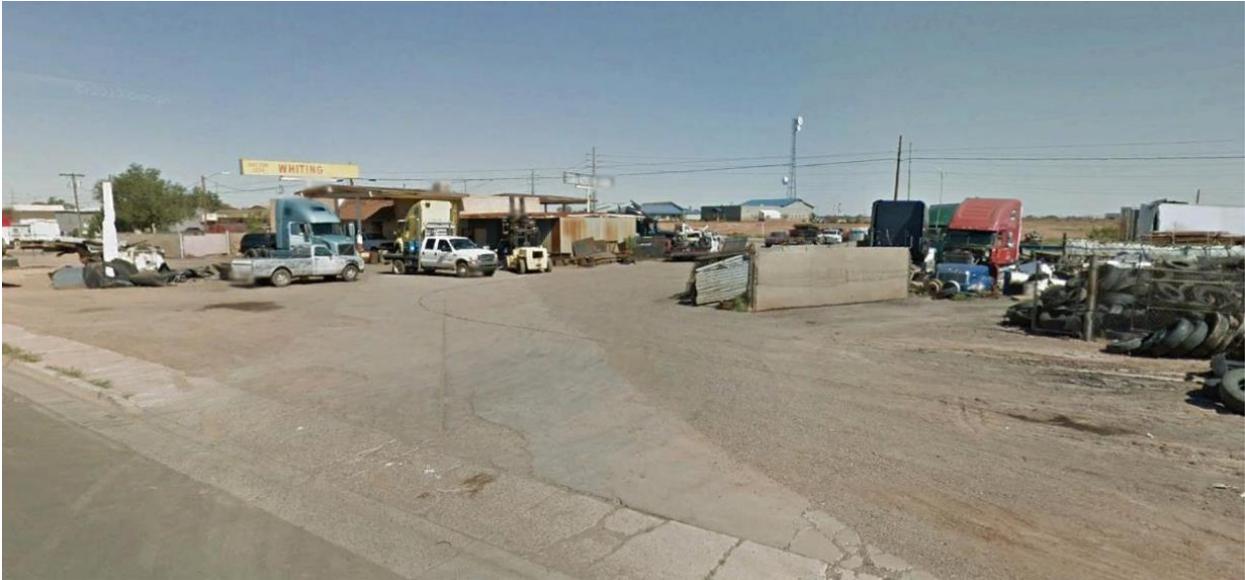
The closest LUST property to the potential realignment of the Winslow Levee is ‘Whiting Station # 23’, at 1402 E. 2<sup>nd</sup> St. (site #1 on Figures 1 and 2; see also Figure 3) (facility ID 0-005653). This site is 0.6+ mi west of a potential levee realignment and 1 mi west from existing Winslow Levee. It also is upgradient of the Levee, with regard to anticipated groundwater flow direction. In June 1994, four separate UST leaks or releases were identified at the property. Permanent tank closures were completed for 9 of the 10 USTs on the site in August 1994, when ownership was ascribed to ‘Sunshine Western Trucking, Inc.’. The tenth UST was pulled and permanent closure completed in June 2002, an action ascribed to a different ownership, that of ‘Sunwest Express, Inc.’ As of early 2010, the groundwater contaminant plume was undefined and site characterization was underway, utilizing a site characterization plan approved by ADEQ in May 2006. By 2013, the State recognized that soil and groundwater contamination are present at levels exceeding one or more standards and that remediation is necessary. Identification of specific contaminant(s) and the contaminant plume map are not among the databases accessible to date (ADEQ LUST database, ADEQ UST database, and ADEQ Route 66 brownfields status list). That information continues to be sought by the Corps. The Corps conducted a drive by examination of the site in September 2013. The photograph, Figure 3, which is from Google Earth and dated June 2012, is representative of the late 2013 site conditions seen by the Corps: an active trucking / vehicle related business with no obvious signs of a remediation process underway.

**Figure 3**— Whiting Station #23 leaking UST site, not remediated, looking northwest. Photograph from Google Earth (June 2012).

- Whiting Station #23 fueling station, site #1;
- Phil Bruchman Trading, site #2;
- Duke City Lumber mill site, site #3.

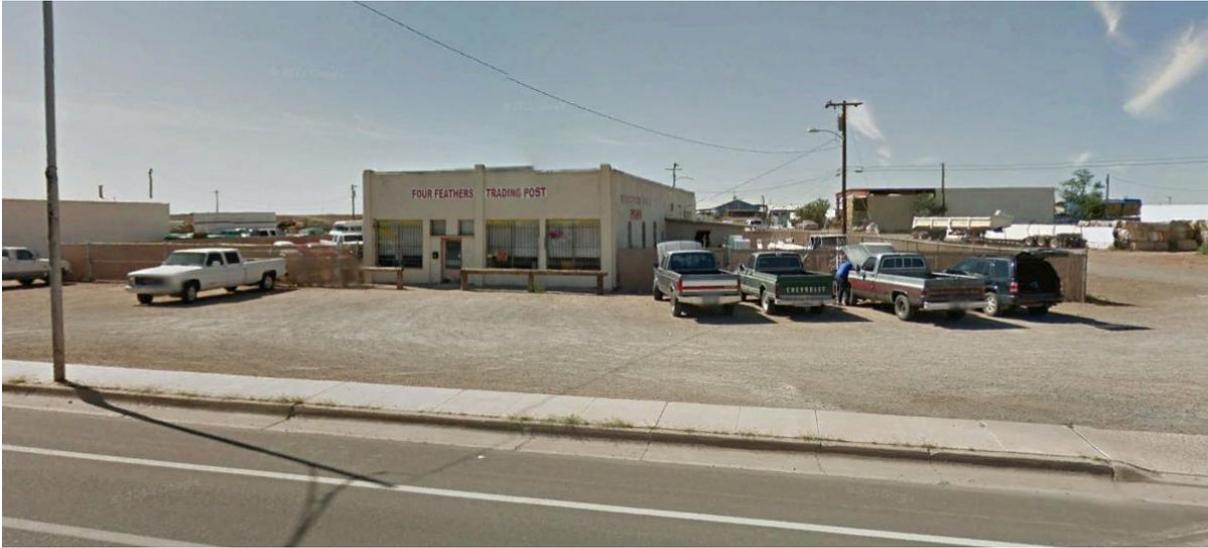
The ‘Phil Bruchman Trading’ LUST site, at 1407 E. 2<sup>nd</sup> St. (site #2 on Figures 1 and 2; see also Figure 4) (facility ID 0-006489), is another LUST site that is not yet remediated. It is 0.6+ mi west of potential levee realignment, 0.9 mi west from existing Winslow Levee, and upgradient of the Levee with regard to anticipated groundwater flow direction. Sometime prior to 2007 (probably in 1989), groundwater contamination that included free-floating product was known, and in November 2007 an additional release of the same type (impacting groundwater, involving free-floating product) was discovered. As of early 2010, site characterization was underway, utilizing a site characterization plan approved by ADEQ in November 2007. By 2013, the State recognized that soil and groundwater contamination is present at levels exceeding one or more standards and that remediation is necessary. Identification of specific contaminant(s) and the contaminant plume map are not among the databases accessible to date (ADEQ LUST database, ADEQ UST database, and ADEQ Route 66 brownfields status list). That information continues to be sought by the Corps. The Corps conducted a drive by examination of the site in September 2013. Figure 4, which is from Google Earth and dated June 2012, is representative of the late 2013 site conditions observed by the Corps: a possibly active business site, named ‘Four Feathers Trading Post’, with no obvious signs of a remediation process underway. Permanent tank removals took place on the property in March 1989 and October 2007, which explains the two different dates of discoveries of LUSTs, one after the 2007 tank pull, and another discovery earlier, probably associated with the previous tank pull.

**Figure 4** — Phil Bruchman Trading leaking UST site, not remediated, looking south. Photograph from Google Earth (June 2012).

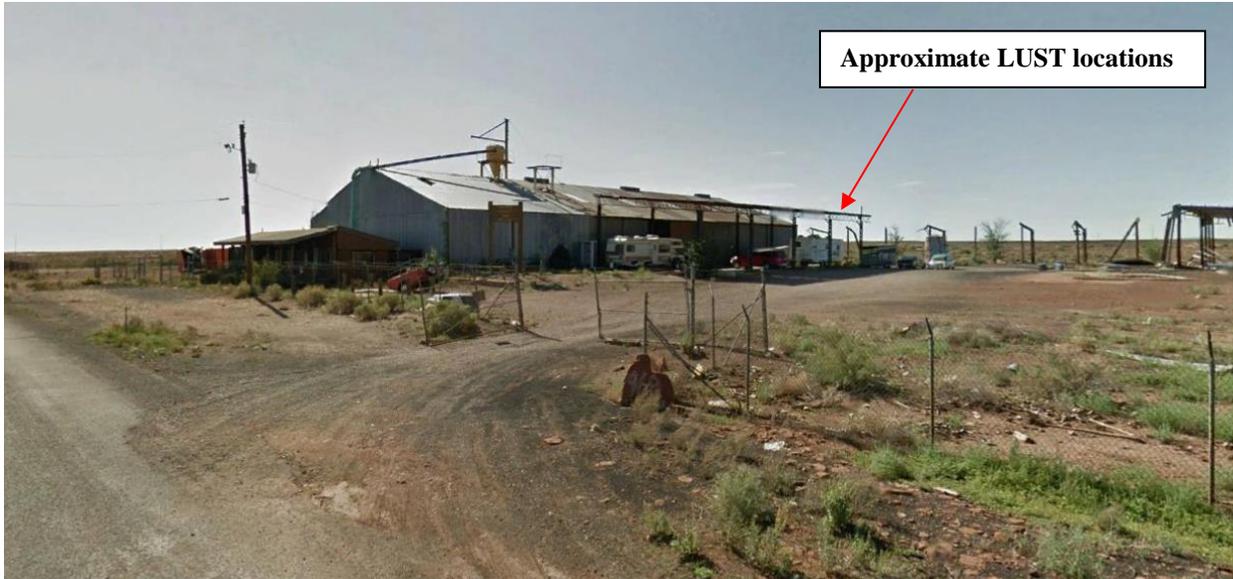
**Figure 5** — Duke City Lumber leaking UST site, which has been under remediation for the past 20 years, looking southeast. Photograph from Google Earth (June 2012).

This site is 0.9 mi west of potential levee realignments and slightly more than 1 mi distant from existing Winslow Levee, and is upgradient of the Levee, with regard to anticipated groundwater flow direction. The mill has four recorded individual UST-related releases, all of which were recognized beginning twenty years ago, in October 1993. At least five USTs were present on the property. The records list only three of them as having been removed, all in November 1993. Remediation began nearly 20 years ago, in November 1993, and all the releases still were undergoing remediation as of October 2013 according to the ADEQ LUST database listing. Each of the releases has a defined groundwater contaminant plume, free-floating product, and is undergoing active remediation comprised of active skimmers, oxygen release compounds, and enhanced bioremediation. The Corps conducted a drive by examination of the site in October 2011 and again in September 2013. The photographs, Figures 5 and 7, which are from Google Earth and dated June 2012, are representative of the site conditions seen by the Corps: an inactive, partly demolished industrial site with some signs of gatekeeping, and possibly remediation, underway.

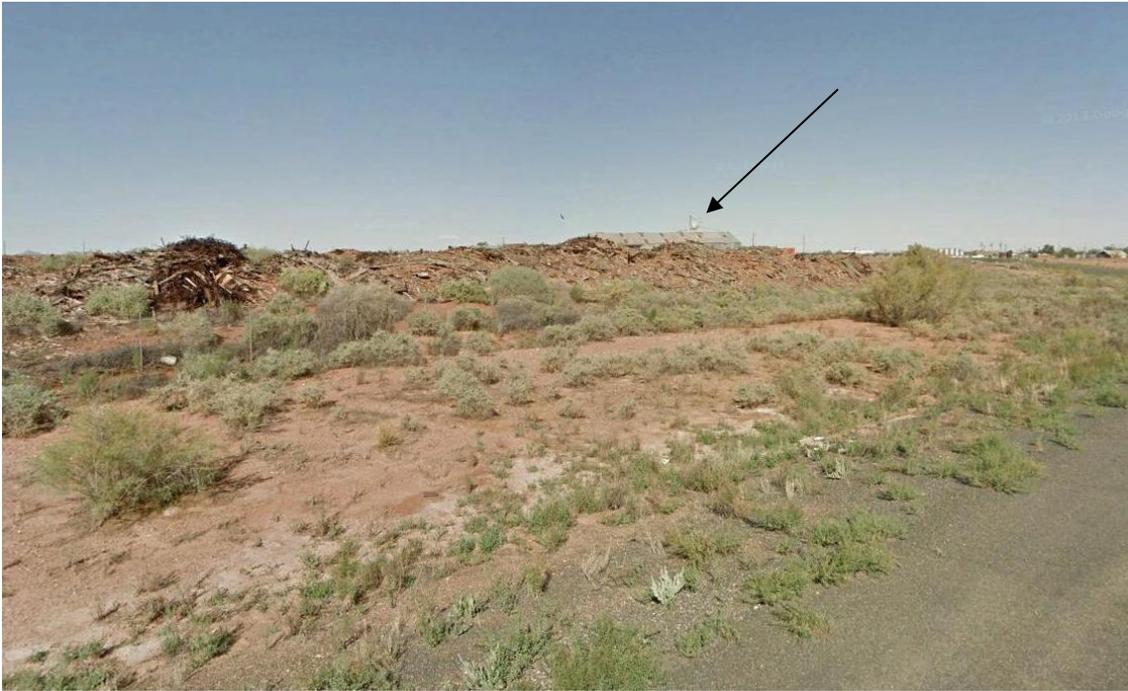
**Figure 7** — Woody mill waste piled east of the Duke City Lumber site, looking northwest. Note mill (arrow). Photograph from Google Earth (June 2012).

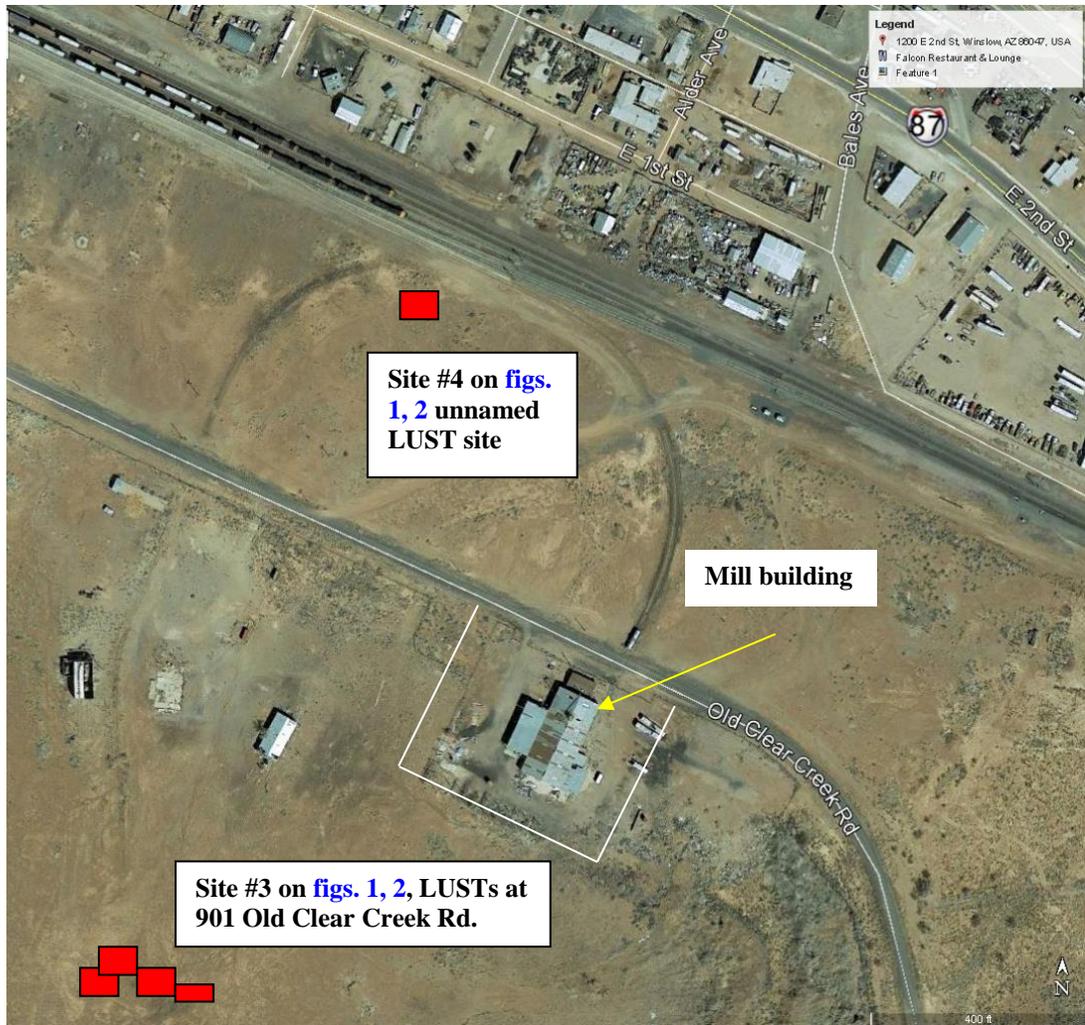
**Figure 8** — Lumber mill and LUST sites, Old Clear Creek Rd. Rd. LUSTs approximated by red squares. See parcel boundaries, Figure 9. Photograph from Google Earth (June 2012).

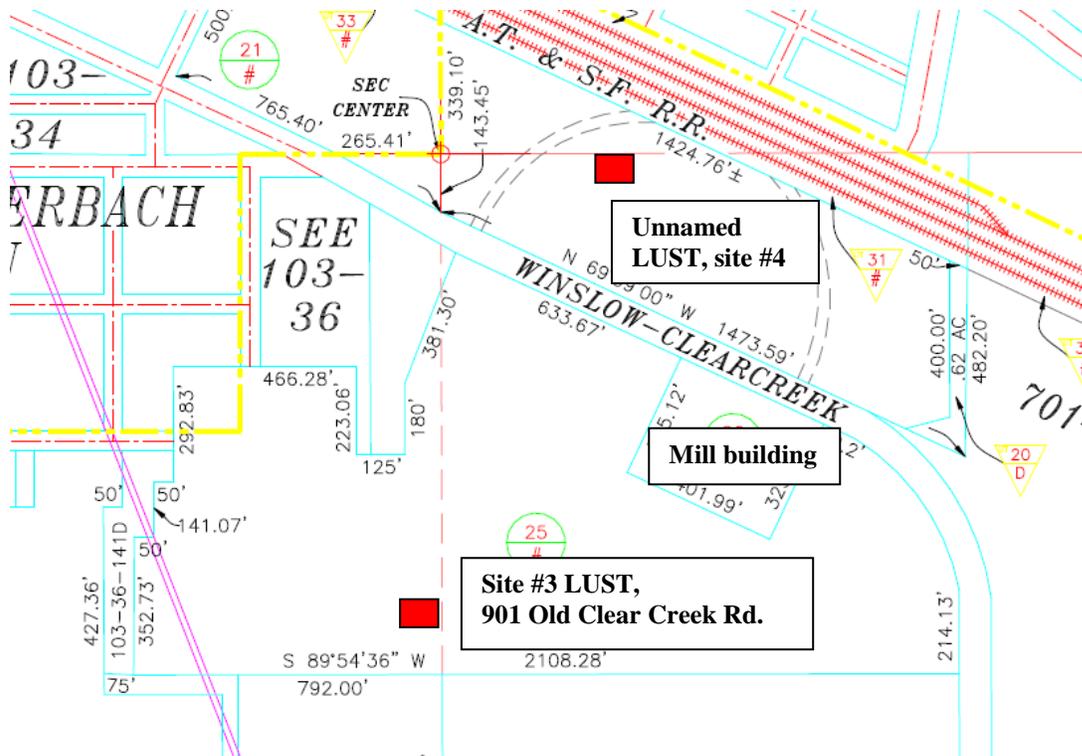
**Figure 9** — Navajo County property plat map (2013) showing Duke City Lumber mill and unnamed LUST sites, and generalized tank locations, Old Clear Creek Rd.

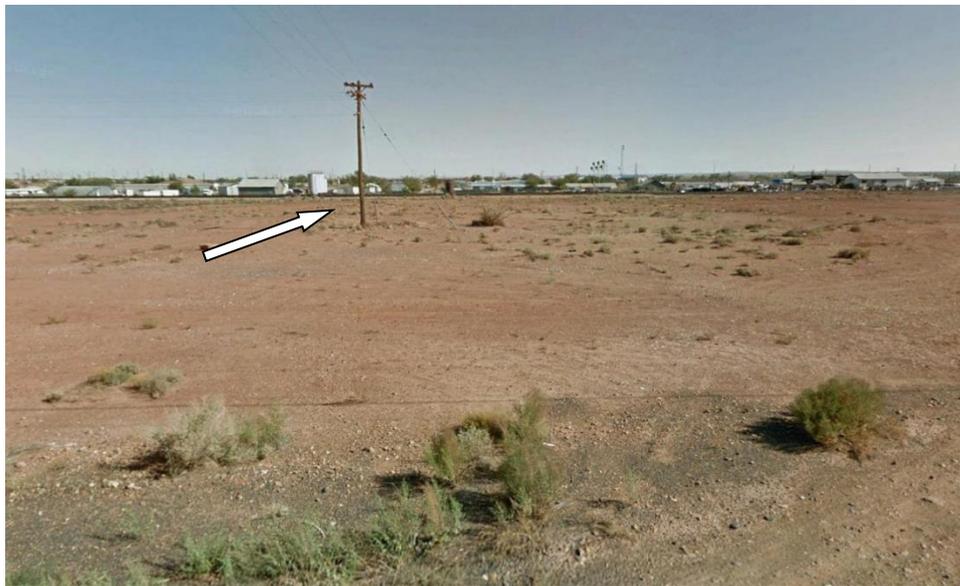
An unnamed LUST site (site #4 on Figures 1 and 2; see also Figures 8, 9, and 10) on the opposite side of Old Clear Creek Rd. from the former Duke City Lumber mill came to the attention of the Phase I ESA evaluator only because it is shown on a December 2011 City of Winslow map of “active” (presumably “not fully remediated”) LUST sites. No other information suggesting the presence of a LUST at this property has been found, and the site is not in the ADEQ LUST database, or in any other regulatory records or sources of information. According to Navajo County parcel records of late 2013 (Figure 9), the site has no street address and its owner is different from both the owner of the former lumber mill building (969 Old Clear Creek Rd.), and the owner of the Duke City Lumber LUST site (901 Old Clear Creek Rd.). The site indicated as the LUST is 1 mi from conceptual Winslow Levee realignments, and was vacant land as of September 2013, when the Corps drove by to examine the area. There were no visible signs of a tank, a release, an investigation, or remediation, at that time. That it is in the center of a former semi-circular railroad spur suggests it was an industrial or railroad site at some point in the past. That former use could not be determined with available sources of information. Records indicating locations of former rail activities sites were searched.

**Figure 10** — Site #4, unnamed LUST site (bare ground at arrow) indicated on City of Winslow map as active LUST site, on north side of Old Clear Creek Rd., View to the northeast. See also figs. 8, 9. Photograph from Google Earth (June 2012).

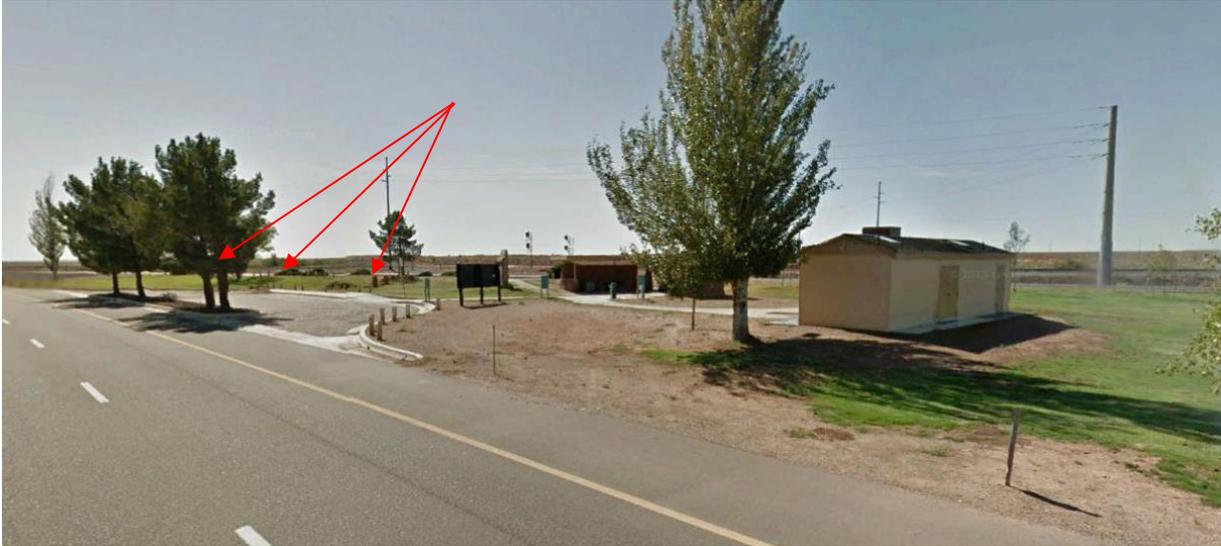
**Figure 11** — Three adjacent, remediated LUST sites on Old Highway 66 at the east end of Winslow (combined “site #5” on Figures 1 and 2). Compositied site is redeveloped as a City roadside park. These are the closest LUST sites of any type to the Winslow Levee. Location is on south side of State Hwy 87, which turns into 3<sup>rd</sup> St. a short distance farther west. LUST property locations approximated by arrows. View to the southeast. Photograph from Google Earth (June 2012).

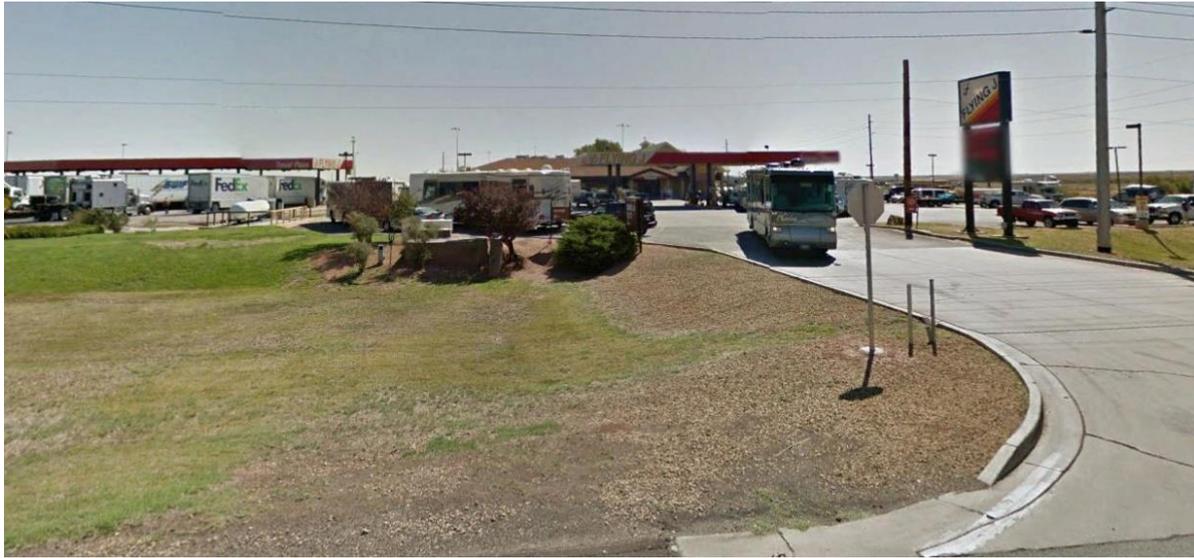
**Figure 12** — Site #13 on Figures 1 and 2. 400 Transcon Lane, an active trucking plaza and site of two diesel fuel spills ¼ mi from the potential Winslow Levee improvements. View to the east. Photograph from Google Earth (June 2012).

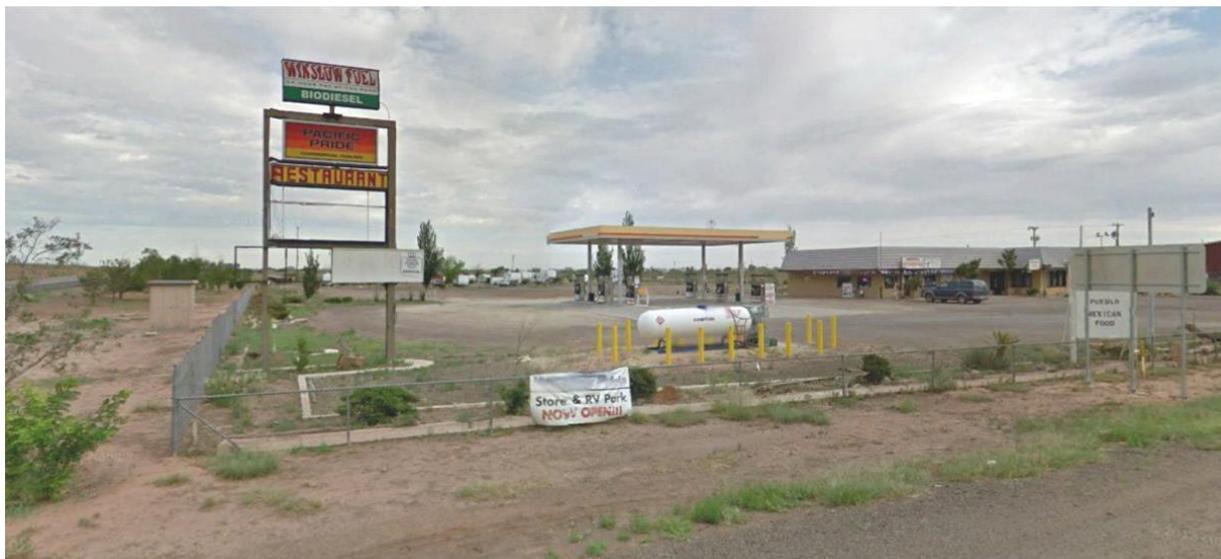
Logic suggests that other petroleum hydrocarbon fuel USTs exist at 1 Transcon Lane, which is the Winslow Fuel business (site #14 on Figures 1 and 2; see also Figure 13), and which has visible gasoline fueling islands and dispensers. No official record of any USTs or UST leaks was found for this property. The site depiction in Figure 13, which is from Google Earth, June 2012, is representative of site conditions observed during the Corps September 2013 drive by examination: an inactive fueling site, with adjoining, active liquor store and restaurant.

**Figure 13** — Site #14 on Figures 1 and 2, Winslow Fuel, 1 Transcon Lane, a site with visible fueling islands, and, presumably, petroleum fuel USTs. View to the west. Photograph from Google Earth (June 2012).

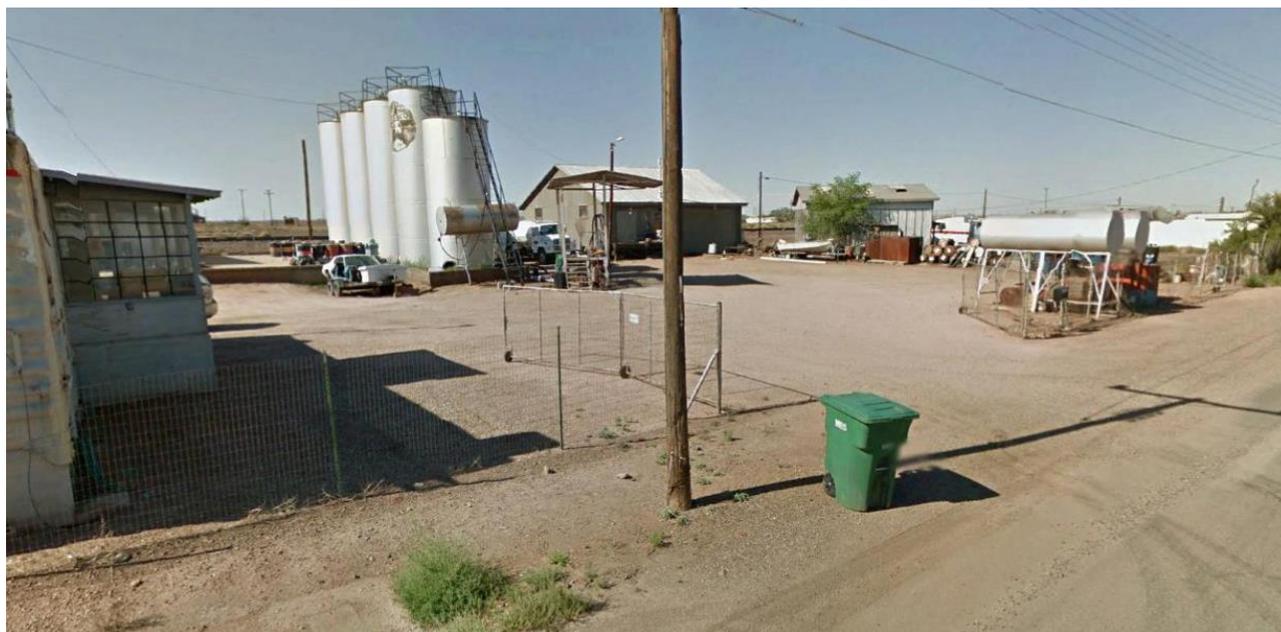
McHood Oil Co., at 1115 E. 1<sup>st</sup> St. (site #15 on Figures 1 and 2; see also Figure 14), has eight ASTs that appear to be in use for petroleum products. None have evidence of leaking.

**Figure 14** — Site #15 on Figures 1 and 2, eight ASTs at McHood Oil, 1115 E. 1<sup>st</sup> St., Winslow. View to the south-southwest. Photograph from Google Earth (June 2012).

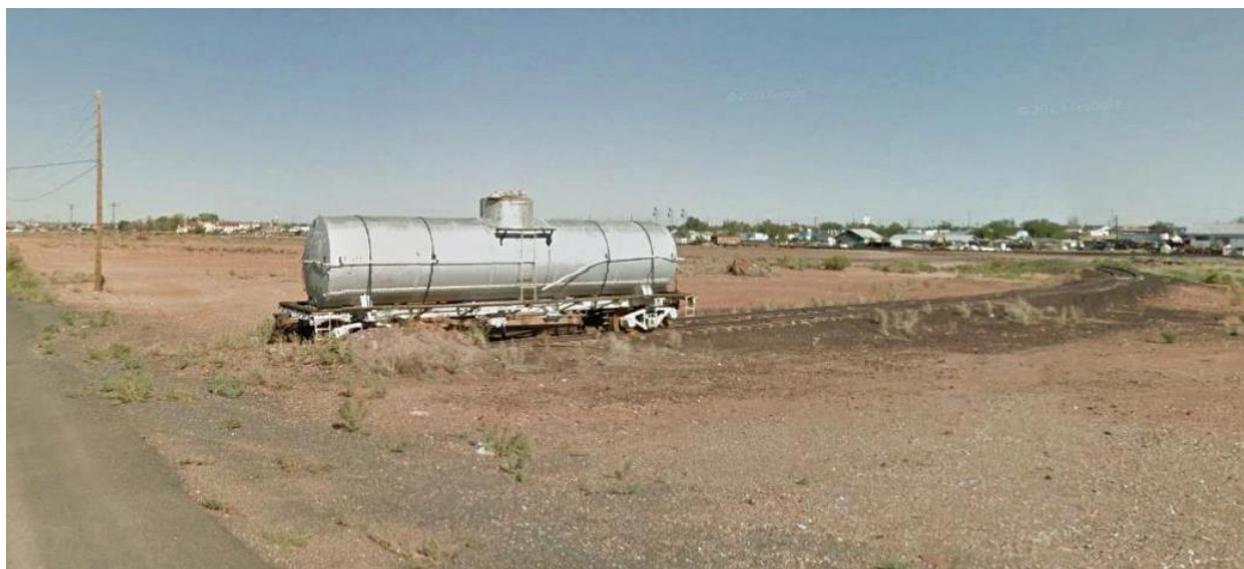
On Old Clear Creek Rd., on the opposite side of the road from the mill, a railroad tank car (site #16 on Figures 1 and 2; see also Figures 15, 16) is stored on a sharply curved rail siding, apparently on a permanent basis, since the siding track does not connect to any other lines. It was in the same location in June 1997, as per an aerial photograph of that date. The tank car appears to have external plumbing in place for managing some type of fluid content. No

**Figure 15** — Site #16, rail tank car AST, opposite the Duke City Lumber site, Old Clear Creek Rd. View to the west. Photograph from Google Earth (June 2012).

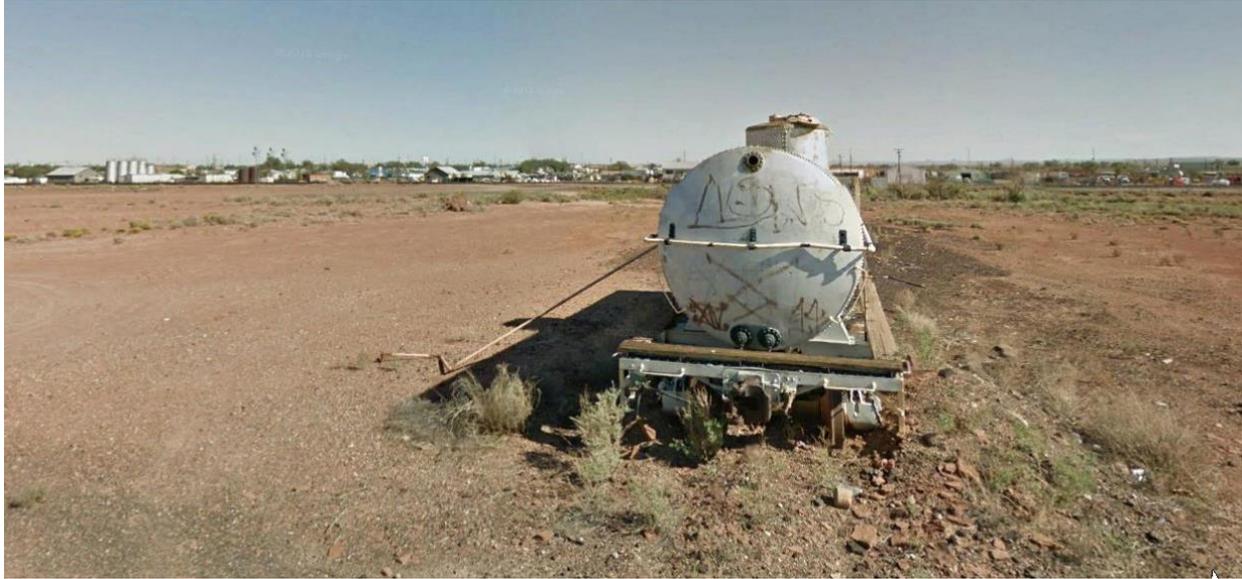
**Figure 16** — Another view of site #16, rail tank car AST, opposite the Duke City Lumber site, Old Clear Creek Rd. View to the north. Stationary ASTs of the McHood Oil property (site #15) can be seen on horizon, upper left of frame (large silver tanks). Photograph from Google Earth (June 2012).

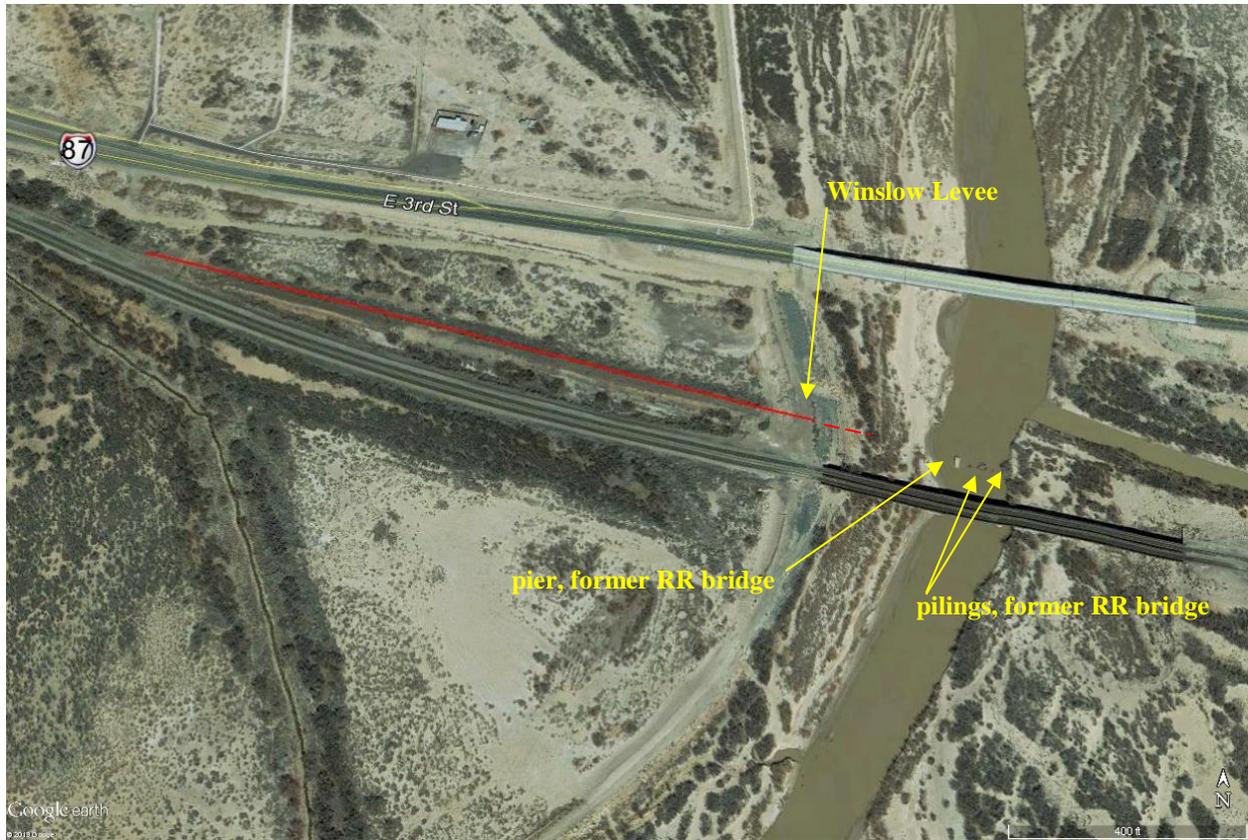
Environmental site assessments of such former rail alignments typically reveal small quantities of petroleum hydrocarbon leakage in soil beneath former tracks. Such hydrocarbon leakage originates from rail car wheel assemblies, primarily as oil from the journal box. Petroleum contaminated soils along the former track alignment can be the result. Trace amounts of some PCBs also can be found in such locations, likely representing trace chemical components of journal box oil. The depth of penetration into soils beneath the tracks in such instances is usually very shallow and less than 3 ft deep because the means of release is small drips occurring over a long period of time, as multiple trains pass the location. No record of soils testing to verify presence or absence of petroleum contaminated soils along this particular former rail alignment is known.

**Figure 17** — REC: Site #18, former railroad alignment (red line) crossing Winslow Levee. Photo: Google Earth June 2012. The old pier noted in Little Colorado River (light-colored rectangle) is 20 ft in the longest dimension.

A former railroad track alignment over the Winslow Levee is presumed to be untested, since the Corps could obtain no information to the contrary, and may contain small quantities of leaked petroleum hydrocarbons in the form of journal box oil, and even related trace PCBs, chemicals that may exist as components of journal box oil. Such occurrence is common enough along former rail track alignments that such release is anticipated to possibly be present here, unless or until proven otherwise through soils testing along the alignment. No such soils testing is planned or anticipated to be done as a part of this feasibility study. The site is considered an REC with regard to the Levee, as long as there is an absence of favorable soil testing.

The former railroad track alignment, which can reasonably be anticipated to have some low level contamination, is anticipated to require some shallow soil removal under all alternatives that cannot fully avoid this area, including the Tentatively Selected Plan. Removal of contaminated soil around the former railroad track alignment is estimated to fall in the range of \$50,000 to \$100,000 if hazardous waste is present, and fall to approximately \$25,000 if only Special Waste is present. These costs include some shallow sampling and testing. Such wastes seldom penetrate to the subsurface to depths of 2 ft because the releases are small drops or particles, lost over a long period of time.

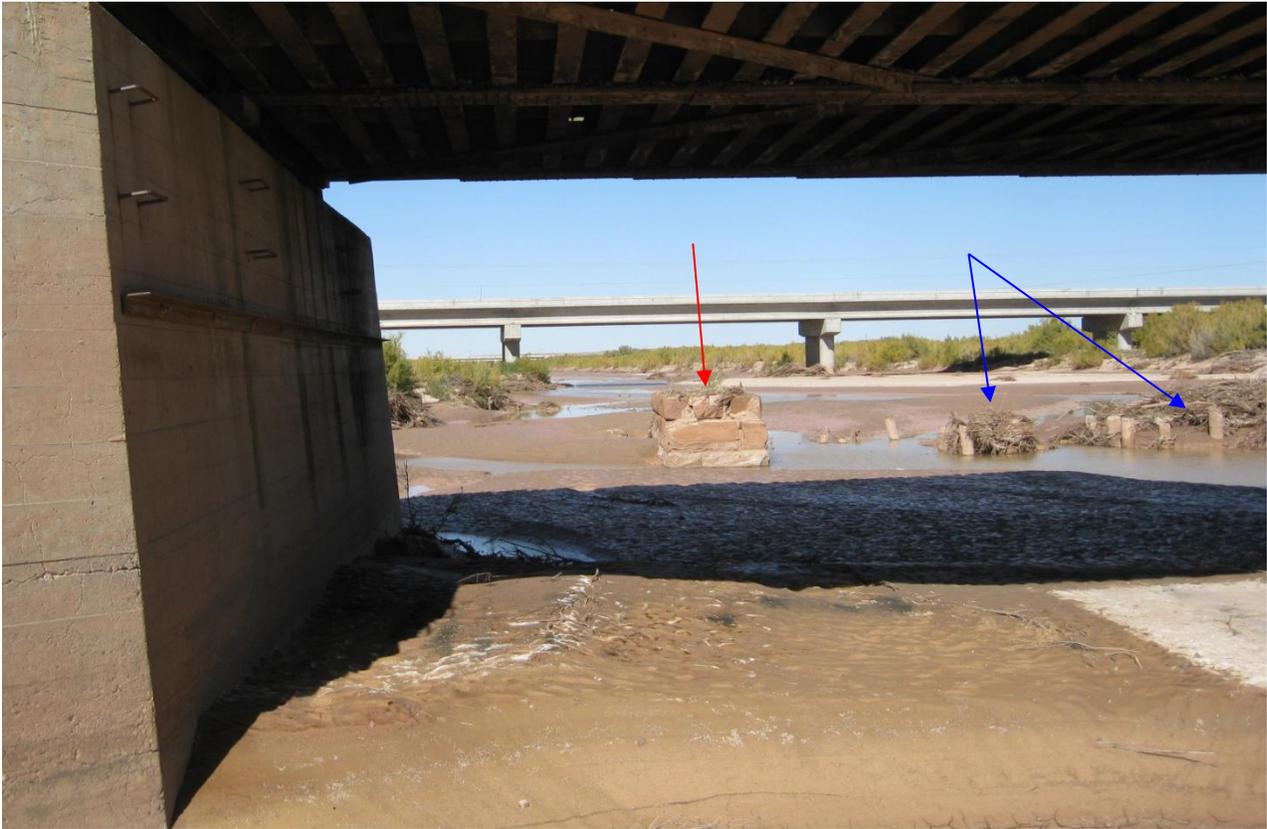
**Figure 18** — Site #18, remnant sandstone block pier (red arrow) and pilings (blue arrows) of former railroad bridge over Little Colorado River. Current BNSF RR bridge in foreground and current State Route 87 bridge in background. View (and river flow) to the north. Photo: Corps of Engineers, October 2011, at low water.

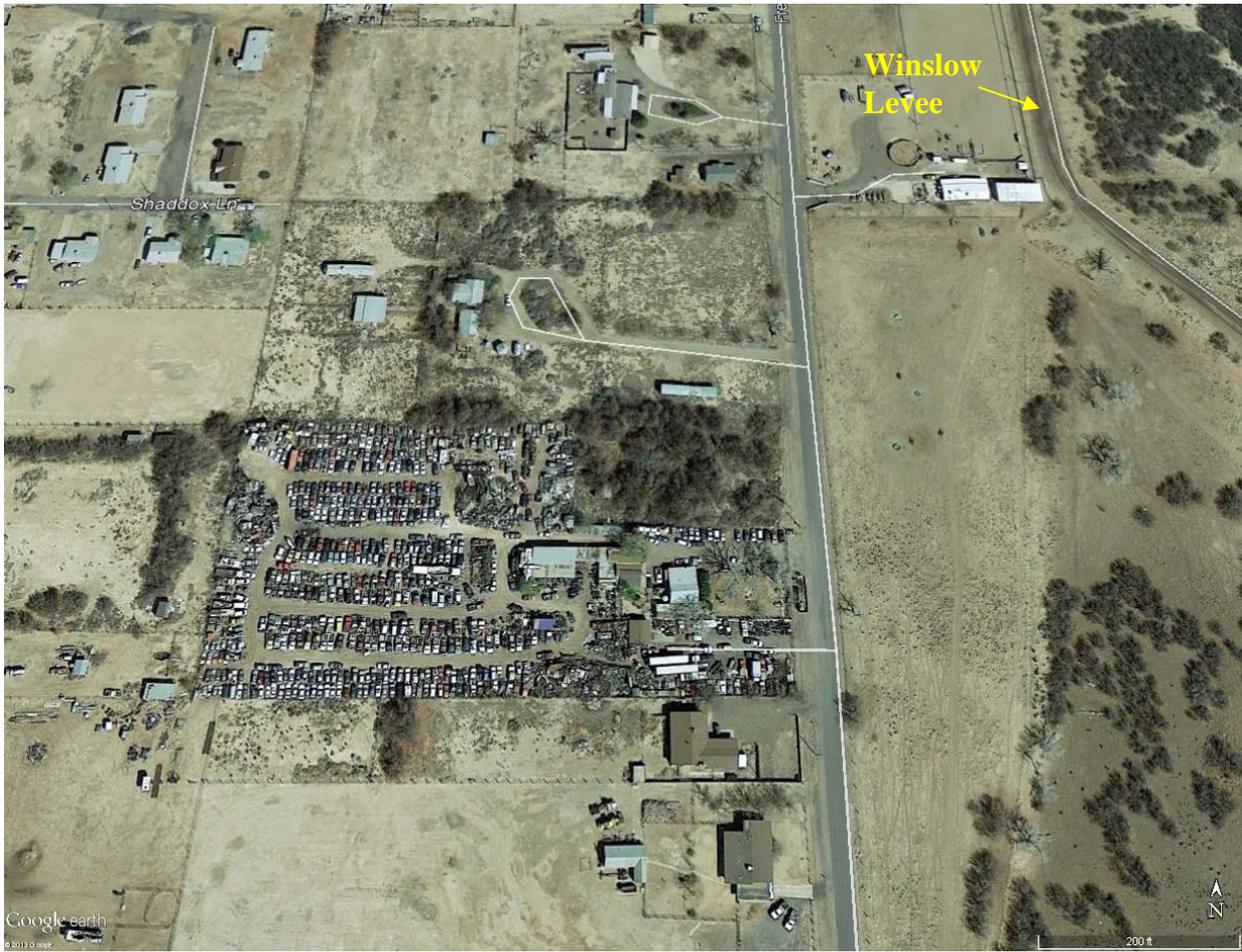
A vehicle salvage yard exists at 'JRS Kachina Auto Wrecking', 637 French Rd., Winslow (site #19 on Figures 1 and 2; see also Figure 19), and is within 600 ft of the Winslow Levee and 250 ft of conceptual levee realignment. At least 500 salvage vehicles are on the site, based on examination of a 2012 aerial photograph. Aerial photographs as old as June 1997 reveal the site then was in much the same array as now, with hundreds of salvage vehicles present within the same perimeter. The September 2013 Corps drive by of the site shows it is an operating salvage business, but large trees along the roadside prevented determining if many salvage vehicles remain. It is certain that some remain and likely that all remain, since the business is operating and junk vehicles could be seen from the road. The site has no record of USTs, no visible ASTs, no record of leaks or spills, and no record of RCRA violations.

**Figure 19** — Aerial view of auto salvage yard (center of frame, note the hundreds of lined-up salvage vehicles) within 600 ft of Winslow Levee. Site 19 on Figures 1 and 2. Photo: Google Earth June 2012

A vehicle salvage site with over 500 junk vehicles is less than 600 ft from the Levee and less than 250 ft from potential realignment. It is not considered a REC at this time with regard to this study, because the business has no known ‘violations’ or other negative environmental records, including no record of any substance releases, or RCRA infractions, or LUSTS, and it has no known USTs or ASTs. The current planning concepts for this area do not include elevating any of the nearby residences or other nearby work.
