**Little Colorado River at Winslow, Navajo County, Arizona**  
**Flood Risk Management Feasibility Study**

**Phase I Environmental Site Assessment**

## Phase I Environmental Site Assessment for pertinent parts of “Little Colorado River at Winslow” Feasibility Study

Winslow, AZ and Vicinity (Navajo County)

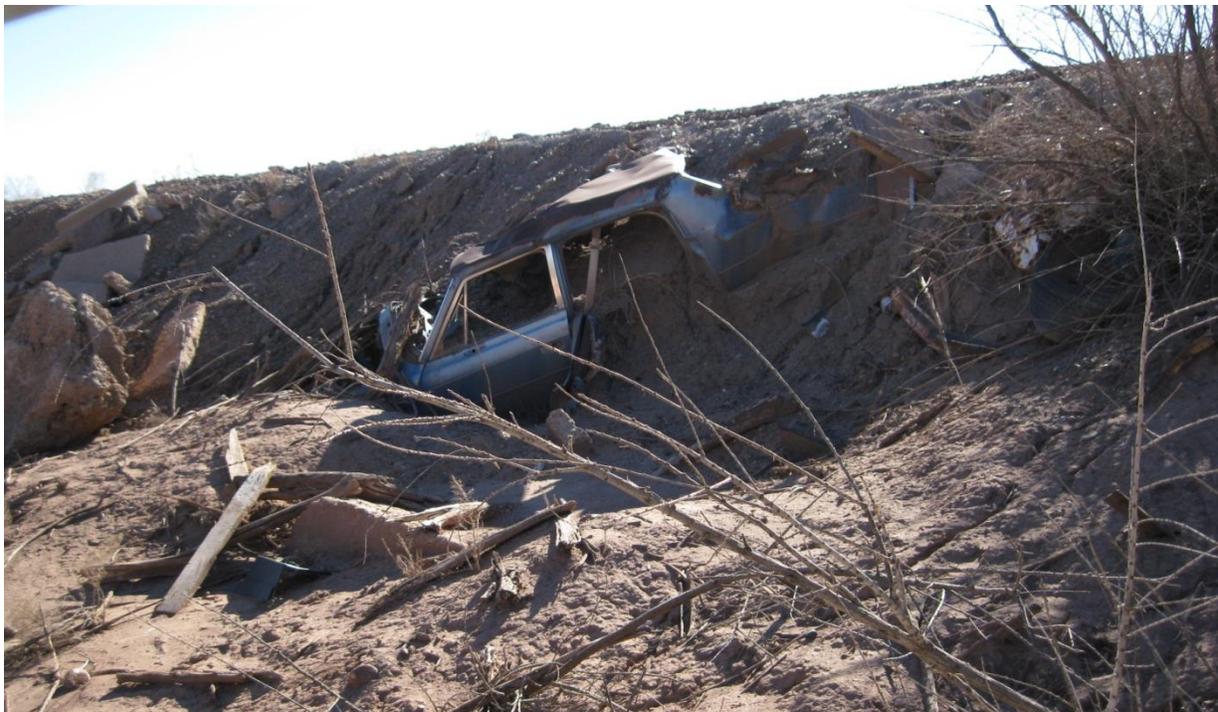
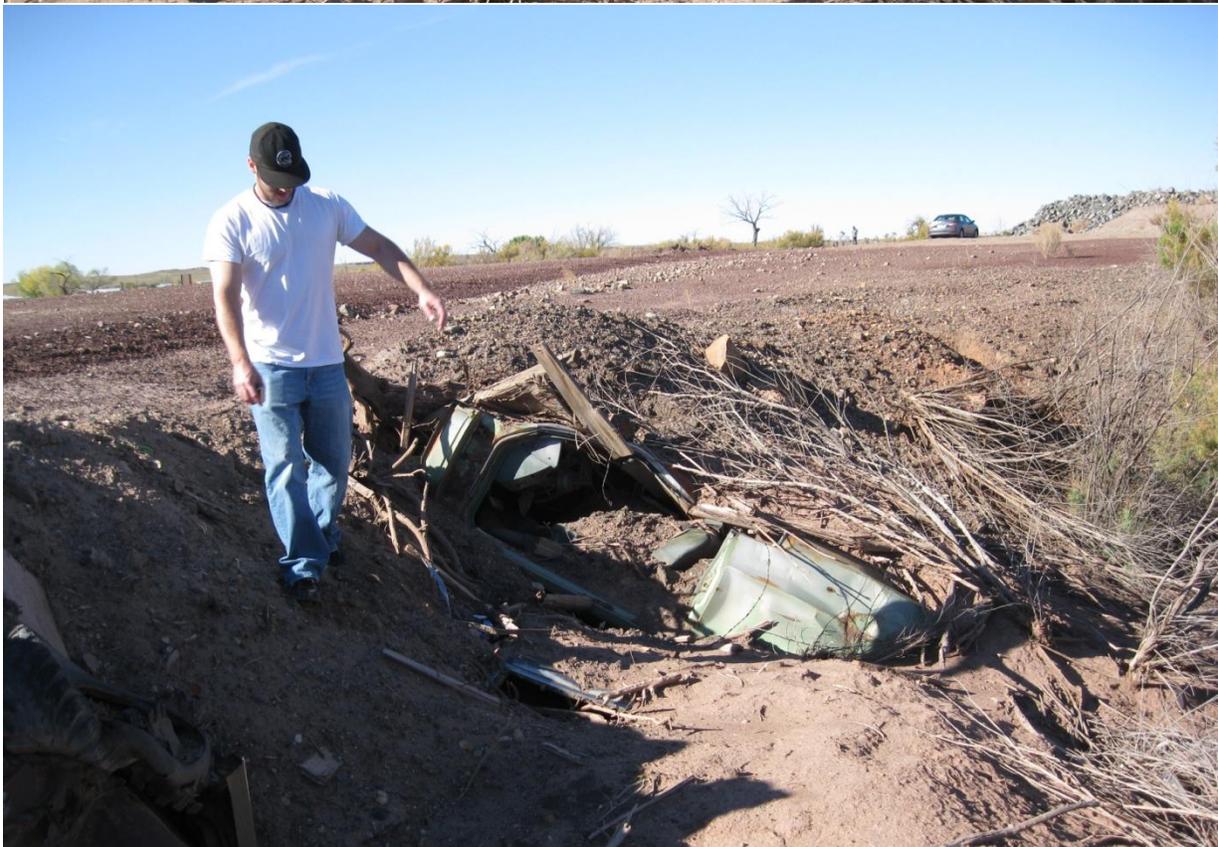
At least two automobiles are buried in the northern part of Winslow Levee and exposed in the riverside Levee slope, 150 ft south of the intersection of McHood Rd. and the Levee (site # 20 on Figures 1 and 2; see Figure 20). Other metal car body parts nearby within the Levee fill may be agglomerations of loose parts or crushed automobile hulks. Reports concerning how the Levee originally was built (pre-1989) make it clear that junk car bodies were used to construct the Levee. While Navajo County and their contractors made the effort to remove such vehicles from Levee fill as the Levee was being raised and improved in 1989, the scene in Figure 20 demonstrates that at least a few more have to be removed. It is not known whether these vehicles, or any others that still may be concealed in the fill, were drained of fluids prior to their placement as levee fill. Anecdotal evidence concerning the original levee construction suggests it was built under duress, in flood-fight circumstances, which supports that draining these vehicles of fluids probably did not occur.

**Figure 20** — Top and bottom frames. REC: Automobiles used as Winslow Levee fill, south of the intersection of the Levee with McHood Rd. Photo: Corps of Engineers, October 2011. The site was unchanged in September 2013. Site 20 on Figures 1 and 2.

Buried automobiles used as Winslow Levee fill, 150 ft south of McHood Road, apparently have been in the fill since original attempts to build a levee, more than 40 years ago. It is not known if they contain fluids, such as oil and gasoline, and it must be presumed they do contain at least some such fluids. Therefore, they are RECs. Those fluids may have leaked and caused small areas of petroleum hydrocarbon soil contamination in the Levee fill. If present, such release(s) readily should be containable, given the apparent small numbers of vehicles present, and probable age and amount of the potential releases.

vehicle removal, record the visual conditions of the soil around and beneath such vehicles, look for staining, and consider taking confirmatory soil samples to verify clean soils, or to document levels of contamination, if any releases exist.

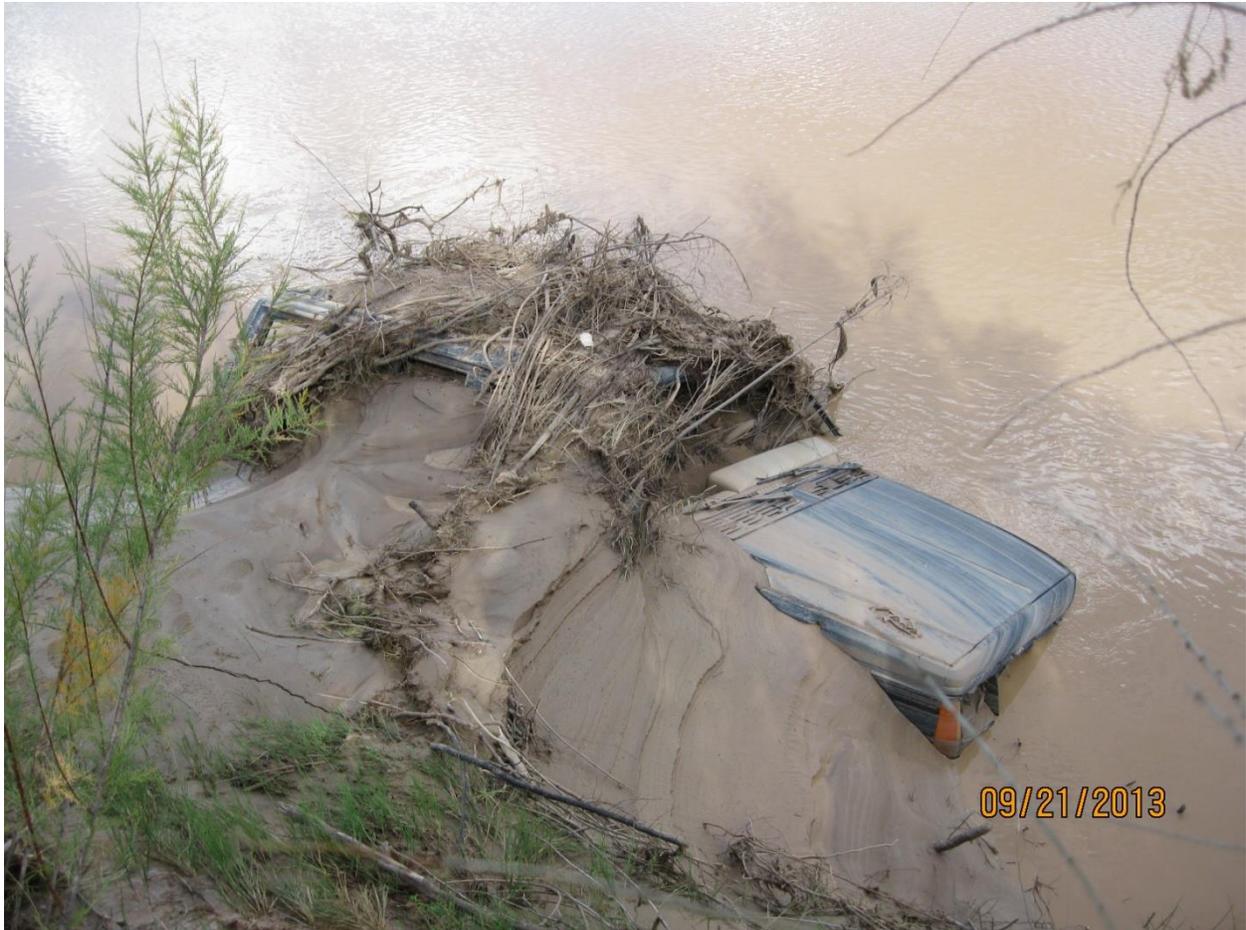
One operational, SUV-type vehicle was lost and became buried in the Little Colorado River in early September 2013, close to the west riverbank and 200 ft north of the northern (west-bound) Interstate 40 bridge (site #21 on Figures 1 and 2; see also Figure 21). This location is within the river alluvium excavation zone of one of the feasibility Alternatives under consideration (Alternative 10.4), an Alternative that has the most extensive footprint of the various Alternatives that involve river alluvium removal. The vehicle was near and east of a place where new Winslow Levee eventually may be constructed, but not immediately adjacent to that area. This vehicle was fueled and was being driven in the dry riverbed at the time it became stuck in deep, loose, dry sand, so it is certain that it contained oil, gasoline, and antifreeze. Reportedly, a few days after it became stuck, the river rose and flooded it, and logs floating down river broke out all the glass, light assemblies, etc., filling it with sand and mud. Efforts to remove the vehicle in the early fall of 2013 failed, and resulted only in the tow truck snapping tow cables and ultimately becoming stuck in loose sand on the river bank, and requiring extraction by another tow truck. The mass of the lost SUV loaded with wet river alluvium was too much to extract by tow cable pulling. There was no evidence of fuel tank, transmission, or differential ruptures at the time it was observed by the Corps (late September 2013), and no oily plume extending into the river from the vehicle. The vehicle successfully was removed, fully, several years ago by disassembling it into smaller pieces of manageable weight that could be extracted from the enveloping river sediment (Rich Legere, USACE, Planning Division, Phoenix, AZ, personal commun., 6 December 2017). No report is available to the Corps on the means used during that effort to contain fuels, lubricants, and other fluids in the vehicle. As of the time of preparation of the Chief's Report phase of this feasibility study's documentation, Alternative 10.4 will not be the Alternative pursued. Alternative 10.1, the NED plan and the more likely footprint if this flood-control project is constructed in the future, has a smaller footprint, ending upstream of this SUV site, and would not require river sediment extraction in the area where this vehicle formerly was embedded in the Little Colorado River alluvium.

**Figure 21** — Site #21 on Figures 1 and 2. REC: Vehicle lost and buried in the Little Colorado River, September 2013, about 200 ft north of the I-40 west-bound bridge. Photo: Corps of Engineers. The vehicle has been removed. Documentation on whether fluids were released during removal is not available to the Corps.
