## THIRD MONITORING REPORT NARRATIVE. FEBRUARY OF 2016

- a. Corps Permit Number: SJA-2008-00123 (IP-CGR). Compensatory Wetland Mitigation Plan. Río de La Plata Flood Control Project, Dorado, Puerto Rico.
- b. Fernando Payan, Subcontractor from Habitat, is the responsible party for conducting the monitoring. Dates the inspection was conducted: To be determined upon completion of planting.

RIO DE LA PLATA FLOOD CONTROL PROJECT  
 DORADO, PUERTO RICO

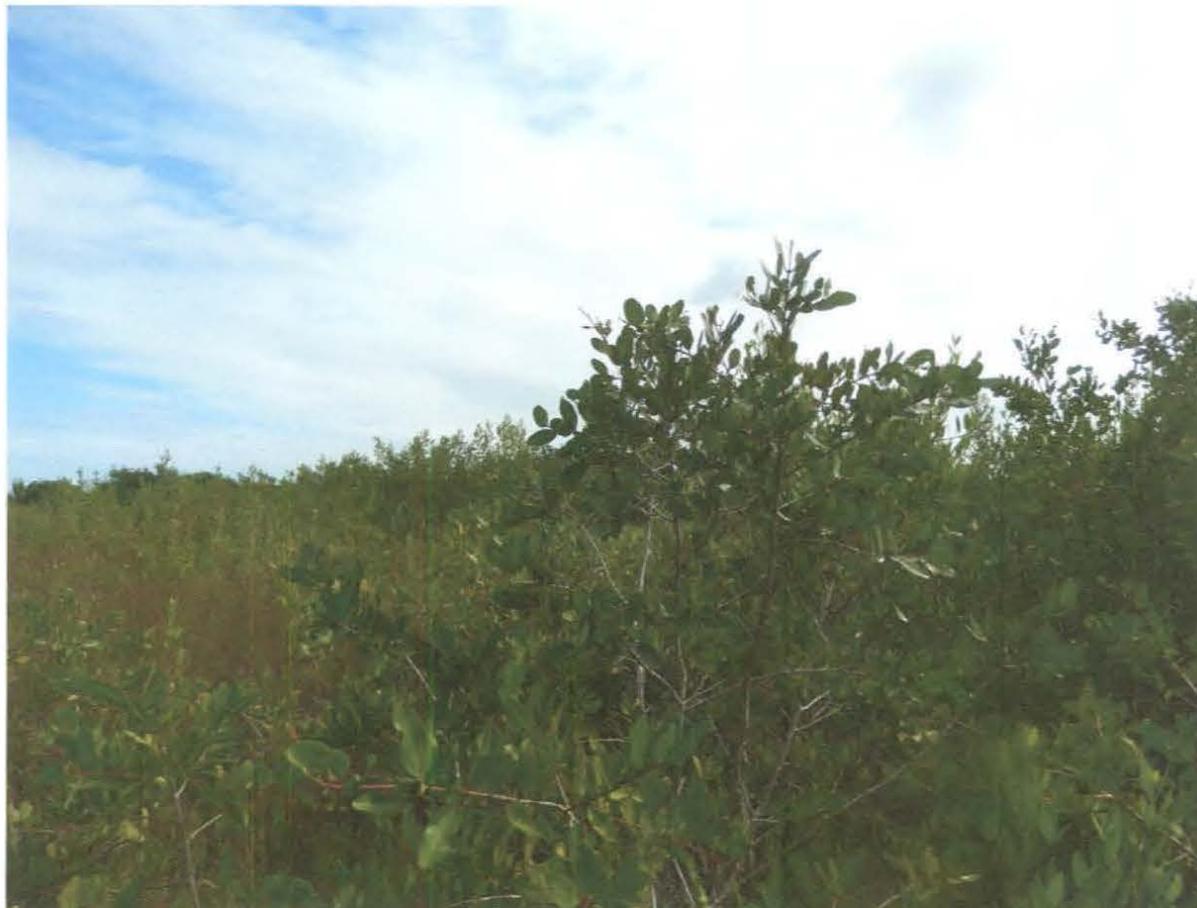
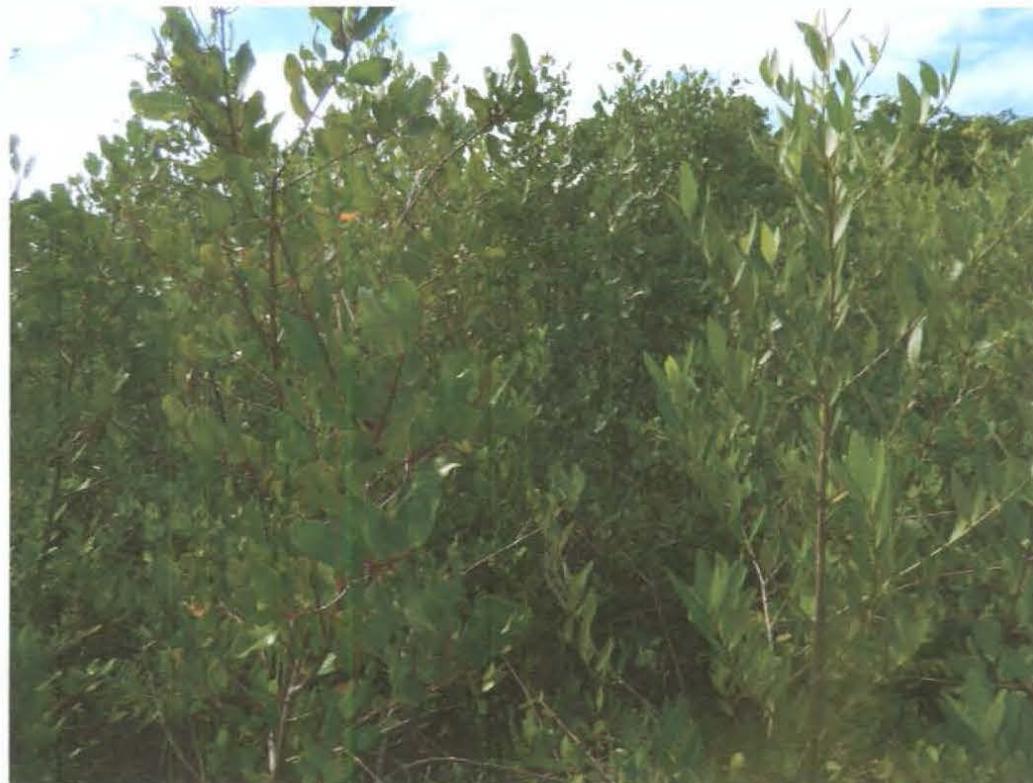
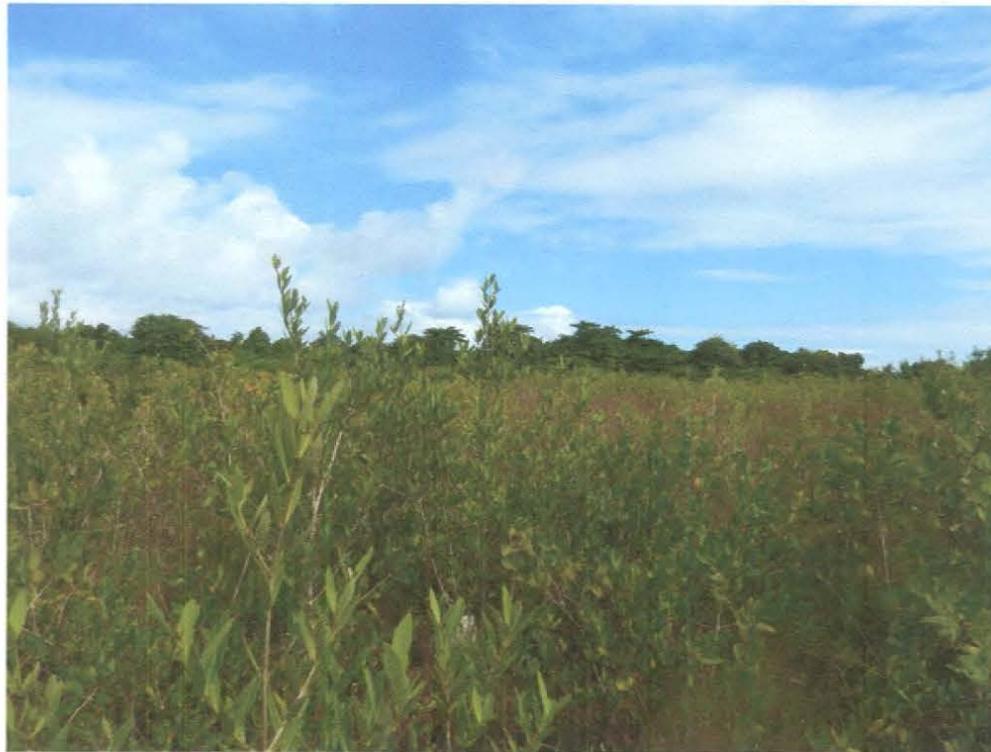
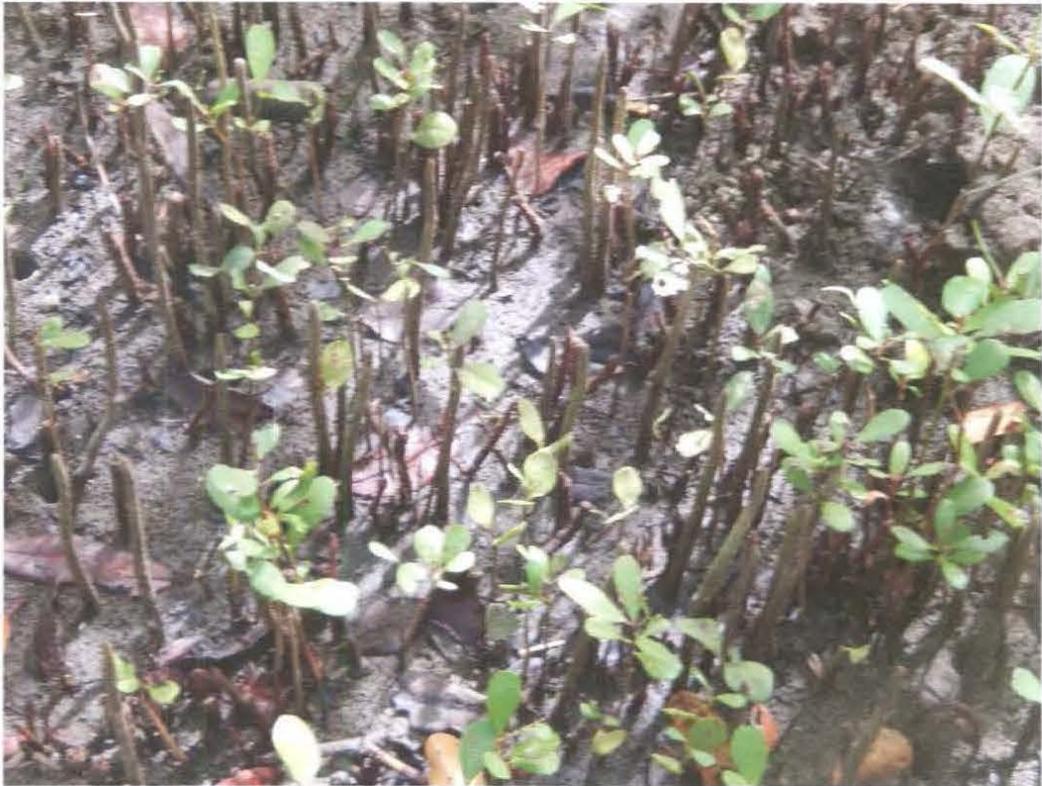
APPENDIX No. 1 – PARCEL No. 6

- 1) Parcel #6: Species to be planted: *Laguncularia racemosa* (White mangroves) and *Avicennia germinas* (Black mangroves). They were planted according to the specifications of the mitigation projects. The planting began on the 24<sup>th</sup> of October of 2011 and ended in January of 2012. Since the last monitoring report (second) the mangroves (white and black) are getting tallest and spreading all over the parcels. Some areas continue to be destroyed by 4x4 vehicles (jeeps and four tracks). The people made roads for these vehicles. The development of the parcel is illustrated in appendix No. 1

White and Black Mangroves

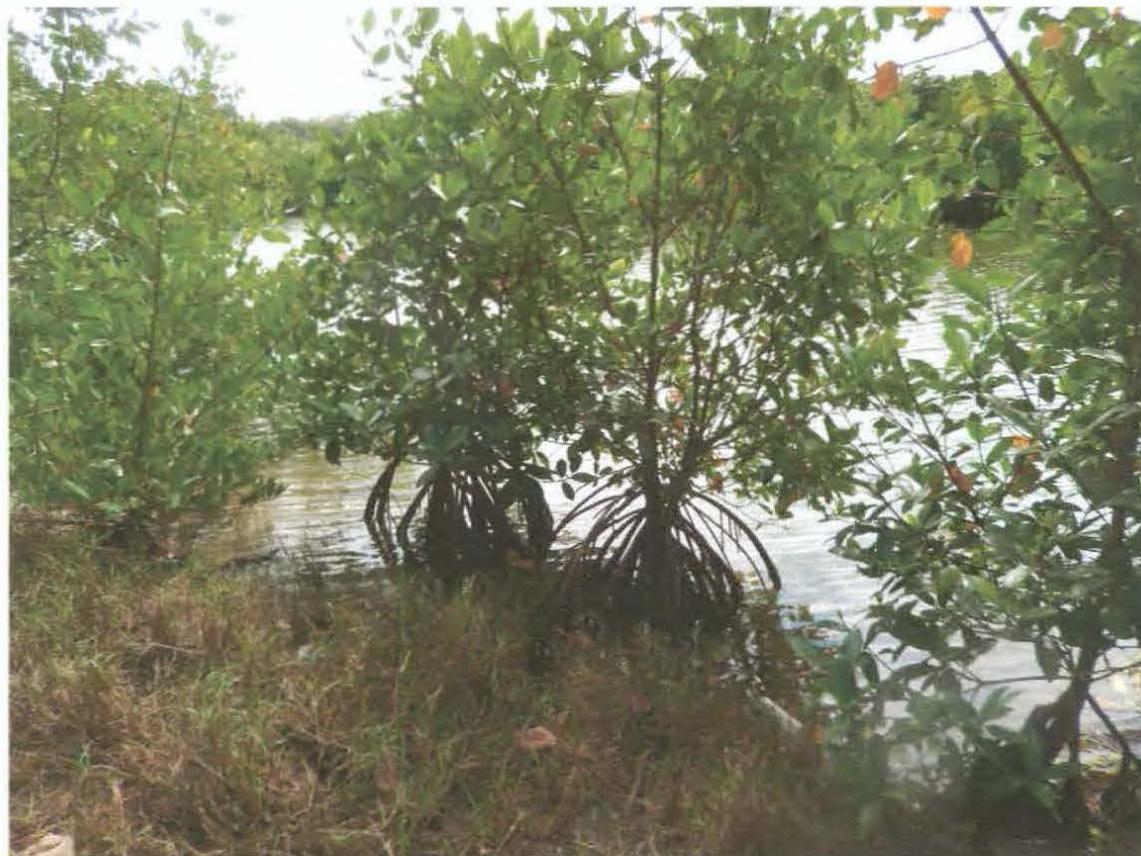
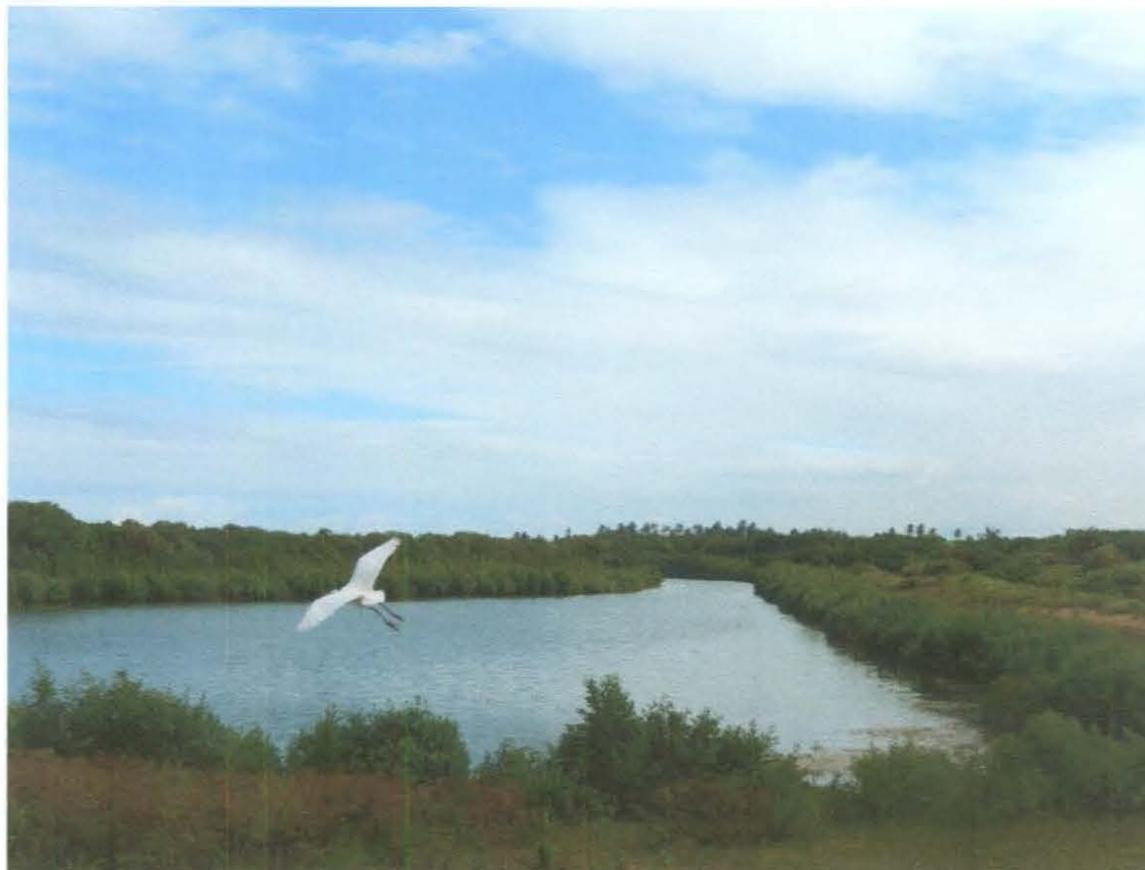
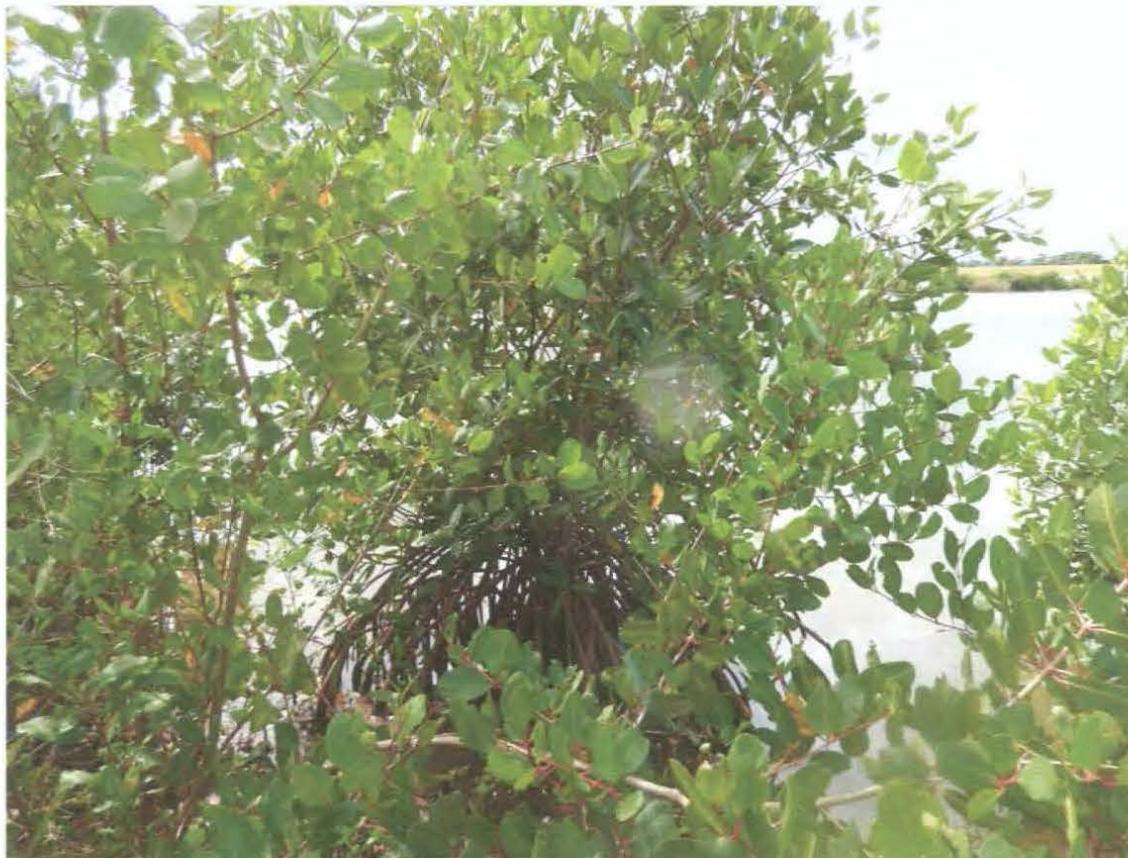
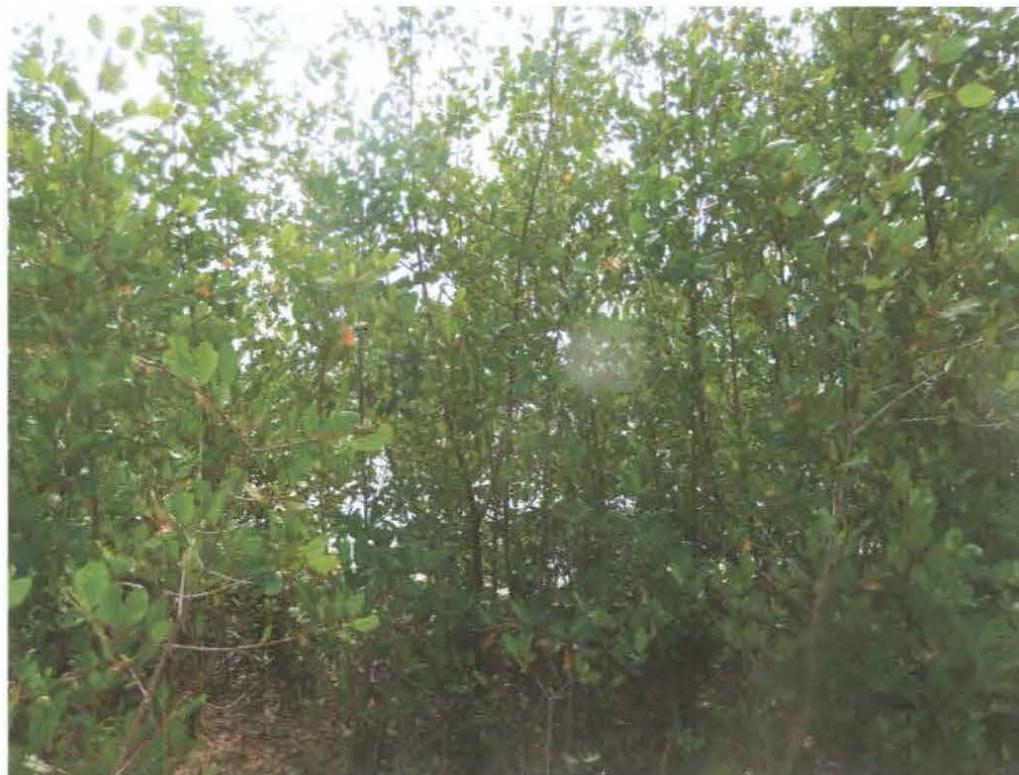
APPENDIX No. 2 - PARCEL NO. 7 - Estuarine Lagoon

- 2) Parcel #7 (Estuarine Lagoon): Specie to be planted: *Rhizophora mangle* (Red mangrove). They were planted according to the specifications of the mitigation projects. The planting began on the 30<sup>th</sup> of November 2011 and ended in December of 2011. The environmental conditions, types of soils and grade of the site continue to be optimal for the development of these red mangroves. There is a significant increase in aquatic, terrestrial and aerial life of the area. See Appendix No. 2

Rhizophora mangle - Red Mangrove

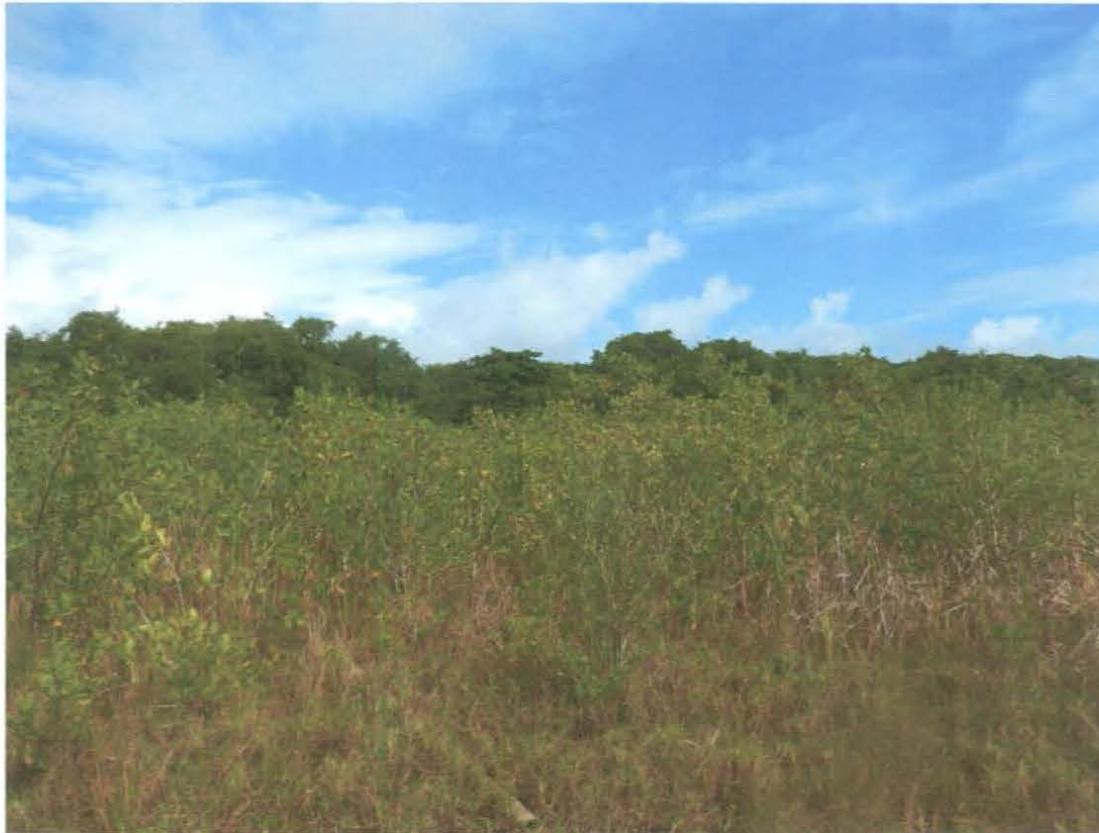
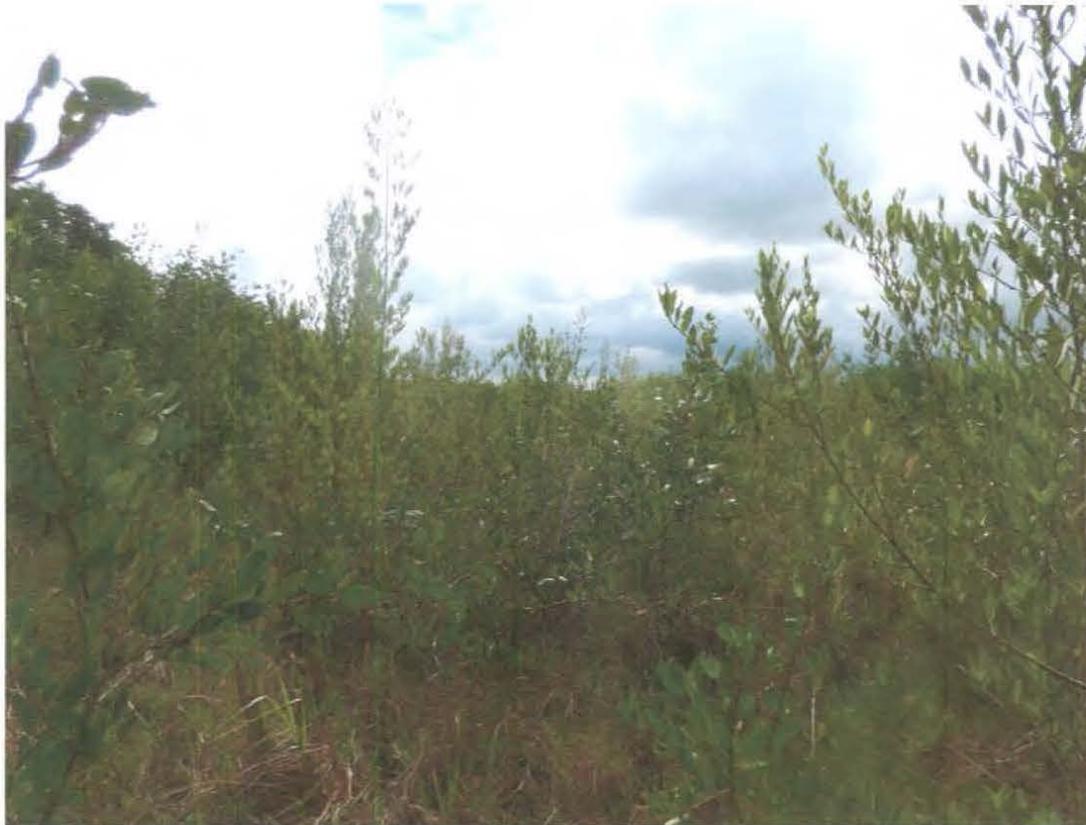
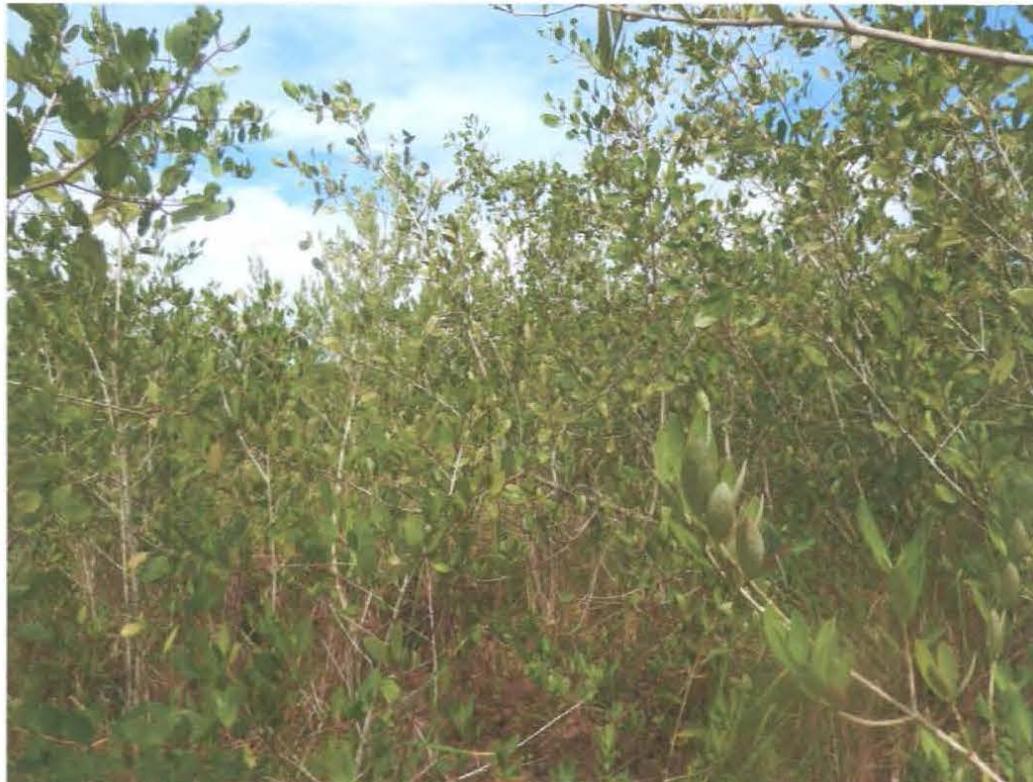
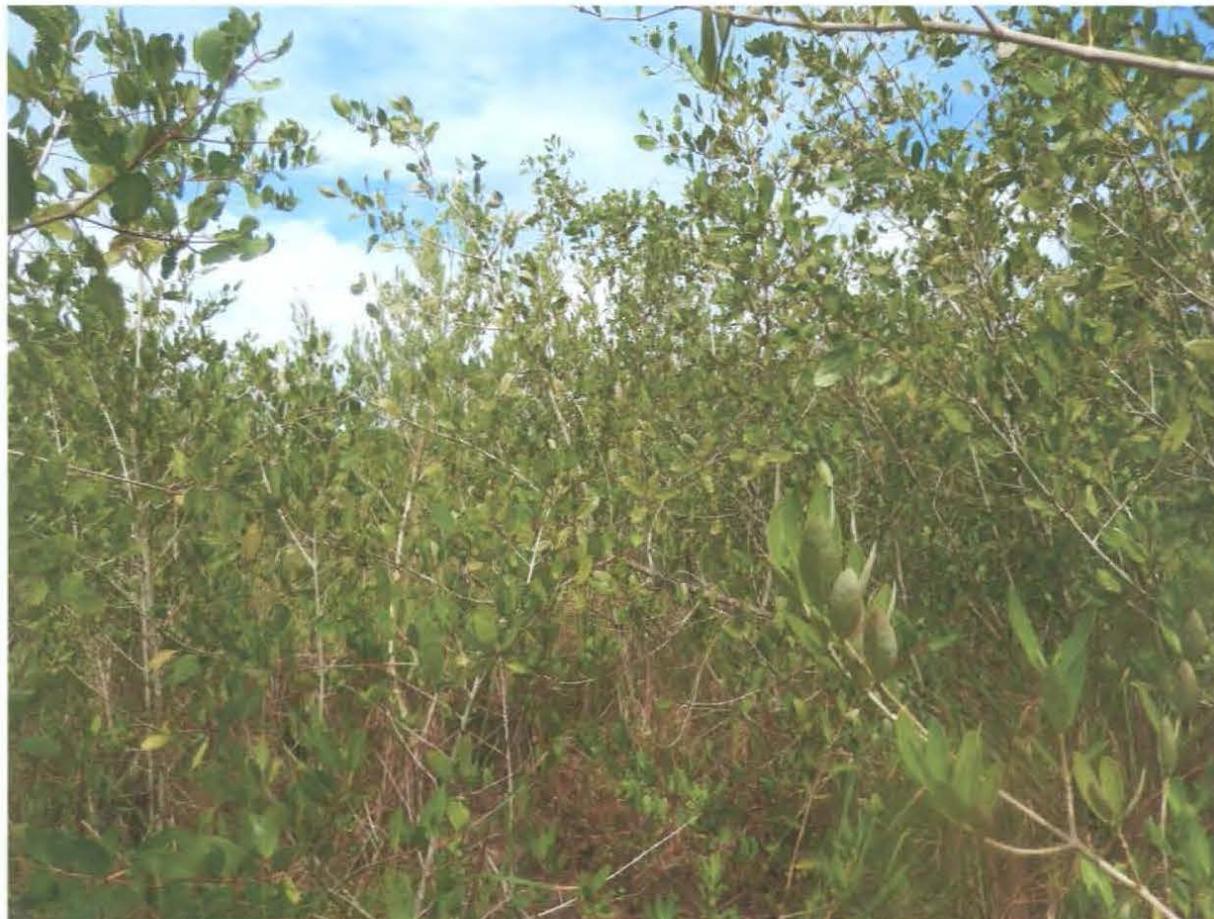
APPENDIX No. 3 – PARCEL No. 8

- 3) Parcel #8: Species to be planted: *Laguncularia racemosa* (White mangroves) and *Avicennia germinas* (Black mangroves). They were planted according to the specifications of the mitigation projects. There were different planting period according to the availability of the areas. The planting began in December of 2011; The Second period in June of 2012; Another in November of 2012; and the last one in October 2014. In general, the development of the species are good (most of them has more then 7 feet tall) but in some areas are not big enough or well development because of the condition of soil and animal or people that damaged the areas. See Appendix No. 3.

White and Black Mongroves.

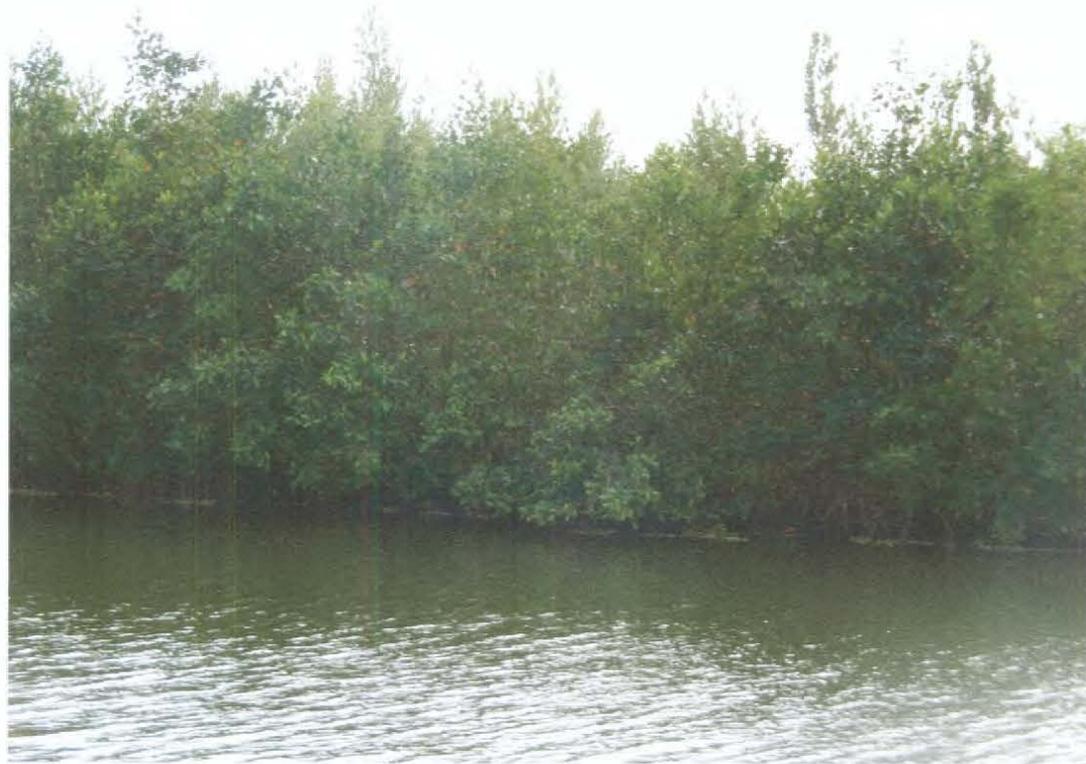
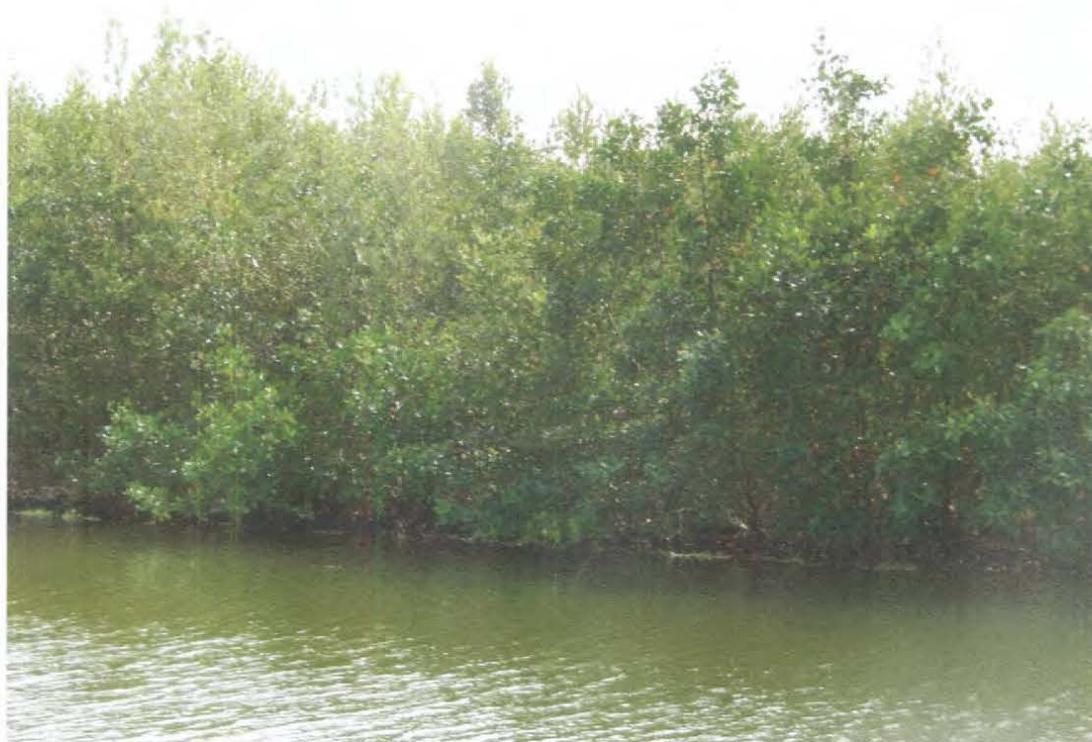
APPENDIX No. 4 – PARCEL No. 5

- 4) Parcel #5: Species to be planted: *Laguncularia racemosa* (White mangroves) and *Avicennia germinas* (Black mangroves). They were planted according to the specifications of the mitigation projects. The planting was completed between May 10 & 12 of 2012. The environmental conditions, the soil and grade of the site were very good. This parcel continues to be the best of all areas. It indicates us that the most suitable conditions to grow mangrove are near a river or a source of water and very close to the water table. See Appendix No. 4.

White and Black Mongroves.

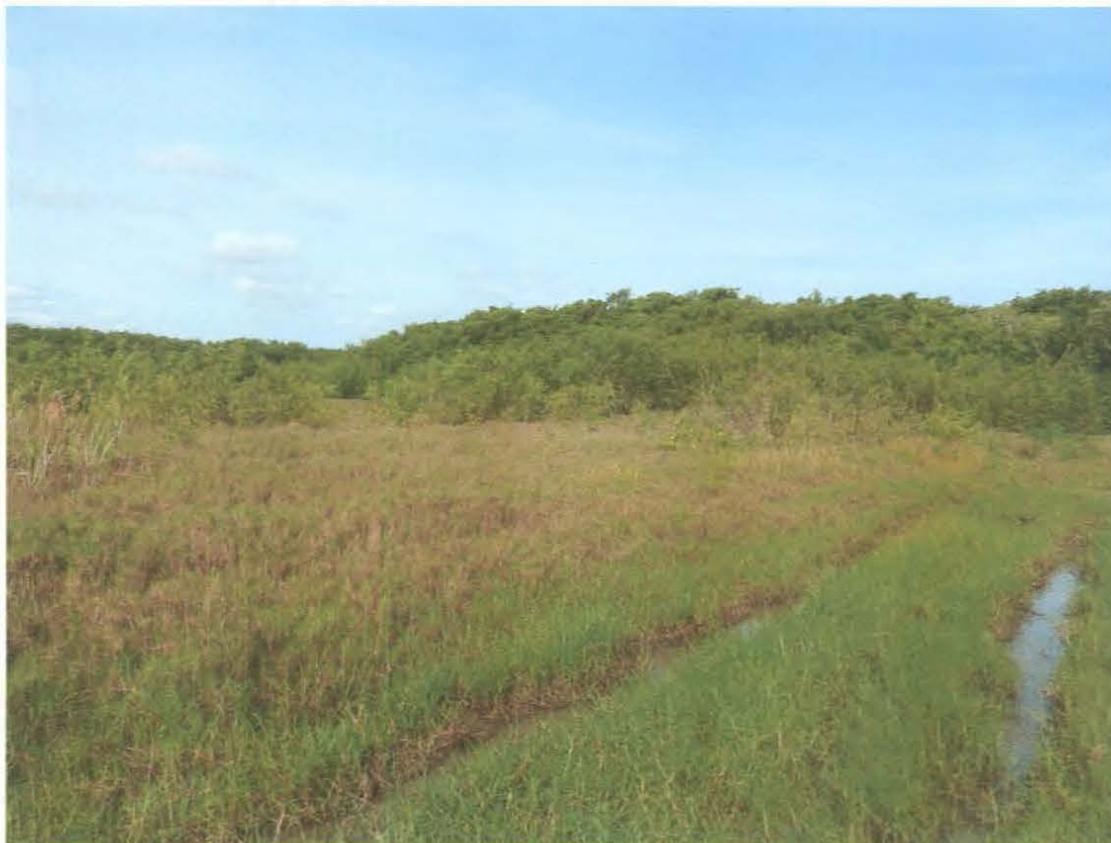
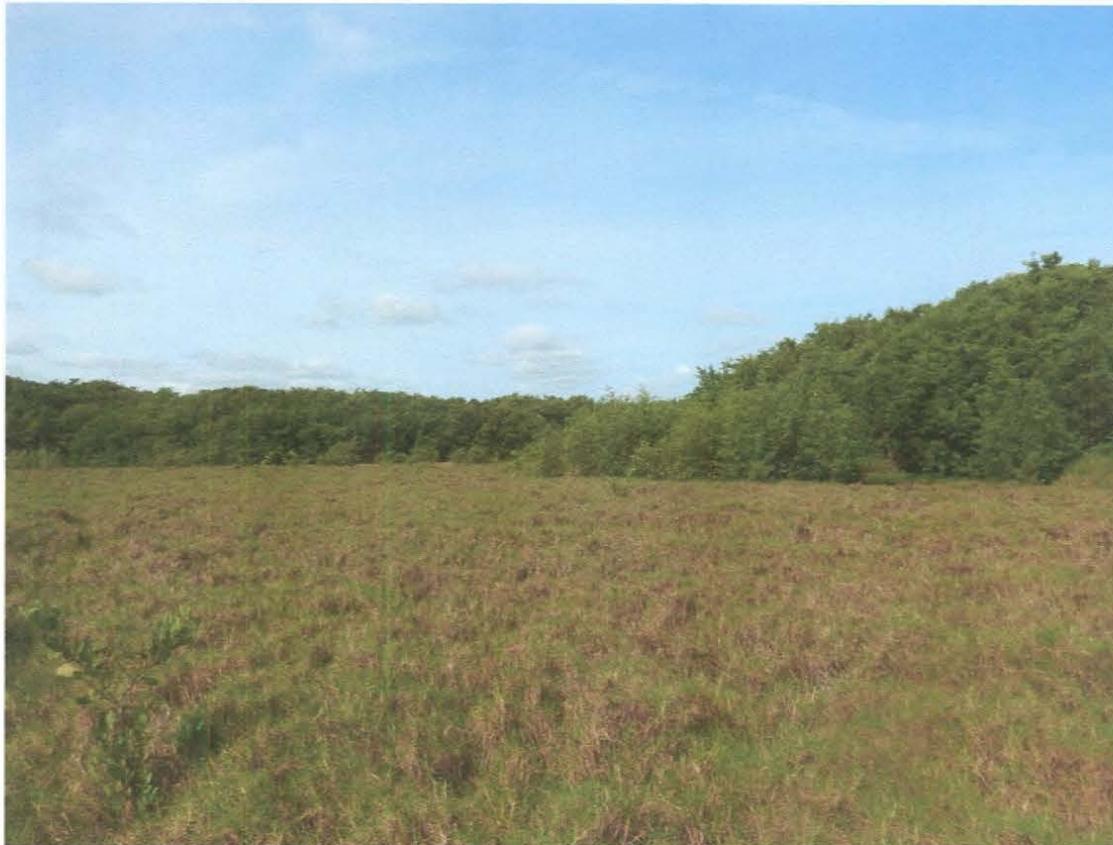
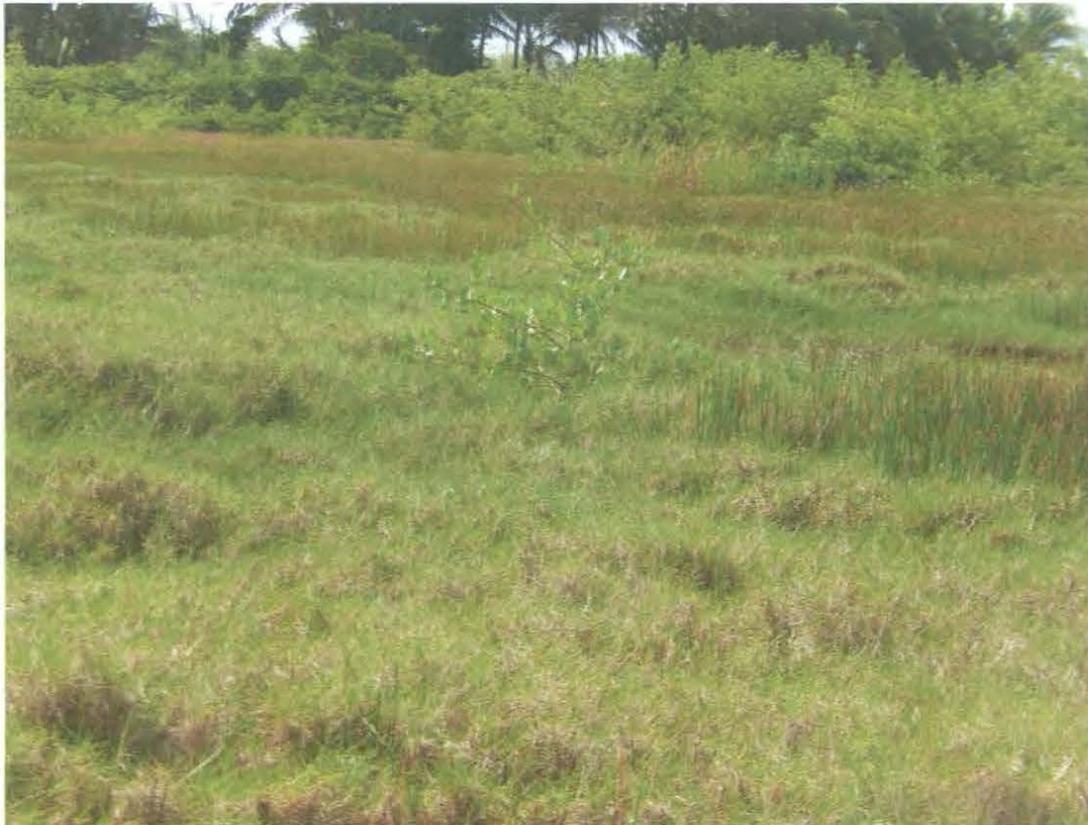
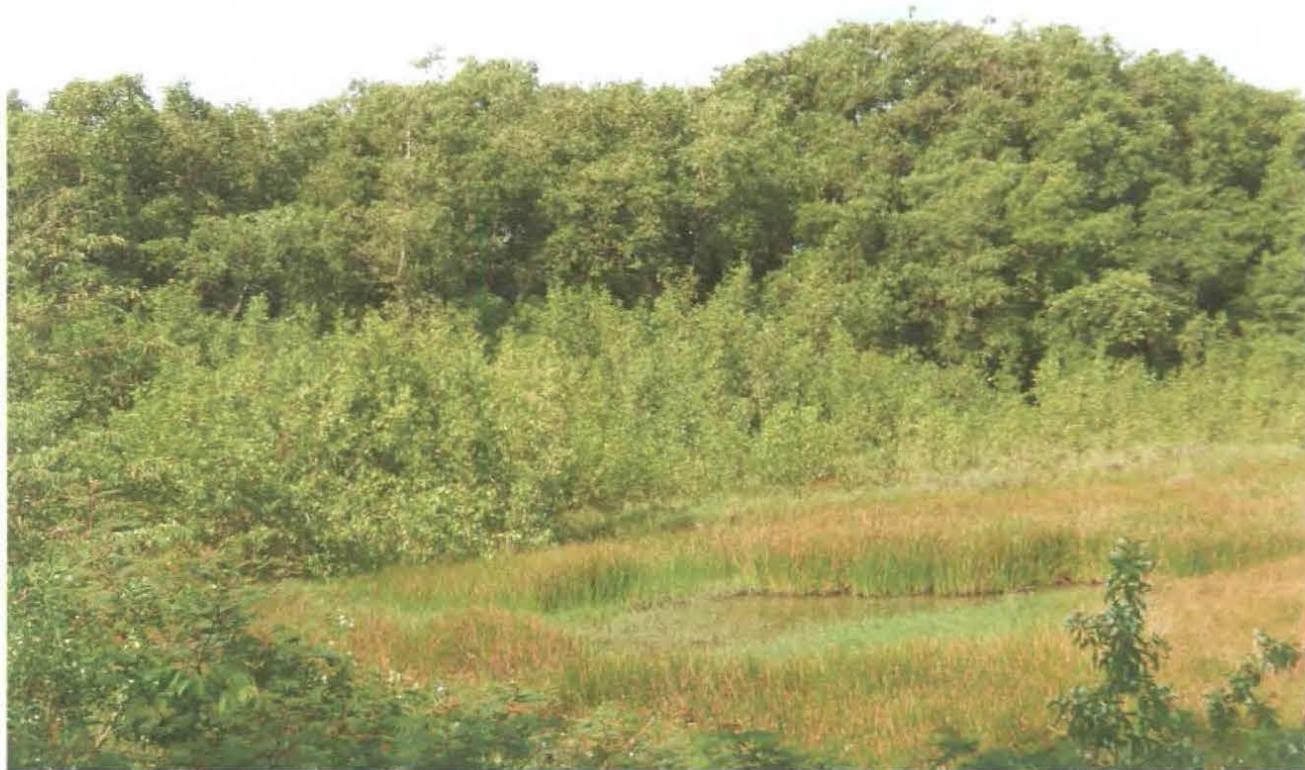
APPENDIX No. 5- PARCEL No. 3

- 5) Parcel #3: Species to be planted: *Paspalidum germinatum*, *Spartina*. They were planted according to the specifications of the mitigation projects. However, a

change of species to be planted in Parcel #3 was required, due to the environmental conditions found. USACE approved the change, *Paspalidum* for *Eleocharis*. There were different planting period according to the availability of the areas. The planting began in June of 2012 and was basically completed by August 2013. The species planted in this parcels are progressing towards meeting its performance standards. In some areas (near the border of the parcel) are growing *Laguncularia racemosa* (White mangroves) See Appendix No. 5. The north area of this parcel was completely destroyed by people. They go in 4x4 jeeps and four tracks during the weekend.

*Paspalidum germinatum*, *Eleocharis* and *Spartina*

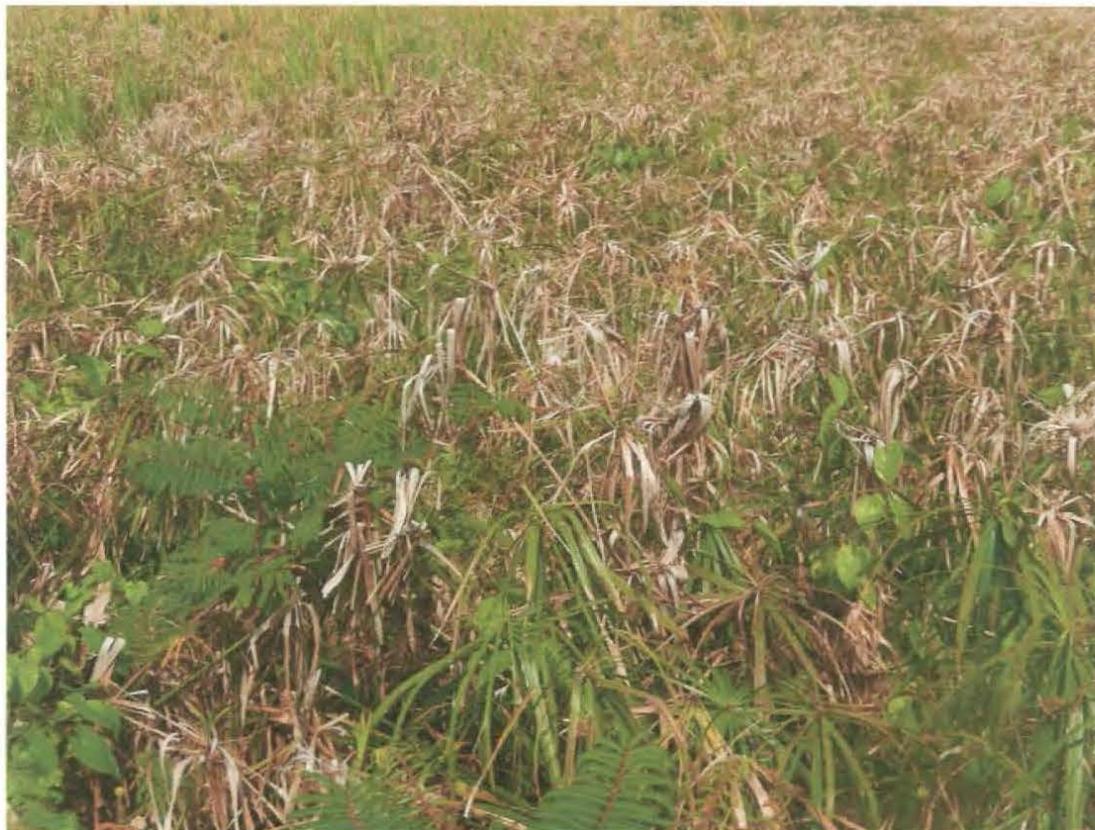
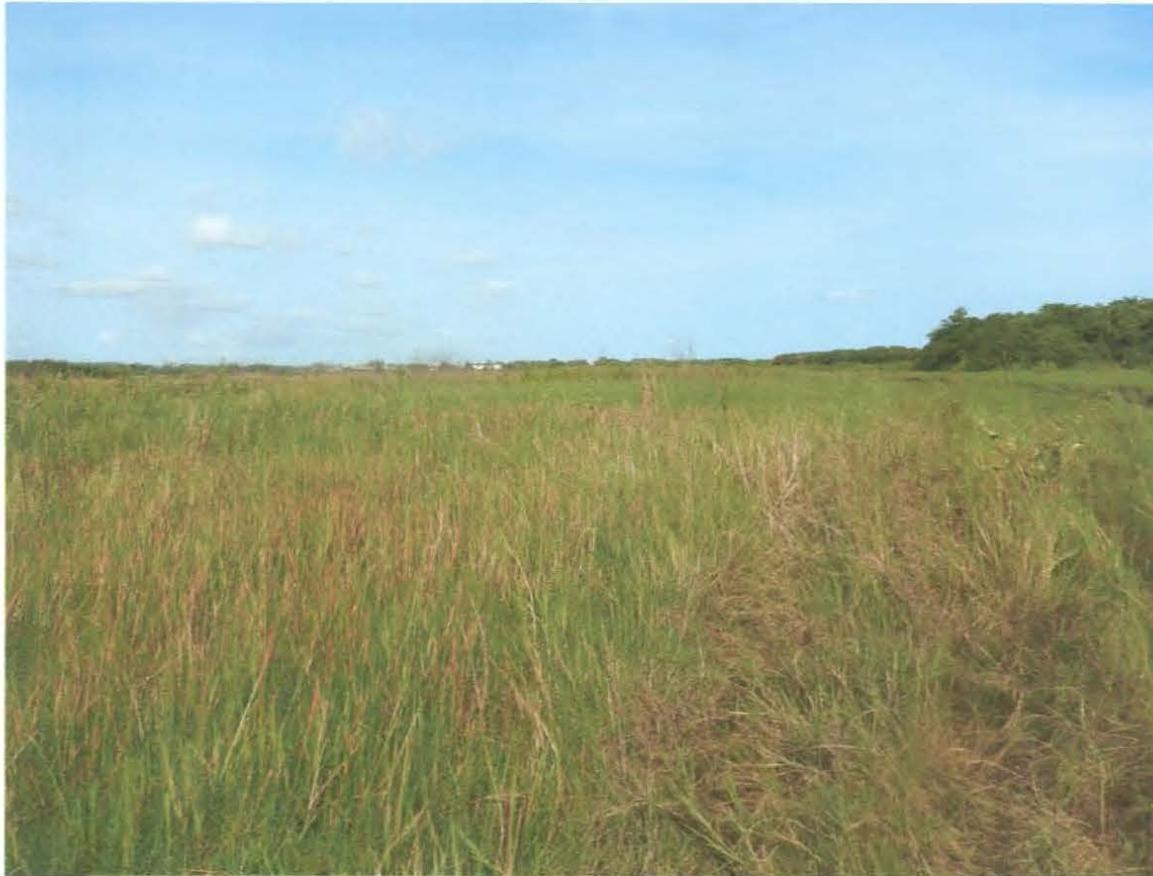
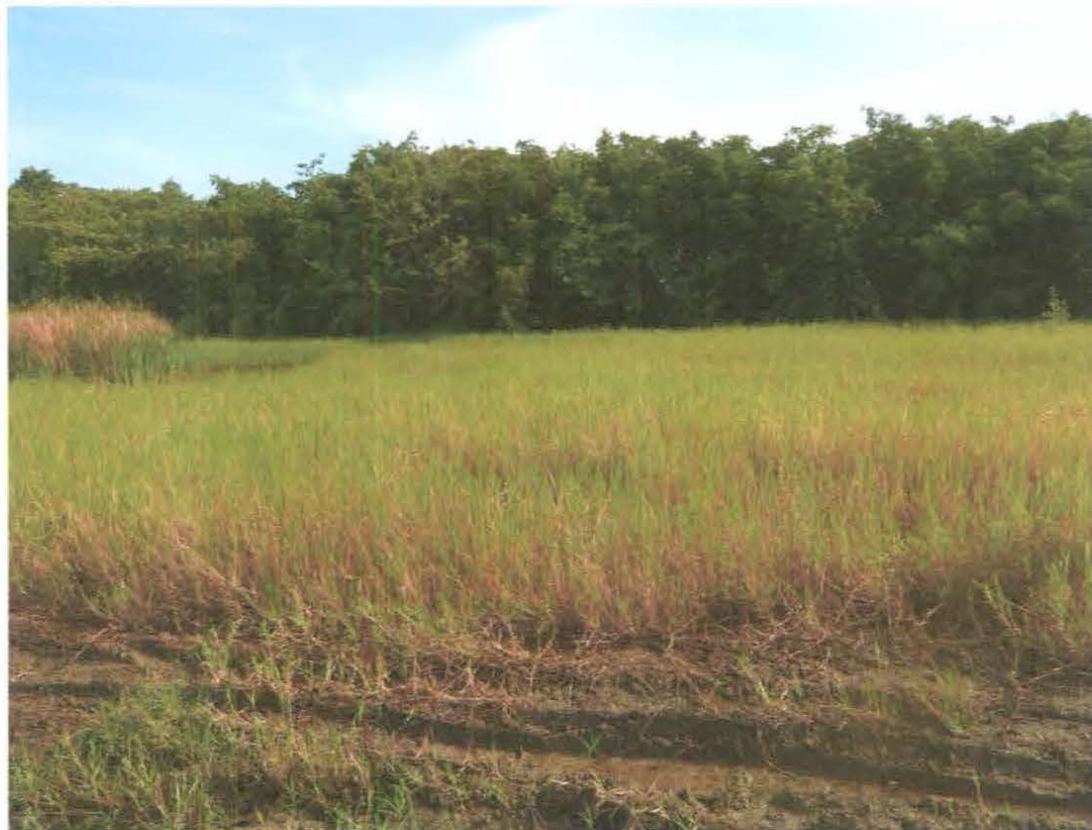
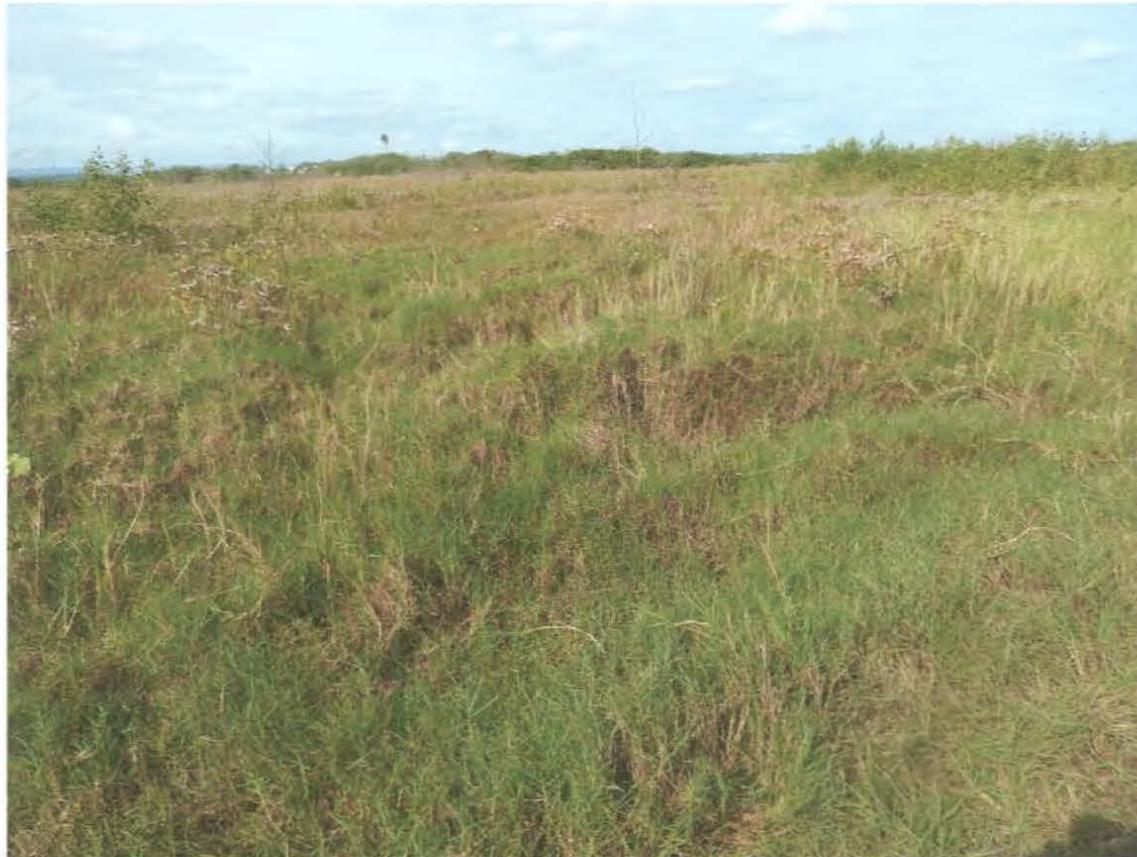
APPENDIX No. 6- PARCEL No. 4

- 6) Parcel #4: The species planted were *Paspalidum germinatum*, *Spartina* and *Eleocharis* and *Cyperus*. There were different planting period according to the availability of the areas. The planting began in August of 2012 and it was finished on October of 2014. The herbaceous vegetation besides control erosion and filter water is providing habitat for aquatic organism (fish, crabs, insects and birds). During wet season we can see new development of the herbaceous species because of the seeds producing during its growing periods. Appendix No. 6

*Paspalidum germinatum*, *Eleocharis*, *Spartina* and *Cyperus*

- h. **The USACE provide instructions for Parcel #4, to control unwanted, nuisance species as requested, so that this last maintenance was completed on March 12, 2015. Habitat also includes the others parcel that need more maintenance.**
