## THIRD MONITORING REPORT NARRATIVE. FEBRUARY OF 2016

- a. Corps Permit Number: SJA-2008-00123 (IP-CGR). Compensatory Wetland Mitigation Plan. Río de La Plata Flood Control Project, Dorado, Puerto Rico.
- b. Fernando Payan, Subcontractor from Habitat, is the responsible party for conducting the monitoring. Dates the inspection was conducted: To be determined upon completion of planting.

RIO DE LA PLATA FLOOD CONTROL PROJECT  
 DORADO, PUERTO RICO

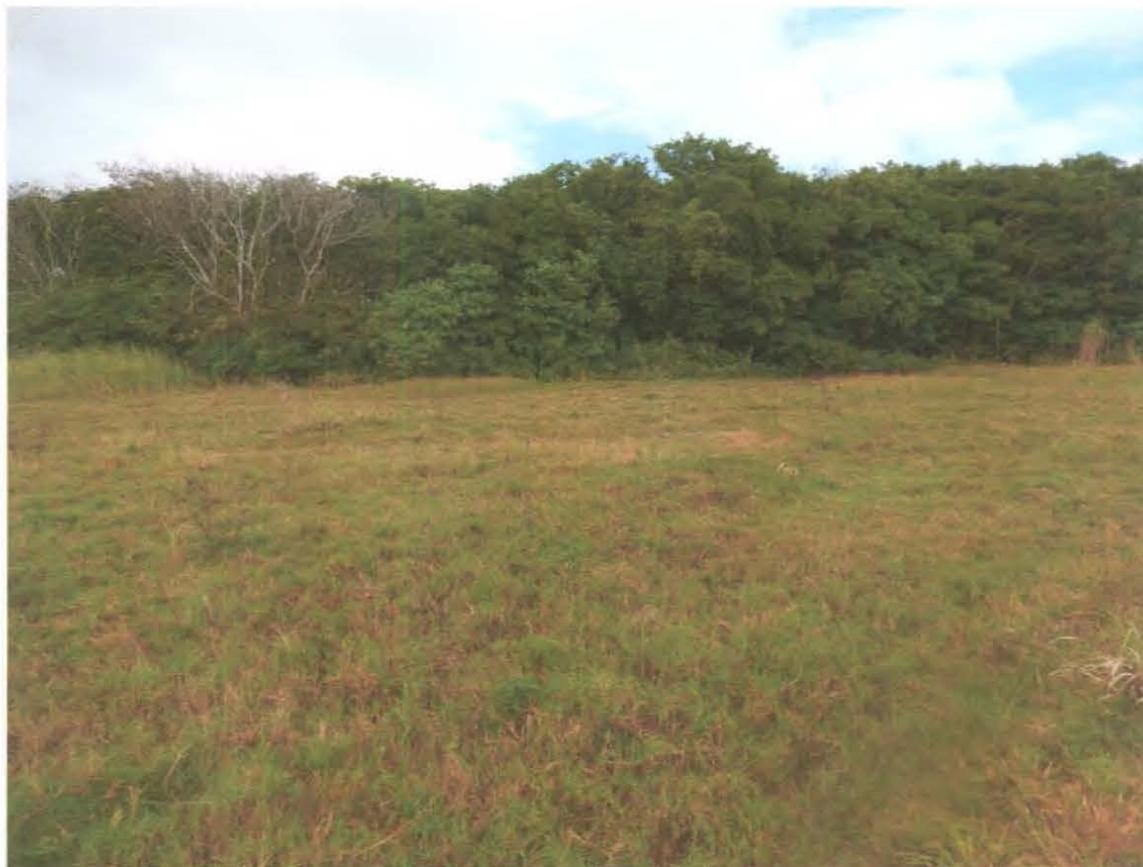
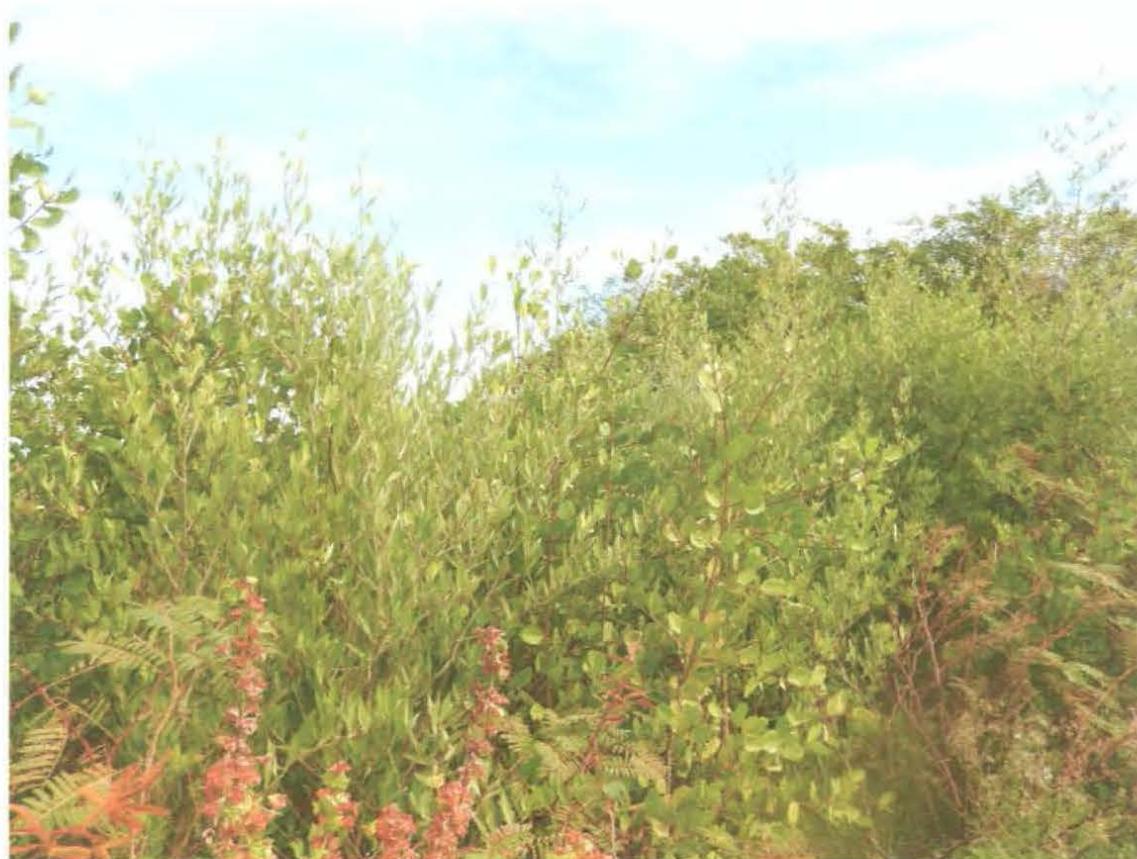
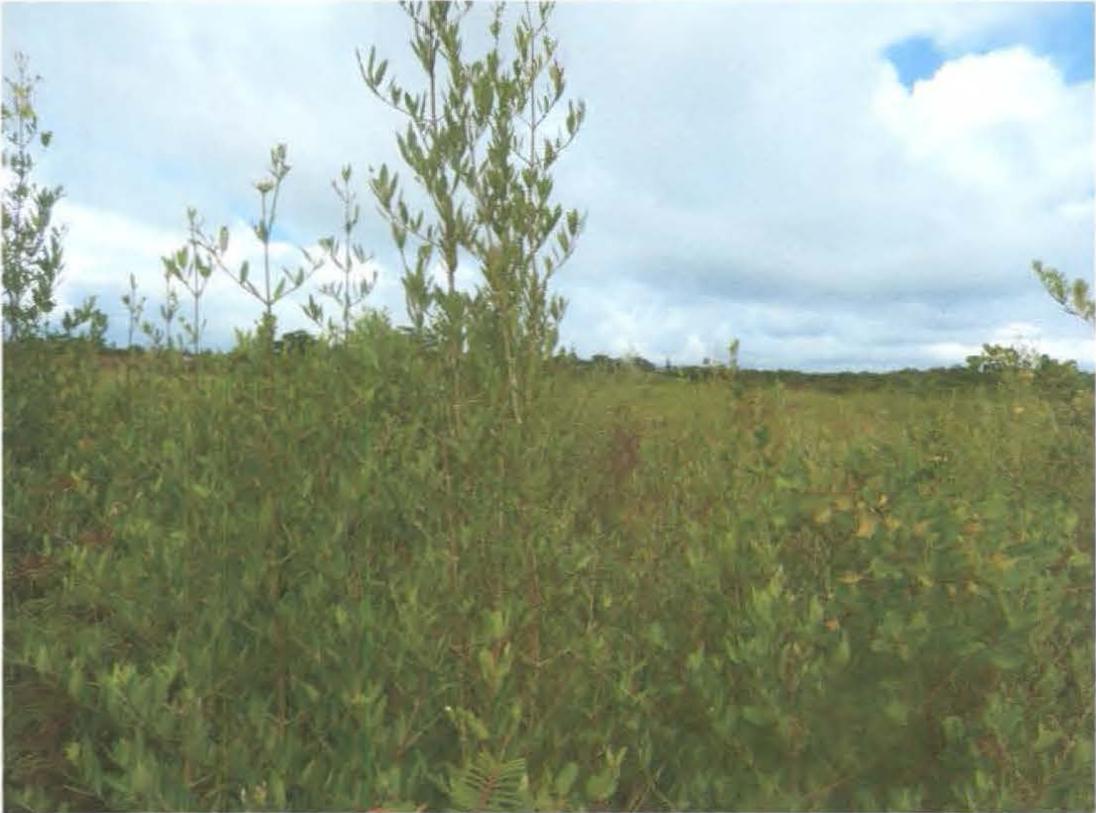
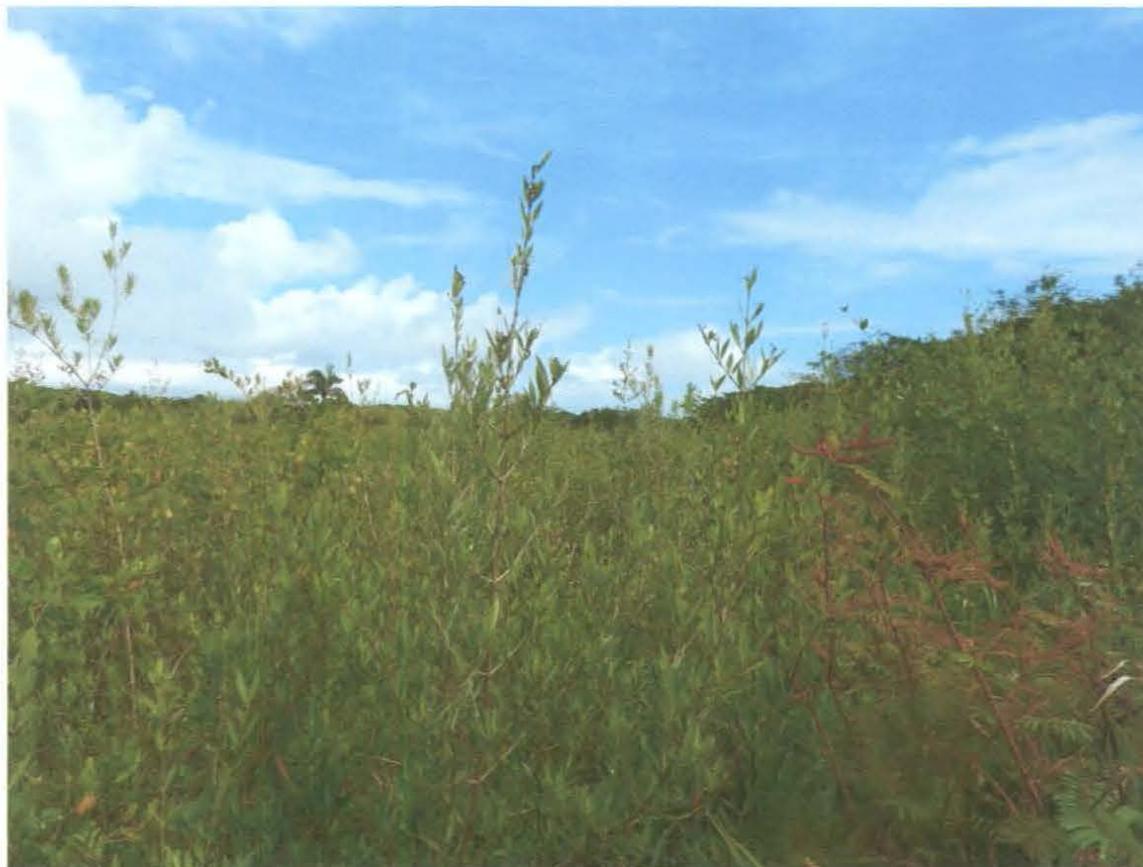
APPENDIX No. 7- PARCEL No. 1

- 7) Parcel #1: Like the Parcels 6, 8 and 5 the species to be planted were *Laguncularia racemosa* (White mangroves) and *Avicennia germinas* (Black mangroves) and *Spartina*. Planting following the specifications of the mitigation project. Planting of mangrove species began in November of 2013 and finished in December of 2013. The mangroves are the development good and producing seeds specially the white mangroves. The *Spartina* was planted in August and September of 2014. This species (*Spartina*) are development very good. The development of the mangroves can be see in Appendix No. 7

White and Black Mangrove and Spartina

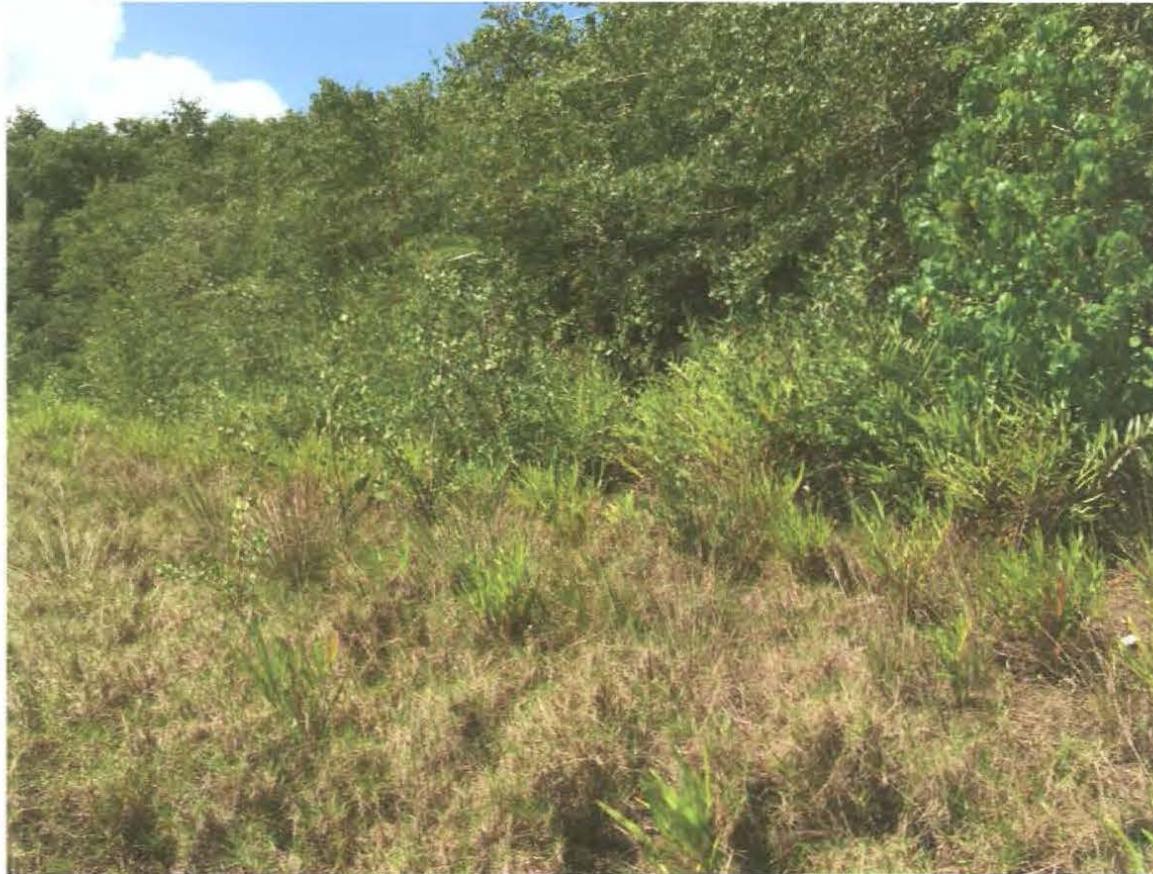
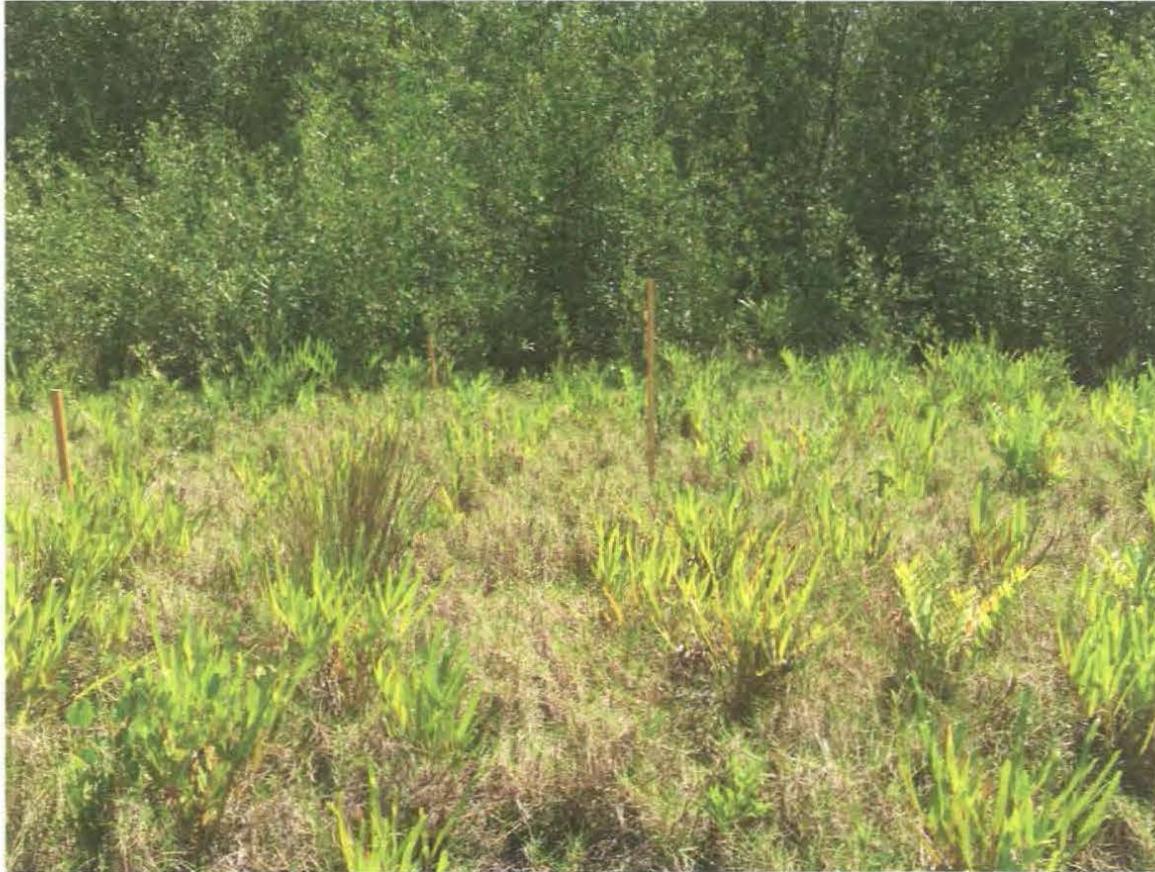
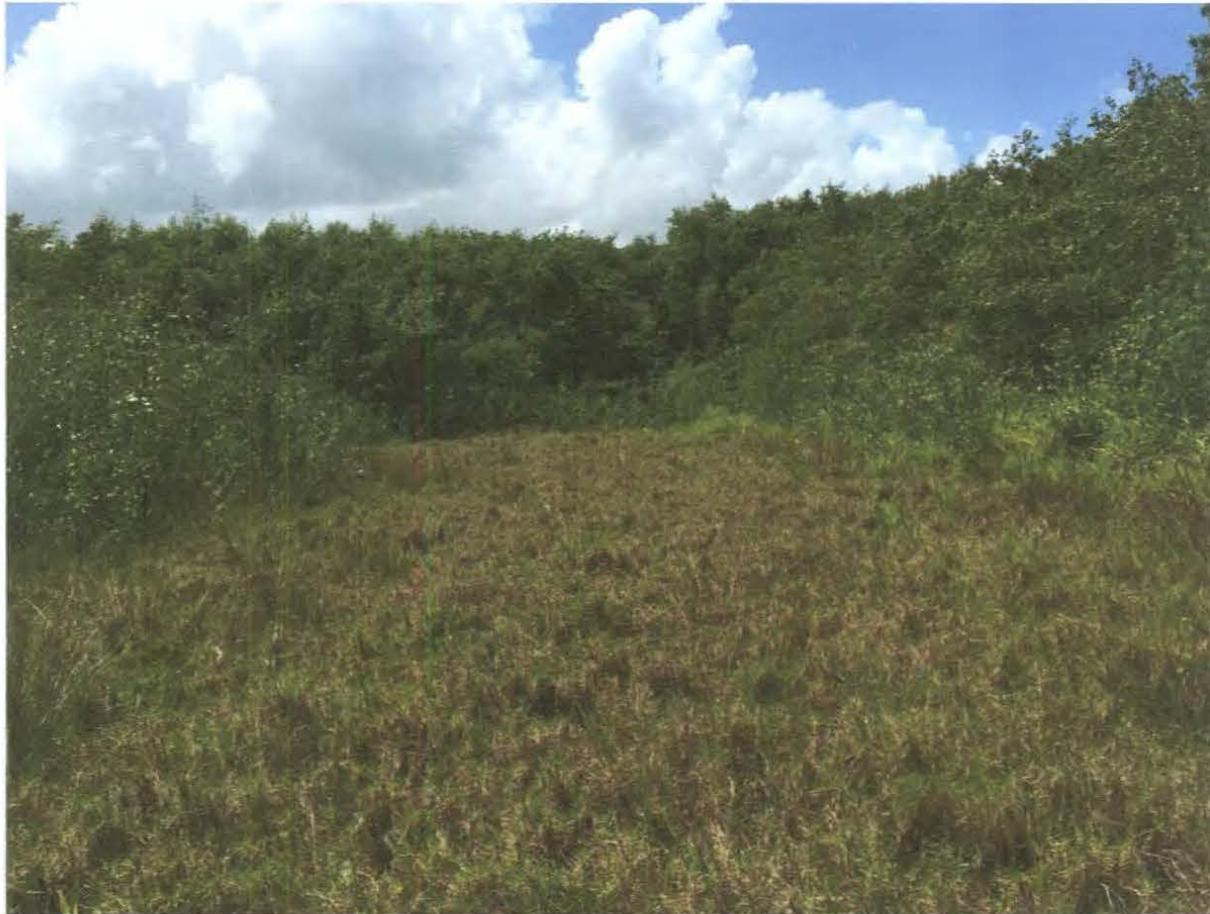
APPENDIX NO. 8 – PARCEL No. 5

- 8) Parcel #2: The species to be planted in this area was *Acrostichum* (a type of fern). The planting period began in August of 2012, but was not completed due to the harsh sunlight other environmental conditions. The plants did not do well at all. A request for a change was made and finally approved. *Paspalidum Germinatum* was planted and immediately completed. There is a good development of the *Acrostichum* planted near the mangroves and where they are not exposed to full sun. The *Paspalidum* developed very well. See Appendix No. 8

Acrostichum and Paspalidum
