A. REPORT COMPLETION DATE FOR APPROVED JURISDICTIONAL DETERMINATION (JD): November 16, 2018

B. DISTRICT OFFICE, FILE NAME, AND NUMBER: Jacksonville District, SAJ-2018-01836-RGH (SIMMONS LOOP APARTMENT PARTNERS, LLC / RIVERVIEW COMMONS / 6617 SIMMONS LOOP / HILLSBOROUGH)

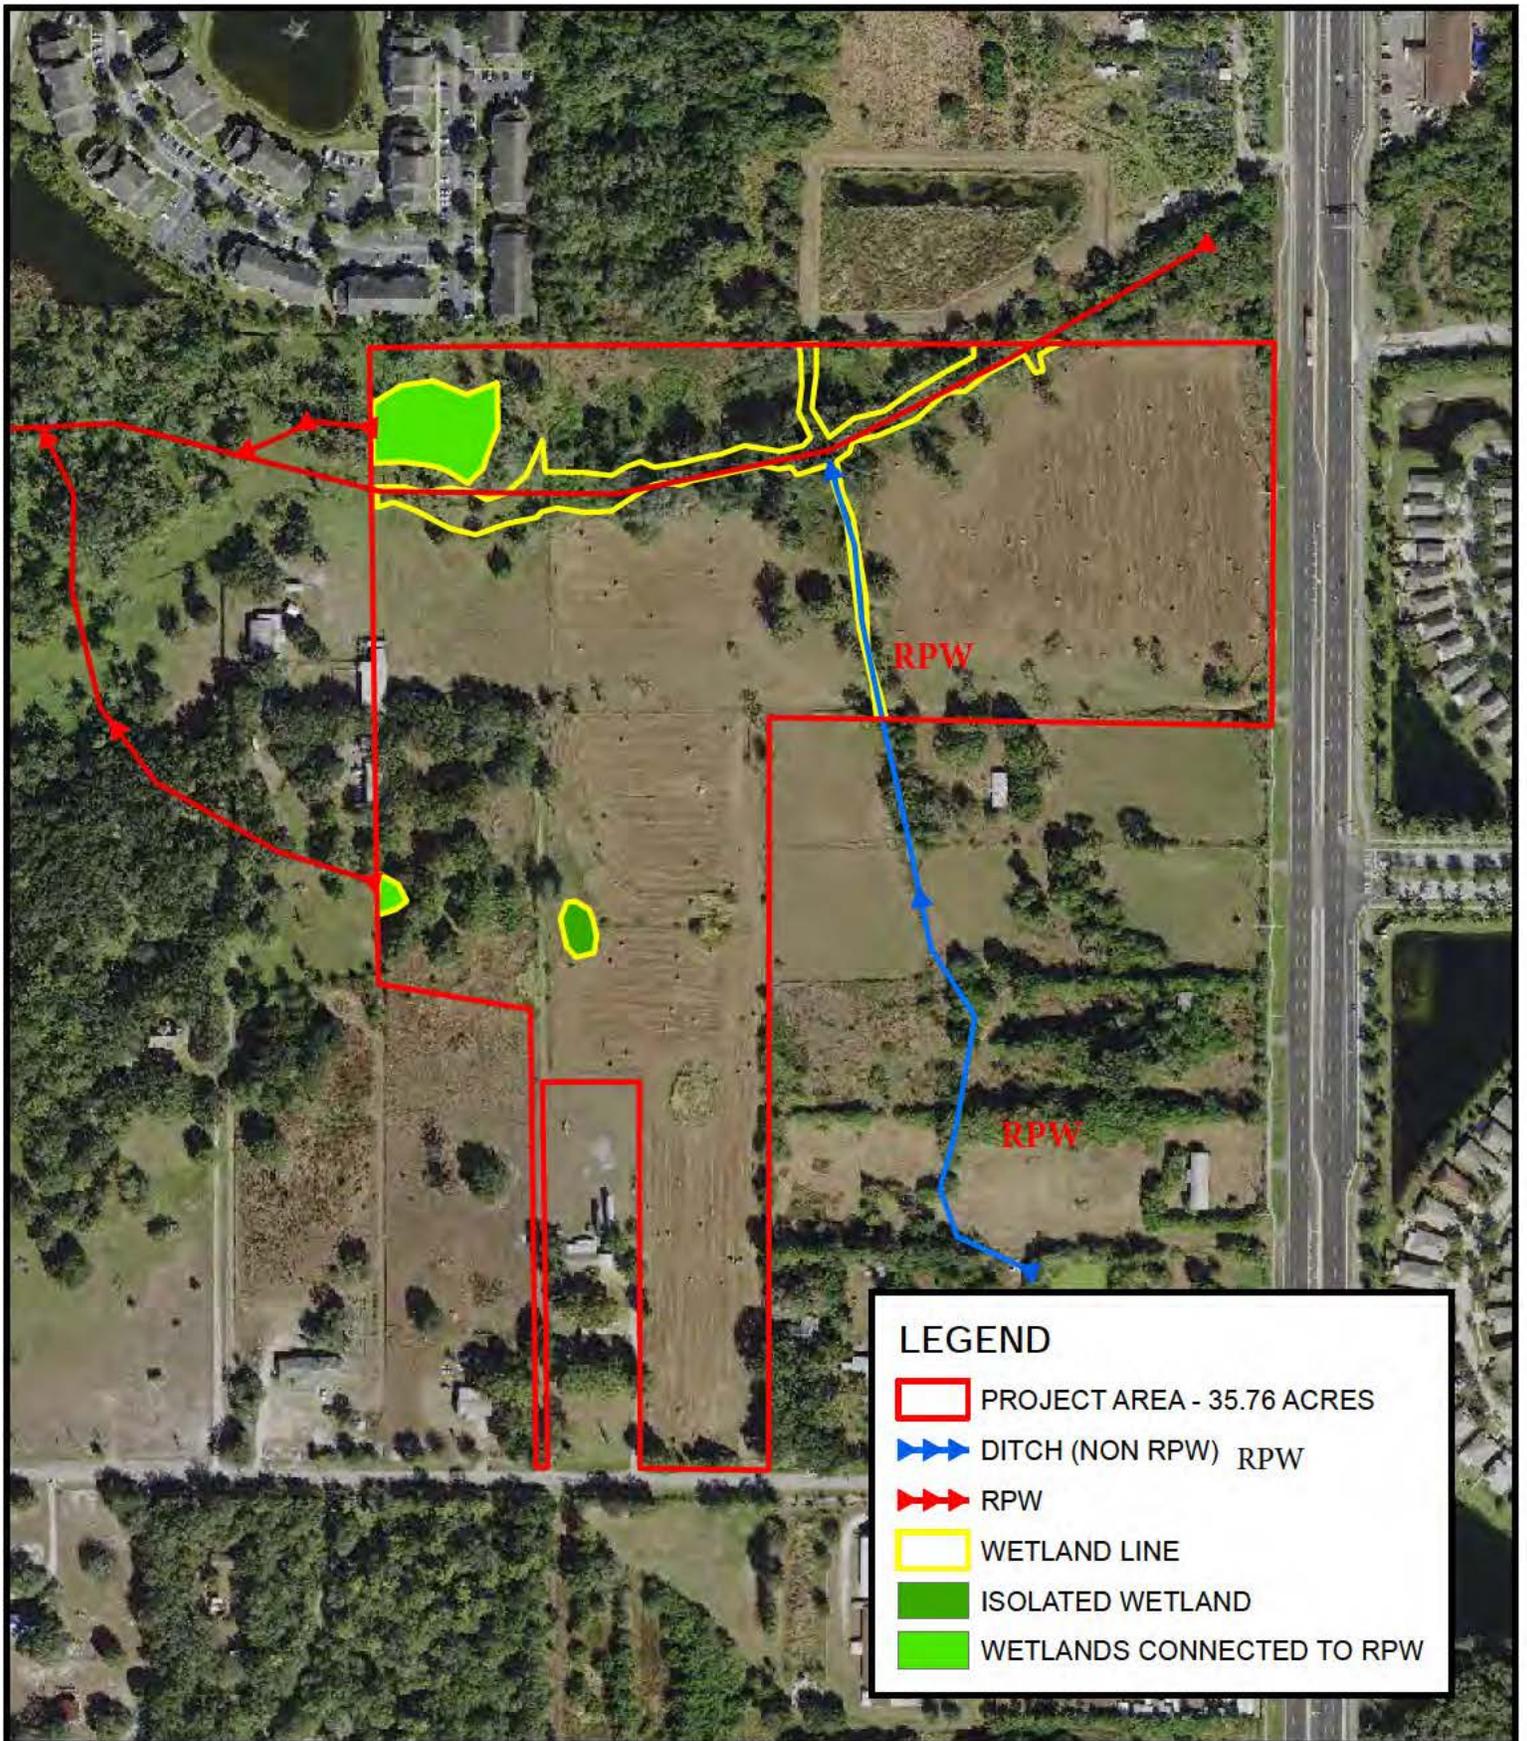
- PROJECT AREA - 35.76 ACRES
- ⇨⇨ DITCH (NON RPW) RPW
- ⇨⇨ RPW
- WETLAND LINE
- ISOLATED WETLAND
- WETLANDS CONNECTED TO RPW

[X] Potentially jurisdictional waters and/or wetlands were assessed within the review area and determined to be not jurisdictional. Explain: Wetland B (0.10 acres) is a upland dug agricultural pond dug in the 1980's.

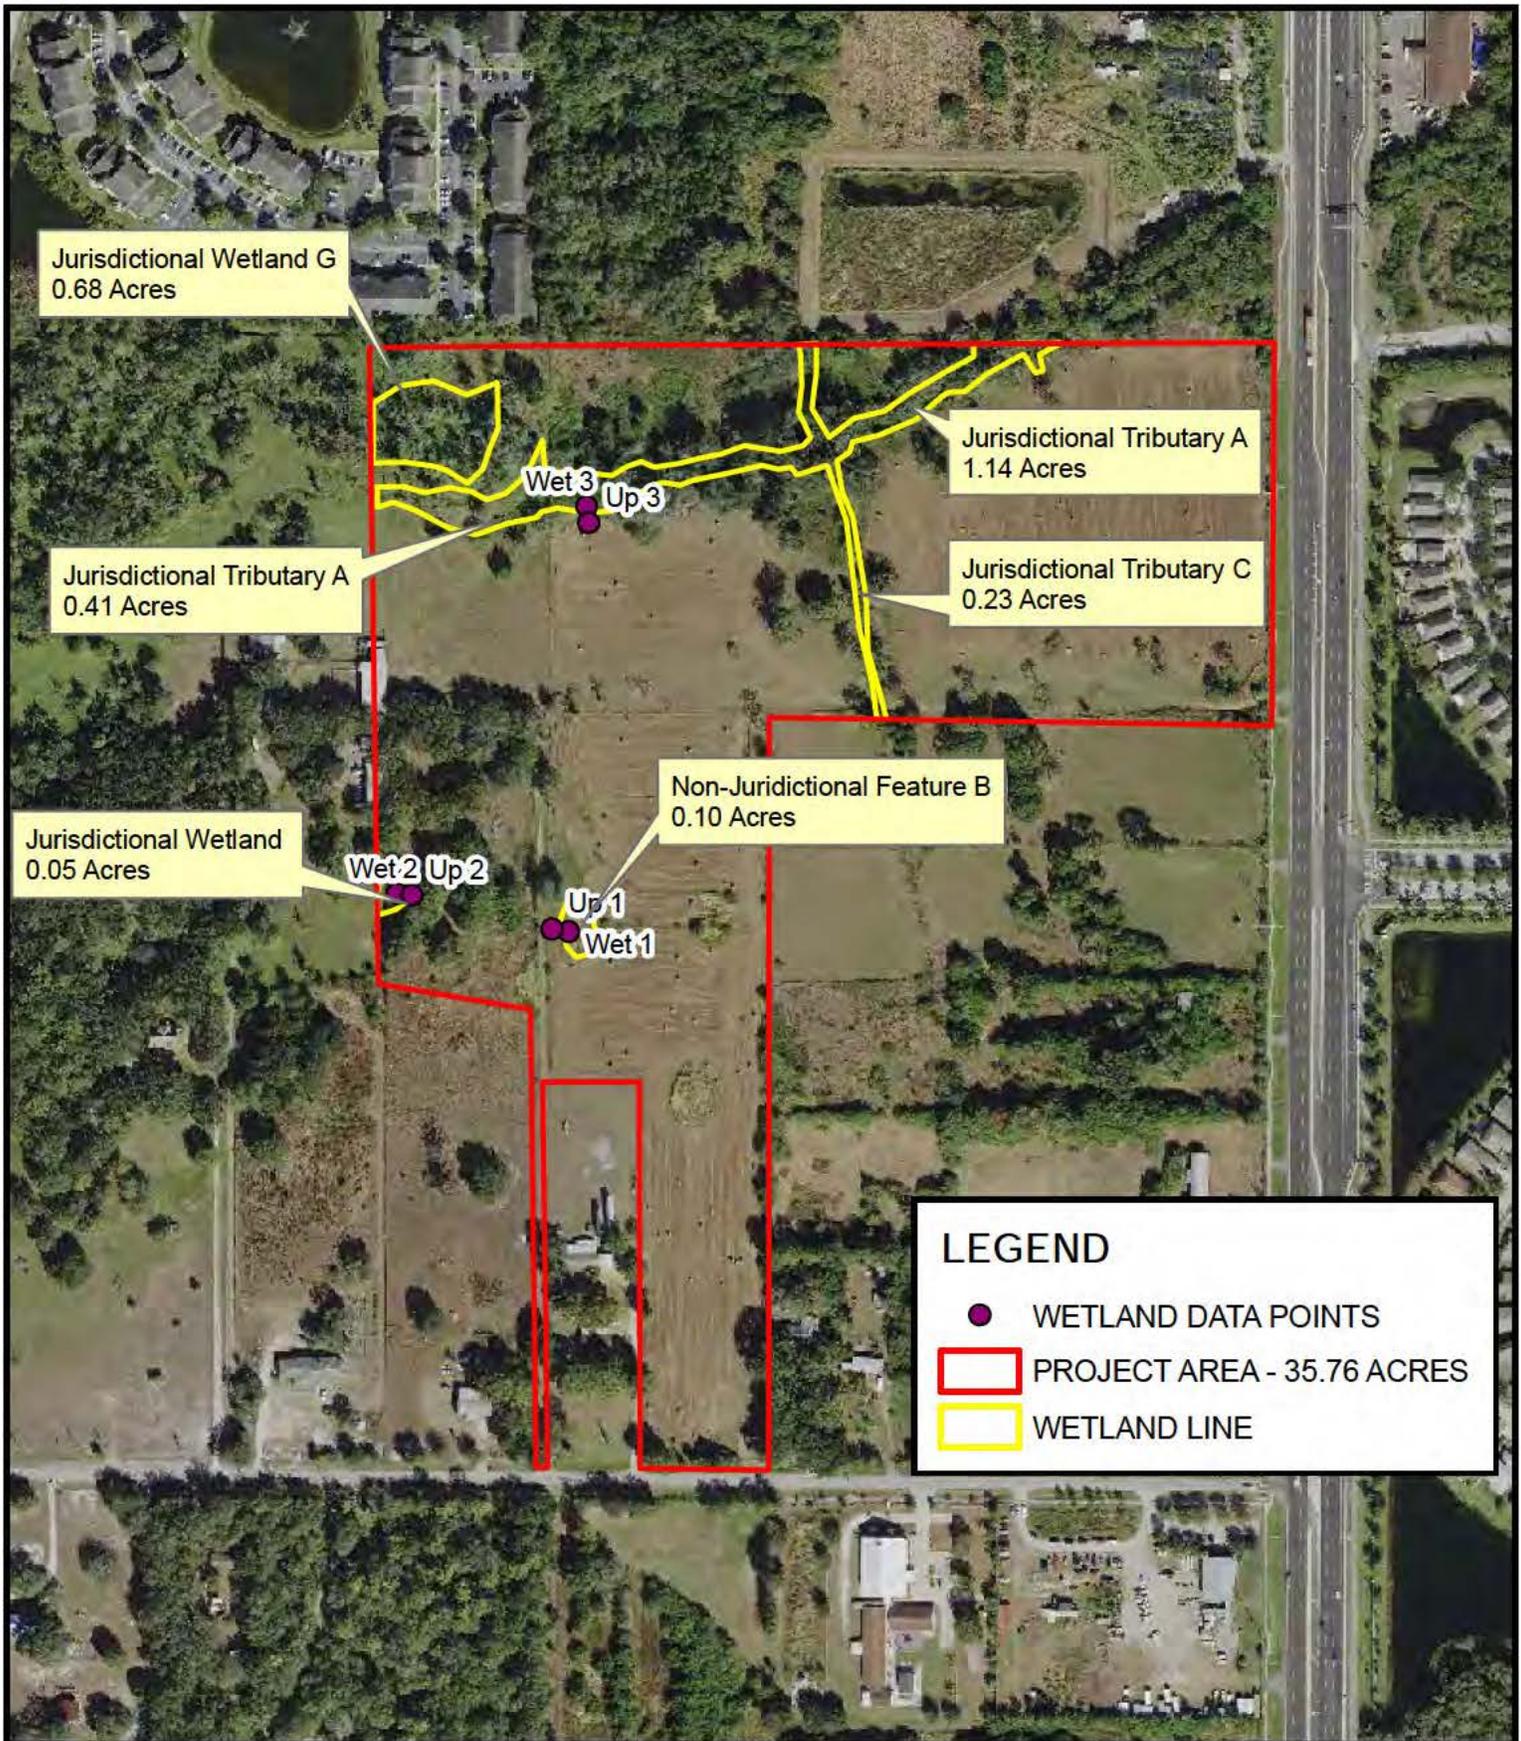
- WETLAND DATA POINTS
- ▭ PROJECT AREA - 35.76 ACRES
- ▭ WETLAND LINE
