MEMORANDUM FOR: RECORD

SUBJECT: DMMP TIER 1 DETERMINATION REGARDING THE SUITABILITY OF PROPOSED DREDGED MATERIAL FROM J.E. McAMIS, LONGVIEW, WASHINGTON.

Figure 1
Vicinity Map
J.E. McAmis Dredging and Deepening Project

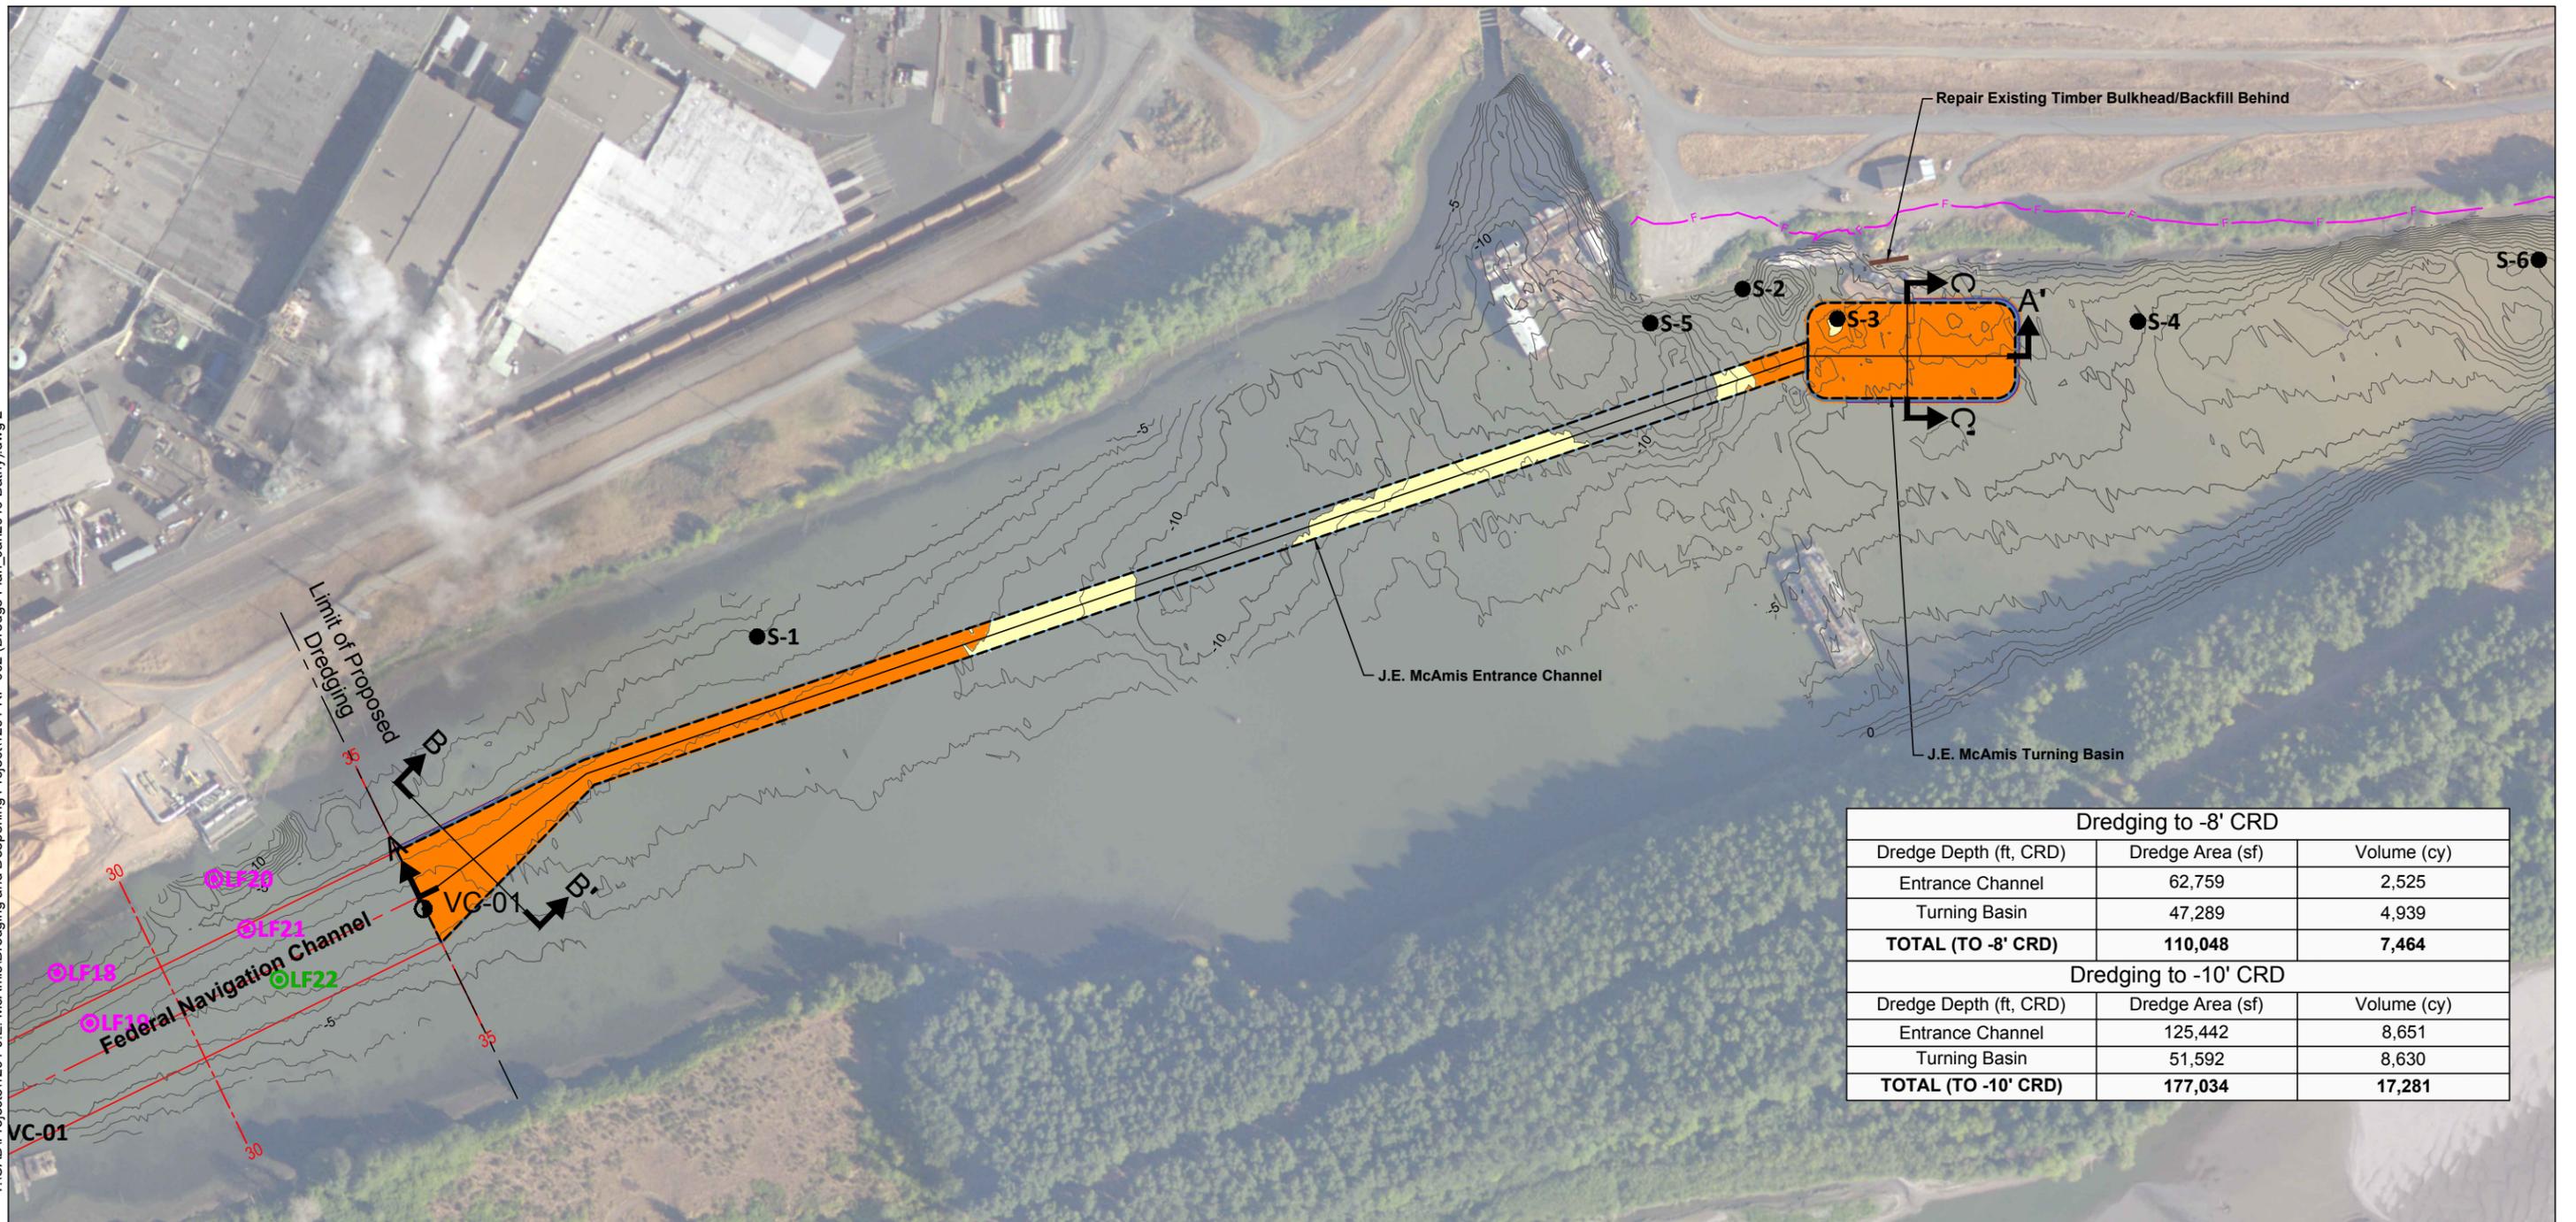
J.E. McAmis Entrance Channel and Turning Basin Dredge Areas		
Dredge Depth (ft)	Color	Area (sf)
-8.0 to Mudline		110,048
-10.0 to -8.0		66,986

SOURCE: Drawing prepared from CAD files provided by J.E. McAmis, Inc. dated 05-11-2015, titled "J.E. McAmis Log Booming". Updated bathymetry provided by NW Hydro, dated January 2016. Samples from USACE, dated 2014.
HORIZONTAL DATUM: Washington State Plane South, NAD83, U.S. Feet.
VERTICAL DATUM: Columbia River Datum (CRD).
DATUM CONVERSION: 0 feet CRD = -2.49 feet NAVD88.

- 4. Evaluation.** Since 2003, five separate sampling events have occurred within the OMCR in areas either near or adjacent to the JE McAmis property. Results of these sampling events are discussed in detail below. **Figures 2 and 3** show the location of the collected samples. Chemical results for all sampling events are presented in **Table 2**.

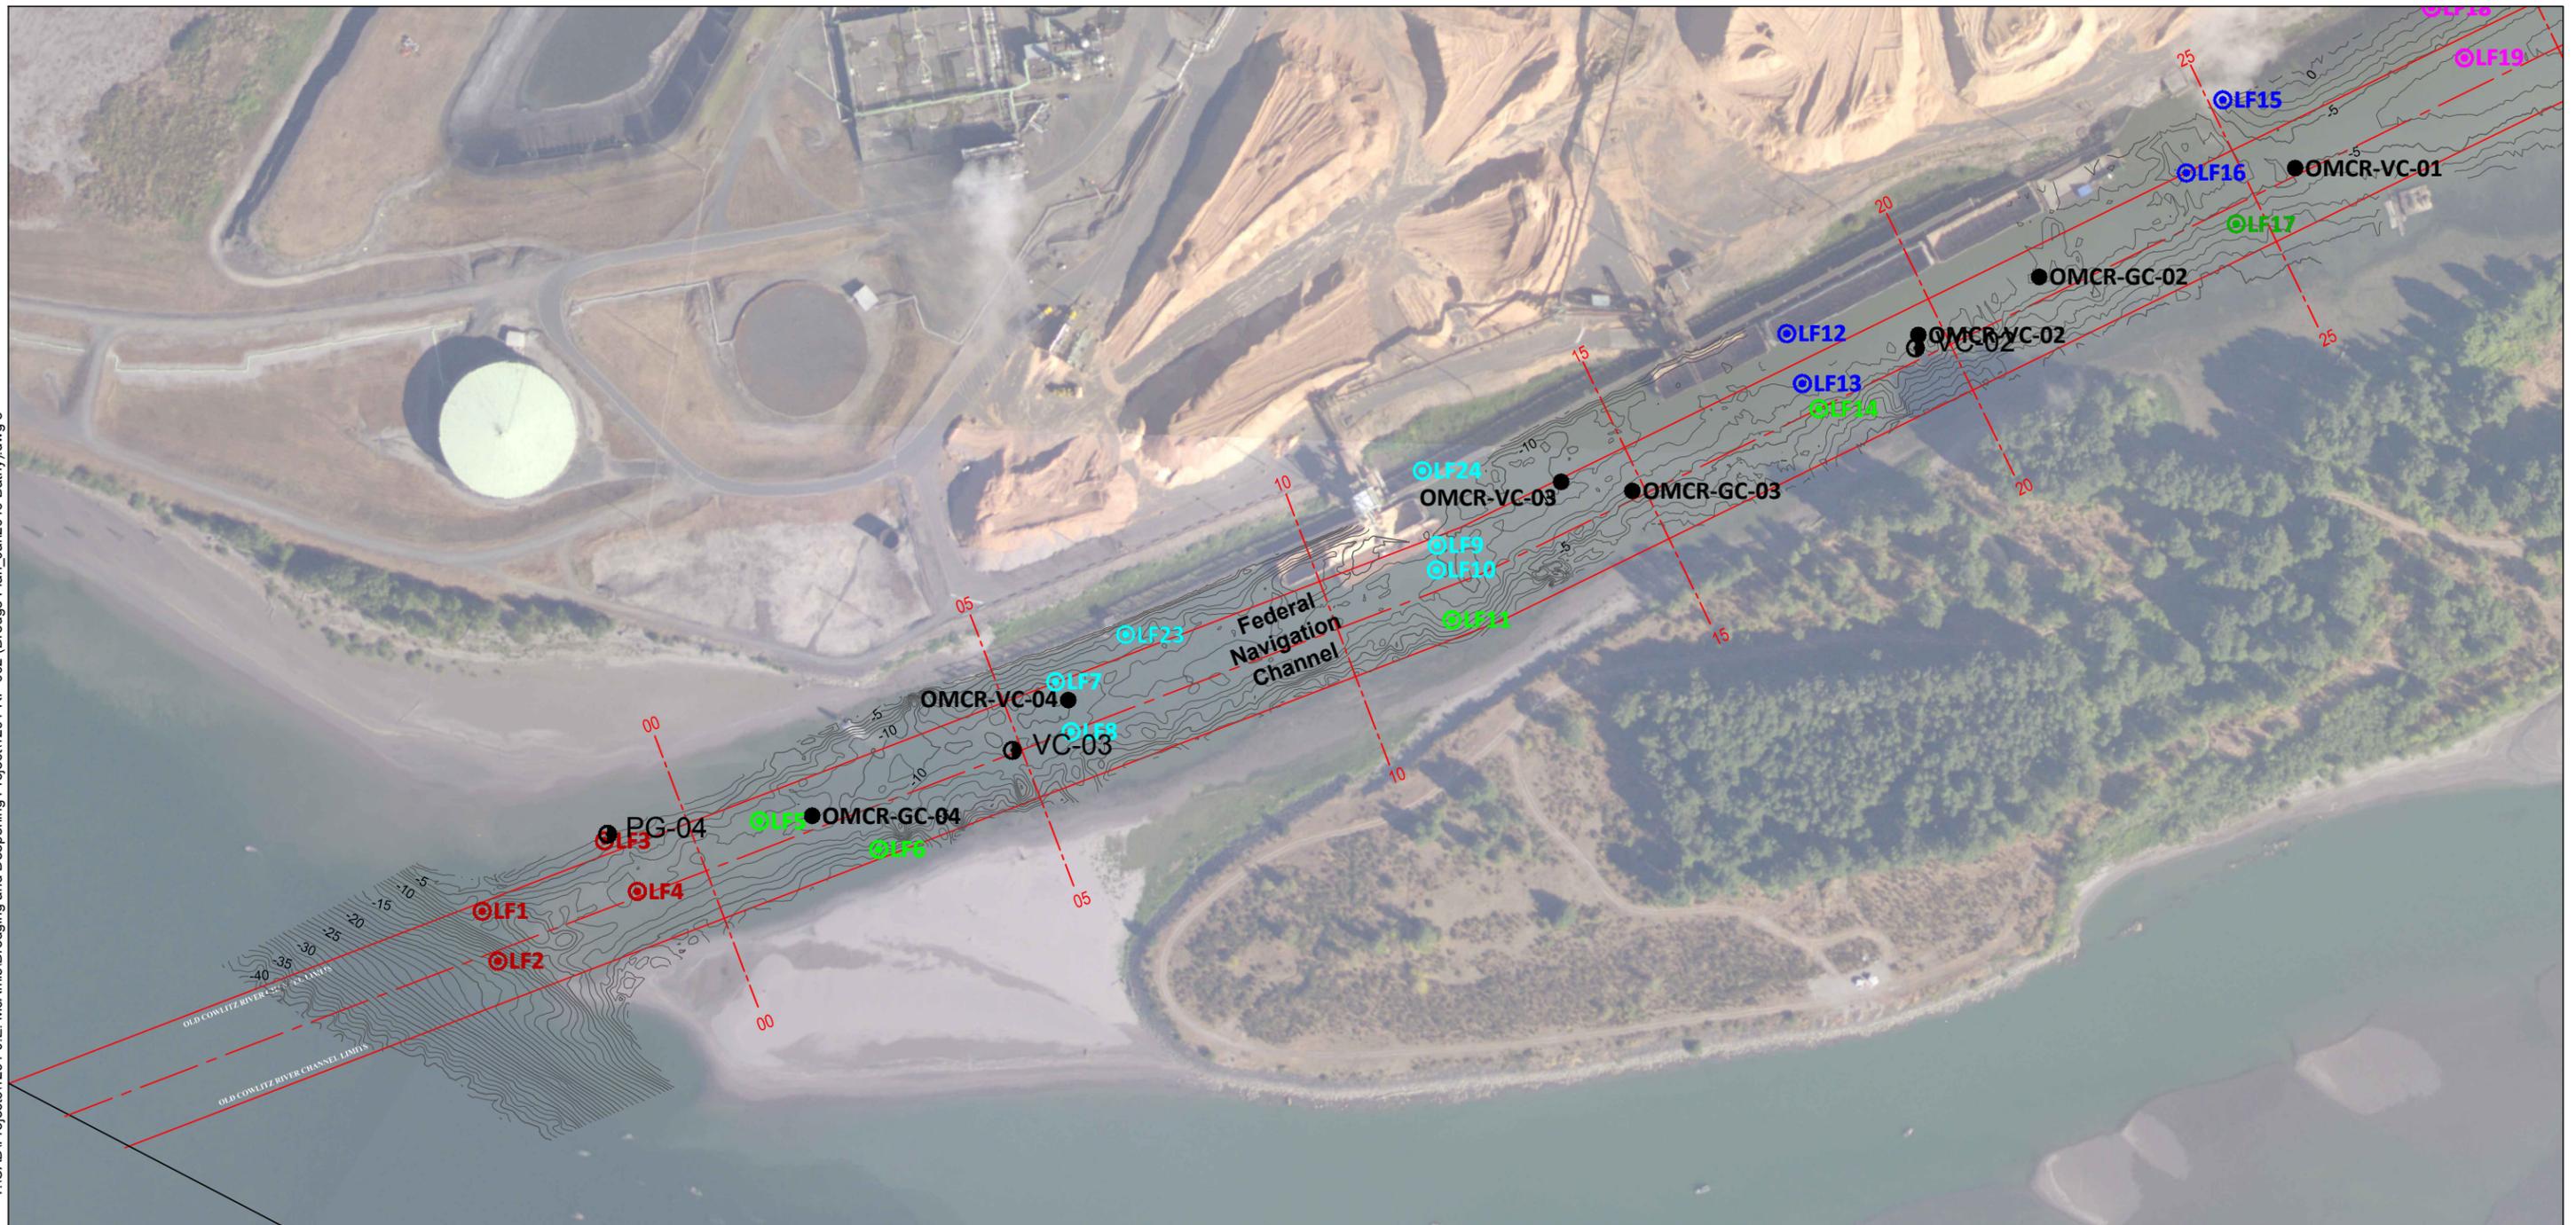
SOURCE: Drawing prepared from CAD files provided by J.E. McAmis, Inc. dated 05-11-2015, titled "J.E. McAmis Log Booming". Updated bathymetry provided by NW Hydro, dated January 2016. Samples from USACE, dated 2014.
