SUBJECT: SUPPLEMENTAL DETERMINATION REGARDING THE SUITABILITY OF PROPOSED DREDGED MATERIAL FROM THE MUKILTEO MULTIMODAL PROJECT, MUKILTEO, WASHINGTON, EVALUATED UNDER SECTION 404 OF THE CLEAN WATER ACT FOR UNCONFINED OPEN-WATER DISPOSAL AT THE PORT GARDNER NON-DISPERSIVE DISPOSAL SITE

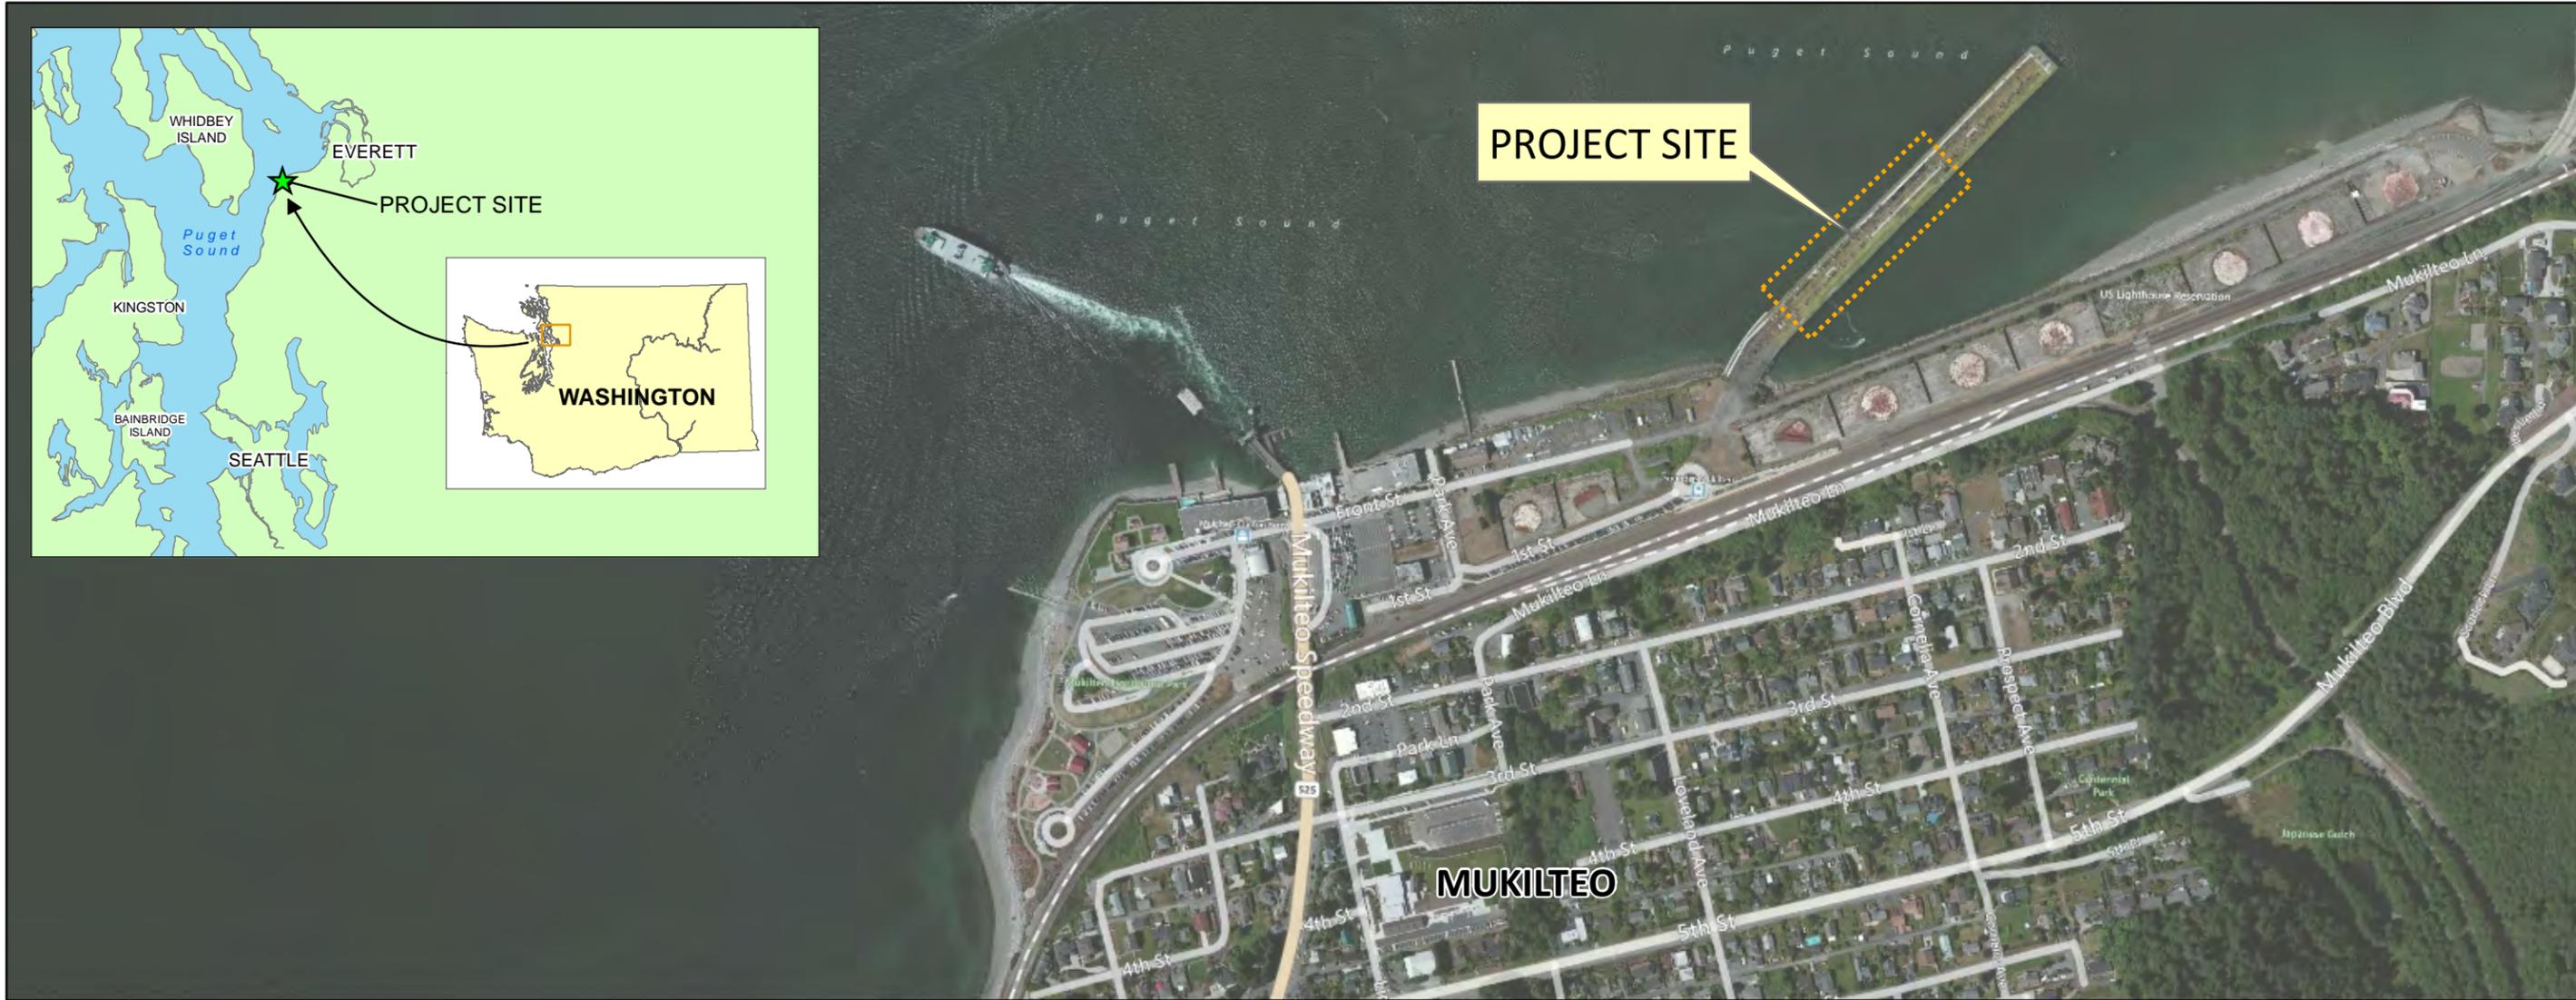
1. THE LOCATIONS OF FEATURES SHOWN ARE APPROXIMATE.
2. THIS FIGURE IS FOR INFORMATION PURPOSES AND IS INTENDED TO ASSIST IN SHOWING FEATURES DISCUSSED IN THE ATTACHED DOCUMENT.

2. **Background.** The Washington State Department of Transportation (WSDOT) Ferries Division proposed the Mukilteo Multimodal Project to improve the operations and facilities serving the mainland terminus of the Mukilteo-Clinton ferry route in Washington State. The entire project will include a new ferry berth, loading area, waiting area, and associated infrastructure to be located approximately 1,800 feet to the northeast of the existing Mukilteo ferry terminal. The project location is shown on the Vicinity Map and Site Plan (**Figures 1 and 2**).

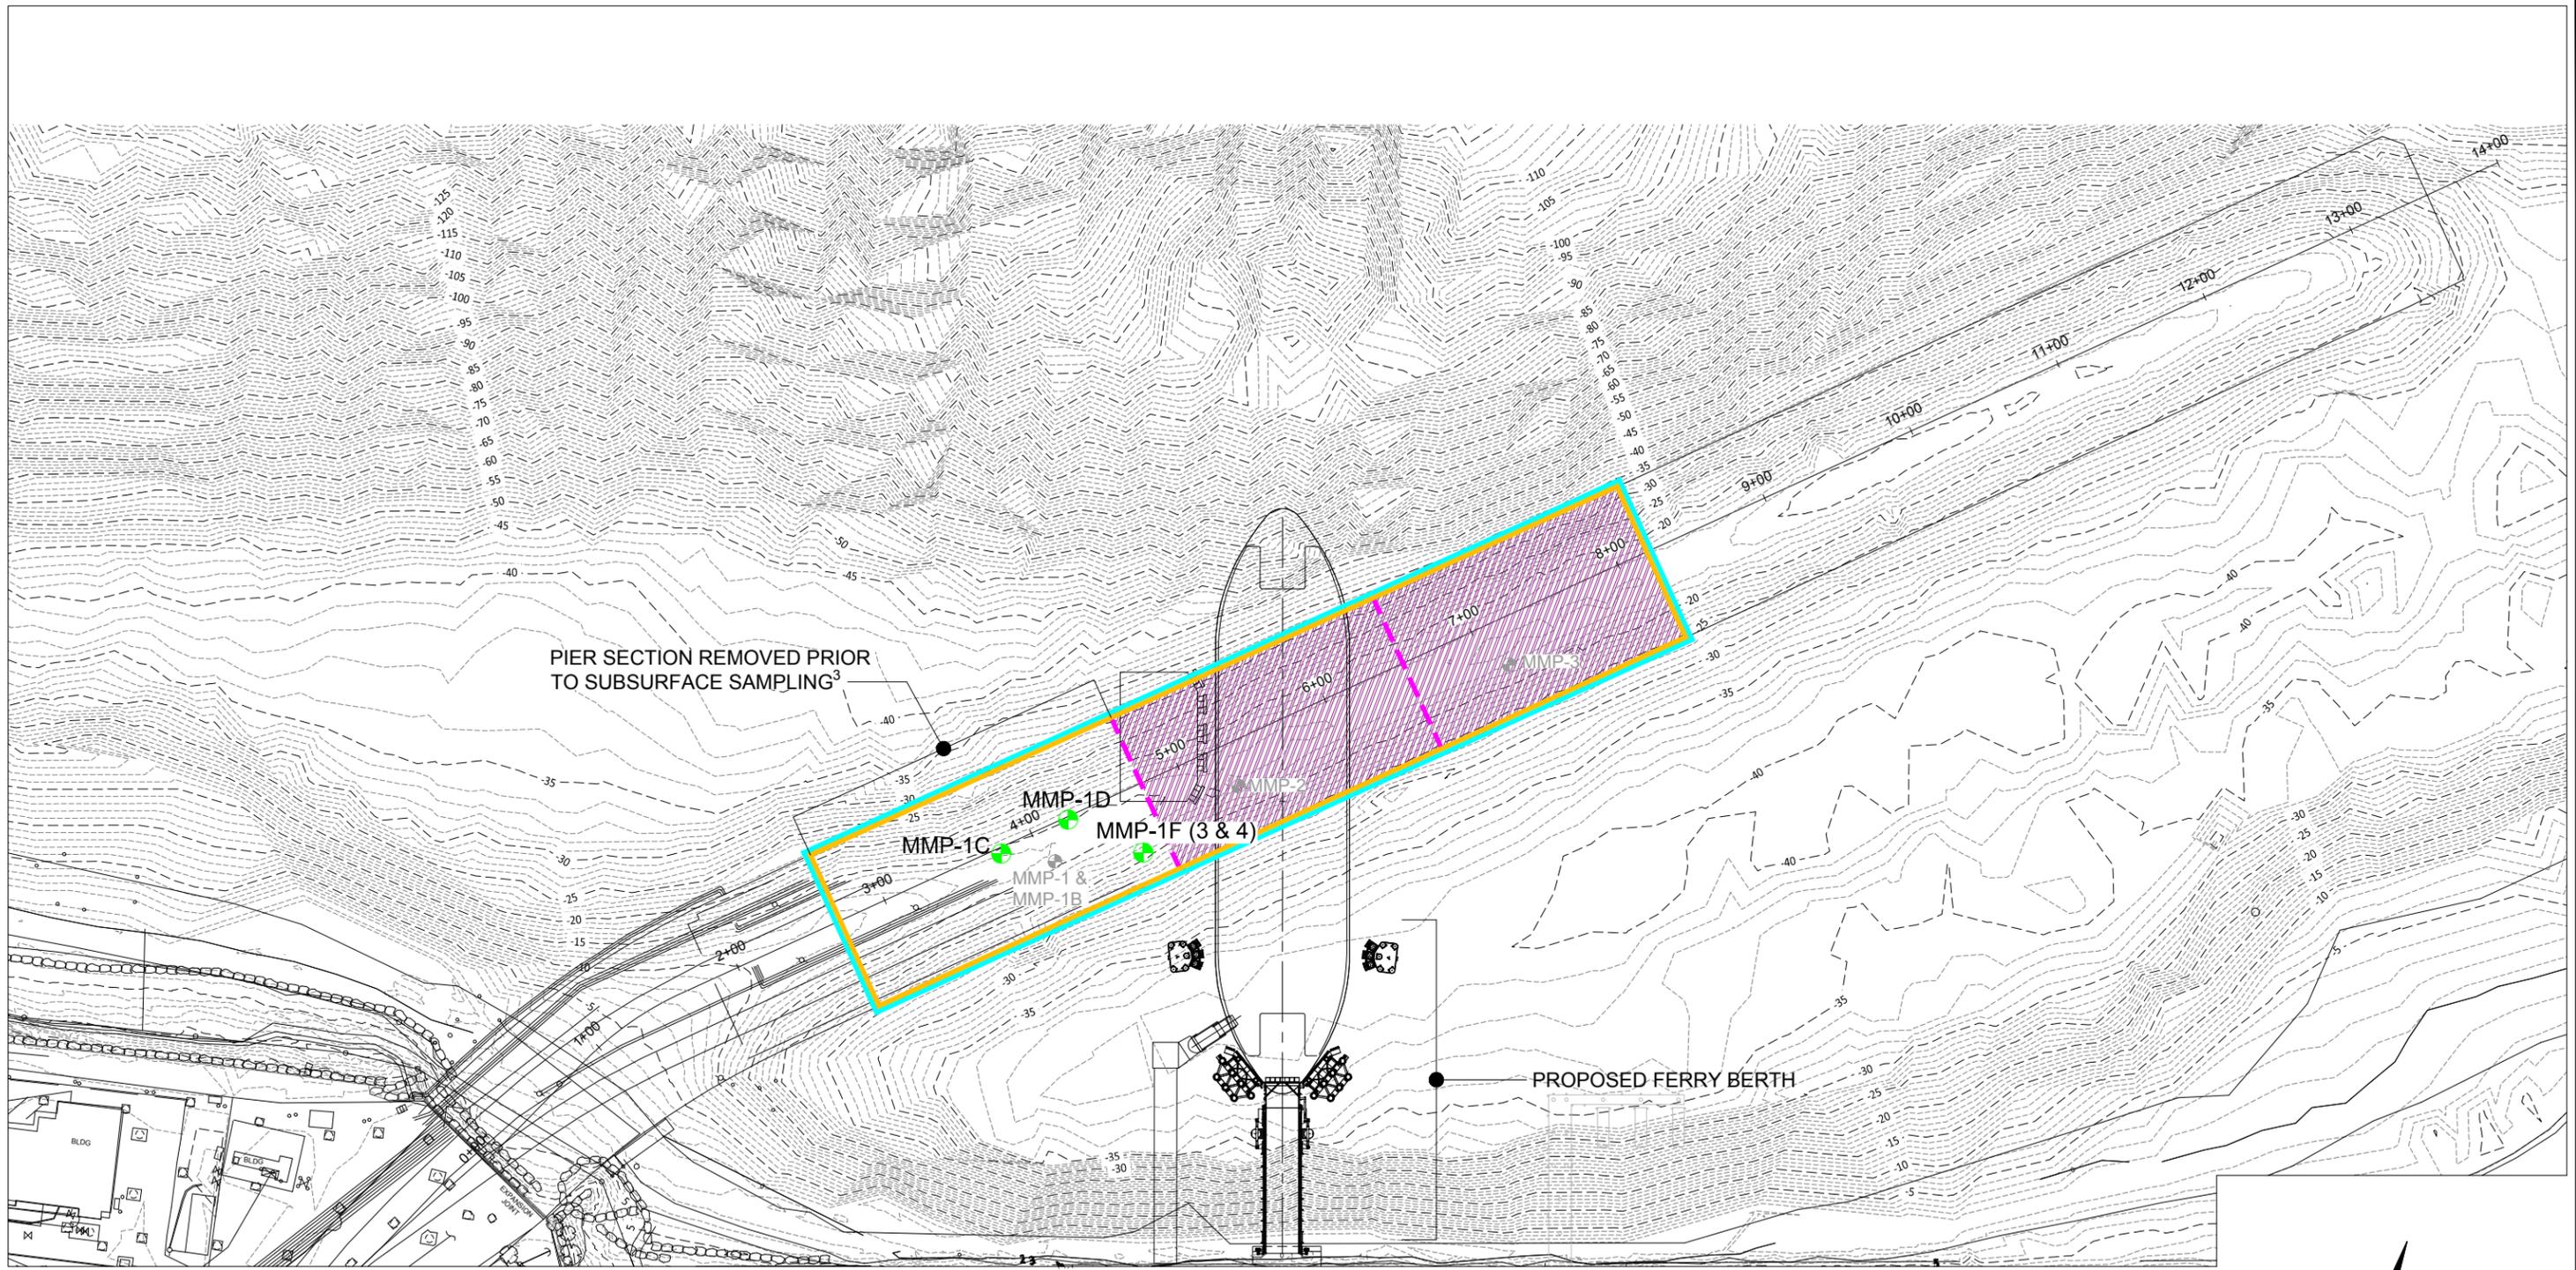
- NOTES:**
1. THE LOCATION OF FEATURES SHOWN ARE APPROXIMATE.
 2. THIS FIGURE IS FOR INFORMATION PURPOSES AND IS INTENDED TO ASSIST IN SHOWING FEATURES DISCUSSED IN THE ATTACHED DOCUMENT.
 3. THE UPPER 7 FEET OF MATERIAL IN NEARSHORE $\frac{1}{3}$ OF THE DREDGE PRISM WAS CHARACTERIZED IN NOVEMBER 2013.

SURFACE DMMU BOUNDARY

MMP-2	LOCATION OF NOVEMBER 2013 VIBRACORE

DMMU SUBUNIT BOUNDARY

MMP-1C	LOCATION OF AUGUST 2015 VIBRACORE

BOUNDARY OF DREDGE PRISM

AREA CHARACTERIZED NOVEMBER 2013 ³

Four attempts were made at each of the two proposed sampling locations, MMP-1C and MMP-1D before an acceptable core was collected in the final attempt at MMP-1D, however only a small amount of material was collected from within DMMU 3C, not enough to be representative of the dredge prism. On the day of sampling, in consultation with the DMMO via phone, two additional sampling locations, MMP-1E and MMP-1F, were identified. Sample location MMP-1E was not attempted due to a higher than expected mudline elevation which diminished the chances of reaching the dredge prism. Four additional attempts were made at location MMP-1F and the last two attempts yielded acceptable cores with good penetration into the dredge prism. Sediment from all three cores collected was composited into one sample for analysis. Compositing information is presented in **Table 3**. Core penetration did not reach the z-samples at any of the stations so no z-samples were collected.
