## MEMORANDUM FOR RECORD

**SUBJECT: DETERMINATION ON THE SUITABILITY OF PROPOSED DREDGED MATERIAL TESTED FOR THE PRIEST RAPIDS RECREATIONAL IMPROVEMENT PROJECT BOAT BASIN AND ACCESS CHANNEL (NWS-2010-1375) EVALUATED UNDER SECTION 404 OF THE CLEAN WATER ACT FOR EITHER IN-WATER OR UPLAND BENEFICIAL USE SITES.**

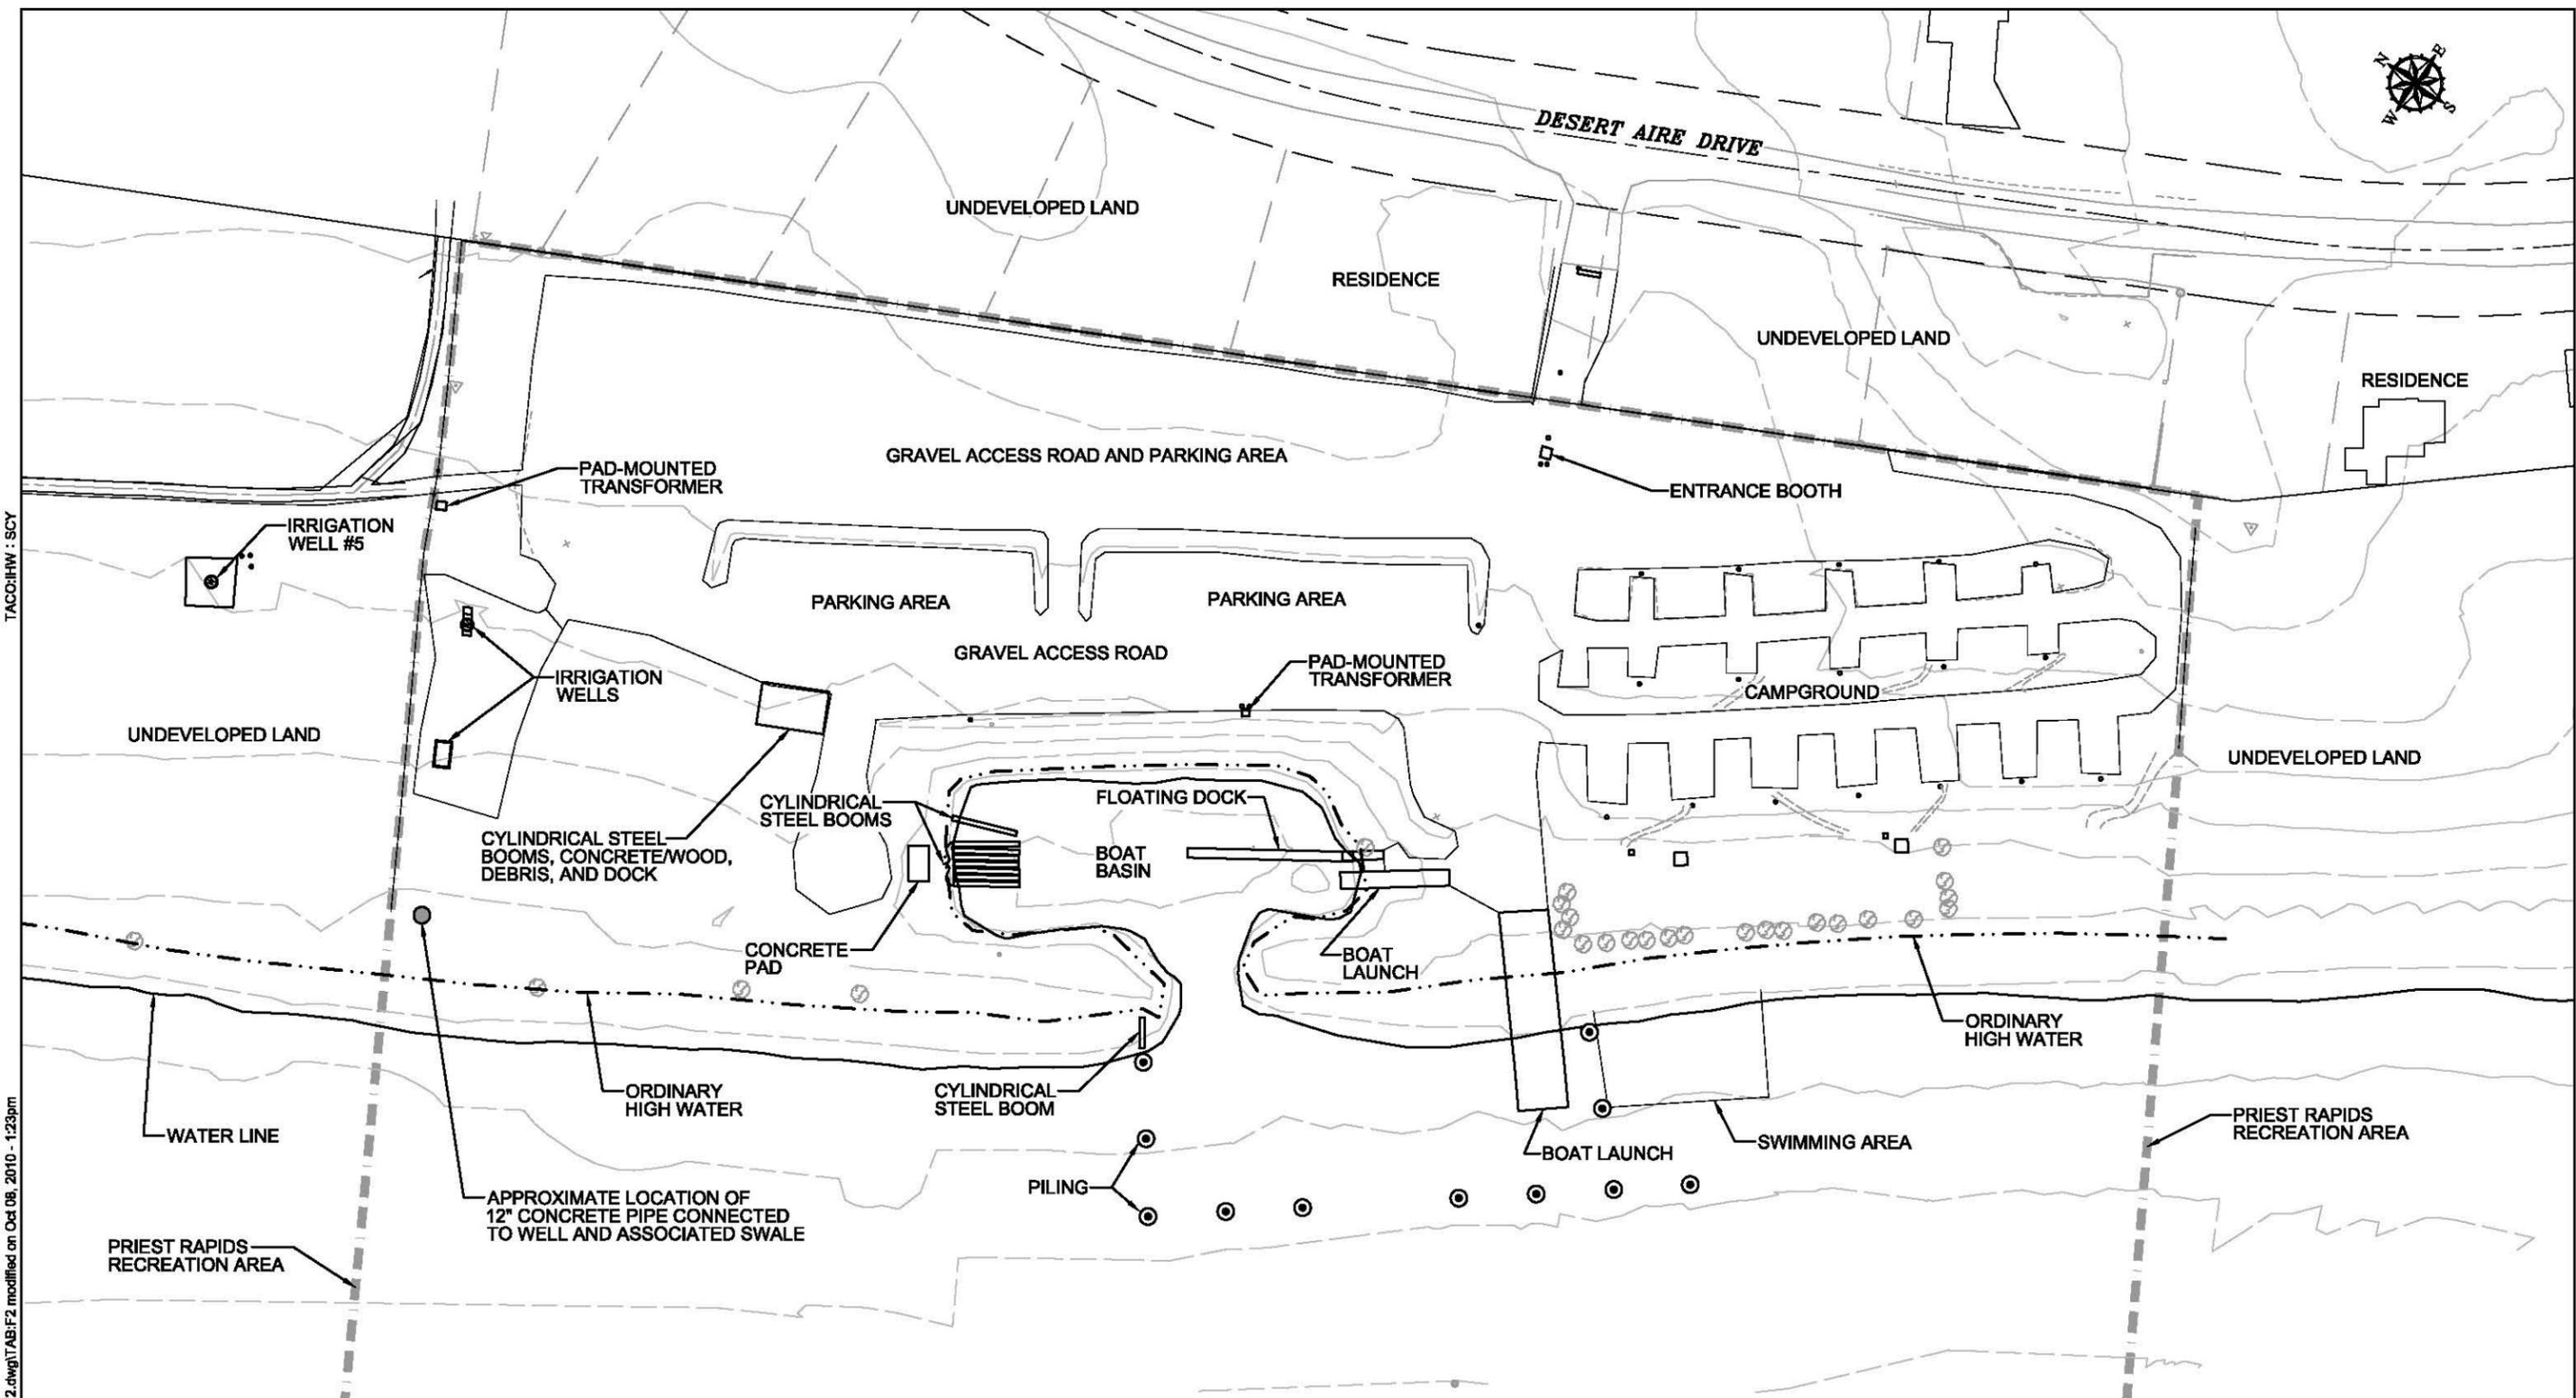
<b>Figure 2</b>

Site Features	
Priest Rapids Recreation Area Improvements Project Desert Aire, Washington

5. **Figure 1** depicts the site vicinity and **Figures 2-3** depict the locations for the 3 sampling stations occupied for the 2011 characterization effort within the single DMMU. The single DMMU was composited from 2 stations/samples collected with a Sonic corer on February 14-15, 2011 (see **Table 2**).

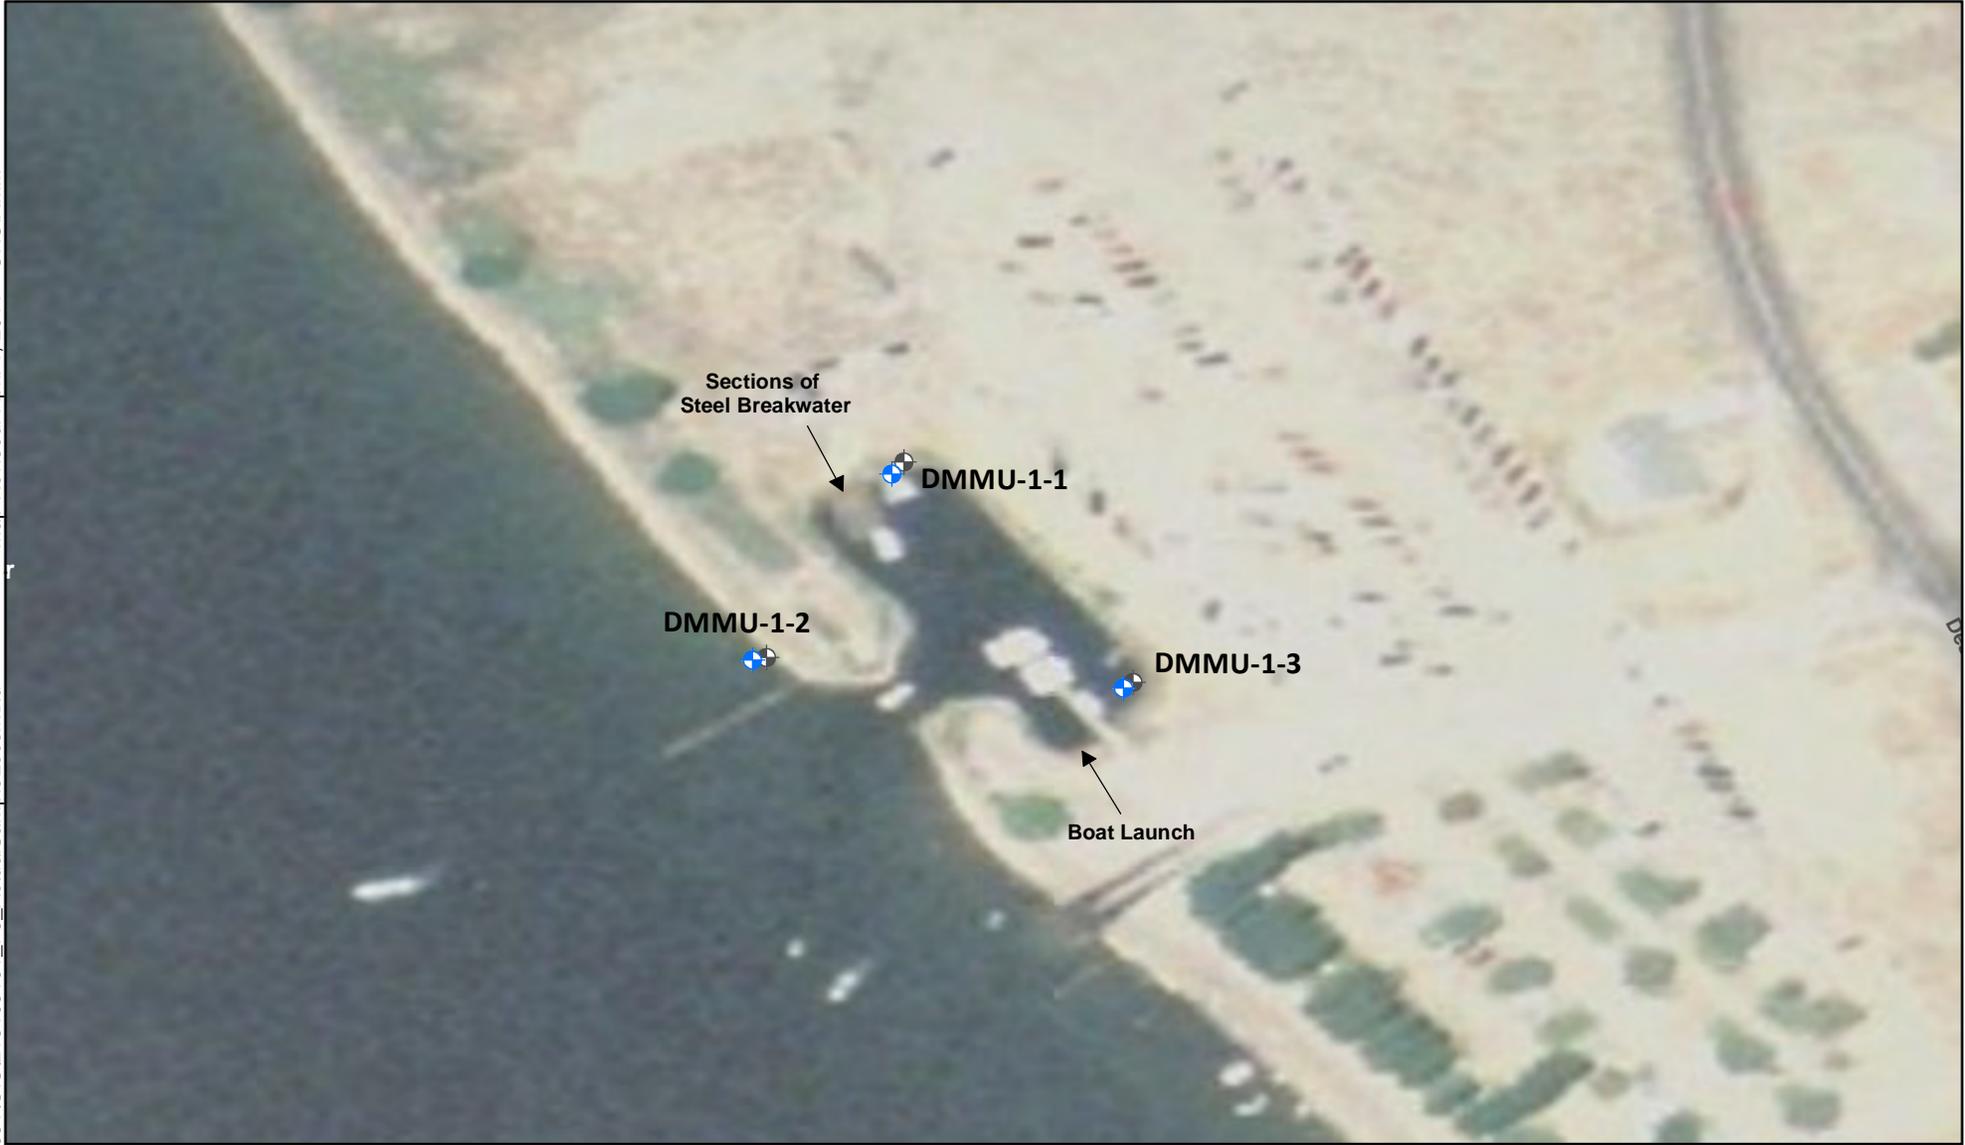
<b>Coring and Sample Locations</b>	
Priest Rapids Recreation Area Improvements Project Desert Aire, Washington	
	<b>Figure 3</b>

- Core samples for DMMU-1-1 and DMMU-1-3 within the boat basin had a 1 foot and 3 foot layer of silty-sand, or silty-gravel-sand, respectively. No fine grained material was observed at DMMU-1-2 outside the boat basin, which was comprised of gravel down to 9 feet, so compositing for DMMU-C1 was limited to Stations 1-1 and 1-3 within the boat basin.

DMMU ID	Core sample ID	Latitude*	Longitude*	Core Target Depth (ft bgs)	Dredge Prism Depth (ft bgs)	Z-Layer Depth Interval (feet bgs)
DMMU-C1 (boat basin)	DMMU-1-1	46.6845341237	-119.932585786	11	0 to 9	9 to 11
	DMMU-1-3	46.6840741234	-119.932085786	11	0 to 9	9 to 11
Channel	DMMU-1-2	46.6841341231	-119.932885787	11	0 to 9	9 to 11
