MEMORANDUM FOR RECORD

SUBJECT: DMMP NO-TEST DETERMINATION FOR MAINTENANCE DREDGING OF 250 CUBIC YARDS OF SAND AND GRAVEL FROM THE NAVIGATION CHANNEL CONNECTING DAVIS BAY AND DECATUR HEAD LAGOON BY THE DECATUR HEAD BEACH ASSOCIATION (NWS-2018-968).

DECATUR HEAD BEACH ASSOCIATION MAINTENANCE DREDGE

DECATUR HEAD MAINTENANCE DREDGE
 COVER SHEET
 VICINITY MAP - NOTES - INDEX
 DECATUR HEAD BEACH ASSOCIATION

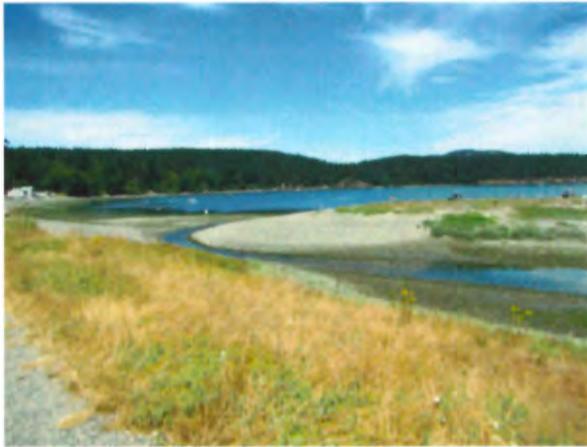
Channel to be dredged, looking north.

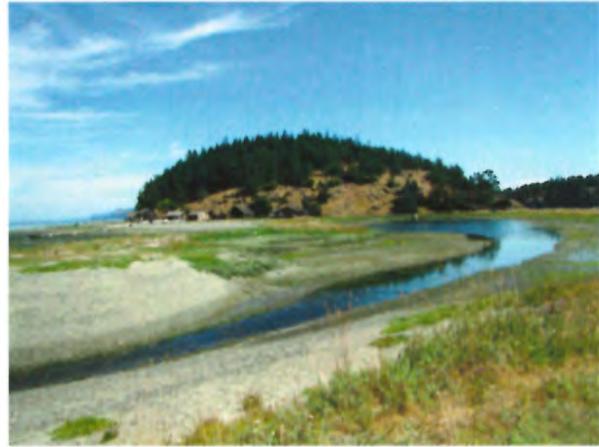
Channel to be dredged, looking east.

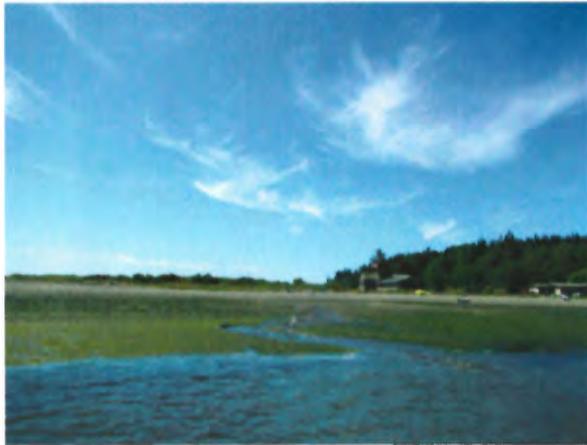
Area of channel dredge. Looking southeast.

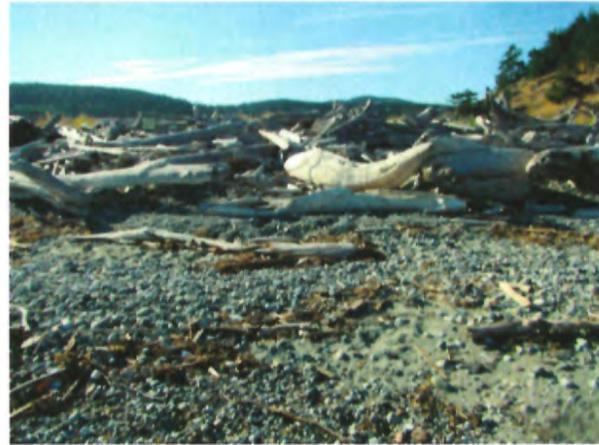
Beach logs, typical of logs within construction access.

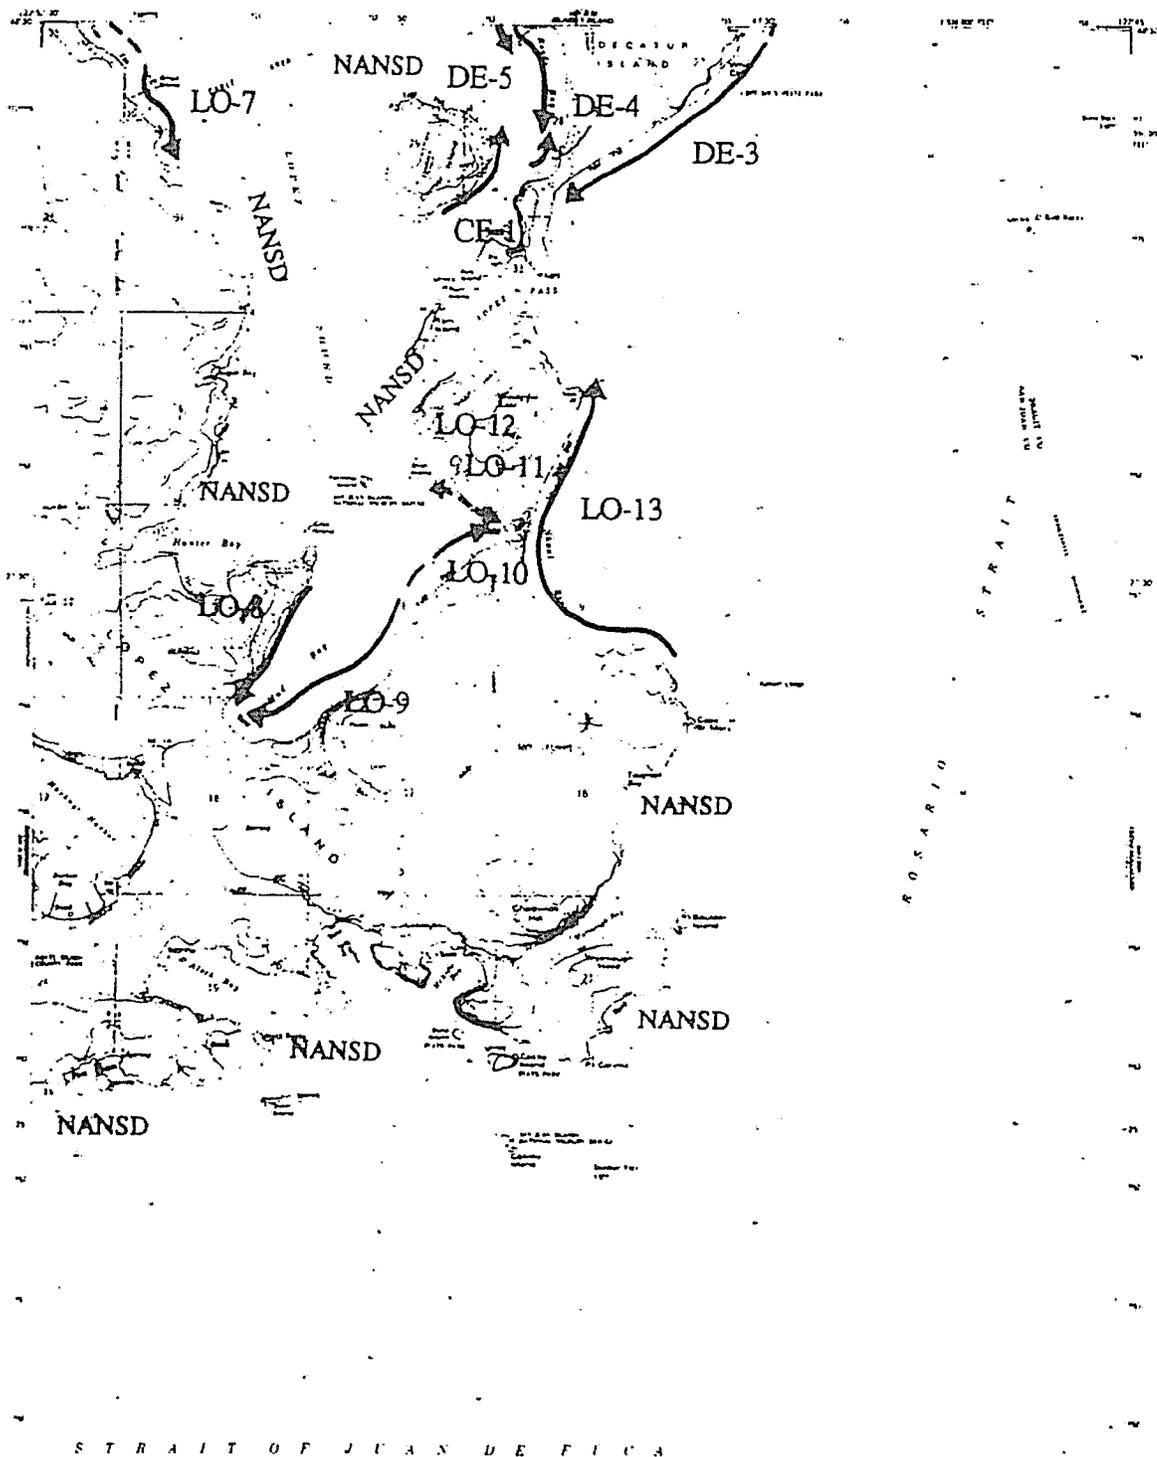
Figure 2. Net shore-drift of Lopez Pass quadrangle (Johannessen, 1992).

At 2.5 km in length, this is the longest drift cell along Decatur Island. Cell DE-2 originates at a zone of drift divergence along White Cliff, a 30- to 40-m-high, eroding bluff comprised of glacial till (Lopez Pass quadrangle). Several bluff failures have occurred recently along this shore, providing additional sediment to the shore drift system. Net shore-drift is to the northeast extending around Decatur Head and depositing sediment in a spit prograding southwestward on the west side of Decatur Head (Blakely Island quadrangle). A narrow beach fronts White Cliff, consisting of pebbles, cobbles and boulders. Lag deposits consisting of boulders up to 2 m in diameter are present in the nearshore area here. Sediment size decreases and beach width increases to the northeast to the tombolo that has prograded to Decatur Head, indicating northeastward net shore-drift.

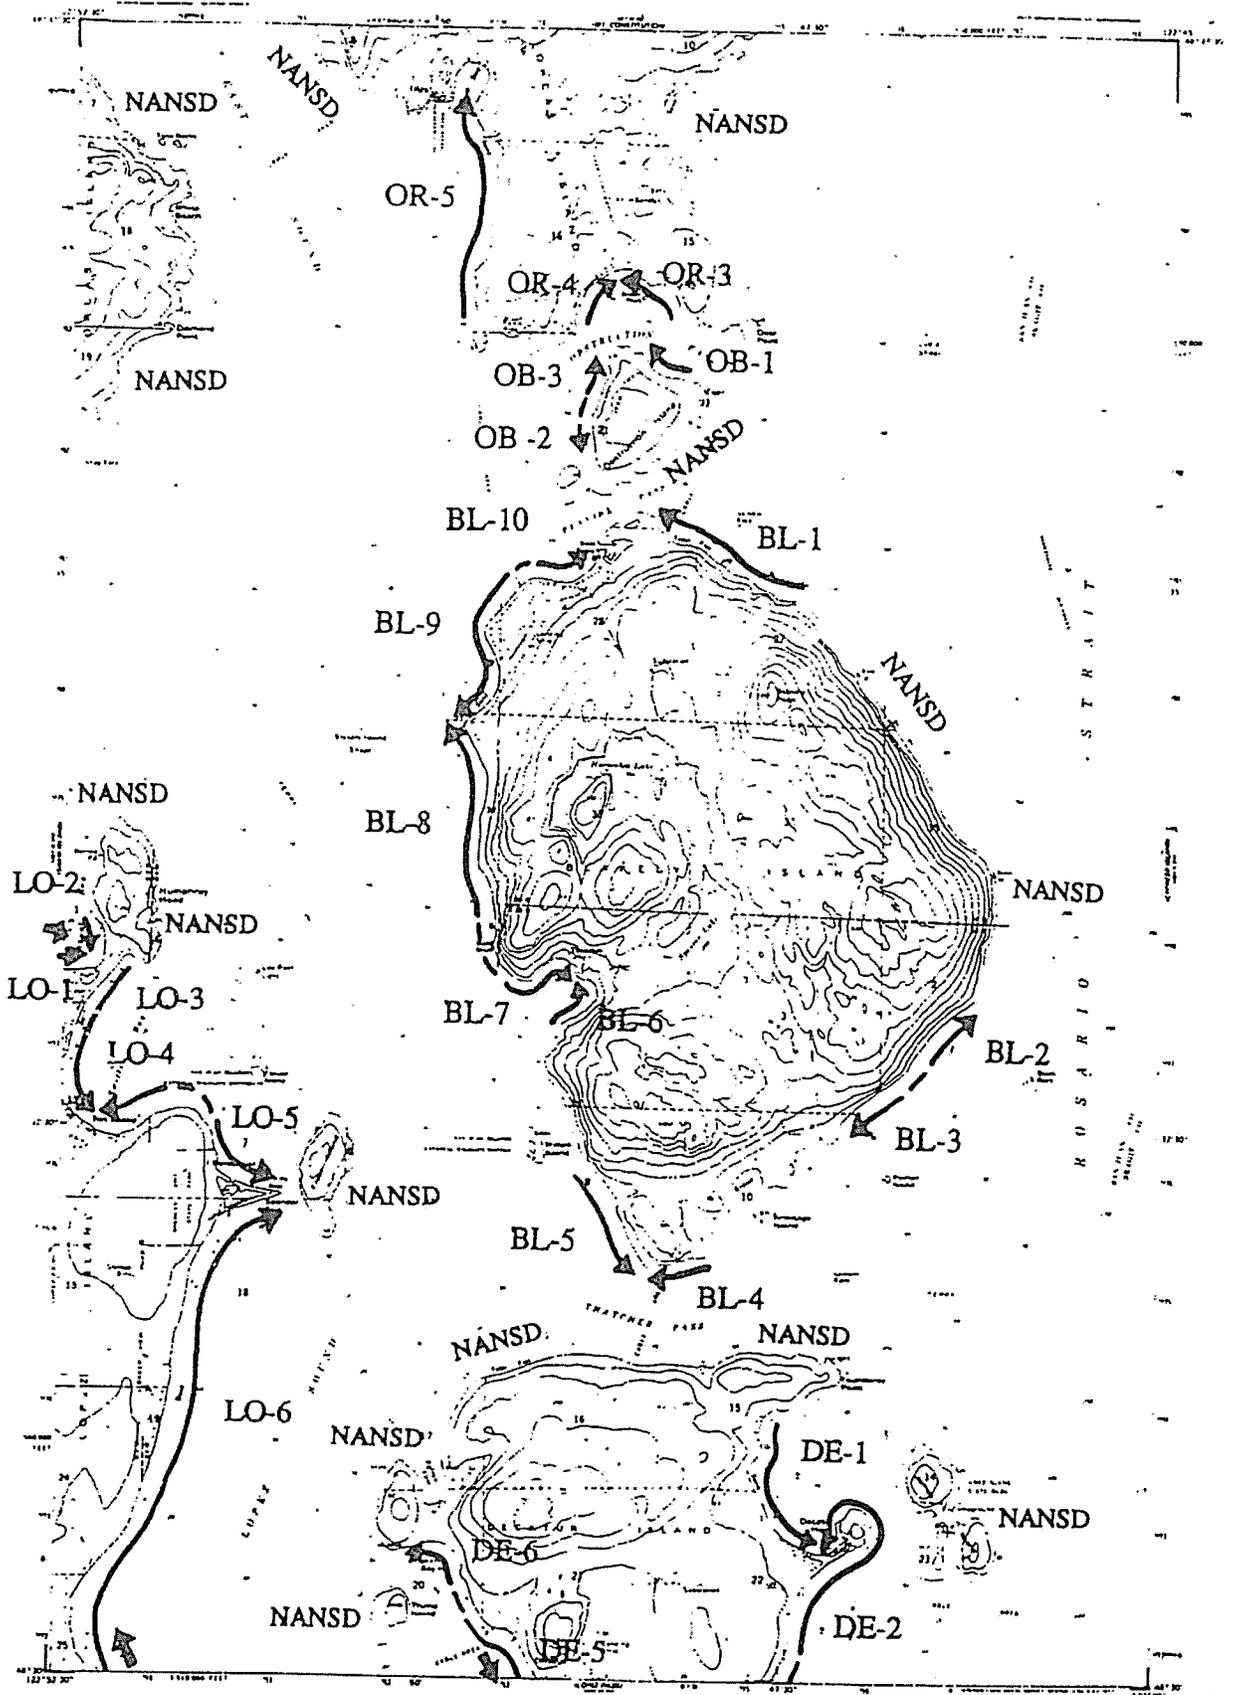
Figure 3. Net shore-drift of Blakely Island quadrangle (Johannessen, 1992).

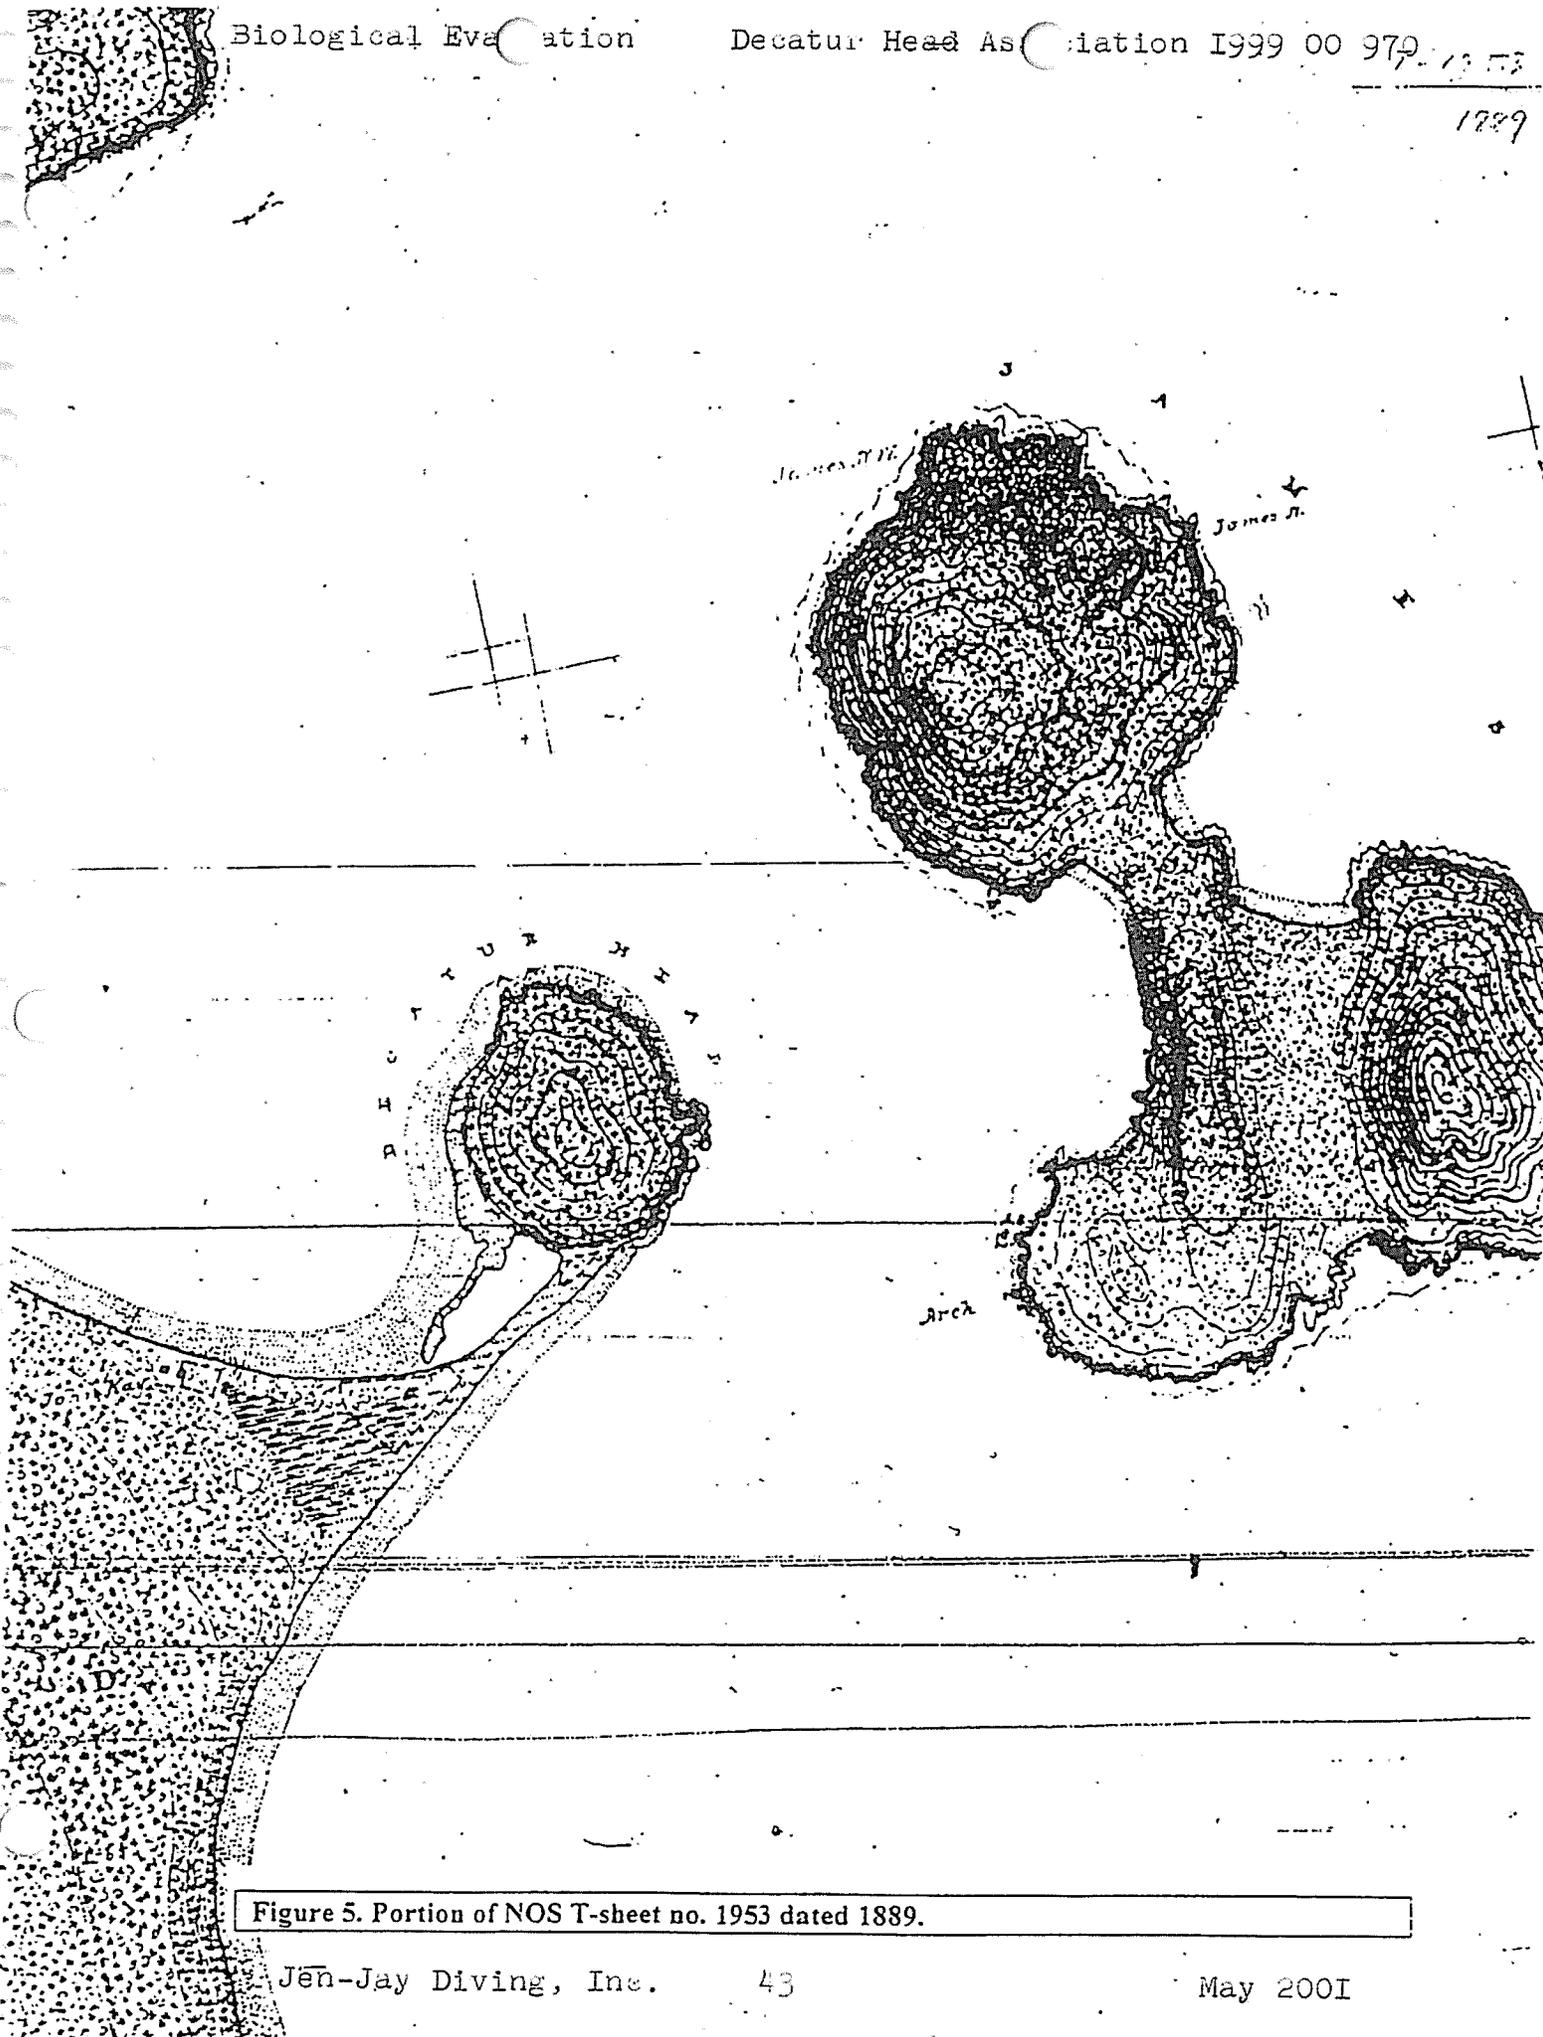
Figure 5. Portion of NOS T-sheet no. 1953 dated 1889.

Shoreline Change (Coastal Geologic Services, 2000) – Historical maps and aerial photos were obtained and examined to characterize the dynamics of the spit and the lagoon channel. The oldest information found was an 1889 T-sheet map (Figure 5) prepared by the National Ocean Service (NOS). High-quality vertical aerial photos (1:12,000 scale) were purchased from the WA DNR. Scaled measurements of shoreline change were made directly from aerial photos. Photos were individually scaled using distances between cabin locations measured from the project base map. Additional scaling and checking was performed using distances between road corners on a 1:25,000 scale NOS chart (no. 18430, Rosario Strait, Northern Part). Scale measurements were made on the portion of the photos that was used for data collection to accurately correct for scale variations and lens and other distortions. Only the photos that were best centered on the lagoon were used to minimize radial lens distortion and parallax. Measurements of control points and beach features were made directly on original prints using a caliper with one-thousandth of an inch precision. The scale of the photos and the absence of surveyed control points limit the accuracy of measurements (discussed below) but this is the best record of historical shoreline position available.

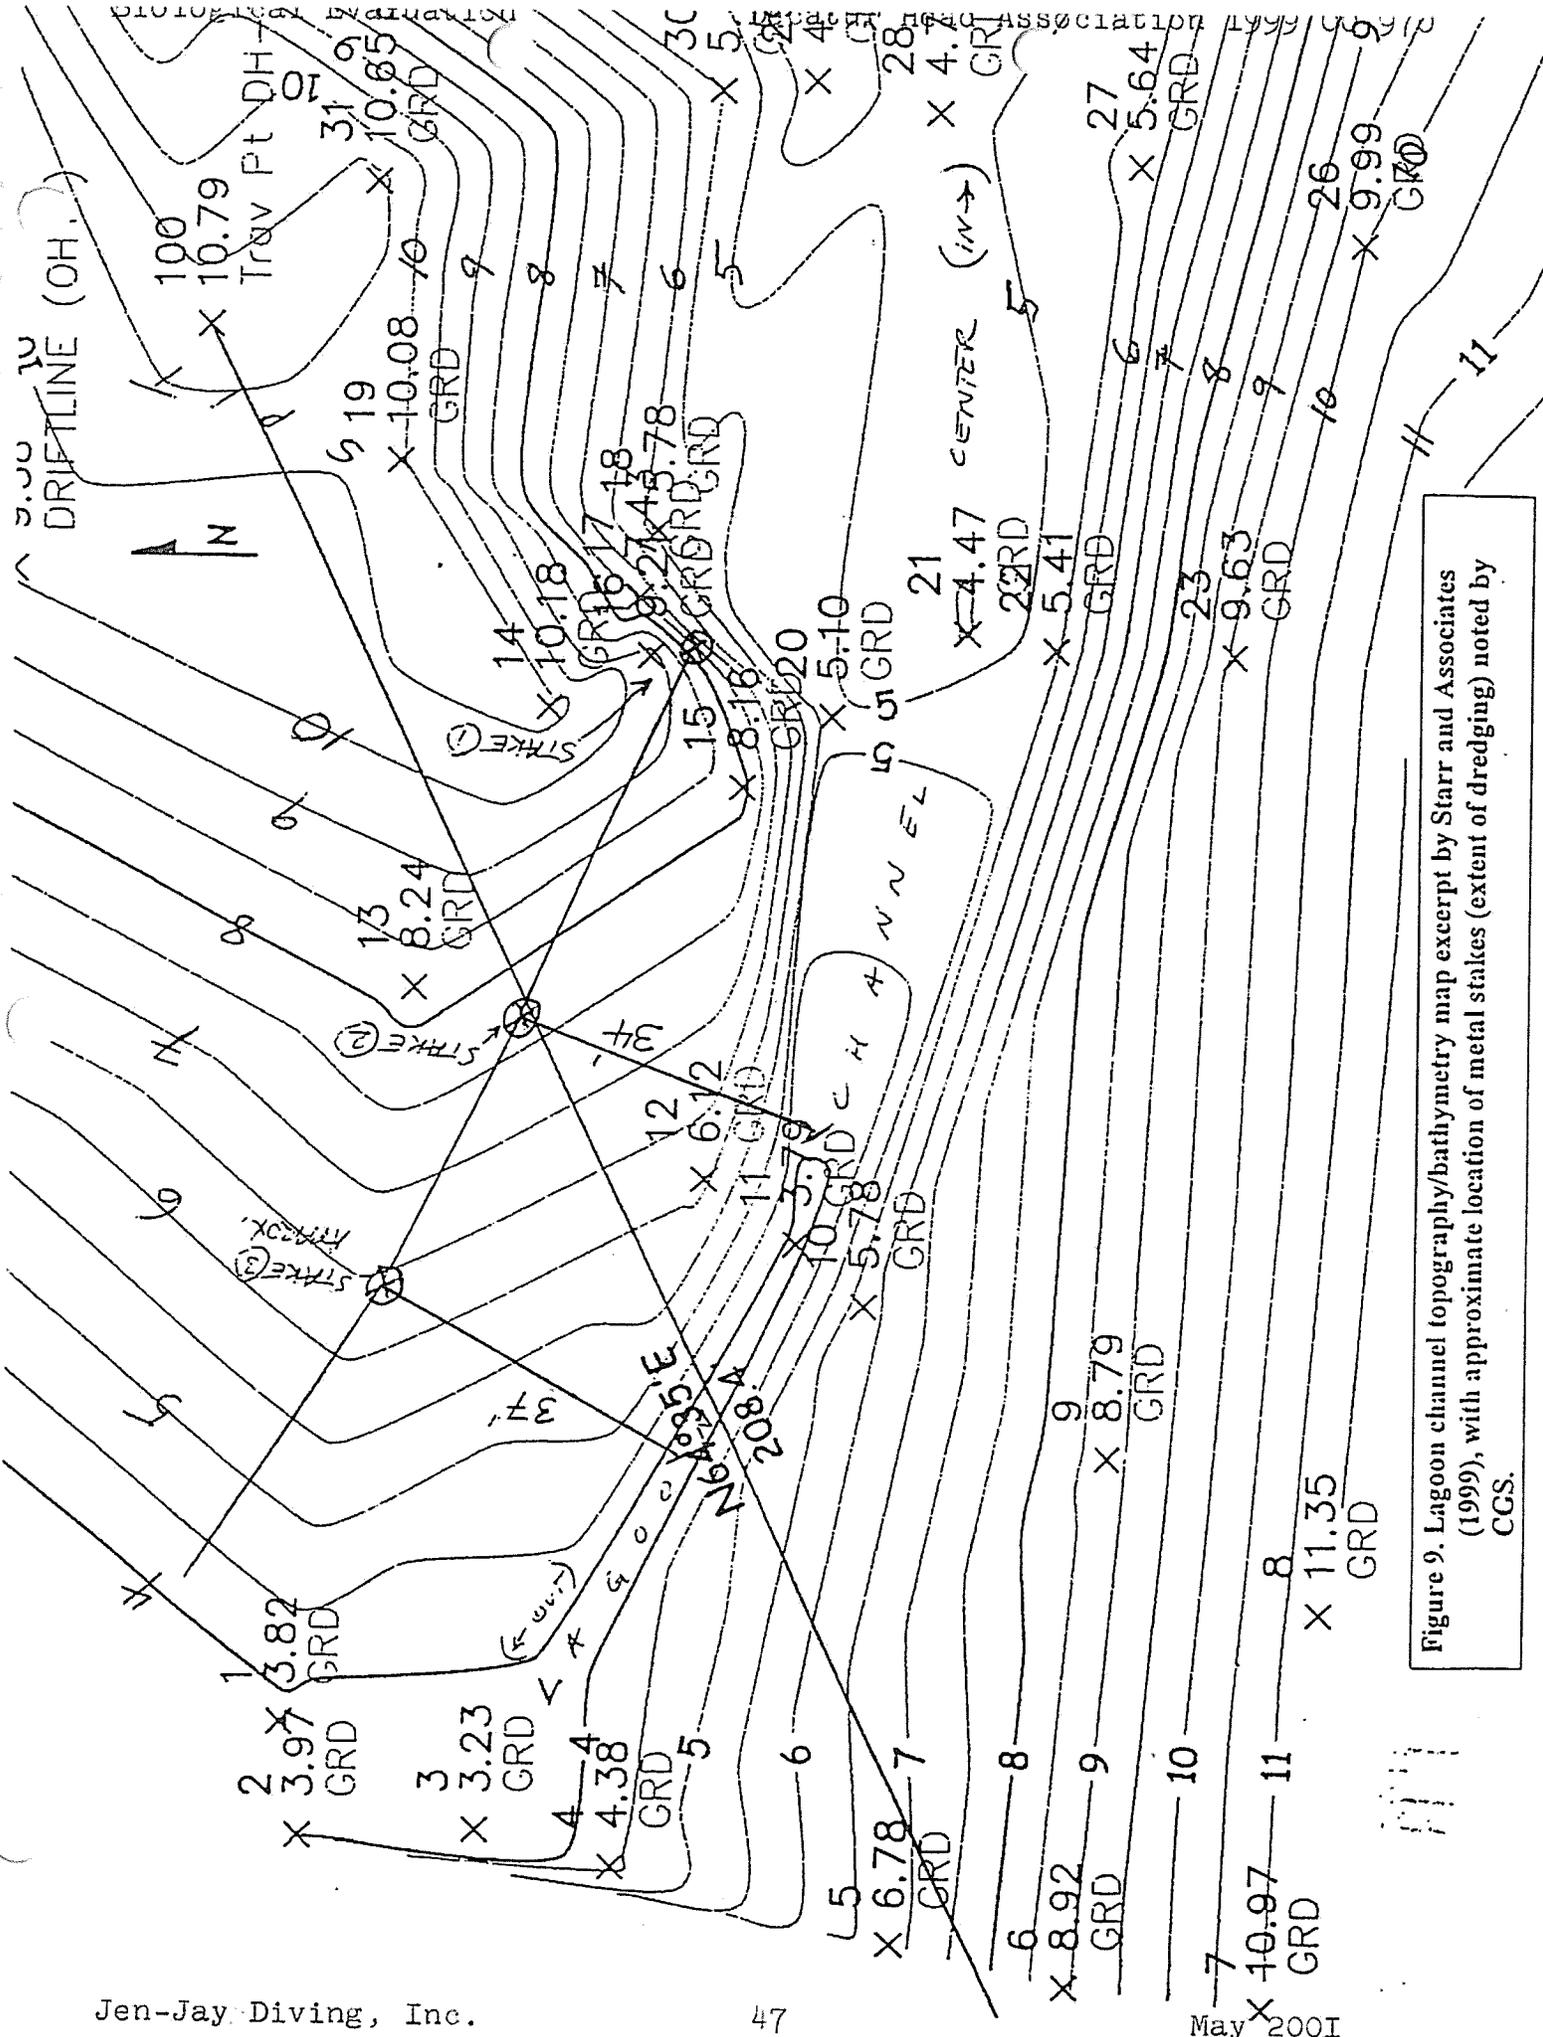
Figure 9. Lagoon channel topography/bathymetry map excerpt by Starr and Associates (1999), with approximate location of metal stakes (extent of dredging) noted by CGS.

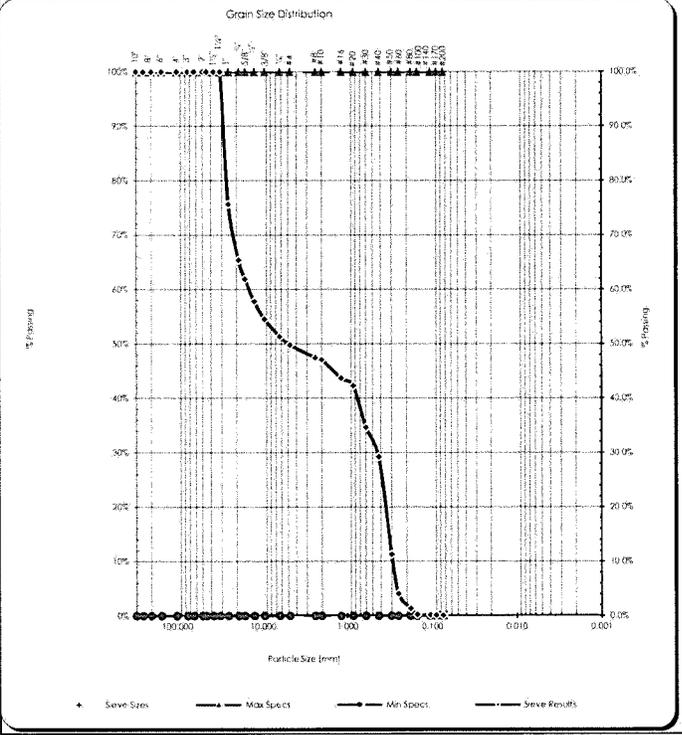
AASHTO T-176, AASHTO T-255, AASTHO T-335, AASHTO T-89, AASHTO T-90			
Specifications No Specs Sample Meets Specs ? N/A	$D_{4.75} = 0.257$ mm $D_{10} = 0.291$ mm $D_{15} = 0.326$ mm $D_{30} = 0.450$ mm $D_{60} = 4.946$ mm $D_{100} = 14.387$ mm $D_{200} = 28.832$ mm	% Gravel = 50.2% % Sand = 49.7% % Silt & Clay = 0.1% Liquid Limit = n/a Plasticity Index = n/a Sand Equivalent = n/a Fracture % 1 Face = n/a Fracture % 2+ Faces = n/a	Coeff. of Curvature, $C_c = 0.05$ Coeff. of Uniformity, $C_u = 49.39$ Fineness Modulus = 4.93 Plastic Limit = n/a Moisture %, as received = 2.6% Req'd Sand Equivalent = Req'd Fracture % 1 Face = Req'd Fracture % 2+ Faces =

Comments: Maximum nominal aggregate size is 1.00", per ASTM table C-136, the minimum sample size for a gradation with a 1.00" maximum nominal aggregate size is 10,000g. This sample provided had a total mass that was below the minimum requirement.

The samples were also analyzed for grain size. The sample taken at cross section 1+40 was found to be 45.9% gravel, 53.8% sand, and 0.3% silt and clay. The sample taken at cross section 0+90 was found to be 50.2% gravel, 49.7% sand, and 0.1% silt and clay. These sediments were clearly beach quality and were originally intended for beneficial reuse as beach nourishment, until San Juan County informed us that was not consistent with the current SMP code.
