Remediation of Sites in the U.S. Virgin Islands and Puerto Rico
Contract DACA87-92-D-0147
Delivery Order 0002

INTERIM REMEDIAL ACTION
CULEBRA ISLAND NATIONAL WILDLIFE REFUGE
PUERTO RICO

FINAL REMOVAL REPORT

November 15, 1995

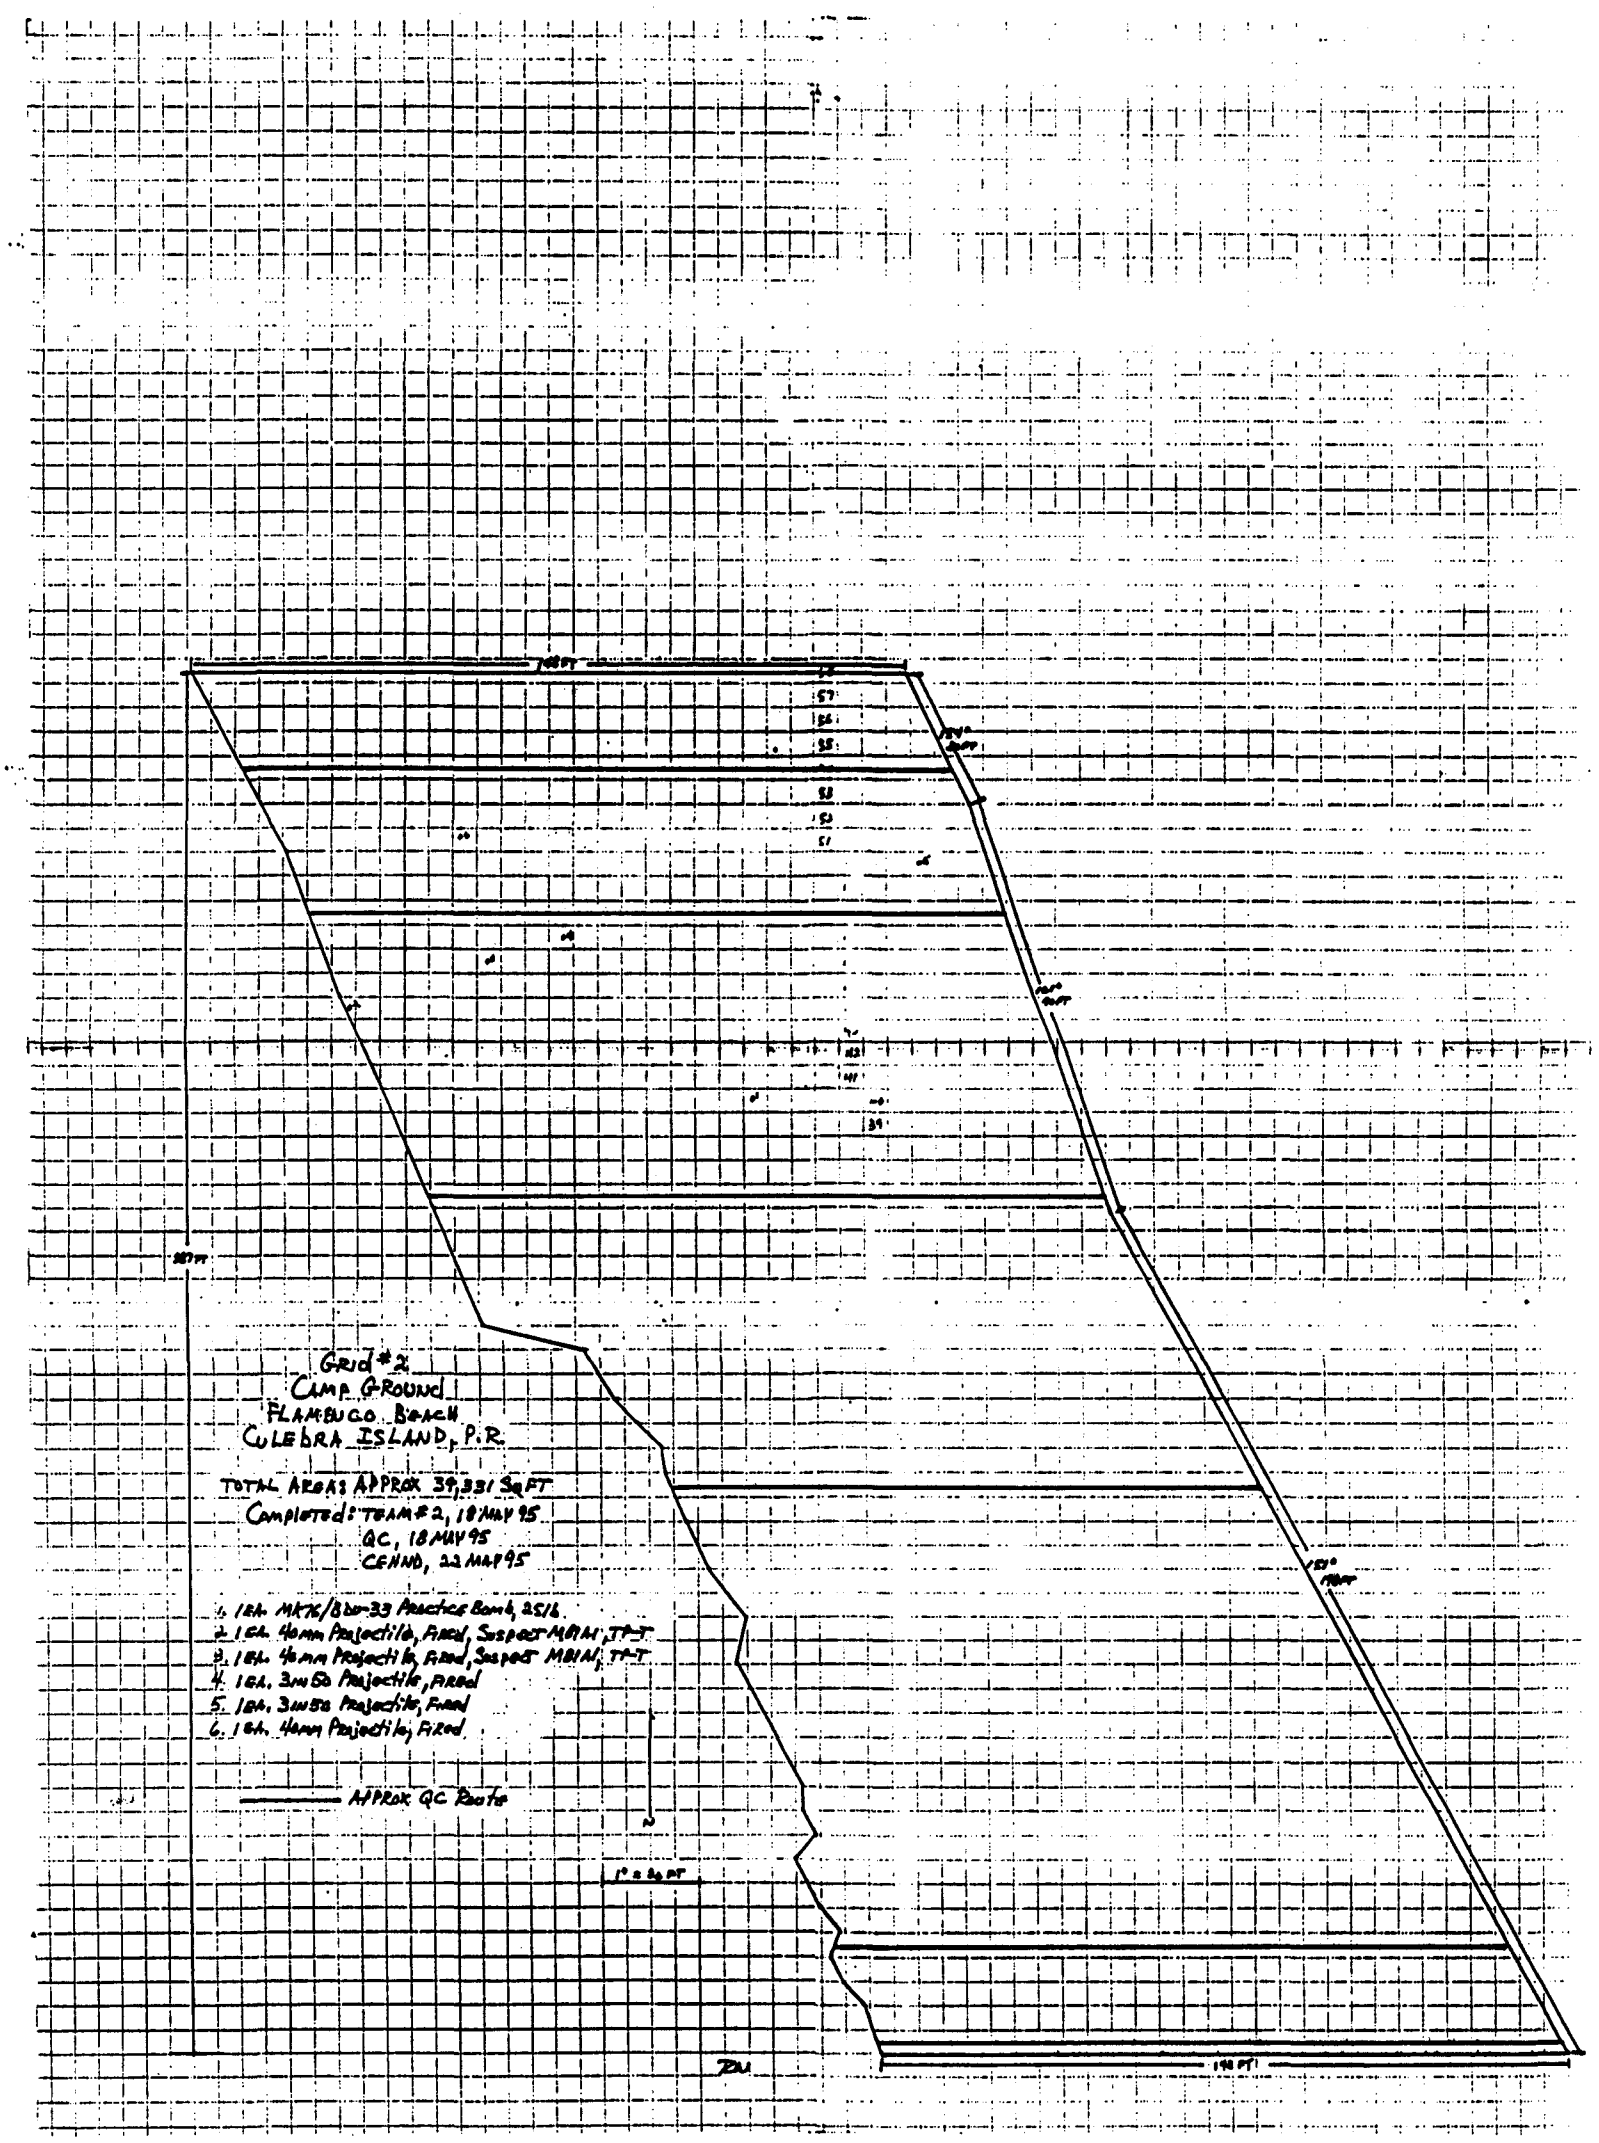
Grid #2
Camp Ground
Flamenco Beach
Culebra Island, P.R.
TOTAL AREAS APPROX 39,331 SqFT
Completed: TEAM #2, 18 MAY 95
QC, 18 MAY 95
CENND, 22 MAY 95
1. 1EA. MK76/BDU-33 Practice Bomb, 25lb.
2. 1EA. 40mm Projectile, Fired, Suspect MPAI, TP-T
3. 1EA. 40mm Projectile, Fired, Suspect MPAI, TP-T
4. 1EA. 3in50 Projectile, Fired
5. 1EA. 3in50 Projectile, Fired
6. 1EA. 40mm Projectile, Fired
APPROX QC Route
N
1" = 20 FT
TDU
