Re: Response to Comments for LOMR for Brickhouse Gully;
City of Houston
Brickhouse Gully (E115-00-00)

Below are our responses to the third HCFCF courtesy review comments to the LOMR for Brickhouse Gully dated April 4, 2014.

Pine Crest Golf Course – Dynamic Flood Depths at Base Flood Event (100 Year Flood)

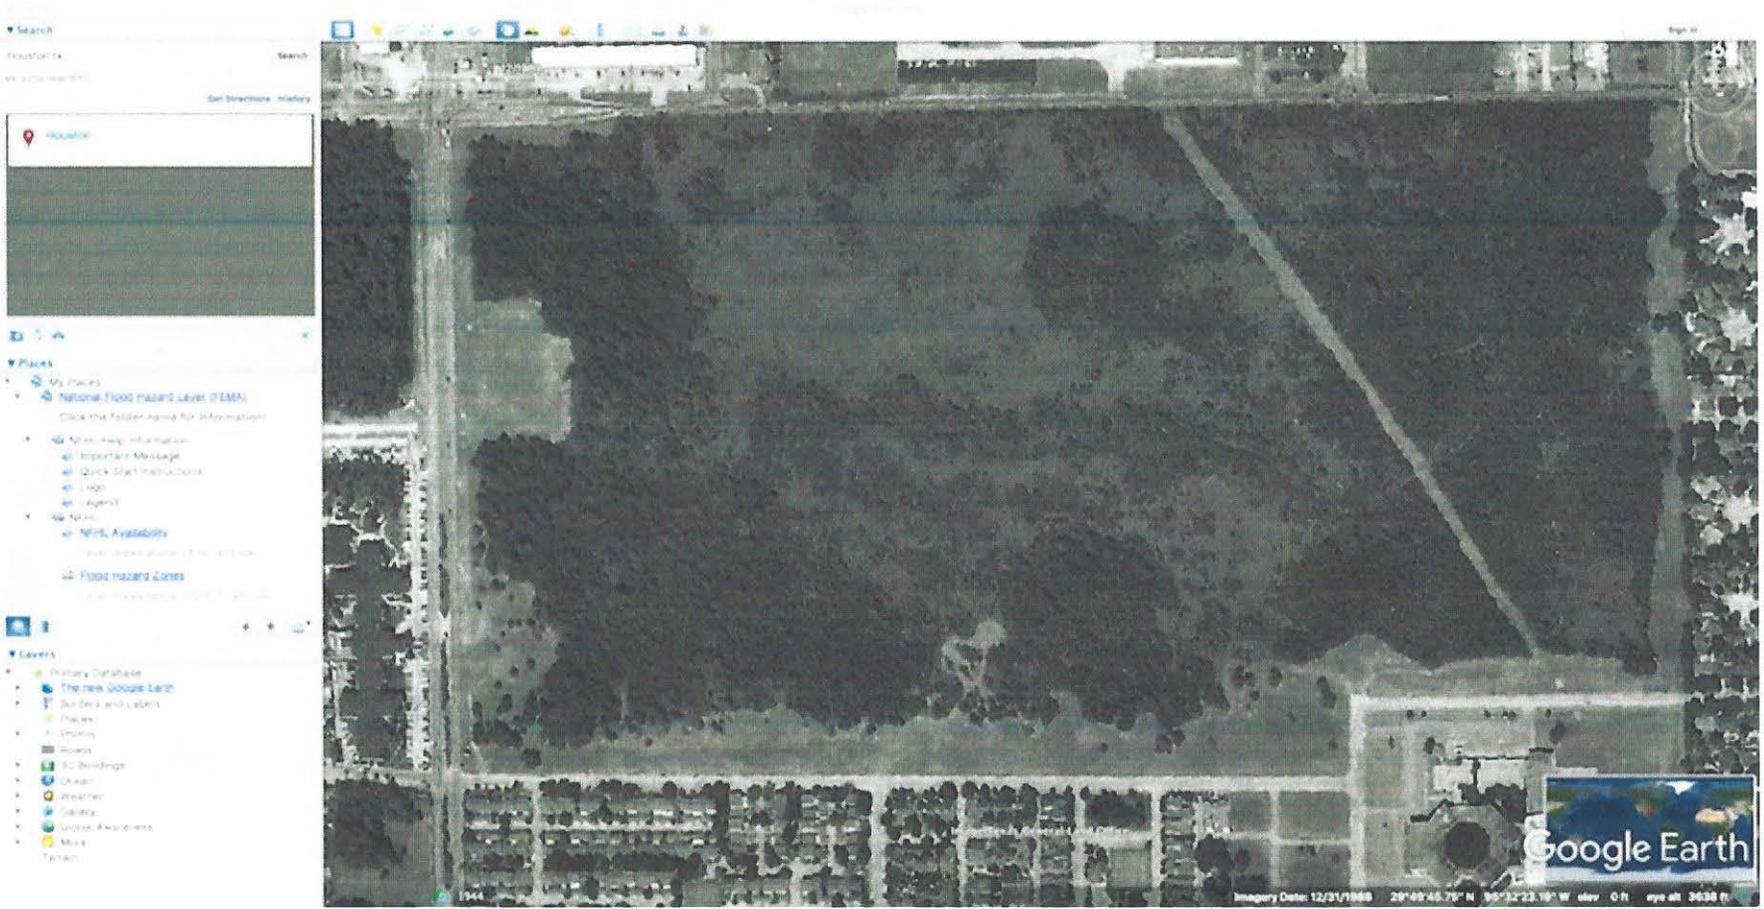
Property in 1989 before golf course.

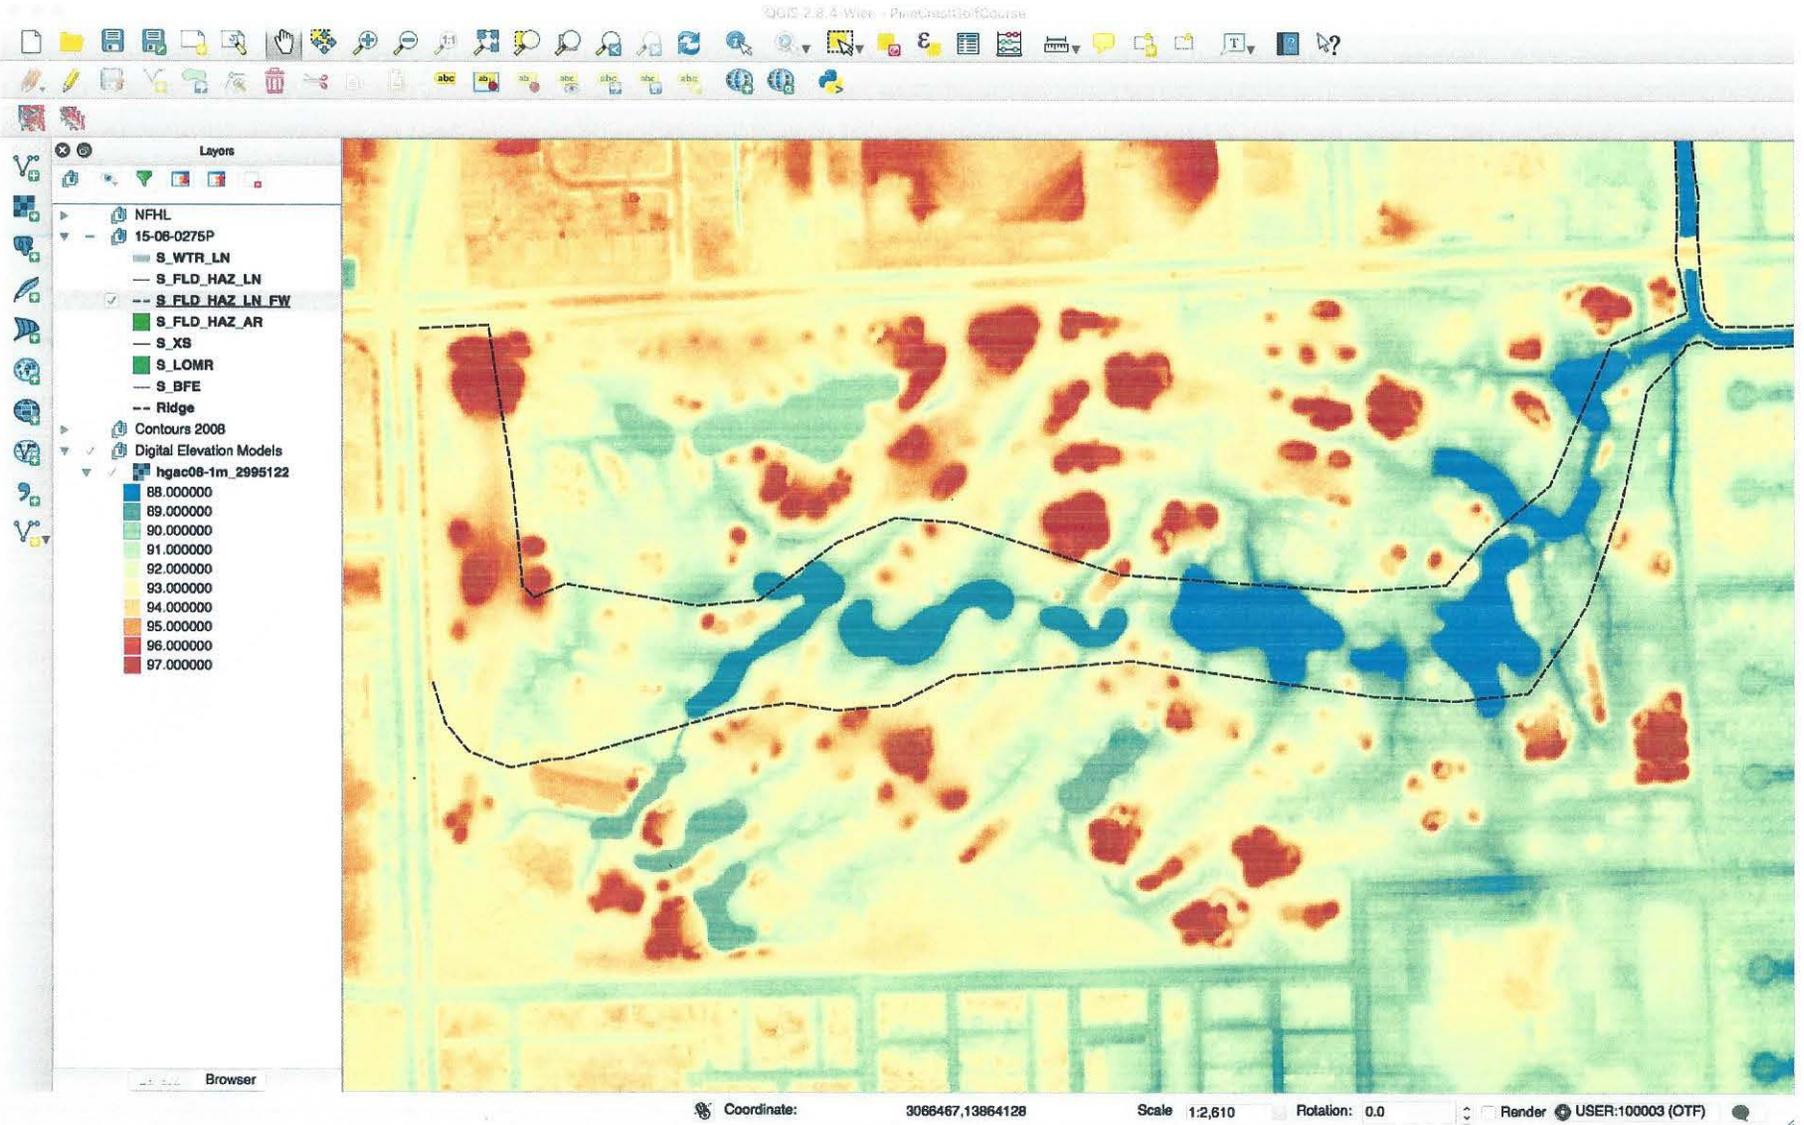
Golf Course Floodway profile - where is the model that connects the golf course to the alleged overflow from Brickhouse Gully?

The proposed floodway.
