RECURRING REVIEW REPORT
Former Jefferson Barracks Post Dumping Grounds
St. Louis County, Missouri

Defense Environmental Restoration Program
Formerly Used Defense Site
Site ID: B07MO0143

September 2014

U.S. Army Corps of Engineers
Kansas City District
Kansas City, Missouri

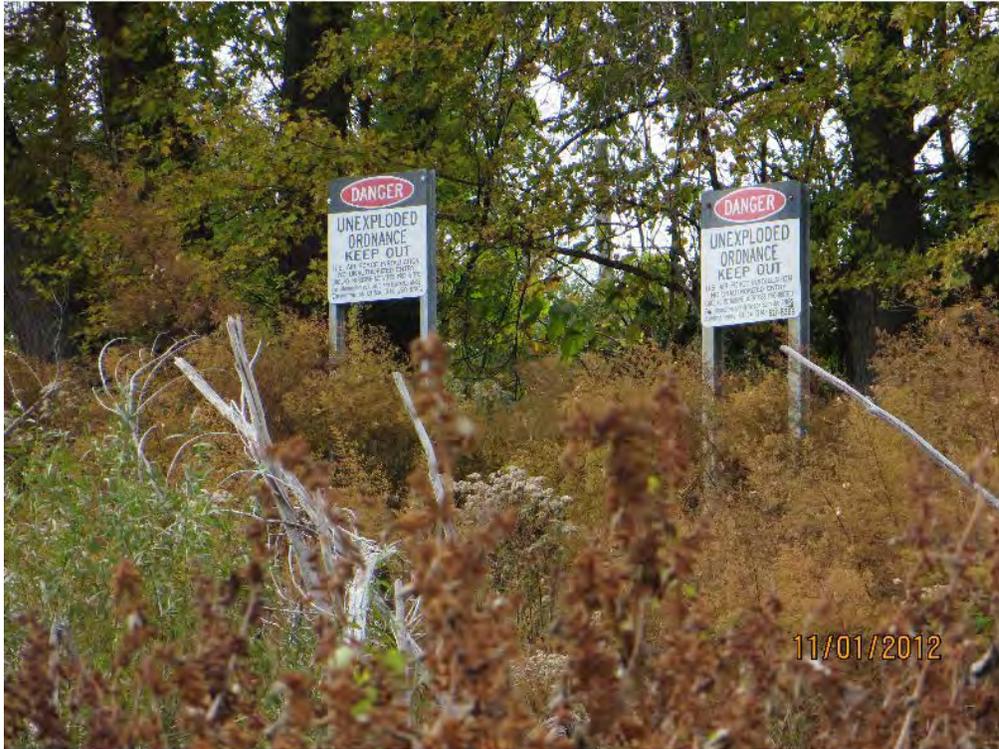
Replacement warning sign on left. Older warning sign still stands even though base has eroded.

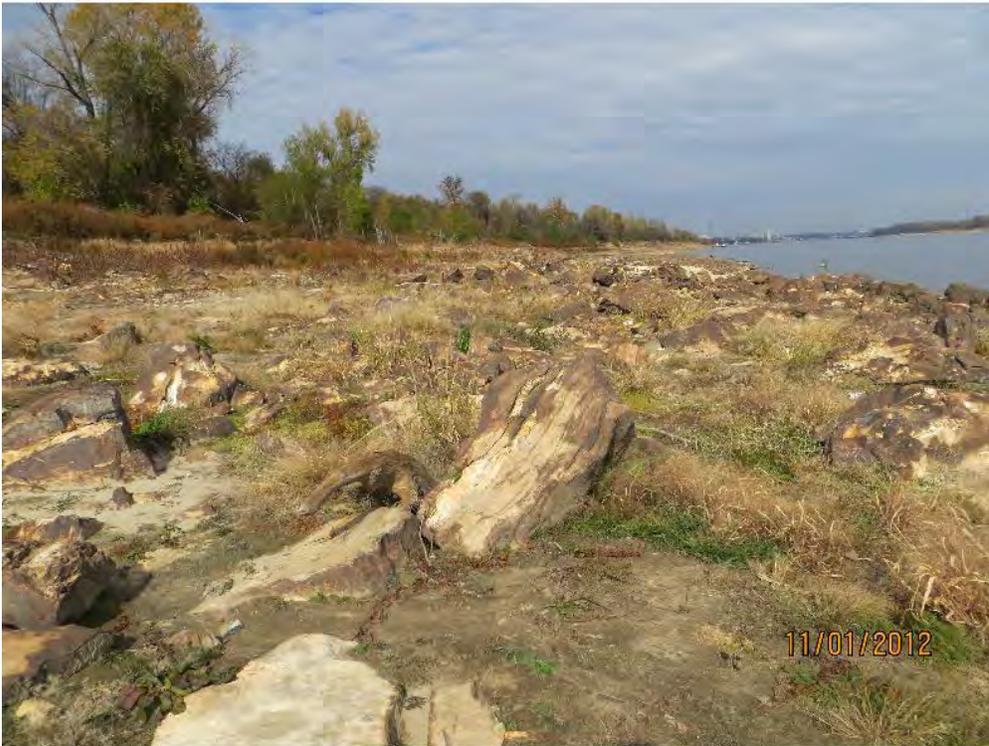
Riprap looking north

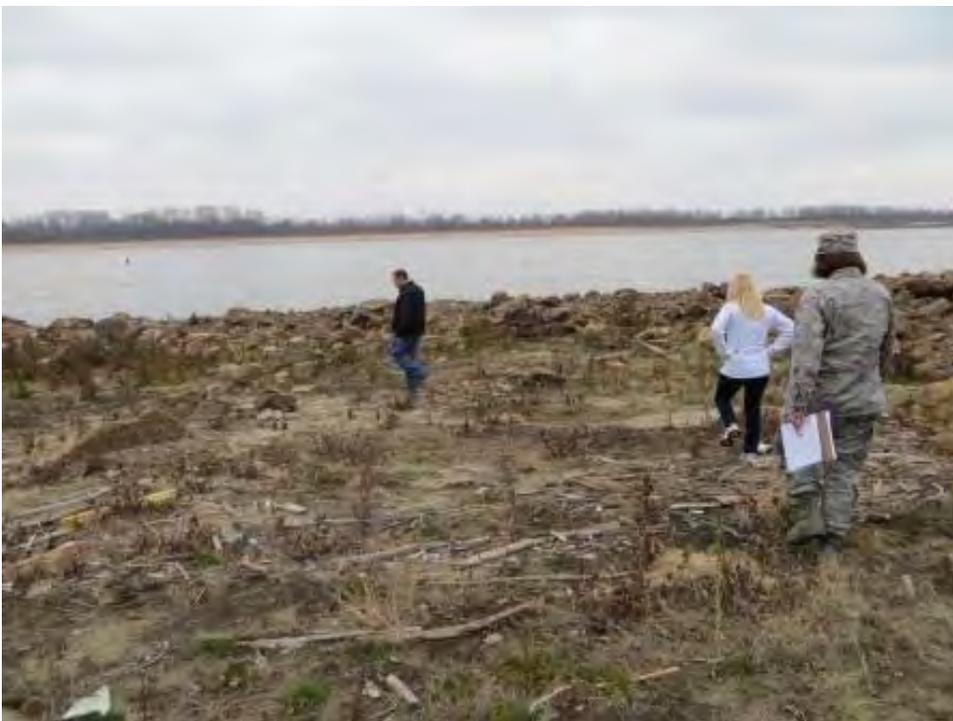
Lower riprap area looking southeast- extensive siltation

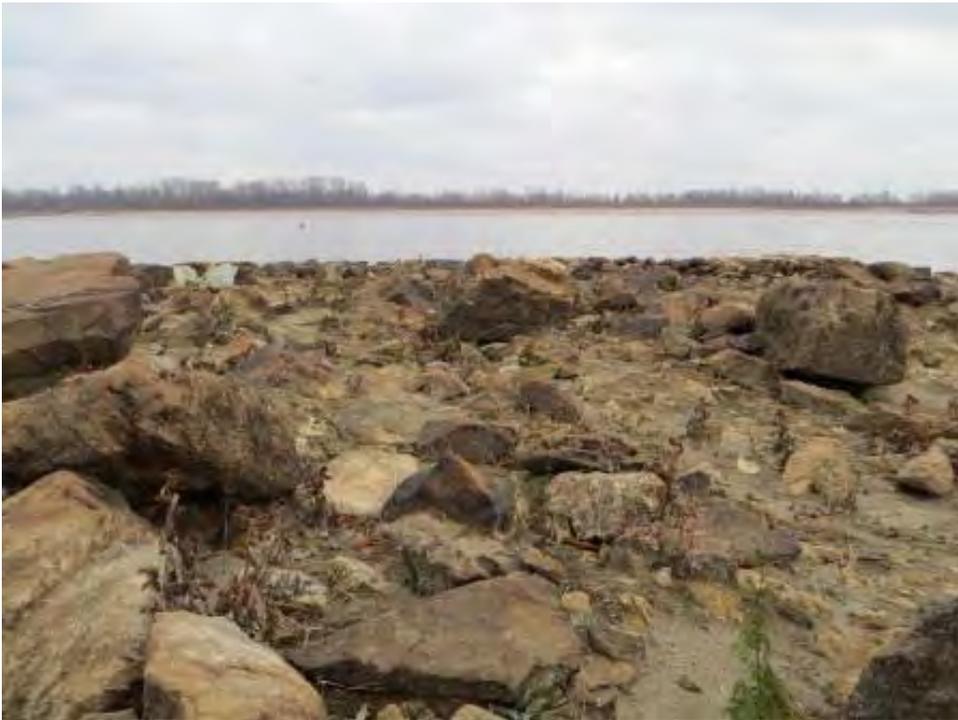
Looking east at Mississippi River- lower riprap

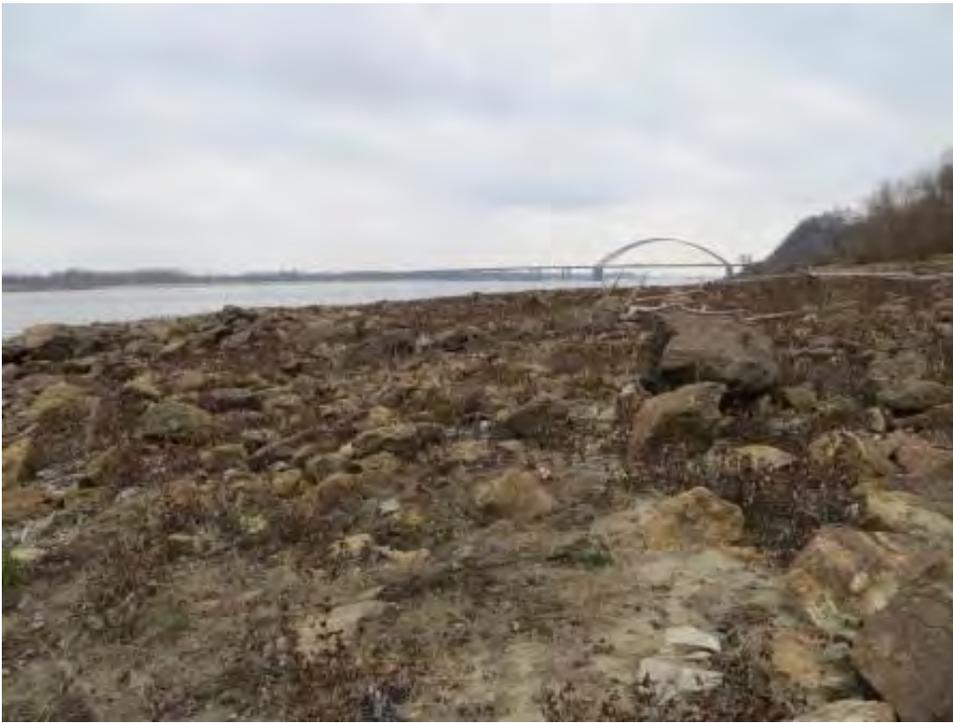
Looking south- lower riprap

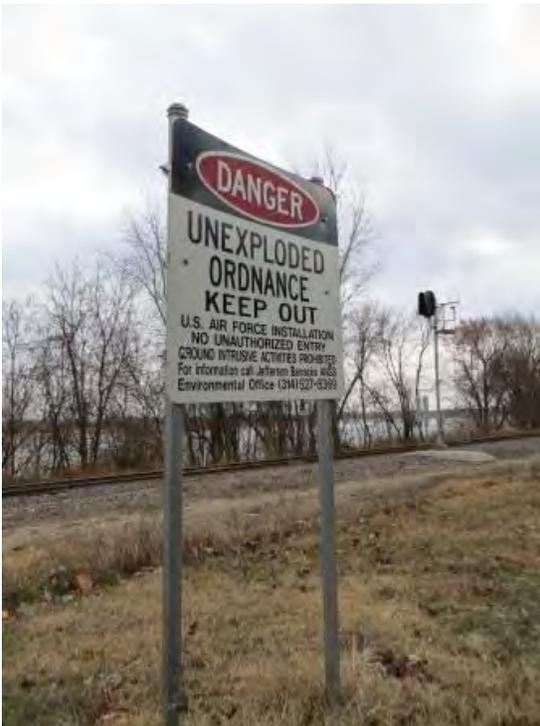
One of the six warning signs on the west side of the railroad tracks

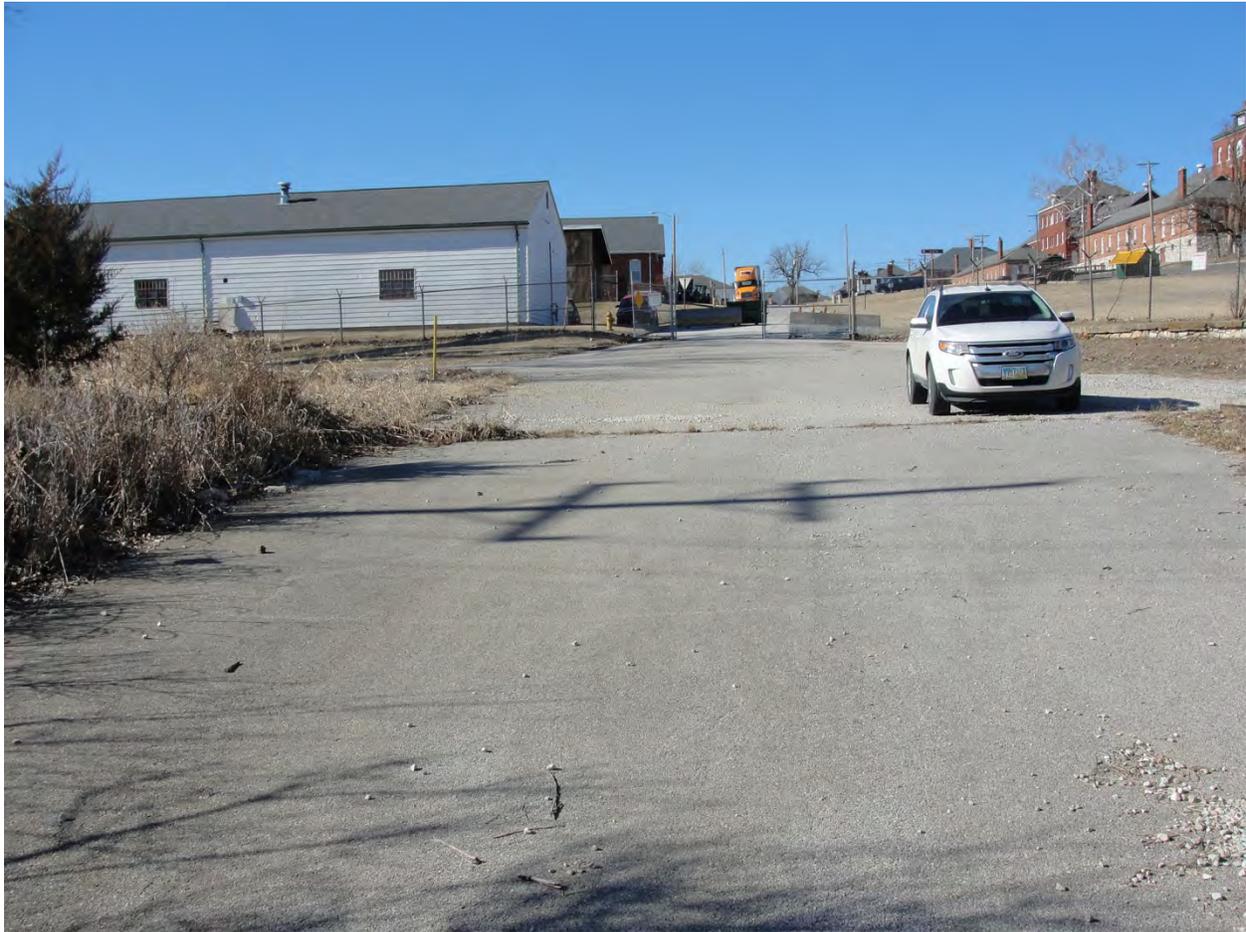
Photo 1. Jefferson Barracks Former Post Dumping Grounds

Description: Entry gate to the Former Post Dumping Ground Site. Locked chain-linked fence topped with multiple strands of barbed wire. View is to the west.

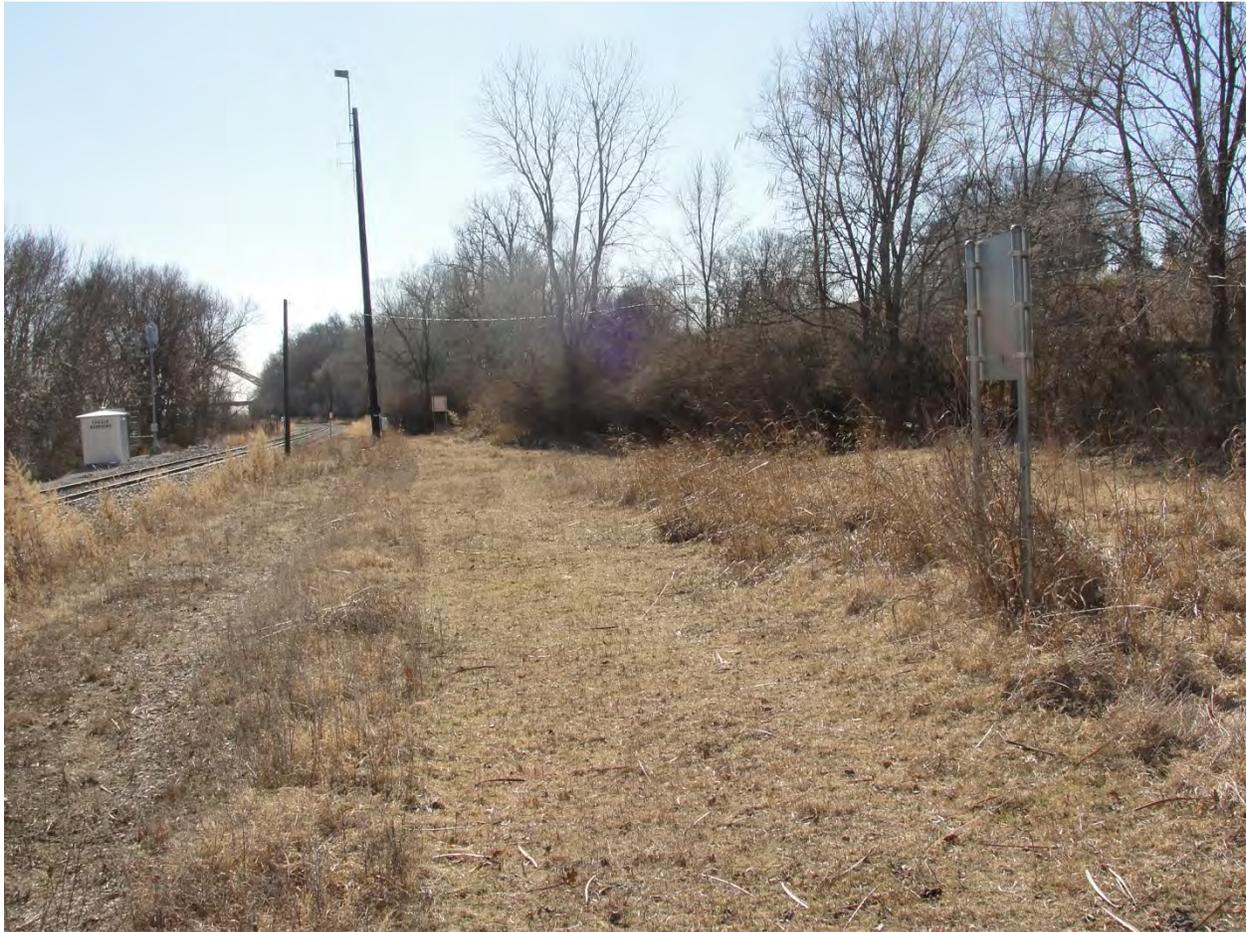
Photo 4. Jefferson Barracks Former Post Dumping Grounds

Description: View is to the south after having walked southward from Warning Sign No. 3; Warning Sign No. 2 is in foreground (backside); Warning Sign no. 1 is visible in the distant center-background (back side of sign).

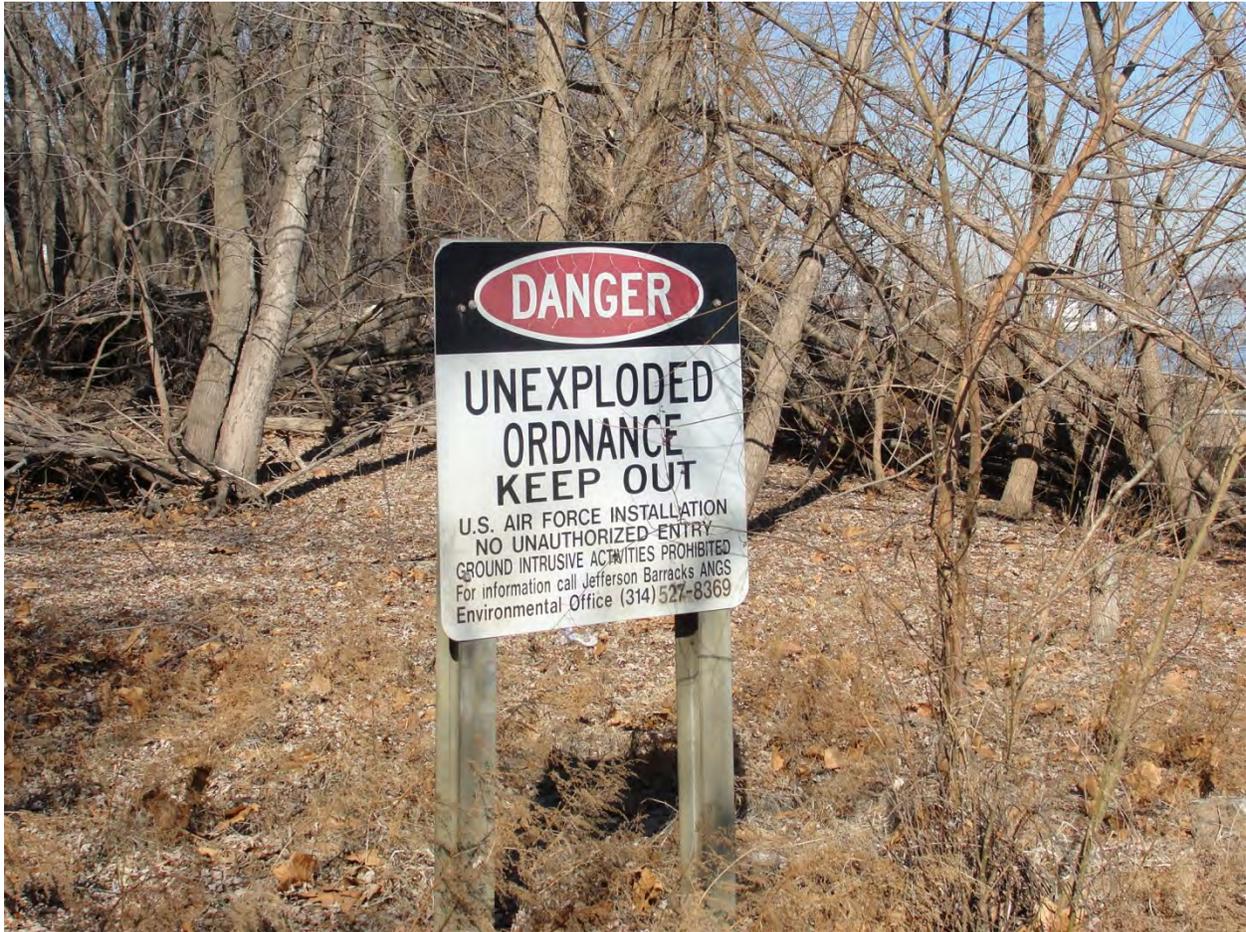
Description: Warning Sign No. 7, located at south end of Site, east of the railroad tracks; view is generally to the north.

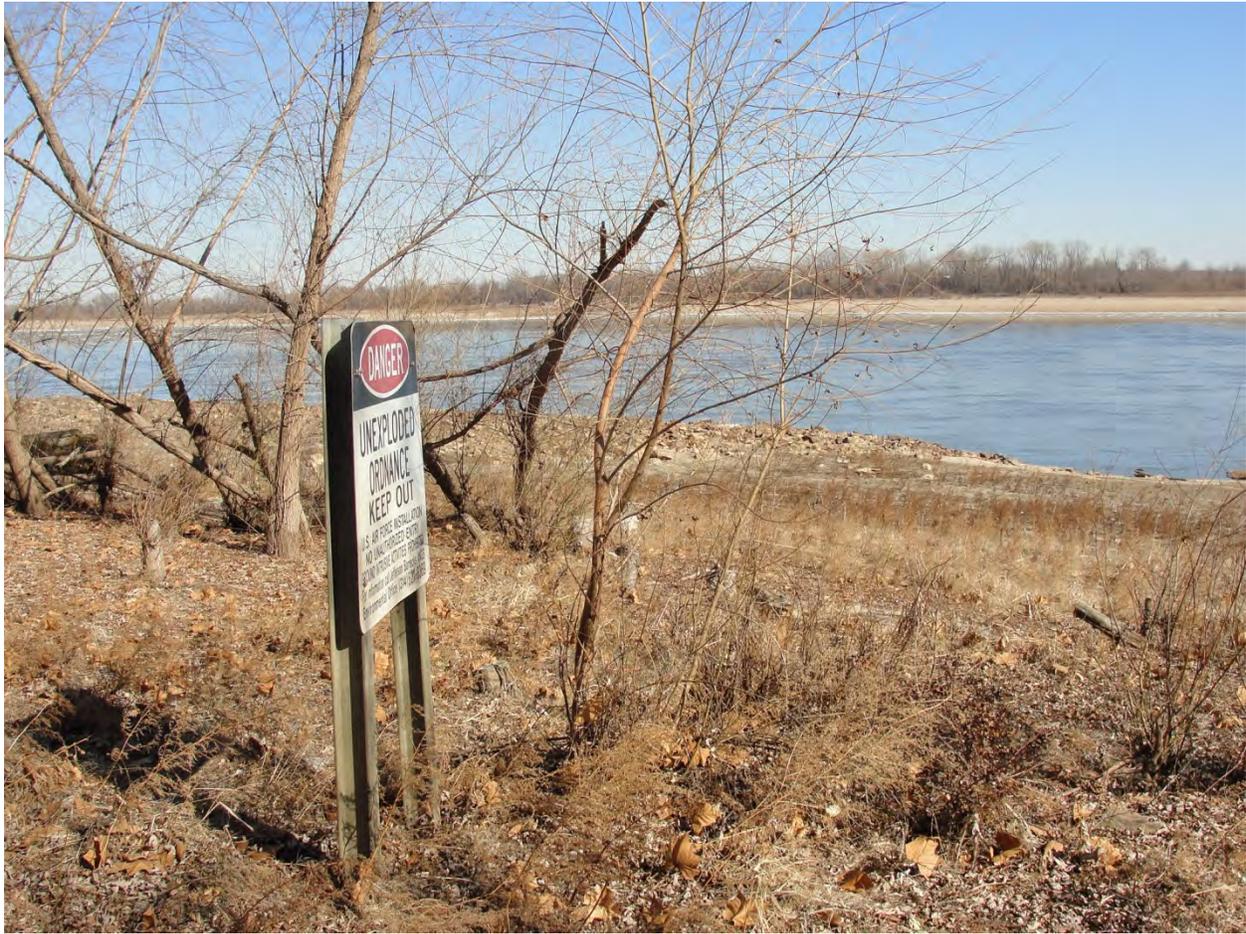
Photo 9. Jefferson Barracks Former Post Dumping Grounds

Description: Warning Sign No. 7 (facing southward); view is generally to the east; the southern extent of placed riprap is visible at center-right of photo.

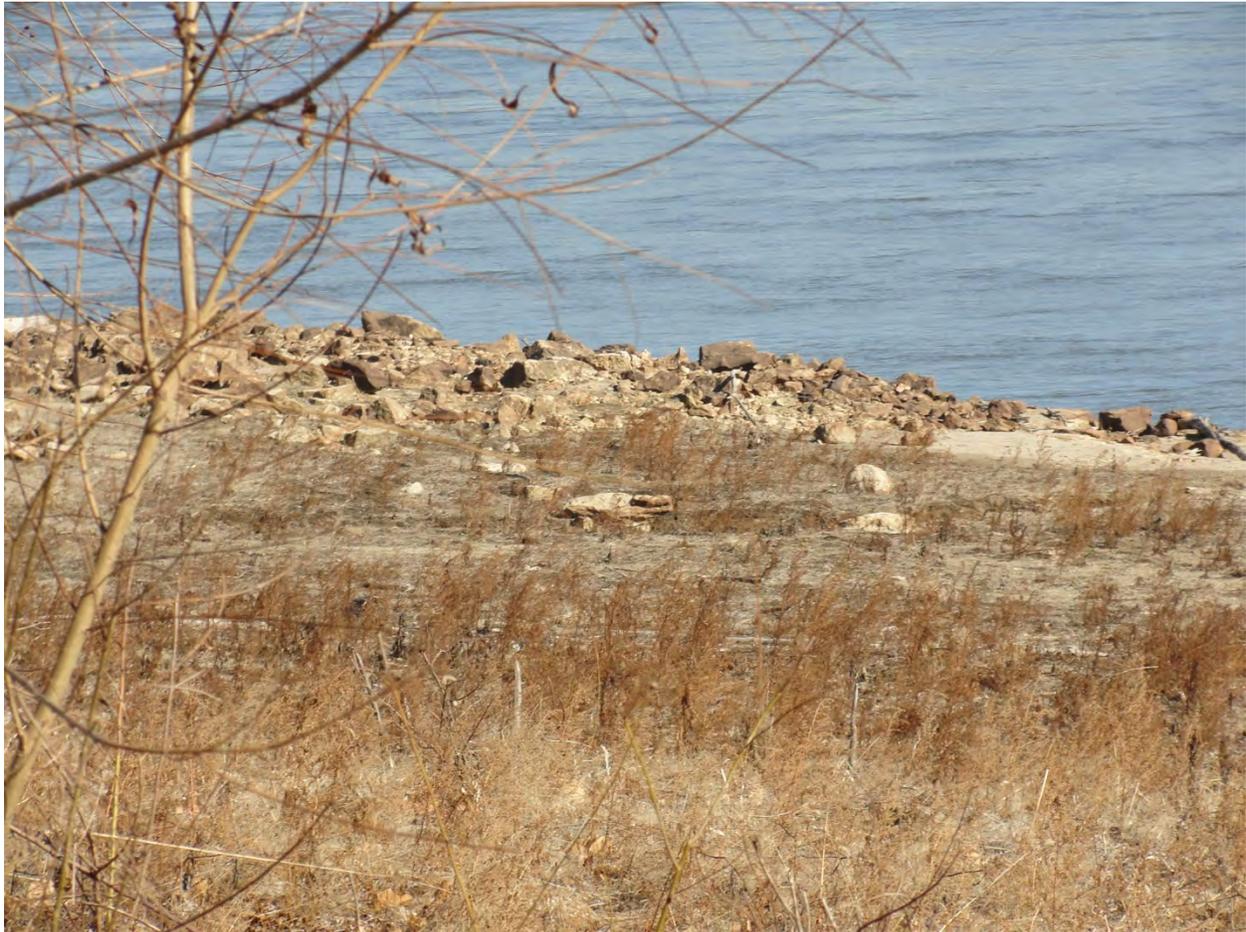
Photo 10. Jefferson Barracks Former Post Dumping Grounds

Description: Zoomed photo of riprap as taken from vantage point of Warning Sign No. 7.

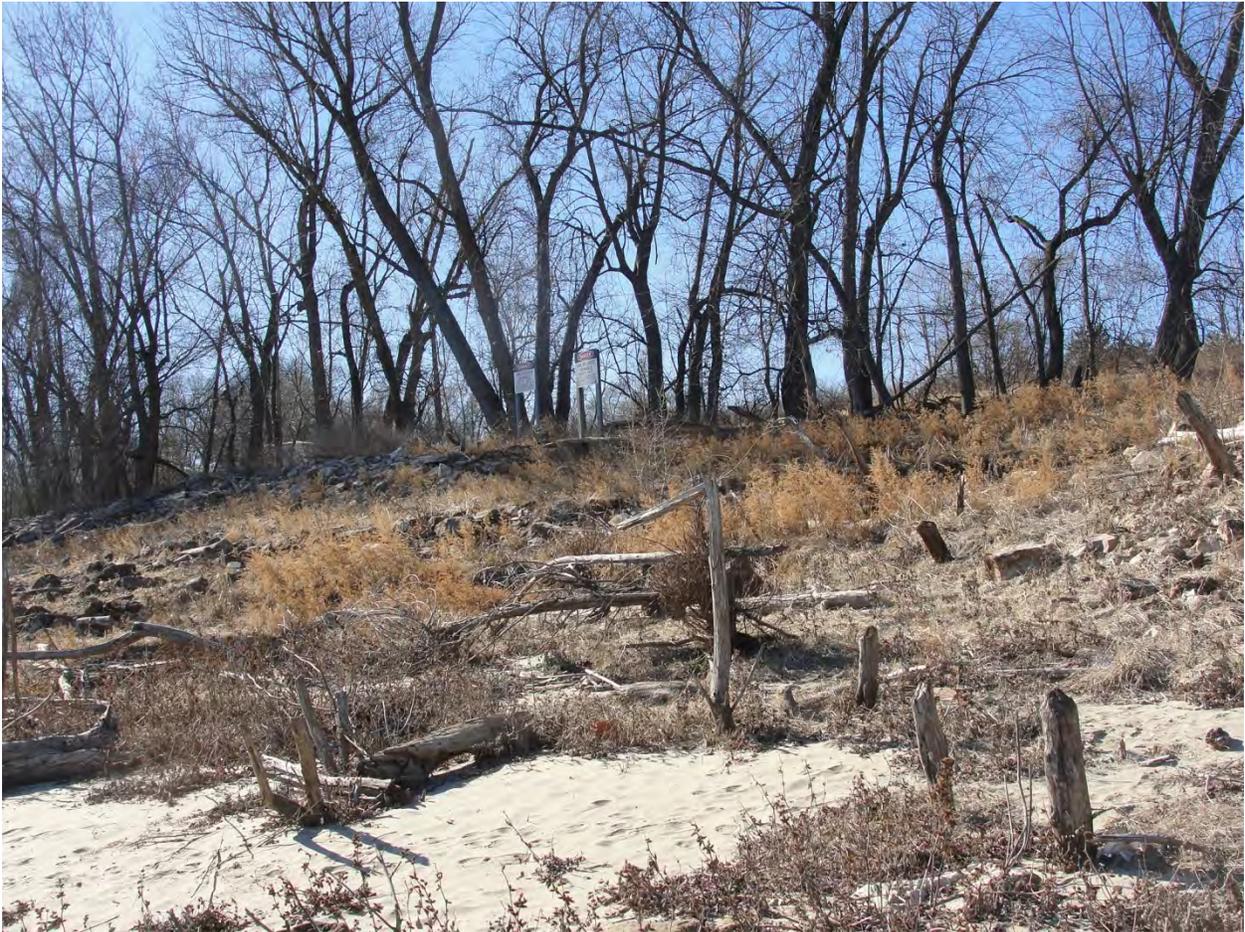
Photo 21. Jefferson Barracks Former Post Dumping Grounds

Description: Warning Sign No. 8 (center top), as viewed from the eroded area depicted by photos #18, #19 and #20.

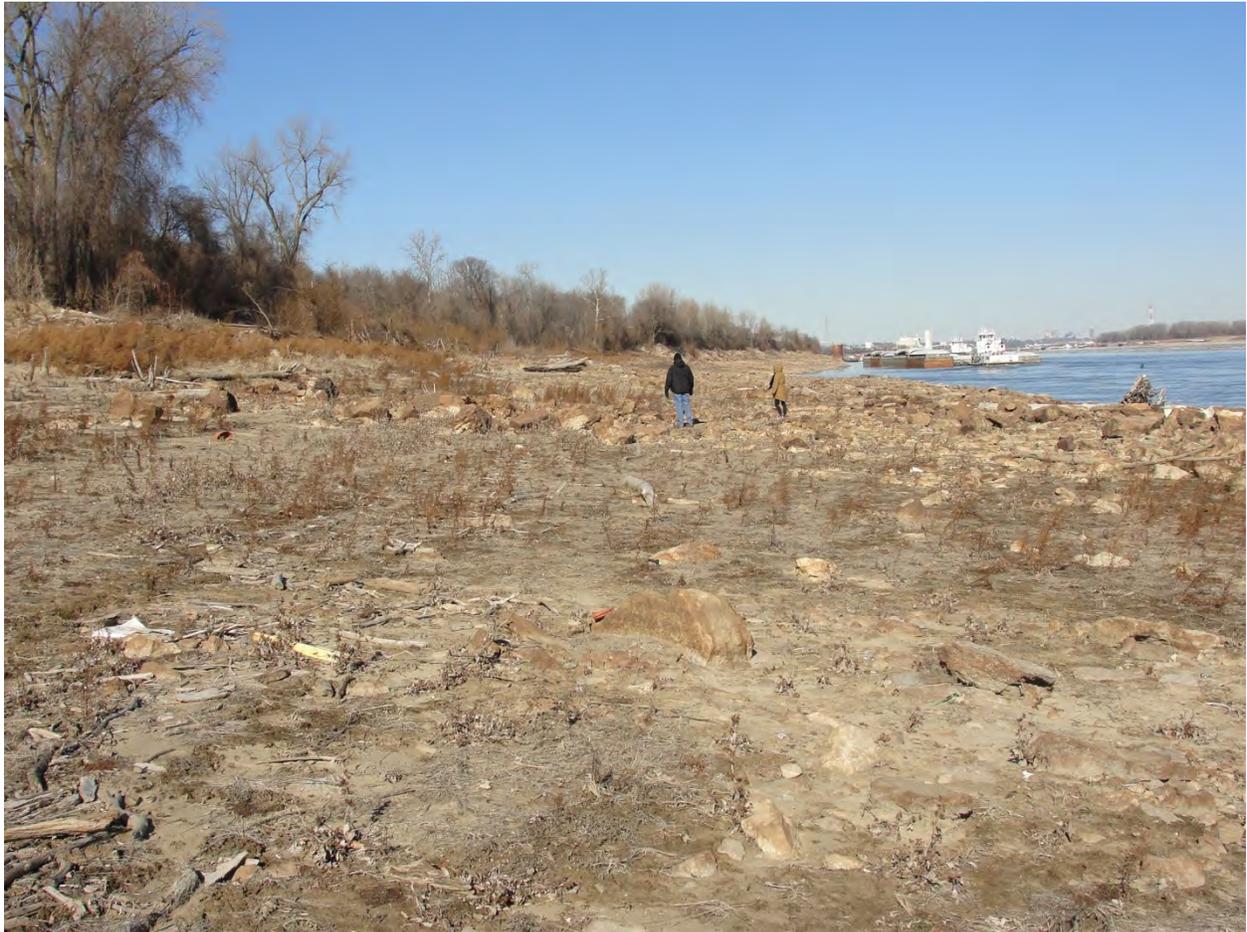
Photo 22. Jefferson Barracks Former Post Dumping Grounds

Description: View is towards the north, taken from an area apparently having more sediment than adjacent area as riprap is not as predominant on the surface. USACE PM states that this area had received placement of riprap. Location is north of the erosion channel, between warning signs #8 and #9. Panoramic photo 1 of 2.

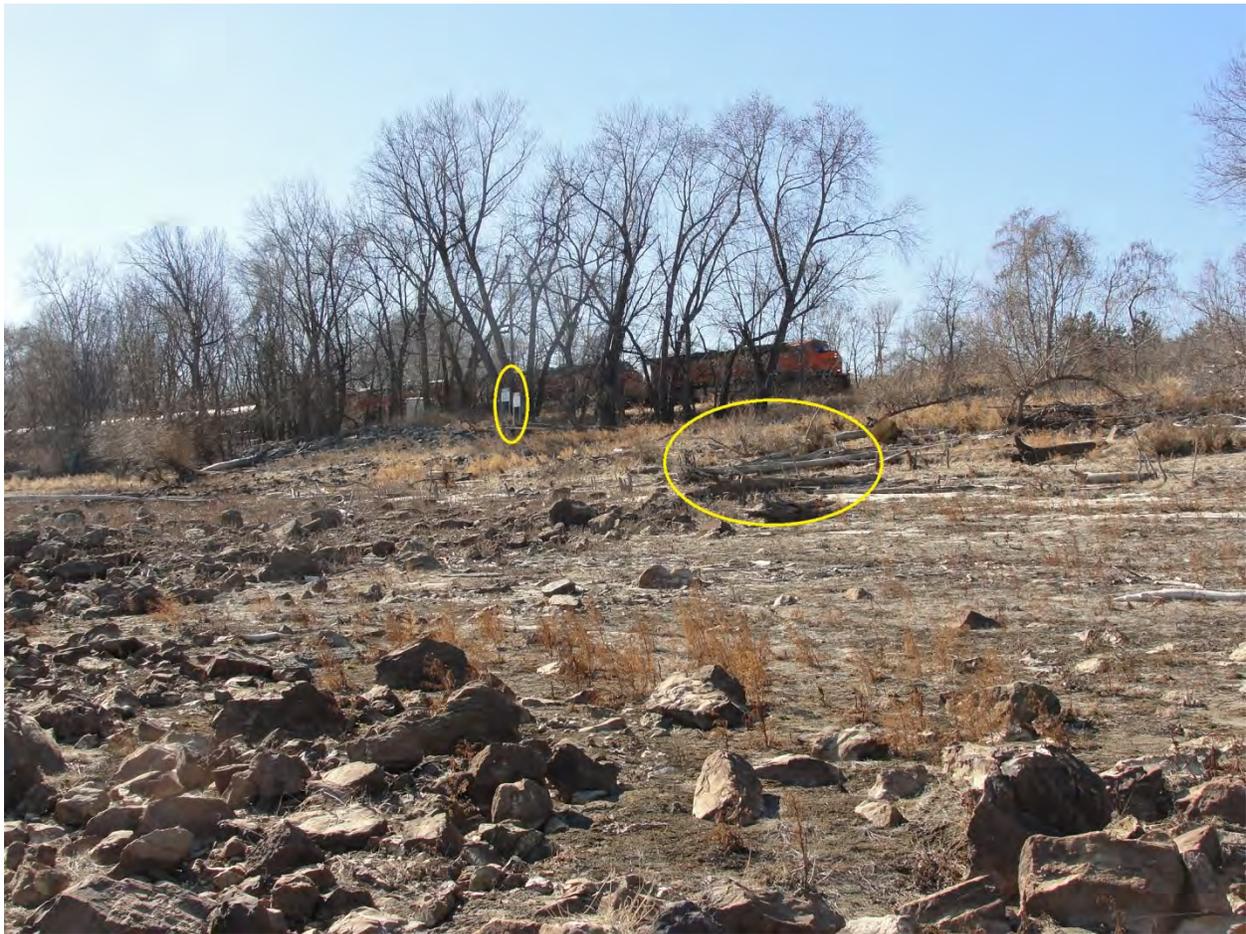
Photo 27. Jefferson Barracks Former Post Dumping Grounds

Description: Continuation of panoramic of photo #26, panning from looking south along the river towards looking westward toward the escarpment. Warning Sign No. 8 (paired with its replacement sign) is visible just left of center, and the erosion channel depicted in photos #18 through #20 is believed to be located at center-right.

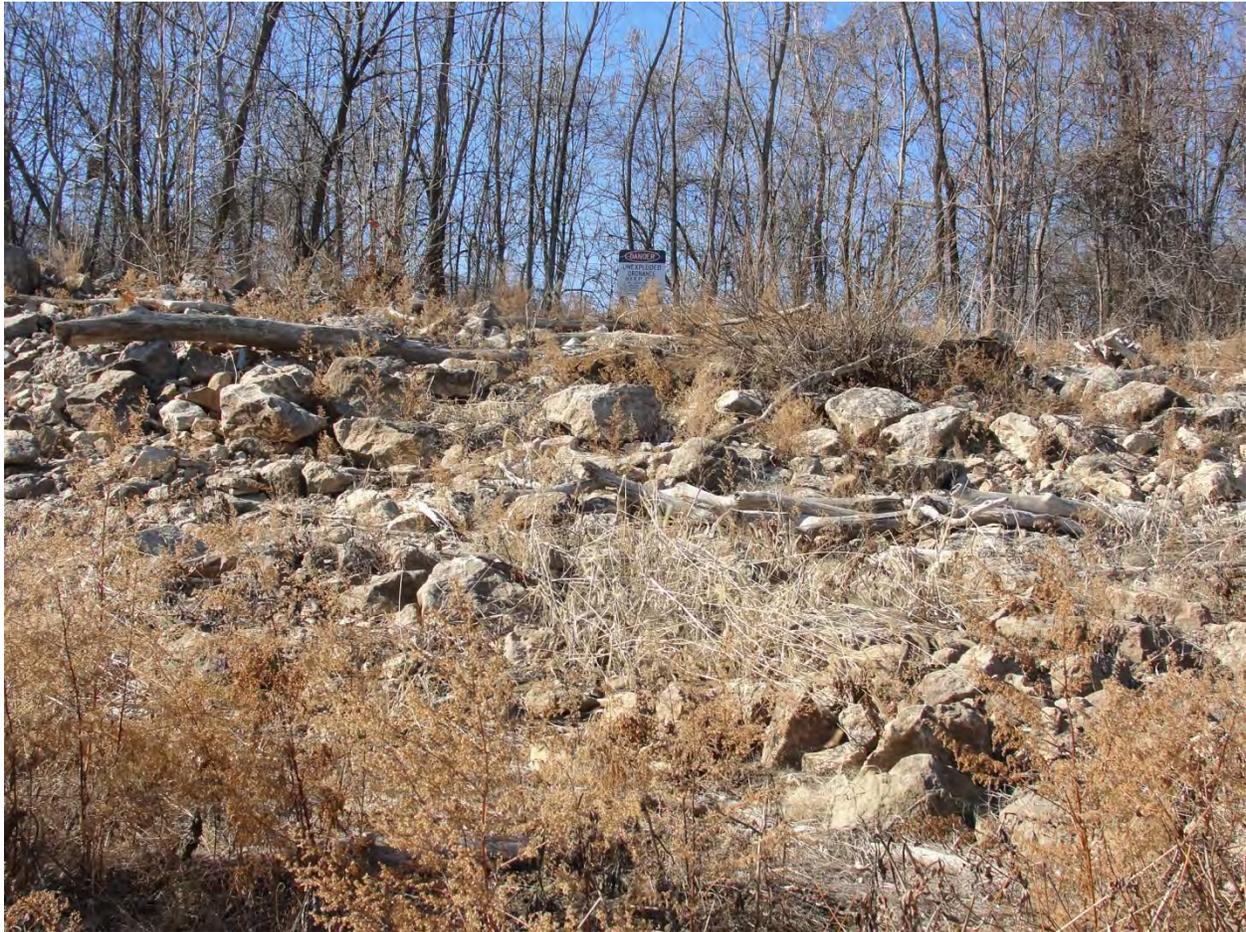
Photo 31. Jefferson Barracks Former Post Dumping Grounds

Description: Warning Sign believed to be #9, taken from a location north of where photos #32 through #35 were taken.

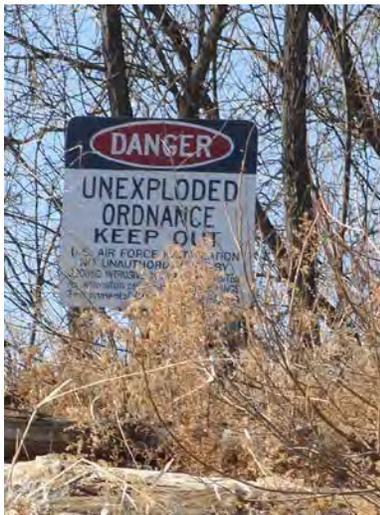
Photo 32. Jefferson Barracks

Description: Zoomed photo of suspected Warning Sign No. 9.

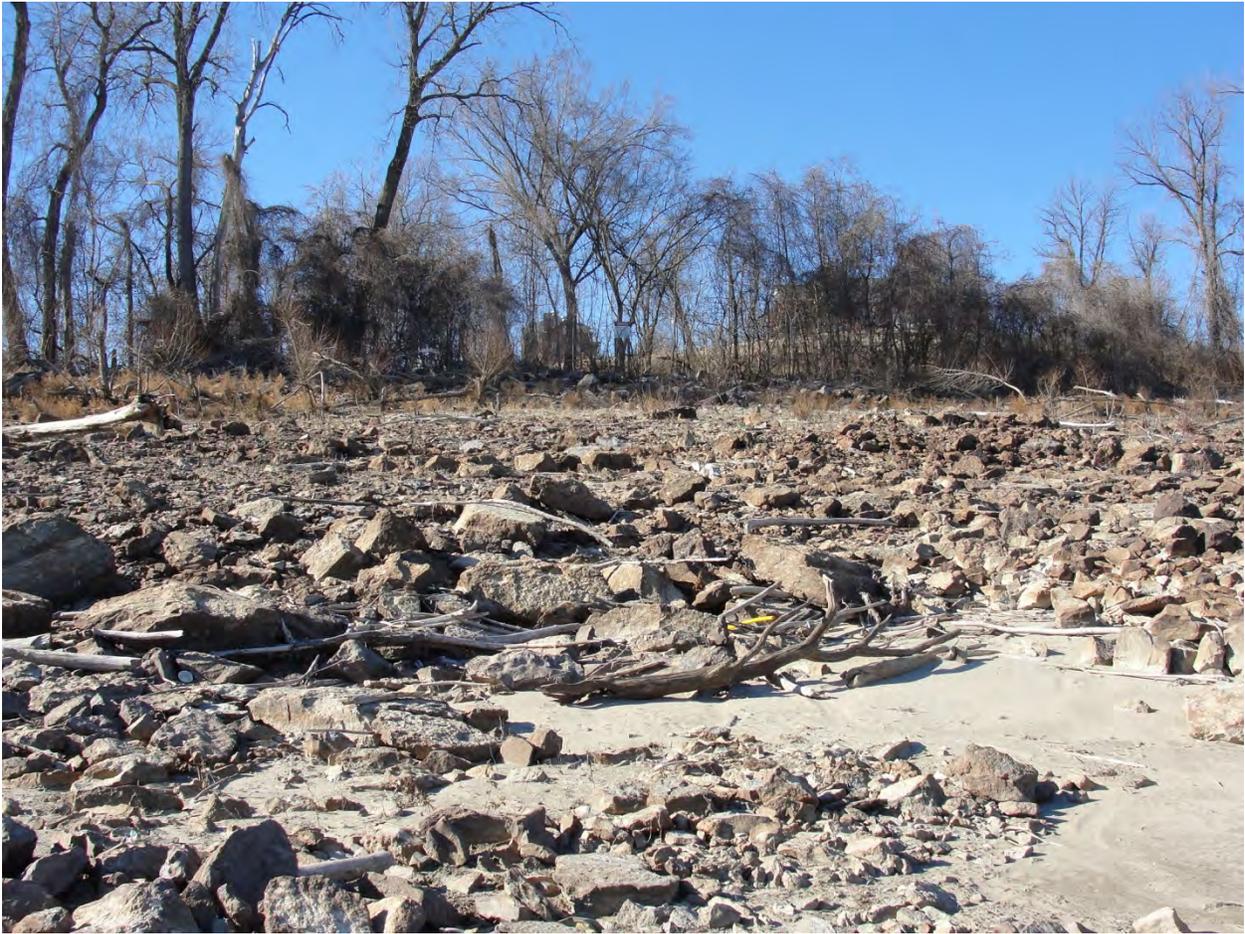
Photo 34. Jefferson Barracks Former Post Dumping Grounds

Description: View is northwest, further northward from location of Photo No. 34. The warning sign visible in the center of the photo (above the riprap) is believed to be Warning Sign No. 10.

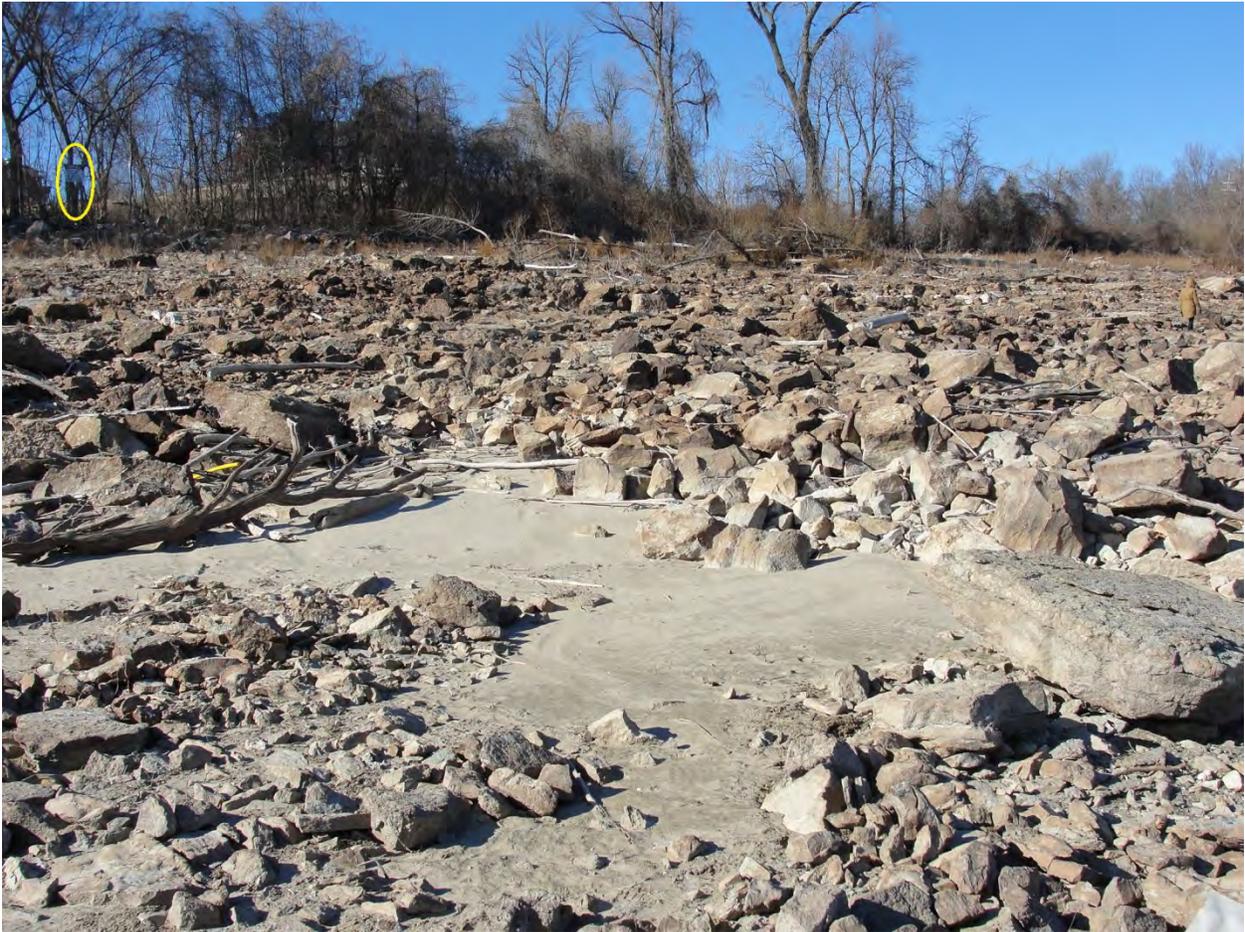
Photo 35. Jefferson Barracks Former Post Dumping Grounds

Description: Panoramic from location of Photo No. 34, panning northward. What is believed to be Warning Sign No. 10 is located at the top left of the photo.

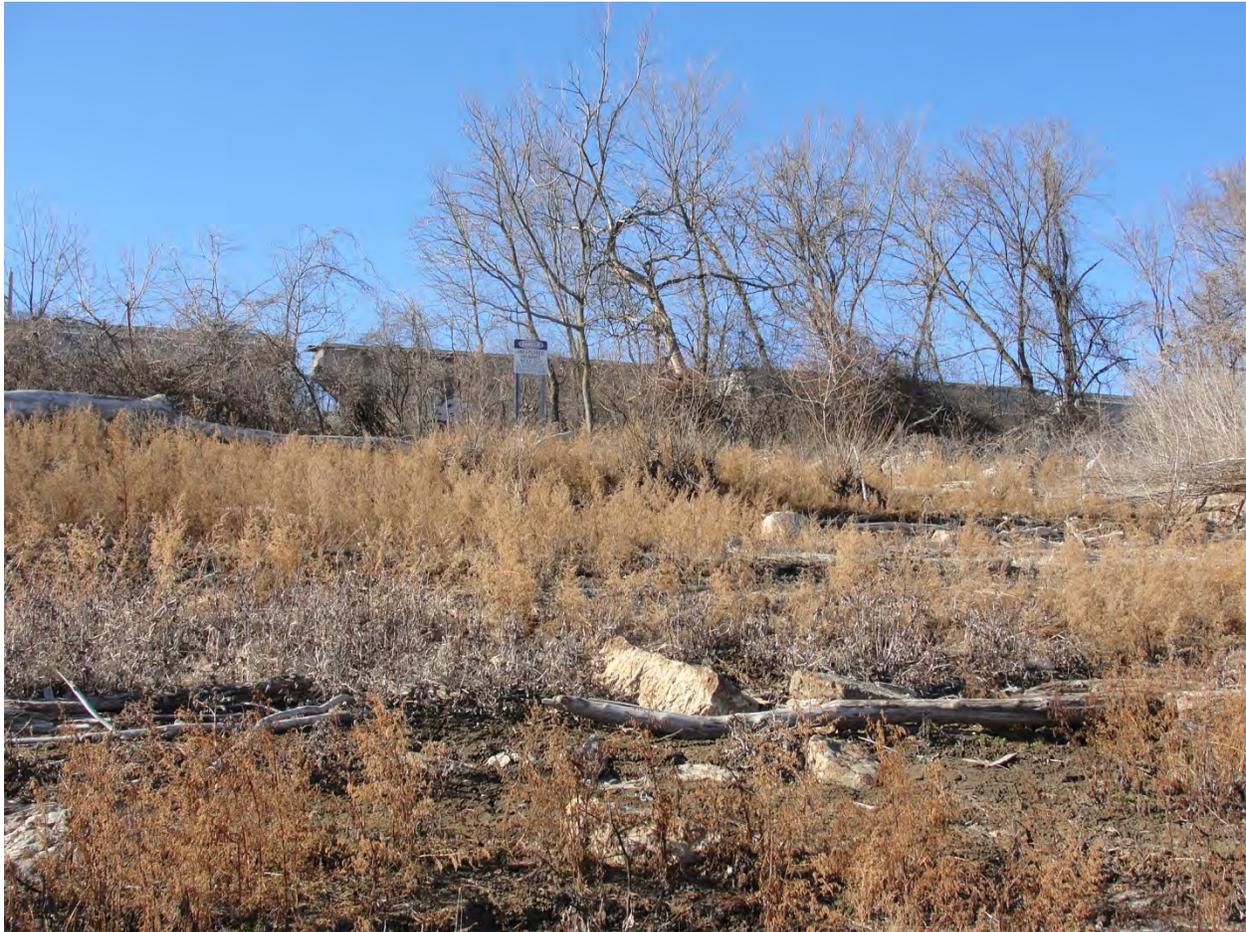
Photo 36. Jefferson Barracks Former Post Dumping Grounds

Description: Warning Sign believed to be No. 11 is visible at center of photo; train is visible behind the sign.

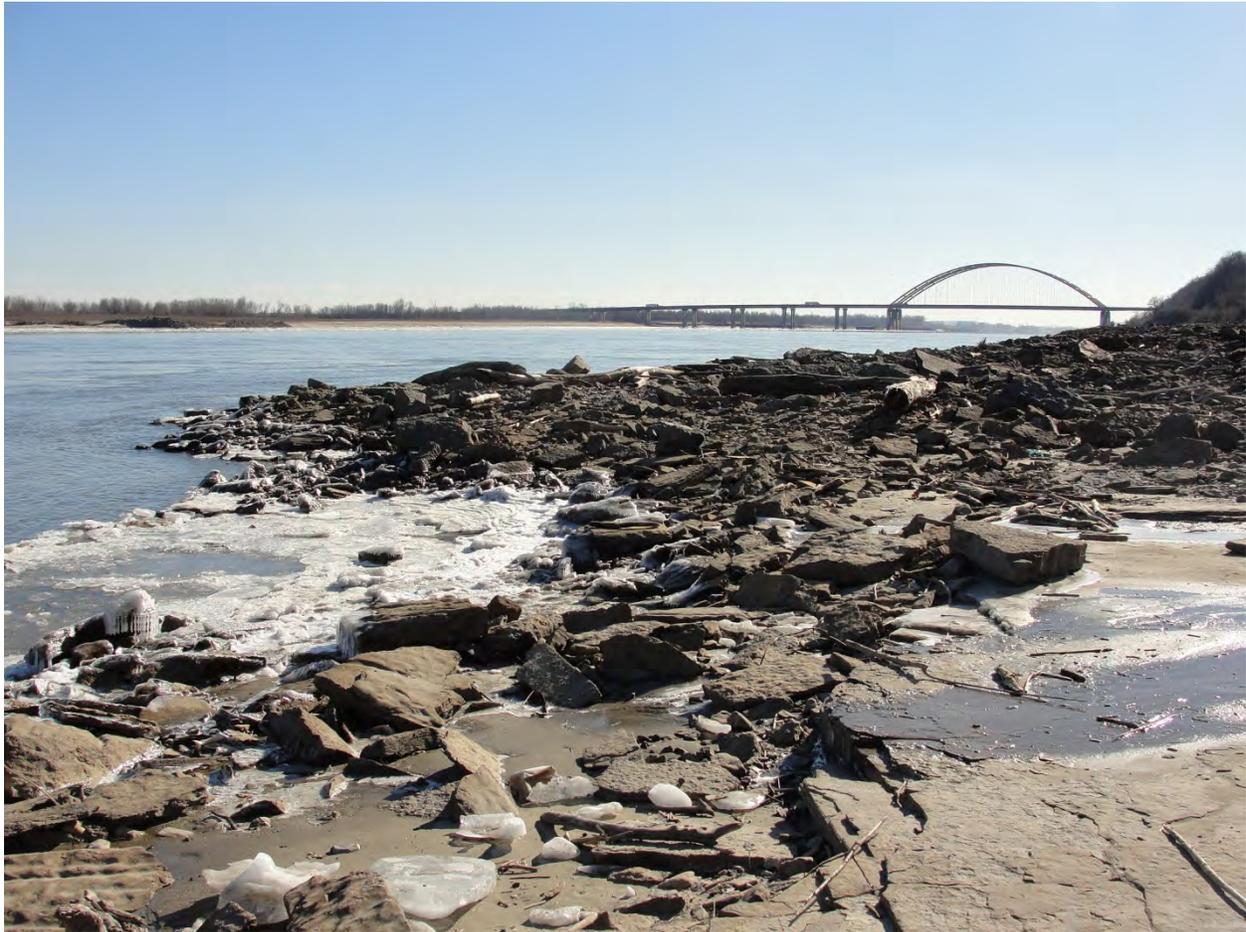
Photo 40. Jefferson Barracks Former Post Dumping Grounds

Description: View is to the south; taken from beyond the northern boundary of the area which received rip-rap; first of three panoramic photos taken (photos 40, 41, 42) which has the camera panning to the west (towards the escarpment).

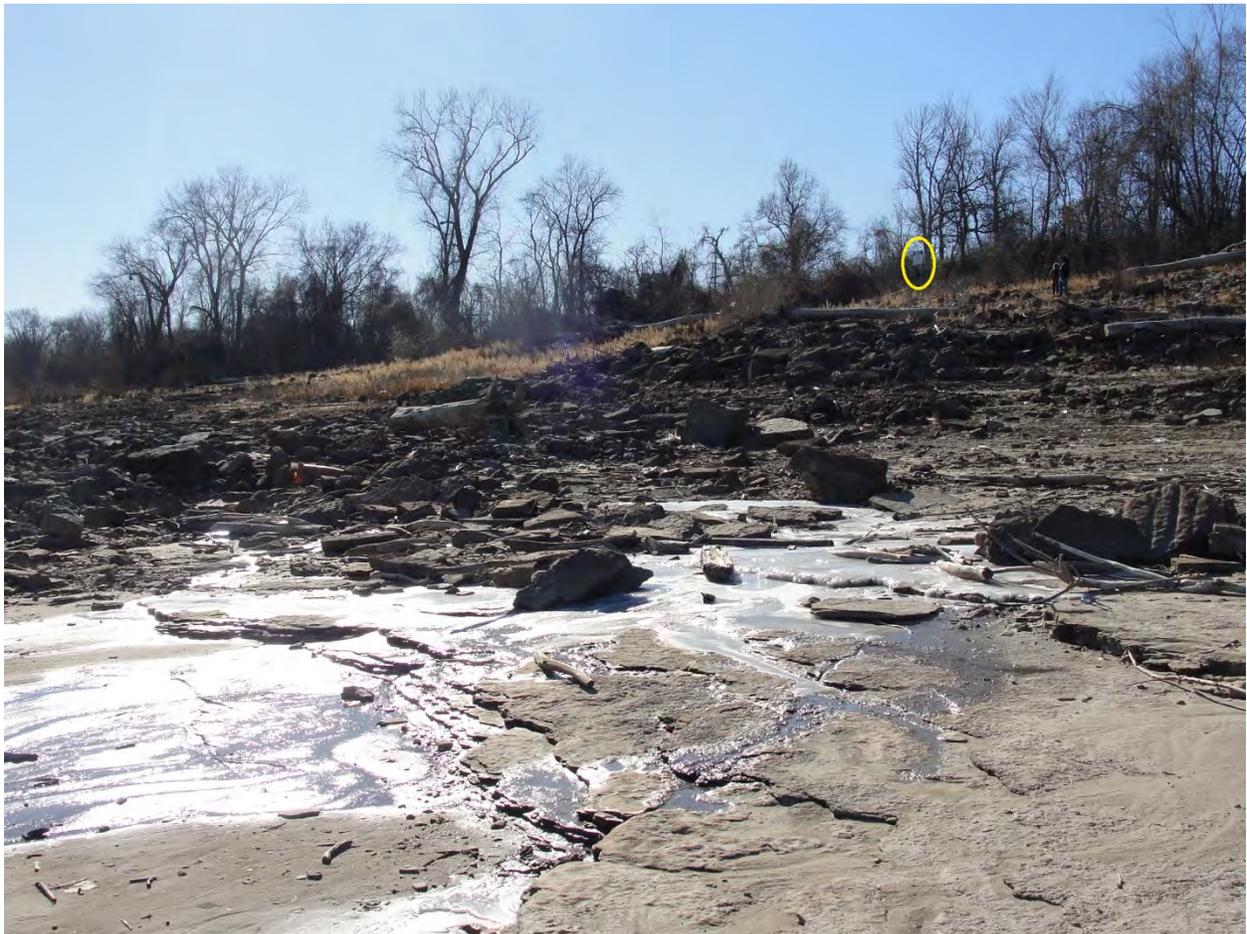
Photo 41. Jefferson Barracks Former Post Dumping Grounds

Description: Second of three panoramic photos taken (photos 40, 41, 42) – view is generally south-southwest as taken from the vantage point of Photo No. 40; camera is panning to the west (towards the escarpment). Warning Sign believed to be No. 12 is visible (circled) in the upper right quadrant of photo.

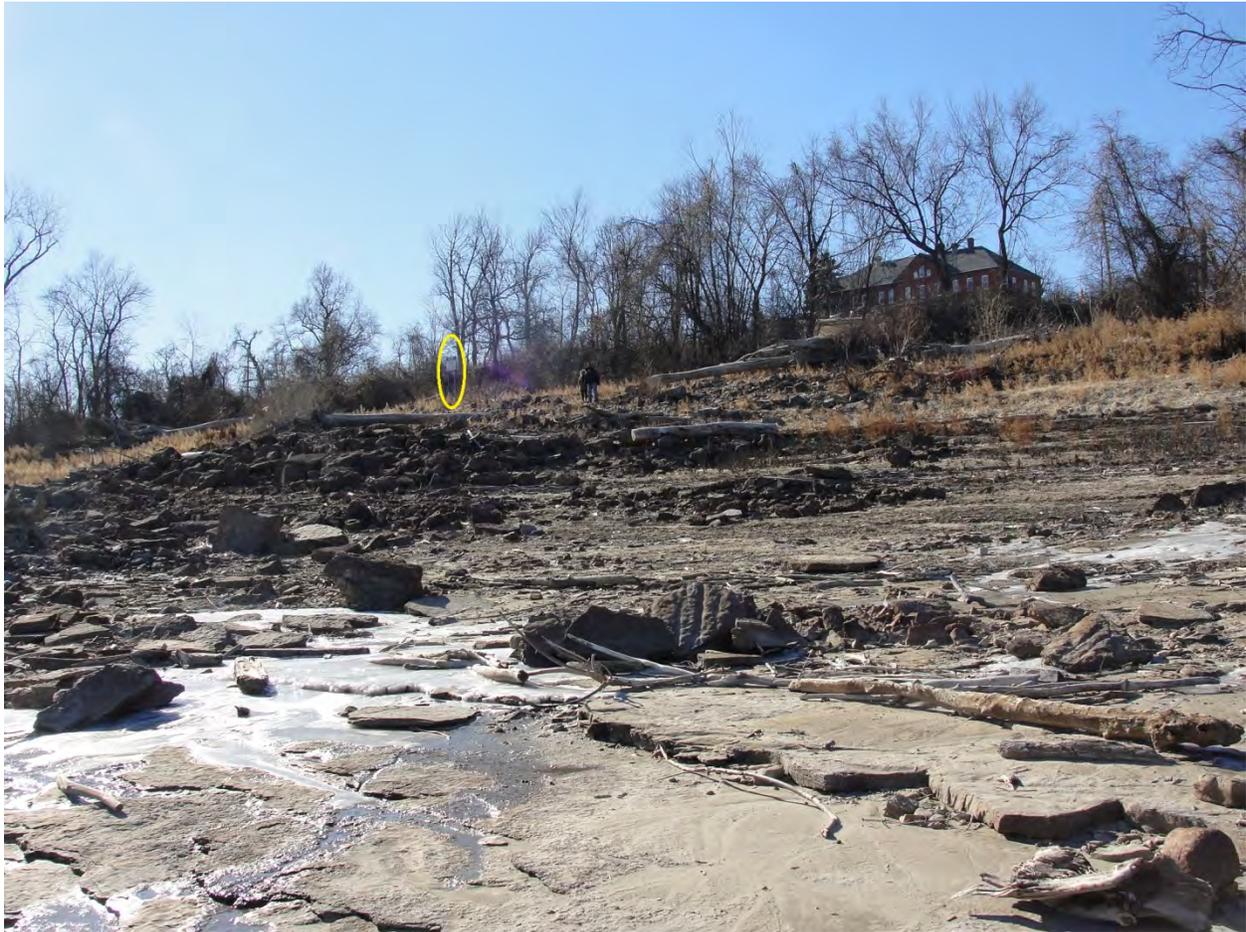
Photo 42. Jefferson Barracks Former Post Dumping Grounds

Description: Third of three panoramic photos taken (photos 40, 41, 42) – view is generally south-southwest as taken from the vantage point of Photo No. 40; camera is panning to the west (towards the escarpment). Warning Sign believed to be No. 12 is visible (circled) in the upper left quadrant of photo.
