RECURRING REVIEW REPORT
Former Jefferson Barracks Post Dumping Grounds
St. Louis County, Missouri

Defense Environmental Restoration Program
Formerly Used Defense Site
Site ID: B07MO0143

September 2014

U.S. Army Corps of Engineers
Kansas City District
Kansas City, Missouri

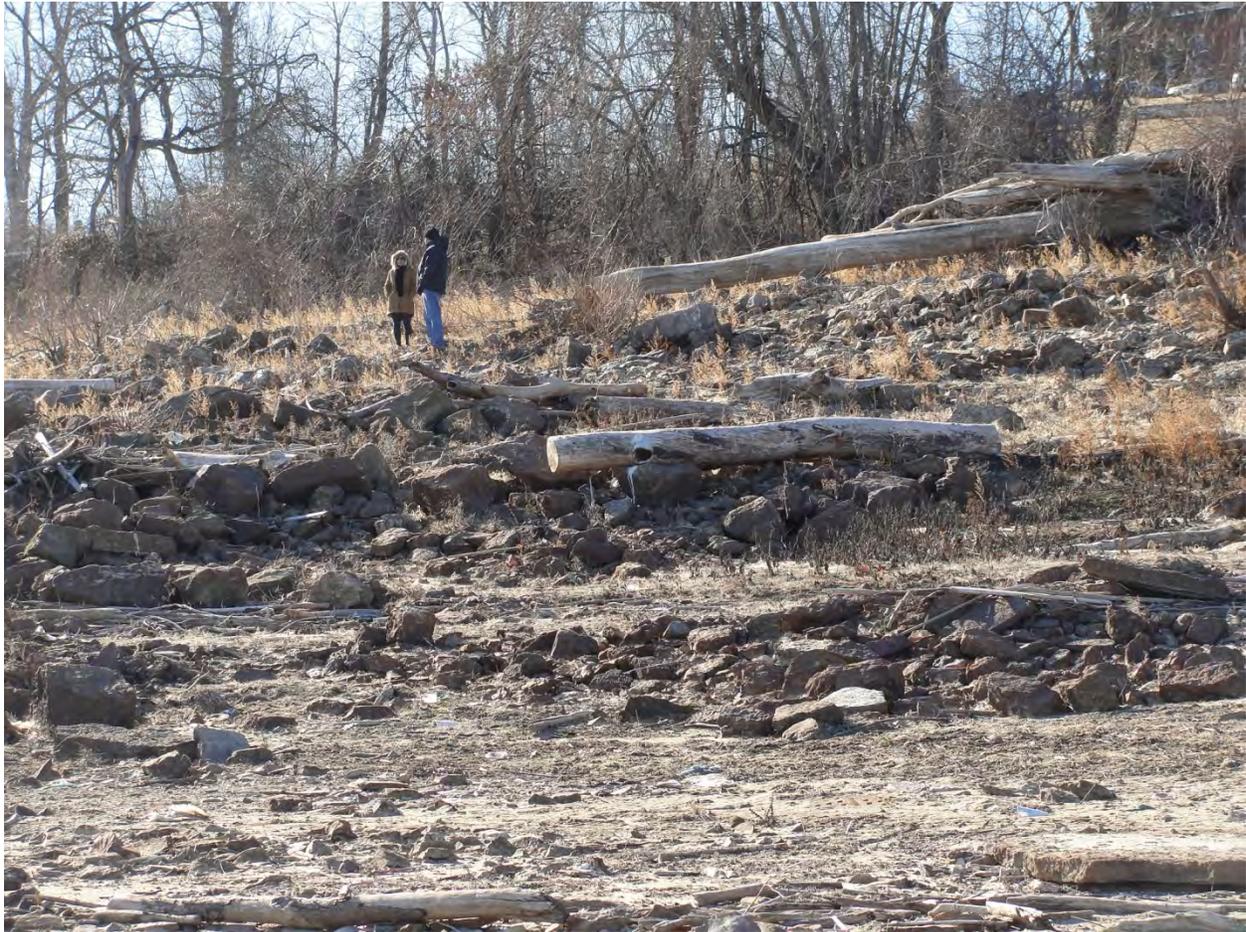
Photo 43. Jefferson Barracks Former Post Dumping Grounds

Description: Zoomed view of Photo No. 42 – view is generally south-southwest as taken from the vantage point of Photo No. 40; this is the northern extent of placed riprap.

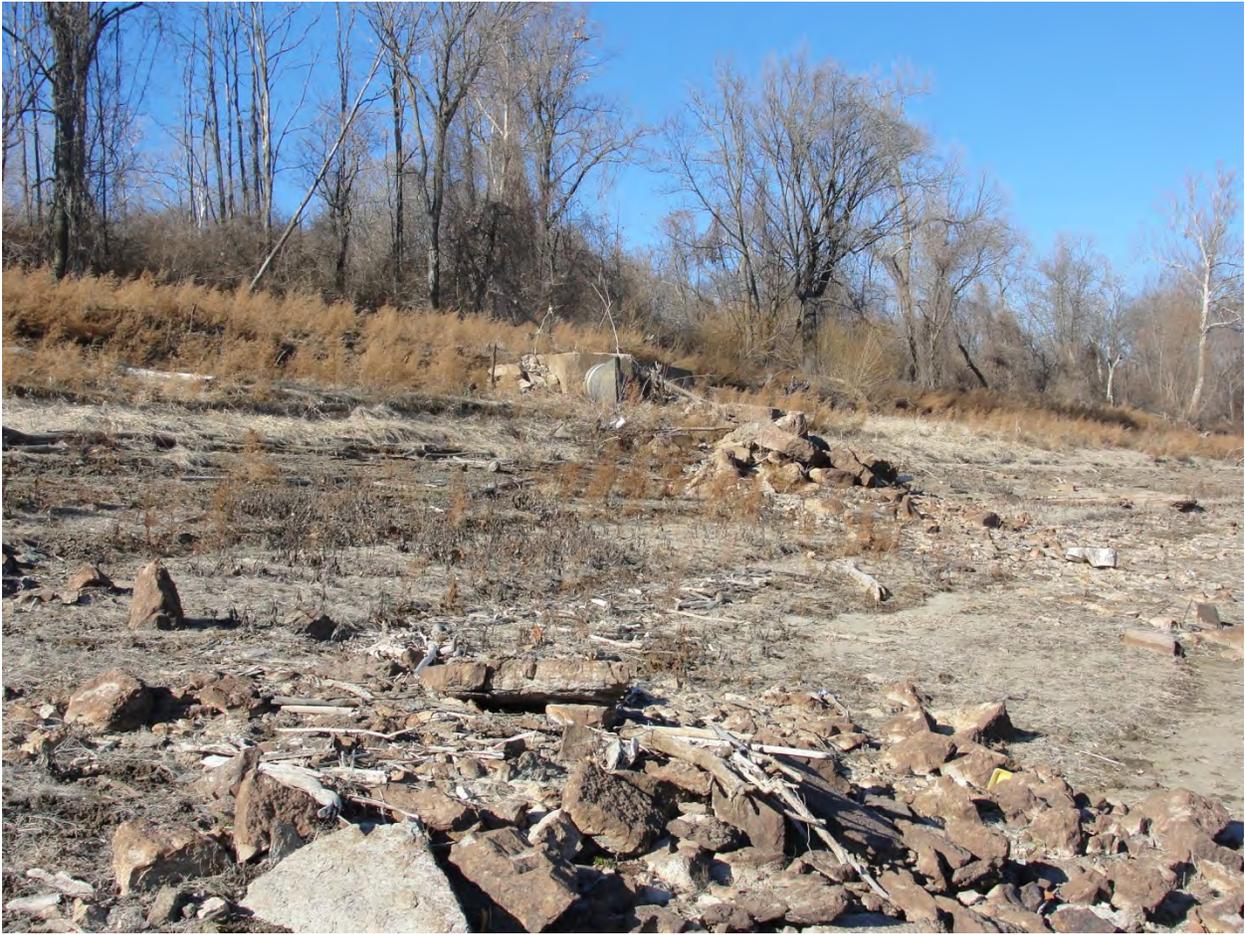
Photo 44. Jefferson Barracks Former Post Dumping Grounds

Description: View is to the northwest as taken from the northern limits of placed riprap; subject of photo is the storm water outfall which is centrally located in the photo.

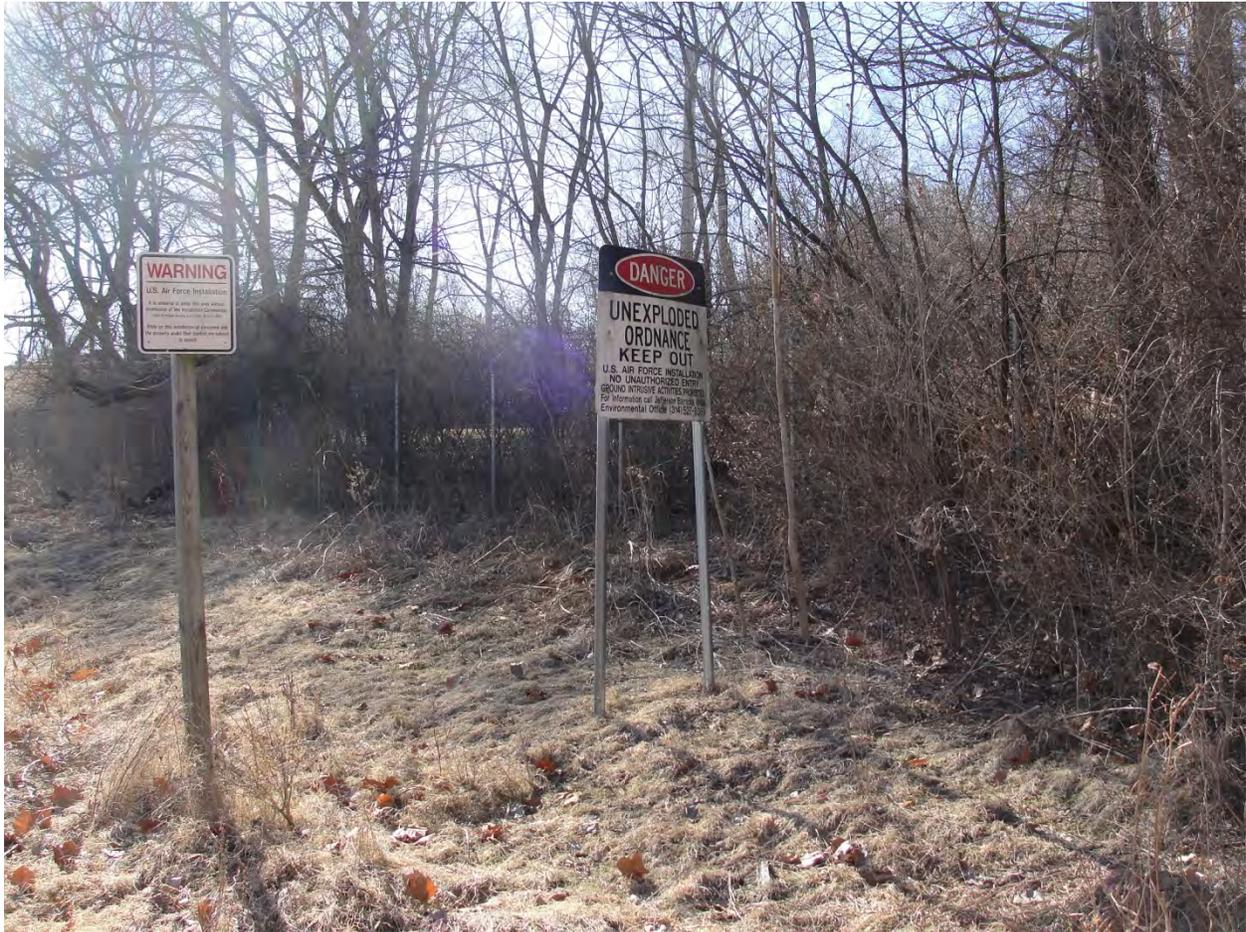
Photo 45. Jefferson Barracks Former Post Dumping Grounds

Description: Warning Sign No. 6; view is towards the south.

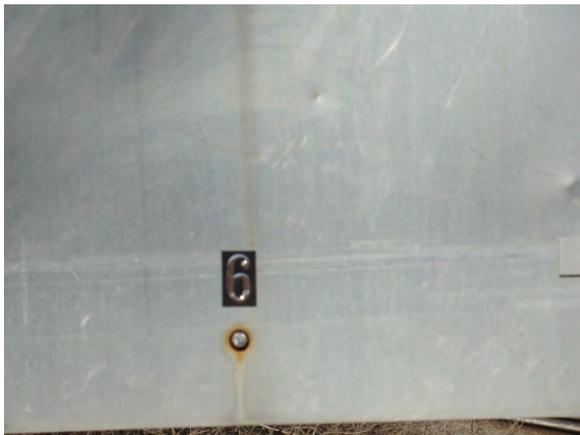
Photo 46.

Description: Backside of Warning Sign No. 6

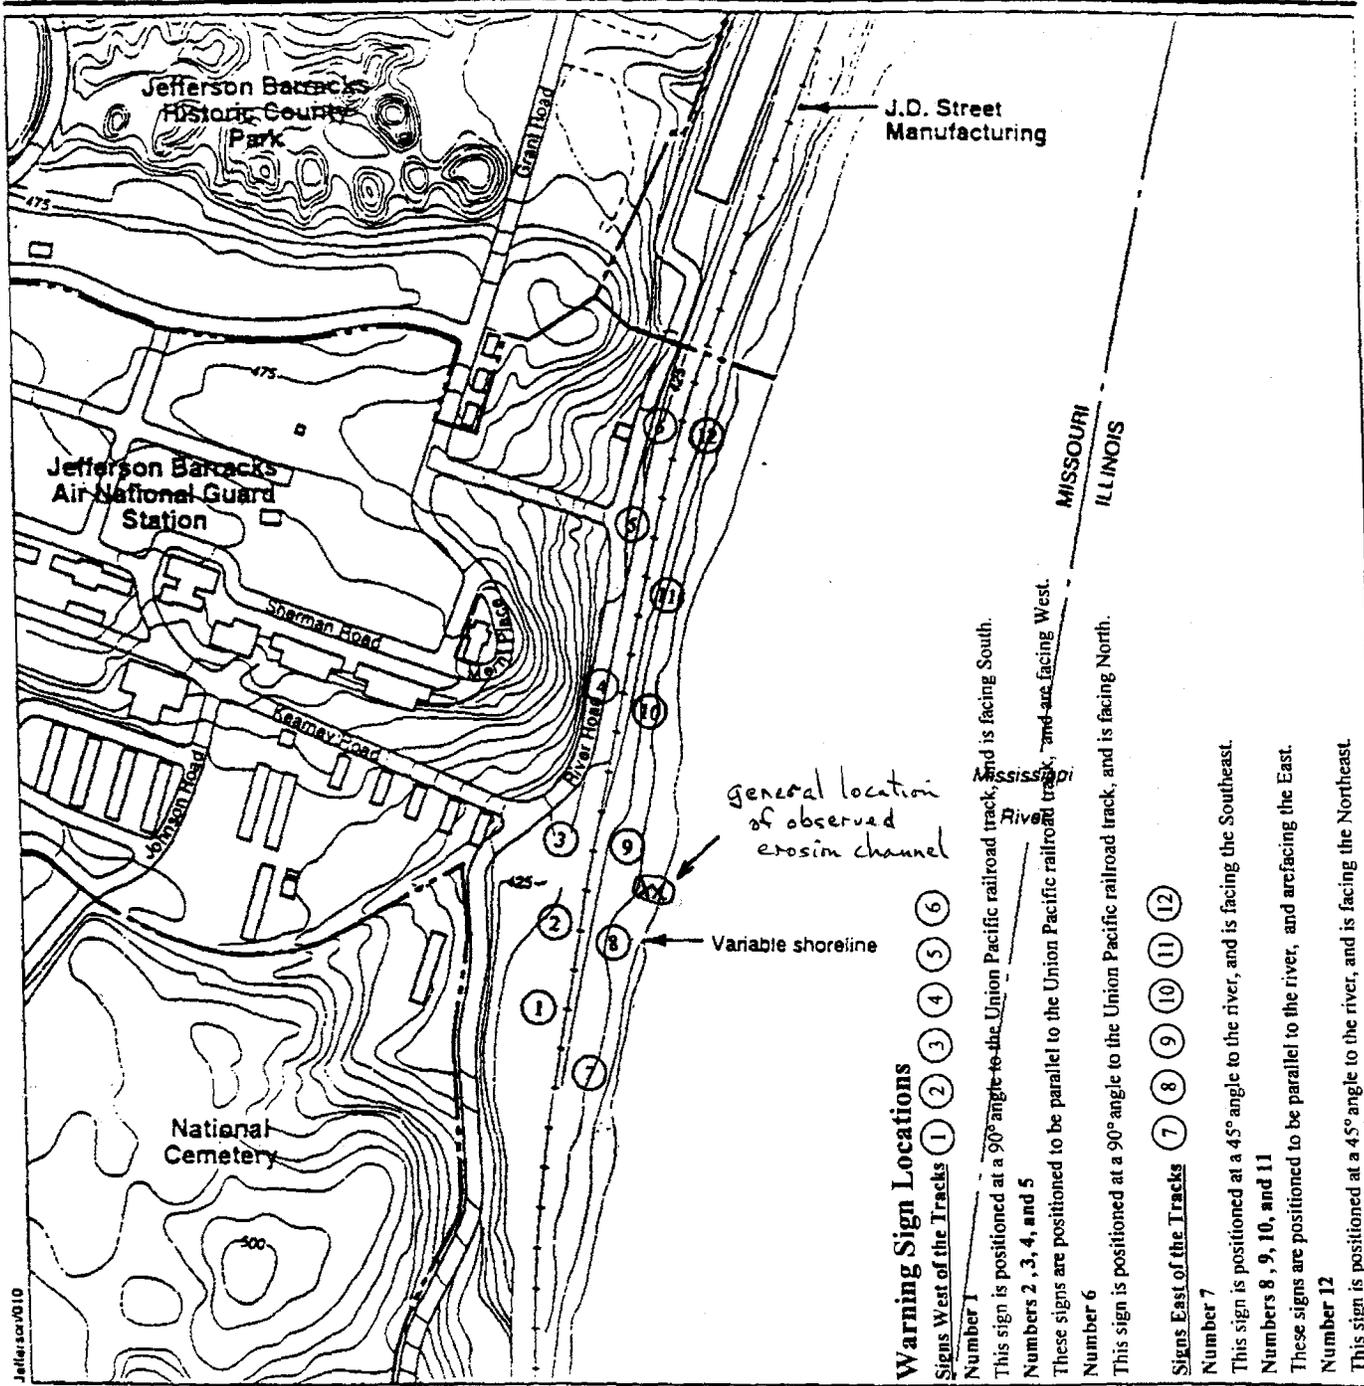
Warning Sign Locations

- Signs West of the Tracks** ① ② ③ ④ ⑤ ⑥
- Number 1**
This sign is positioned at a 90° angle to the Union Pacific railroad track, and is facing South.
- Numbers 2, 3, 4, and 5**
These signs are positioned to be parallel to the Union Pacific railroad track, and are facing West.
- Number 6**
This sign is positioned at a 90° angle to the Union Pacific railroad track, and is facing North.
- Signs East of the Tracks** ⑦ ⑧ ⑨ ⑩ ⑪ ⑫
- Number 7**
This sign is positioned at a 45° angle to the river, and is facing the Southeast.
- Numbers 8, 9, 10, and 11**
These signs are positioned to be parallel to the river, and are facing the East.
- Number 12**
This sign is positioned at a 45° angle to the river, and is facing the Northeast.

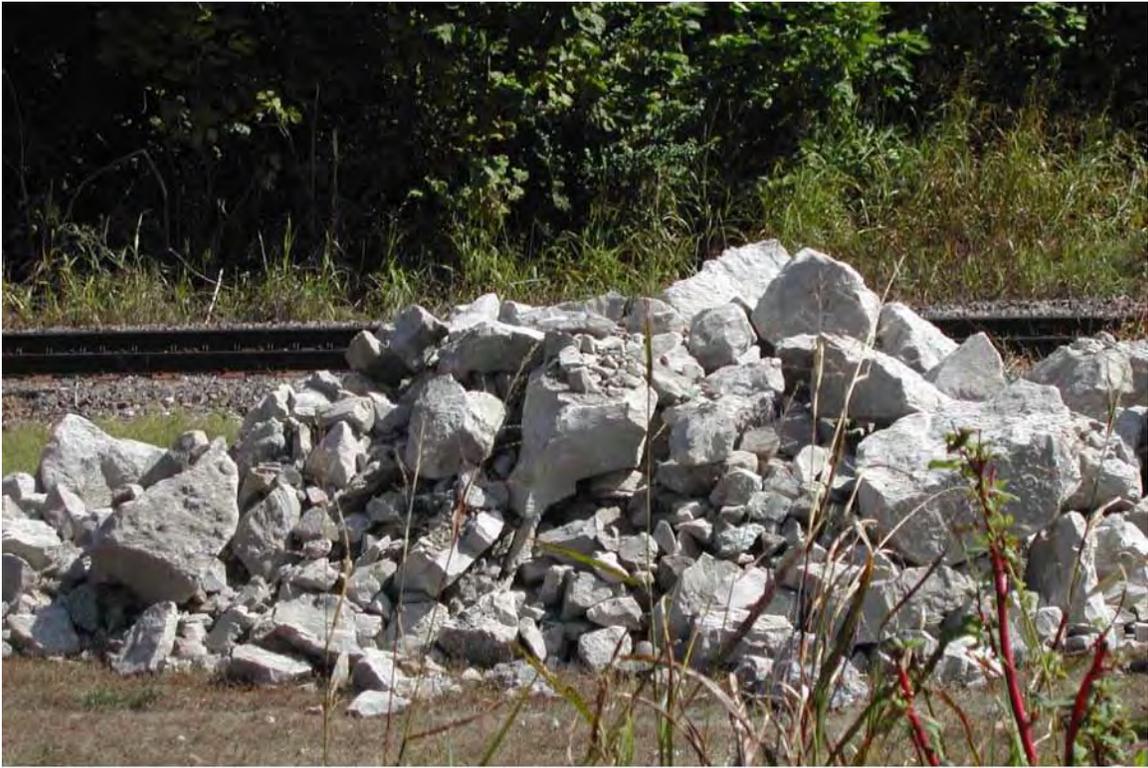
Figure 7

grubbing operations. The front end loader remained at the staging area (Figure 6) on the western side of the RR tracks to off-load sewer pipes and transport and stockpile crushed aggregate and rip-rap. The representative from MSD rejected the first loads of rip-rap (Figure 7) due to the fact that it failed the specifications for Class C stone. This issue was later resolved and the stone used. Work was periodically interrupted by passing trains (Figure 8). There were no other noteworthy incidents during site mobilization.

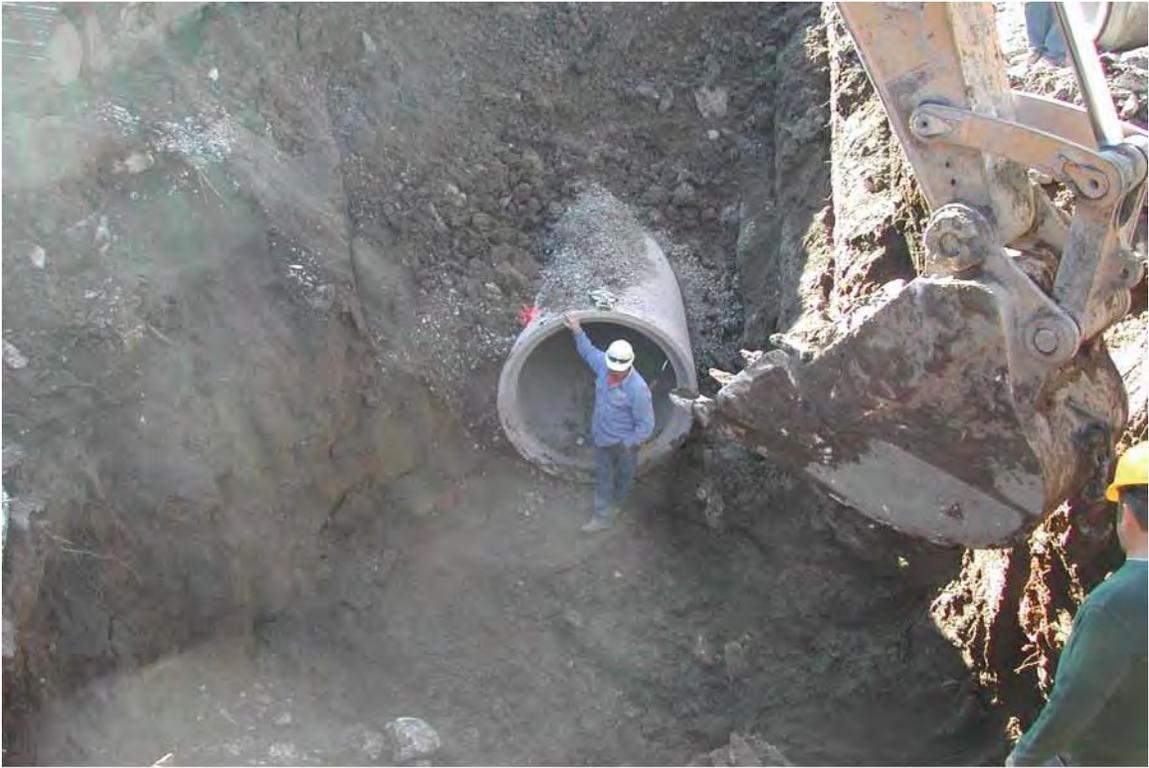
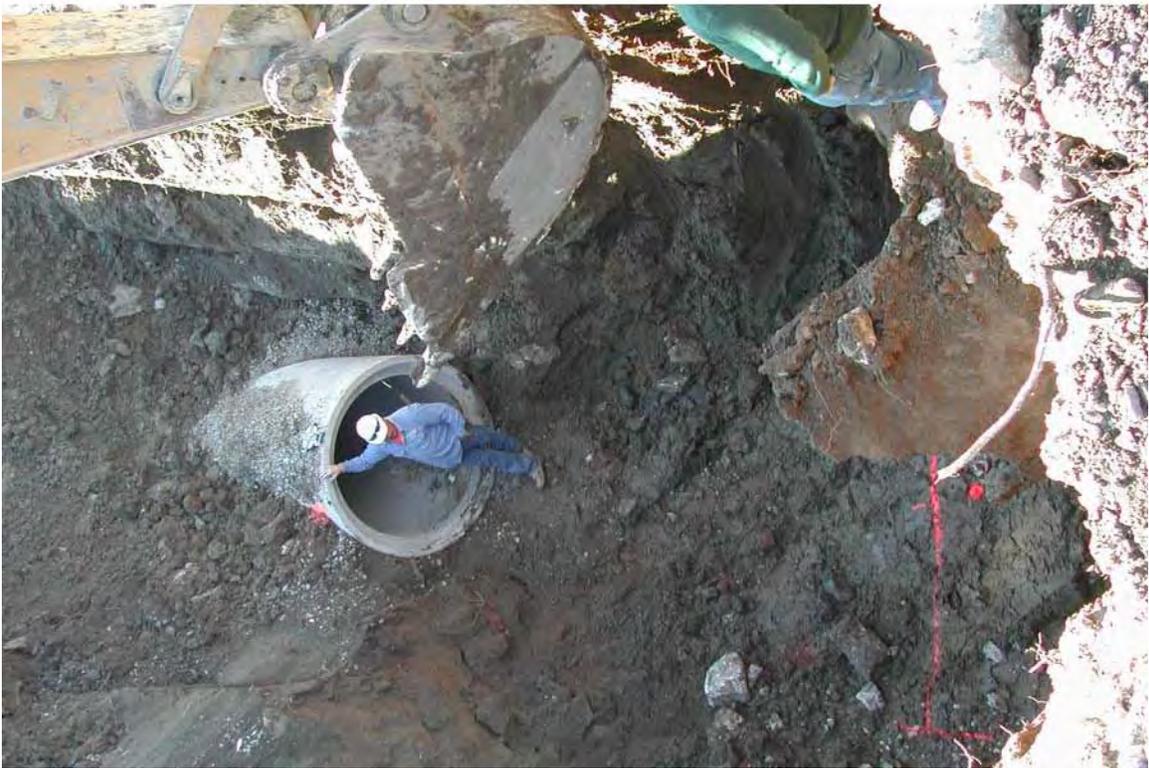
The sewer line replacement standard operating procedure was to excavate a sufficient length of the trench to allow for the installation of two sections of sewer pipe (Figure 33). The trench was excavated (Figures 34-37) to required depth, surveyed, backfilled with crushed aggregate (Figure 38), and pipes were set and joints glued. This process was repeated continuously until

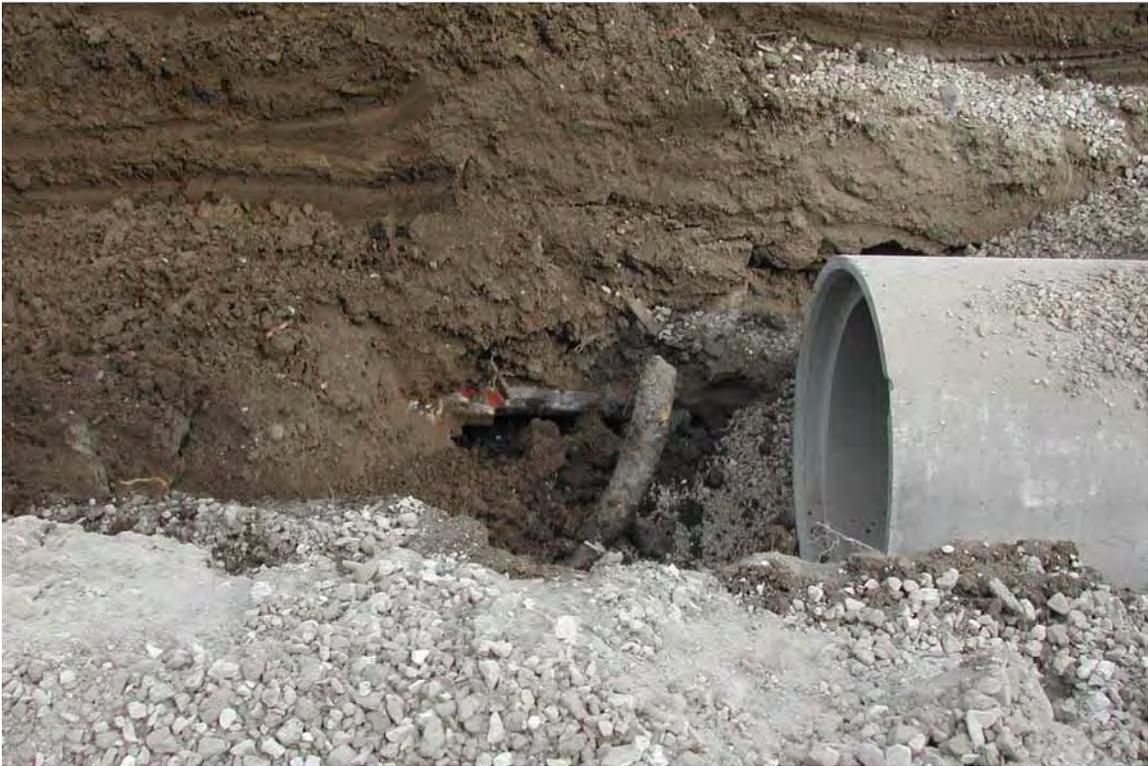
The excavation removed the southern side of the 1930s era sewer (Figures 39-40). Due to unexpected site conditions the excavation was both wider and deeper than originally expected (Figures 36-37). The manhole was then removed (Figures 41-42). Shoring was installed (Figure 43) and the headwall was being installed. Although the excavation was still open at the time, MDNR suspended field oversight, the rip-rap remaining to be installed was staged at the end of the trench and the remaining spoil/backfill had been examined repeatedly for munitions debris and solid waste.

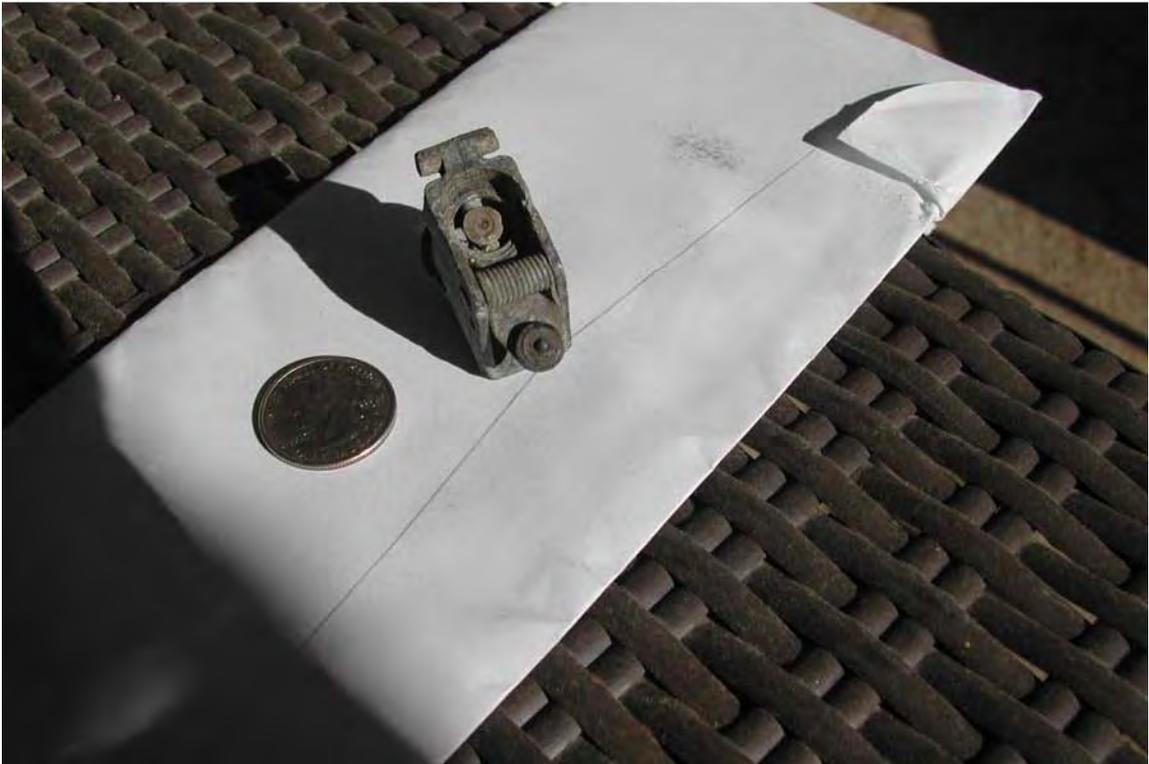
Mr. Mitchell Scherzinger and Mr. Patrick Anderson provided MDNR field oversight for this project. Their primary responsibility was to ensure that no solid waste or hazardous waste attributable to the Jefferson Barracks Dumping Grounds, were excavated. Their secondary responsibility was to assist the USACE in watching for excavated munitions debris and UXO. MDNR personnel scrutinized the material as it was being excavated (paying particular attention to sidewalls and the bottom of the trench), the spoil as it was being dumped, and the spoil piles. Spoil piles and disturbed areas were routinely reexamining for debris. Only two items potentially attributable to the Jefferson Barracks Dumping Grounds were encountered. These were found in the spoil piles. The first item resembles the remnants of a hand grenade fuse (Figures 44-45) and a slag (slightly magnetic) covered rock (Figure 46).
