Proposal Name: Incorporate the Cherokee Park Levee into the Red River below Denison Arkansas, Louisiana and Texas Dam Flood Control Project

by Agency: Caddo Levee District, a State Government Agency located in Shreveport, Caddo Parish, Louisiana

Flood Damage Reduction Segment / System
Inspection Report
Cherokee Park Levee (CHER)

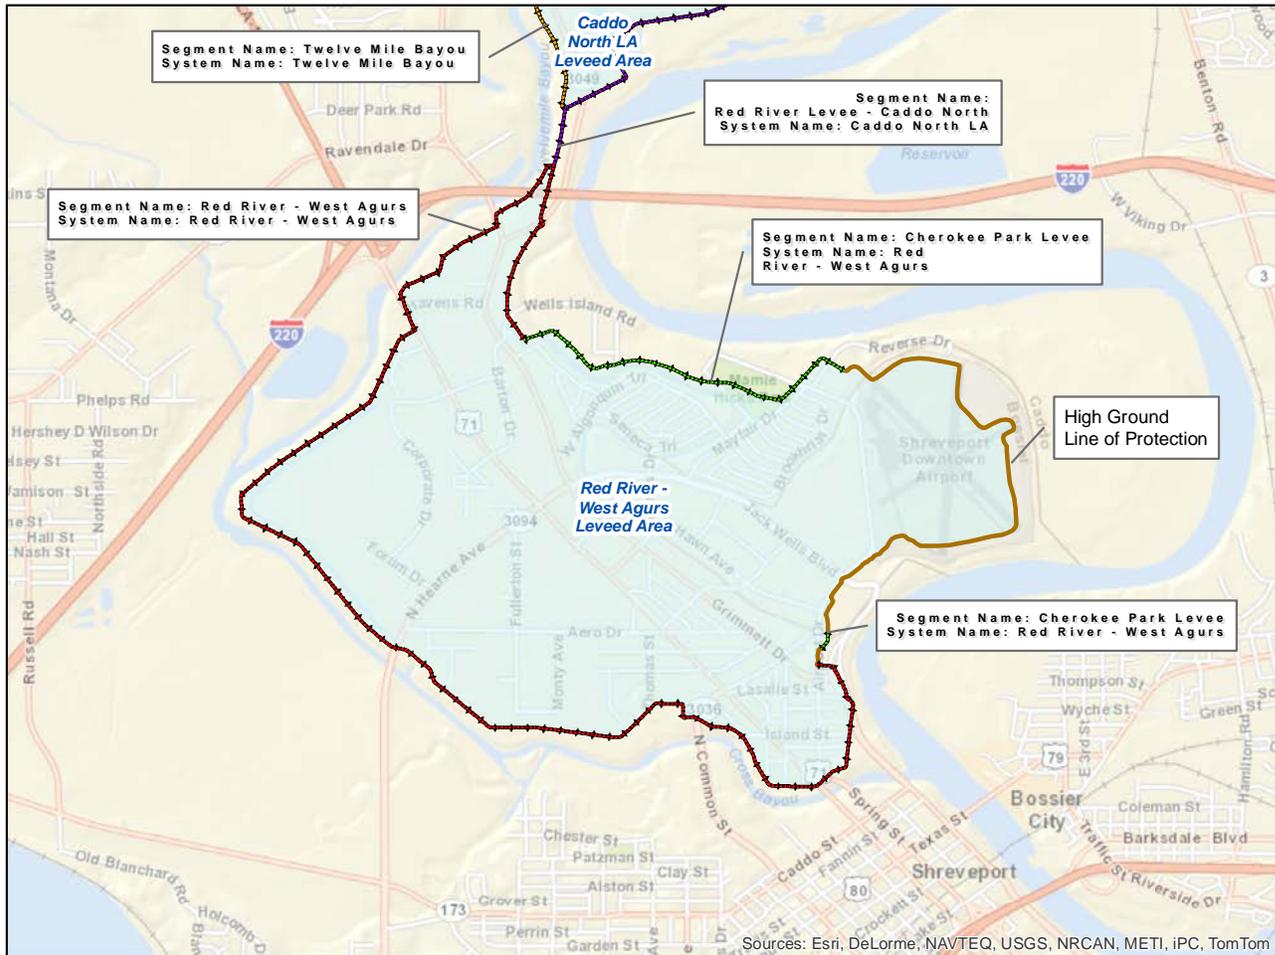
Segments: West Agurs, Caddo North, Cherokee Park, Twelve Mile Bayou

- Cherokee Park Levee
- Red River - West Agurs
- Red River Levee - Caddo North
- Twelve Mile Bayou

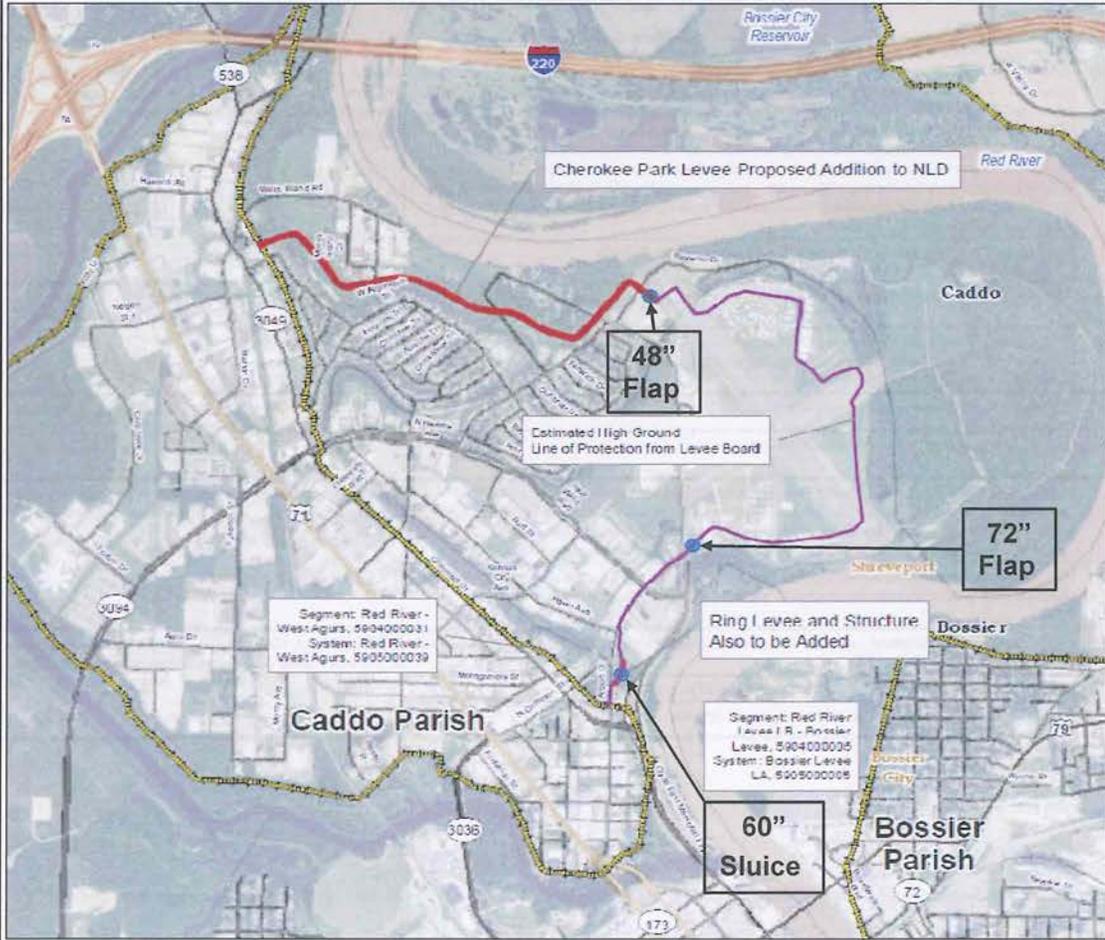
Cherokee Park Proposed NLD Addition

- Cherokee Park Levee
- Current NLD Levee
- Estimated High Ground From Levee Board
