MEMORANDUM FOR RECORD

SUBJECT: TIER 1 DETERMINATION REGARDING THE SUITABILITY OF PROPOSED DREDGED MATERIAL FROM OFFSHORE SAND BORROW AREAS IN WILLAPA BAY FOR USE IN THE RESTORATION OF THE GRAVEYARD SPIT BARRIER DUNE AT THE SHOALWATER BAY INDIAN RESERVATION.

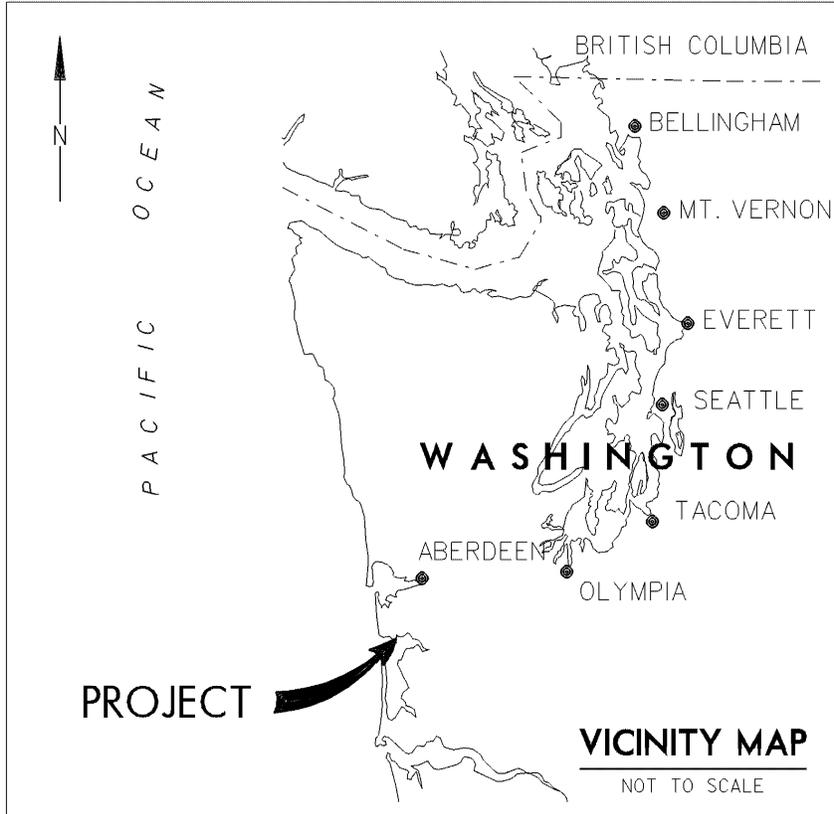
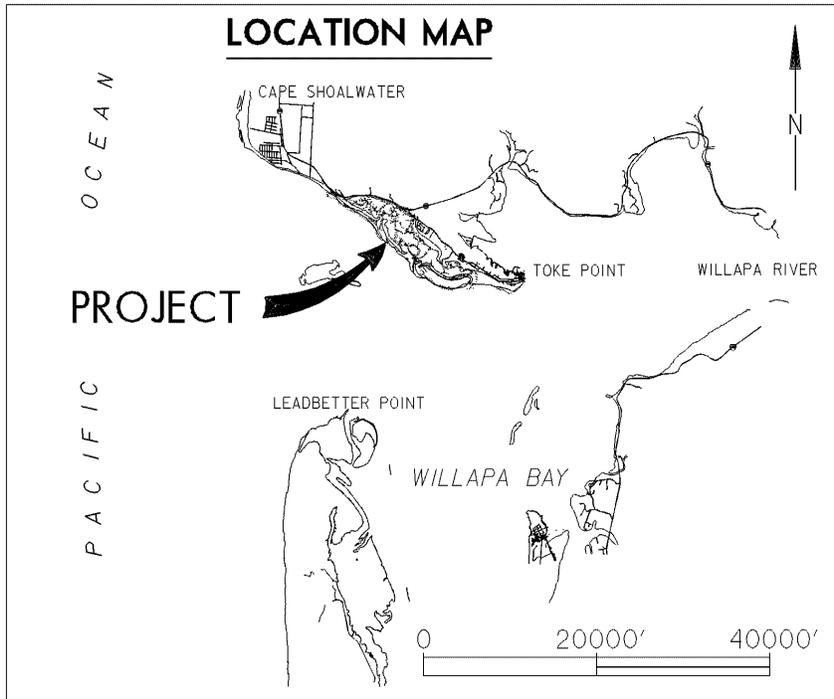
Attachment 3 Spill Response Incidents Within 10 miles of Borrow Areas

10-mile radius

To verify that conditions have not changed with respect to known sources of contamination since the 2007 DMMP suitability determination, USACE reviewed spill response records for Pacific County from the Department of Ecology’s Environmental Response Tracking System (ERTS). The DMMP agencies expressed interest in all spill responses within a ten-mile radius of the borrow areas and any others greater than 100 gallons within the Willapa Bay watershed regardless of distance from the borrow areas.
