**APPROVED JURISDICTIONAL DETERMINATION FORM**  
**U.S. Army Corps of Engineers**

**B. DISTRICT OFFICE, FILE NAME, AND NUMBER:** Jacksonville District, Tampa Office, 12619 DEAD RIVER RD, SAJ-2018-01047.

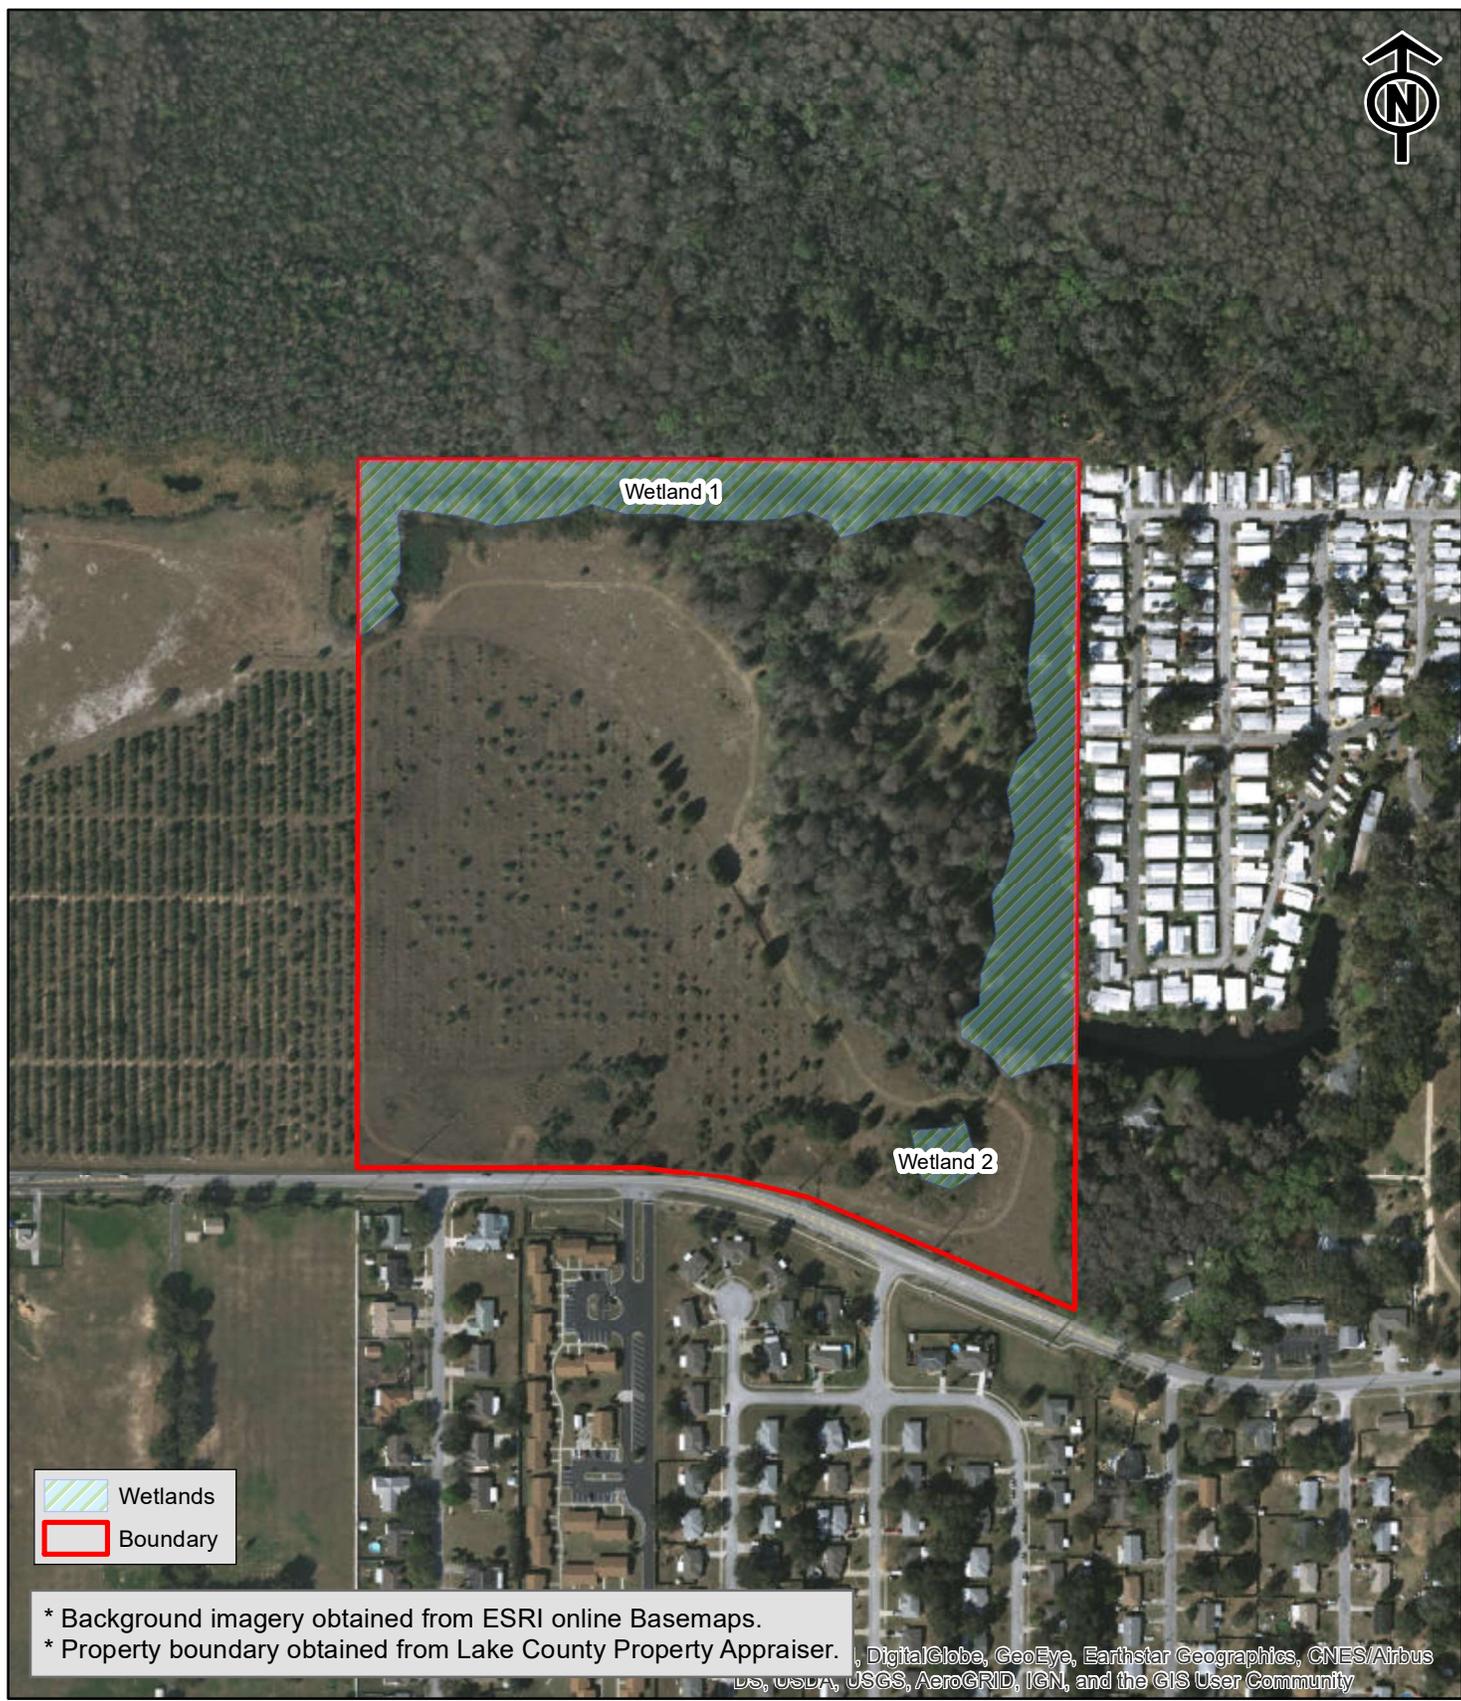
Figure 5- Wetlands Map Section  
 30 and 31, T19S, R26E Lake  
 County, Florida

Explain: **The 41 acre project site is uplands except for a 0.25-acre isolated wetland (Wetland 2) and a 6.26-acre man-made canal system (Wetland 1), which is classified as a RPW. Historical aeriels show Wetland 2 has existed since before 1958 when it was part of a larger system that has since lost its hydrology due to the large ditch/canal system. Wetland 2 is a depressional palustrine forested, Broad-Leaved Deciduous system (PFO1) with no hydrologic**

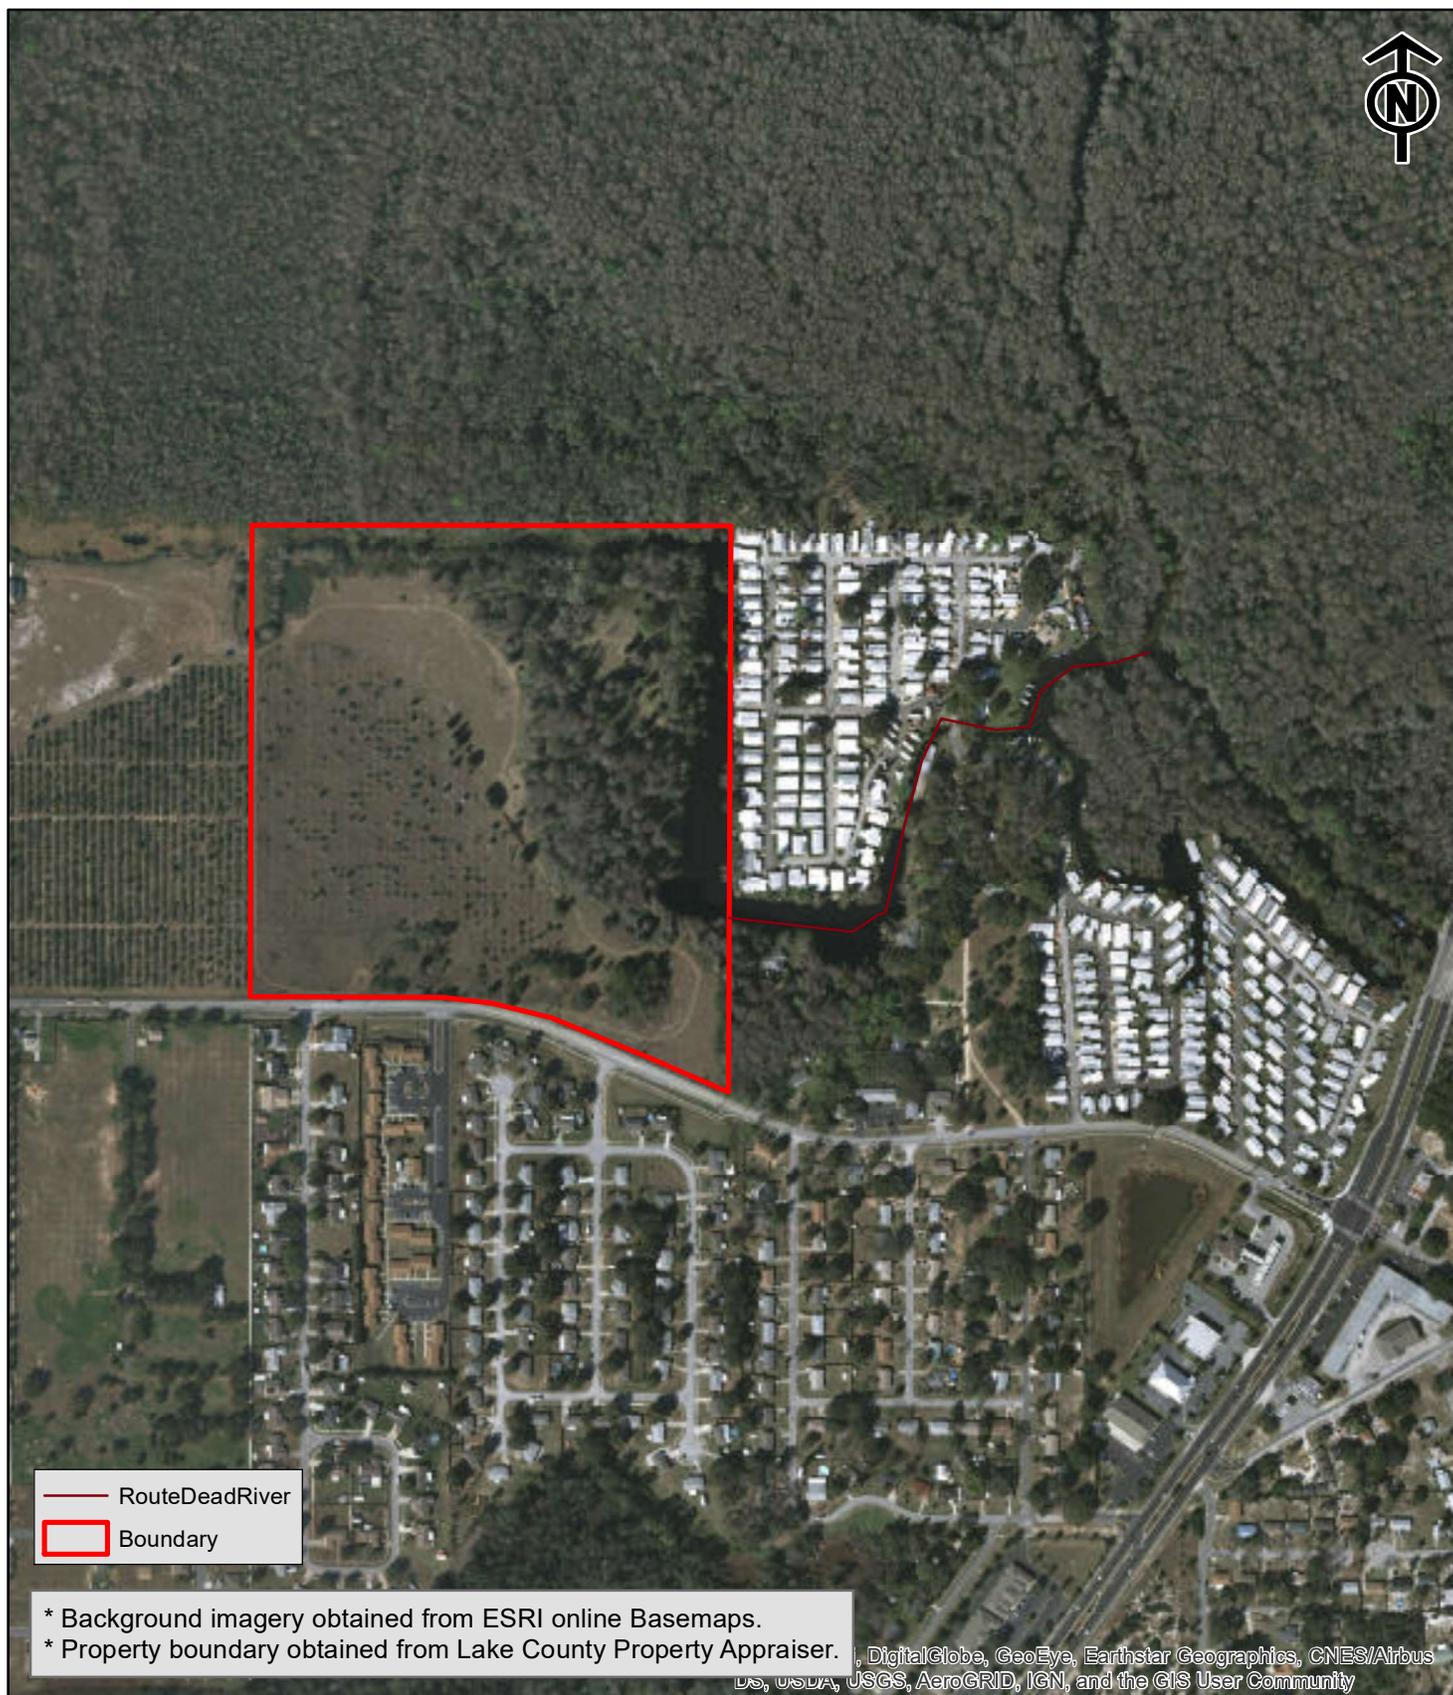
Figure 7- Route to TNW Map  
Section 30 and 31, T19S, R26E  
Lake County, Florida

Identify flow route to TNW<sup>5</sup>: Onsite wetland is continuous offsite, flowing into the Dora Canal..

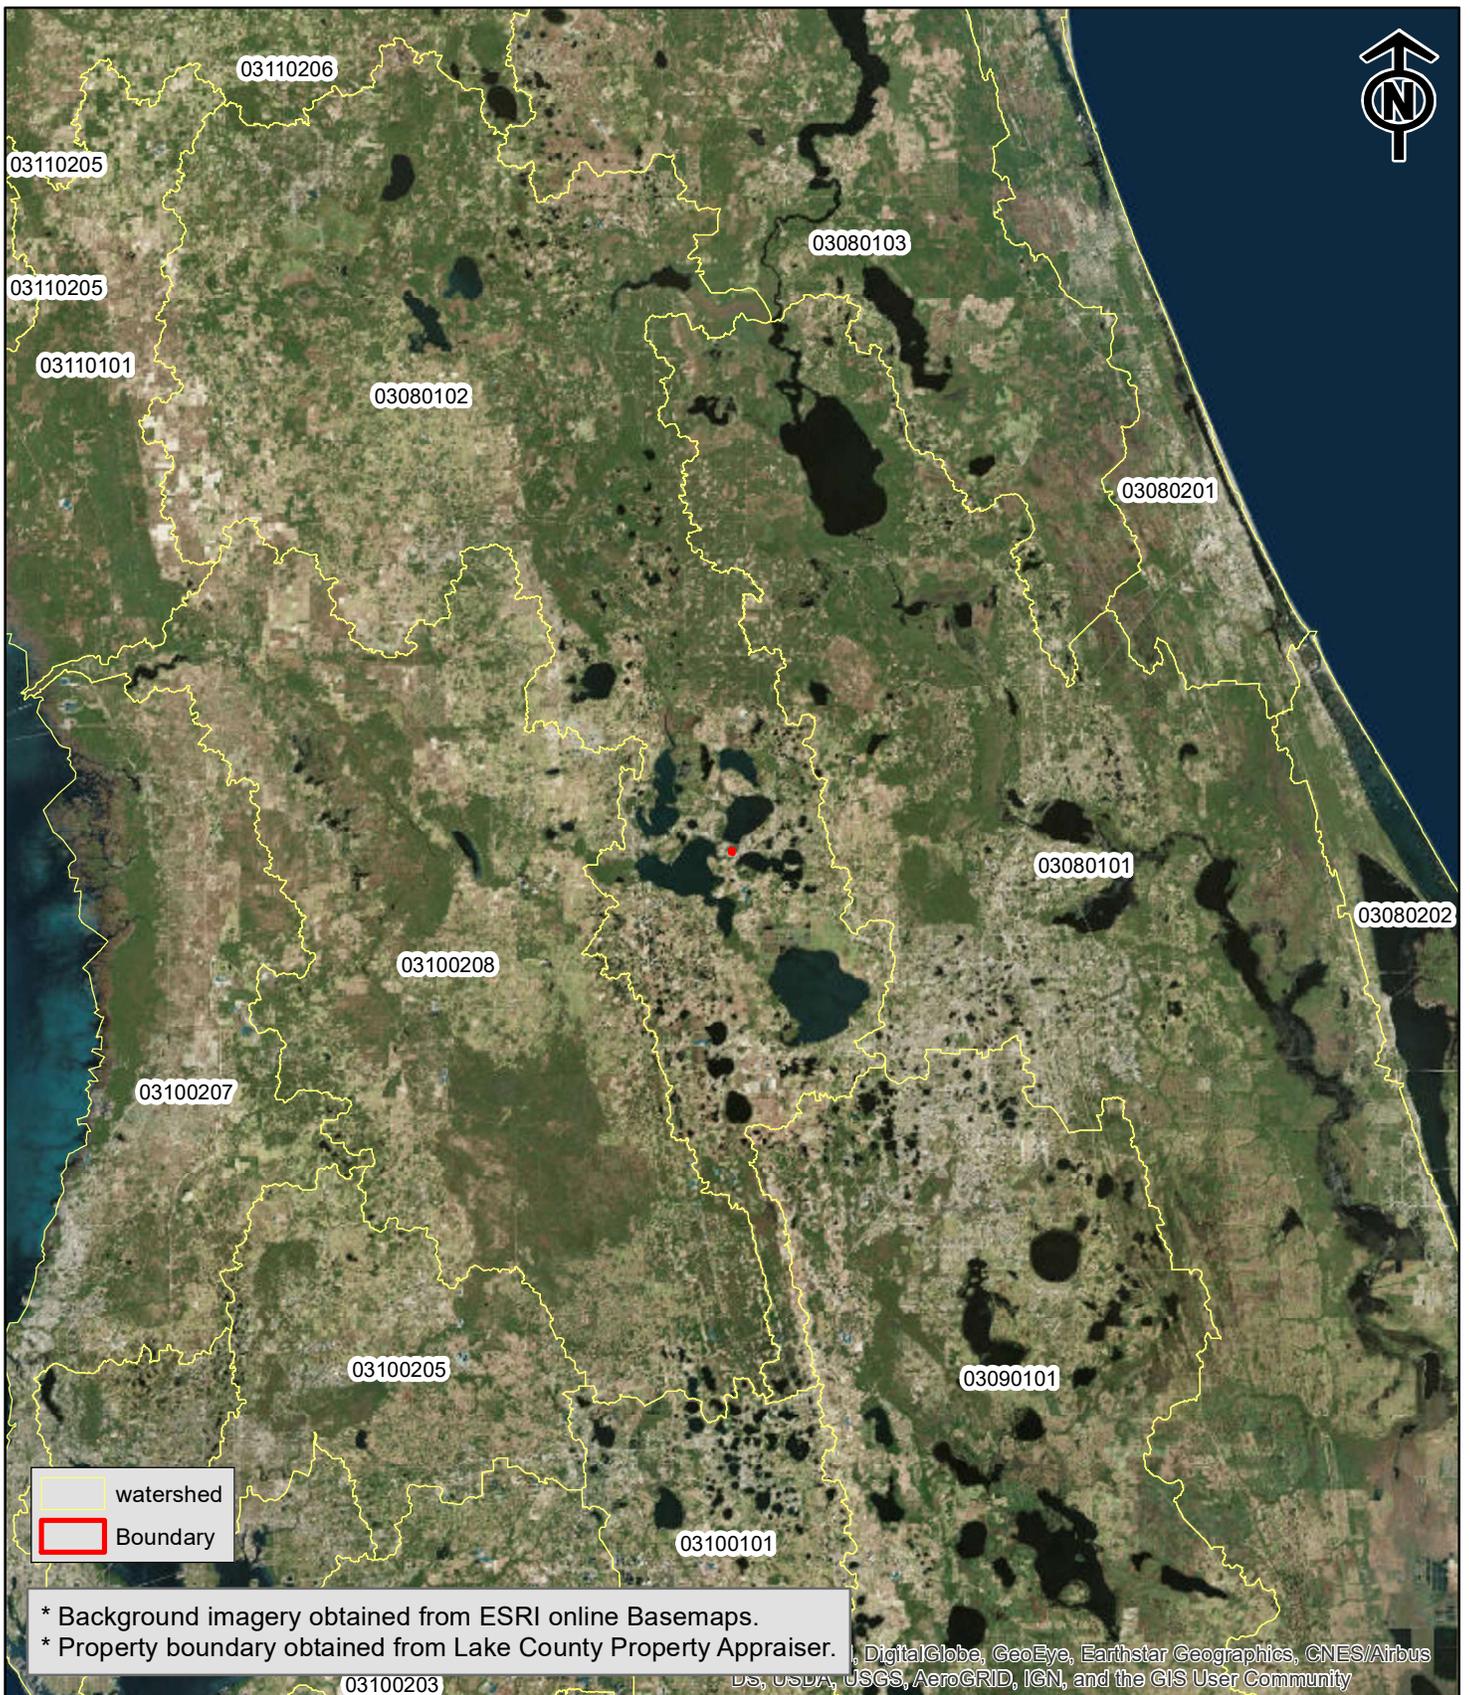
Figure 10- HUC 8 Digit Map  
 Section 30 and 31, T19S, R26E  
 Lake County, Florida

Name of watershed or Hydrologic Unit Code (HUC): 03080102
