**Final  
Abbreviated Preliminary Assessment Report  
for the  
Specific Congressionally Authorized Areas  
Within the Northwest Peninsula of Culebra  
Culebra, Puerto Rico**

**FUDS Property No. I02PR0068**

**U.S. Army Corps of Engineers, Jacksonville District  
701 San Marco Boulevard  
Jacksonville, FL 32207**

**June 2016**

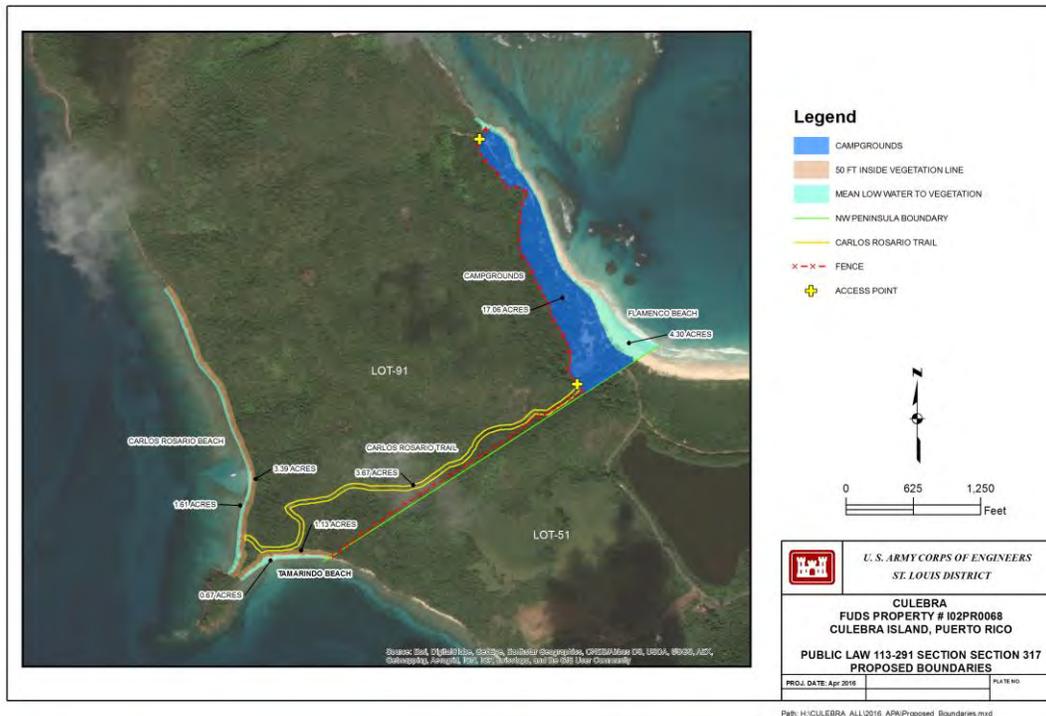
Figure 2 – Proposed Boundaries per PL 113-291 Section 317

- Flamenco Beach (4.30 acres): From the mean low water line to the vegetation line.
- Flamenco Campground (17.06 acres): From the vegetation line to the campground fence line.
- Carlos Rosario Trail (3.67 acres): 20 feet (ft) from either side of the trail centerline, excluding areas that cannot be reached due to physical constraints such as steep slopes or existing fences.
- Carlos Rosario Beach (5.00 acres): From the mean low water line to the vegetation line and extended 50 ft into the vegetation line (tree line).
- Tamarindo Beach (1.8 acres): From the mean low water line to the vegetation line and extended 50 ft into the vegetation line (tree line).

Those features and associated acres are shown in *Figure 2*.

This APA is being prepared as part of the process to implement those activities to render safe limited portions of the former Culebra bombardment area. The activities were specified by PL 113-291 § 317, which stated that it is the sense of Congress that certain limited portions of the former bombardment area on the Island of Culebra should be available for safe public recreational use while the remainder of the area is most advantageously reserved as habitat for endangered and threatened species. Those limited portions include those parts of Flamenco and Tamarindo Beaches located inside the former bombardment area and the entire areas of the Flamenco Campground, Carlos Rosario Trail, and Carlos Rosario Beach. These limited portions were identified as the result of the Congressional Study report that was developed for the bombardment area (see *Figure 2*).

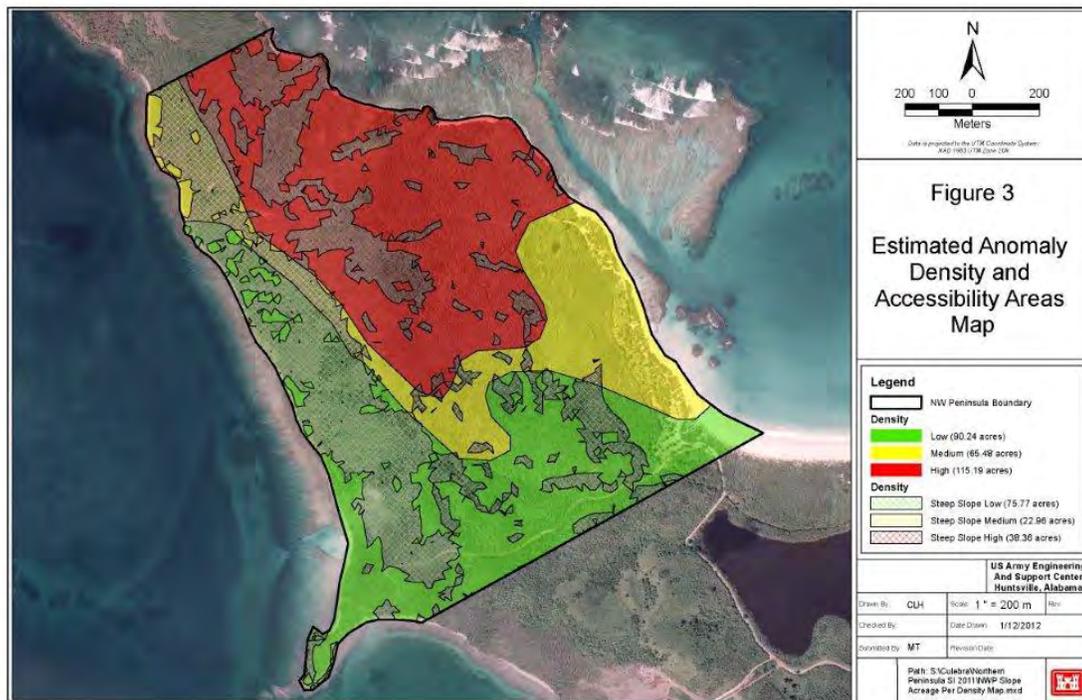
*Figure 4 – Estimated Density and Accessibility Areas – 2012*

After the survey, USACE used specialized software to map the distribution and type of military munitions (e.g., UXO) found along the survey paths. Because the survey paths only covered a portion of the Study Area, experts used the survey data to develop a model to predict the potential distribution of UXO across the entire Study Area. The resulting map (see **Figure 4**) divides the Study Area into distinct areas based on density of anomalies (High, Medium, and Low) and steepness of the terrain.

As part of the Congressional Study, USACE divided the Study Area into three areas based upon the number of metallic anomalies that USACE detected during the geophysical survey, USACE’s estimate of the density of those metallic anomalies within each area, and the steepness of the terrain (see **Figure 4**). USACE based its estimate on the costs associated with digging each anomaly and destroying any UXO encountered. The three areas reflect an estimated anomaly density of:

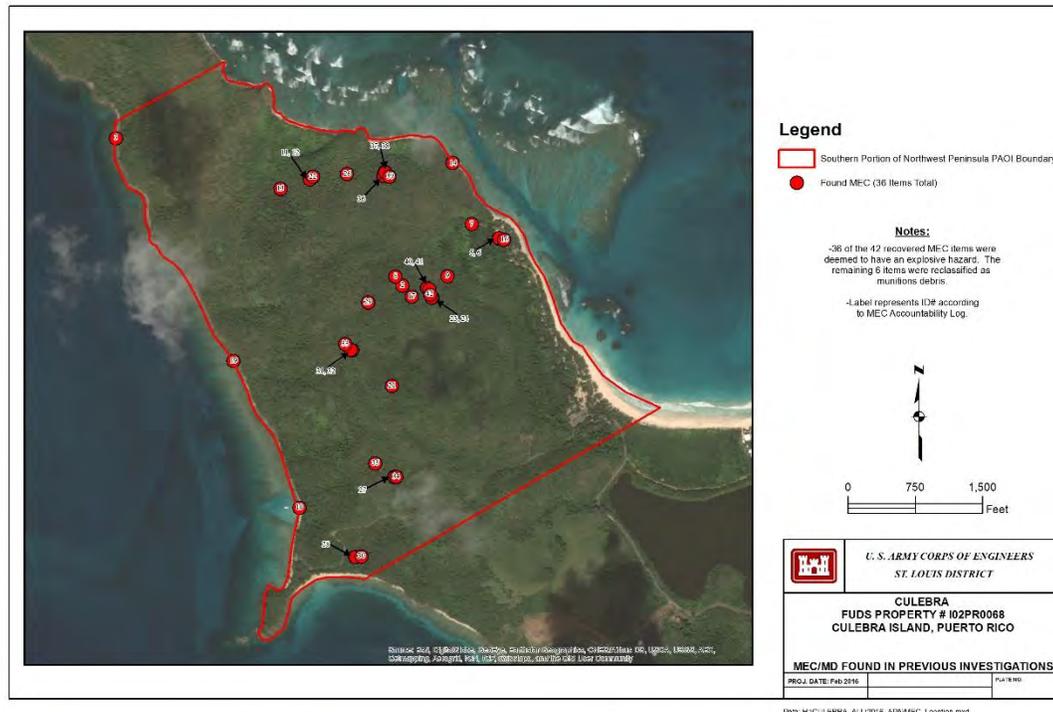
Figure 5 – Locations of Individual or Multiple UXO – 2012

Since 1995, 70 UXO have been encountered within approximately 19 acres of the Study Area. This total, which includes 36 UXO discovered during this study, equates to approximately 3.7 UXO per acre. The locations of the 36 UXO discovered during USACE's 2012 assessment are shown on *Figure 5*.

The predominant military munition encountered within the Study Area as UXO was the 5-inch High Explosive (HE) naval projectile. Other UXO encountered included the following types of military munitions: 2.75-inch rockets, 3-inch naval projectiles, 40mm projectiles, 75mm projectiles, 81mm mortars, 100-pound General Purpose (GP) bombs, a 500-pound GP bomb, and Bomb Dummy Unit (BDU)-33 practice bombs.

MEC intrusive operations were conducted subsequent to the completion of analog/flag and DGM grid mapping operations. The locations of recovered MEC items are shown on **Figure 5**. **Table 5** contains a list of all MEC items found during the 2012 Congressional Study.

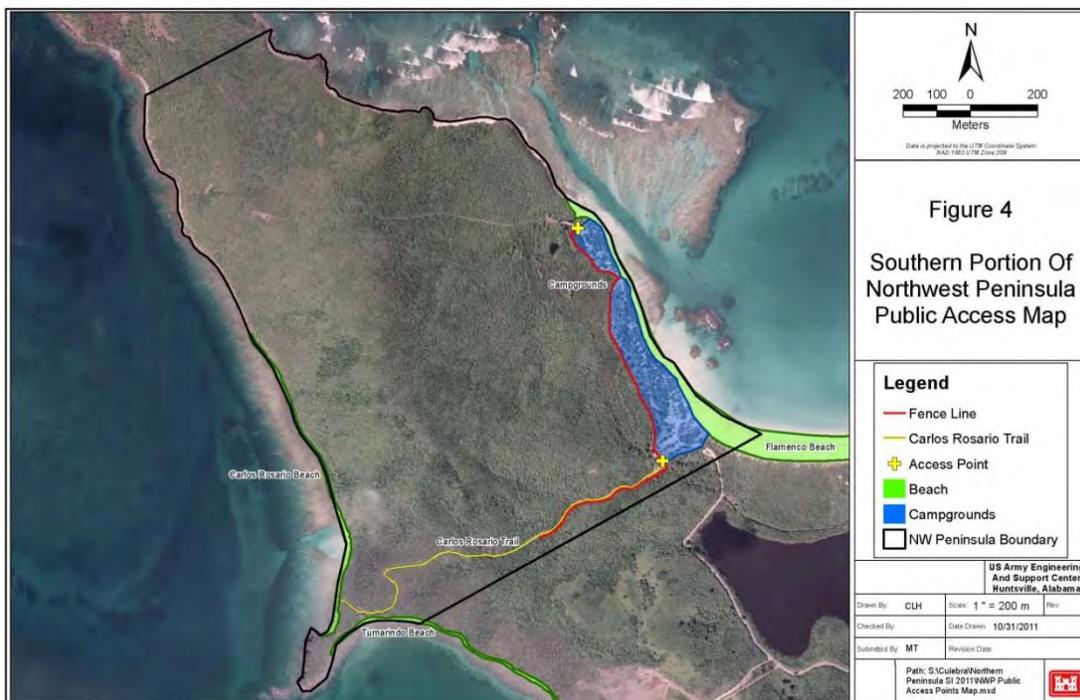
Figure 6 – Public Access Map – 2012

As shown in **Figure 6**, a fence was installed along the western border of the Flamenco Beach Camping Area. Another fence, which was installed during the 1970s, runs partially along the Study Area’s southern boundary. This fence, which begins at the Flamenco Beach parking area, extends west and terminates short of the top of the ridgeline. Vegetation growth or visitors have compromised multiple areas along the fence line.

There are two gates in the fence that provide access to the Study Area. One is at the parking area on the south end of the campground, with the other at the campground’s northern most point (see **Figure 6**). The southern access point is controlled by a chained and locked gate. However, visitors have been able to bypass this gate, gaining access to the trail that leads to the Carlos Rosario and Tamarindo Beach Area. The Study Area’s vegetation is very restrictive, generally deterring travel off established trails and roads. Additionally, the Study Area is accessible by sea on both the eastern and western sides along the beach areas.

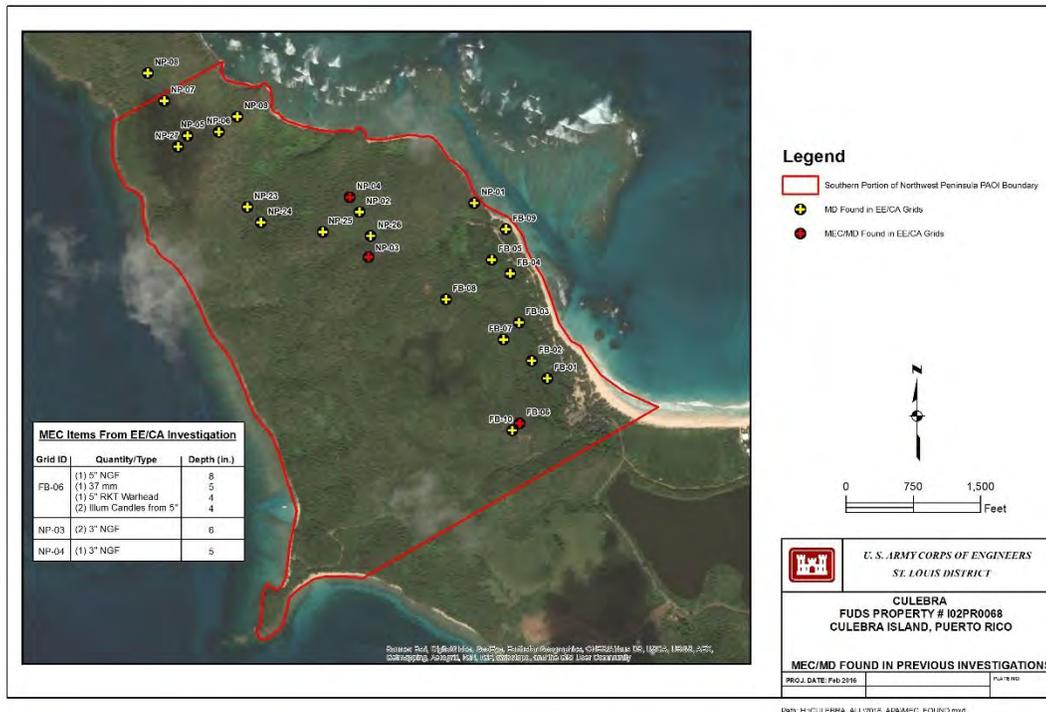
Figure 7 – MEC/MD Found During EE/CA Investigation Prior to the Congressional Study Report

In March 1997, Environmental Science and Engineering, Inc. (ESE) submitted the Final Engineering Evaluation and Cost Analysis (EE/CA) for the Former Culebra Island Naval Facility, Culebra Island, Puerto Rico (ESE, 1997). The EE/CA investigation included surface and subsurface sample grids on NWP, Isla Culebrita, Cayo Botella, Cayo del Agua, Cayo Lobo, and Cerro Balcon. UXO items were found in all areas except Cayo Lobo and Cerro Balcon, where only ordnance-related scrap was identified. Items found included 20mm high-explosive incendiary (HEI) devices, Mk76 practice bombs, Mk50 5-inch projectiles, 37mm projectiles, 5-inch rockets, 76mm projectiles, 3 and 6-inch naval projectiles, 81mm mortars, and a grenade. The UXO items found in grids located specifically in the Southern Portion of NWP are listed in *Table 1* and identified on *Figure 7*.

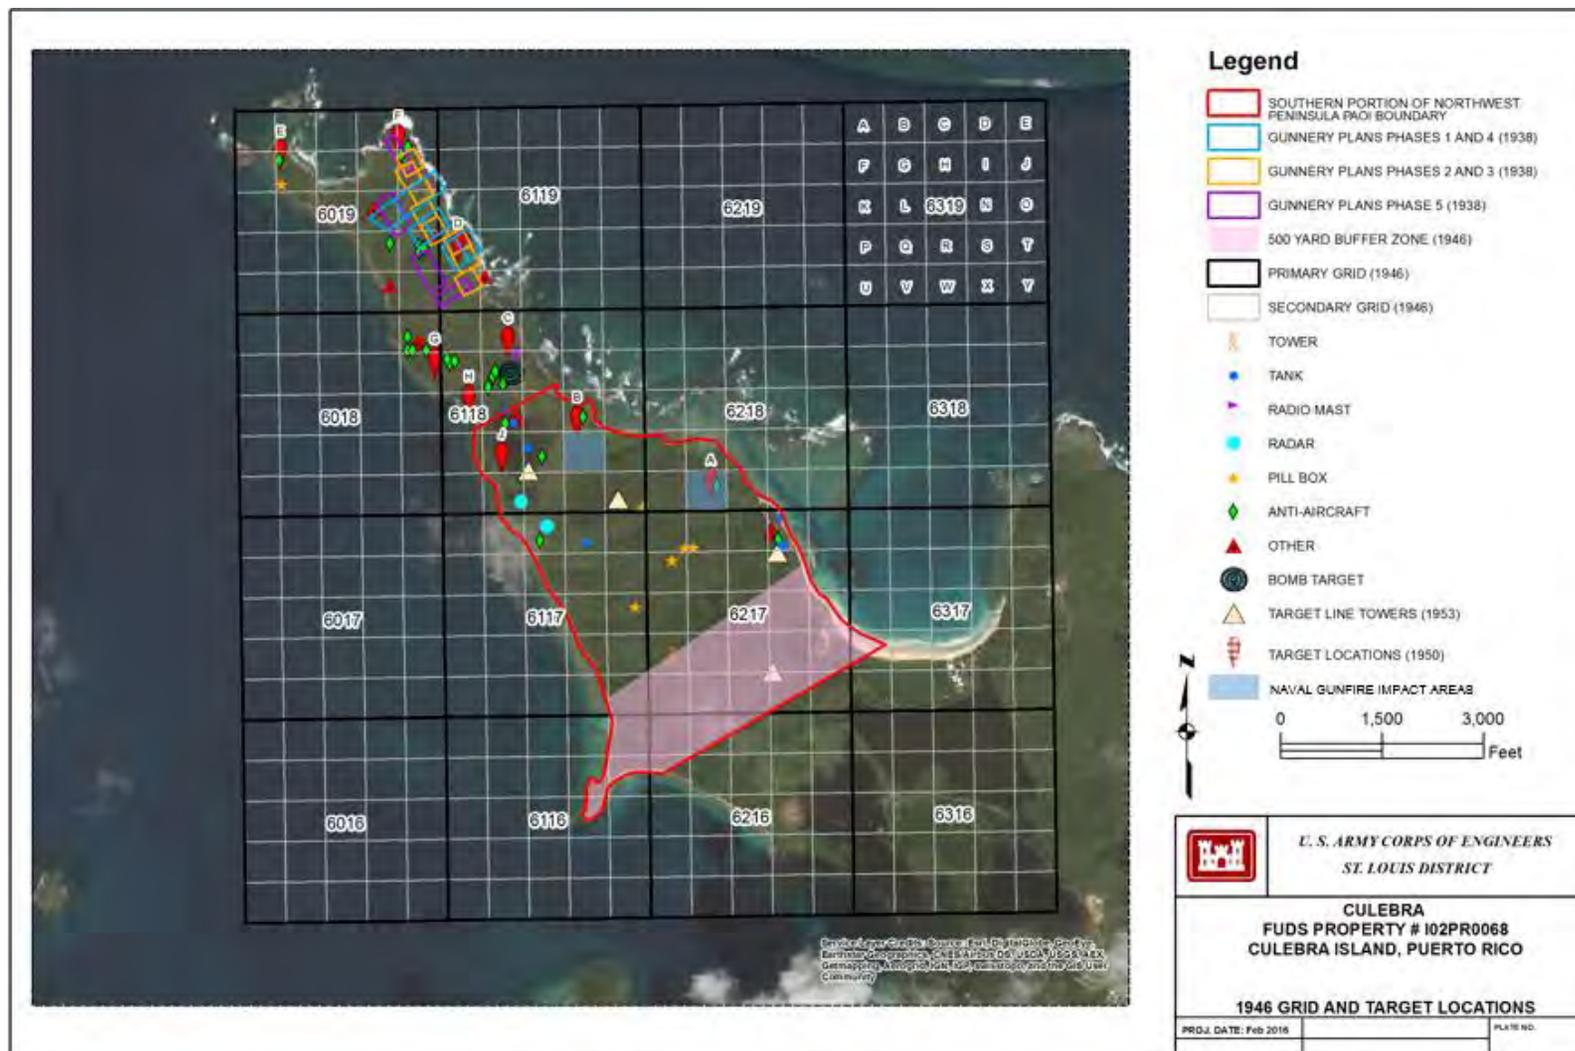
Figure 14 – 1946 Grid & Target Locations

The following map (see **Figure 14**) depicts the grid system used by the Navy Air Group FOUR in accordance with the Culebra Strike Approach Procedure & Operational Doctrines on 04 April 1946. It is shown that the naval gunfire impact areas (shaded in blue) are located within the Study Area. Targets such as pill box, anti-aircraft and tanks are identified.

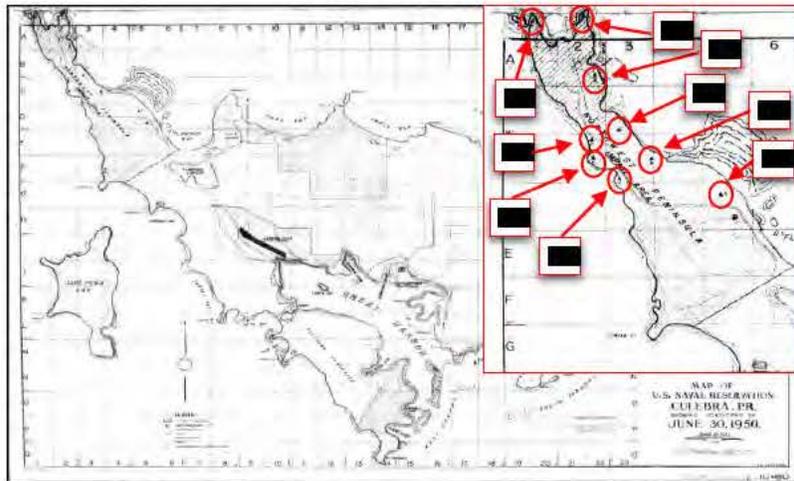
*Figure 15 – Map of NWP showing nine targets – 1950*

The Navy continued the use of the NWP in the 1950s. The map of the US Naval Reservation Culebra, PR, dated 30 June 1950, depicts a series of nine targets spaced around the perimeter of the NWP (see *Figure 15*). Targets A through F appear to be direct fire targets visible along the eastern side of the peninsula. Targets G, H, and J are located along the western side of the peninsula and would have been suitable for indirect fire operations.

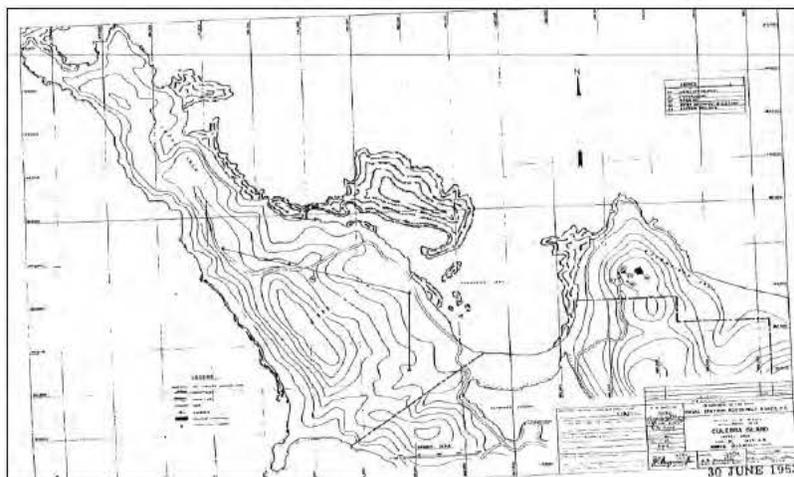
*Figure 16 – Map of NWP showing Target Line Towers – 1953*

A map, dated on 30 June 1953, depicts three additional features, labeled as “Target Line Towers”. The targets would have been in the generally vicinities of the towers (see *Figure 16*).

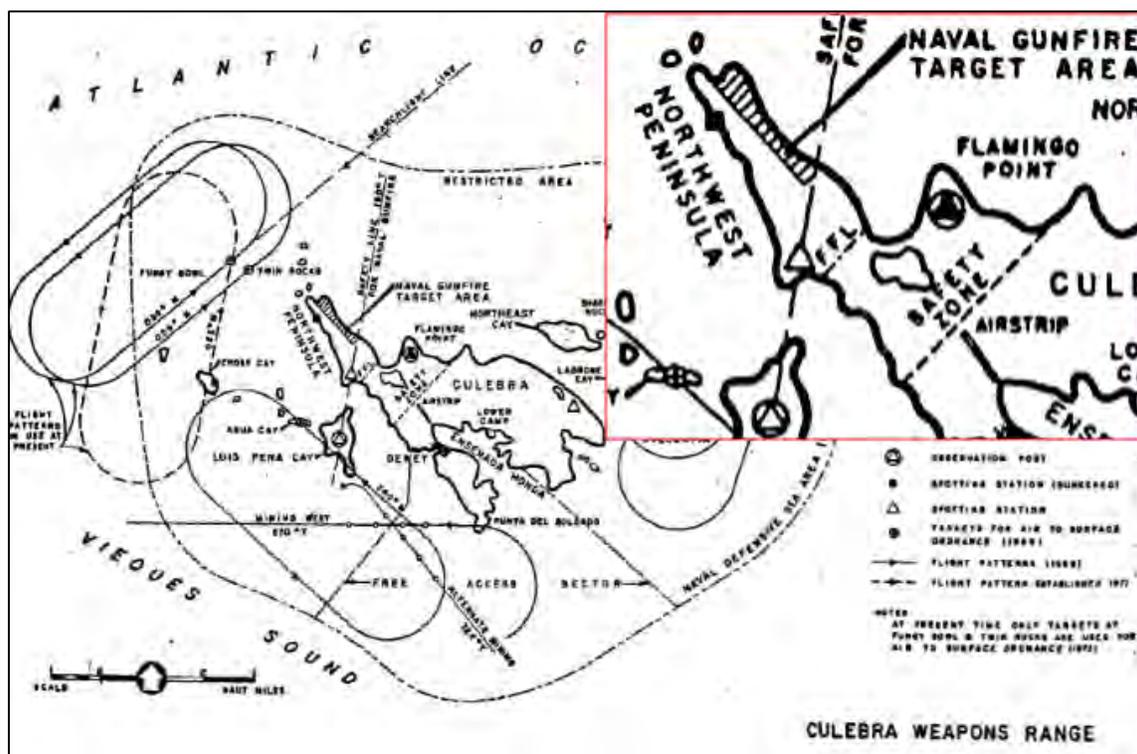
*Figure 17 – Culebra Weapons Range – 1960s*

Firings were observed and scored visually from an observation post and control center on Flamingo Point (see *Figure 17*).

In some instances, 81mm white phosphorous (WP) spotting rounds were fired from near the Flamenco Point OP (see *Figure 17*). It is likely that 81mm illuminating rounds were also used. The range was also used by ships from the Coast Guard as well as from the following foreign countries: Great Britain, Canada, Germany, The Netherlands, France, Brazil, Colombia, and Venezuela. These foreign ships fired live rounds varying from 3” to 5”. Aircraft bombing and strafing of the Flamenco Peninsula ended around 1970 and the use of live rounds for NGFS ended in 1971. Naval ships fired only quieter smoke (puff) rounds from then on.

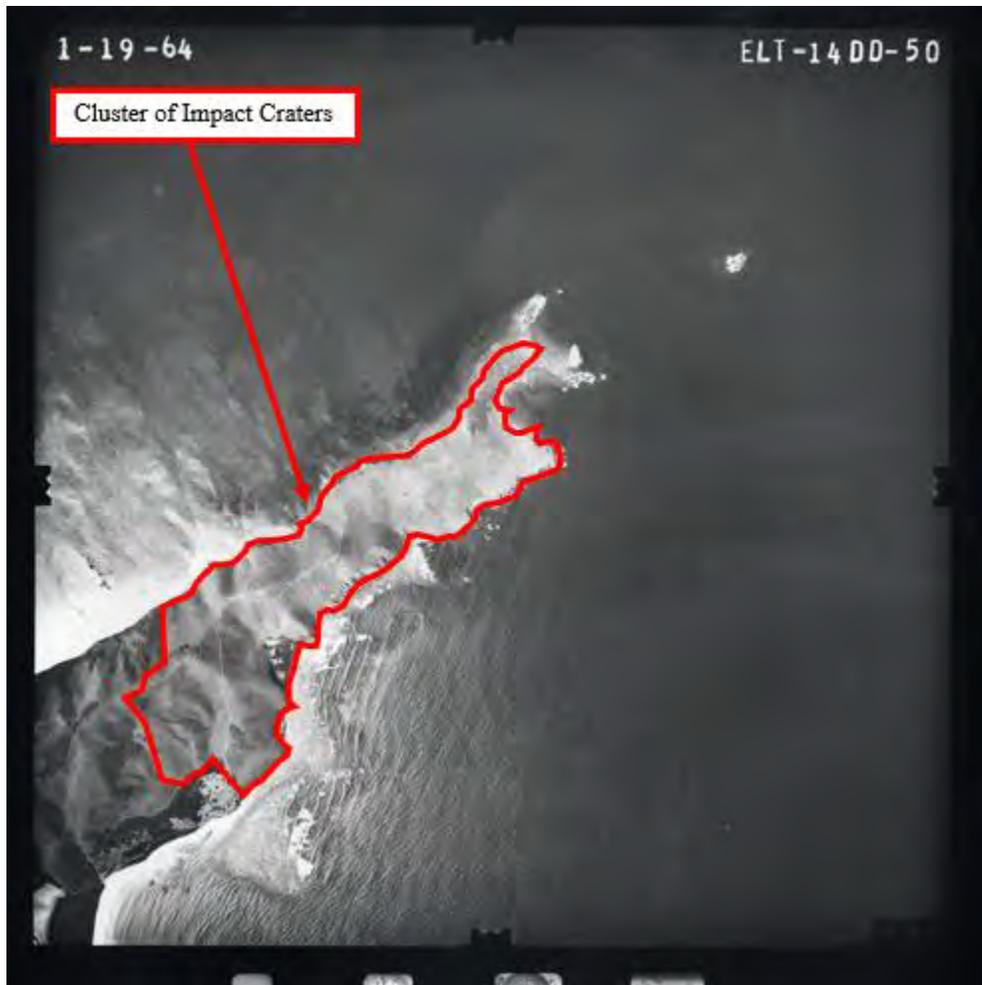
Figure 18 – NWP Cluster of Impact Craters – 1964

The following 1964 aerial image depicts cluster of impact craters on the NWP and Southern Portion (Study Area). Impact craters relate to past military training such as the NGFS.
