MEMORANDUM FOR RECORD

SUBJECT: LEVEL-1 DETERMINATION ON THE SUITABILITY OF PROPOSED DREDGED MATERIAL TESTED FOR THE WANAPUM DAM UPPER BOAT LAUNCH IMPROVEMENT PROJECT EVALUATED UNDER SECTION 404 OF THE CLEAN WATER ACT FOR UPLAND AND IN-WATER BENEFICIAL USE SITES.

Vicinity Map	
Level 1 Dredge Material Assessment Upper Wanapum Dam Boat Launch Grant County, Washington	
	Figure 1

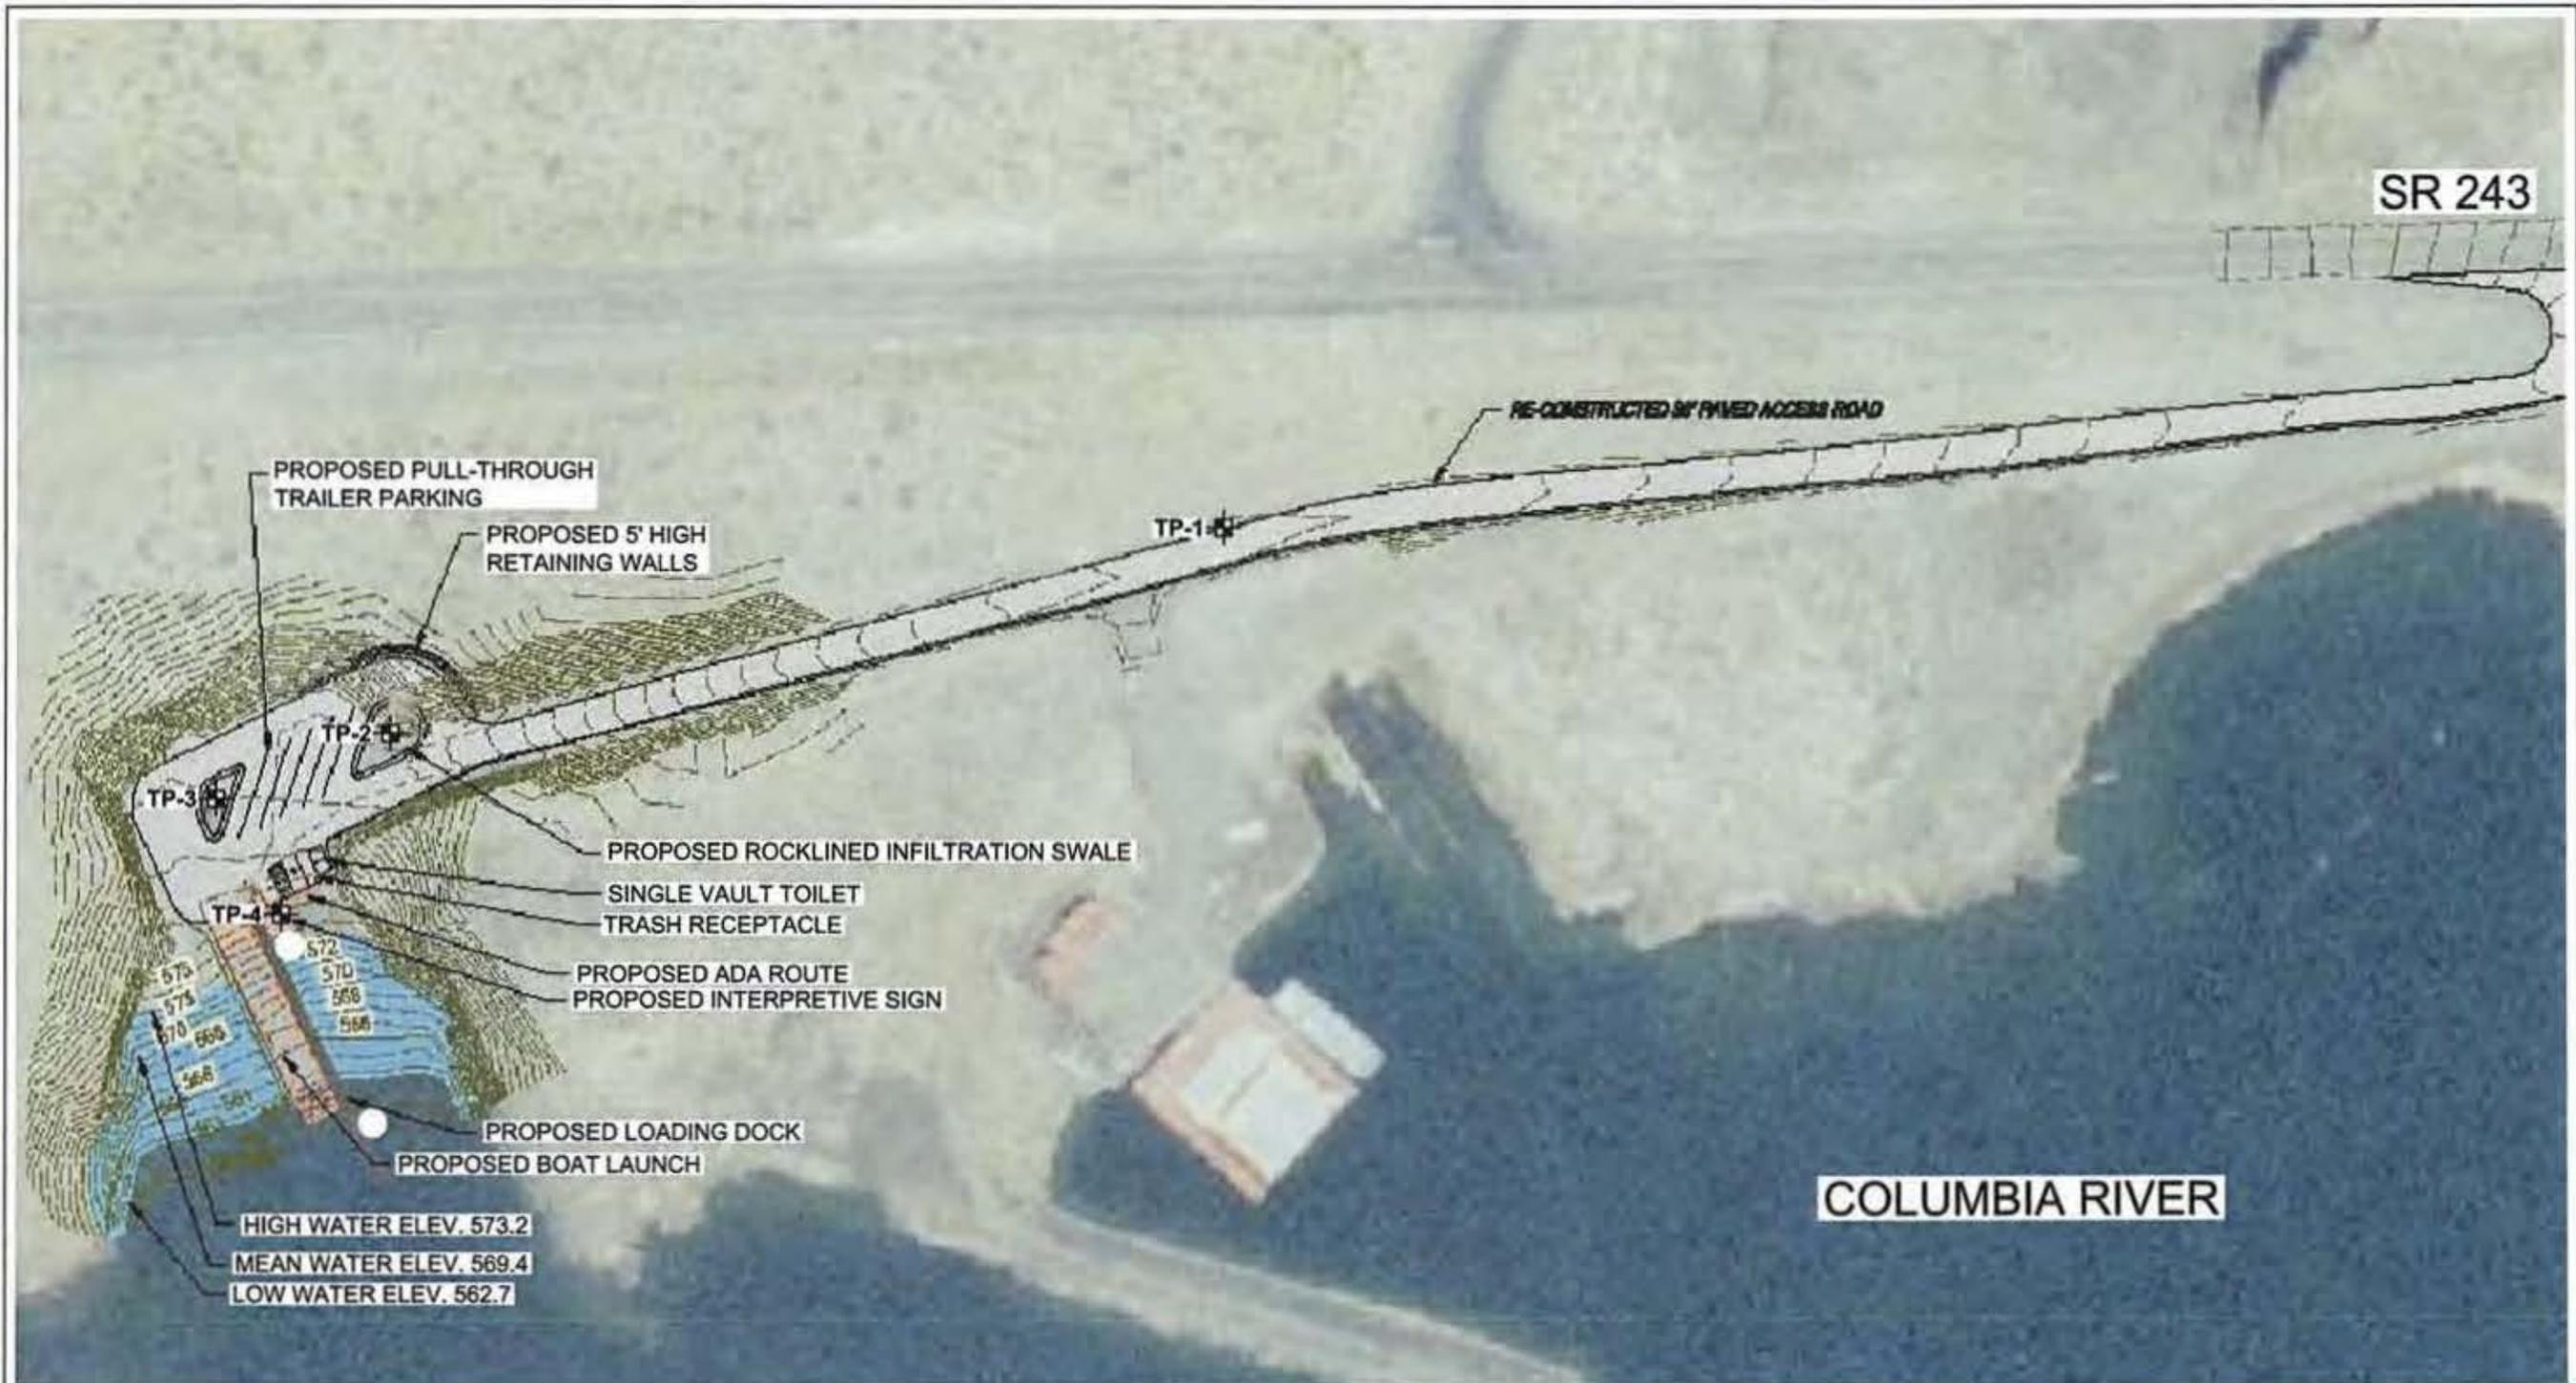
Figure 2

TP-1 [Symbol] Test Pit number and approximate location

Site Plan

2. The Level 1 analysis included an evaluation of the stratigraphy of the sediments within the boat launch area at 4 test pit locations (**Figure 2**). The sediments were evaluated in four locations, and consisted of fine to coarse sand and silt, gravel, and cobble. Basaltic bedrock was observed beneath the sand at one of the test pit locations (i.e., TP-2). Samples from three of the four locations were subjected to grain size analysis, and these analyses confirmed that the material was predominately fine to coarse sand (i.e., between 90 and 95 percent) with silt and occasionally gravel (**Table 2**).
