**Final
Hazardous, Toxic, and Radioactive Waste (HTRW)
Site Inspection Report
DERP-FUDS Site IO2PR006800
Former Lower Camp Debris Site
Culebra Island, Puerto Rico**

July 2012

Former Lower Camp Debris Site
Culebra Island, Puerto Rico

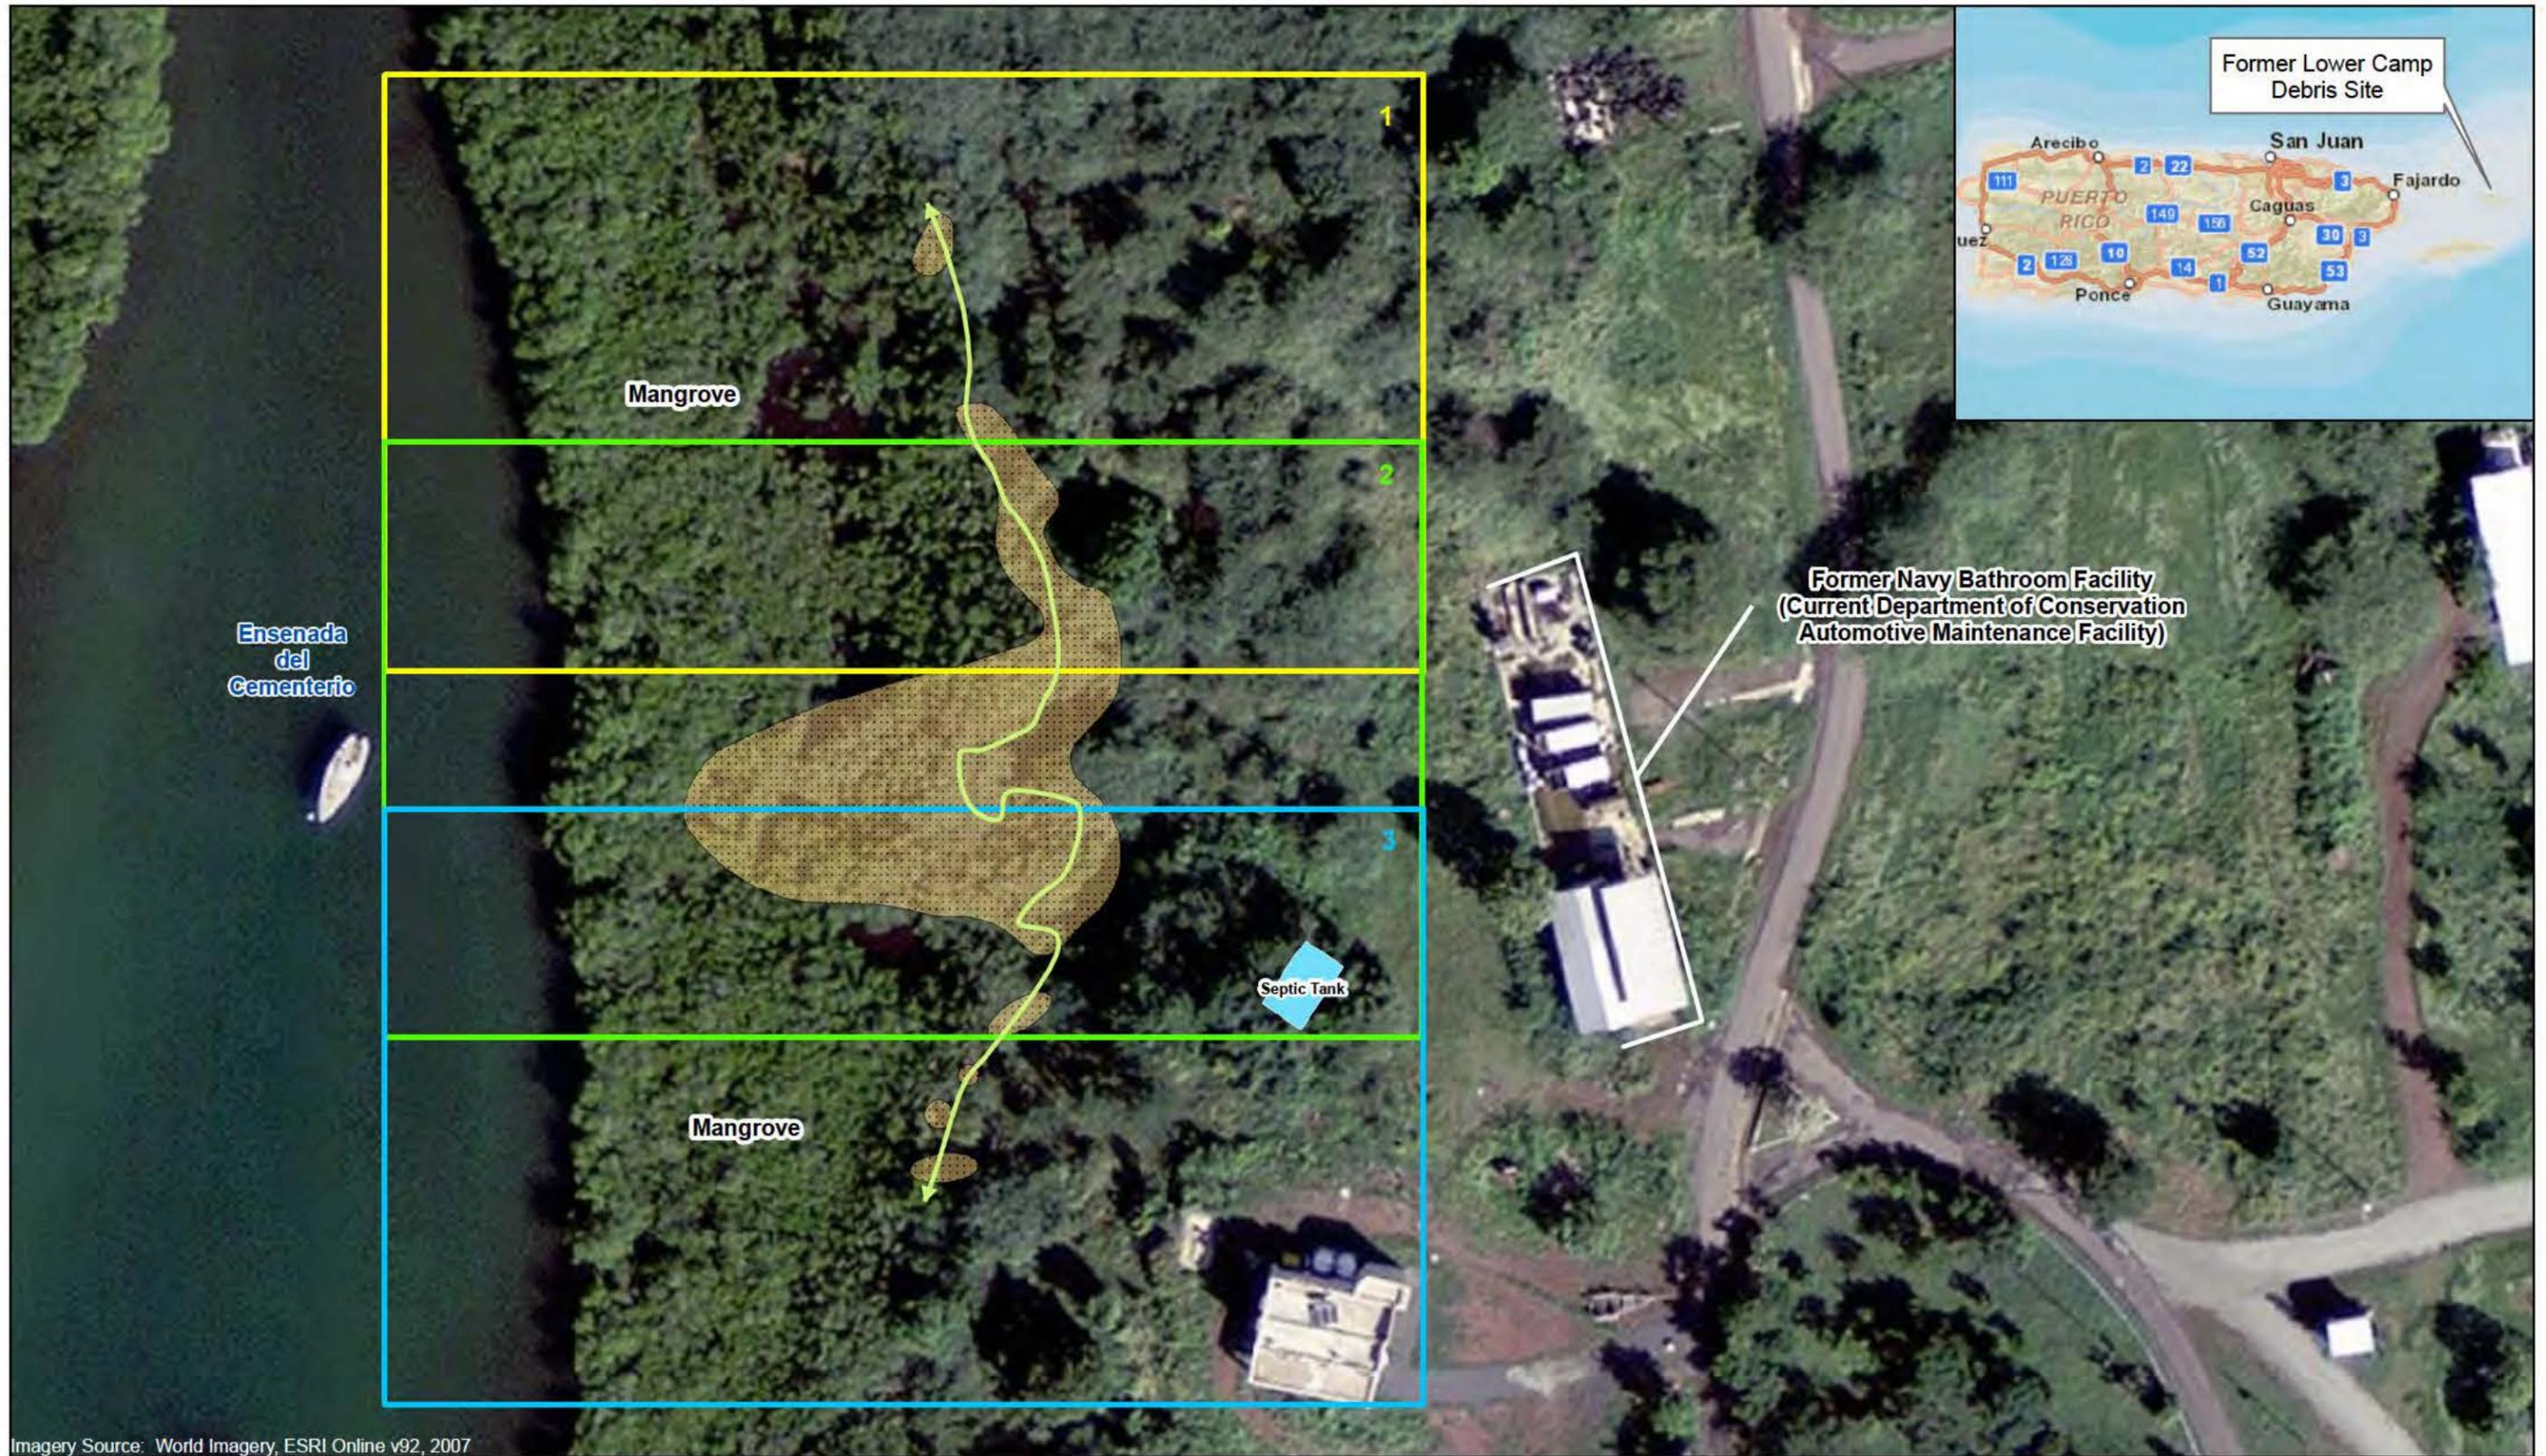
FIGURE 3-1
Site Inspection Location Map
 Former Lower Camp Debris Site
 Culebra, Puerto Rico

The estimated extent of debris is located in a total area of 15,070 ft² (0.35 acre), and extends a distance of 350 feet from the southernmost to the northernmost tip of the debris field (**Figure 3-1**). The widest point of the debris field is approximately 165 feet. The debris consisted of broken bottles, building materials (i.e., bricks both broken and whole and mortar), highly deteriorated oxidized metal (i.e., pipes, beams, rods/rebar, bolts, mattress springs, cables, water valves, and cans), rusted metal walkway sheets, rusted refrigerator type appliance, rusted corrugated metal sheets, concrete stormwater pipes, old vehicle engines, a battery, tires, axles, transmissions, body frames, and broken porcelain..

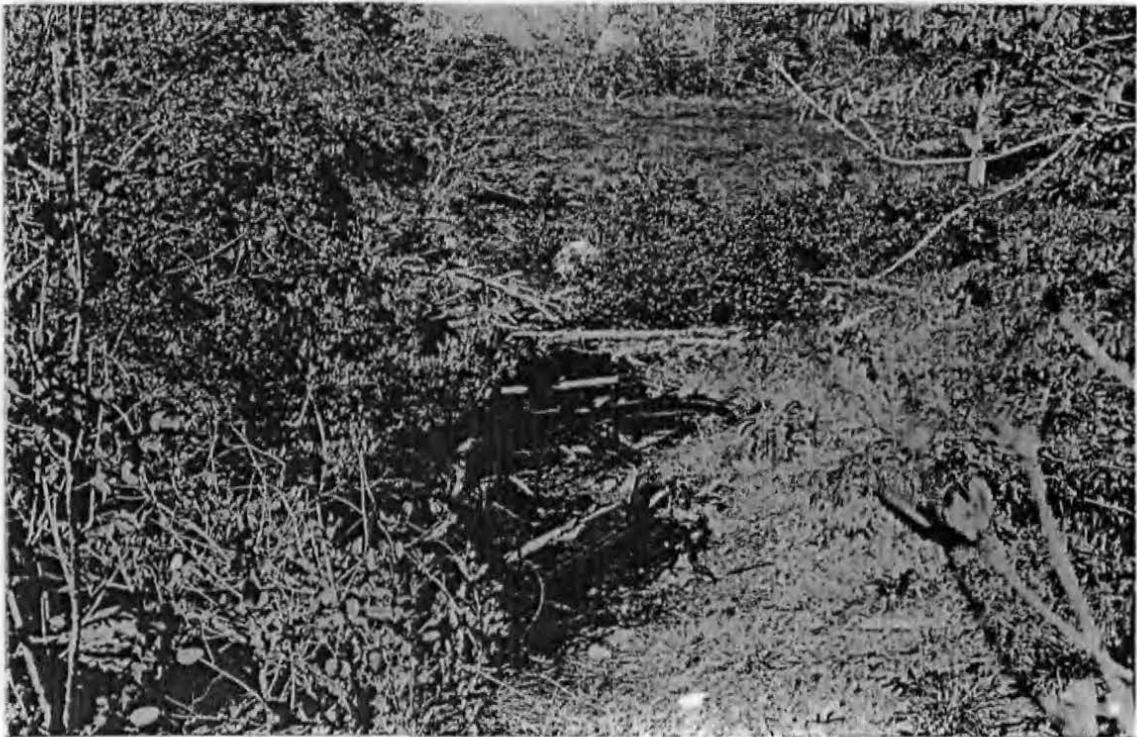
4. Culebra Island NWR (metal debris in wetland area)

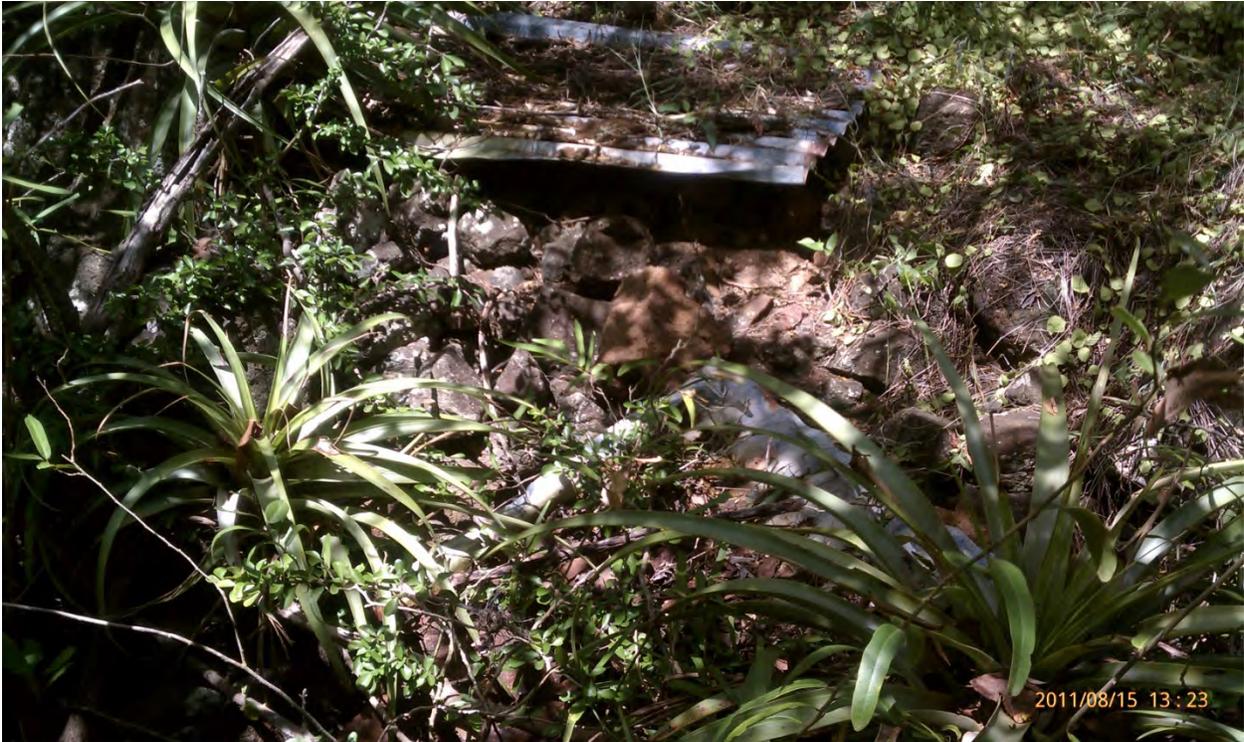
Photograph #45

Corrugated Sheet:

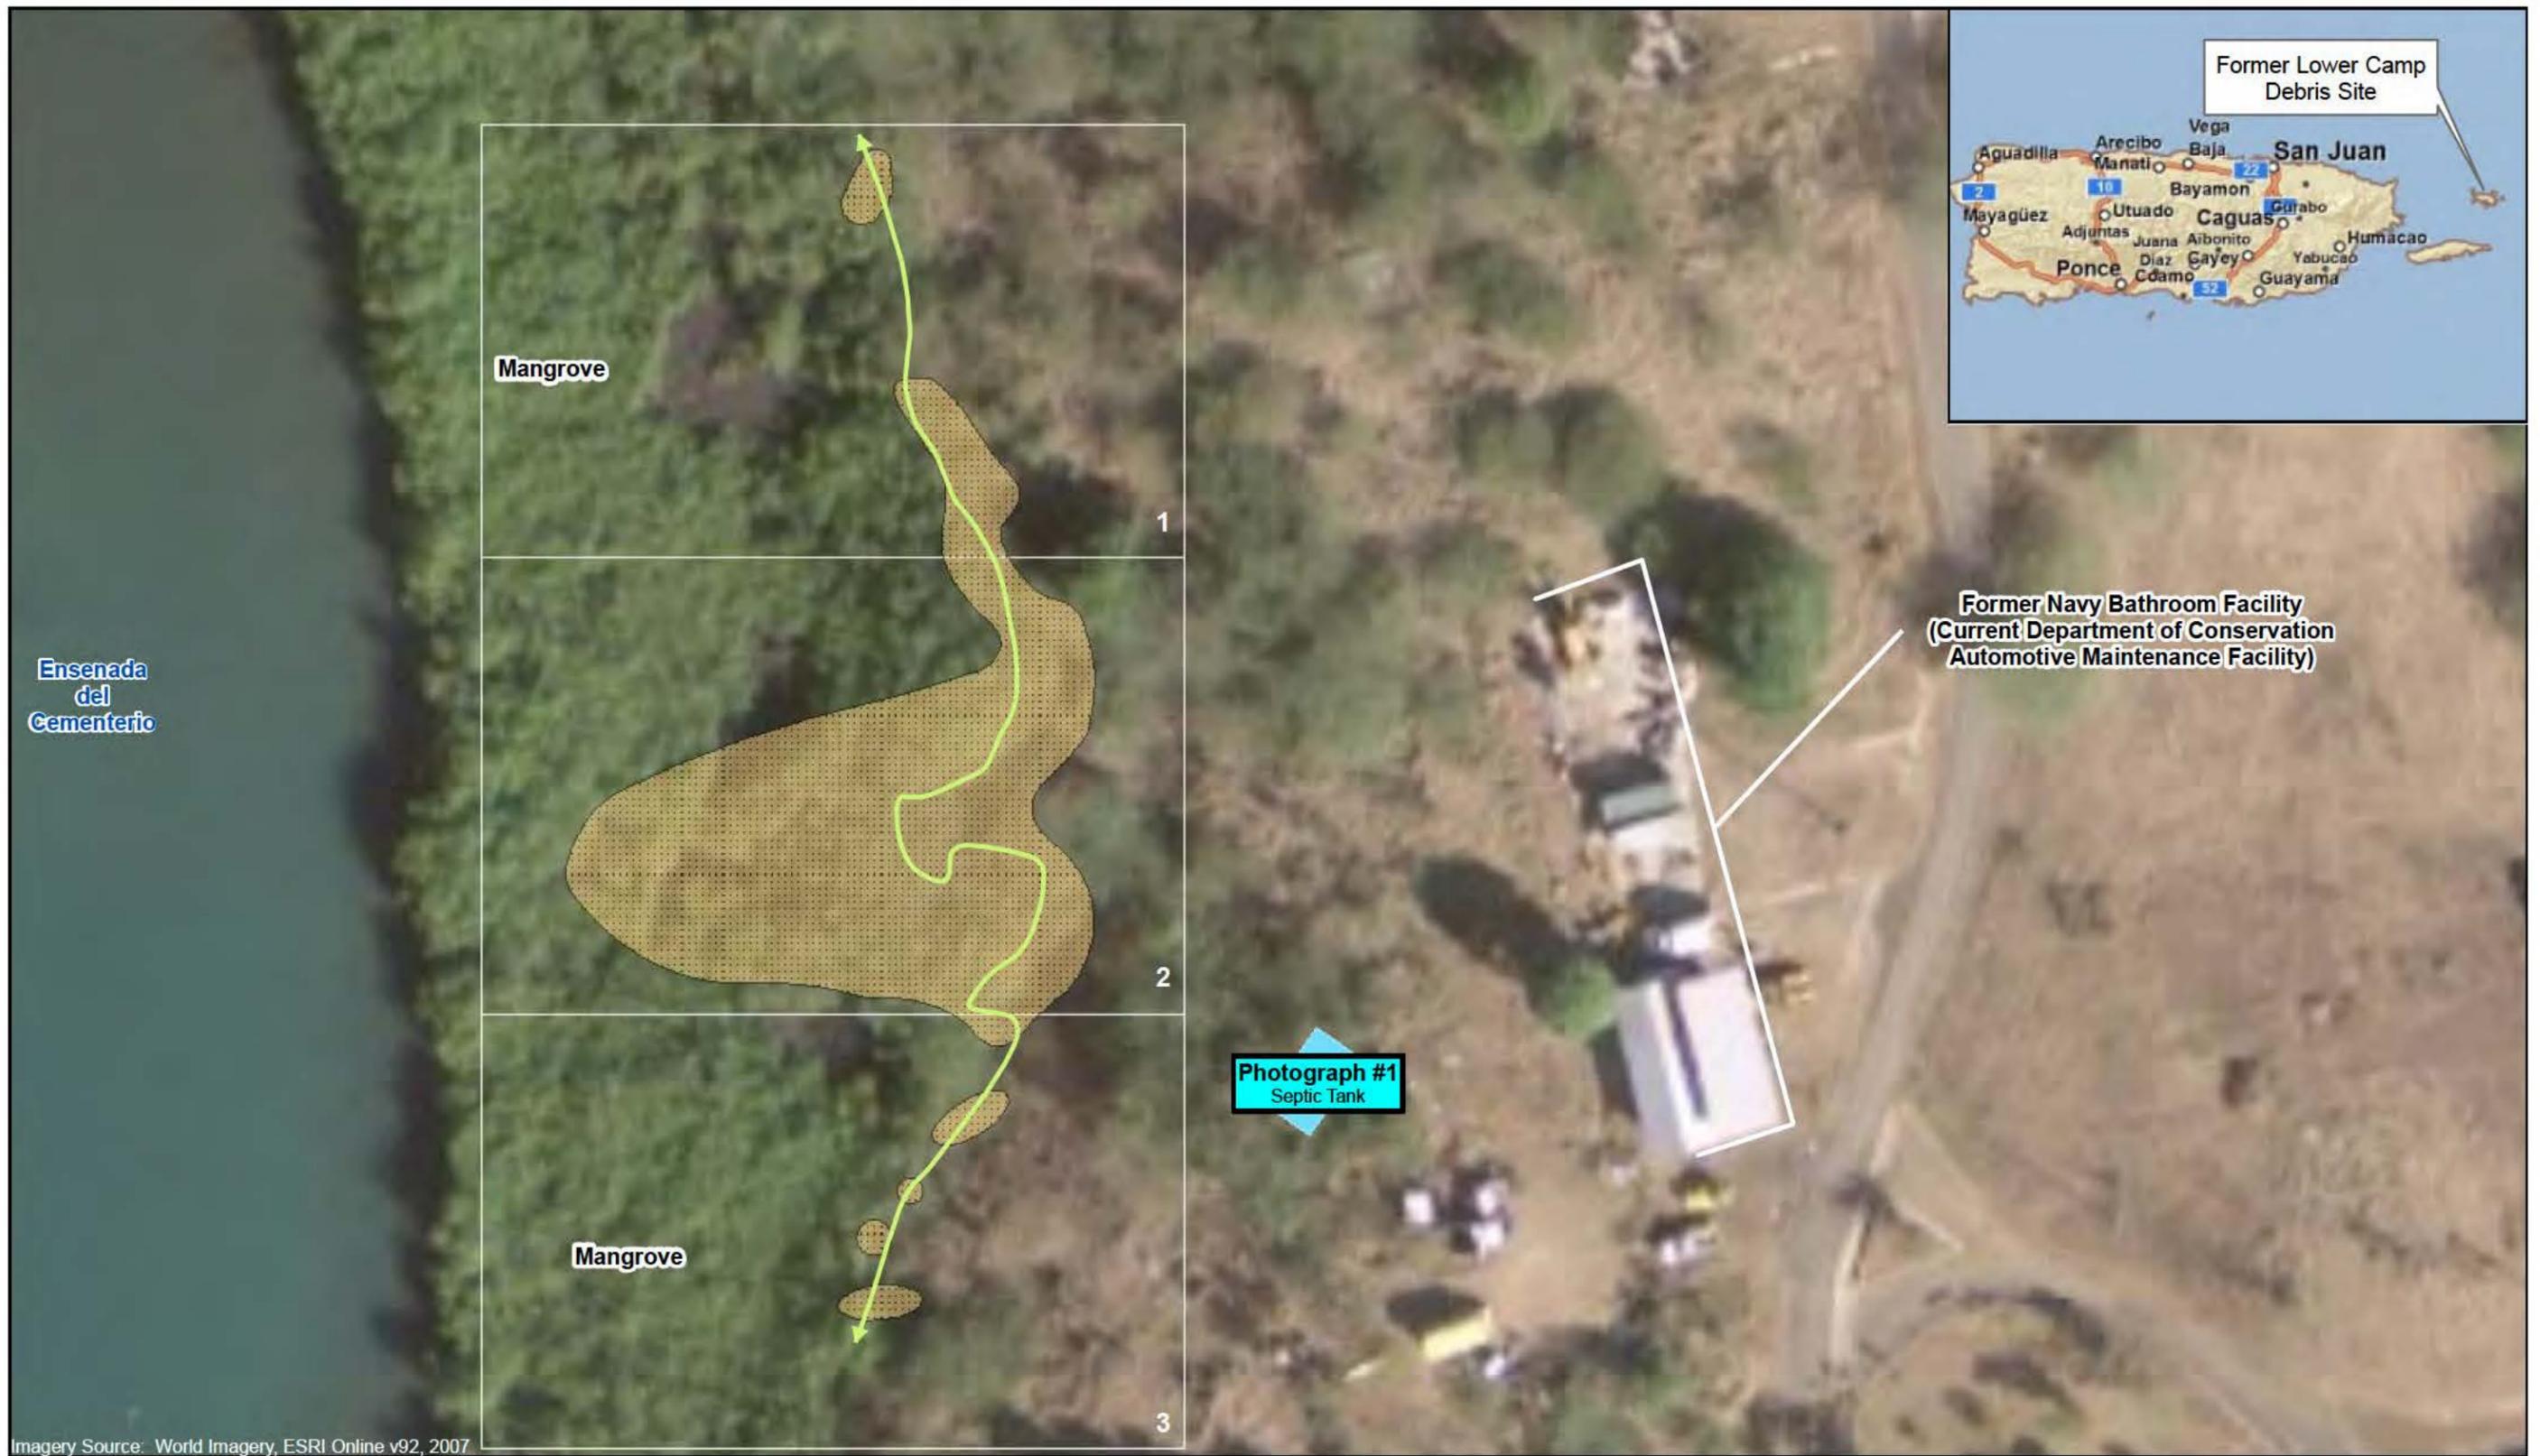
FIGURE 1
Site Inspection Location Map
 Former Lower Camp Debris Site
 Culebra, Puerto Rico

Locations of existing debris – ie; tires, rusted metal framing, glass bottles, etc. were confirmed visually and locations logged in with GPS coordinates by Bryan Burkingstock on site defining the limits of each debris pile discovered. The largest pile discovered was in the mangroves even with the north end of the former fueling station.
